# Pen y Cefn Water Treatment Works: **Dolgellau, Gwynedd**

## Archaeological Evaluation

GAT Project No. 2110

Report No. 866

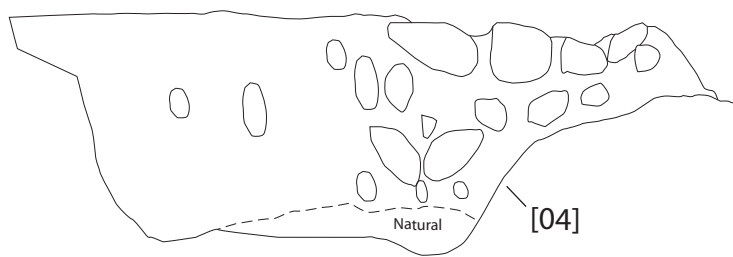
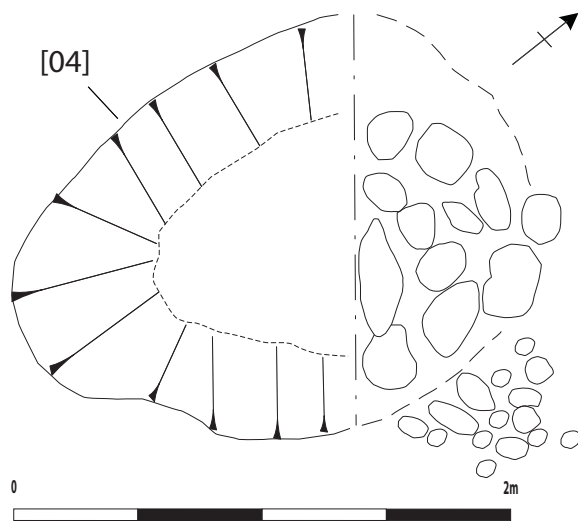
Fig. 4 Stone-filled pit (04) in trench 1

Between 0.4m and 0.5m of topsoil was excavated revealing clean orange-brown silt with patches of light grey very hard stony silt. One feature (004 Fig. 4), a concentration of stones, was visible. This extended beyond the southern side of the trench. A 4m x 2m extension to the trench was excavated in order to fully investigate the feature. It was half sectioned revealing a hollow with dimensions of 2.3m x 1.8m and a depth of 0.9m. The southern half and some of the lower part of the hollow was filled with silty loam similar to the topsoil. Overlying this on the northern side was a concentration of sub-rounded stones which extended into the lower part of the subsoil and appeared to have been plough-dragged to form a tail of stones to the north-west. No finds were recovered from the feature. There was little indication of the origin of the hollow; it was fairly regular suggesting that it was not a tree root bole. Possible interpretations are a large stone hole associated with field clearance or a deliberately dug pit of unknown date and function. The fills suggest that it was either partly backfilled or partly filled by eroded soil and then filled with stones. The stones are typical of the larger stones in the topsoil and it seems likely that this is a feature created during field improvement.
