Land at Tan y Coed: **Beaumaris, Anglesey**

Archaeological Assessment

GAT Project No. 2103

Report No. 838

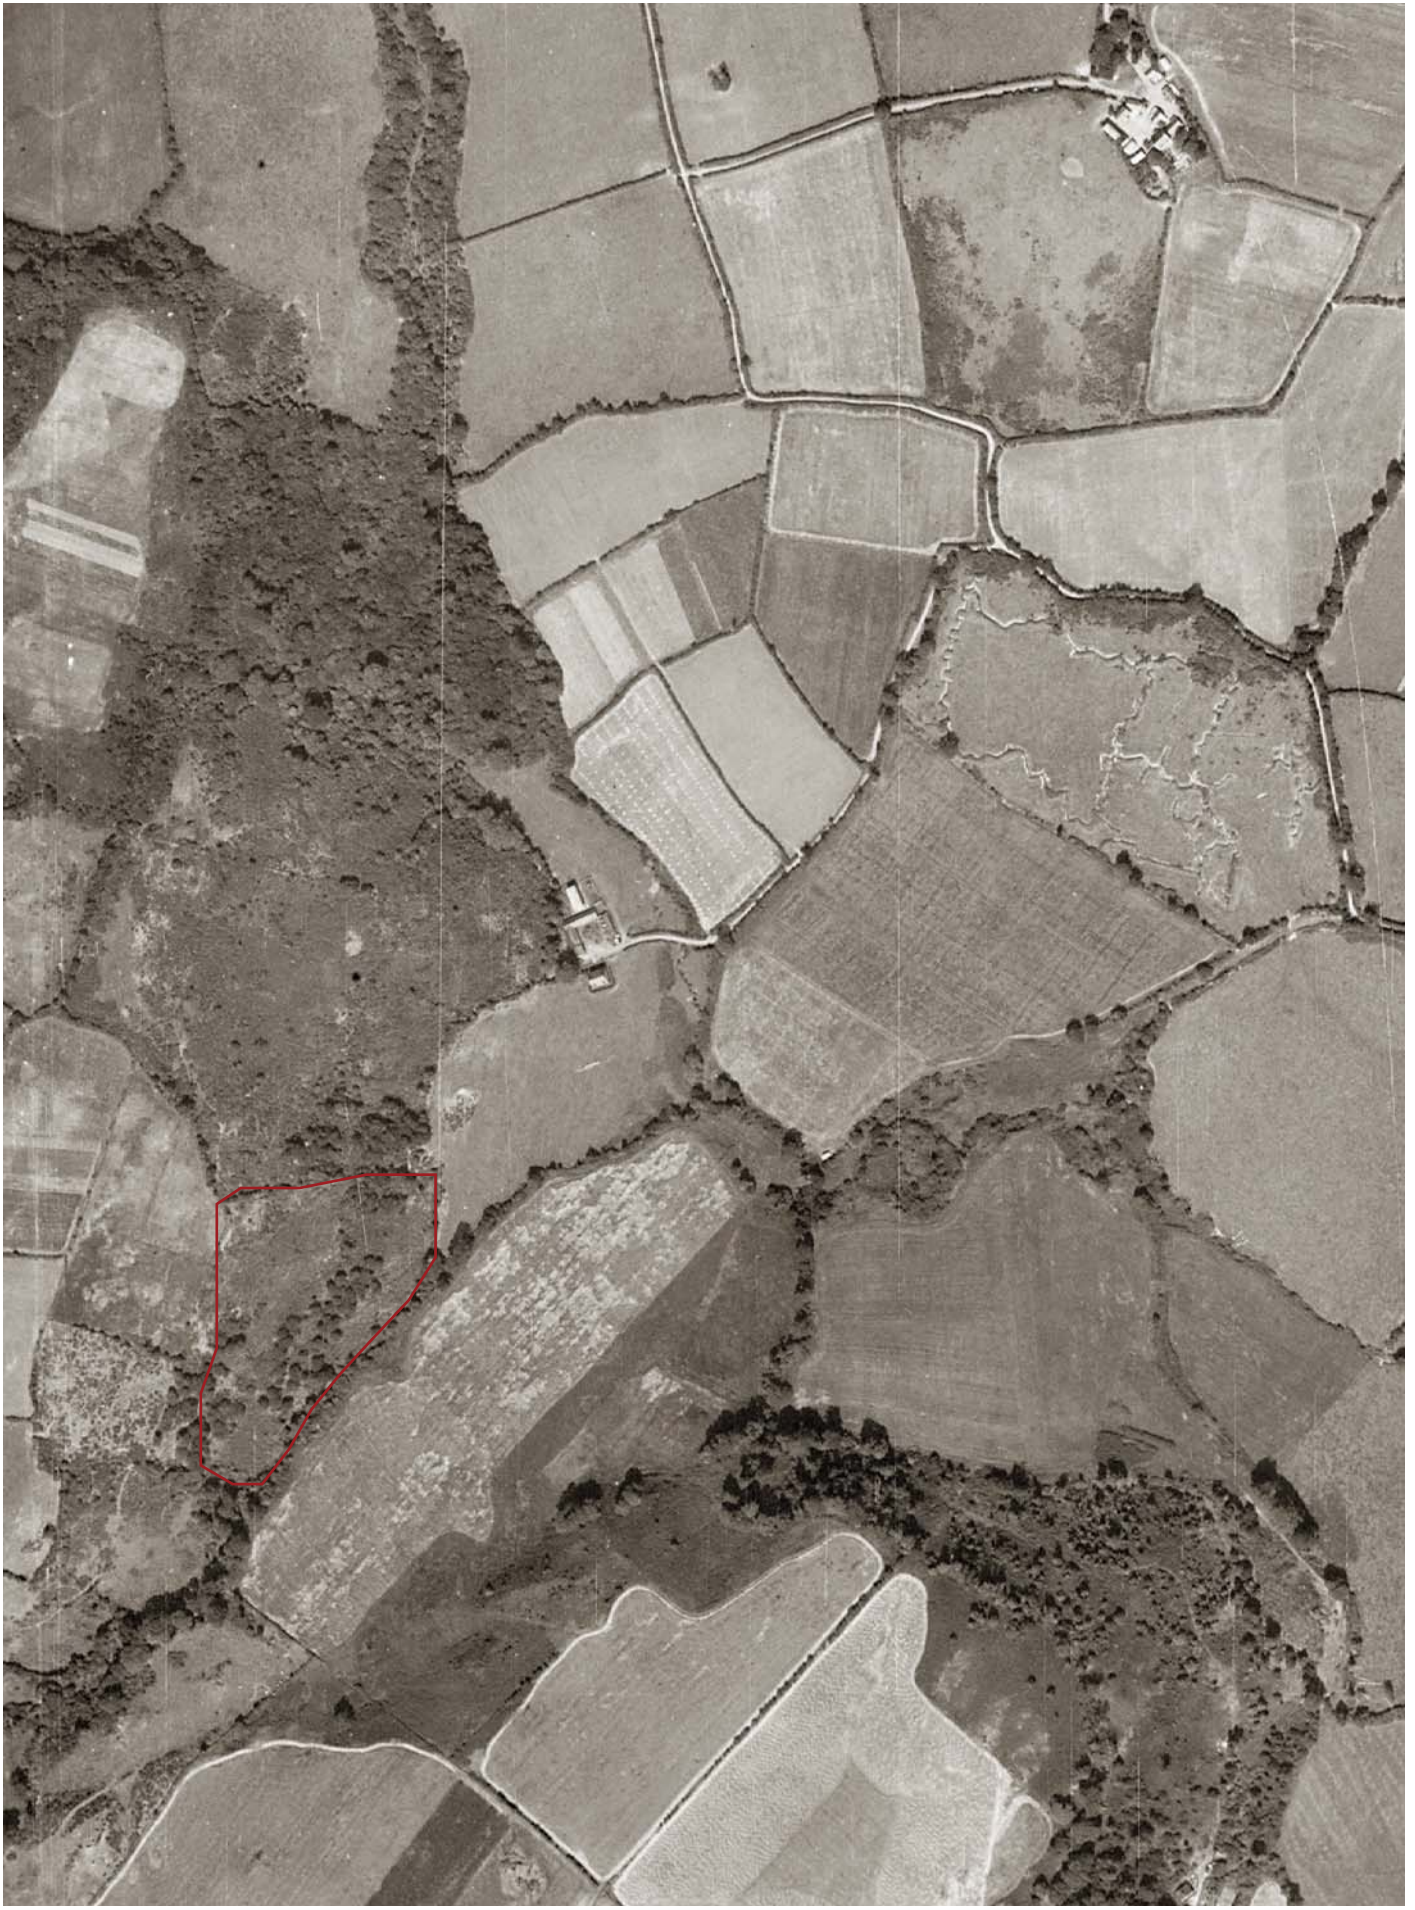
Fig. 9 Extract from RAF aerial photograph 106G/UK655 frame 3042 showing open trenches in the foreground (Feature 3) and Feature 1 outlined in red

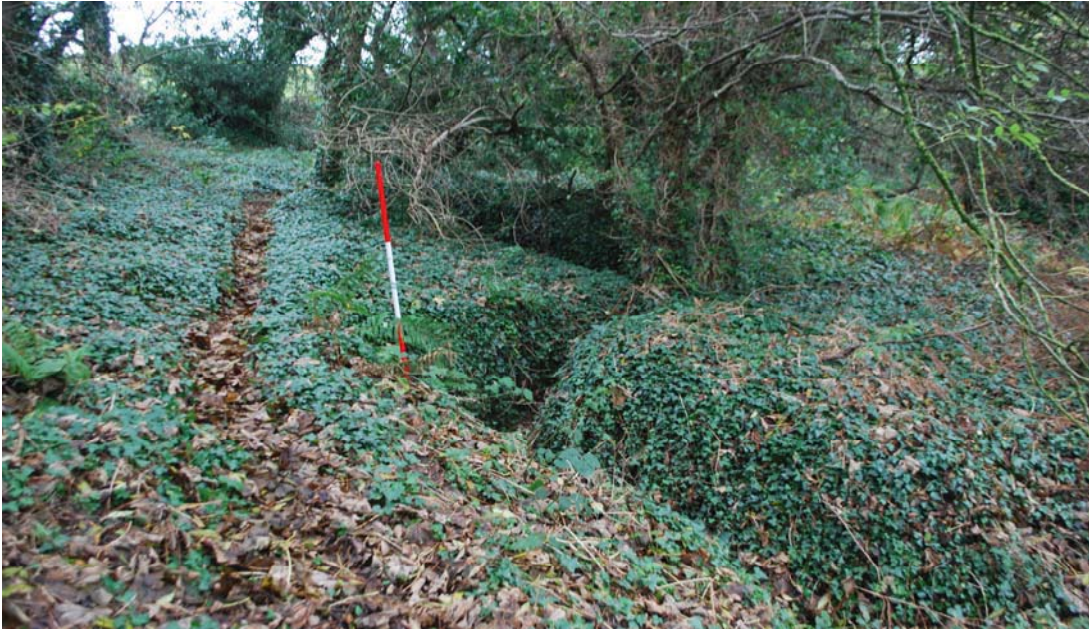
To the west of Tan y Coed a remarkably complete set of practice trenches associated with this camp were dug (Plate 1). These seem to consist of a front line, or 'fire trench' down slope and service and zig-zag access or communication trenches running up slope behind it towards a support trench, linking both to a rear or reserve line. These trenches formed part of a trench training system used nationally and designed by Colonel Corry in 1915, based on his experiences in the Boer War and the Western Front in 1914 (Dawson 2007, 179), being an improvement on the methods recommended in the British General Staff Manual (Solano 1914). It is not thought likely that offensive and defensive military tactics were taught at Tan y Coed (Parry *pers. Comm.*). Other surviving examples are located at Penally in Pembrokeshire and Bodelwyddan in Flintshire (Driver 2007, 260-261). The practice trenches provided low-cost training to the million volunteers and later conscripts who served in the British Army. They were also seen as a propaganda tool, showing the level of preparedness of the army (Brown 2004). There must have been a certain amount of woodland clearance of the area to enable this work to be carried out, and the 1945 aerial photograph (Fig. 9) shows the woodland to be less dense than it is today. The area has since regenerated considerably and a significant amount of archaeology is probably obscured with scrubland. It was not unusual for practice trenches to be dug in woodland, at Pullingshill Wood, Marlow a considerable amount of tree felling was carried out in advance of entrenchment construction (Dawson 2007, 183-184).

Plate 1 First World War Access trench (Feature 1), looking towards the front line.

Recommendations for mitigatory measures: Avoidance

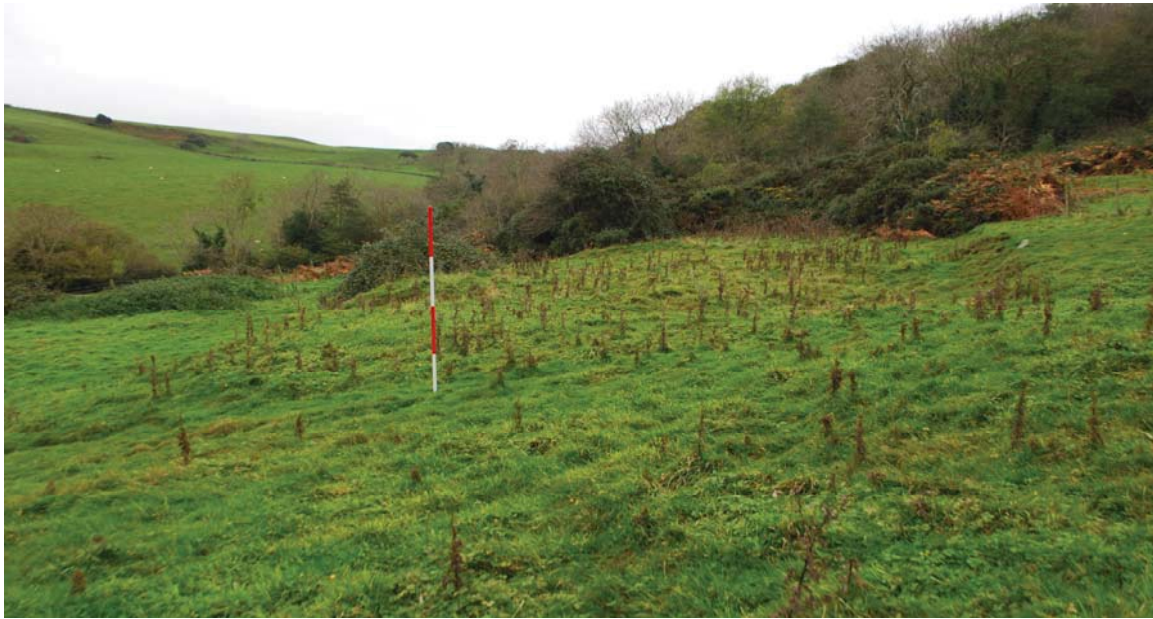
Plate 3 Rising ground to the north-east of Tan y Coed, showing possible evidence of terracing, or strip lynchets agriculture (Feature 2).

Recommendations for mitigatory measures: Avoidance

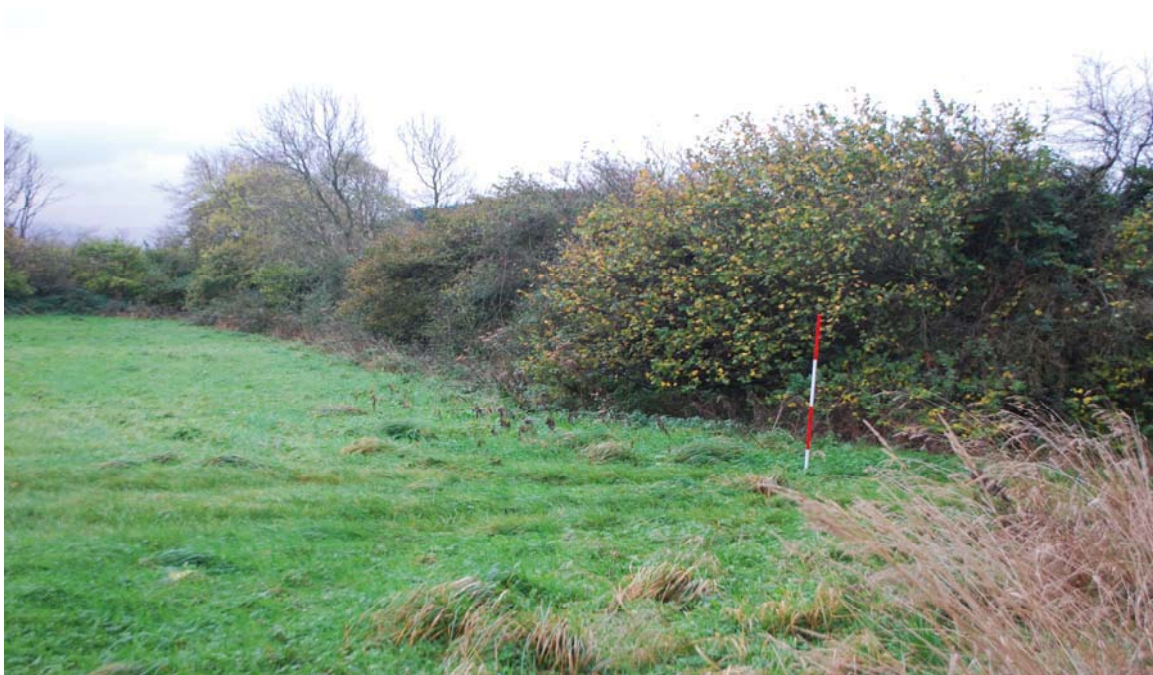
Plate 4 19th century hedgerow containing hawthorn, bilberry and sloe.

No hedgerows or field boundaries of pre 19th century date were definitely identified, and it would appear that the surviving examples date largely from agricultural improvements carried out between 1840 and 1889. However these are characteristic of the predominantly agricultural landscape and it is recommended that they be retained where possible.
