# Abbey Lodge, Llys Helyg Drive: **LLANDUDNO**

## Archaeological Evaluation and Building Recording

GAT Project No. 2140

Report No. 883

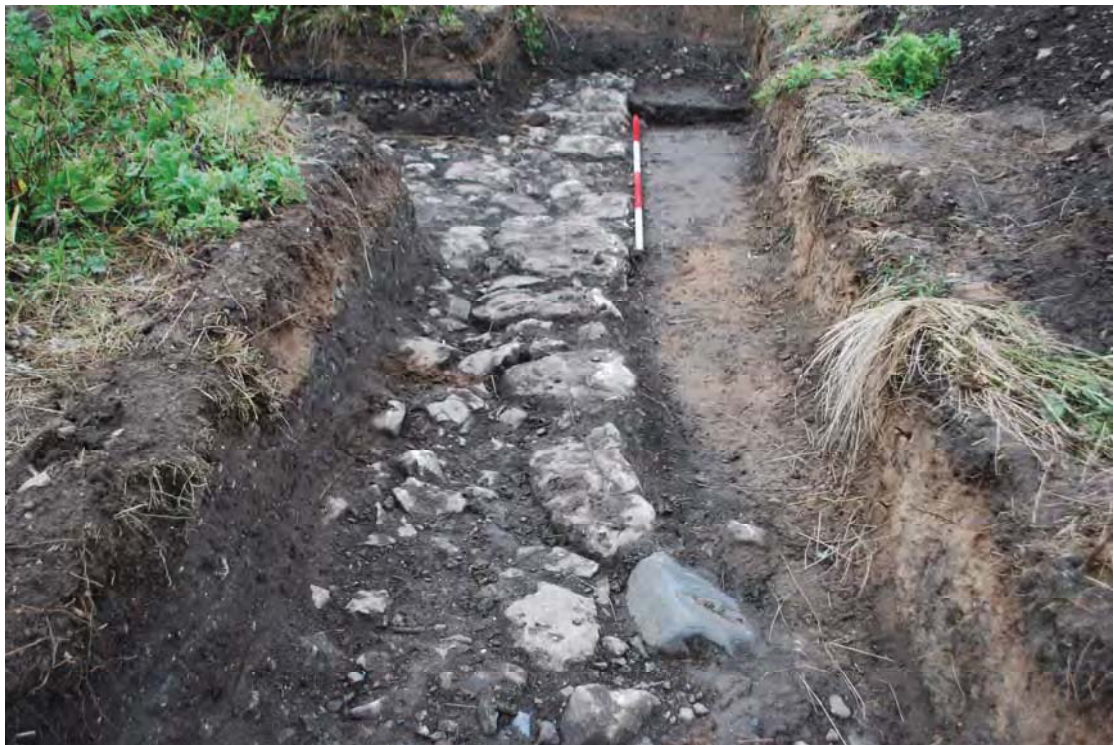
**Plate 2** Trench 1. View of wall foundations (105) from the south west

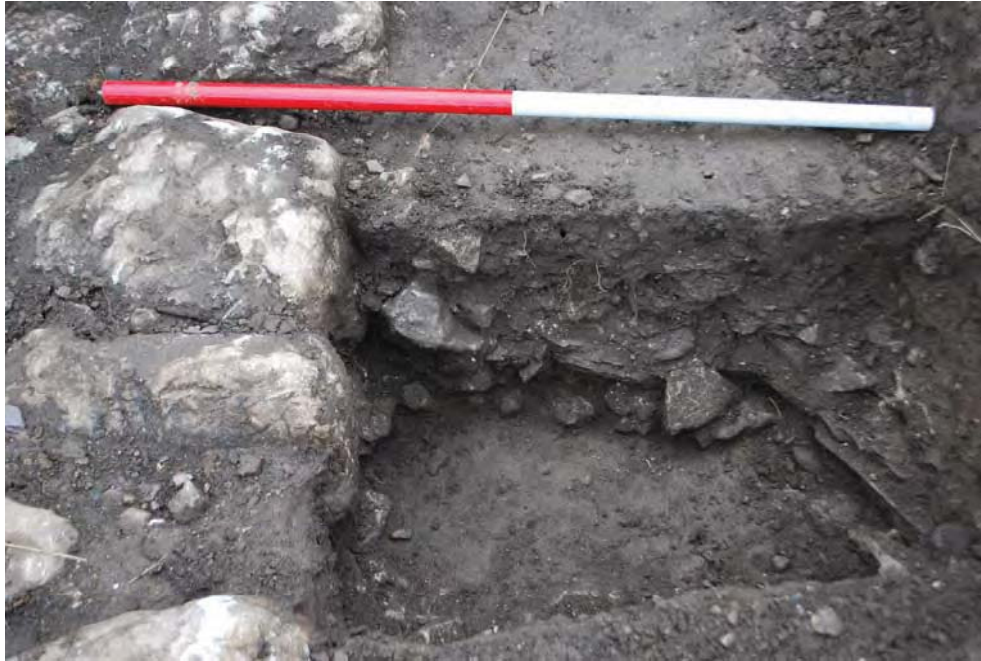
**Plate 3** Trench 1. Sondage showing demolition rubble (106) adjacent to wall (105)

0.6m, and a substantial quantity of roofing slates. To the north-east of the wall foundations the rubble layer was found to overlie the colluvial silt (106) (Plate 3).

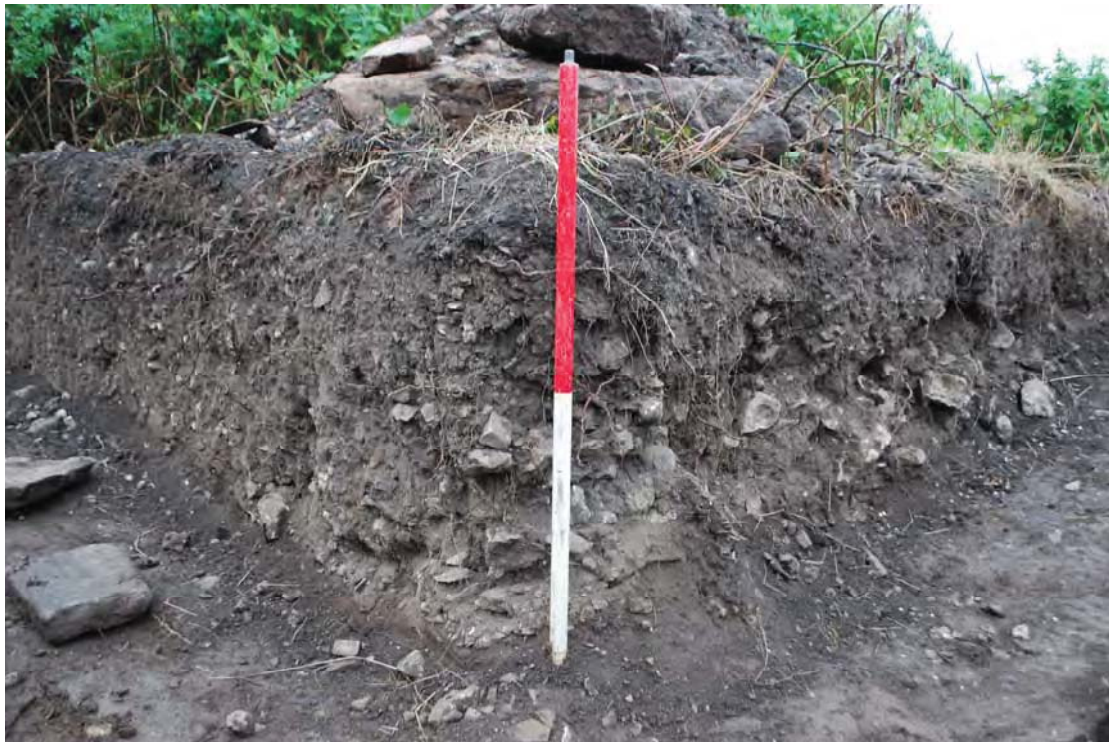
**Plate 4** Section at junction of Trenches 1a and 2, showing demolition rubble (104)

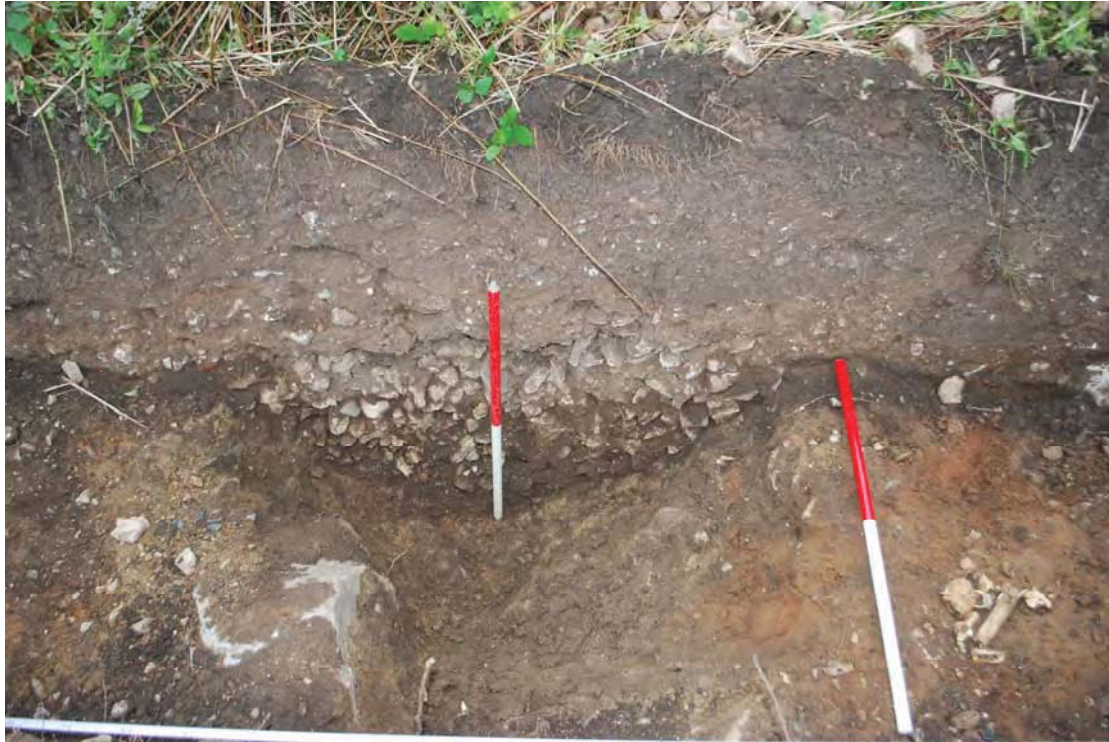
**Plate 7** Detail of pit [305] in Trench 3, showing the toney fill (306) in section. Scales 2 x 1m

turn overlay a natural glacial orangey buff stone sand and gravel (304), with the colluvial deposit not being encountered. Two features were noted cut into the glacial soil [305] and [308]. Pit [305] was 1.5m wide and 0.6m deep and was wider than the trench on both sides, and therefore could be a large pit or possibly ditch (Plate 7). It had irregular sides, with a large natural stone present on the south edge. The fine silt and stony fill of this (306) contained a significant quantity of animal bone, within a very high proportion of stones 80%. A shallow pit [308], 0.8m across and up to 0.2m deep had a very fine grey silt fill (309) containing limpet shells and small mammal bones.

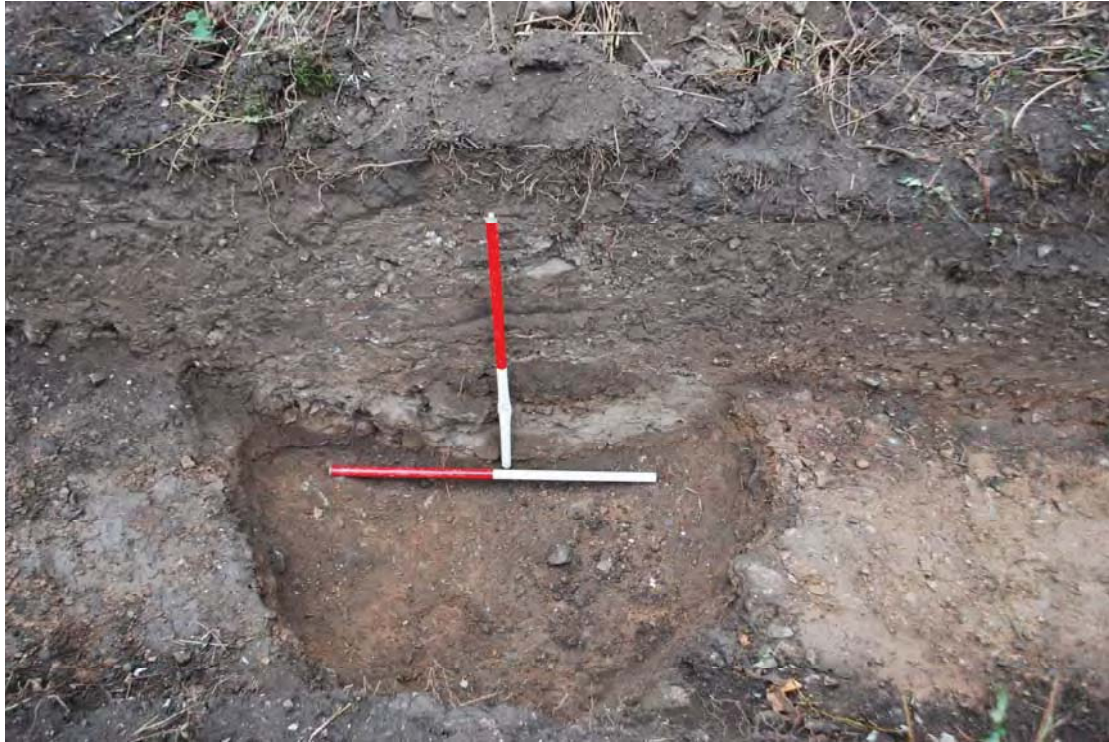
**Plate 9** Detail of pit [406] in Trench 4 from the north. Scales 2 x 1m

Below an overburden containing a number of layers of build-up deposit, two pits [406] and [408] were cut into the glacial deposits, which are of uncertain date, as no deposits were found within them. They clearly represent evidence of past human activity, but cannot be directly related to the probable medieval activity and later noted in Trenches 1 and 1a. They possibly may be contemporary with the pits found in Trench 3, owing to their similar character, but this cannot be proved at the present time.

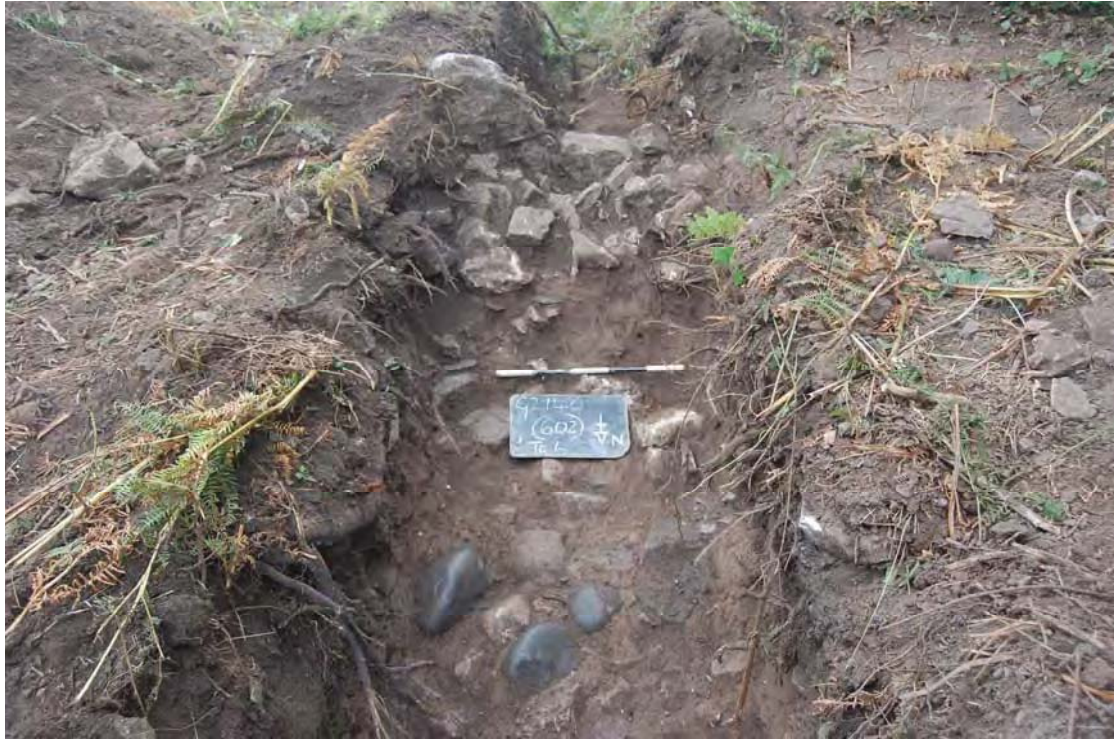
**Plate 11** Trench 6 from the south, showing wall (602)

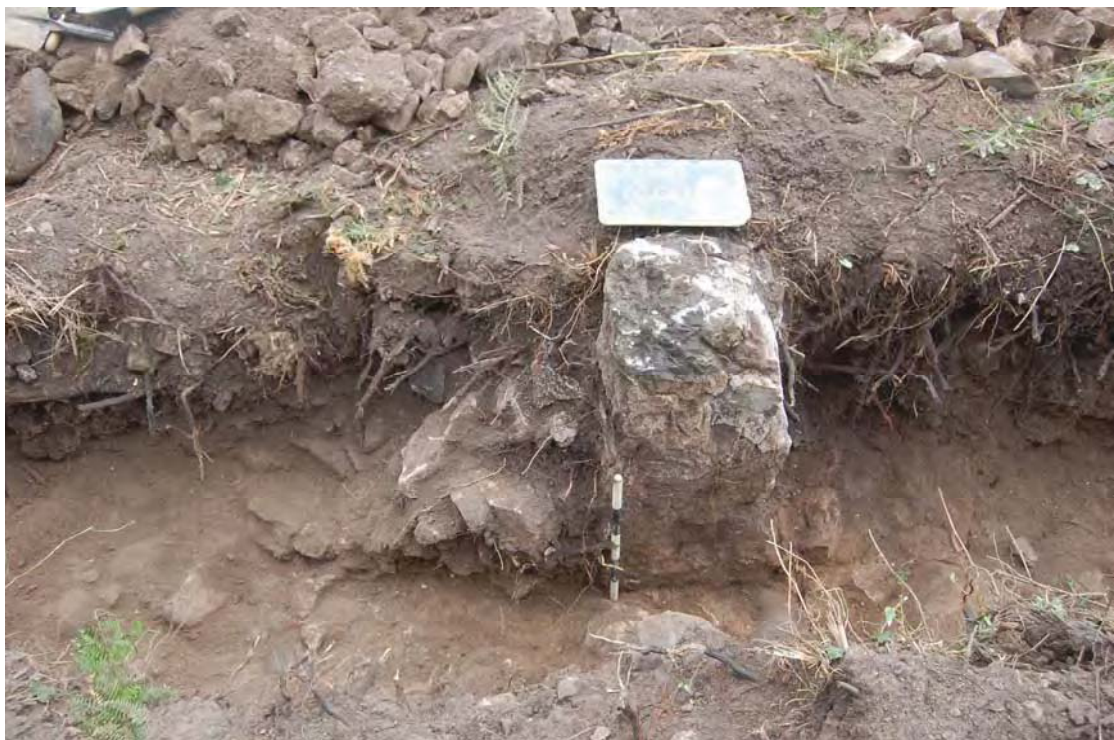
**Plate 12** Trench 6 from the west, showing stone (603) within wall (602) during excavation. Scale 50cm

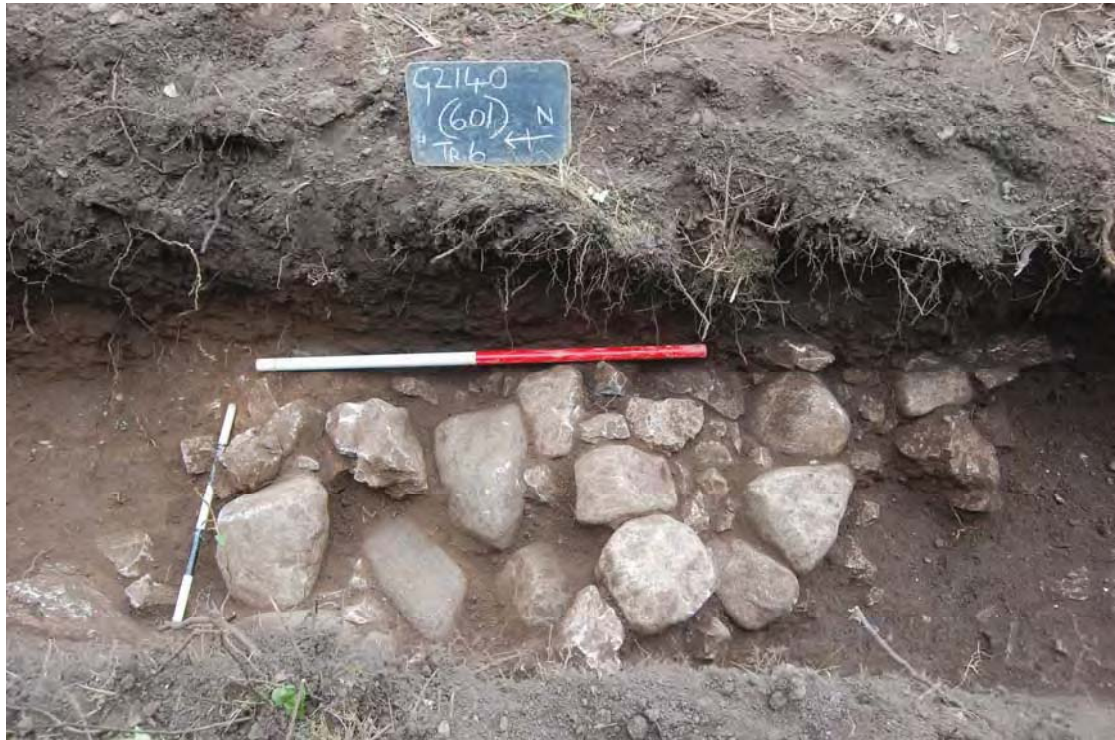
**Plate 13** Trench 6 from the west showing stone spread (601). Scales 1m and 50cm

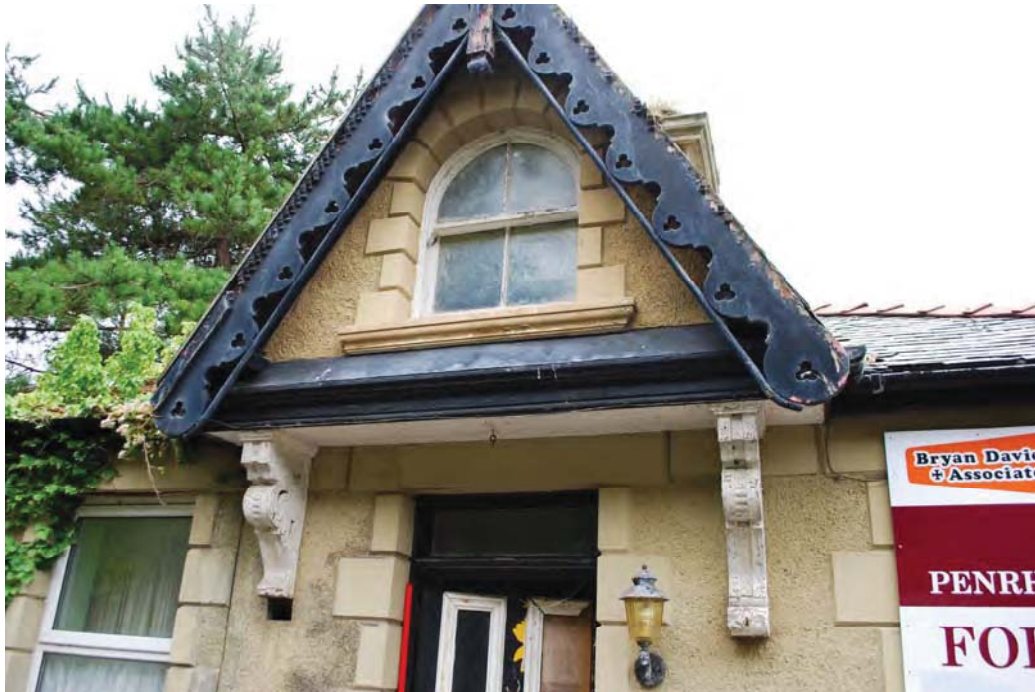
Plate 16 The pediment over the front door

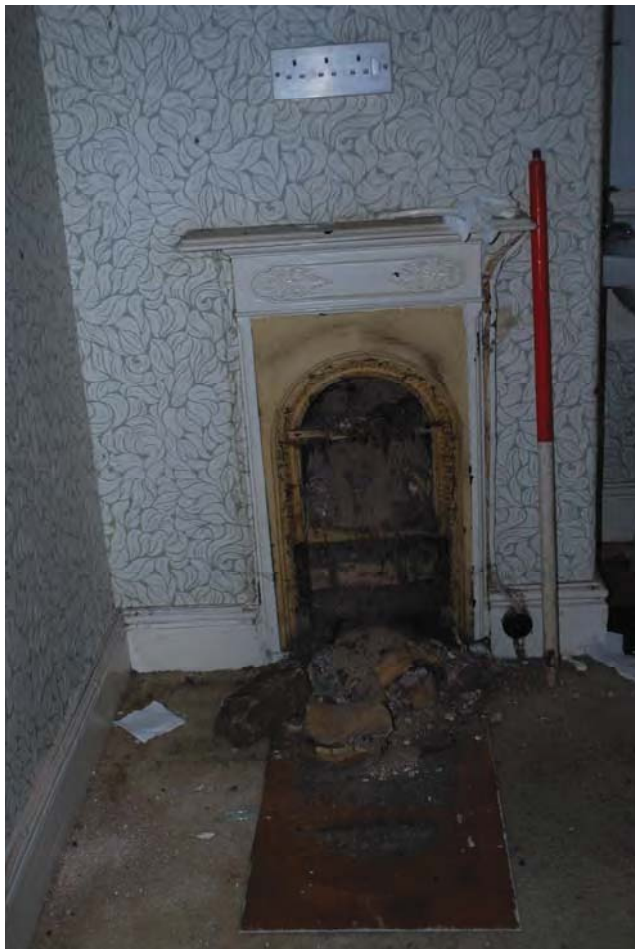
**Plate 18** 19<sup>th</sup> century fireplace in Room 2

This room is probably best interpreted as the front parlour. It has dimensions of 3.7m by 3.2m and has a height of 2.8m. An original late 19<sup>th</sup> century fireplace survived to the rear of the main fireplace noted in room 1 (Plate 18). A modern sink unit has been added between the fireplace and the panelled door, otherwise no architectural details noted, except some surviving coat hooks to the right of the doorway.

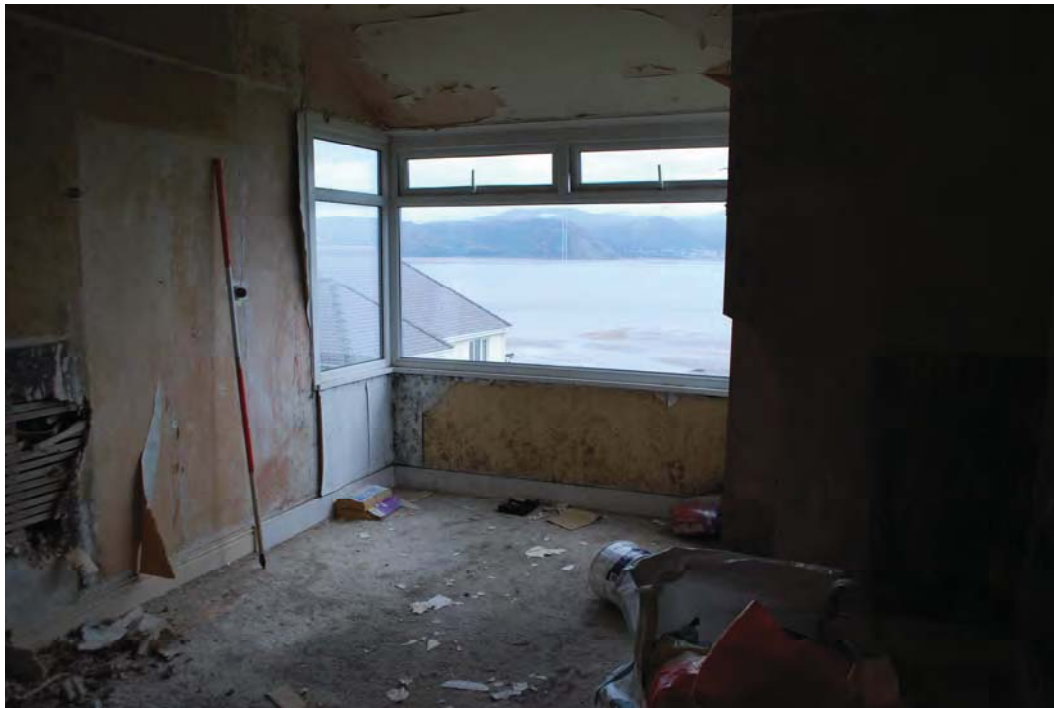
**Plate 20** Bay window in Room 3. Scale 2m

This room to the rear of the building was entered by a panelled door from the hallway (Room 1). The dimensions of the room were 4.5m by 4m with a height of 2.8m. A modern bay window was added to the building to the south, of double-glazed uPVC construction. Damage to the internal non load-bearing walls showed them to have been of post and lath construction (plate 20). No other features of note were observed.

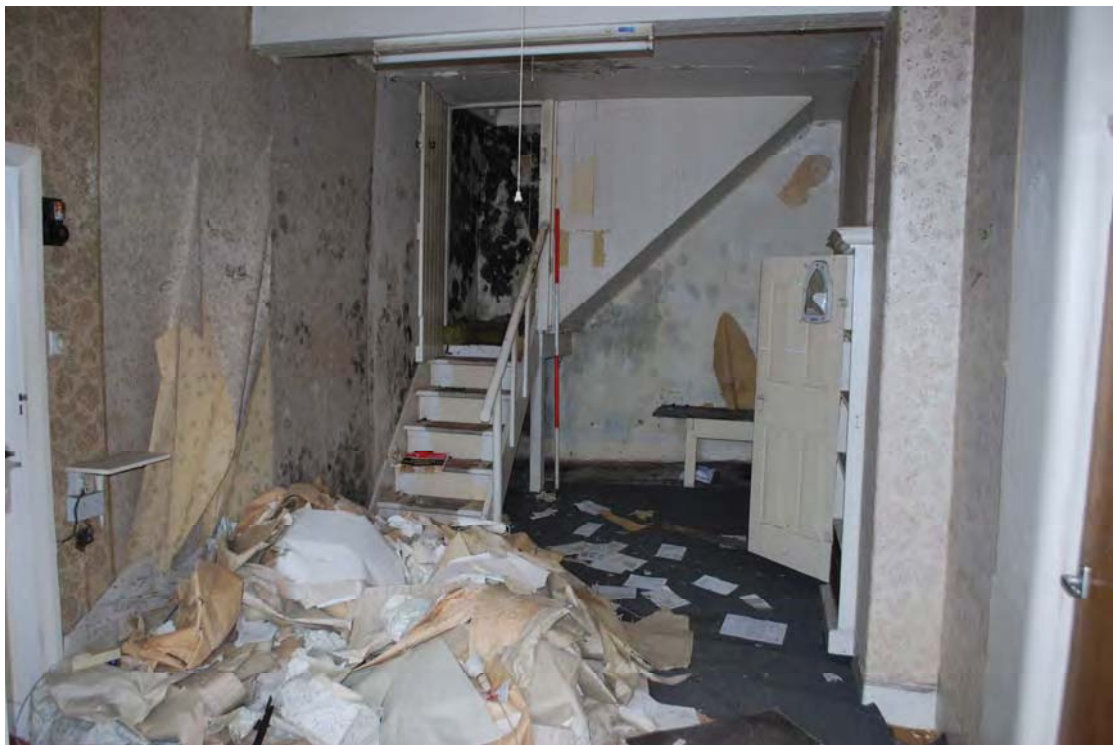
**Plate 22** Room 5 showing late 19<sup>th</sup> century stair and cupboard

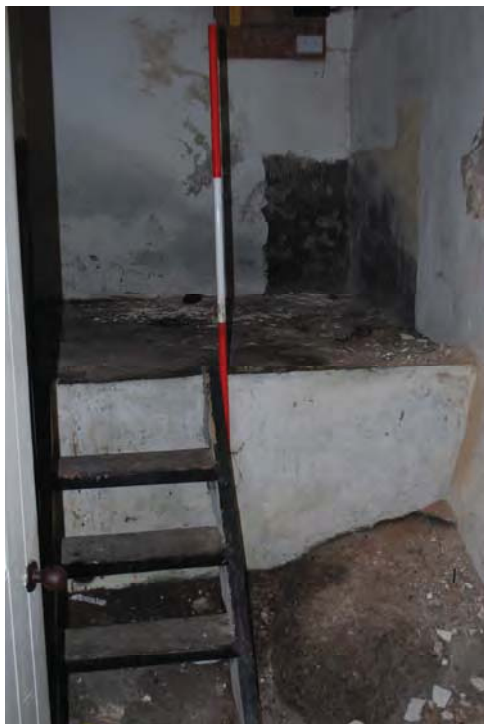
**Plate 24** Cellar Room 6. Scale 2m

Room 6, 4m by 2.6m and 2.8m high was accessed by a modern softwood doorway on the western side of the room, and ascends 0.8m by way of a large step (Plate 24). A wooden tongue and grooved partition divided it from the bathroom (room 7) and a cupboard (room 8) to the south. The room formed a kind of cellar, and a coal-hole was noted on the north wall. A substantial internal buttress wall was also set against the eastern side of the room. This arrangement appears required due to building over the original bedrock, which was built upon bedrock. There were no light openings, and the room is believed to have functioned as a form of cellar.

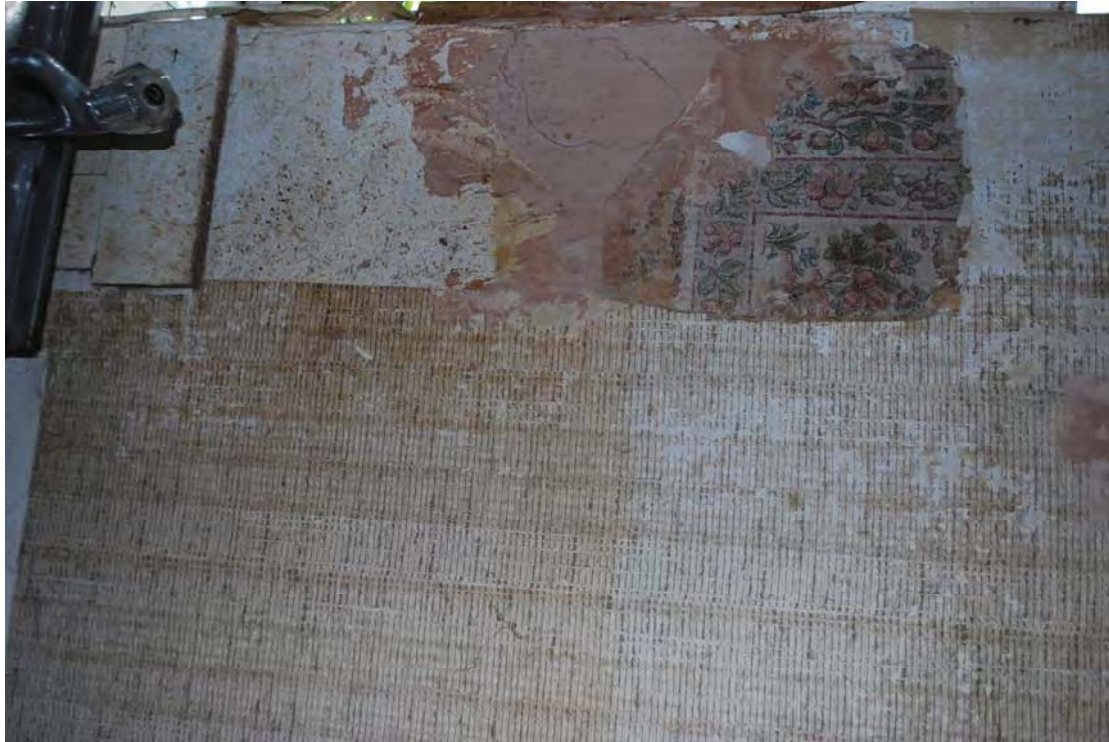
**Plate 29** Evidence of early decorative wallpapering scheme in room 1

Some light fittings made of bakelite were noted, which may have dated from before the Second World War. Some early internal wallpapering (Plate 29) and painted wall surfaces (Plate 30) were also noted, which may form part of the initial decorative scheme of the building.

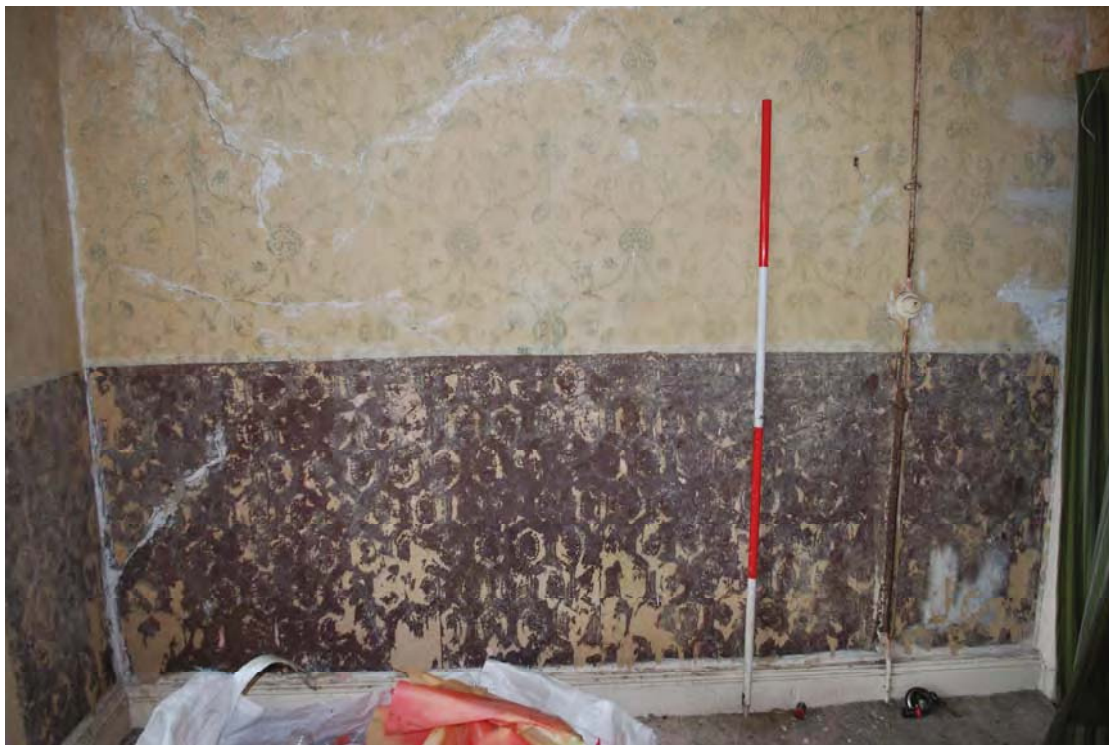
**Plate 30** Surviving early paint scheme in room 4. Scale 2m
