Cae`r Eglwys, Llanengan. Water Mains Renewal Sceme: Ground Investigation Programme

Archaeological Watching Brief

GAT Project No. 2146

Report No. 881

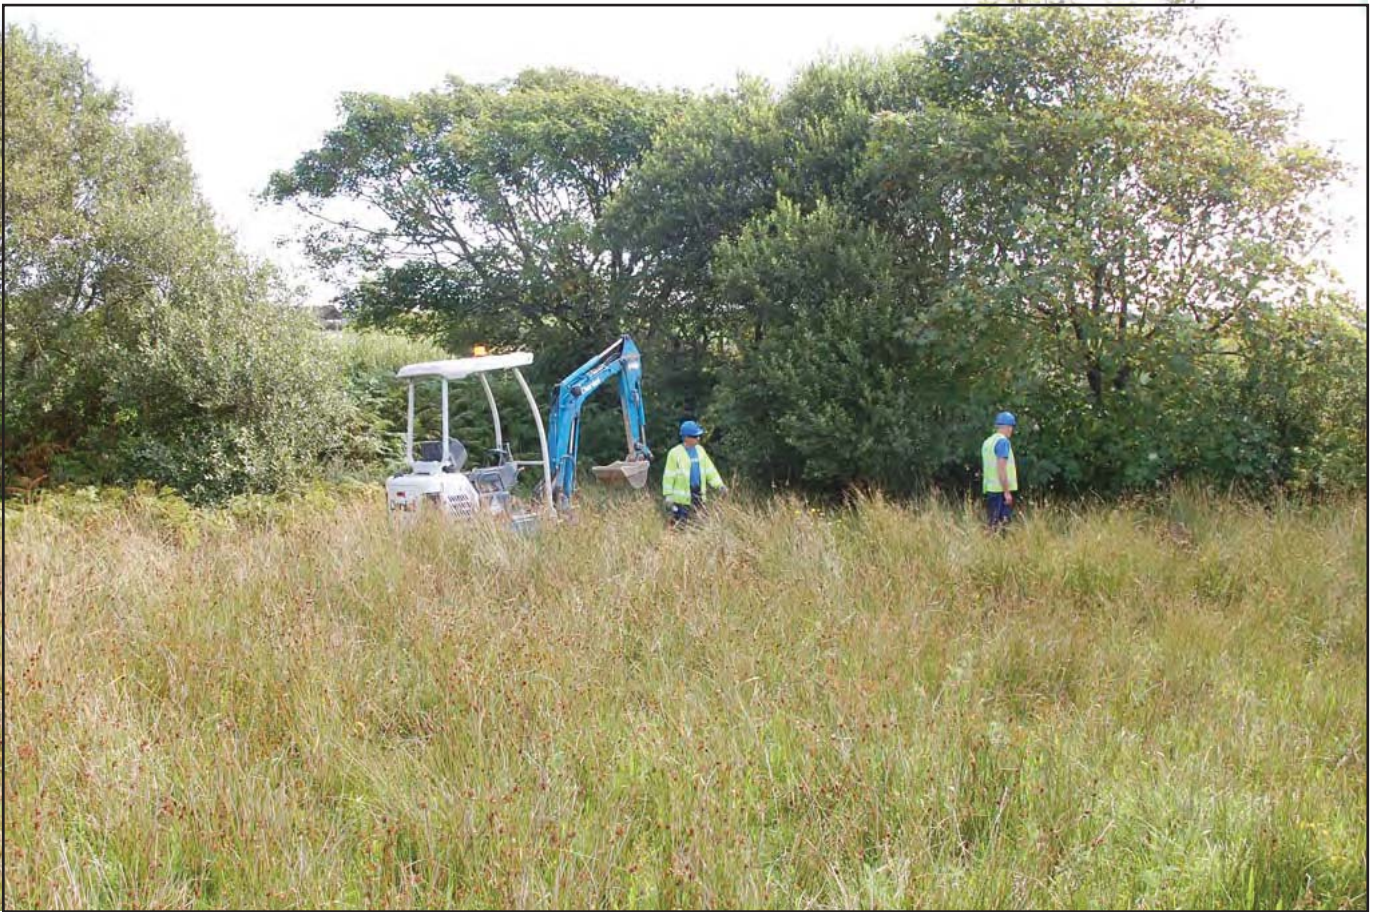
Thin band of dark greyish brown topsoil within a marshy area, underlain by a mid brownish grey sandy silt with a moderate amount of stone, total depth of these upper layers was 0.35m. Below which was a lighter orangey grey natural with a frequent amount of stone, of which was both pebble and cobble sized. The water main was discovered at the southern end of the test hole at a depth of 1.0m.

Plate 01 - Location of TH10 within the marshy area, the minor Abersoch to llanengan road is the other side of the hedge.

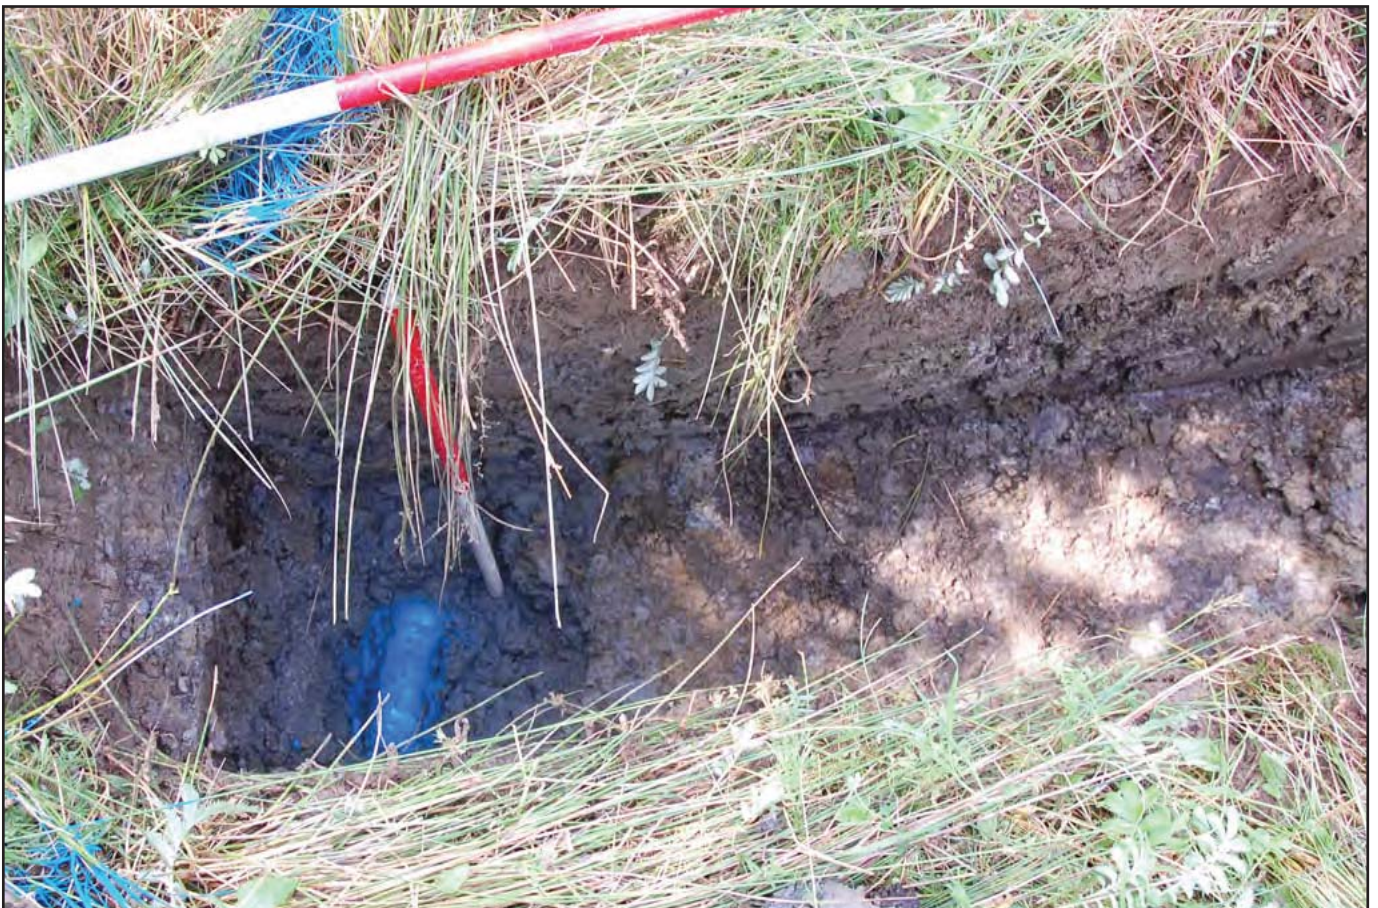
Plate 02 - Excavated test hole showing the water main (blue paint) cut into thye natural.

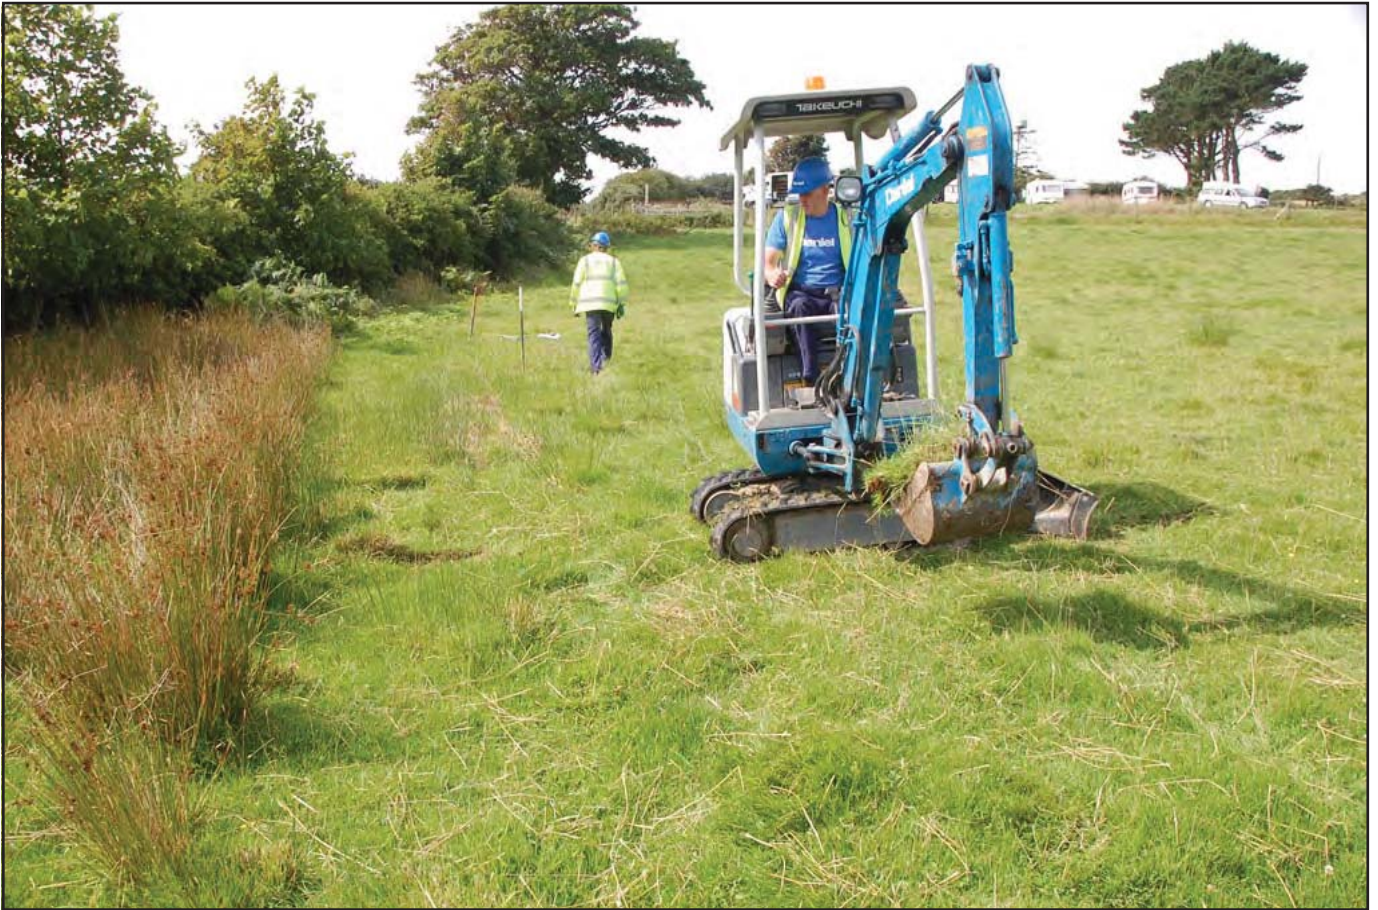
Plate 03 - Location of TH11, to the SW of TH10, the minor road is behind the hedge at the left hand side.

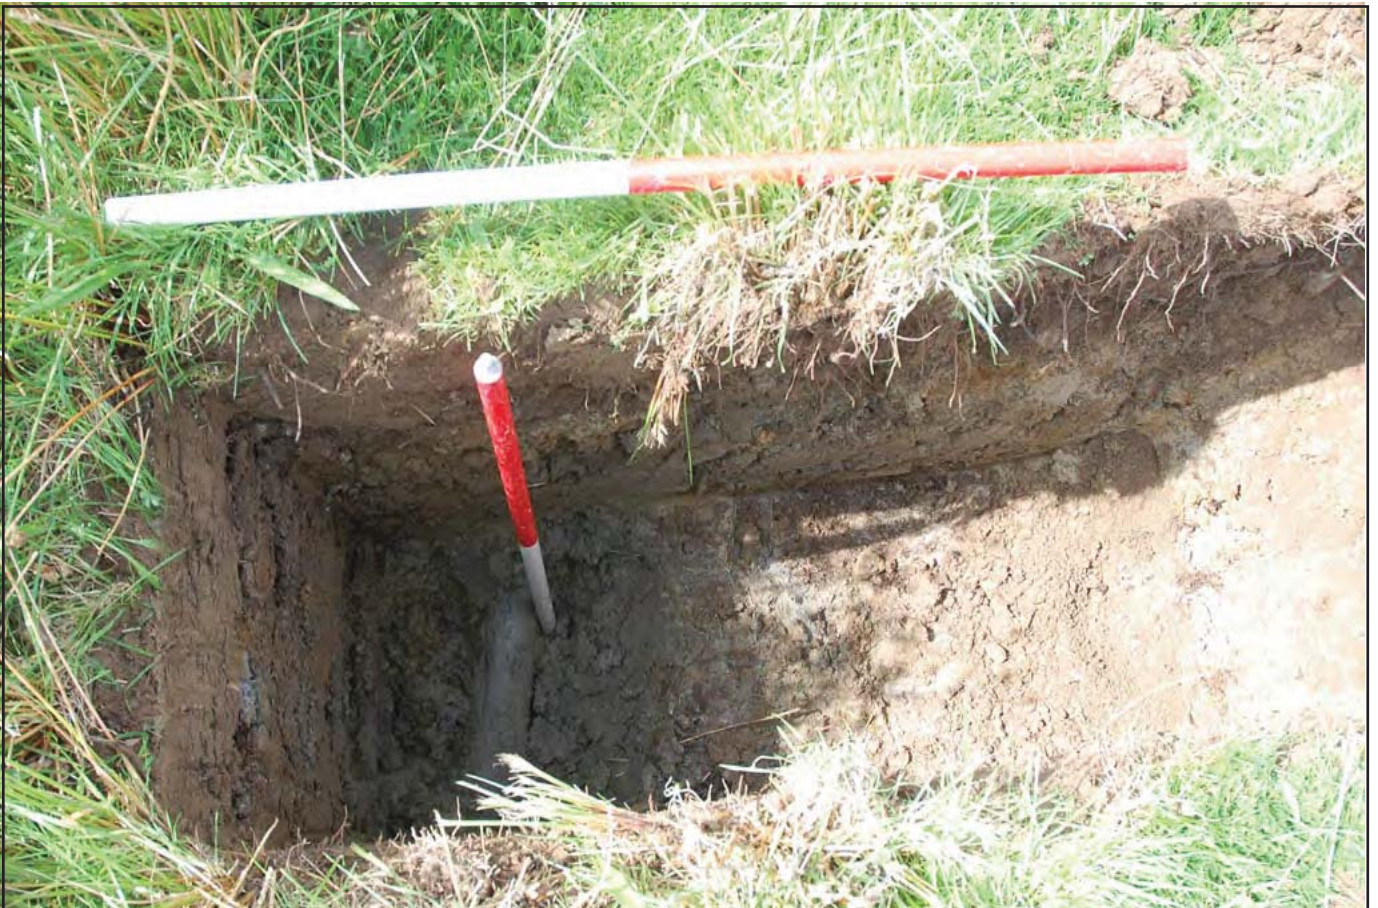
The topsoil was a mid greyish brown sandy silt, friable and containing occasional sub-angular stone with a depth of 0.20m. The subsoil had a depth of 0.18m and was a mid orangey brown, clayey sandy silt containing moderate sub-angular stone. The natural was similar to the subsoil, although slightly lighter and firmer in compaction.

Plate 04 - Post excavated section of TH11 with the water main next to the ranging pole.

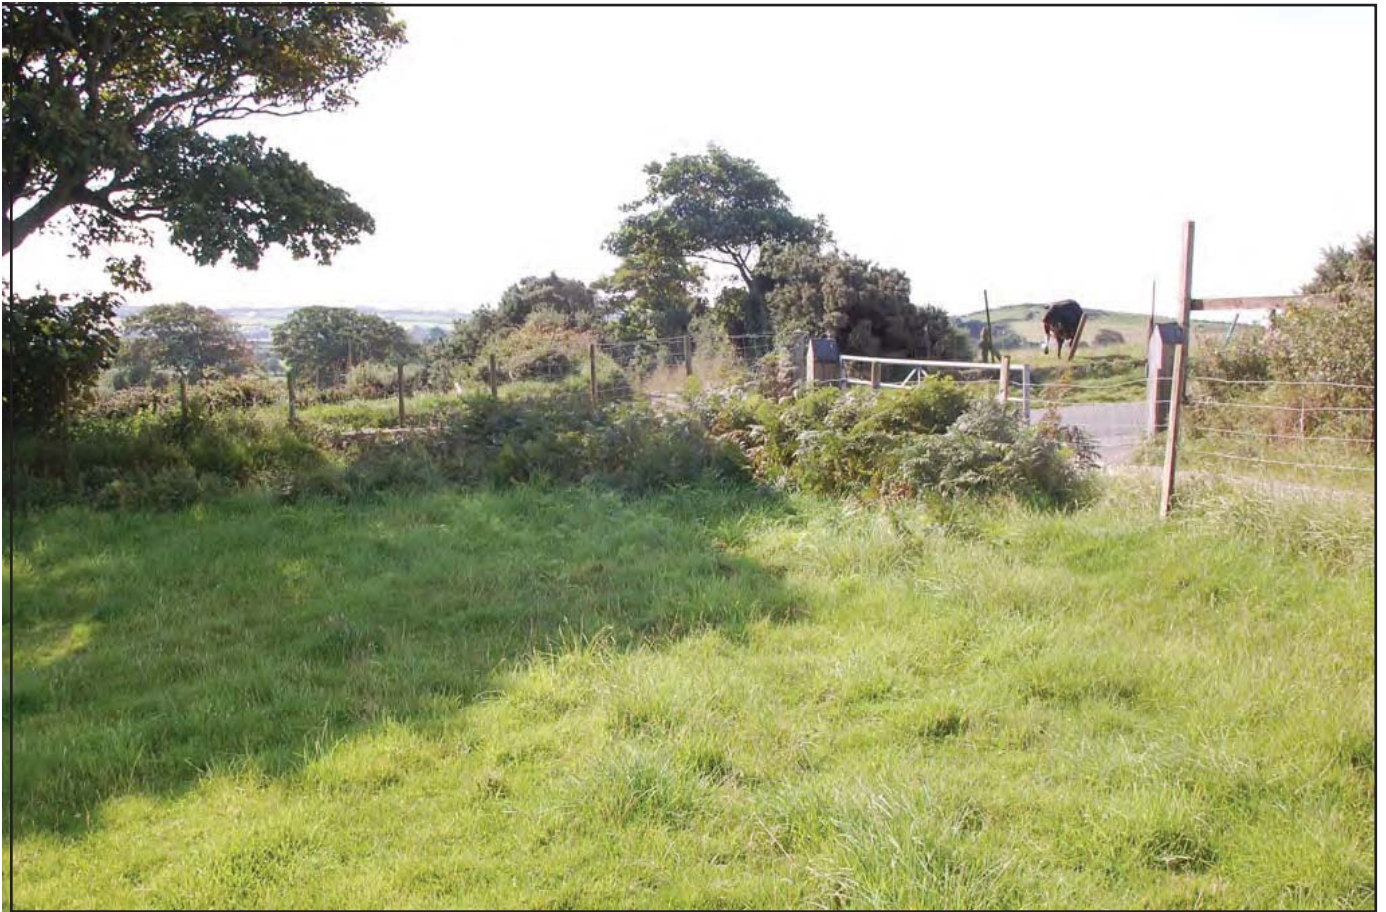
Plate 05 - Location of TH12 near entrance to Clegir Uchaf Farm..

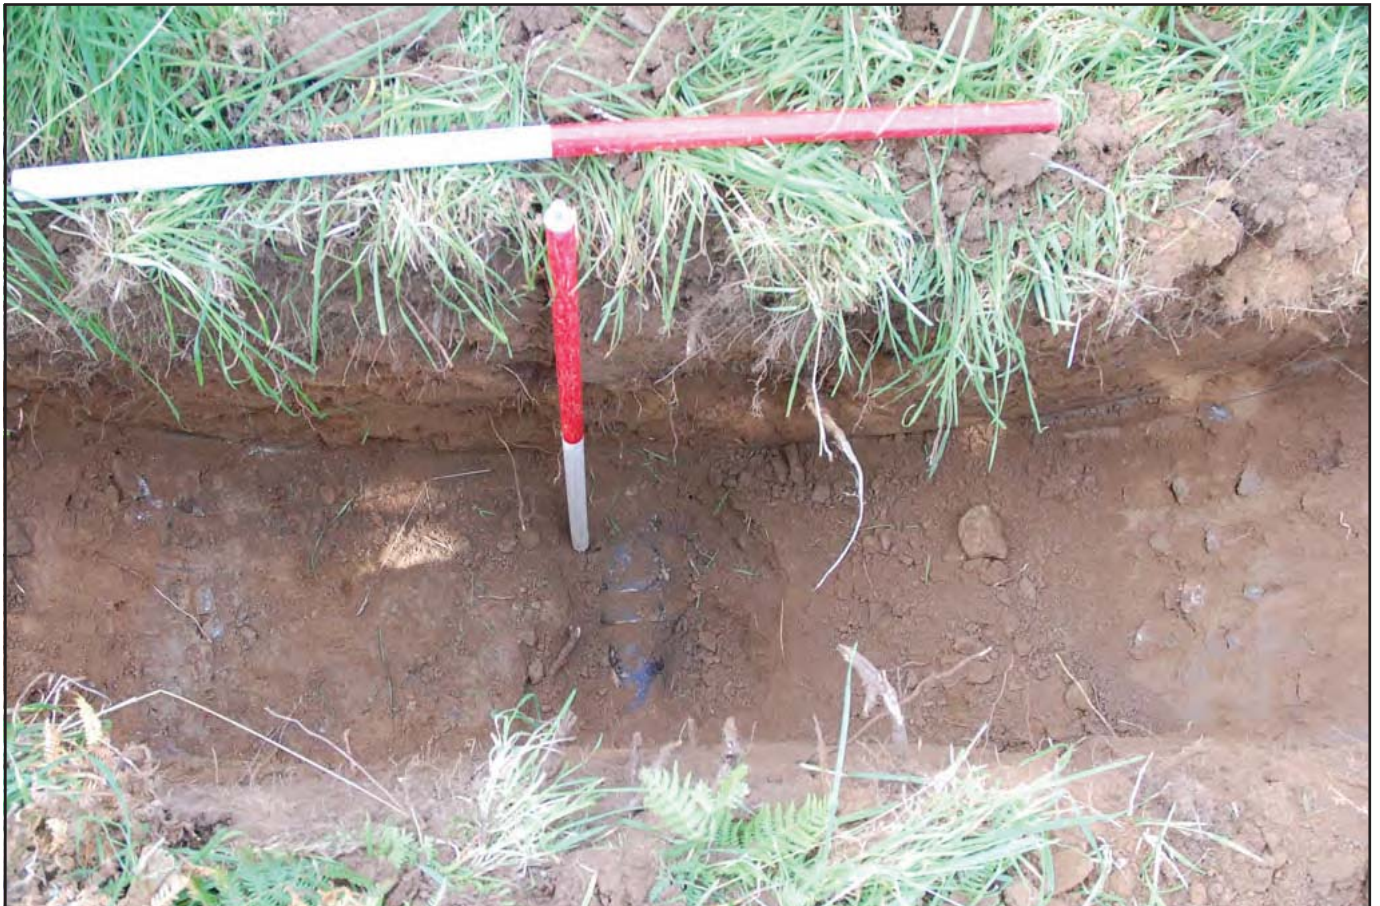
A mid greyish brown sandy silt topsoil with a moderate amount of pebble and cobble sized stone inclusions, reaching a depth of 0.25m. The subsoil was a mid greyish brown sandy silt, firmly compacted and contained the occasional stones of similar size to the above topsoil, and had a depth of 0.12m. The natural was a light orangey brown silt-sand with occasional stone.

Plate 06 - Excavated section of TH11 with exposed water main.

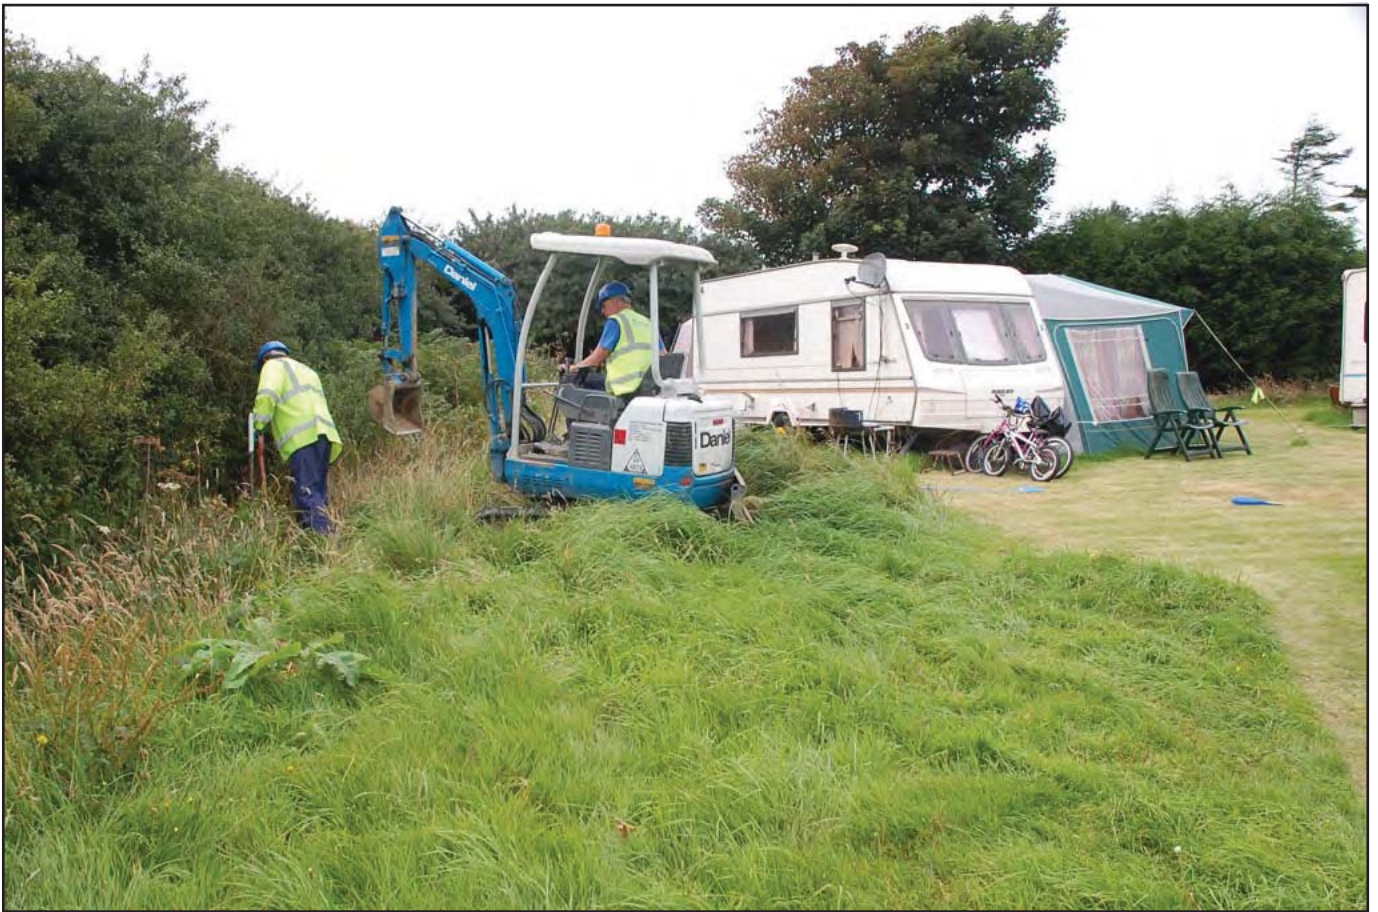
Plate 07 - Location of TH13 inside the caravan park, the Abersoch to Llanengan road is behind the hedge to the left.

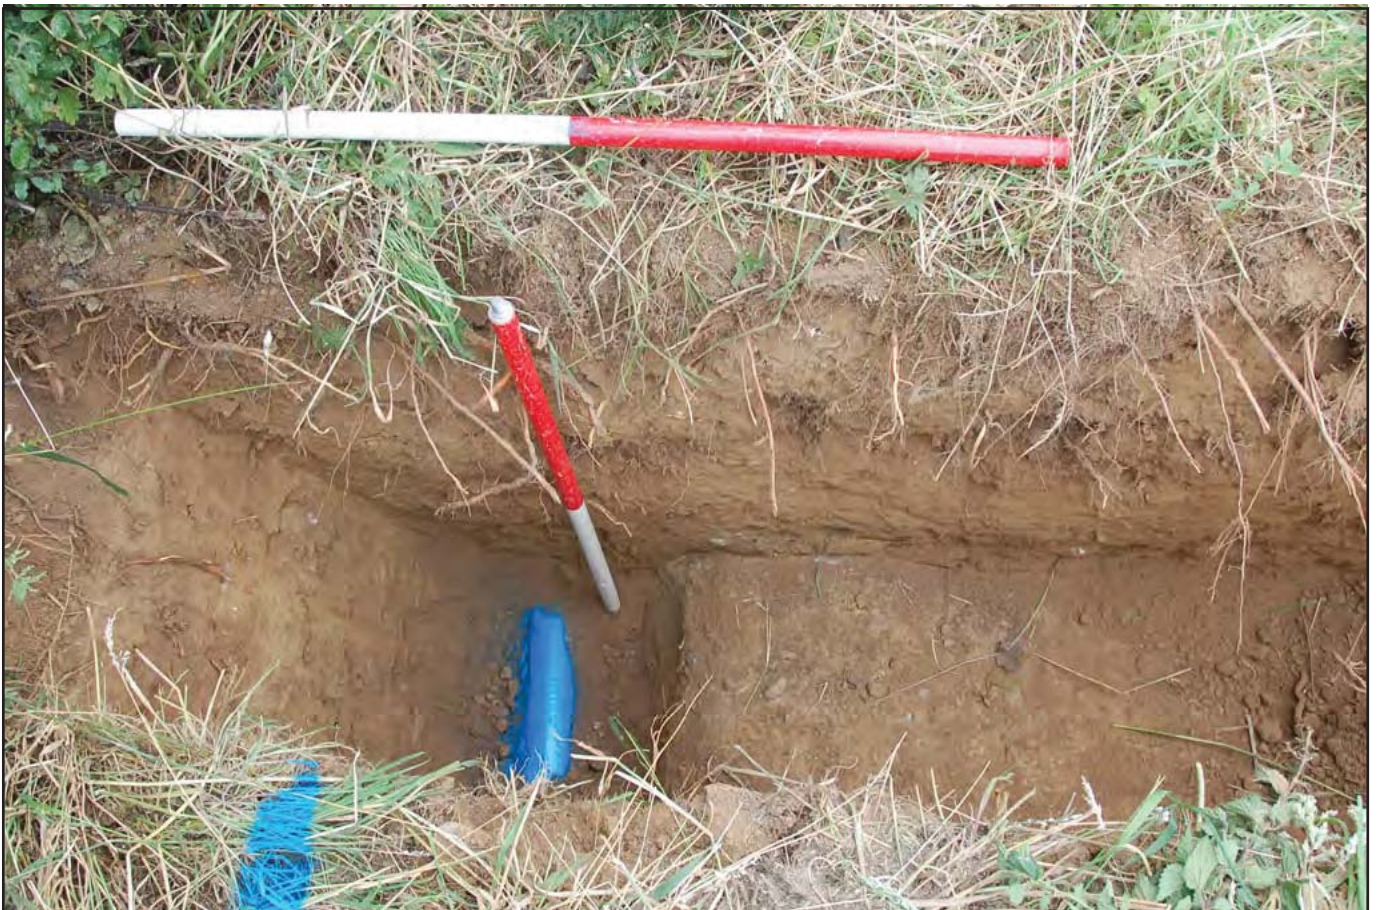
A mid greyish brown sandy silt topsoil with a moderate amount of pebble sized stone inclusions, reaching a depth of 0.10m. The subsoil was a mid greyish brown sandy silt, firmly compacted and contained a moderate amount of stones of similar size to the above topsoil, and had a depth of 0.25m. The natural was a light orangey brown silt-sand with occasional stone.

Plate 08 - East facing section of TH13 showing the bpainted water main and natural surface to the right.

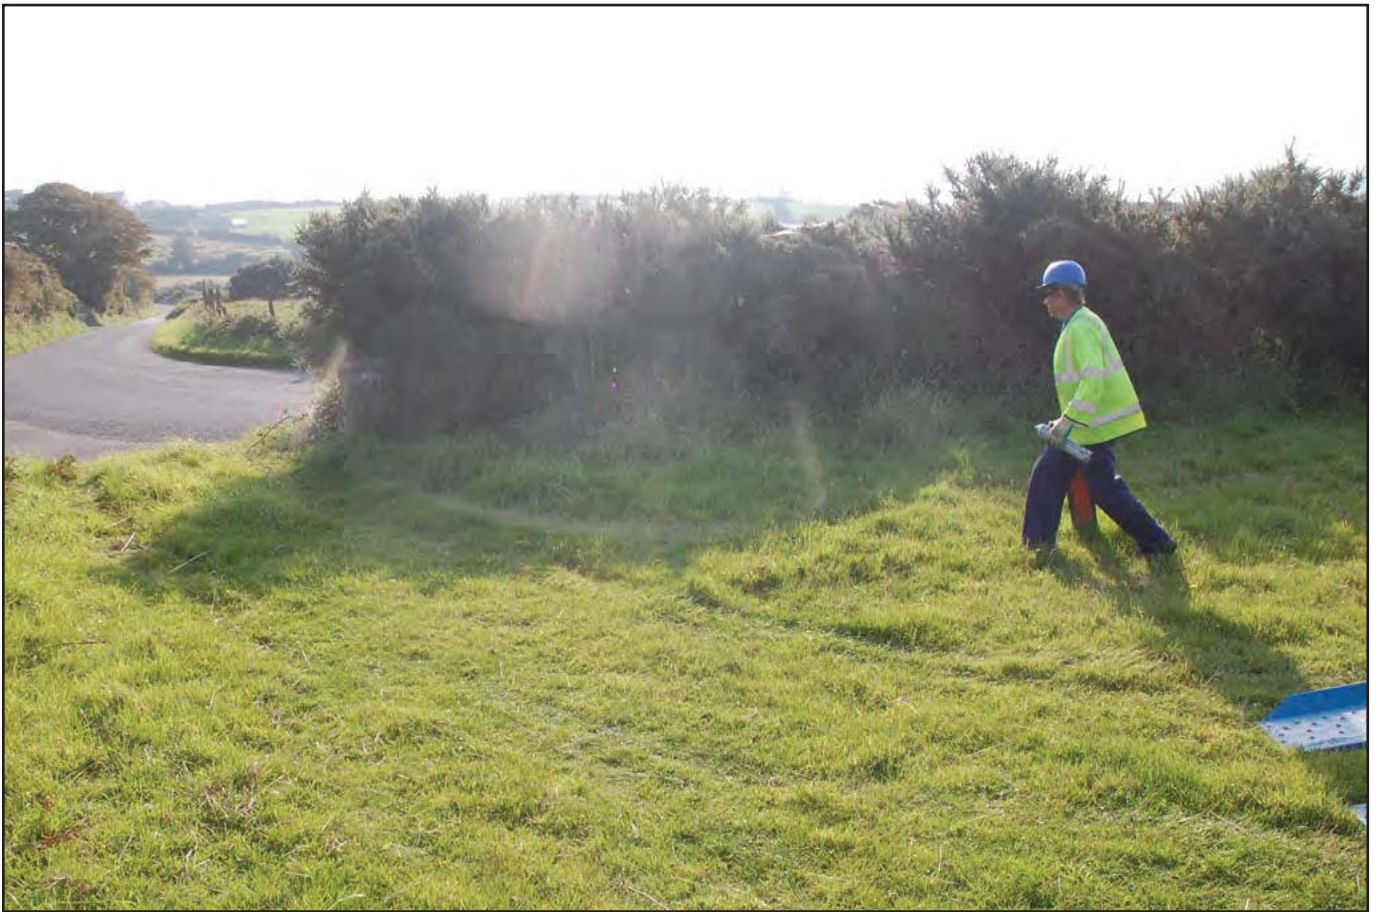
Plate 09 - Location of TH14 at the entrance to Cae'r Eglwys Farm at the left hand side of the road..

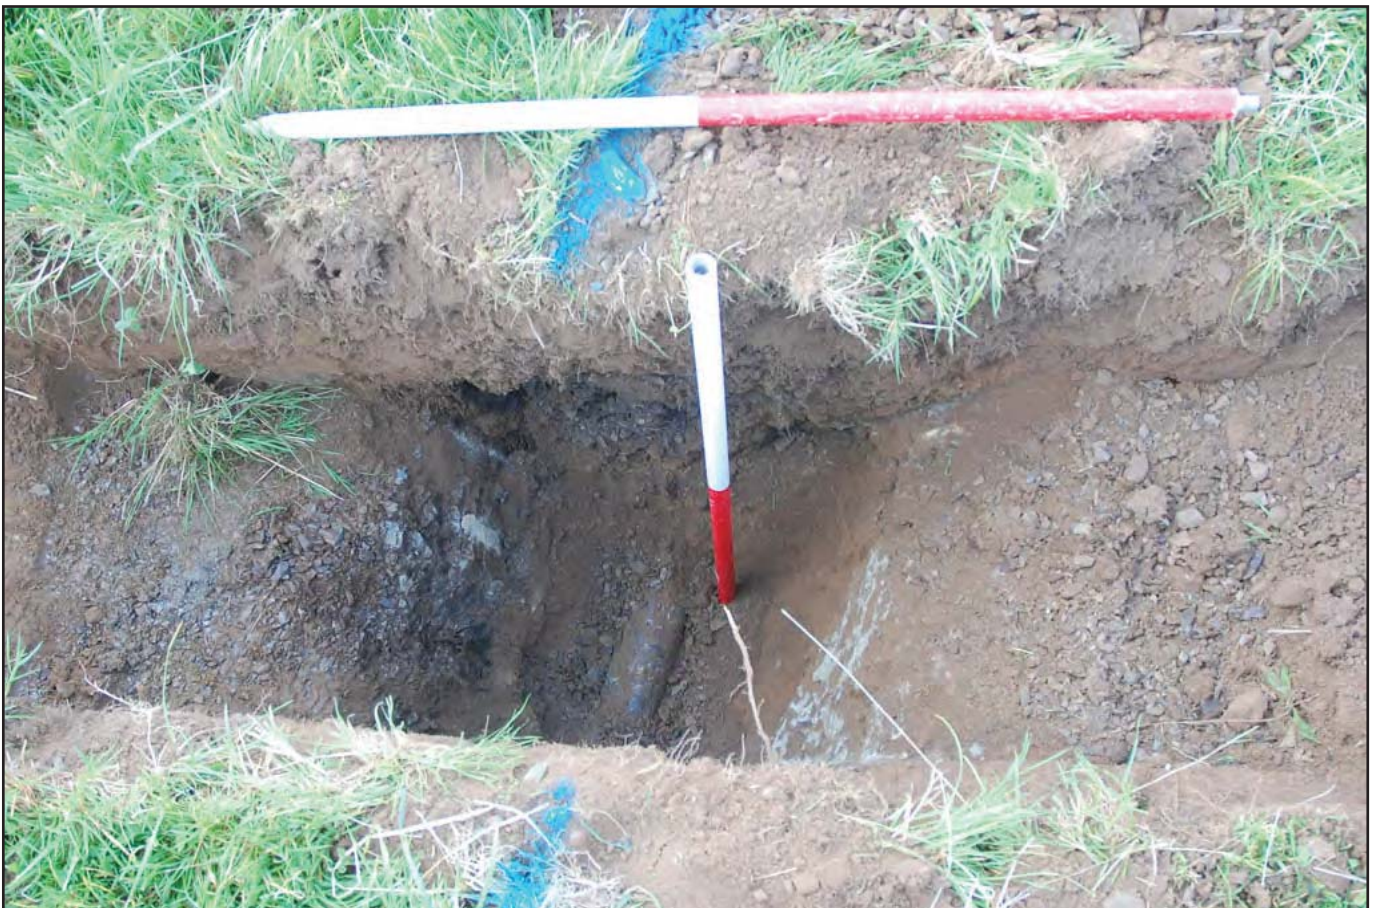
The topsoil was a greyish brown sandy silt containing frequent amount of sub-angular shale stone, with a depth of 0.20m. Below which was a lighter greyish brown sandy silt with very frequent shale stone with a depth of 0.10m. The existing water main was cut into the bedrock.

Plate 10 - Post excavated section of TH14 showing the cut into the bedrock. .

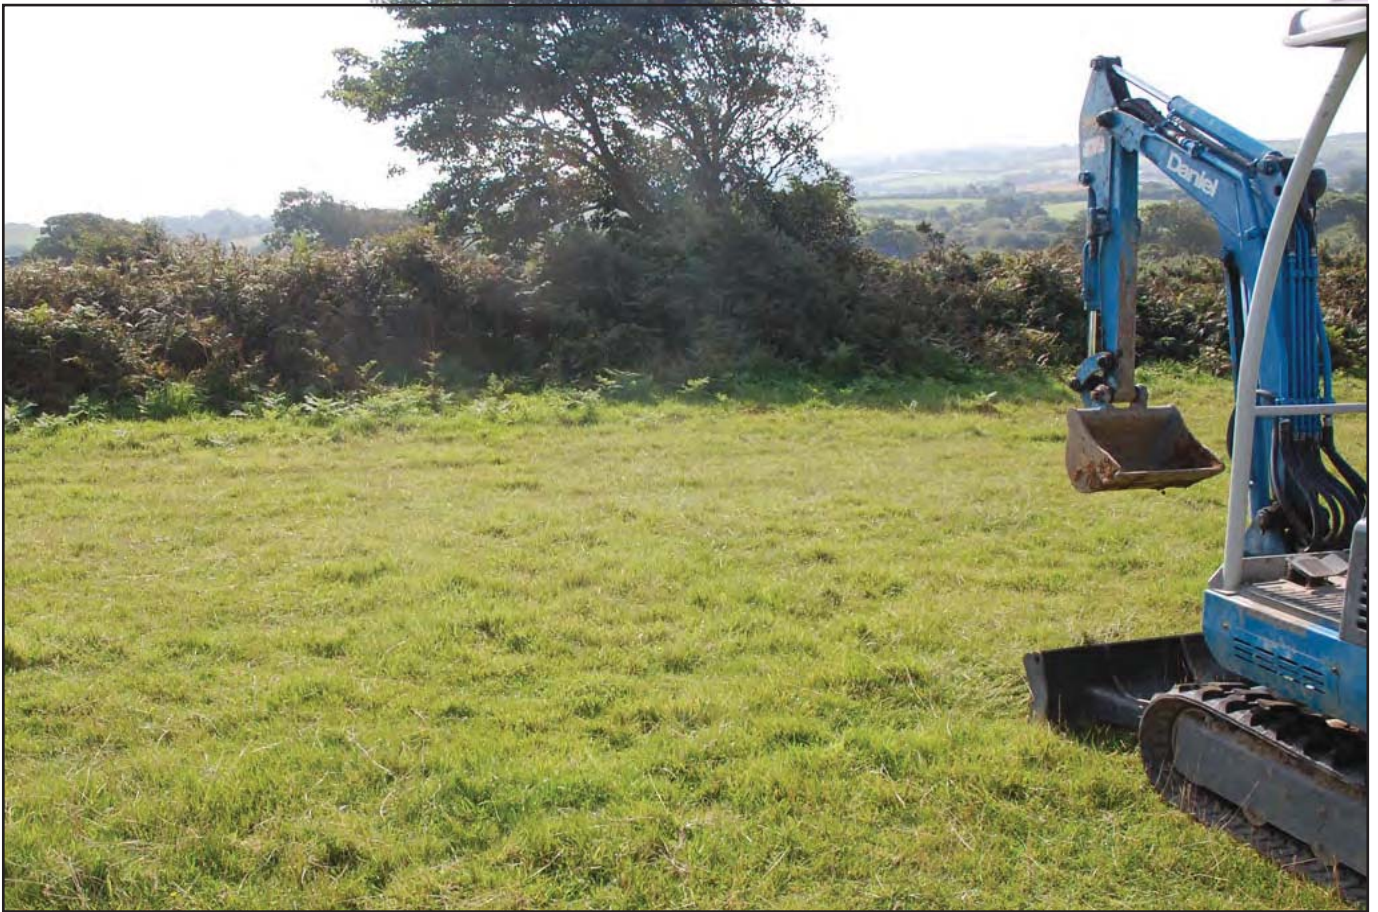
Plate 011 - Location of TH15 with the Abersoch to Llanengan road the other side of the tree.

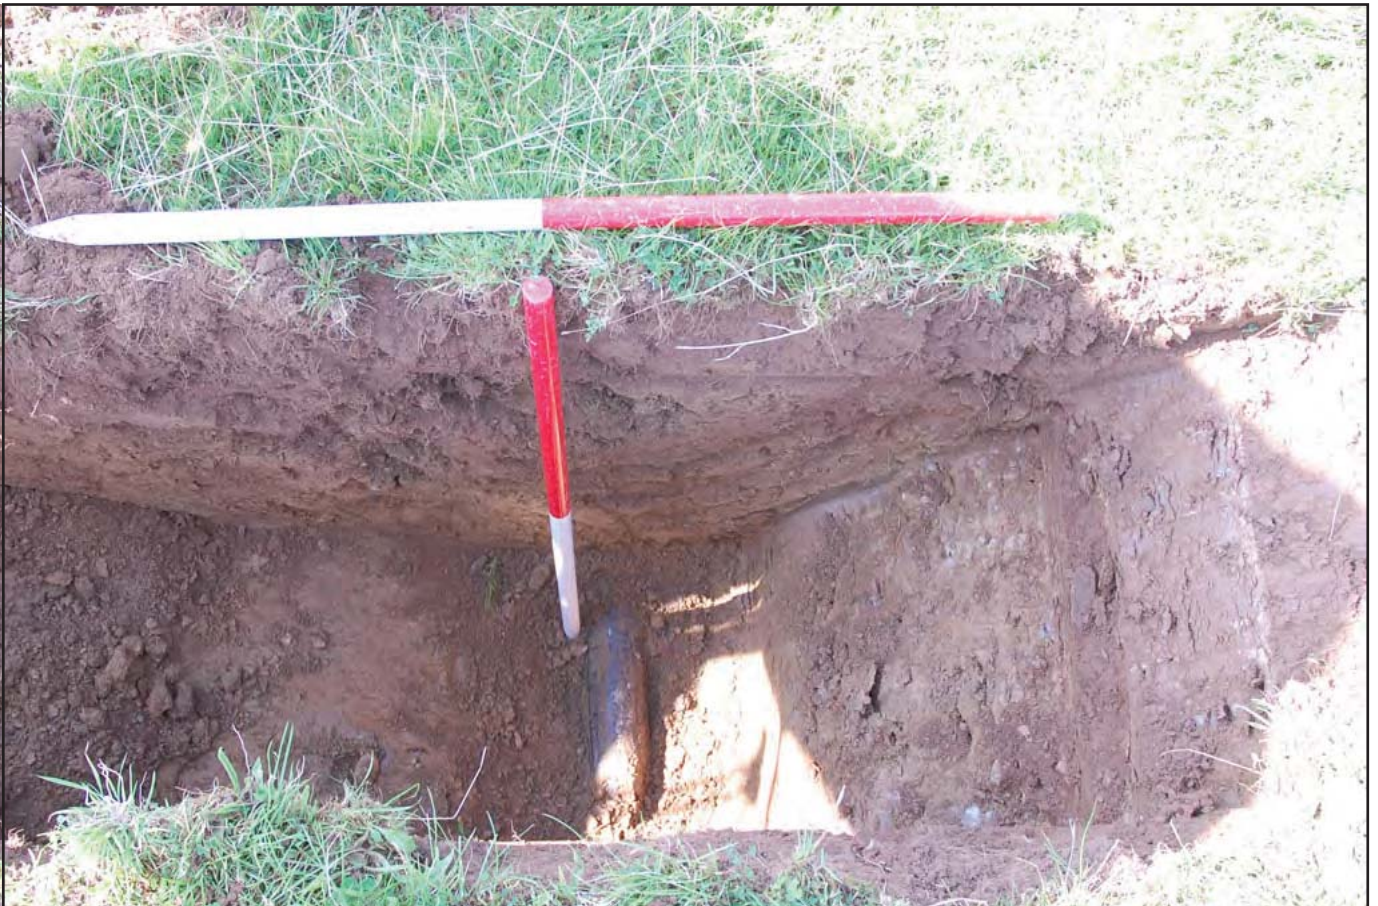
Thin layer of topsoil, which was a mid greyish brown sandy silt with a depth of 0.20m and containing frequent shale stone. The subsoil was a mid brownish grey sandy silt, again with frequent shale stone and slightly lighter than the topsoil and firmer. The natural was an orange-brown silt sand, very firm and contained frequent sub-angular and shale stone.

Plate 12 - Excavated section of TH15, water mains at base of trench.

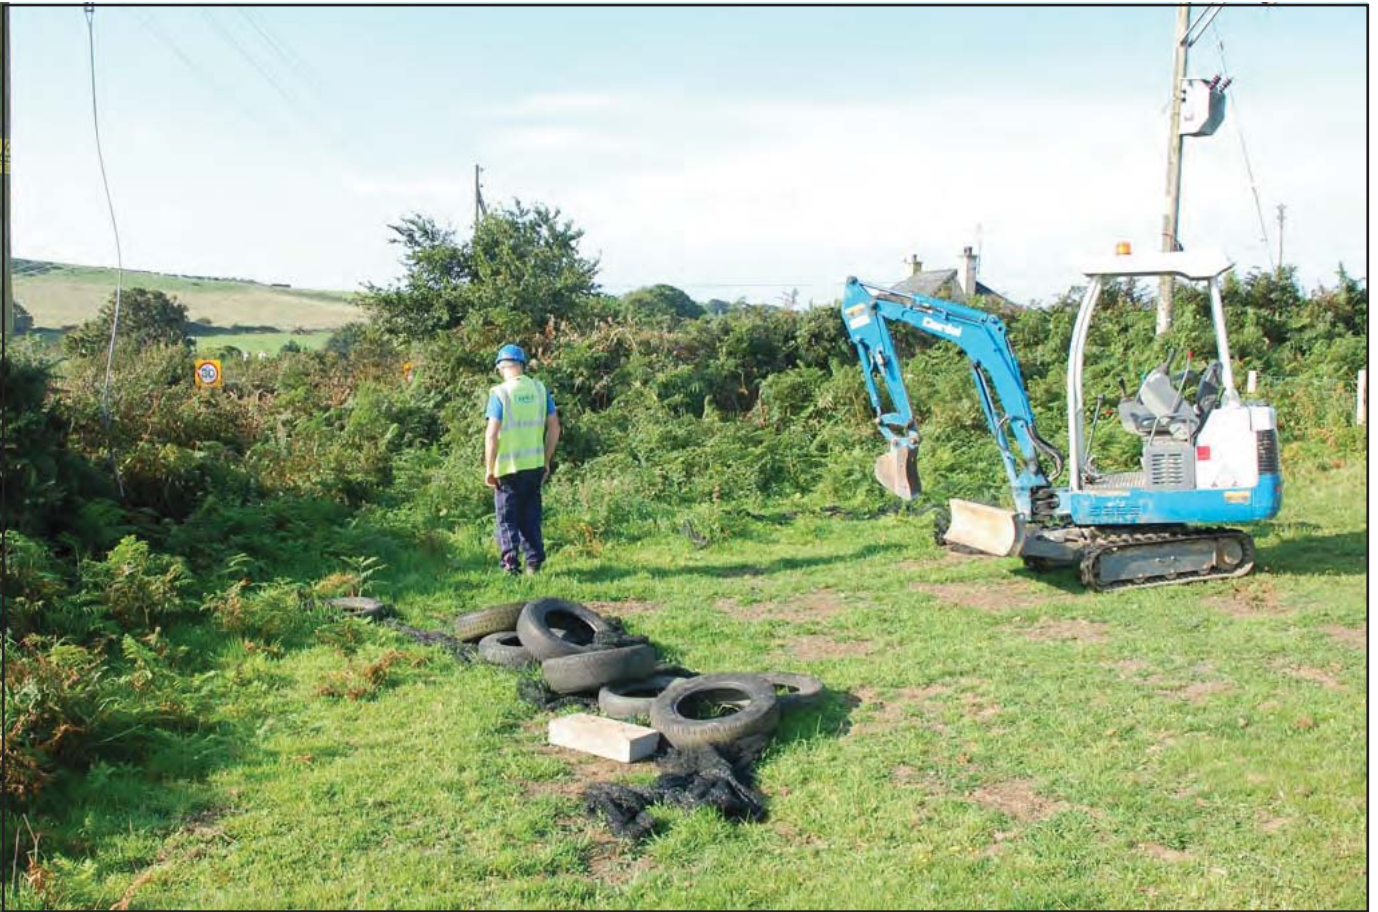
Plate 13 - Location of TH16 at the southern end of Cae'r Eglwys field.

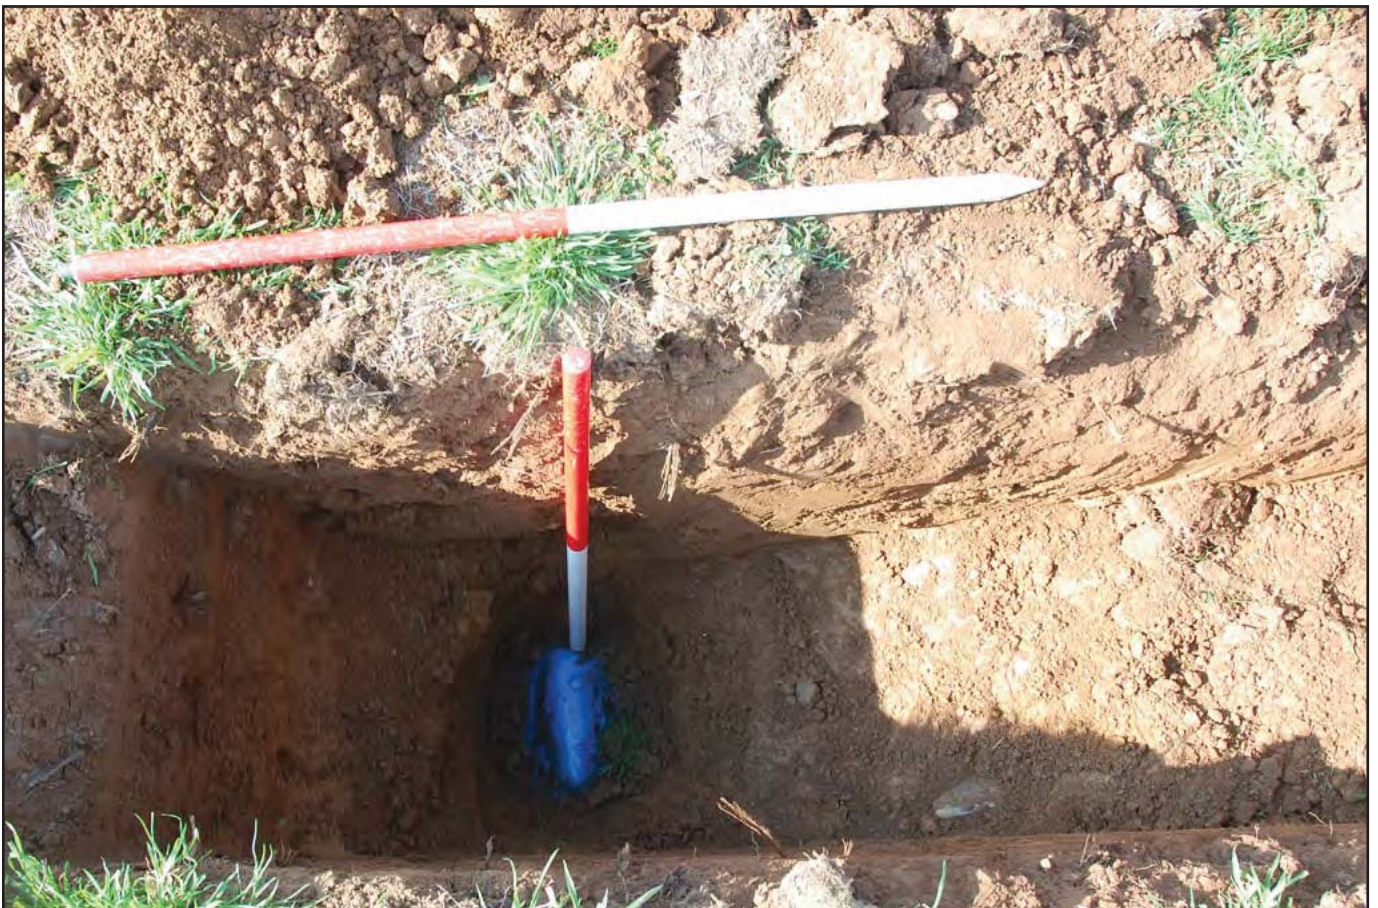
A much degraded topsoil with a depth of 0.10m, mid grey-brown sandy silt. The subsoil was a light brown-grey sand-silt with frequent small shale stone. Natural was a mid orangey brown silt-sand with occasional to frequent shale stone.

Plate 14 - Excavated section of TH16, north facing with natural ground surface at the right side.
