The Gardener's Cottages
Mathern Palace
Mathern
Monmouthshire
(NGR ST 52340 90832)

Building recording and watching brief

Hereford Archaeology Series 689

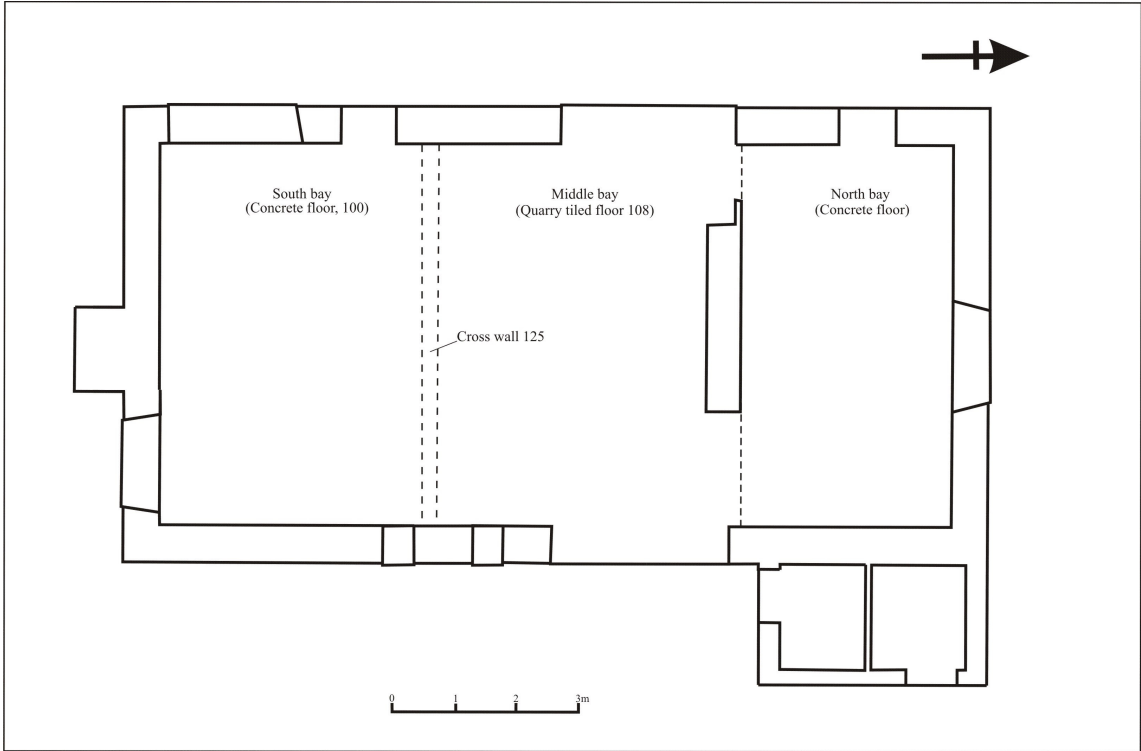
The Gardeners Cottage divided into compartments (scaled to fit), Fig.6.

Prior to the start of the watching brief the Gardeners Cottage had been gutted and the concrete floors (context 100) had been broken up and removed, as had part of a quarry tiled floor (108/109). An internal stone wall (125) that had enclosed a bay in the south end of the building (located at 4.20m from the south end) had been removed, down to the floor level (Fig.6).

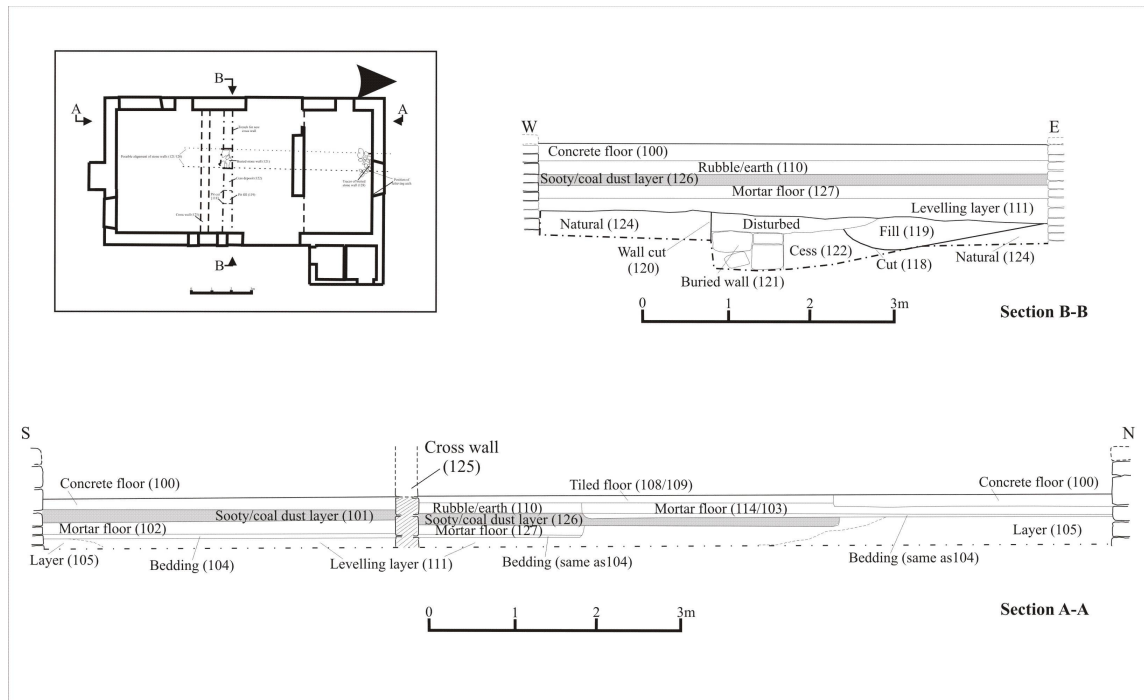
Cross sections through the Gardeners Cottage (at 1:50 scale), Fig.7.

The ground floor of the building was divided by internal crossing walls into the three bays that were probably created in the late 19th century, south, middle and north, the middle bay was divided by the remains of a central, north-south aligned timber partition. The north and south bays of the building had concrete floors, while the floor of the middle part of the building was quarry tiled. Underlying the modern floors was a series of earlier floor layers and deposits that varied in composition between bays (Fig.7).
