## FRONGOCH MINE REPORTED COLLAPSE

Following reports of a further collapse at Frongoch Mine, close to the footpath, I visited the site on Friday 27 April 2012.

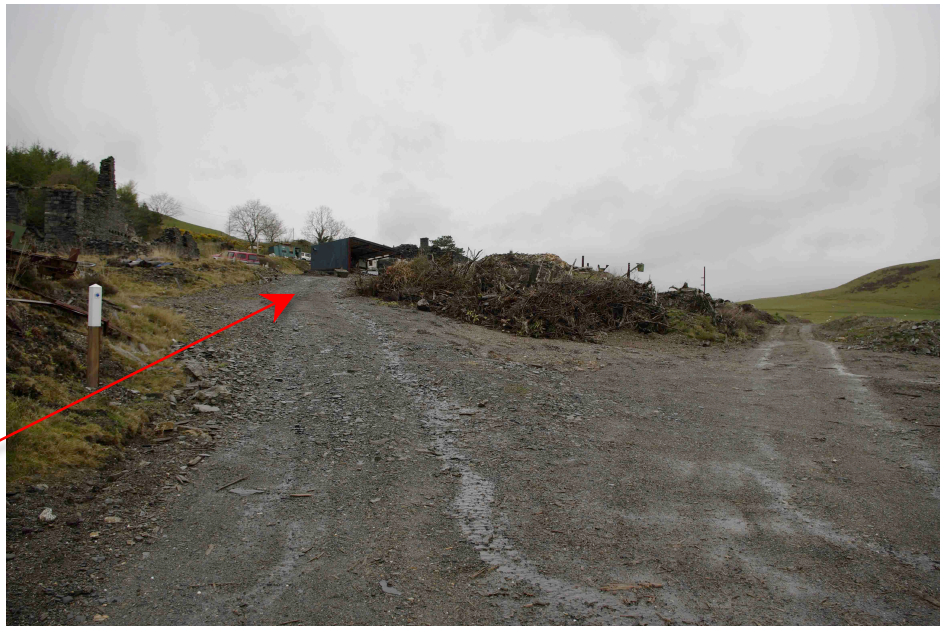
Dangerous  
route  
passing  
Engine  
House and  
shaft

*Photo No 1: View taken looking north-east from the diversion point. The diversion to the right is a safe route, the route straight on is the unsafe route passing the dangerous area on the left. The post in the left foreground has an arrow pointing to the route to the right but on the right-hand side of the post is an arrow pointing to the unsafe route.*

In my opinion Ceredigion County Council should consider closing the footpath leading north-east from the diversion until some form of fencing and suitable signage is erected to prevent accidental access to the dangerous area.

I understand that the Environment Agency are planning some future work on the Fines Dumps at Frongoch, perhaps suitable signage, fencing and/or a diversion of the footpath can be incorporated in this work.

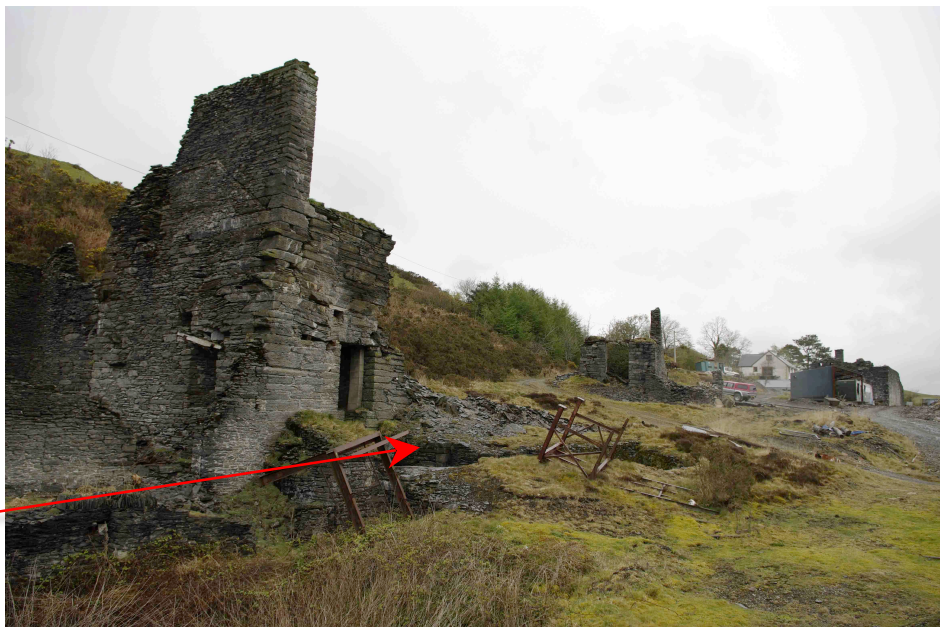
Shaft

*Photo No 2: View taken from edge of path of the Engine House and shaft*

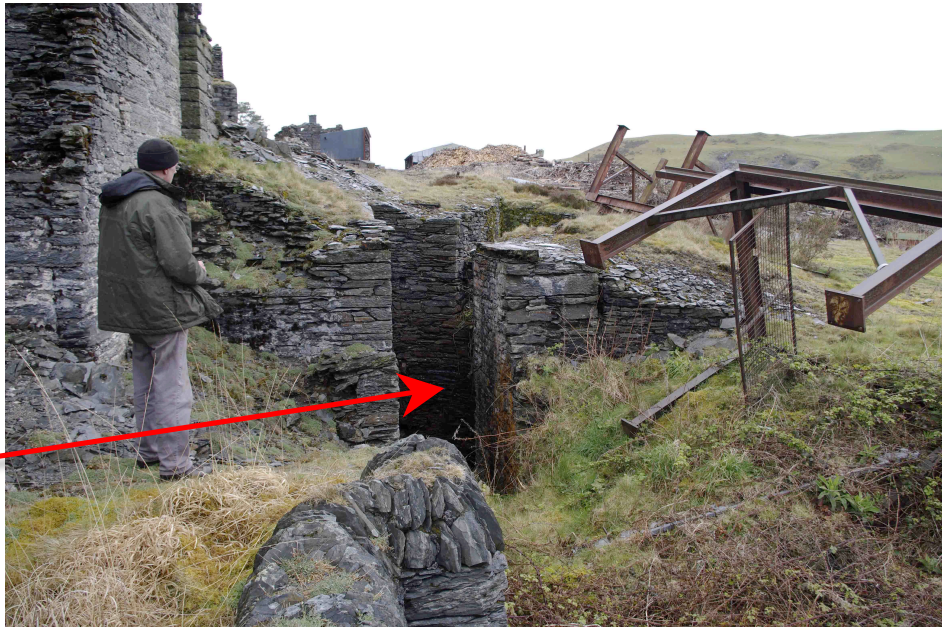
Shaft

*Photo No 3: View of shaft*

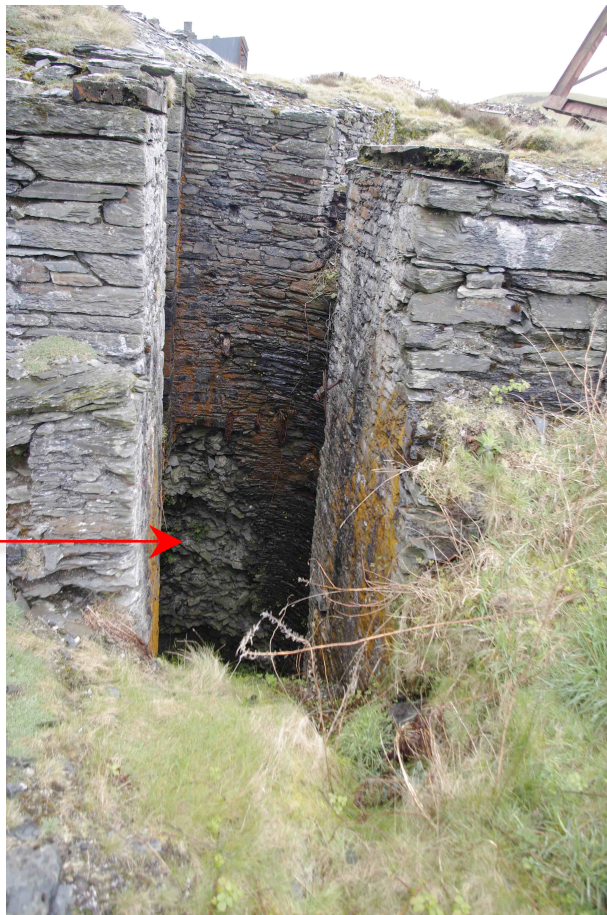
Whilst there were no surface signs or effects of the latest collapse there had been some recent collapse of the stone lining of the Engine Shaft (SN 72089 74432). The Engine Shaft and the adjacent Engine House are deteriorating badly, the area is not a safe one for casual visitors from the nearby footpath to get close to.

*Photo No 4: The recent collapse in the shaft of the stone lining (lighter coloured rock) arrowed.*

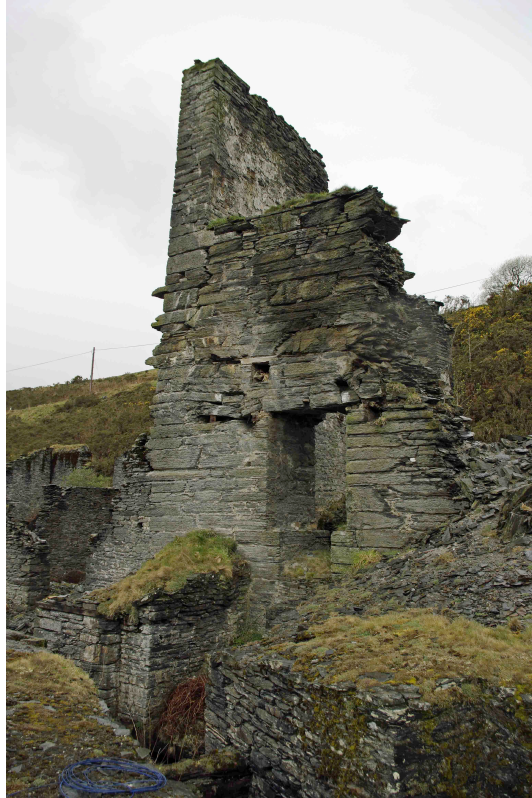
*Photo No 5*

In addition to the collapse in the shaft, the major problem at Frongoch is the condition of the buildings especially the remains of the Engine House. It is a miracle that it is still standing, there are several terminal structural faults with the building itself but these are added to by the gradual erosion of the shaft and its stone lining.

Years ago Frongoch had the best collection of mine buildings in Cardiganshire, efforts by David Bick the founder of the Welsh Mines Society and the Welsh Mines Preservation Trust to ensure their conservation failed; even though they were at one time Scheduled Monuments. In my opinion the area around the Engine House and shaft should be fenced off and the building be allowed to decay and collapse with dignity rather than be demolished.
