Bythynnod: Toeon o Wellt a Cherrig

Cottages: Roofs of Thatch and Stone

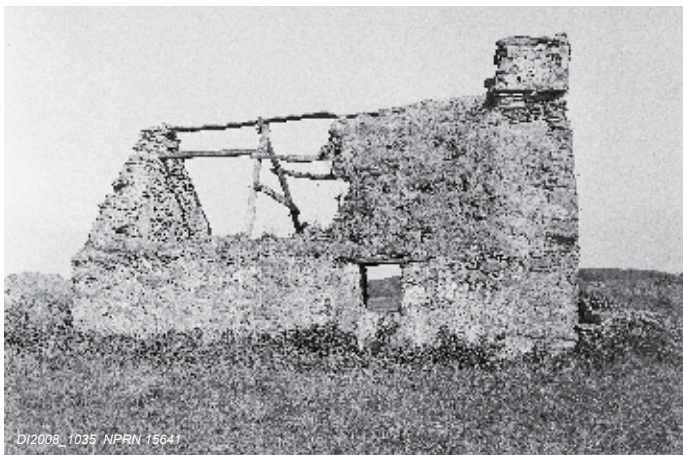
Chwith: Roedd Cerrig, Rhoscolyn, Môn, yn adfeilion pan dynnwyd y llun hwn ohono yn y 1930au. Rwbet garw iawn wedi'i roi mewn mwd oedd ei walliau, a meini clo garw oedd i'r sinnai.

Left: Cerrig, Rhoscolyn, Anglesey, was in ruins when this photograph was taken in the 1930s. Its walls were of very rough rubble set in mud, and the chimney has a rough schist coping.

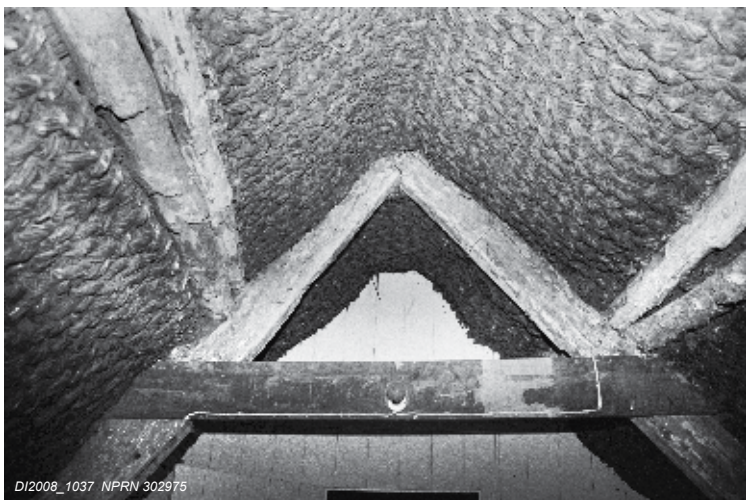
Uchod: Mat gwellt yn ddefnydd dan y to, Seamount Cottage, Southerdown, Morgannwg, 2001.

Above: Straw mat underthatch, Seamount Cottage, Southerdown, Glamorgan, 2001.

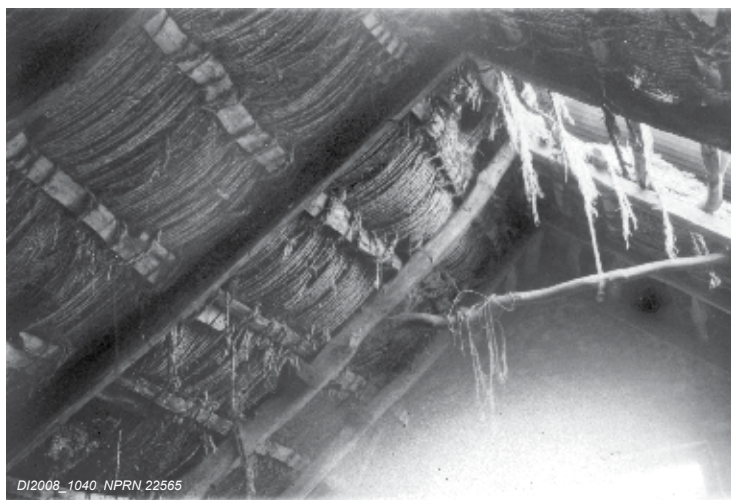
Uchod: Rhaffau gwellt y defnydd o dan y to yn pydru yn ysgubor Croftufty, Tyddewi, Sir Benfro.

Above: Straw rope underthatch in decay at Croftufty Barn, St Davids, Pembrokeshire.

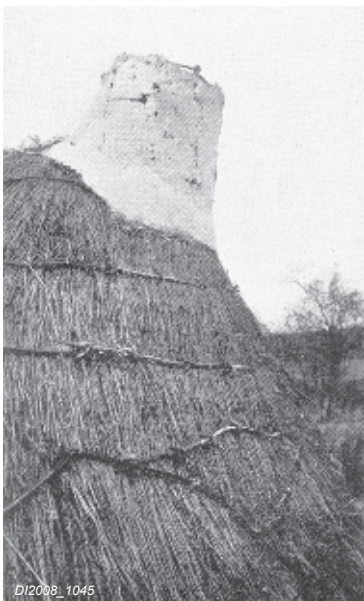
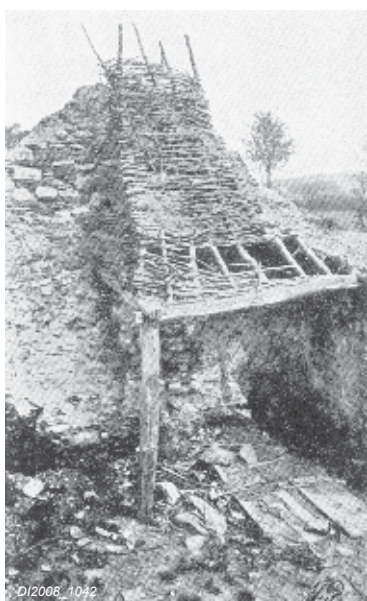
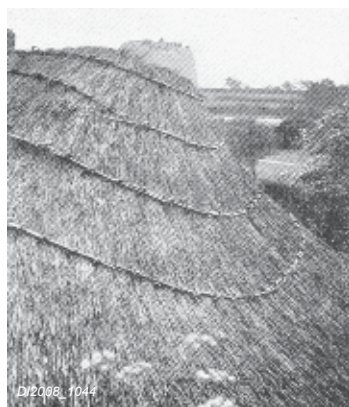
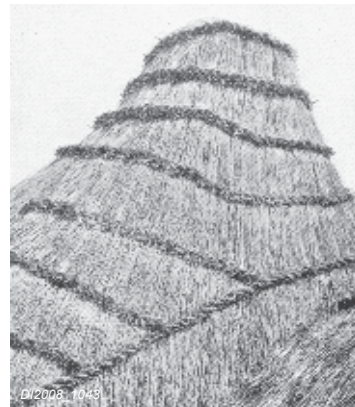
Pedwar llun o Inventory y Comisiwn Brenhinol o Sir Gaerfyrddin yn 1917 sy'n dangos typoleg cynn sinnai. Mae'n debyg i'r addurno â rhaffau gwellt fod yn gyfyngedig i ogledd pell y sir, a gallai'r llun (isaf, de) fod yn hawdd yn un o do yn Sir Aberteifi.

Four illustrations from the Royal Commission's Carmarthenshire Inventory of 1917, showing a typology of chimney-stacks. The decorative straw-rope treatment appears to have been confined to the extreme north of the county, and the picture (bottom right) could very well be of a Cardiganshire roof.
