Black Rock Road Portskewett, Monmouthshire

Archaeological Watching Brief and Historic Building Recording

Ref: 207290.3
March 2019

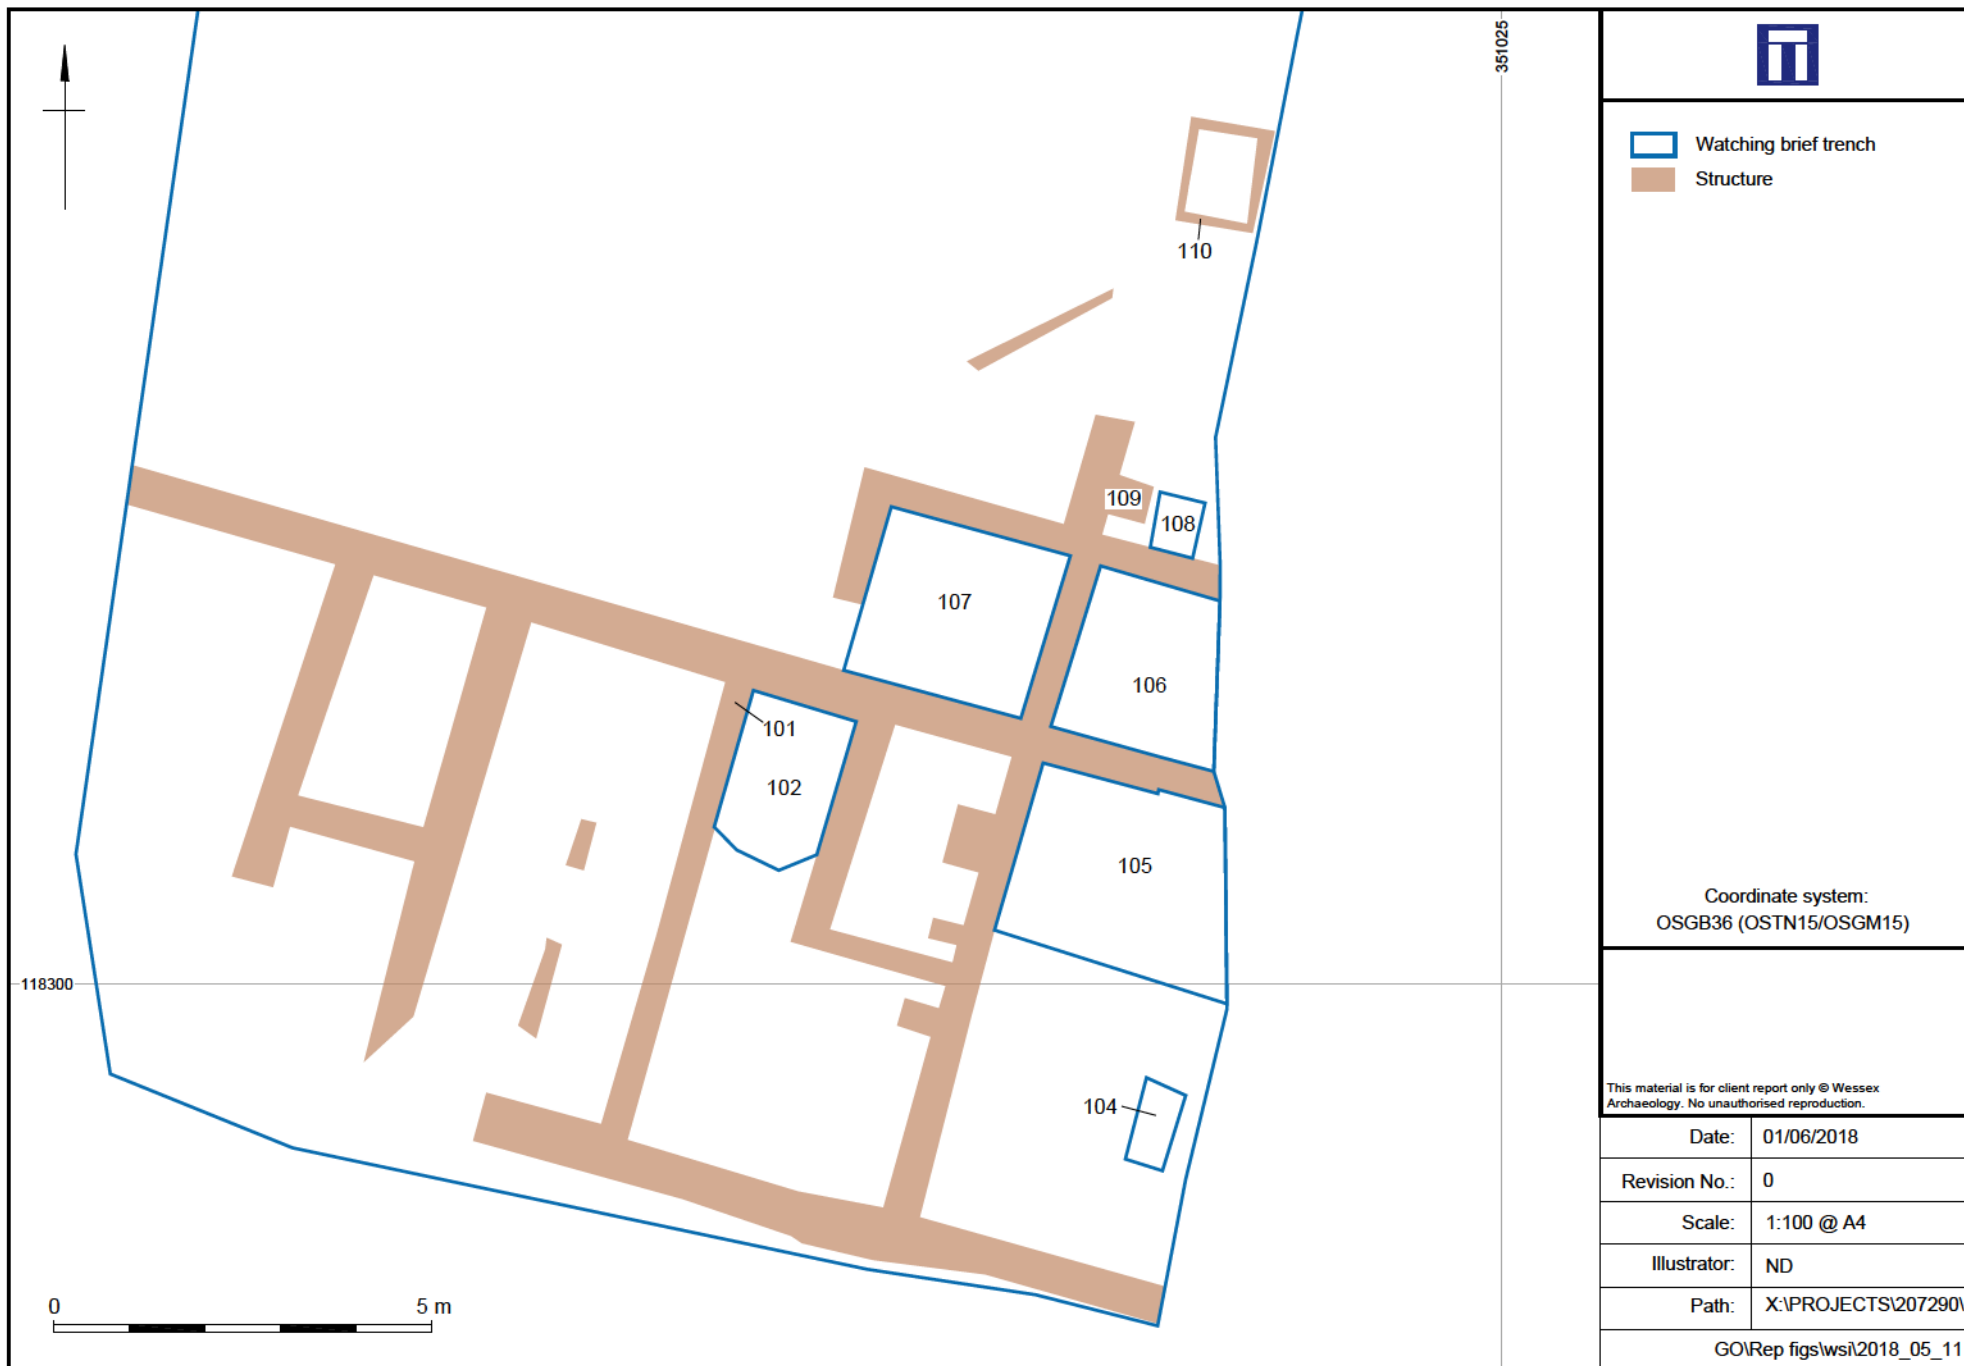
Figure 2

Plan of Area 1

- 5.3.1 The surviving remnants of Blackrock Cottages comprised wall foundations 101 with an integral extant fireplace, floor surfaces 104, 105, 106, 107 and 108, an internal brick structure 109 and a brick-lined cess pit 110 within the garden area to the north (**Figure 2**).

- 5.3.5 The construction sequence of the main walls could not be ascertained but are considered to be part of a single contemporary structure. The plethora of internal walls may suggest some degree of internal alteration with some structural features later than the original build (**Figure 2**).

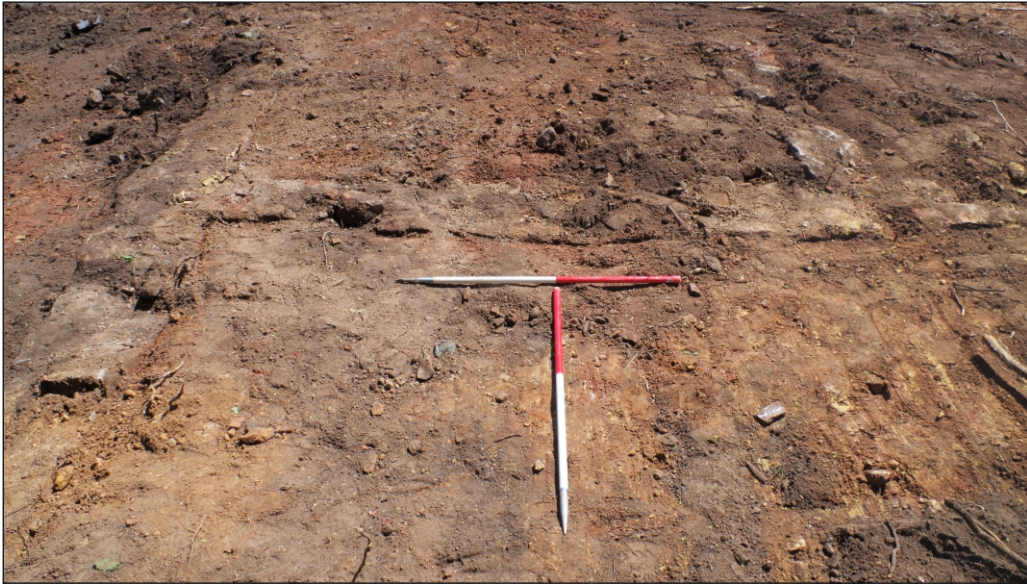
Plate 1: Cottage walls 101, looking east, 2 x 1 m scales

- 5.3.3 Constructed directly upon made ground 103, structure 101 consisted of a rectangular building plan with several internal divisions subdividing the space into seven separate rooms, four extending the full width of the property, with three smaller square rooms extending into the back yard. A brick fireplace constructed as part of an internal wall, dividing the easternmost two rooms, was the only above ground part of the structure surviving, measuring 1.5 m in height (**Plate 3**).

- 5.3.4 The initial wall build consisted of random uncoursed yellow, grey and red sandstone blocks, with occasional handmade brick, bonded with cream coloured lime mortar containing coal and ash inclusions (**Plates 1 and 2**). The fireplace was constructed of handmade bricks measuring 230 mm x 110 mm x 70 mm bonded with the same lime mortar (**Plate 3**). The external walls measured 0.46 m thick, the internal walls 0.33 m thick.

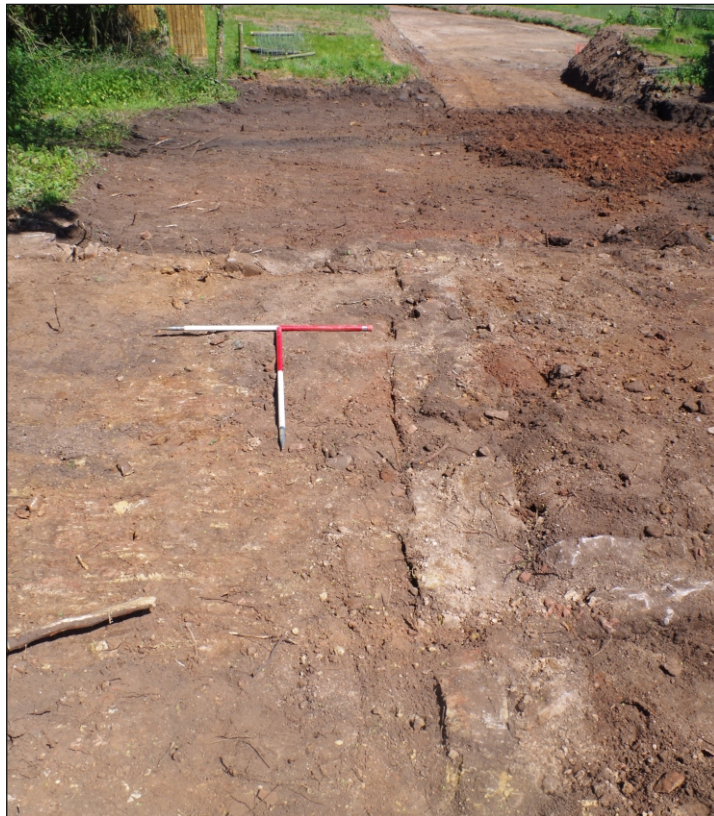
Plate 2: Cottage walls 101, looking north, 2 x 1 m scales

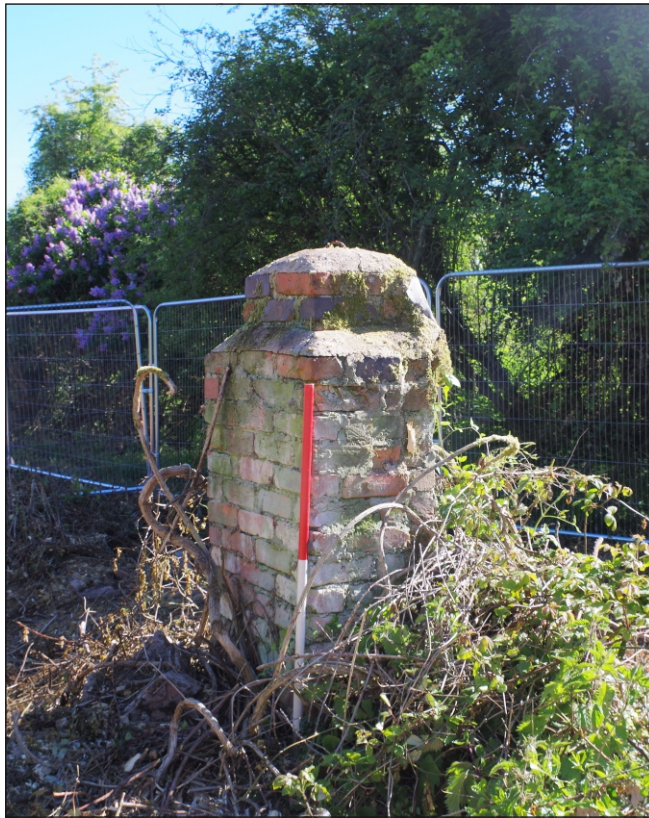
Plate 3: Detail of chimney 101, looking north-east, 1 m scale

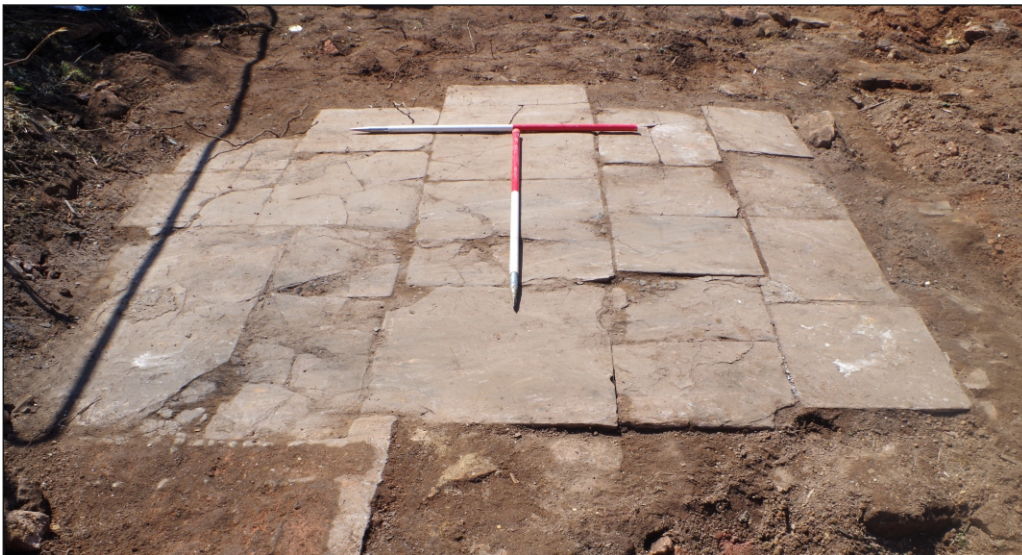
Plate 4: Floor 105, looking south, 2 x 1 m scale

- 5.3.7 Floor 105 was constructed of pennant flagstones varying in size from 0.28 m x 0.44 m to 0.64 m x 1.0 m (**Plate 4**). Floor 104 was within the same room as 105 and was constructed of brick and pennant flagstones, only a small area surviving and heavily fractured.

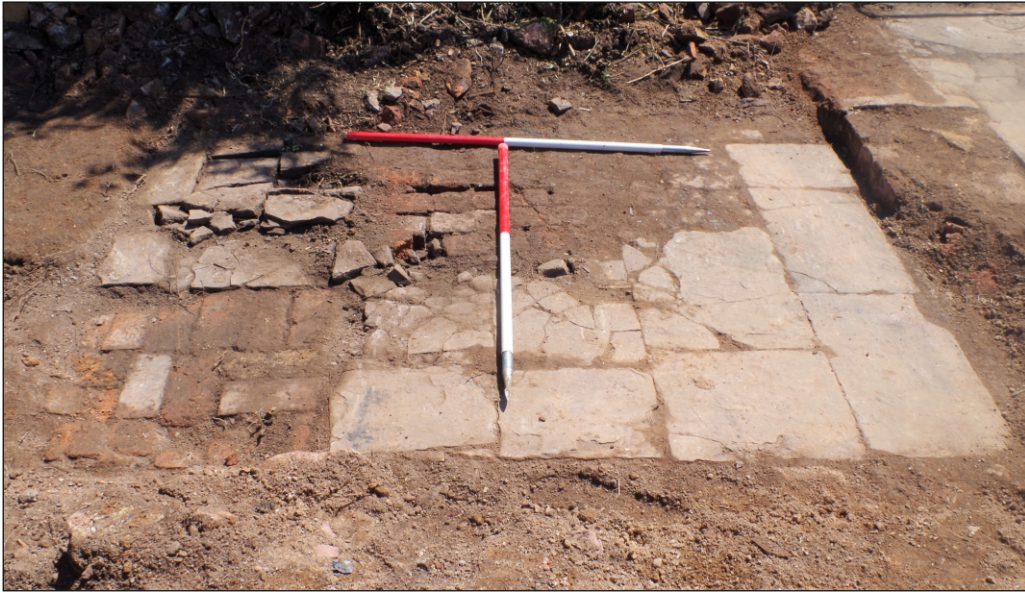
Plate 5: Floor 106, looking east, 2 x 1 m scale

- 5.3.8 Floor 106 was constructed of orange brick and pennant flagstones. The bricks measured 220 mm x 100 mm, the flagstones varied in size from 0.27 m x 0.29 m to 0.37 m x 0.54m (**Plate 5**).

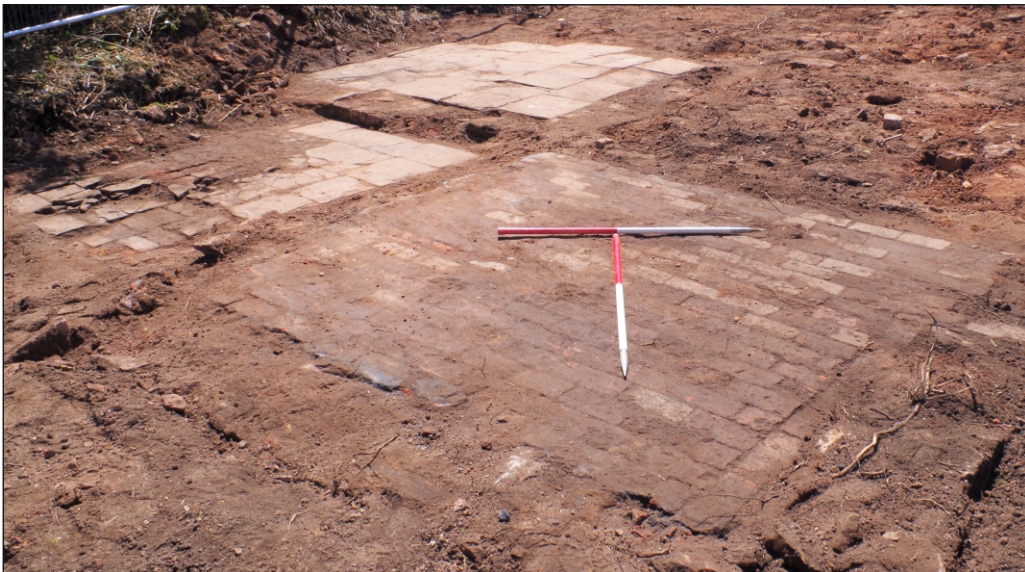
Plate 6: Floors 105, 106 and 107, looking south-east, 2 x 1 m scale

- 5.3.9 Floor 107 was constructed from bricks measuring 220 mm x 100 mm (**Plate 6**).

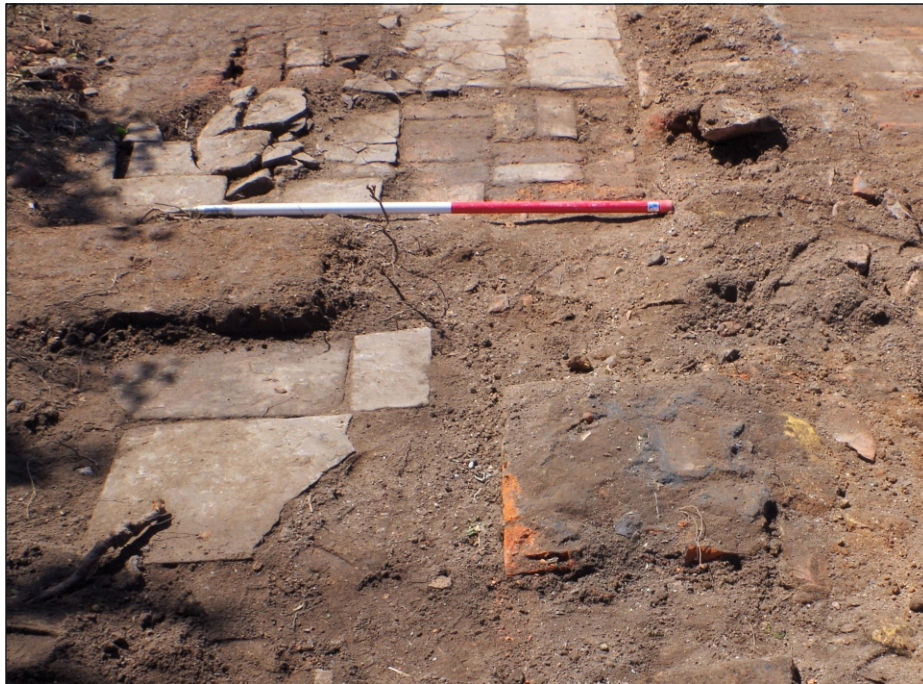
Plate 7: Brick structure 109, looking south, 1 m scale

- 5.3.11 Within the same room as floor 108, a square brick structure measuring 0.43 m x 0.47 m, was revealed butting wall 101. Constructed of bricks measuring 220 mm x 100 mm bonded with black ashy lime mortar, the structure has been interpreted as the lowest surviving course for an internal column or other internal cottage feature (**Plate 7**).

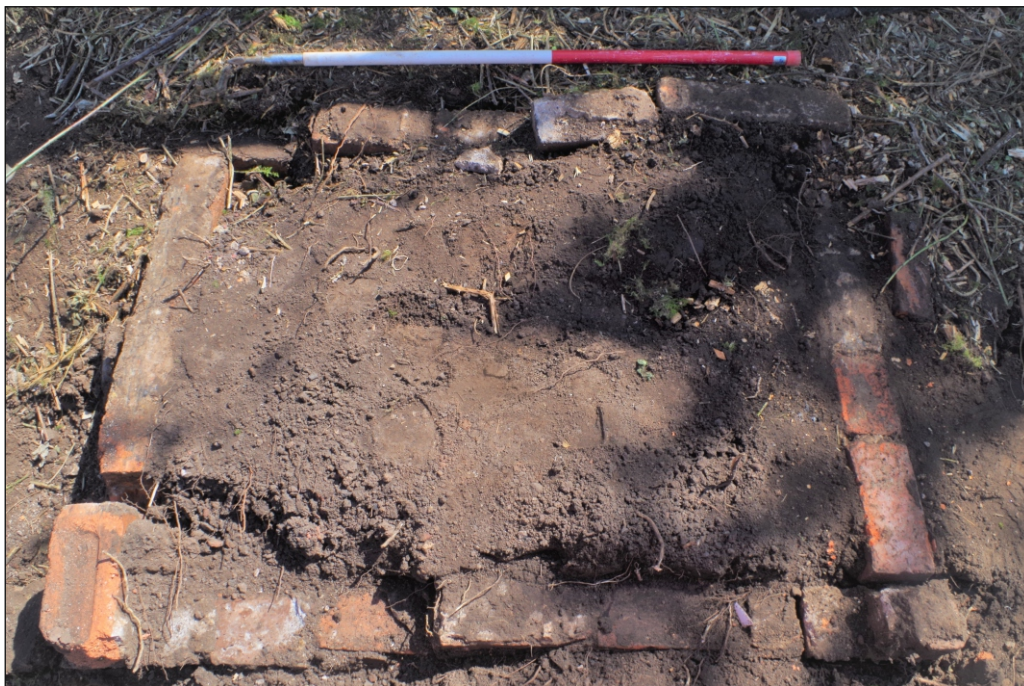
Plate 8: Brick cesspit 110, looking east, 1 m scale

- 5.3.12 Within the garden area to the rear of the cottages, a rectangular brick built structure 110, interpreted as a cess pit measuring 1.37 m x 1.06 m, was revealed surviving to two courses in height (**Plate 8**). Constructed of brick measuring 230 mm x 100 mm x 70 mm, bonded with white lime mortar with charcoal inclusions, a ceramic drain was noted entering the southern side of the structure.
