Tudno Castle Hotel, Vaughan Street, Llandudno

Interim Statement: Garage Building

Report No. 1532

December 2016

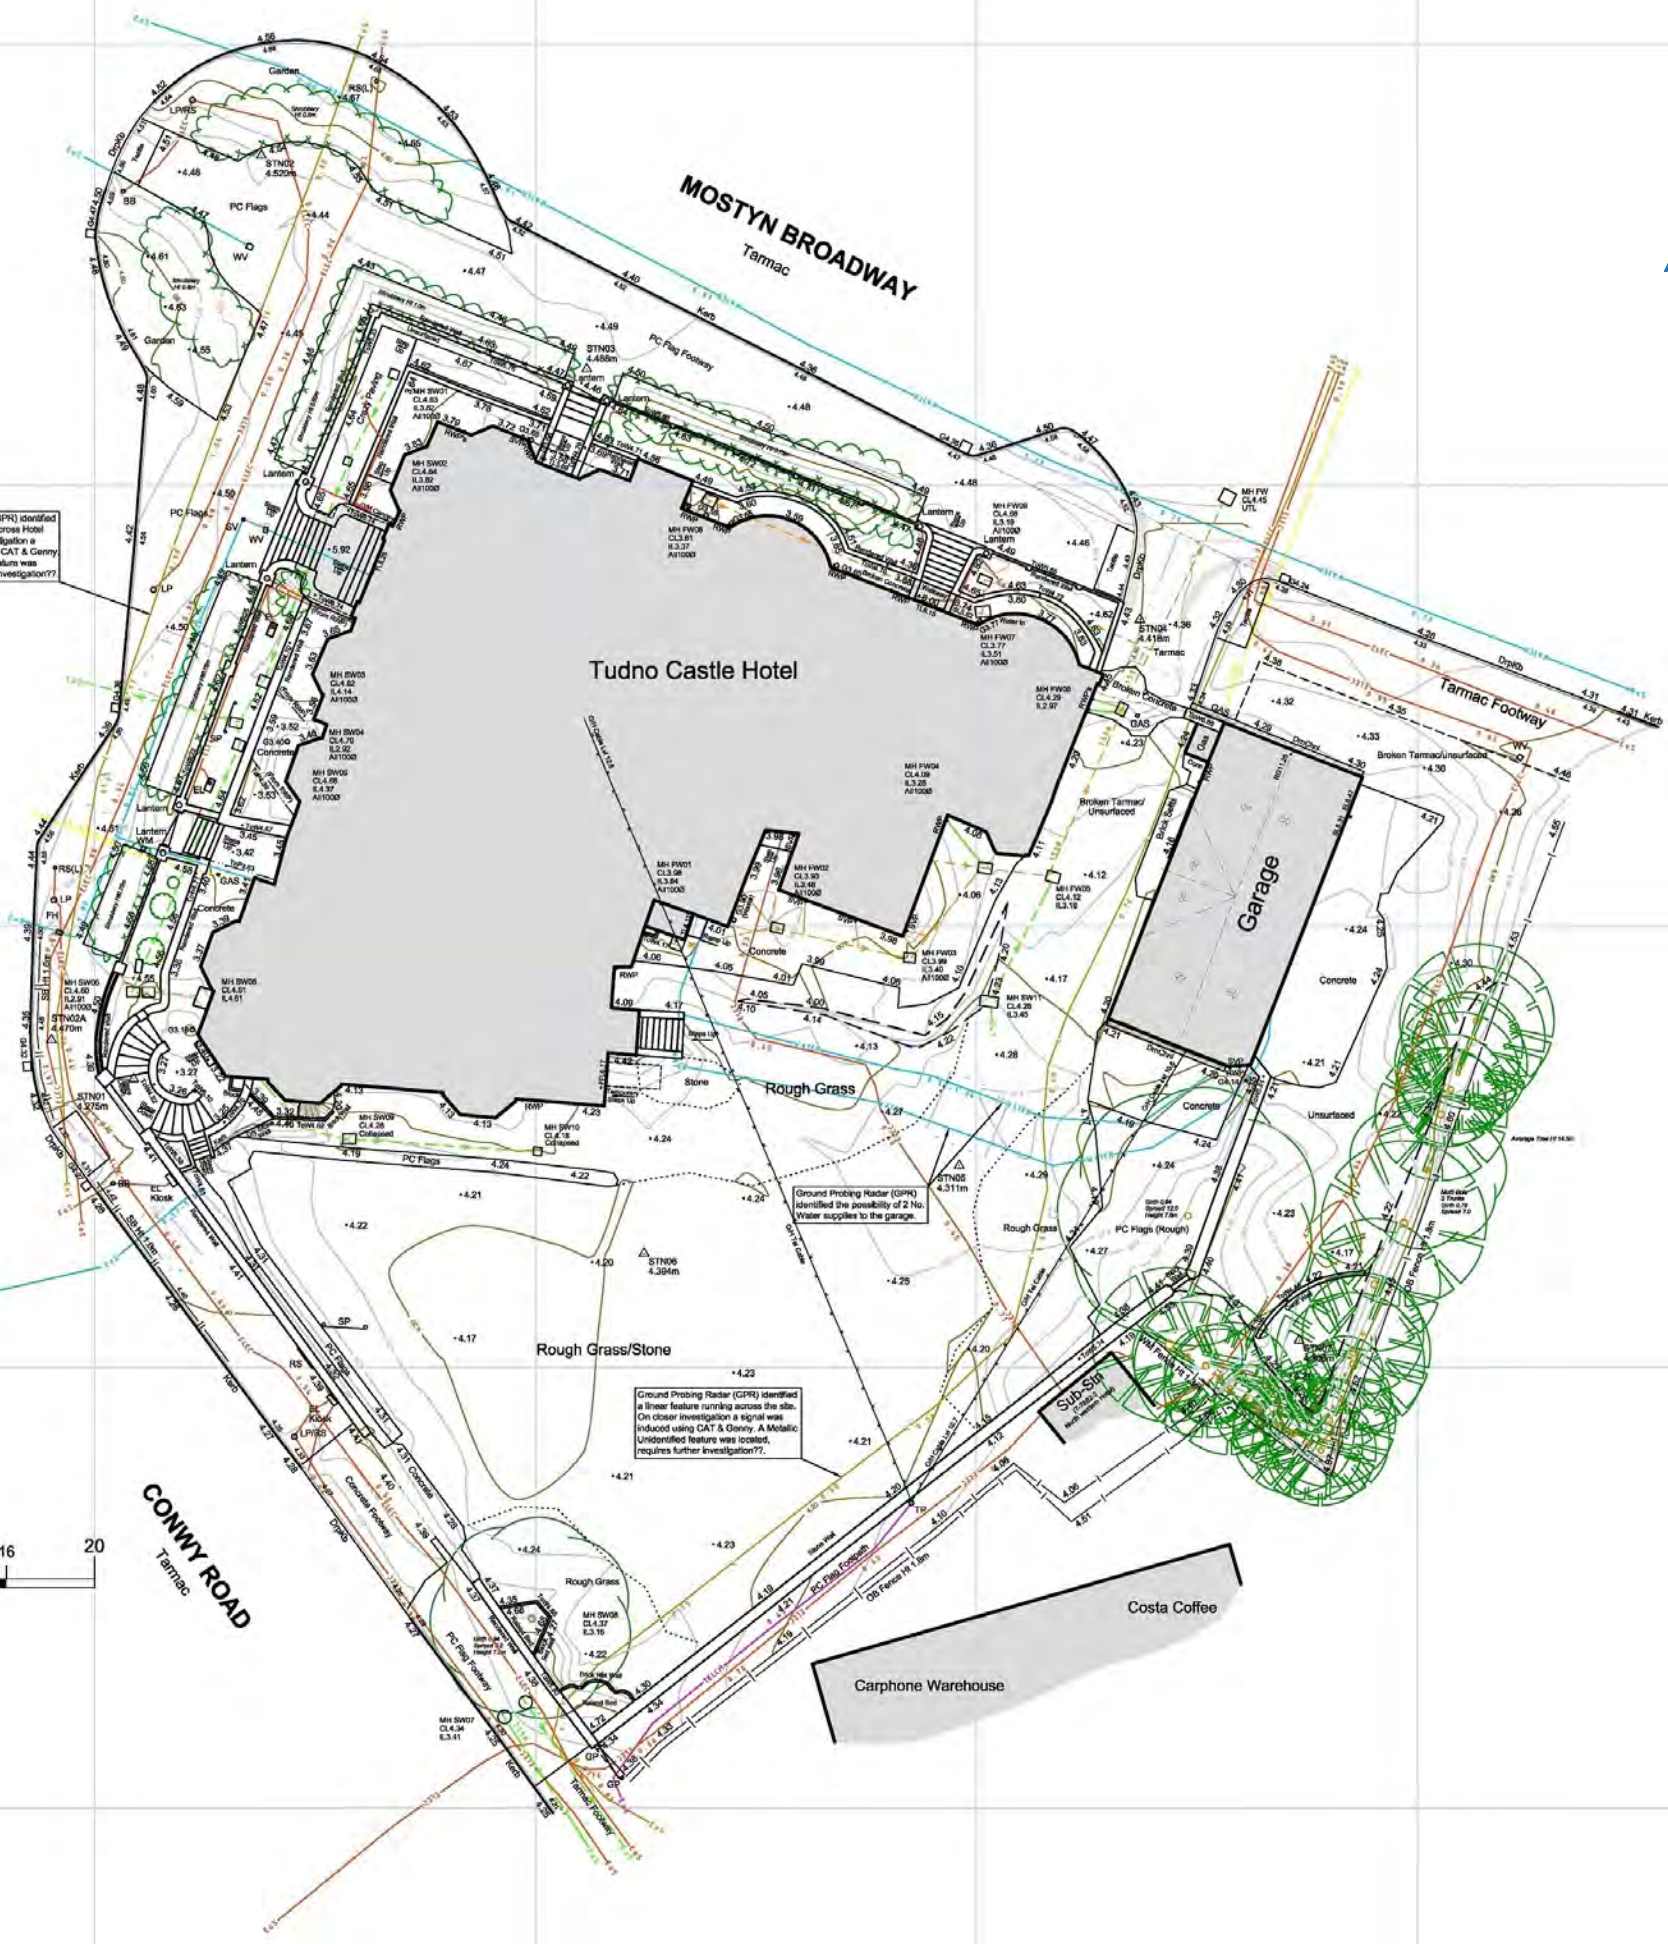
Figure 3: Plan of existing buildings on site, from developers supplied information, 1:200

Figure 3 shows the existing ground floor plan of the hotel and garage, while figure 4 shows the location and direction from which the photographic plates were taken on the ground floor. All the useable photographs taken on site are presented in this report.

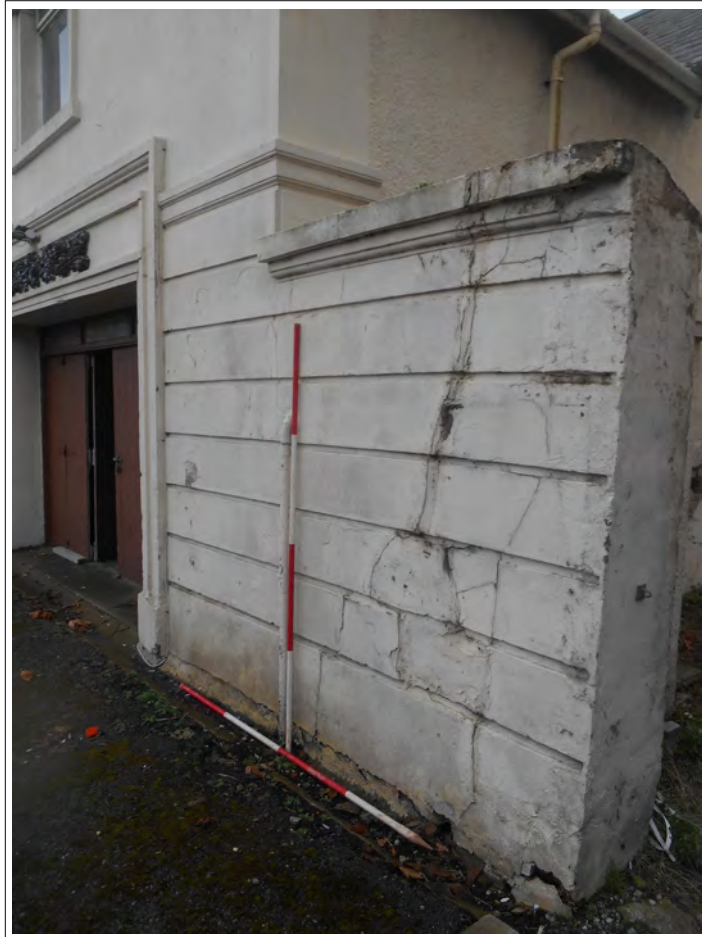
Plate 1. View of western wall of facade. Looking south. Scales 2 x 2m

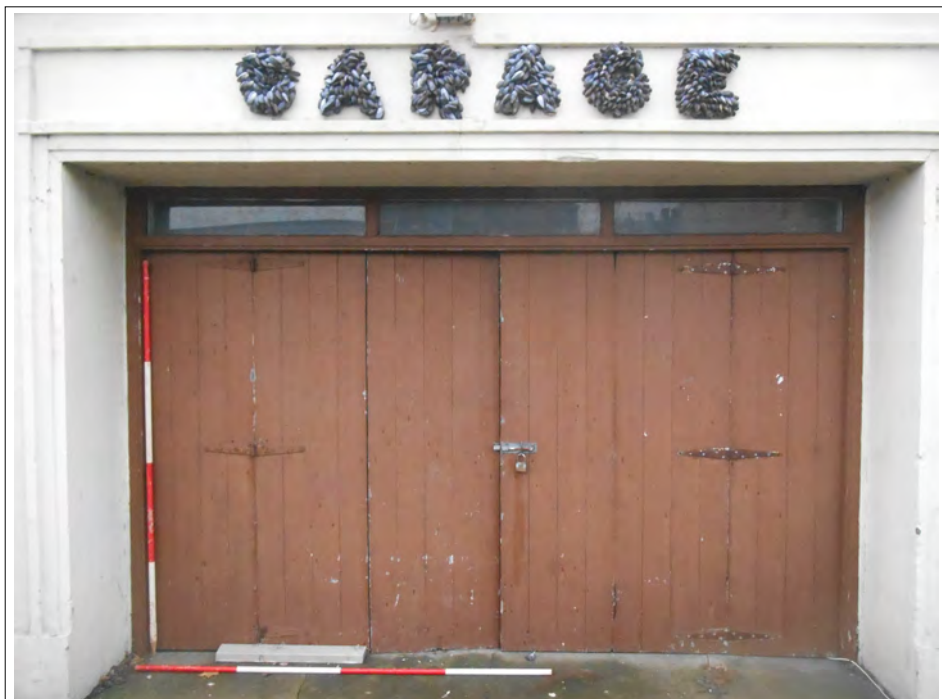
The entrance is defined by an architrave and sealed by a panelled wooden door. The latter is known not to be original as the ground floor interior evidences the remains of the rails of an earlier door (see interior).

Plate 2. Main garage entrance. Looking south. Scales 2 x 2m

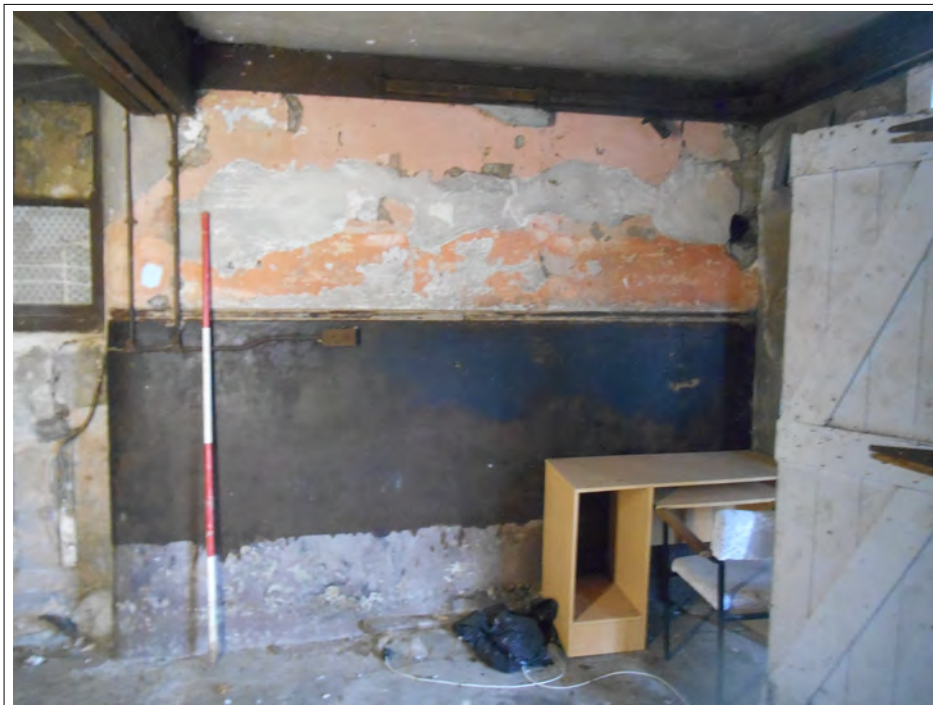
Plate 4. East facing wall of ground floor interior, with dado rail. Scale 2m

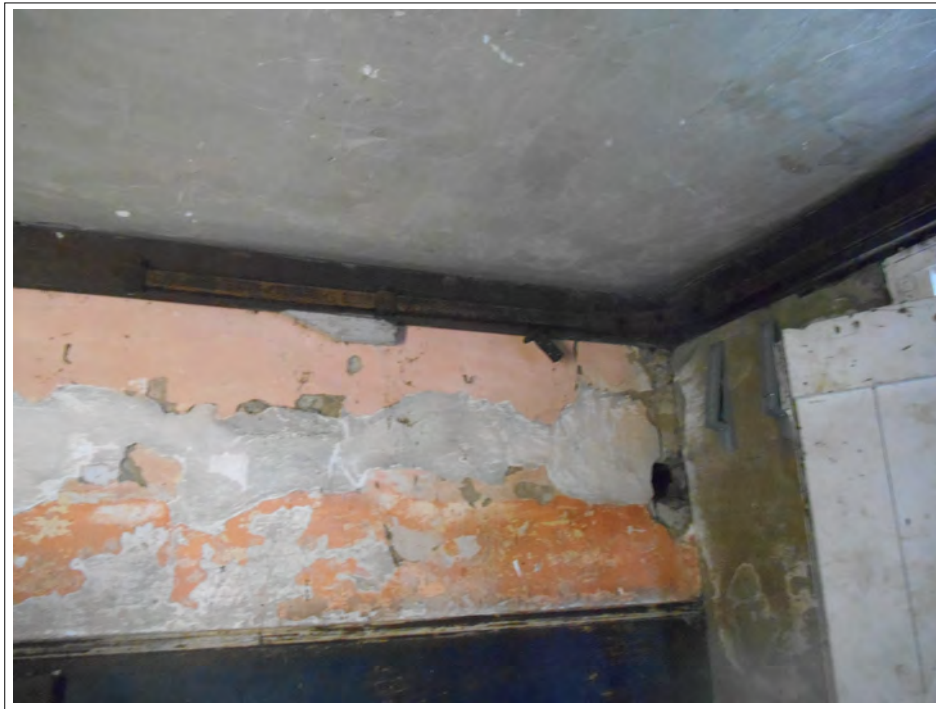
Finally, it is worth noting that, from the interior, a railing was visible that probably relates to an entrance door that is no longer in use. These railings may be components of the original structure.

Plate 5. Detail of door track/slide - no longer in use

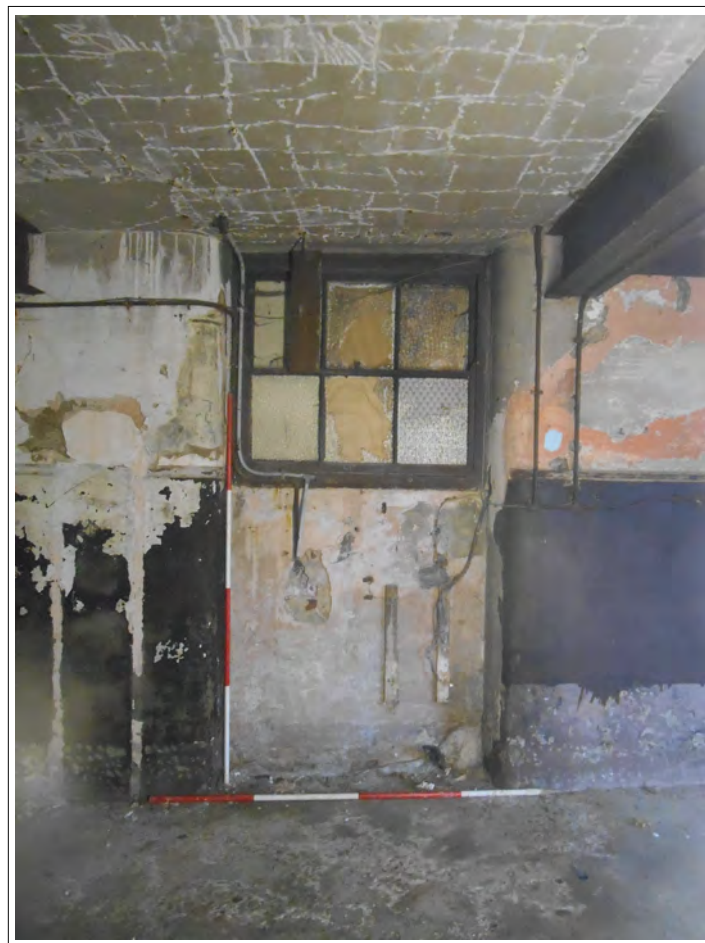
Plate 6. Remains of early door, subsequently transformed into a window which is currently blocked. Eastern facing interior wall. Scales 2 x 2m

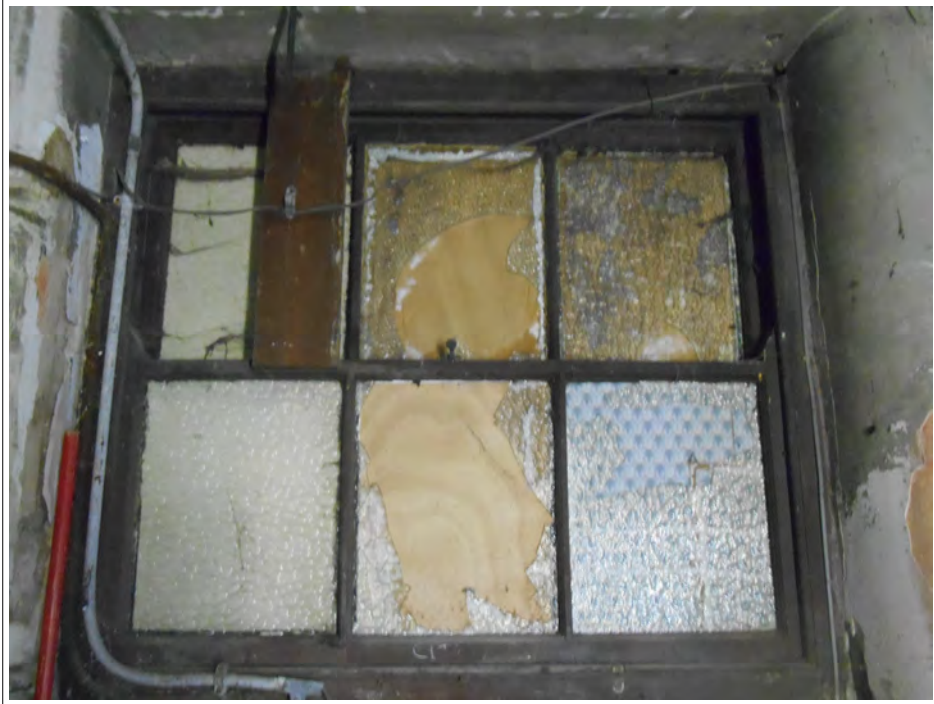
Plate 7. Detail of sash window. Eastern facing interior wall.

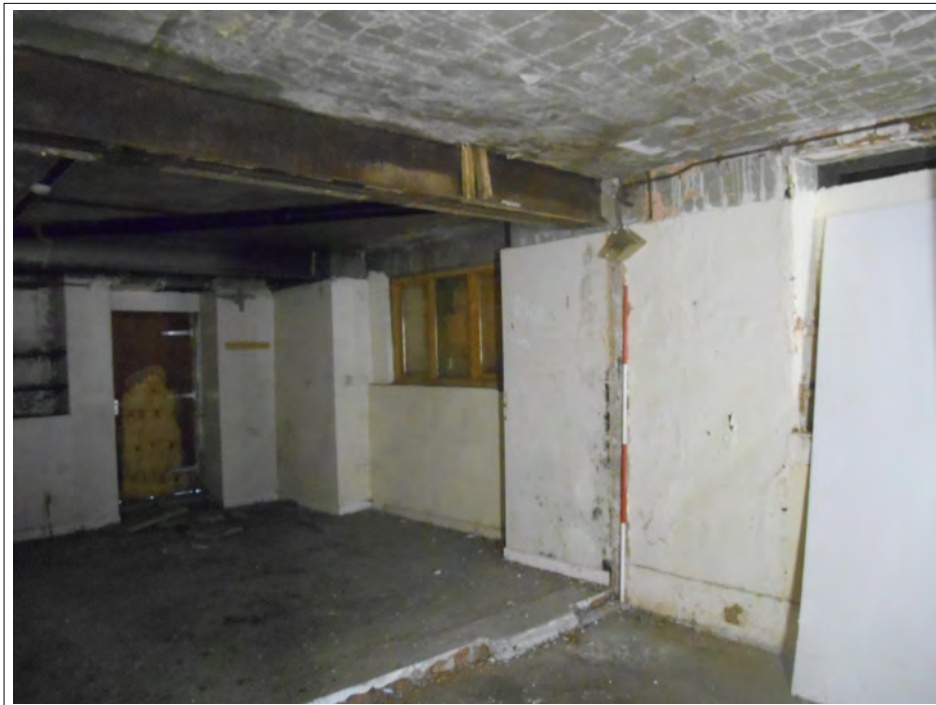
Plate 8. East facing wall. 1960's Window subsequently repaired. North facing wall with back entrance. Not original. Scale 2m

3010: East facing wall. 1960's window subsequently repaired. North facing wall with back entrance. Not original. (Plate 8)

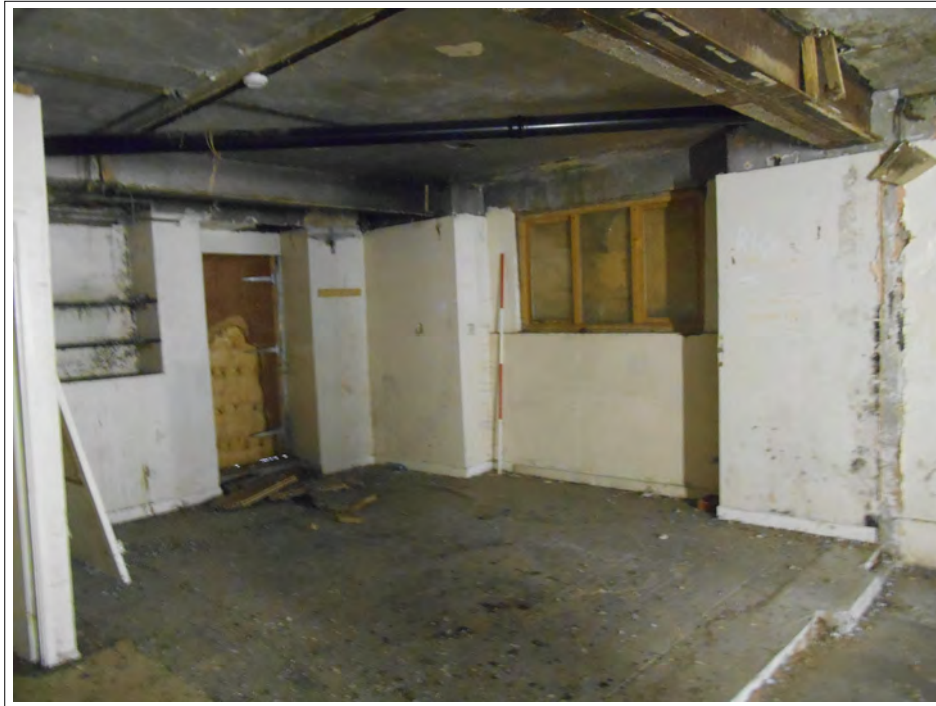
Plate 9. East facing wall. 1960's Window subsequently repaired. North facing wall with back entrance. Not original. Scale 2m

3014: East facing wall. 1960's window subsequently repaired. North facing wall with back entrance. Not original (Plate 9)

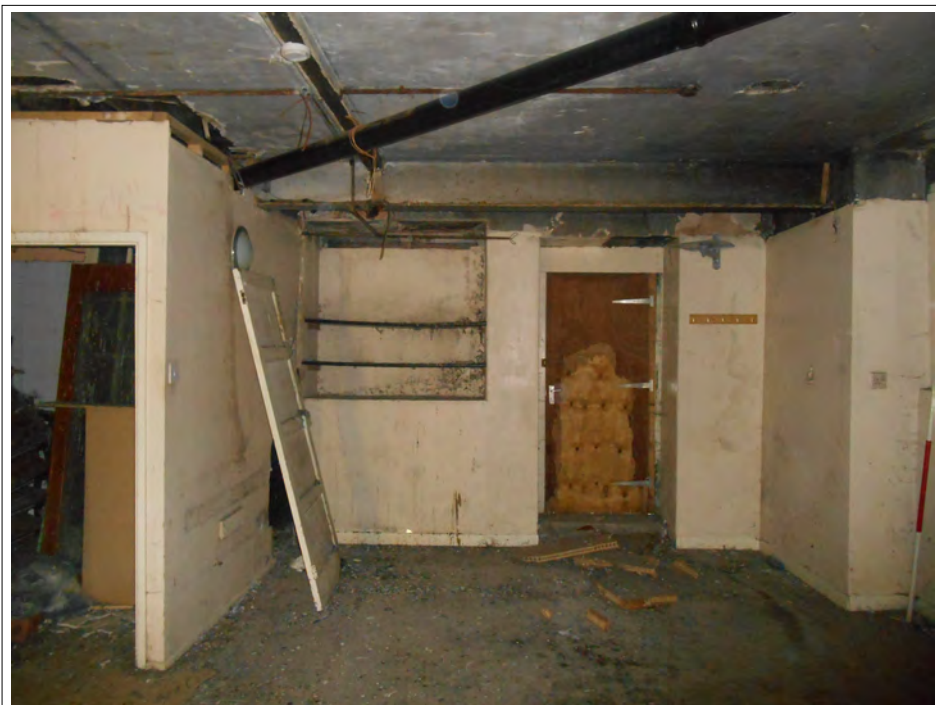
In the centre of this wall shelves have been inserted. As previously noted, this area utilises the space created by a window that had been sealed. Finally, another door is located to the east of the wall. Compared to all the other openings, it was possible to note that this access was used until recent times.

Plate 10. North facing wall. Inset blocked window transformed into shelving.

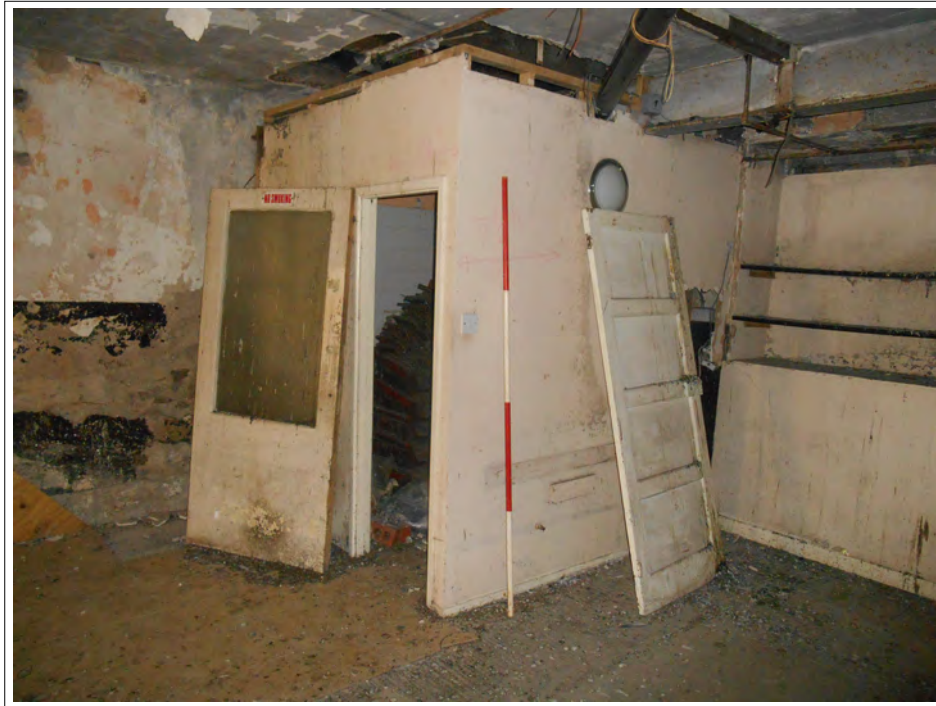
This area contained a modern alteration, including a room made of plaster board. This room would have had access from the outside, as noted, with the door observed in the exterior.

Plate 11. Modern studded wall. Facing west. Scale 2m

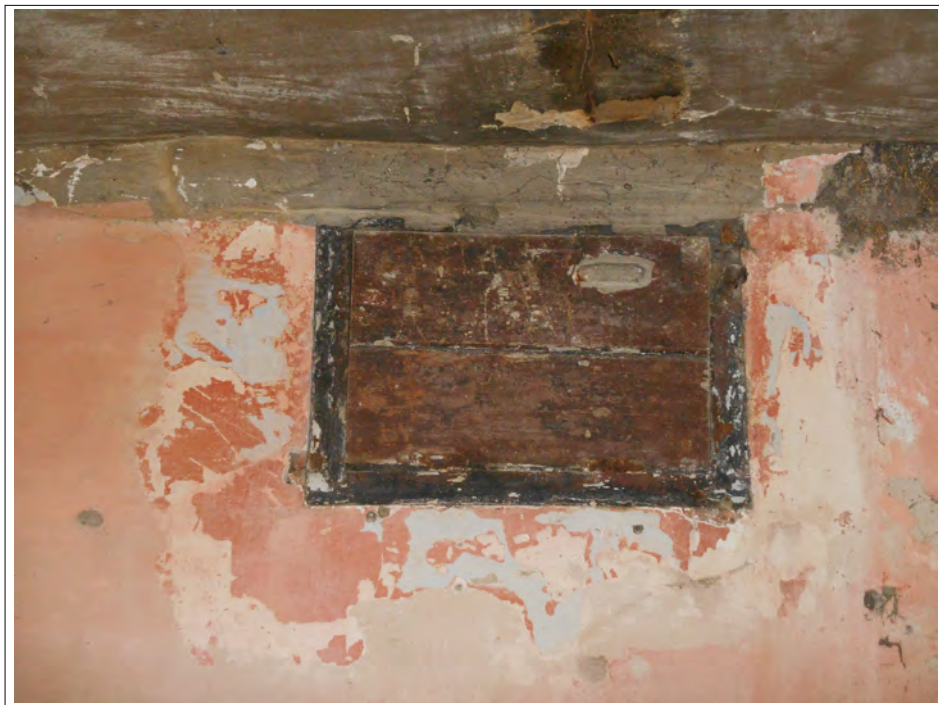
Plate 14. Possible vent, west facing wall.

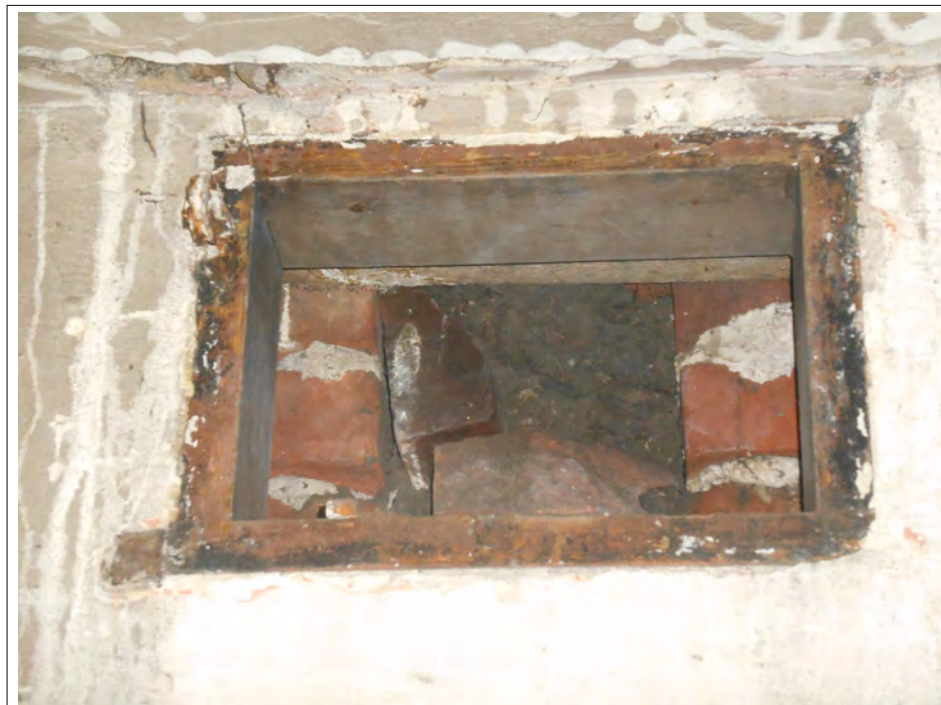
This wall contains three blocked vents. These may belong to the original structure and have been subsequently remodelled by the addition of an attached structure to the NE of the building. This hypothesis is reinforced by noting that the vents are not visible on the exterior wall.

Plate 16. Blocked vent, west facing wall.

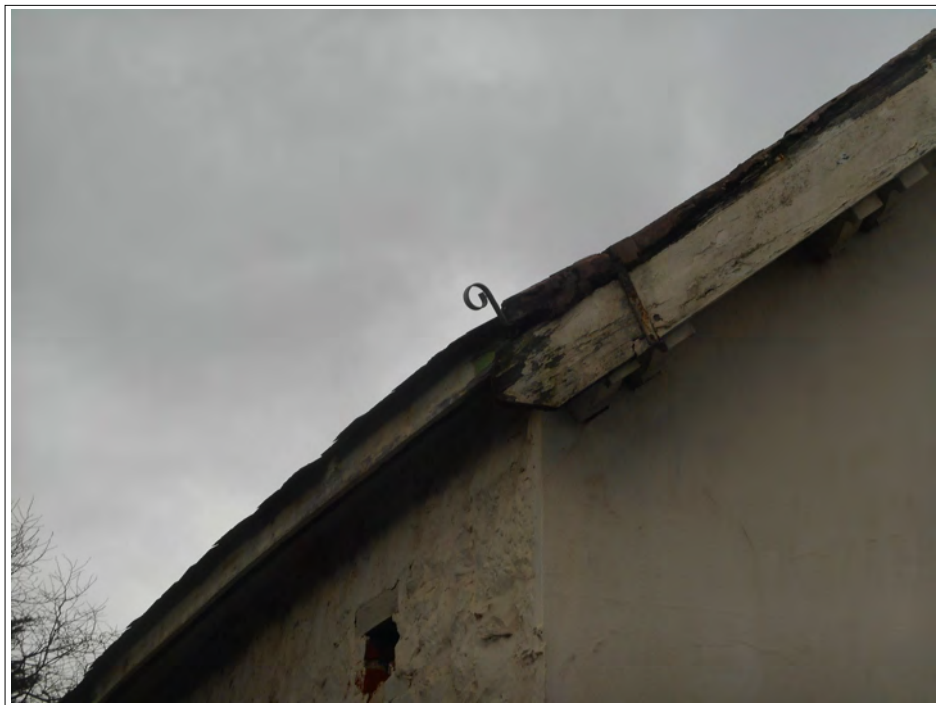
Plate 20. Detail of corbel.

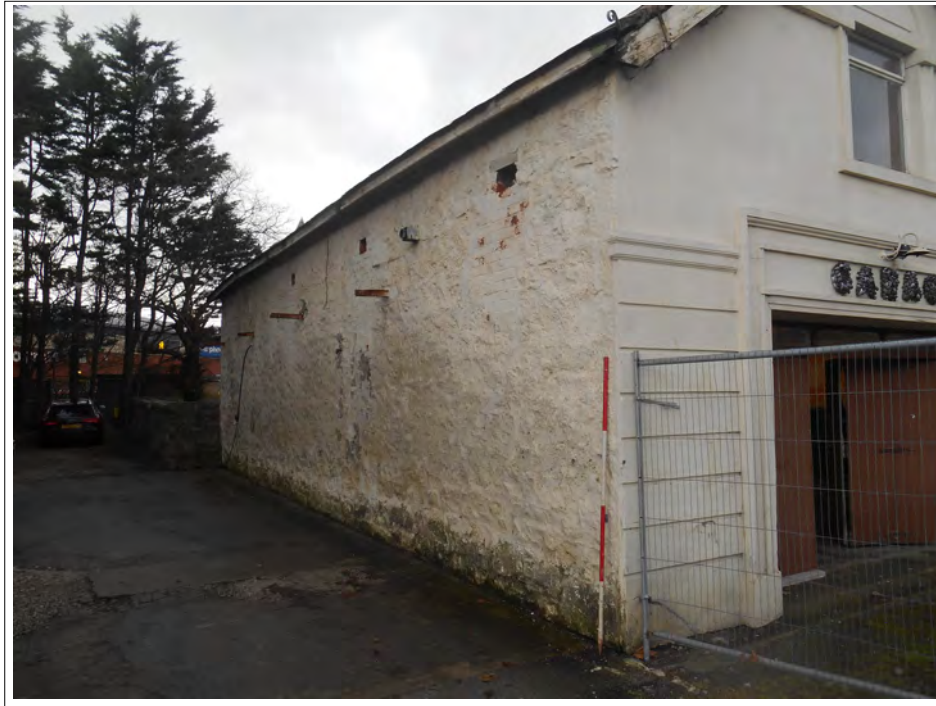
Plate 21. Oblique view of west facing exterior wall with corbels. Scale 2m

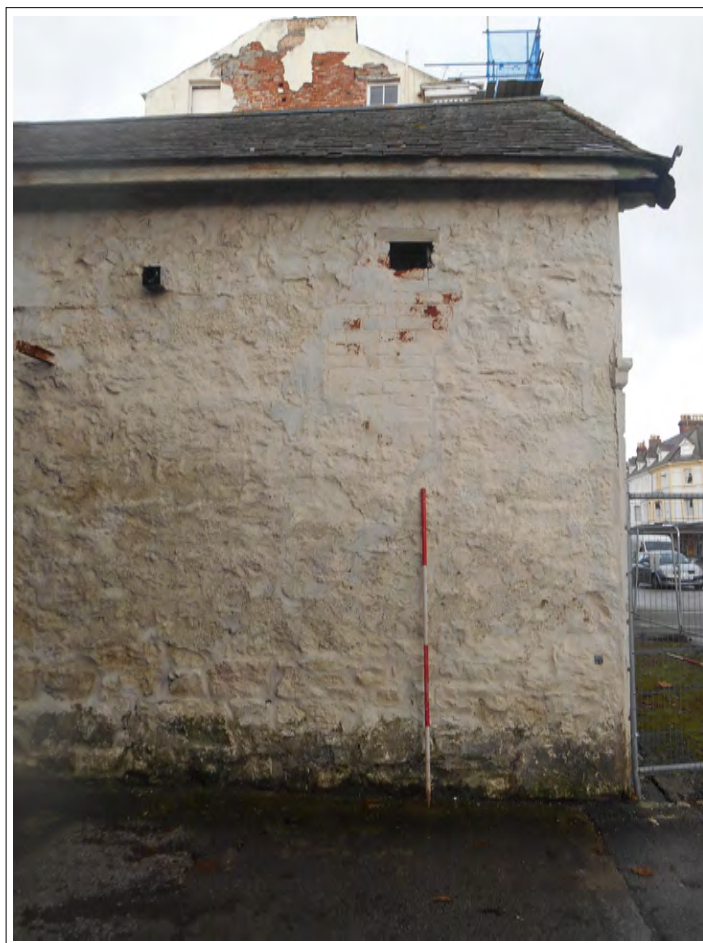
Plate 22. Detail of repair or alteration of possible window or vent. Scale 2m

3037: detail of repair or alteration of possible window/vent? (Plate 22)

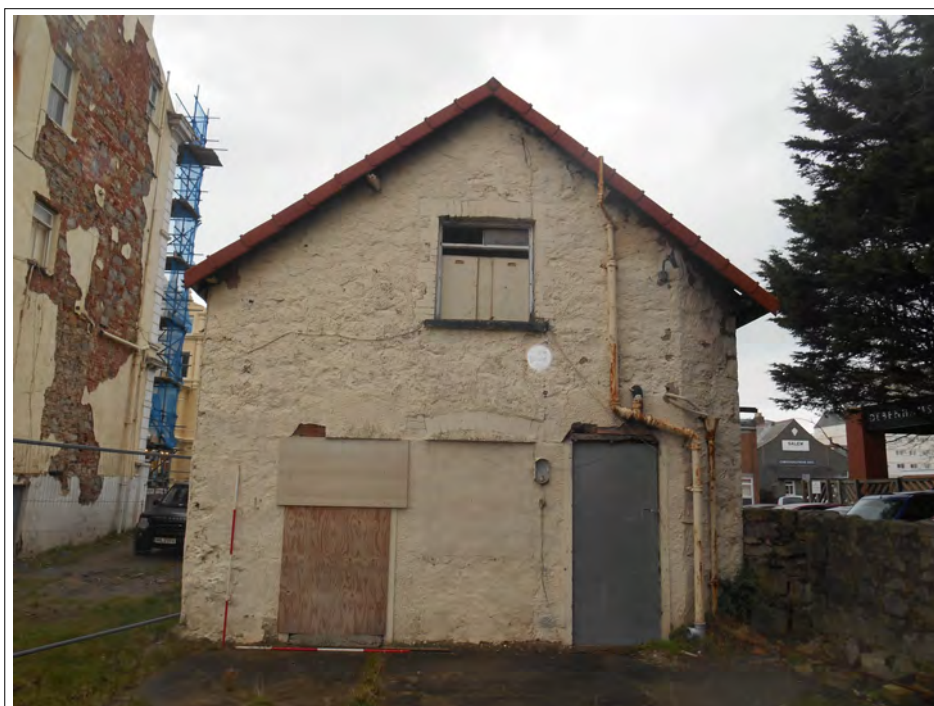
The top window is square and confined within a toothed style brick pattern. It is thought that this window was built when the structure was remodelled to suit space for a first floor. Judging from historical OS maps, it is likely that the first floor was an addition pre-dating 1950.

Plate 24. View of back entrance. Windows and doors are not original and demonstrate a number of alterations over time. 1960's hoods. First floor window with reveal toothed brick effect. Scales 2 x 2m

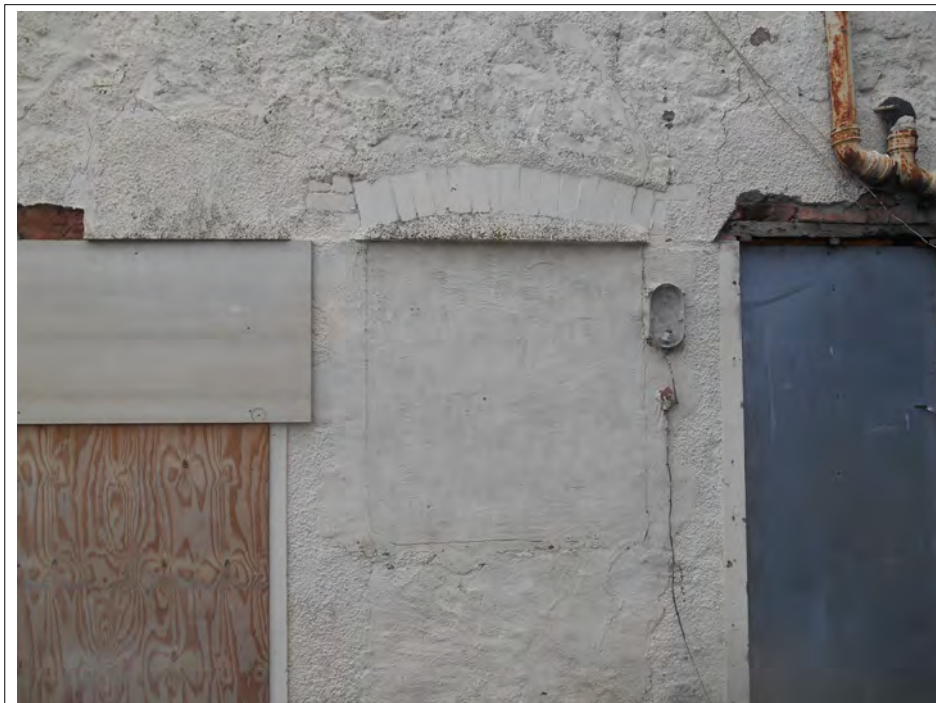
Plate 26. Detail of window hood.

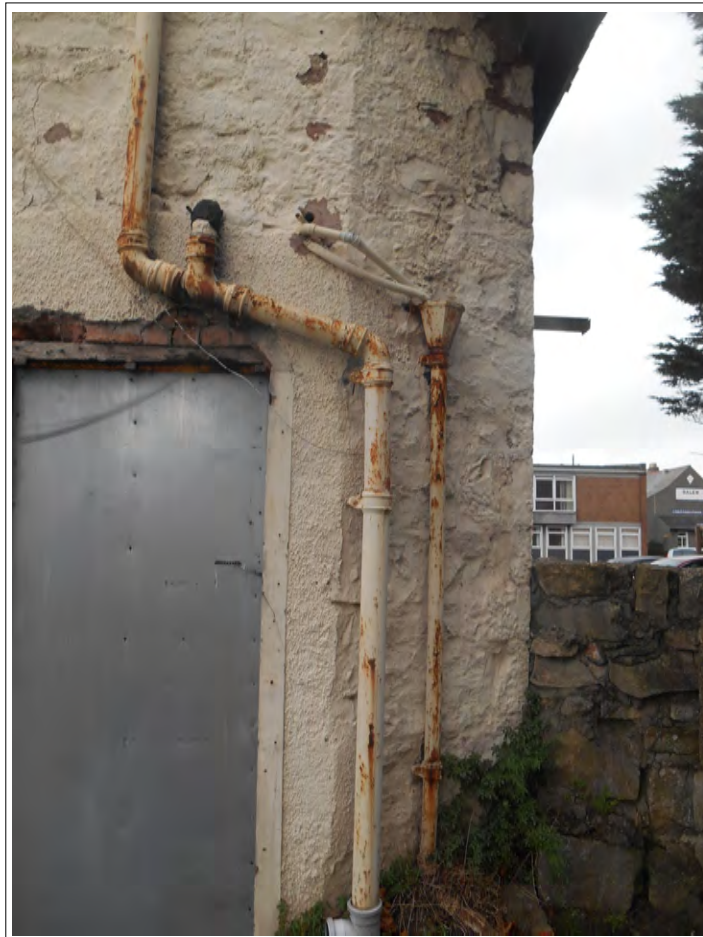
The cast iron guttering found to the west of this wall is connected to an outlet pipe on the first floor.

Plate 29. View of cast iron guttering.

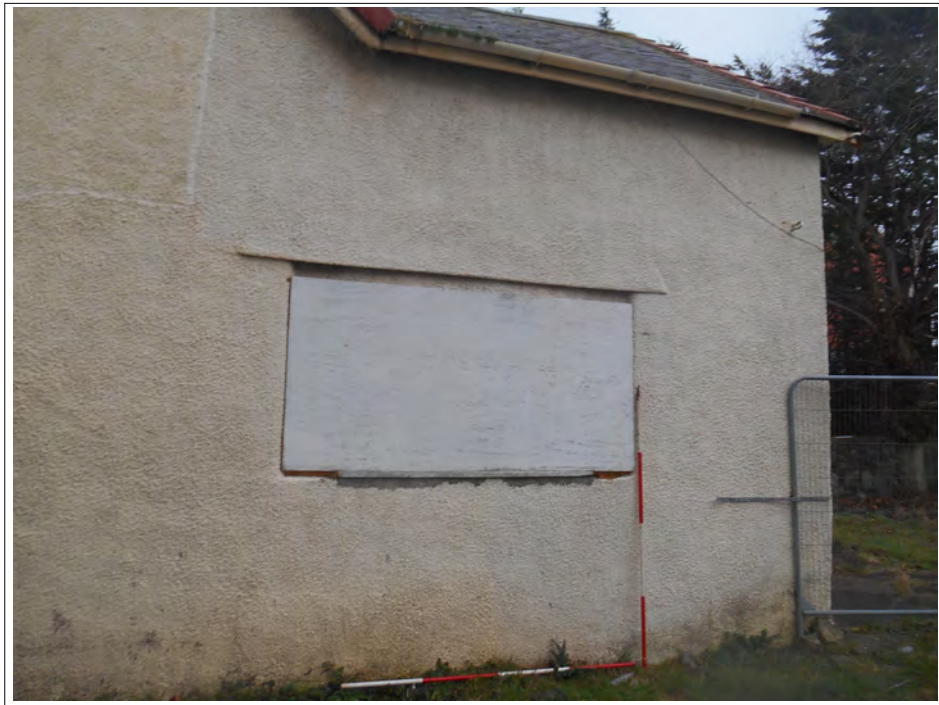
Plate 32. 1960's Window with hood. Pebble dashed wall, east facing.
Scales 2 x 2m

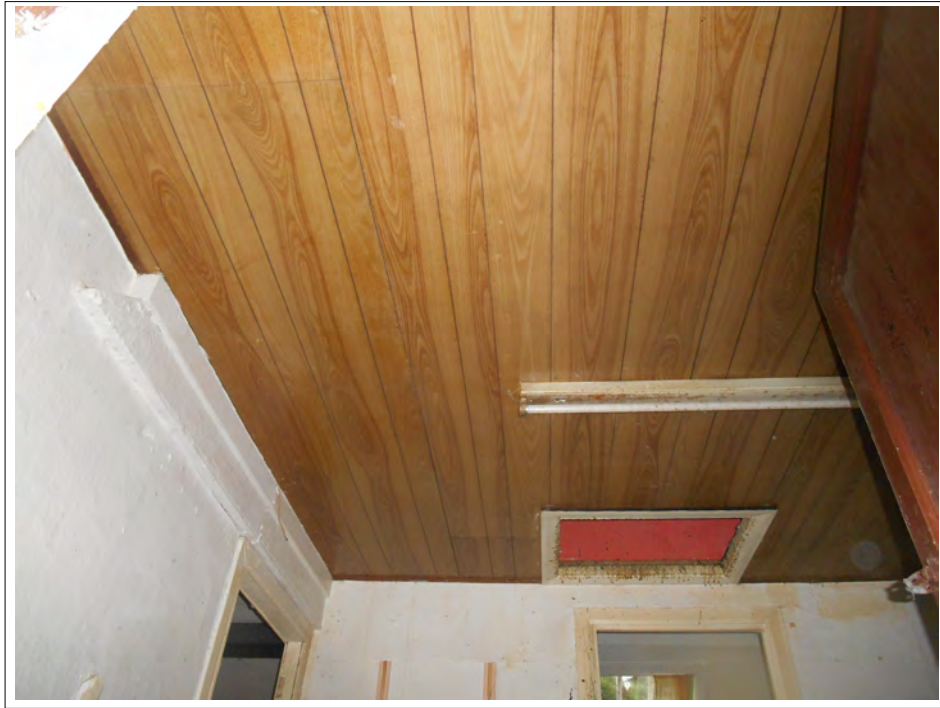
Plate 37. First floor sealing.

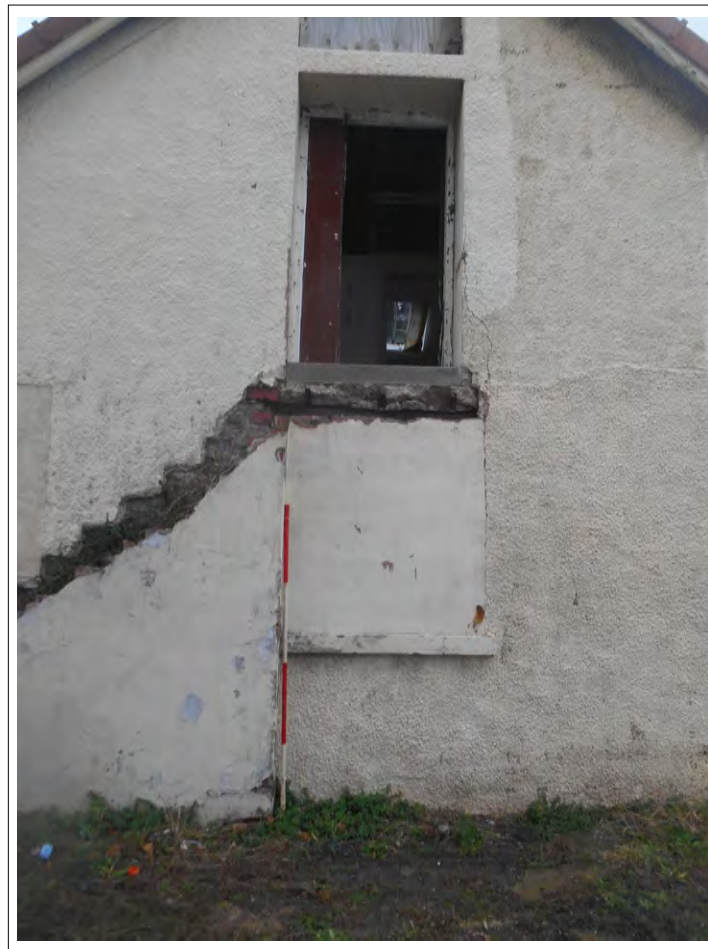
Finally, the footprint of a staircase is present on this wall face, evidencing that, similarly to the SE elevation, the wall was made of brick and rendered with pebble dash.

Plate 38. Detail of first floor door and exterior stair case, east facing wall. Scale 2m

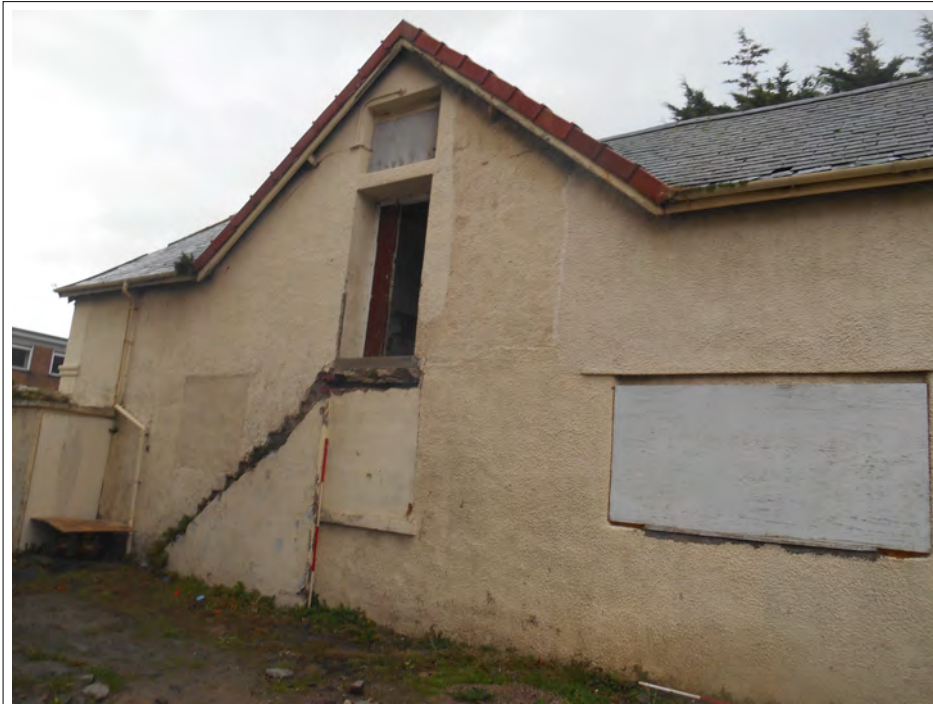
Plate 39. Detail of first floor door and exterior stair case, east facing wall. Scale 2m

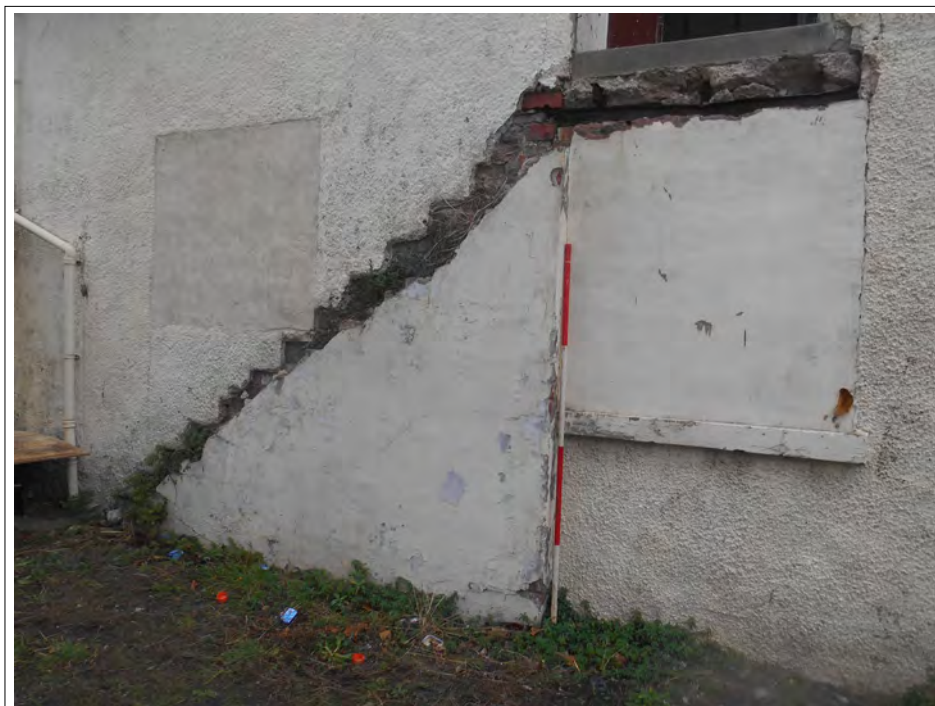
Plate 40. Detail of exterior stair case and doorway/window. Scale 2m

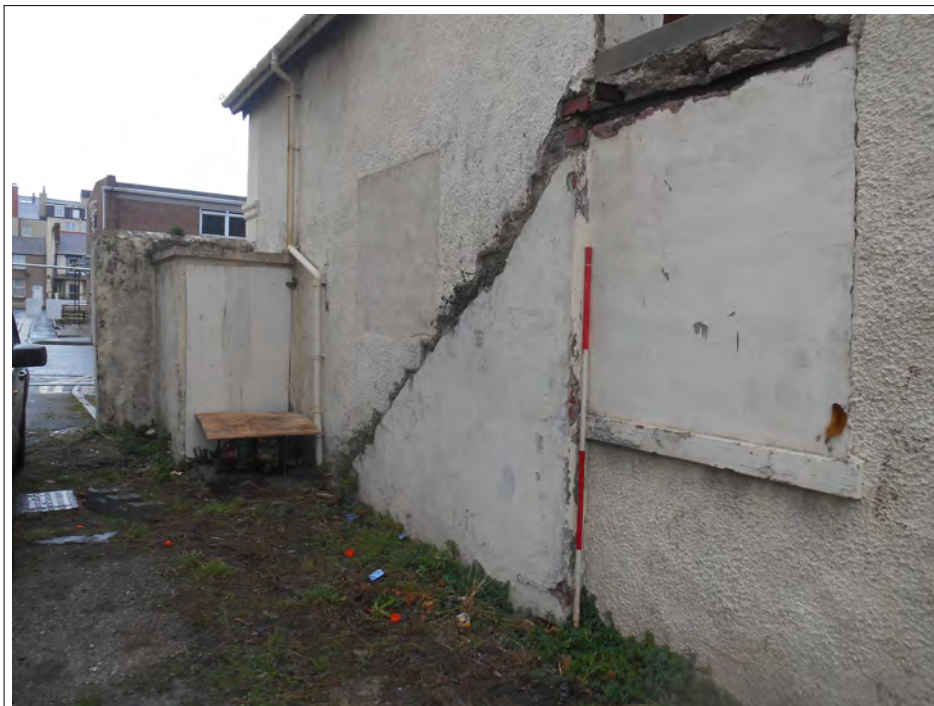
Plate 41. Outbuilding attached to garage behind facade wall.
West facing wall. Scale 2m

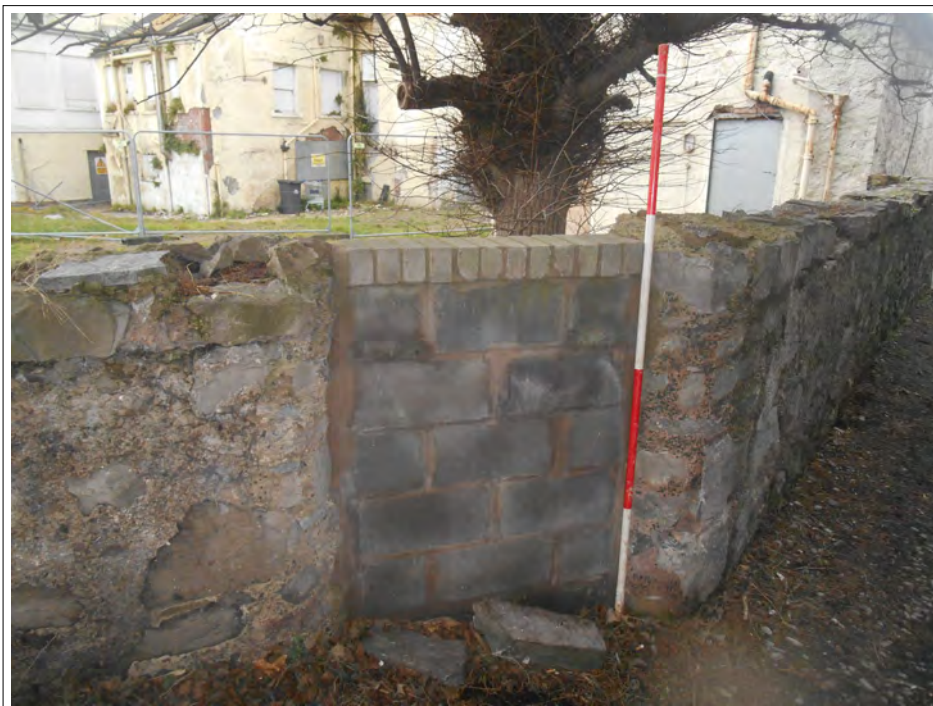
Plate 45. Modern alteration of circuit wall. Scale 2m
