CPAT Report No. 1645

Brook House Tank, Leighton, Powys

BUILDING SURVEY

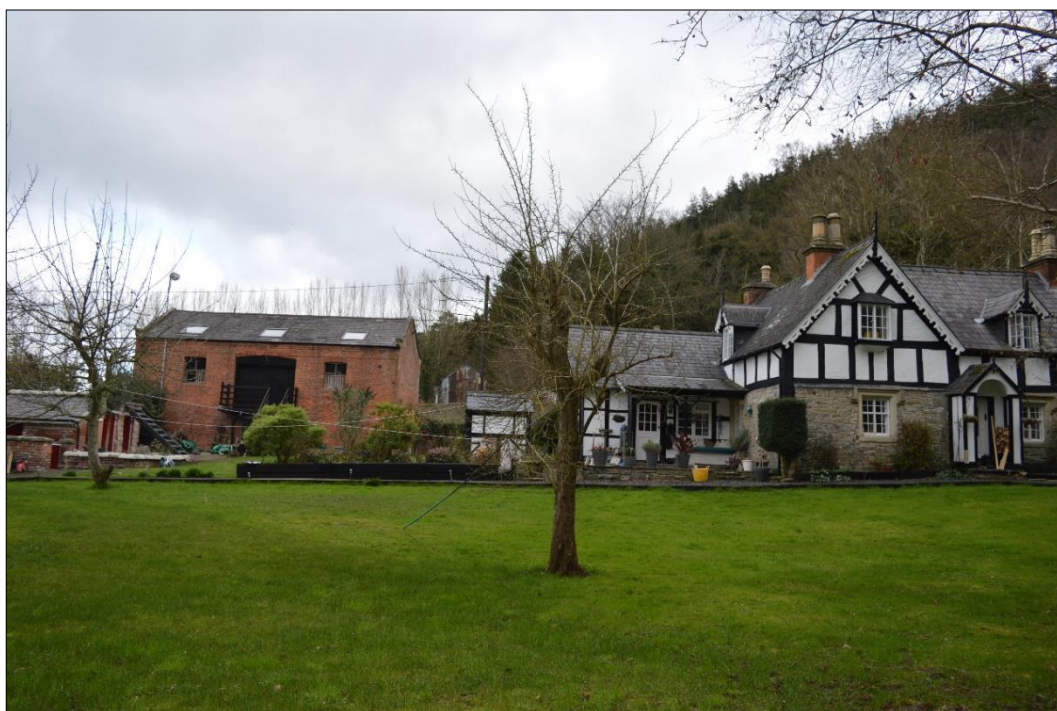
Fig. 2 The Tank House, with Brook House to the right. Photo CPAT 4602-0032

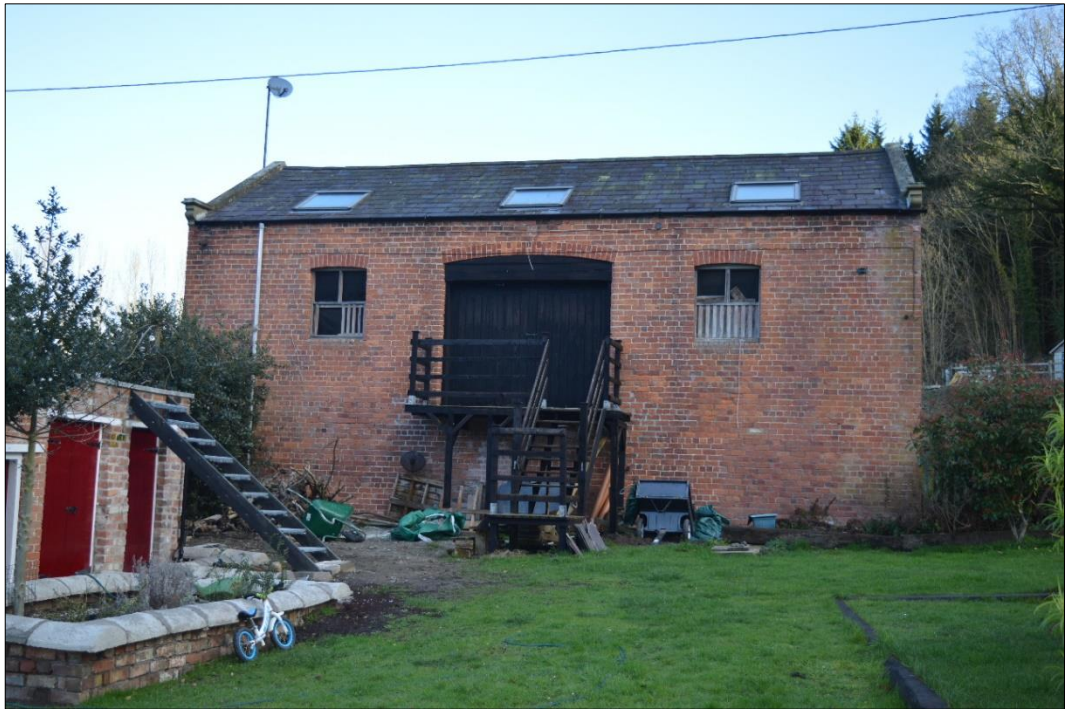
- 2.8. There is a large central, planked doorway to the front elevation (Fig 4) which is accessed via a set of wooden steps. The doorway has a chamfered brick surround and a segmental head of 35 bricks. There are single windows to either side with chamfered brick sills and segmental heads of 13 bricks above. The frames are wooden. To the roof, three roof lights are visible. An oval, iron tie bar is visible below and to the left of the doorway.

Fig. 4 The front elevation of the Tank House. Photo CPAT 4602-0001

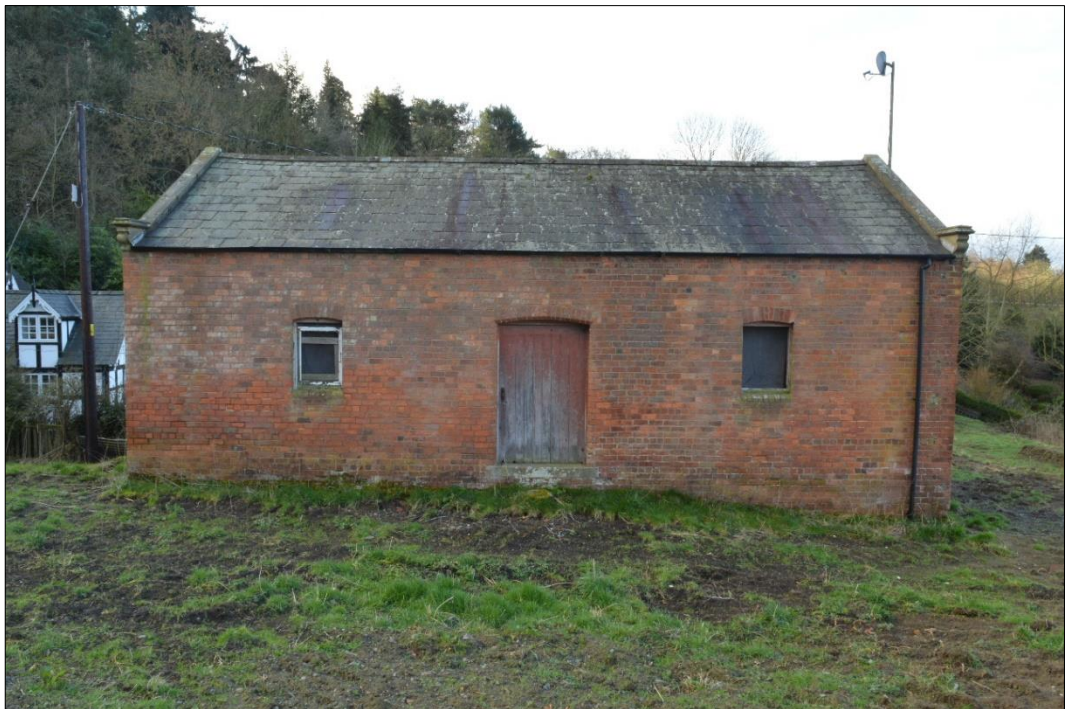
- 2.9. The rear elevation (Fig. 5) is set into the hillslope, with a single wooden planked doorway to the centre with a chamfered segmental arch above of 19 bricks and stone sill. As on the front of the building there are single windows to either side with segmental heads of 10 bricks above and chamfered brick sills below.

Fig. 5 The rear elevation of the Tank House. Photo CPAT 4602-0008

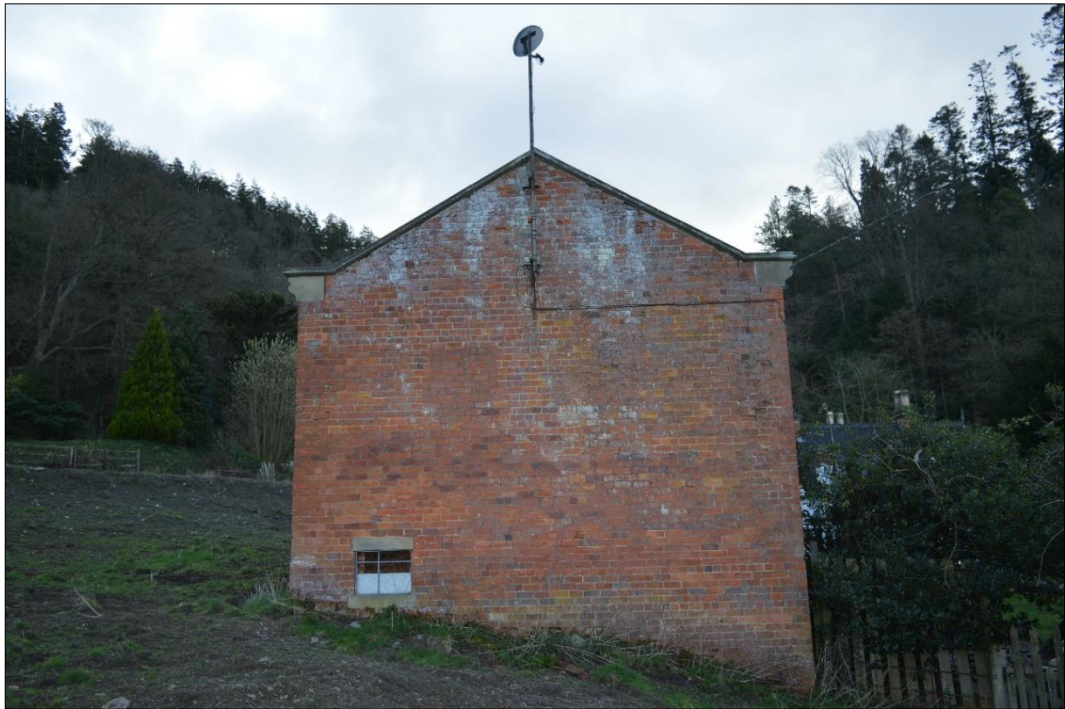
- 2.10. The western elevation (Fig. 6) contains a small opening at the lower left corner measuring 0.74m across by 0.56m high, with sandstone sill and lintel. The opening afforded a somewhat restricted view into the lower part of the building, which was otherwise inaccessible. A large iron pipe could be seen projecting into the building just below the opening (Fig. 7) and a limited view of the internal arrangement of the tanked area could be seen, which is double brick vaulted with a series of brick arched partitions, constructed from blue engineering bricks (Fig. 8). The iron tie beam could also be seen extending across from the façade towards the rear of the building.

Fig. 6 The west elevation of the Tank House. Photo CPAT 4602-0005

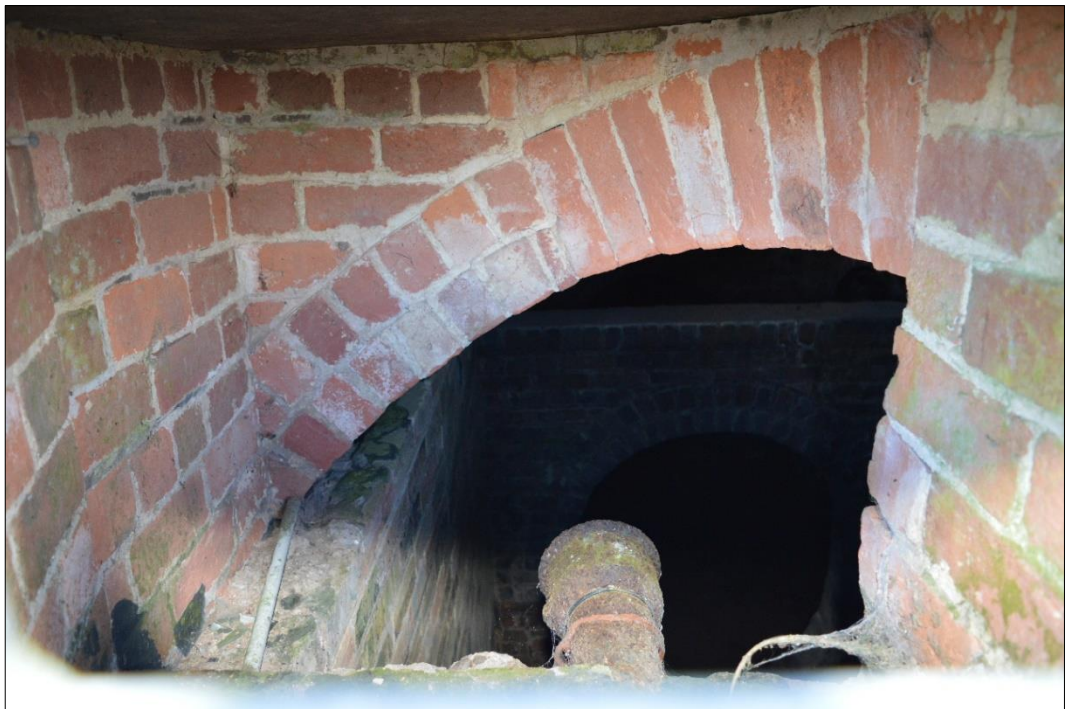
Fig. 7 The access to the tank at the base of the west elevation. Photo CPAT 4602-0007

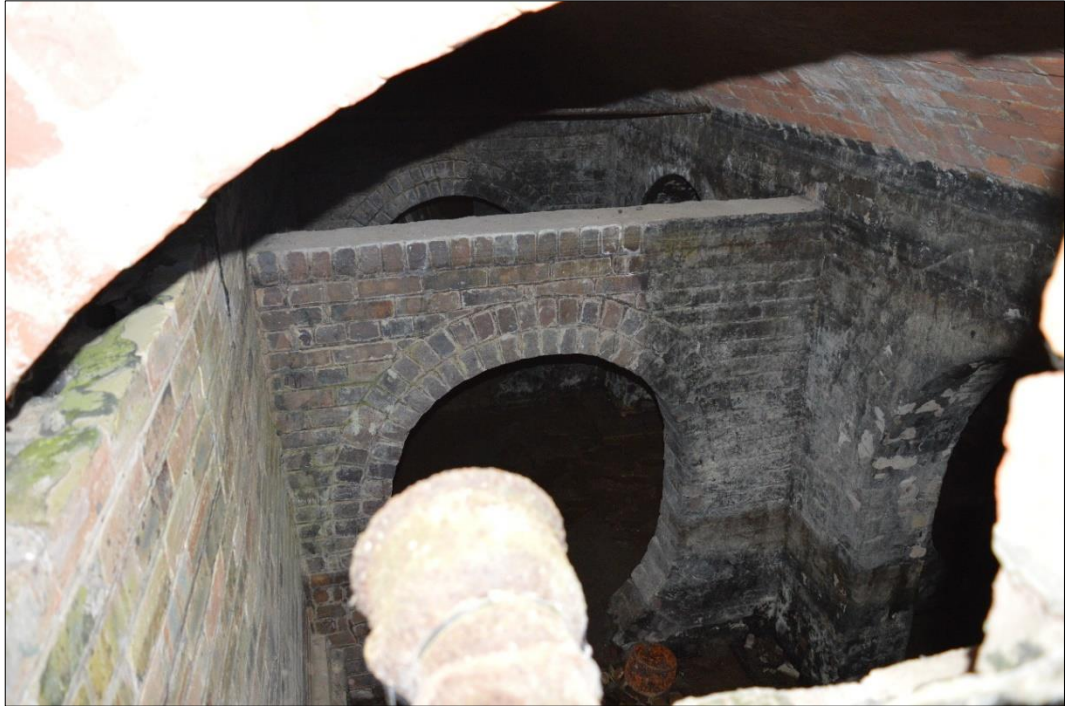
Fig. 8 The interior of the tank. Photo CPAT 4602-0012

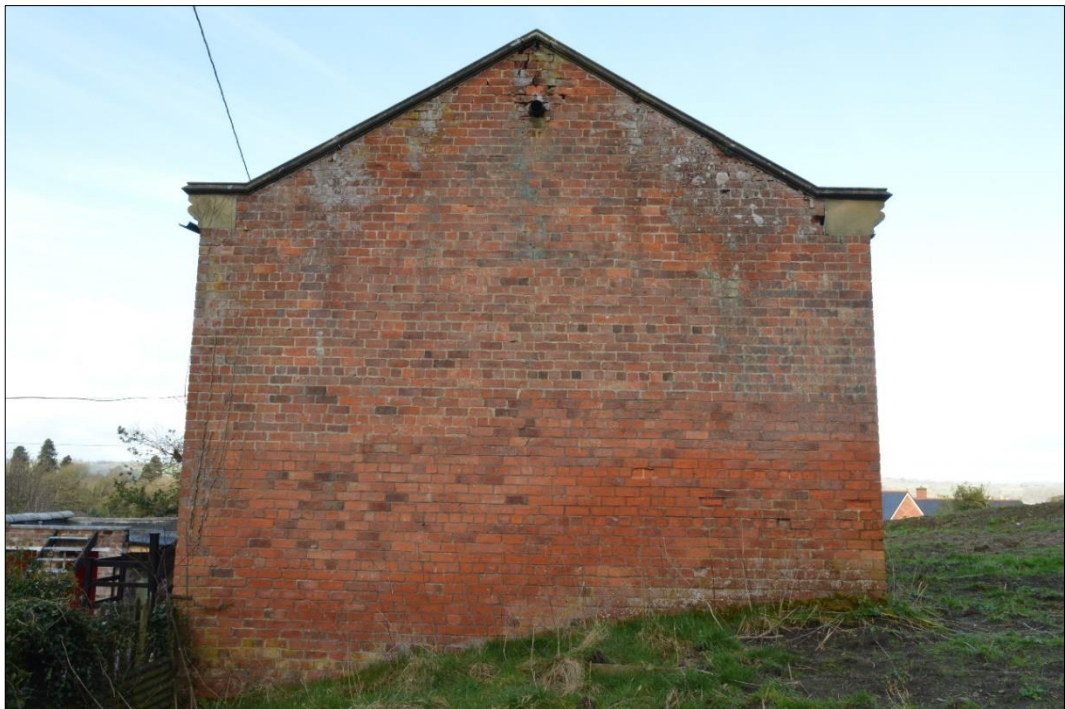
- 2.11. While the eastern elevation (Fig. 9) is relatively plain, a rectangular, overgrown, stone lined drain was noted adjacent to it with a series of iron fixings adhered to the stone.

Fig. 9 The east elevation of the Tank House. Photo CPAT 4602-0009

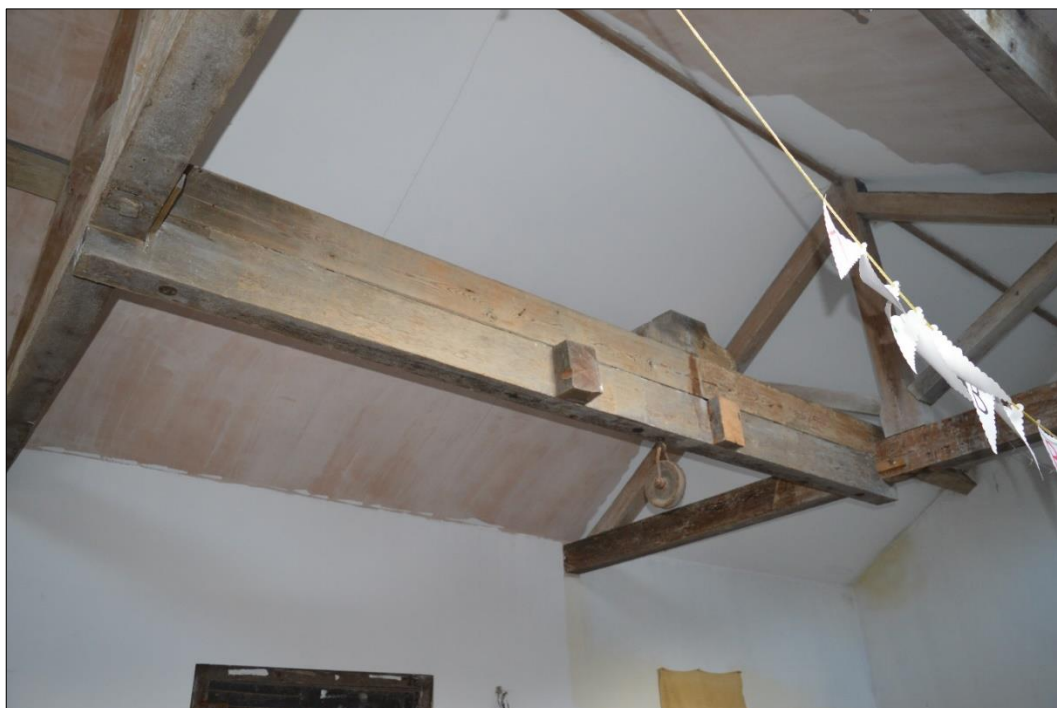
- 2.12. Internally, the building comprises a single, open-plan room. All of the walls were of modern plaster and partly painted. The room is open to the ceiling, with two king post roof trusses with struts.
- 2.13. In between the trusses, two beams (one placed immediately above the other) had been inserted, the ends of which had been cut to fit around each of the truss tie beams. An iron pulley had been fixed to the underside of the cross beam and a wooden mounting block was visible on the upside (Fig. 10). Aligned with the mounting block, a smaller iron pulley could be seen adhered to the side of the northernmost purlin, with the remnants of an iron chain hanging below.

Fig. 10. CPAT Image 4602-0015 showing the beam arrangement.

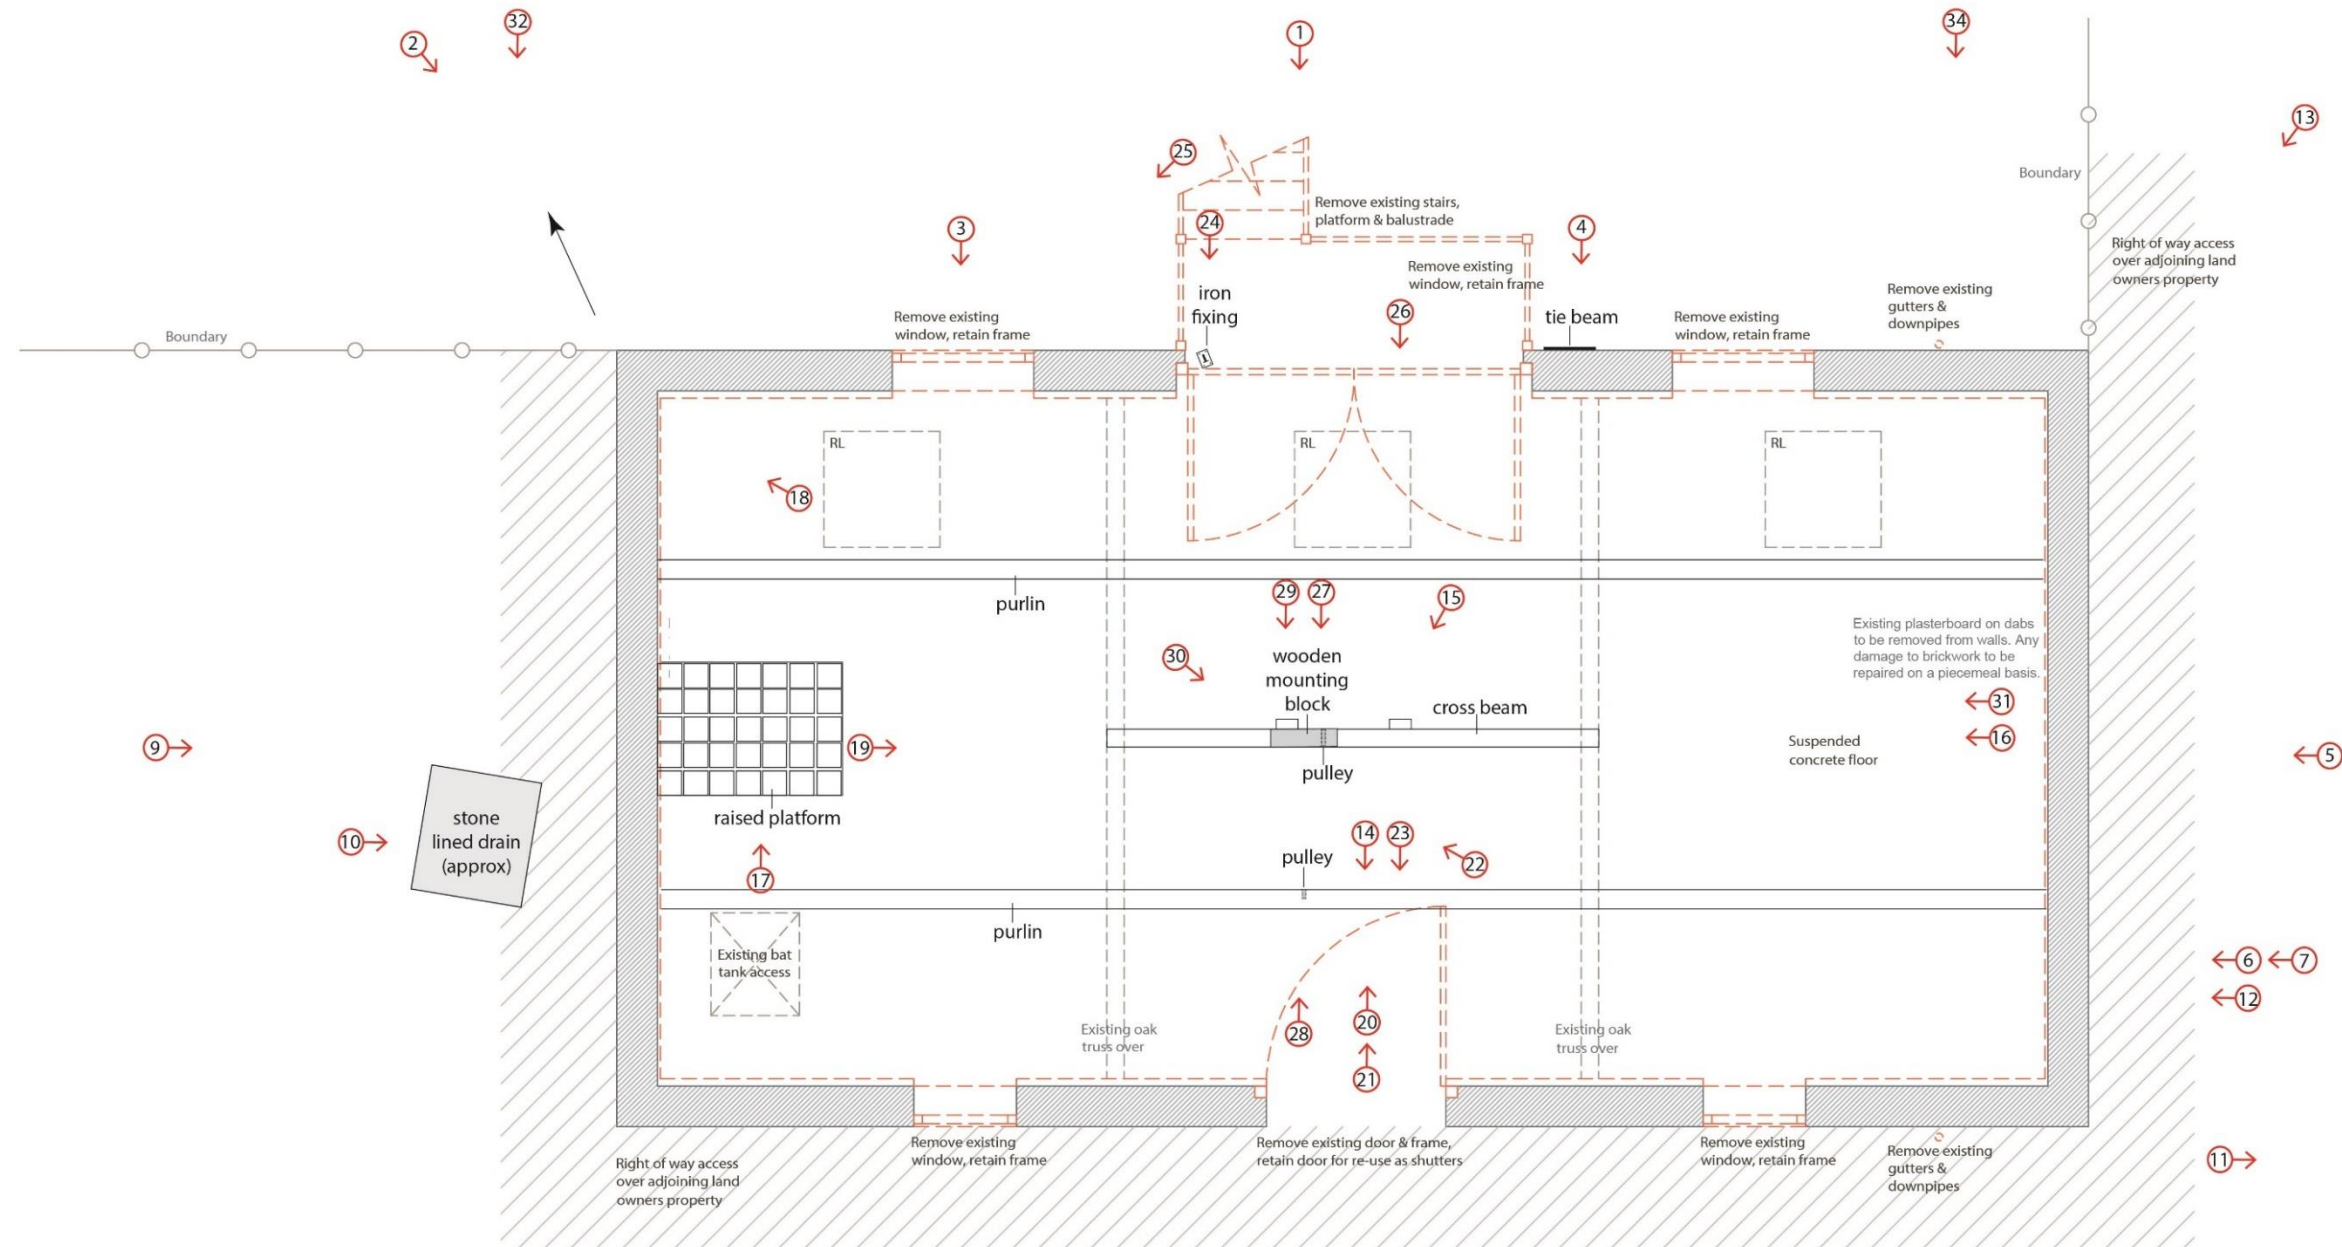
EXISTING GROUND FLOOR PLAN Demolitions and Alterations

Figure 11. Plan (based on existing) showing locations of photographs and additional structural detail.

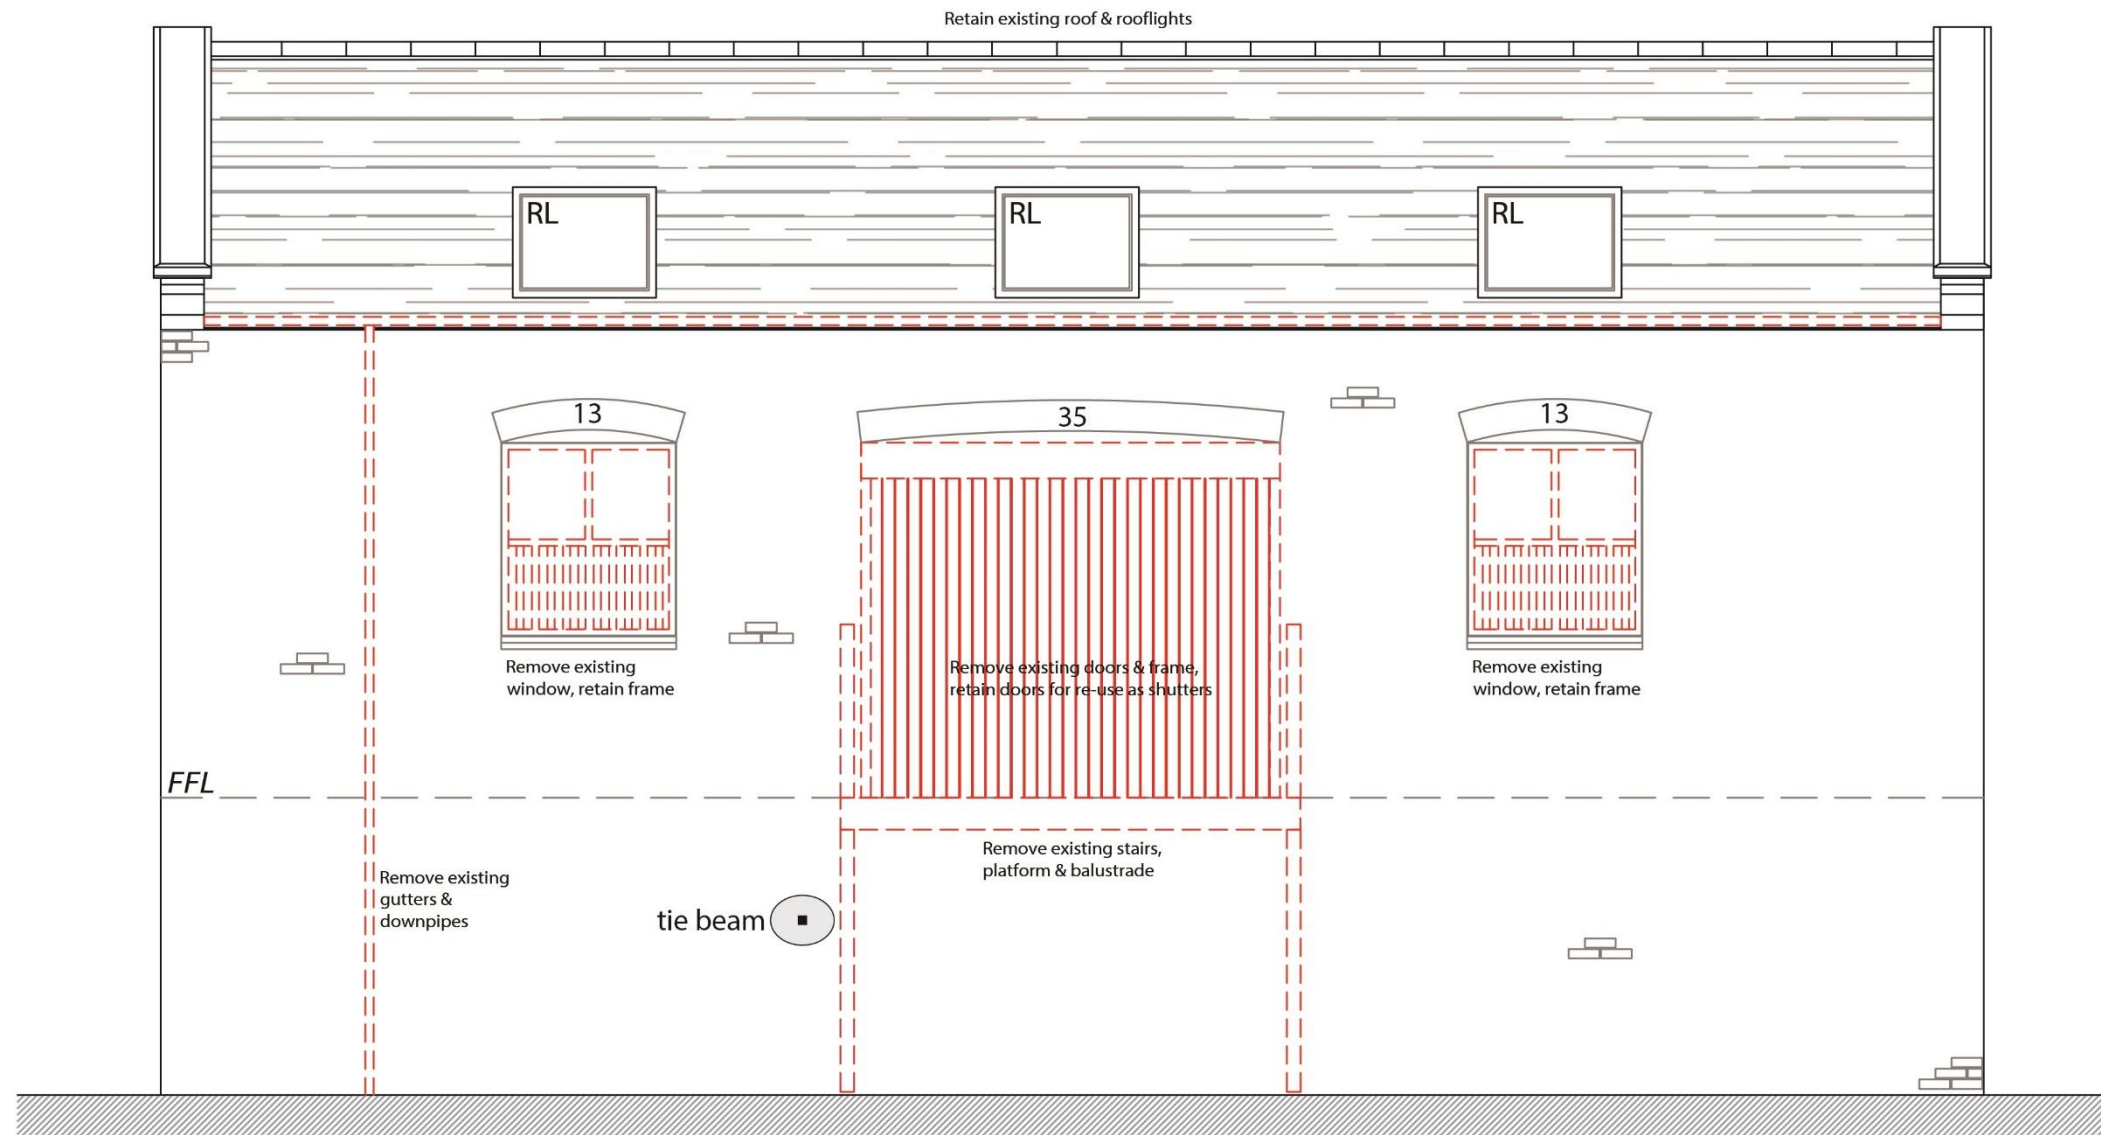
EXISTING SIDE ELEVATION - West Demolitions and Alterations

Figure 12. Front elevation (based on existing) showing additional structural detail.

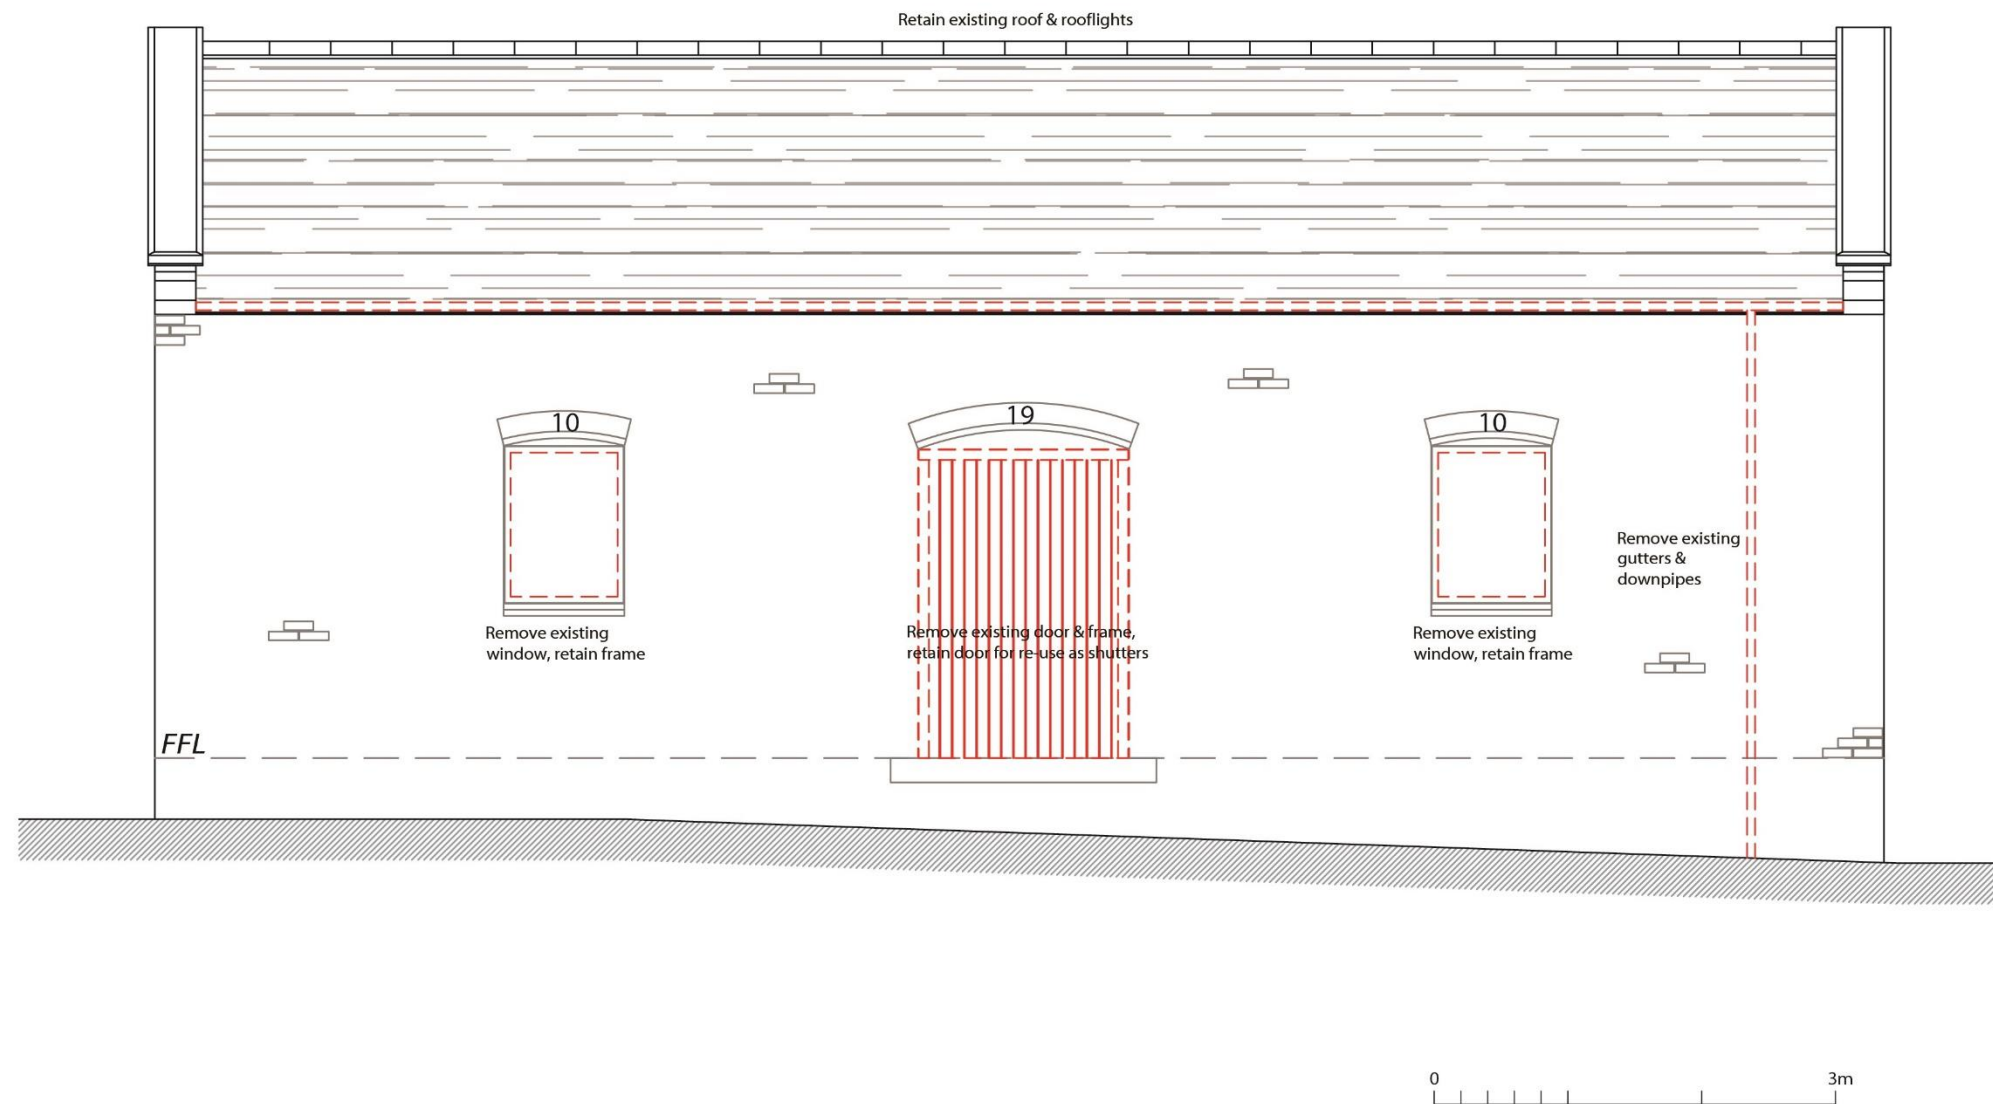
EXISTING REAR ELEVATION - North Demolitions and Alterations

Figure 13. Rear elevation (based on existing) showing additional structural detail.
