Archaeological Building Survey
of buildings at
**THE WEST GATE, NEWPORT CATTLE MARKET SITE,
NEWPORT.**
for
ISG Pearce

Report No. 2056B/2009

Centred on
N.G.R. ST 31578 87477

Two small blocks on the west side of the mid-19th century Cattle Market at Newport were recorded to level 3 standard before their removal as part of a redevelopment of the site. Part of the building south of the west gate had been recorded in 2004. Other structures on the site will also be recorded, to be the subject of a further report at a later date.

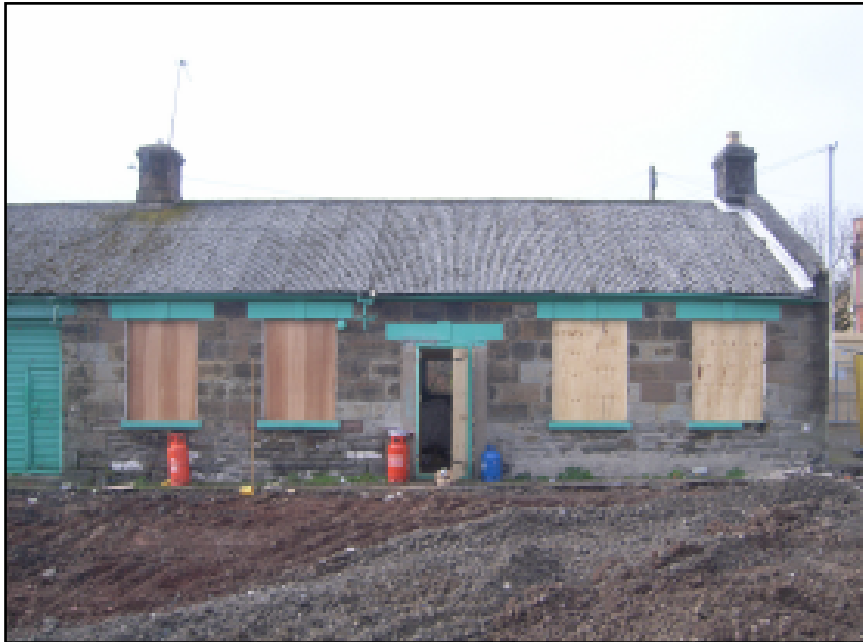
Plate 1
Cottage façade (east
elevation)

- 4.3 Facing east into the market is a symmetrical façade of two windows either side of a central entrance door (**Plate 1**). Lintels are one-piece cast-iron, all of the one design, flat with a slightly enlarged 'keystone' and incised 'voussoirs', that above the doorway being set lower than for the windows (**Plate 8**). Cills are also one-piece cast-iron items, the northernmost being partly broken at its right-hand end (**Plate 9**). The current windows are modern timber-framed examples. At present there is a 1950s-style front door with a glazed upper panel, but this is in a narrowed entrance: the original, wider iron door frame survives behind the modern door. A pair of bolt-holes at the rear of the lintel indicate that there were a pair of inward-opening doors: the outer side of the frame is decorated with a scroll moulding.

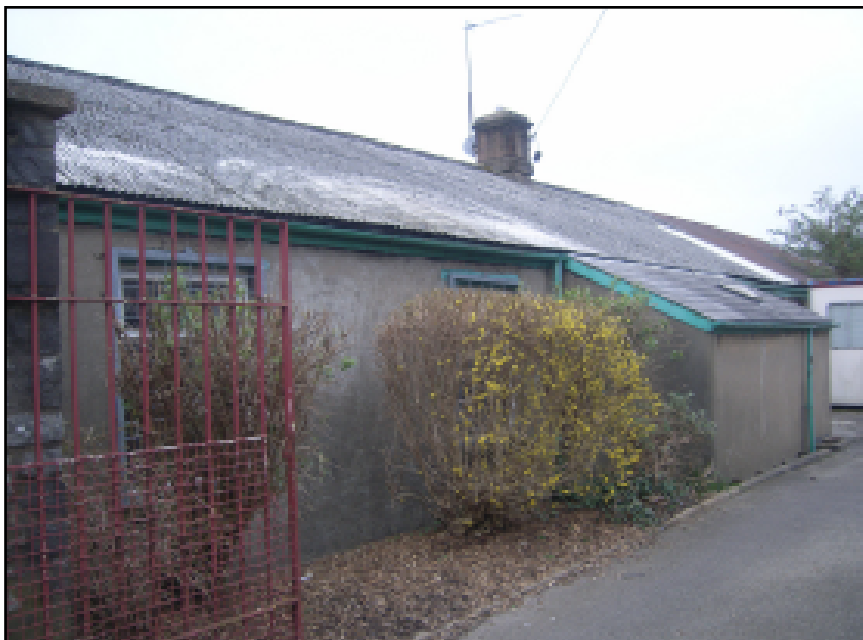
Plate 3
Cottage west elevation,
from north-west

- 4.6 Built beyond the rear wall, and therefore apparently on next door's property, is a small extension containing a bathroom and w.c. (**Plate 3**: n.b. not fully measured). Rendered externally with no windows but a small skylight, this has a slate-covered roof that is a continuation of the main roof pitch on this side of the building. Due to being fully rendered inside and out, the building material has not been identified. The doorway from the main building is splayed outwards on the bathroom side of the wall.

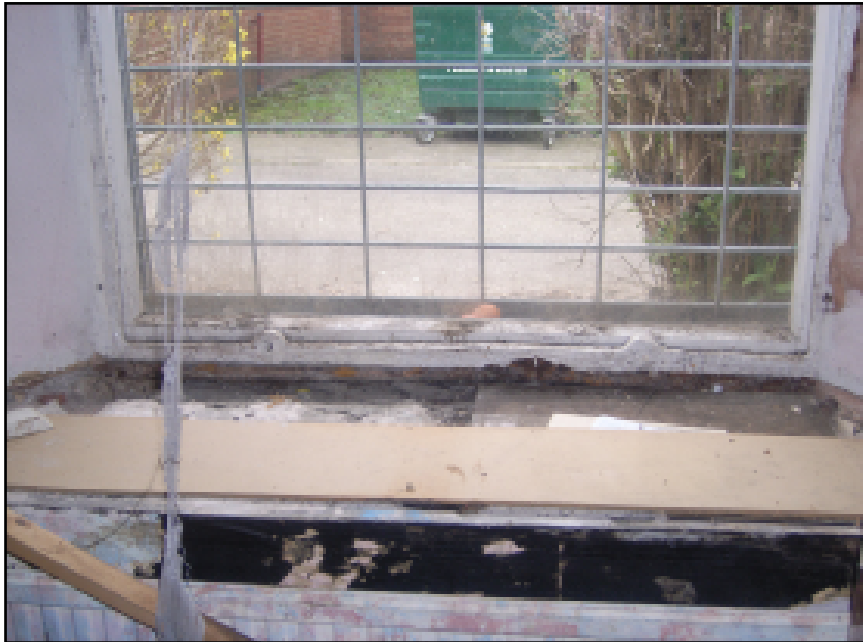
Plate 10
Bottom of window in
west elevation

- 4.4 Two windows in the rear wall may have been inserted later. Both have been provided with timber lintels and cills, unlike the cast-iron examples on the east elevation. However, they do have cast-iron window frames with small lugs along their top and bottom edges (**Plate 10**).

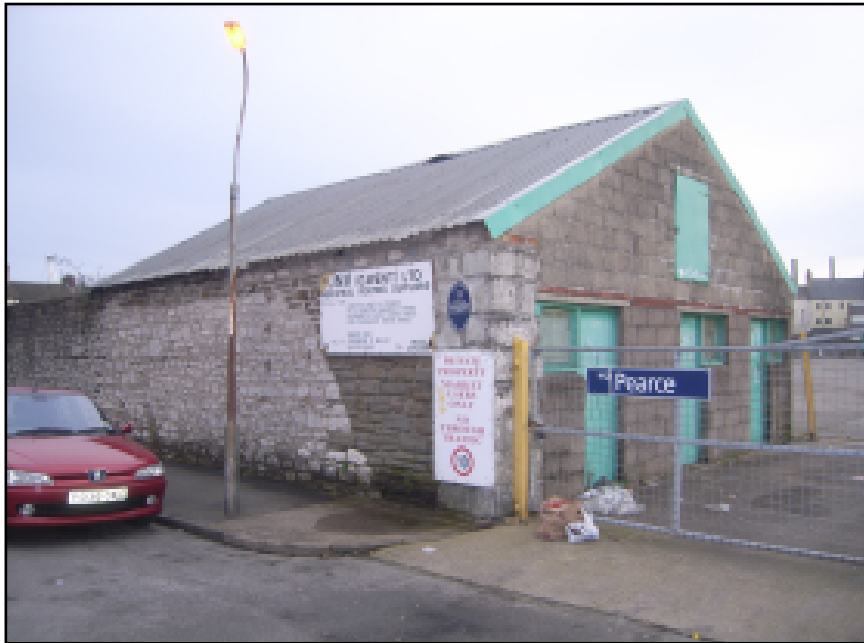
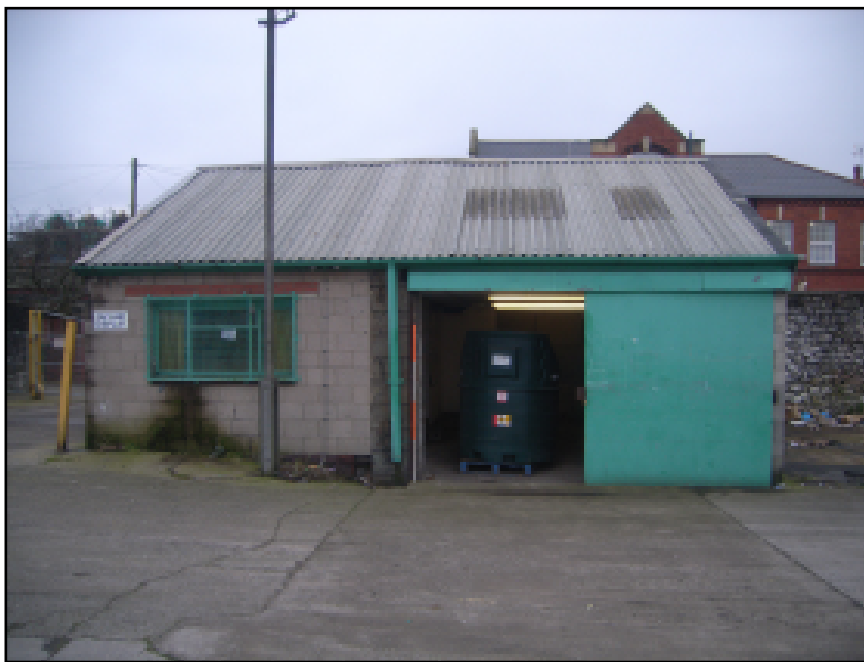
Plate 13
Block north of gate, from
south-west

- 5.2 The building comprises two parts: the older, northern 60%, and the southern remainder of later 20th century date (**Plate 14**). Although most of the exterior is modern, the northern part is a survival from the original 1844 cattle market. Three roof bays survive from an estimated original number of 36; this was a long open-fronted shed facing eastwards into the main market area. The southern end is a much later extension infilling the angle between the original west range and the west gate (**Plates 13 & 14**).

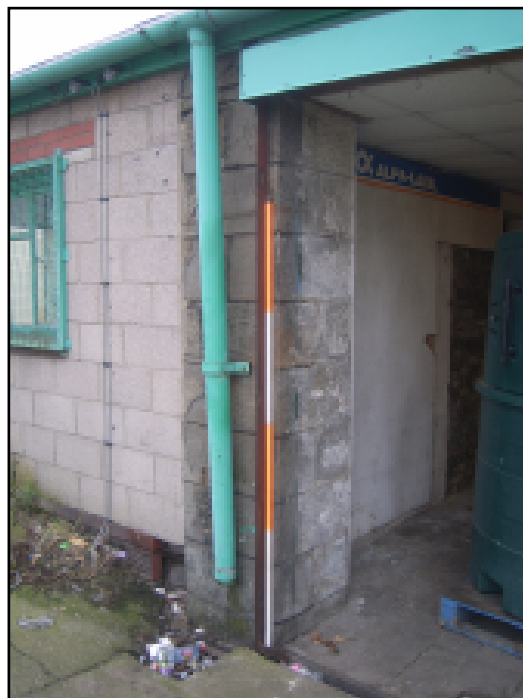
Plate 15 Stone pier, from north-east

- 5.5 In the east elevation is a square stone pier, its eastern side flush with the main wall face (**Plate 15**). A brick wall runs westwards as far as the boundary wall, with the access through to the southern area of the building off-centre and up two steps. However, the pier has every appearance of having been built as a free-standing feature, unconnected to any walls. The north wall and northern half of the east wall are also built from blockwork, with a large sliding door closing off the remainder of the latter. A flagstone floor survives in this part of the building, at the original lower level (hence the steps up into the southern end). For most of its length the west wall was obscured behind a later false wall. Four scissor trusses survived from the roof of the original, and much longer, building, a structure that had once reached as far as Ruperra Street at the north-west corner of the site. Beneath the trusses is a modern suspended ceiling.
