CPAT Report No. 1474

St Mary's Church, Ruabon

Archaeological Watching Brief

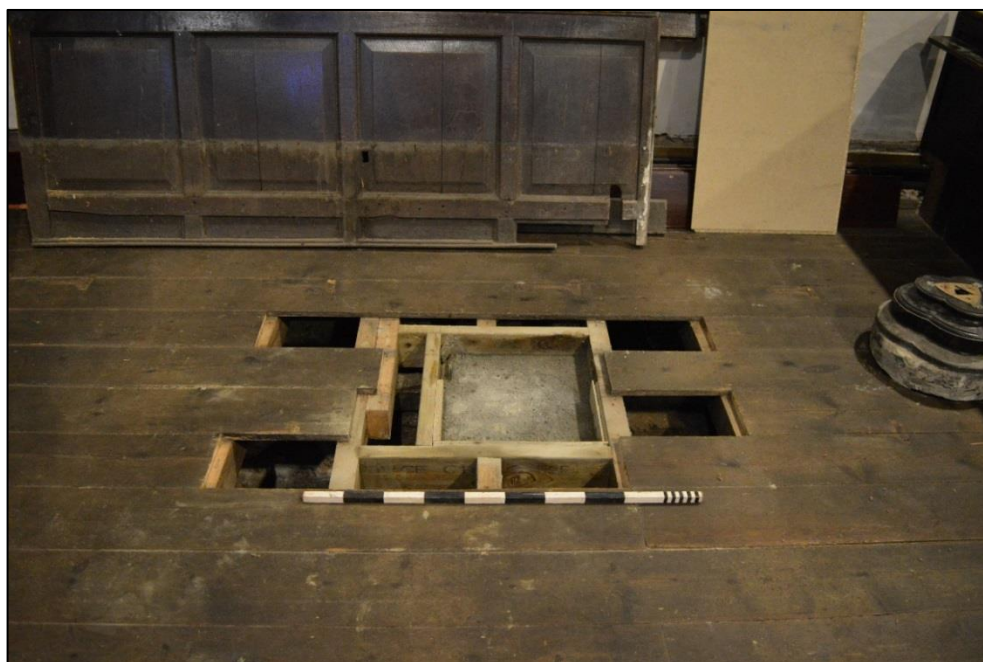
Fig. 2: The new supporting structure for the font, from the north. CPAT 4283-0001

- 2.1. The pews lining the south wall of the south aisle of the church are set on a wooden, boarded floor and a small section of this was removed to allow for the insertion of a supporting foundation beneath the font.
- 2.2. The area was limited but the overall nature of the structure underneath the existing floor was exposed; the floor here can best be described as being suspended on parallel sleeper walls constructed of brick and stone and running in an east/west direction, with the main axis of the church. One of these was presumed to have been placed against the wall of the church but this could not be readily seen owing to limited access. The supporting structure for the font was placed on top of a second wall, 0.25m wide, running below the centre of the boarded floor on the main axis of the

church, while on its northern side the floor was supported by a low wall which was presumably part of the structure of the tiled walkway running the length of the church on this side. The tiled walkway was at a level 0.14m below the surface of the boarded floor. In between the walls supporting the boarded floor, there was what may have been an earlier floor of the church comprising a reddish brown stony silt, at a level of 0.50m below the wooden floor, but this was not disturbed and was only subject to a brief examination; some disturbed human remains were evident, as might be expected.

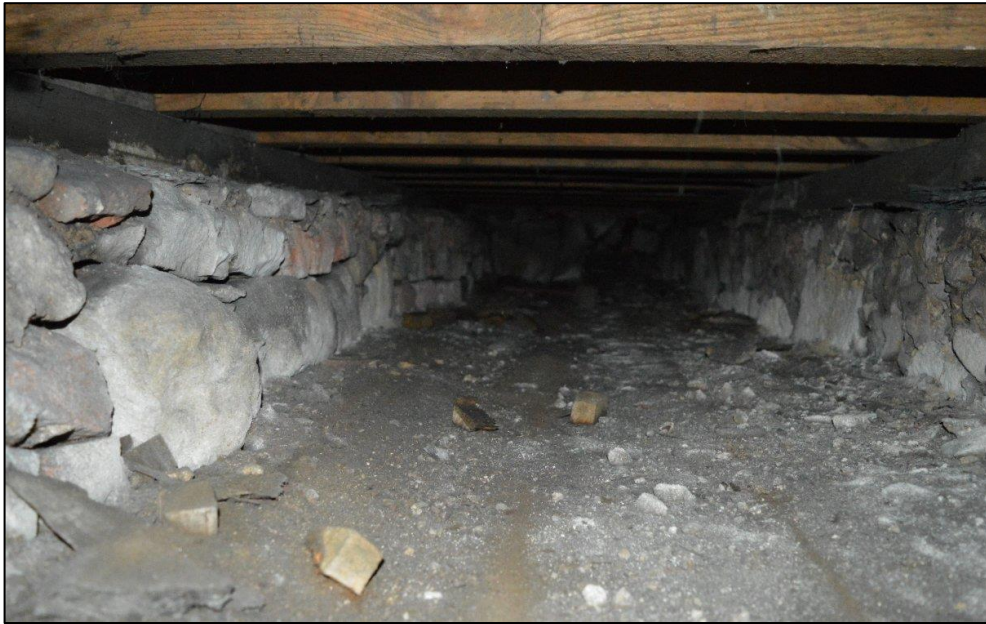
Fig. 3: The structure below the wooden flooring on the south side of the church, showing the possible earlier floor between the sleeper walls. CPAT 4283-0008

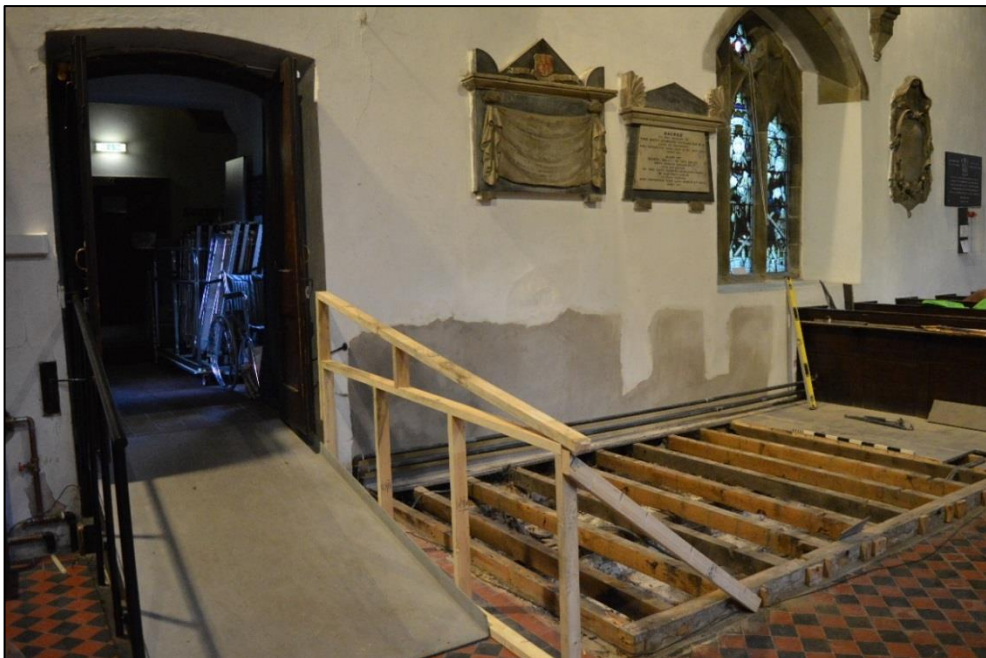
Fig. 4: The location of the new disabled access ramp after the pews and existing floor were removed, showing the adjoining tiled walkways. CPAT 4283-0010

- 2.3. In the north aisle, work to create a new disabled access ramp immediately to the east of the entrance from the north porch involved the removal of five pews and the boarded floor on which they were placed to reveal the underlying structure in advance of the commencement of construction. The layout was essentially similar to that found in the south aisle, although the larger area of floor boards that were taken up allowed for a better understanding of the supporting structure.

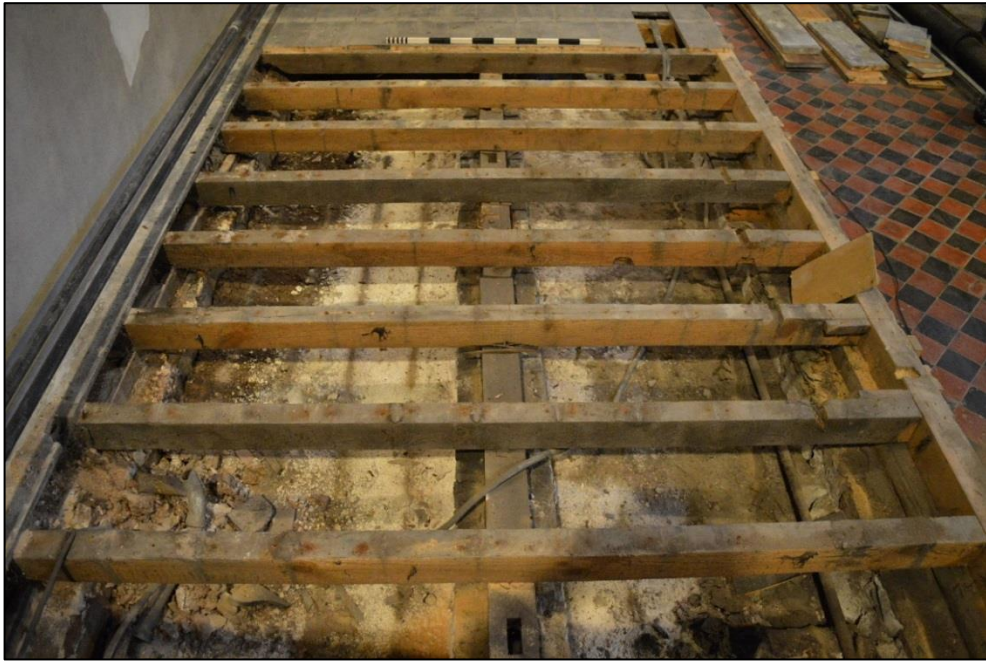
Fig. 5: The structure below the pews, showing the presumed earlier floor of the church between the sleeper walls and the north wall of the church. CPAT 4283-0009

- 2.4. Again, as in the south aisle, the floor had been built up from parallel, east/west aligned, walls of stone and brick. In this case, however, the north wall of the church could be seen and it appeared that there an internally projecting course of masonry formed the base on which a reused wooden beam had been laid. Similar wooden beams were present on the central sleeper wall and on a projecting part of the base for the adjoining tiled floor to the south of the area examined. The existing floor comprised sawn softwood beams running north/south on which the boarded floor had been laid. The softwood beams appeared to be relatively recent, probably dating to the second half of the 20th century.

- 2.5. Between the walls on which the current floor has been laid was a further part of what appeared to be an earlier floor of the church, akin to that exposed in the south aisle. This comprised a reddish brown stony silt with a significant lime content, at a level of between 0.30m and 0.40m below the wooden floor. As was the case with the south aisle, this was not examined in detail, but again some disturbed human remains were evident.
