ARCHAEOLOGICAL

WATCHING BRIEF

WB/JB/10

Angidy Ironworks, Tintern.

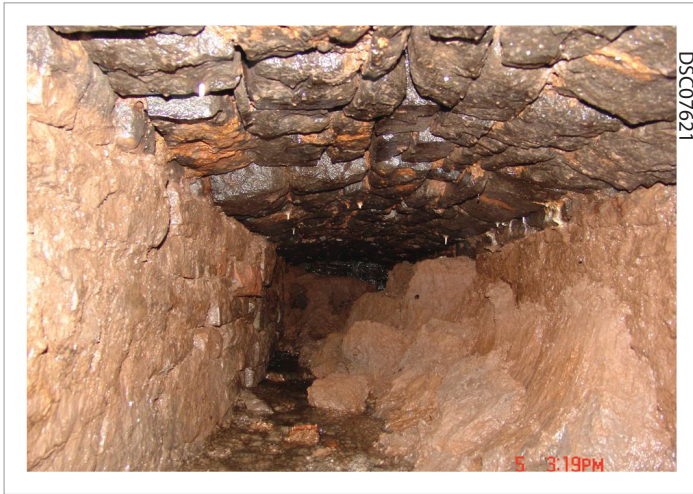
DSC07621

This attempt to; further de-silt the culvert, had a positive affect in that a further drop in water level was achieved within the culvert. This reduction allowed access to the culvert itself which had been previously denied. Plate 01 shows a view up the culvert and the extent of the silt that had built up over the years.

The increase in access allowed a greater understanding of the nature of the problem. The amount of silt within the culvert; even in Plate 01 there is a further <0.4m beneath the surface, illustrates how mammoth a task it will be to unblock the culvert. The fact that a reduction of the silt within the culvert did not greatly affect the Iron works floor shows that there is a bund of silt between the two that is holding the flow, and water level back.

Plate 01: Silting within outfall

The next step has to be further work to reduce this blockage. Either by pressure washing up stream or by creating access holes into the culvert at intervening sites between the wheel pit and the outfall and then clearing from there.

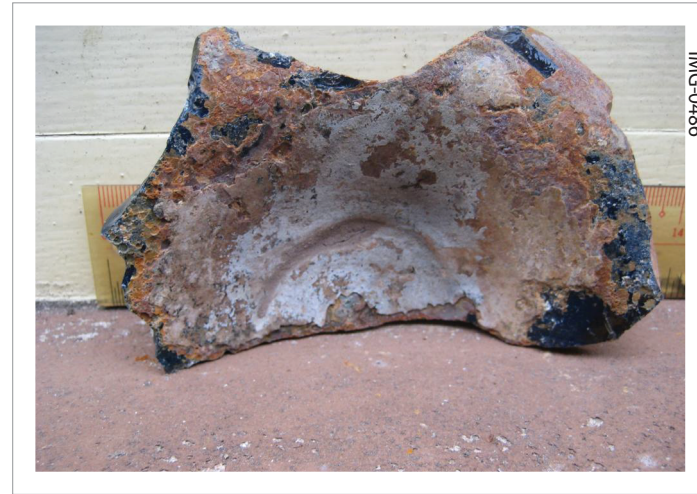
IMG-0486

Two pieces of dark green/black Onion Bottle washed out of the silt at the mouth of the outfall. The smallest Plate 02, had a 4½inch diameter base, whilst the larger Plates 03 & 04 had a 7 inch diameter base.

Plate 02: Small Onion Bottle

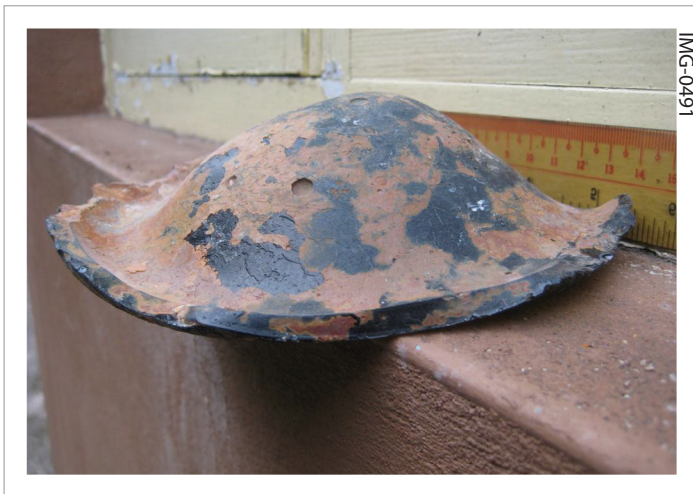
IMG-0491

Plate 03: Large Onion Bottle

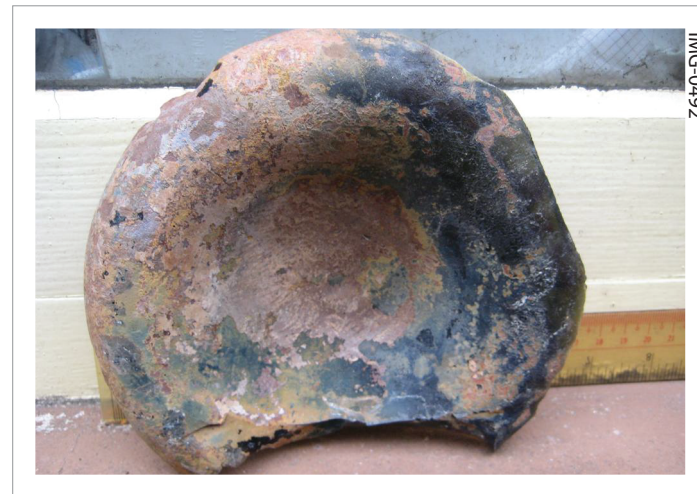
IMG-0492

Plate 04: Large onion Bottle
