CPAT Report No. 1632

Stafford House, Hawarden, Flintshire

Archaeological Watching Brief

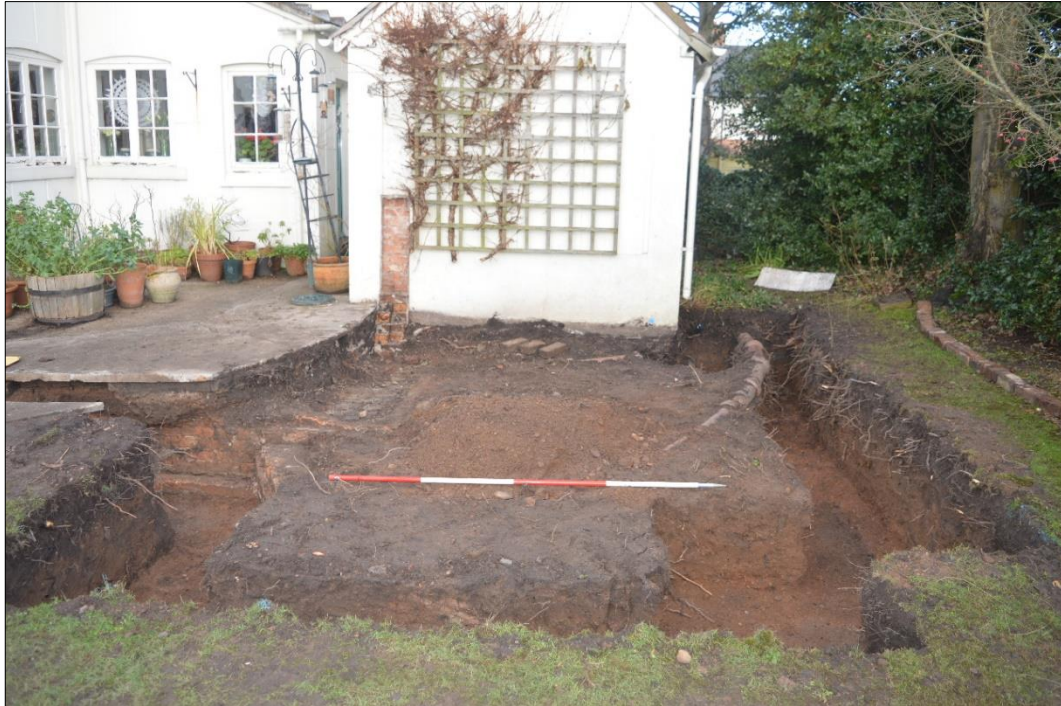
Fig. 3 The area for the new extension viewed from the south. Photo CPAT 4579-0008

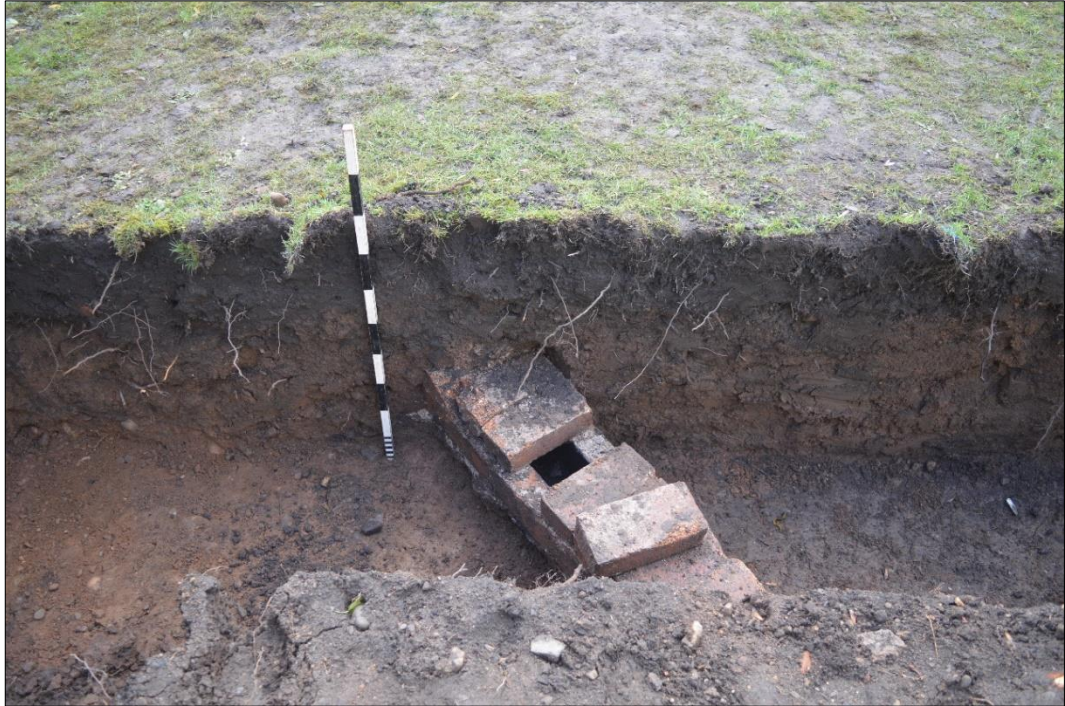
Fig. 4 Part of the 19th-century culvert. Photo CPAT 4579-0006

- 3.3. The earliest features revealed consisted of a narrow, rectangular pit, measuring 1.2m by 0.25m, the fill of which contained late 18th-century pottery and a possible posthole. A brick-built culvert was revealed in two of the foundation trenches and is assumed to be contemporary with the original construction of the house in 1842.

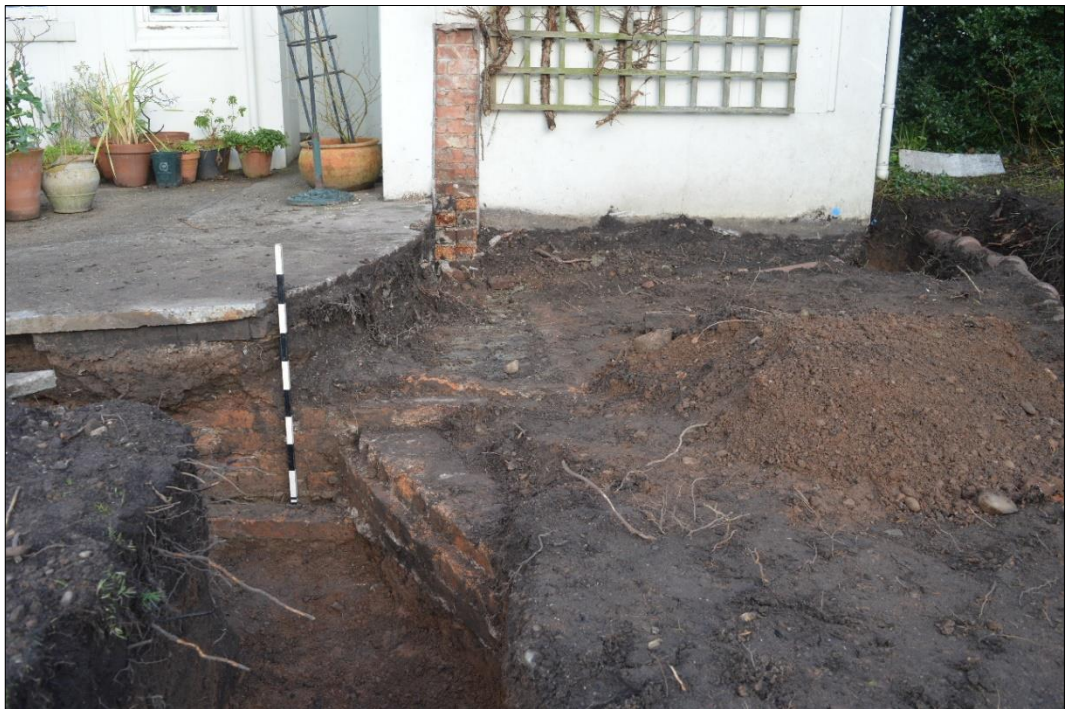
Fig. 5 Part of the 19th-century culvert, with the scale against the brick wall of the cess pit. Photo CPAT 4579-0001

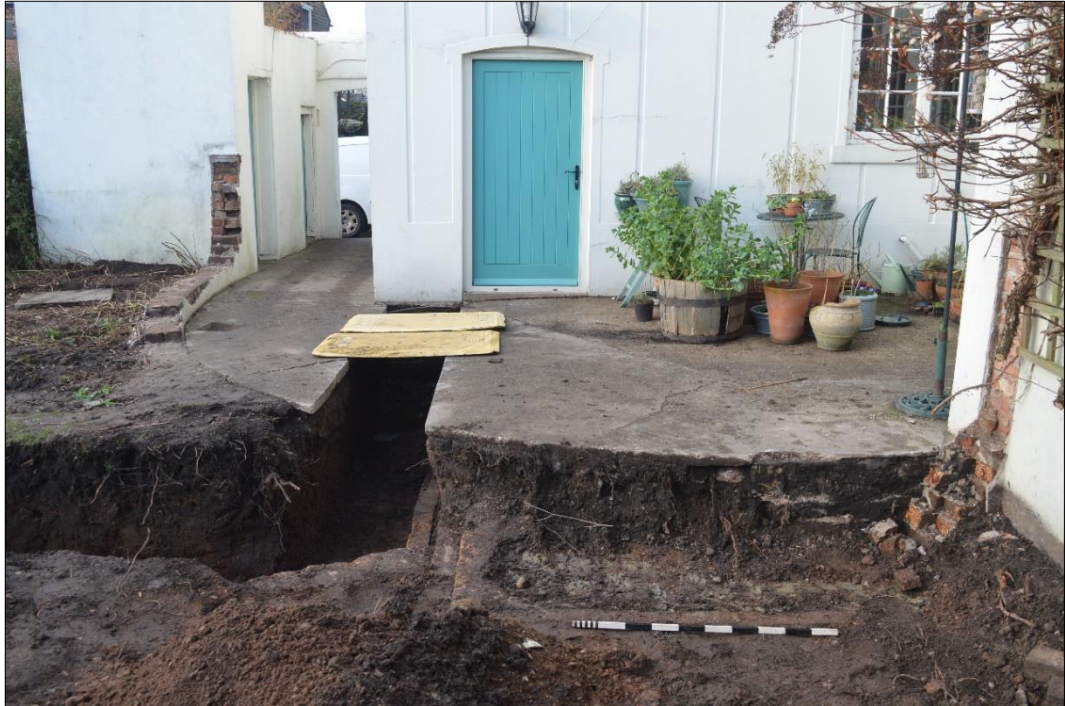
- 3.4. Part of a brick-built cess pit was also exposed, the fill of which consisted of yellow-green clay. The only other features consisted of two late 20th-century, salt-glazed drains, 4" (100mm) in diameter.

Fig. 6 Part of the brick-built cess pit, extending beneath the concrete patio. Photo CPAT 4579-0005

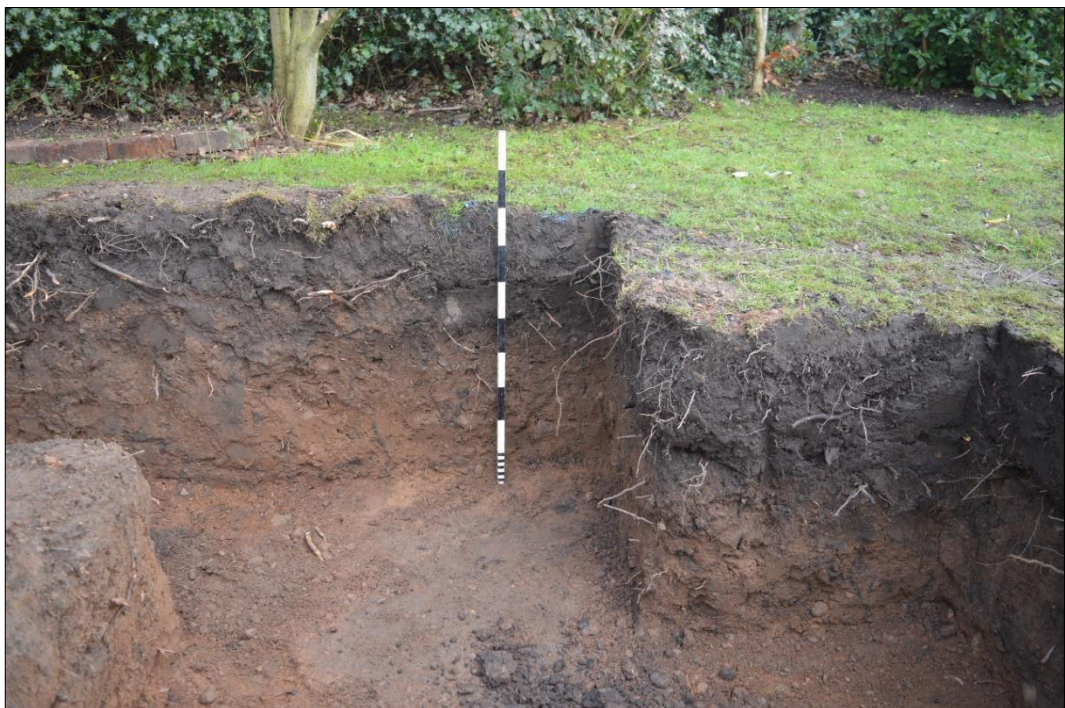
- 3.2. Typically, the deposition of soils exposed by the foundation trenches consisted of an upper topsoil, around 0.2m thick, comprising a dark brown-grey silty sand, overlying a layer of pinkish-brown silty sand, 0.5-0.6m thick. The topsoil contained 19th-century and later artefacts, while the underlying layer contained no dateable material.

Fig. 7 Typical soil profile exposed in the foundation trenches. Photo CPAT 4579-0007
