# **Daybook**

**Black Rock Road,  
Portskewett, Monmouthshire**

**Archaeological Watching Brief  
& Historic Building Recording**

**WA project: 207290**

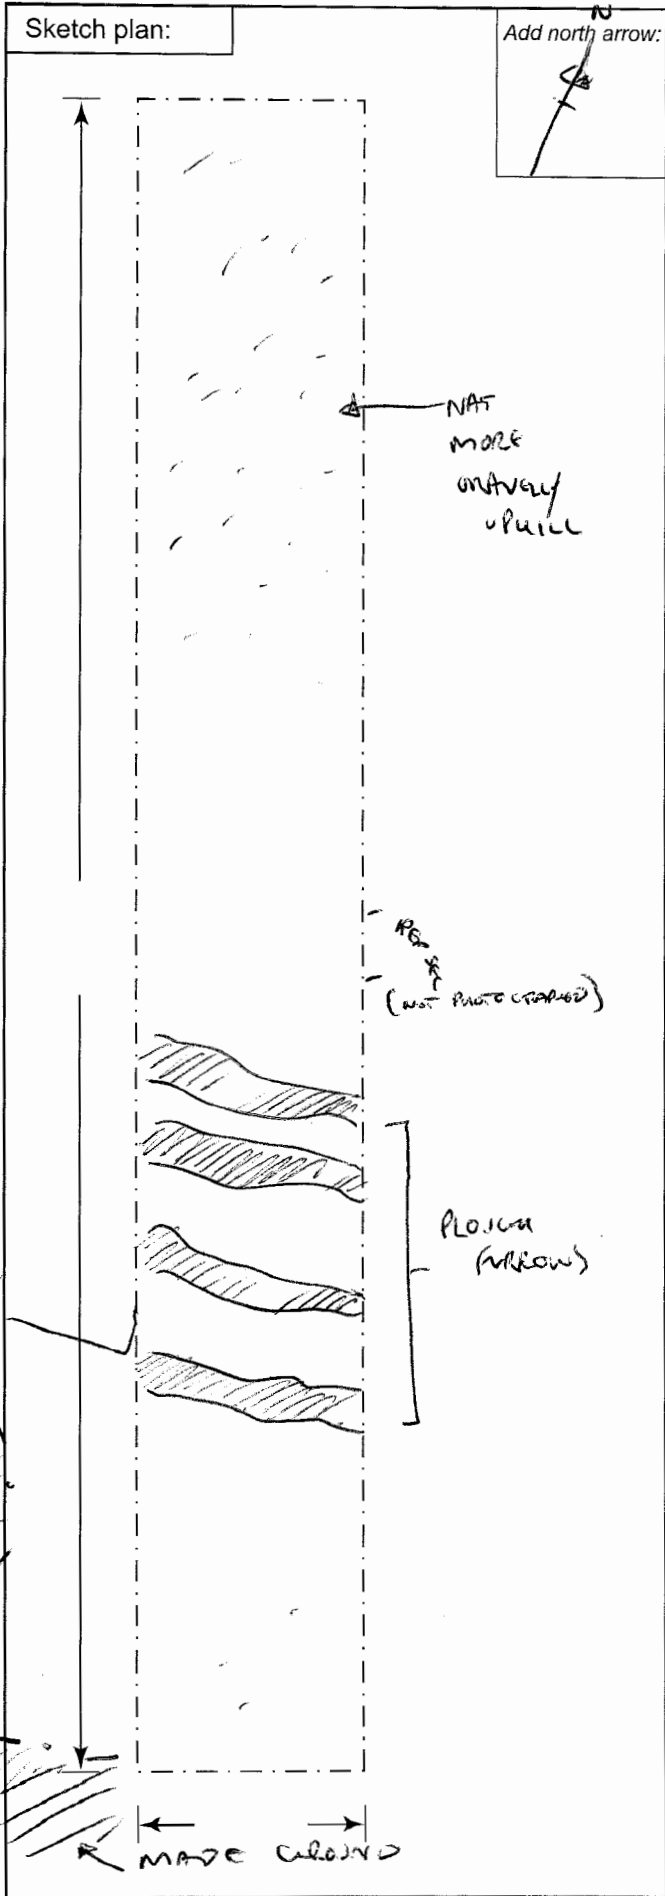
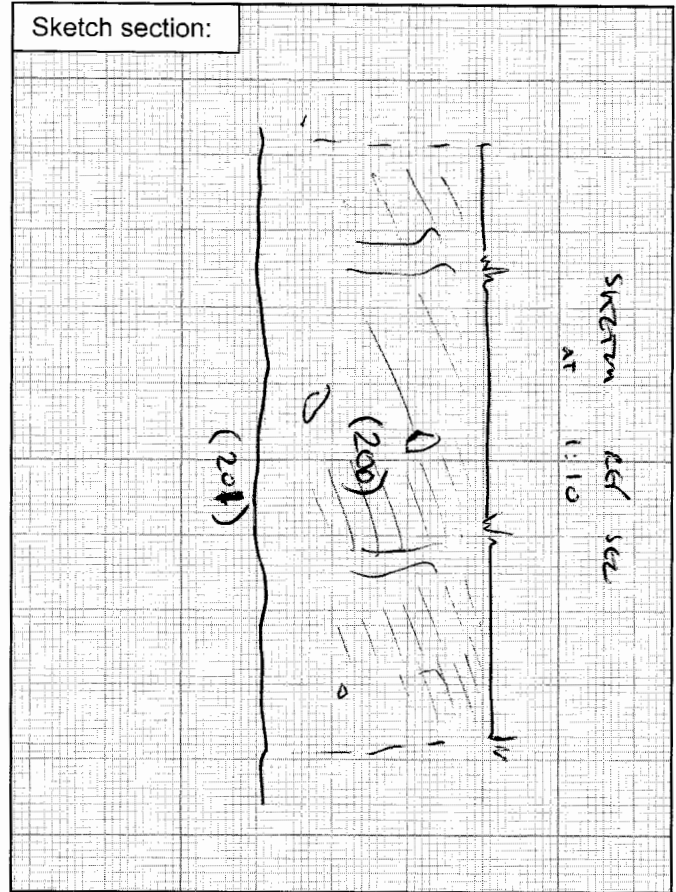
Context number	Context type	Fill of/ filled with	Interpretative category/description	Depth from ground surface (m)
(2001)	LAYER DEPOSIT	/	TOPSOIL - MID BROWN LOAMY SAND WITH MOD SUB-ANGULAR STONE INCL (UP TO 0.06m) AND IMPREG. MOD. POTTERY (NONE RETAINED)	0.0-0.3
(2002)	LAYER DEPOSIT	/	NATURAL - MID ORANGEY-BROWN SANDY LOAM WITH PATCHES OF ROUGH LARGE GRAVEL (UP TO 0.05m) (TO THE NW ONLY - UPALL)	0.3+
(2003)	DEPOSIT	-	LAYER OF MADE GROUND COMPOSED OF NATURAL/TOPSOIL AND LARGE QUANTITIES OF CONSTRUCTION RUBBLE AS WELL AS MOD. POTTERY, GLASS + ASBESTOS (APPROX. 30cm THICK - ONLY PRESENT AT SW EXTENT OF SITE. (SEE REVERSE))

- SW CORNER CONTAINS RIDGE OF MADE GROUND (ON TOP OF ~~LOWER~~ ~~AREA~~ ~~2~~ ~~THAT~~ ~~WASSES~~) - ~~AREA~~ LIKELY 20mC WHEREAS THE MADE GROUND THE NEARBY HOUSES SIT ON (TO THE W) AREA IS LIKELY ~~AREA~~ 19mC.

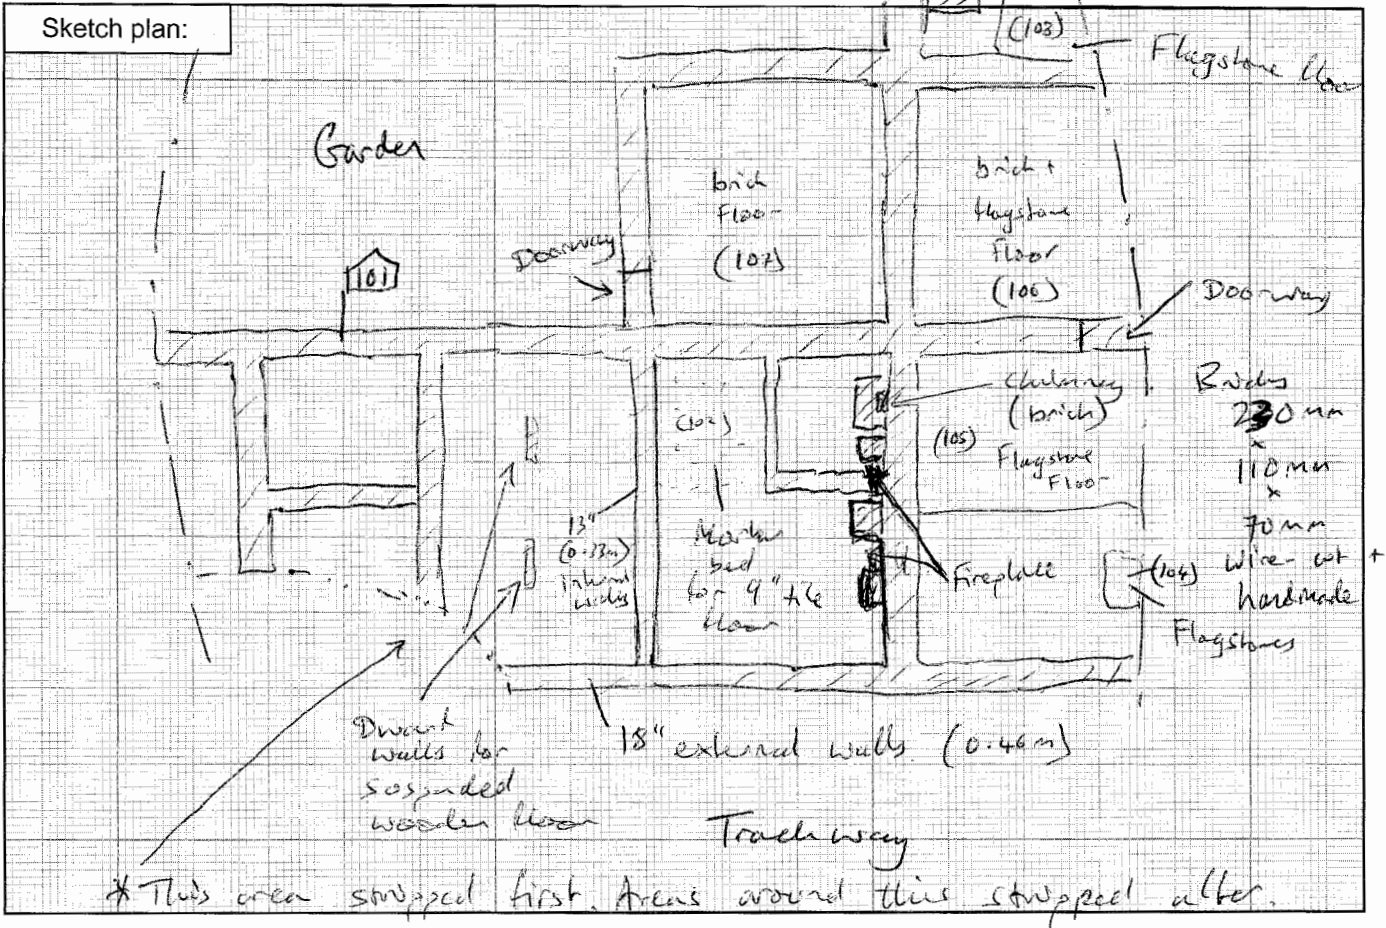
Intermittent dwarf walls with for suspended floor.  
 (102) Is an area of 9" square tile flooring (tiles removed), but impressions remain.

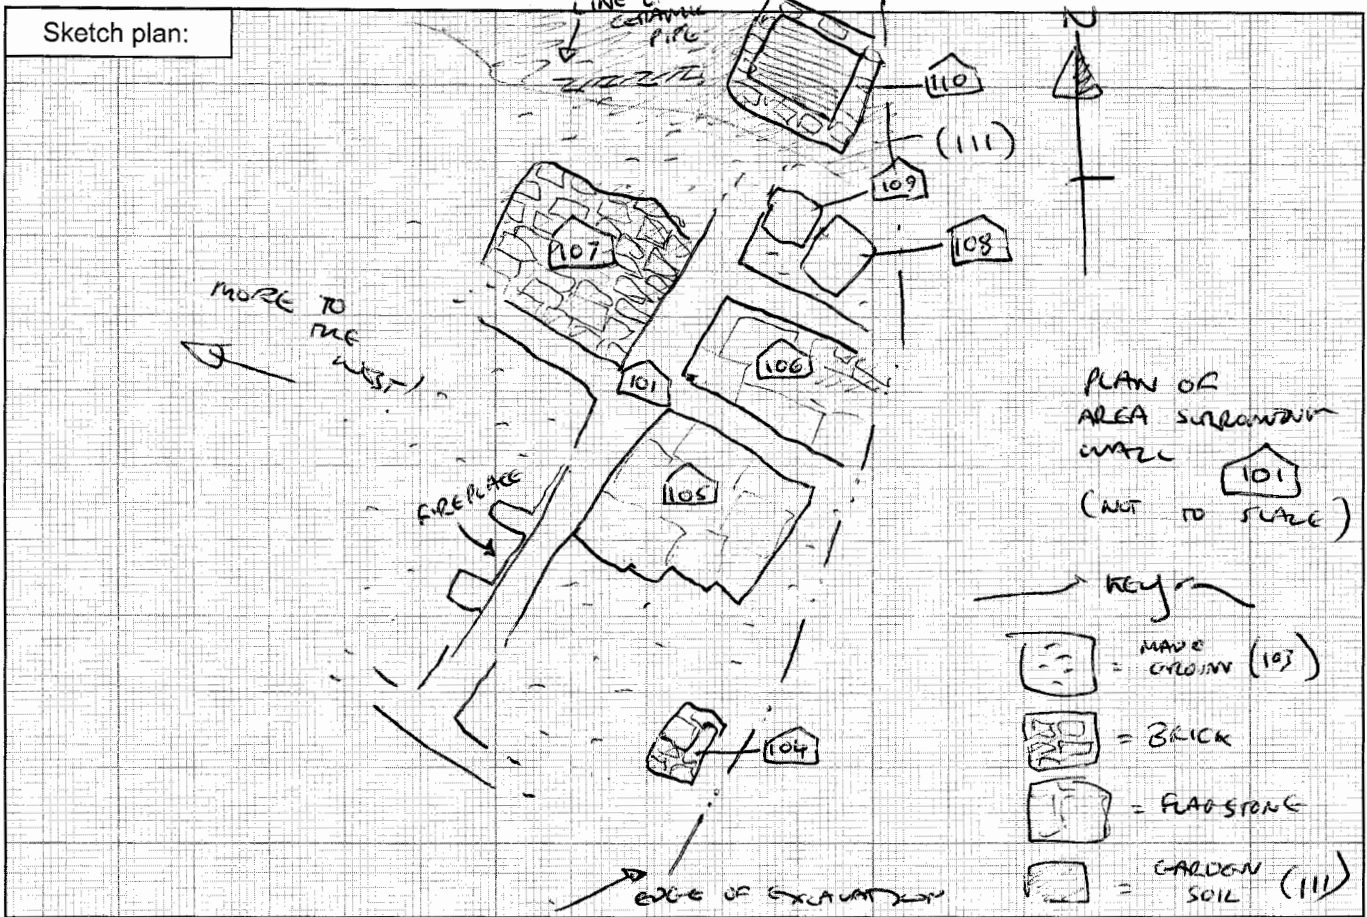
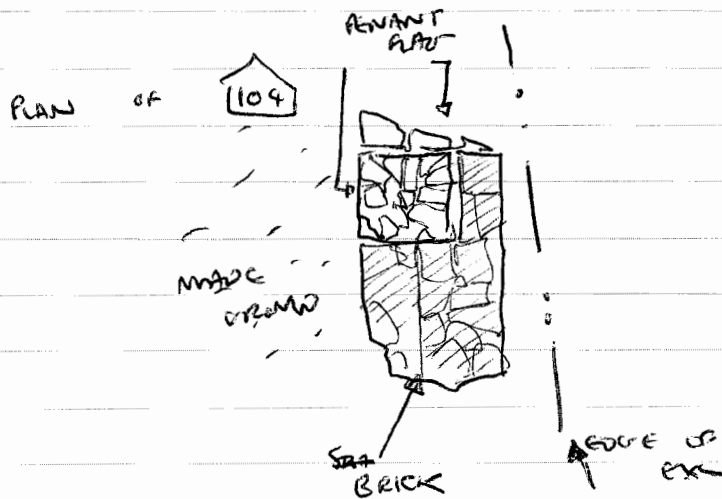
Additional description: SINGLE SMALL PATCH SURVIVING MOSTLY BRICK

Interpretation (including relationship to other features): POSSIBLY PART OF 105 BUT SURROUNDING AREA OF EXPOSED MAKE GROUND COULD HAVE BEEN RUBBED OUT.

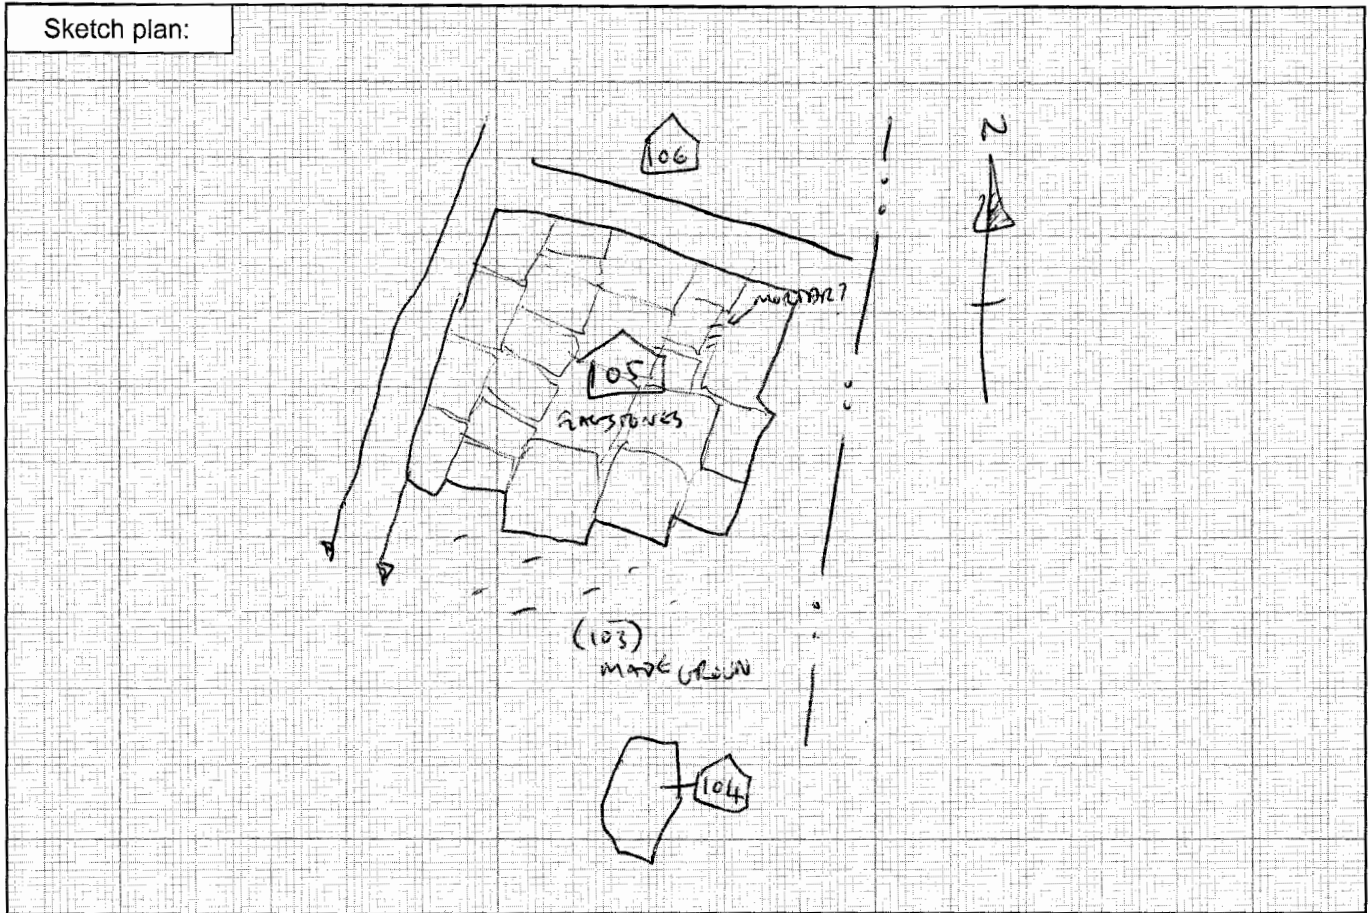
Additional description: DOESN'T SURVIVE TO THE S -

Interpretation (including relationship to other features): <sup>CONTIGUOUS</sup> FLAGSTONE INTERIOR FLOOR - POSSIBLY  
SAME AS 104 - AREA TO SOUTH PROBABLY RUSTED OUT.

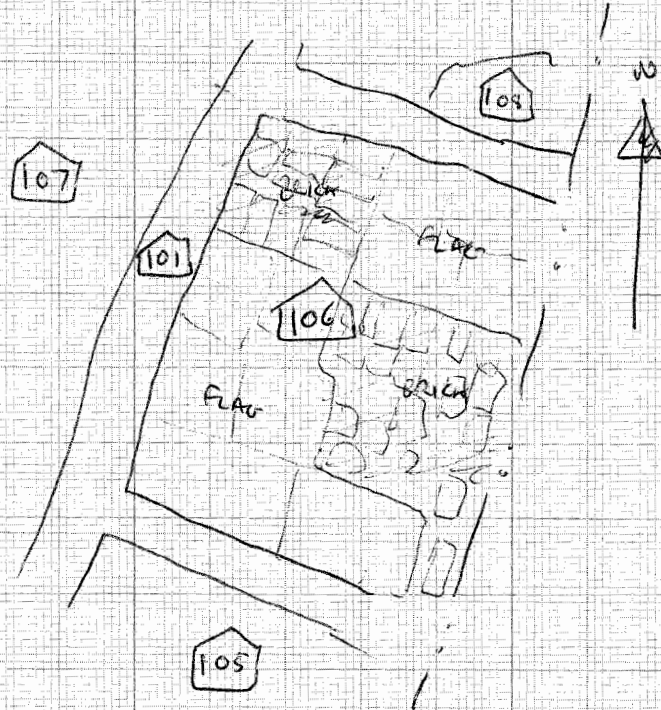
Additional description: SQUARE PATCHES OF BRICKWORK ALMOST "ENQUERED" WITH FLINT (SEE REVERSE SKETCH)

Interpretation (including relationship to other features): INTERIOR COTTAGE FLOOR - UNKNOWN ROOM - INSTALLED AFTER WALL 101

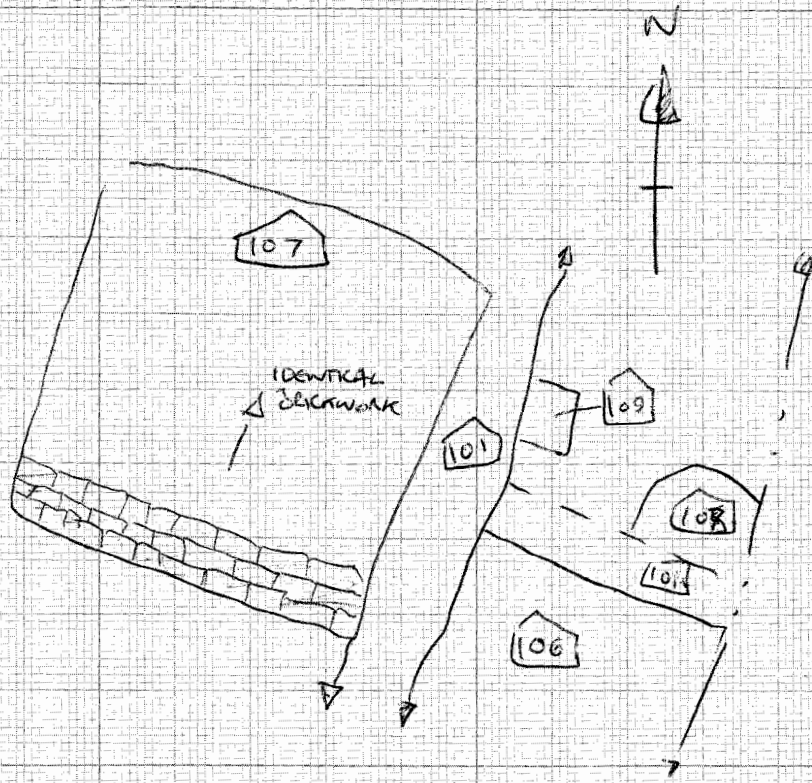
Additional description: VERY "NEAT" SQUARE SHAPE - LARGELY DISTURBED

Interpretation (including relationship to other features): ~~possible~~ FLOOR OF POSSIBLE EXTERNAL BUILDING

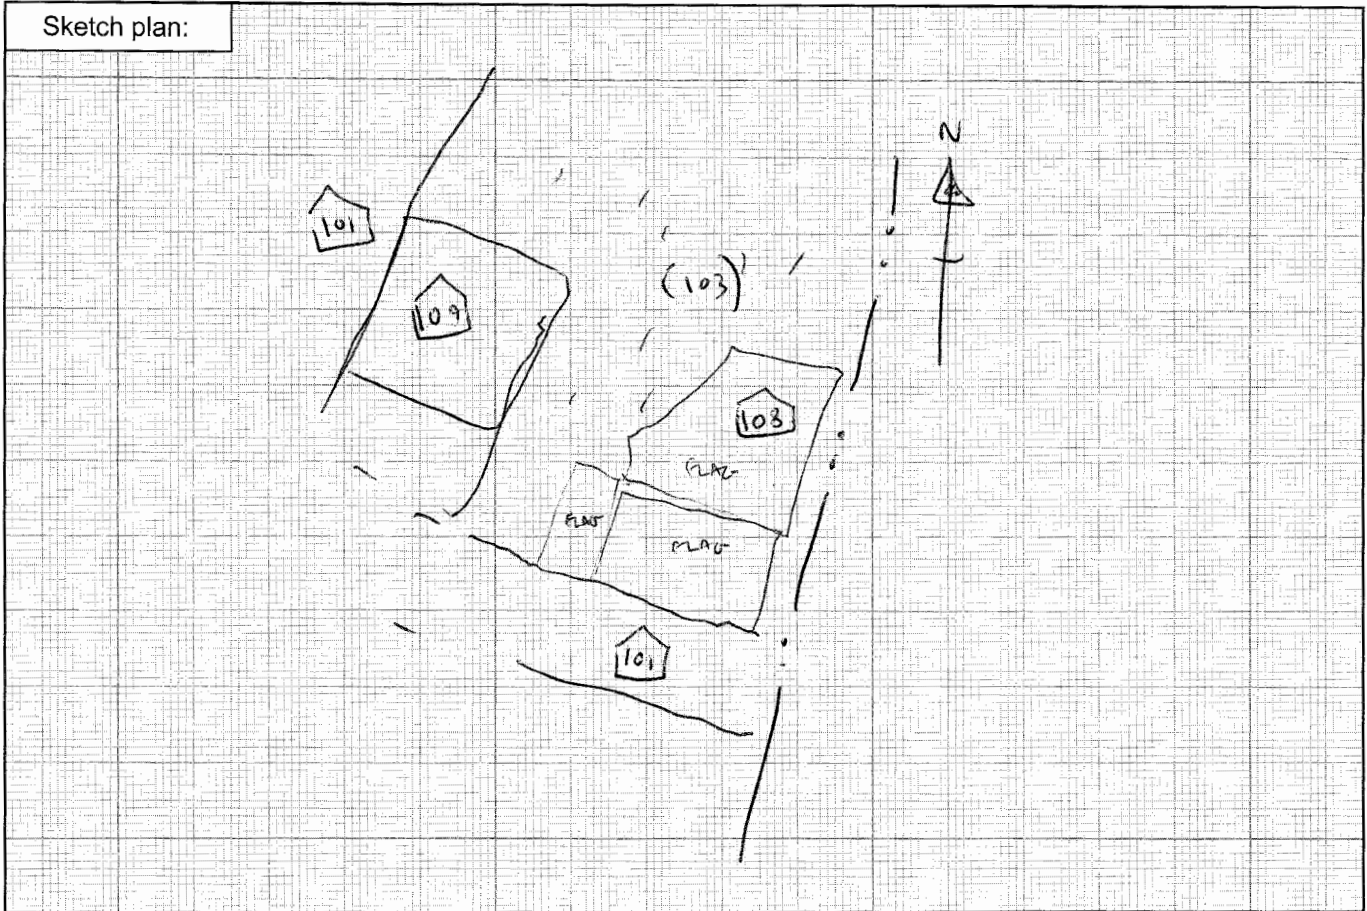
Additional description: composed of 3 stories only

Interpretation (including relationship to other features): INTERIOR FLOOR OF COTTAGE - UNKNOWN RELATIONSHIP TO RED BRICK 3 COLUMN BASE TO IMMEDIATE N

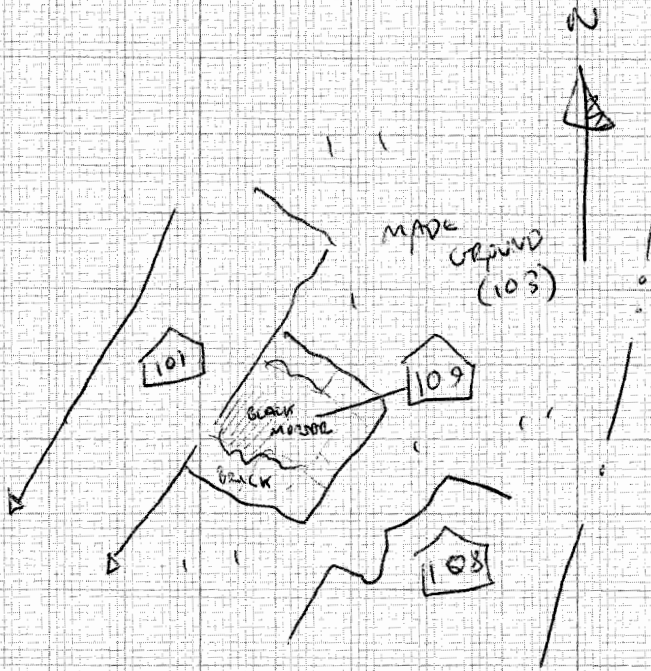
Additional description: SINGLE COURSE OF BRICKS SURVIVES WITH COMPACTED BLACK MORTAR UNDERNEATH

Interpretation (including relationship to other features): BASE OF INTERIOR COLUMN? WITHIN COTTAGE - UNKNOWN PURPOSE - UNKNOWN RELATIONSHIP TO NEARBY 108 FLOOR

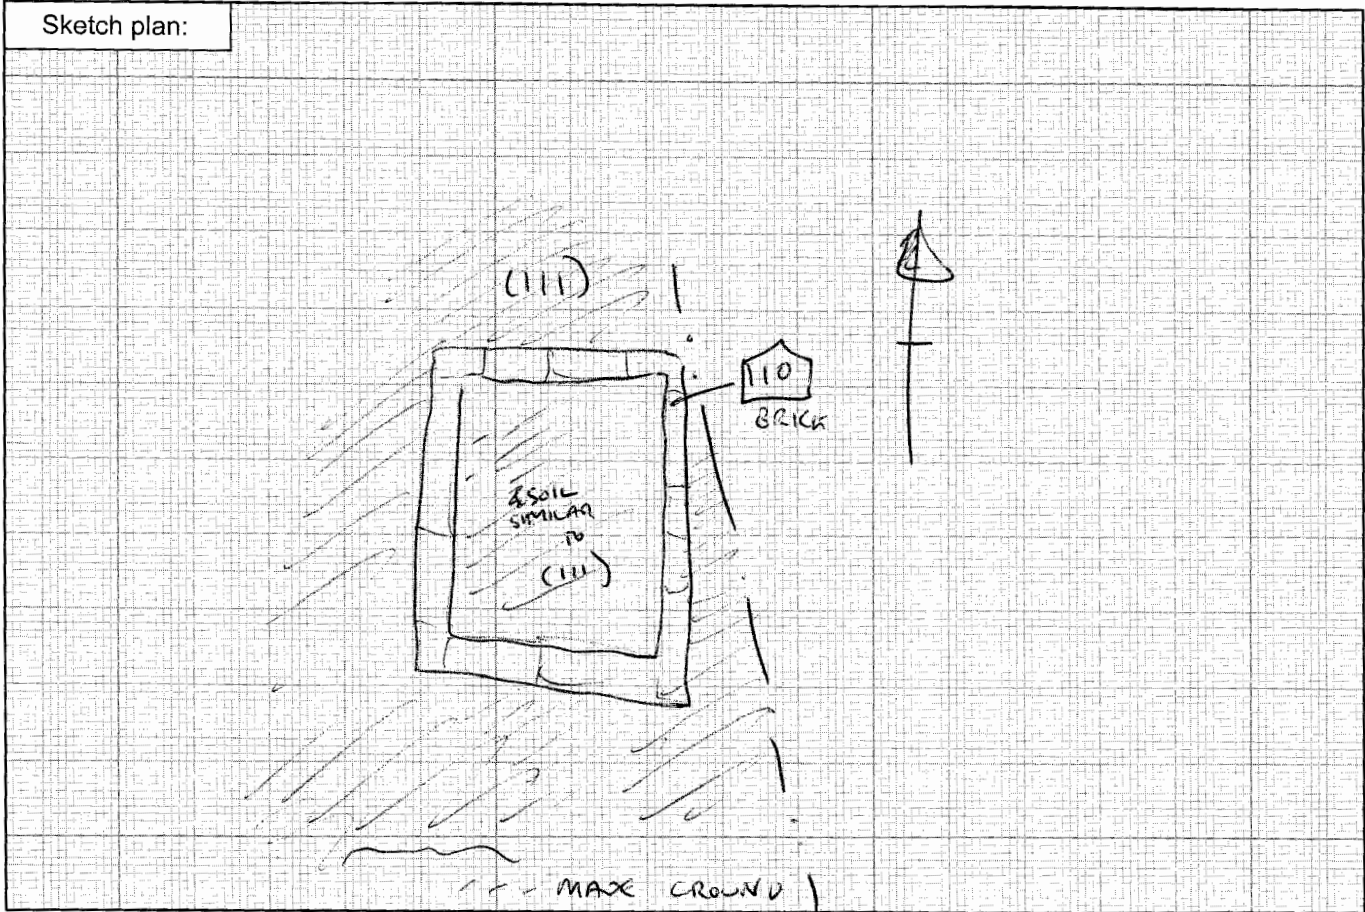
Additional description: ~~NOT DIRECTLY~~ A CERAMIC PIPE LEADING TO PIT WAS VISIBLE TO THE NW.

Interpretation (including relationship to other features): BRICK-LINED CESS PIT AT REAR OF CONTACT - NOT DIRECTLY ASSOCIATED WITH WALLS 101
