Pengwern Isaf, Cenarth, Carmarthenshire Cable Trench Watching Brief

Report by: Trysor

November 2014

Trysor Project No. 2012/355

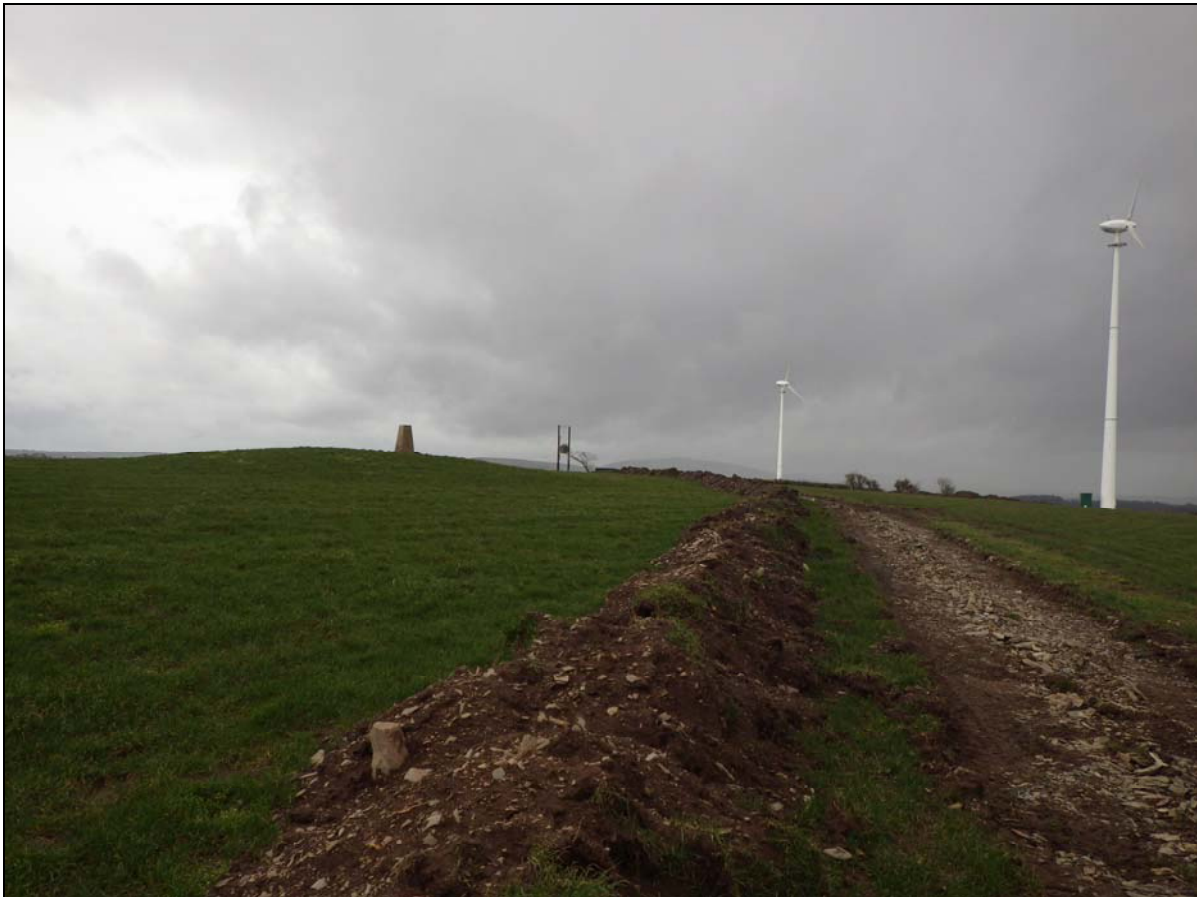
Cover photograph: Cable trench with the two turbines and round barrow with an Ordnance Survey triangulation pillar on top, looking southwest.

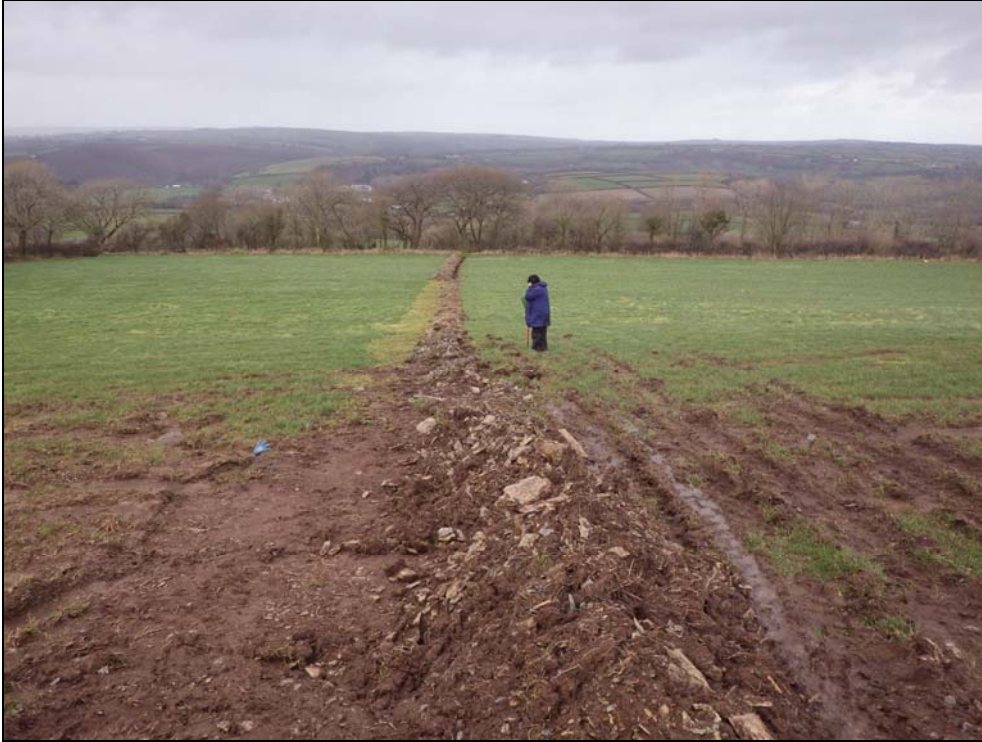
Plate 1: PGI2014_101, the southern part of the cable trench running north from the eastern turbine, looking north northwest. This part of the cable trench had been re-covered.

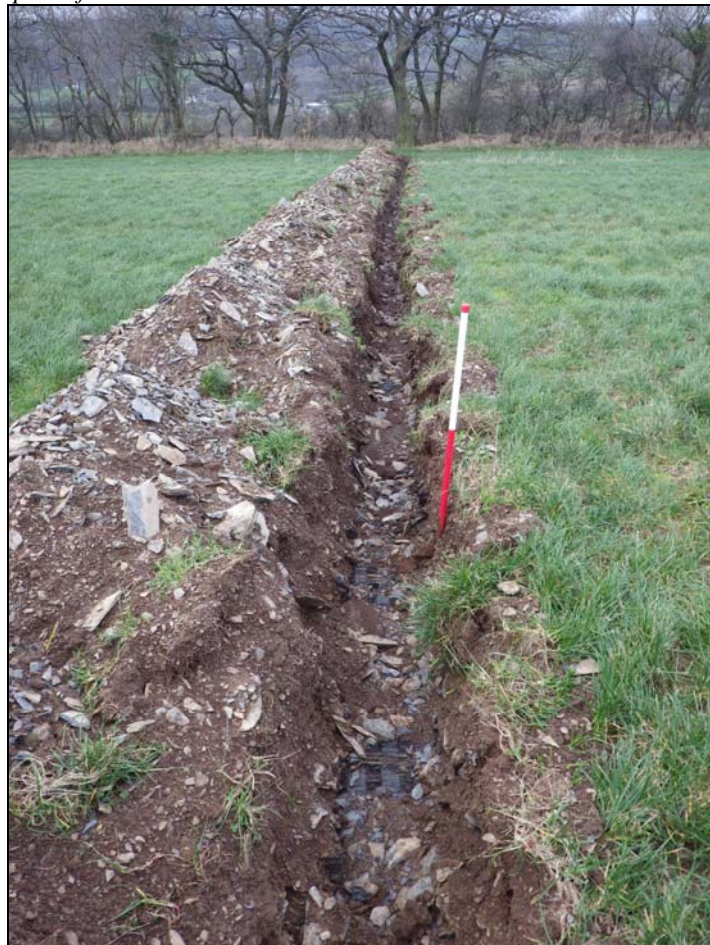
Plate 2: PGI2014_102, the northern part of the cable trench running north from the eastern turbine, looking north northwest. This part of the cable trench was open, but revealed no archaeological contexts or artefacts.

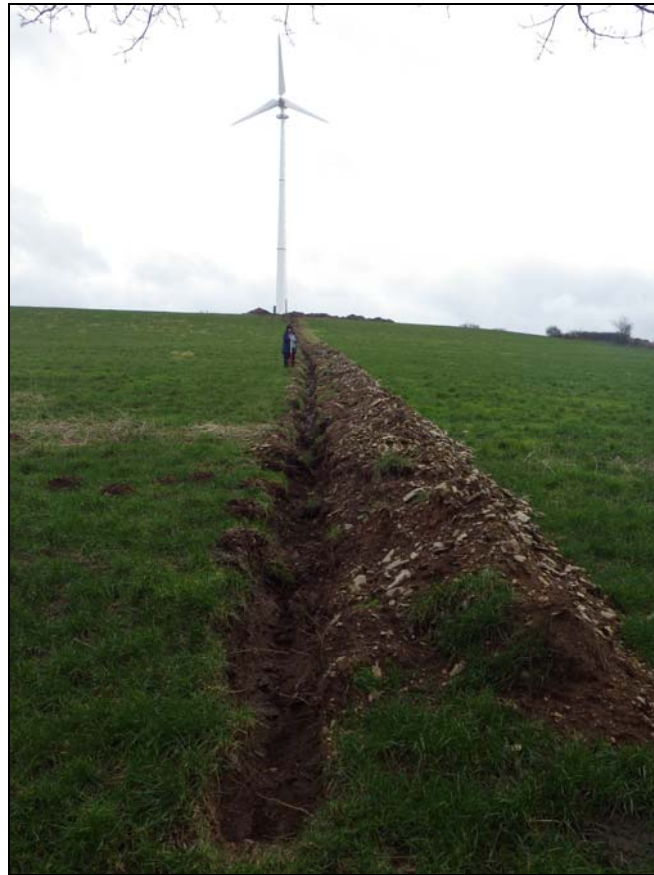
Plate 3: PGI2014_103, the northern part of the cable trench running north from the eastern turbine, looking south southeast. This part of the cable trench was open, but revealed no archaeological contexts or artefacts.

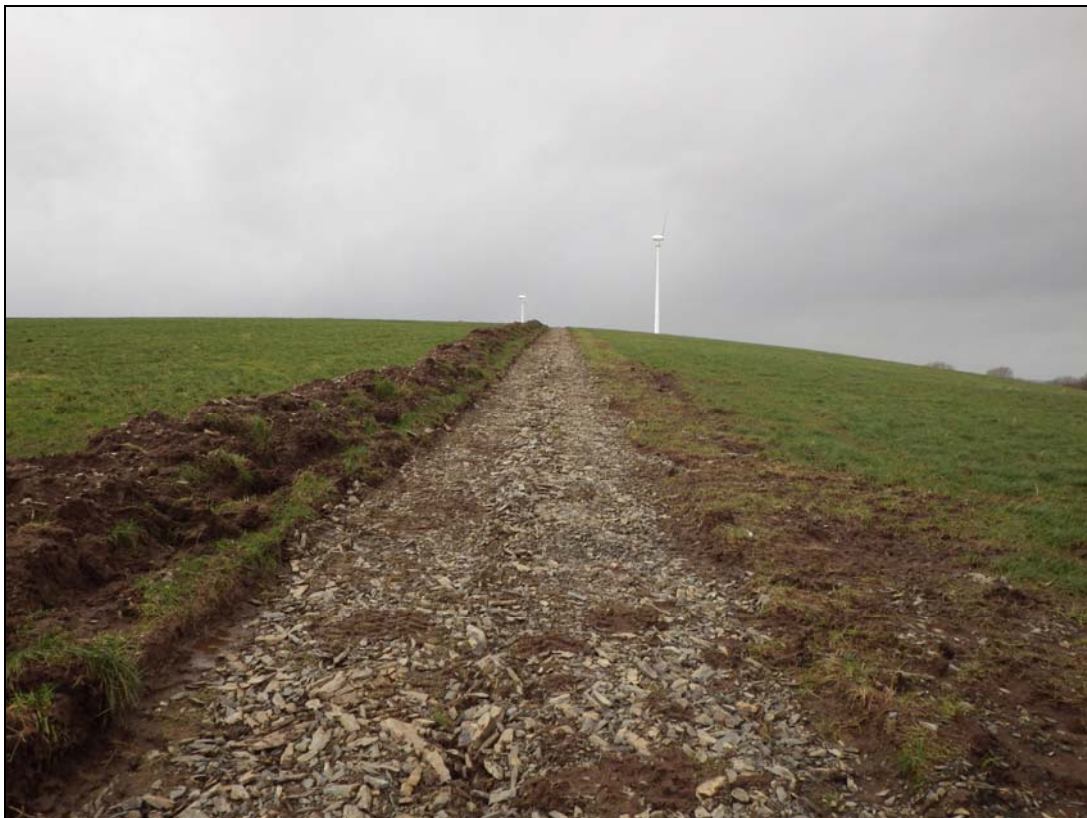
Plate 4: PGI2014_104, the eastern cable trench running east from the eastern turbine, looking southwest. The area stripped of topsoil was visible but no archaeological contexts or artefacts were revealed.

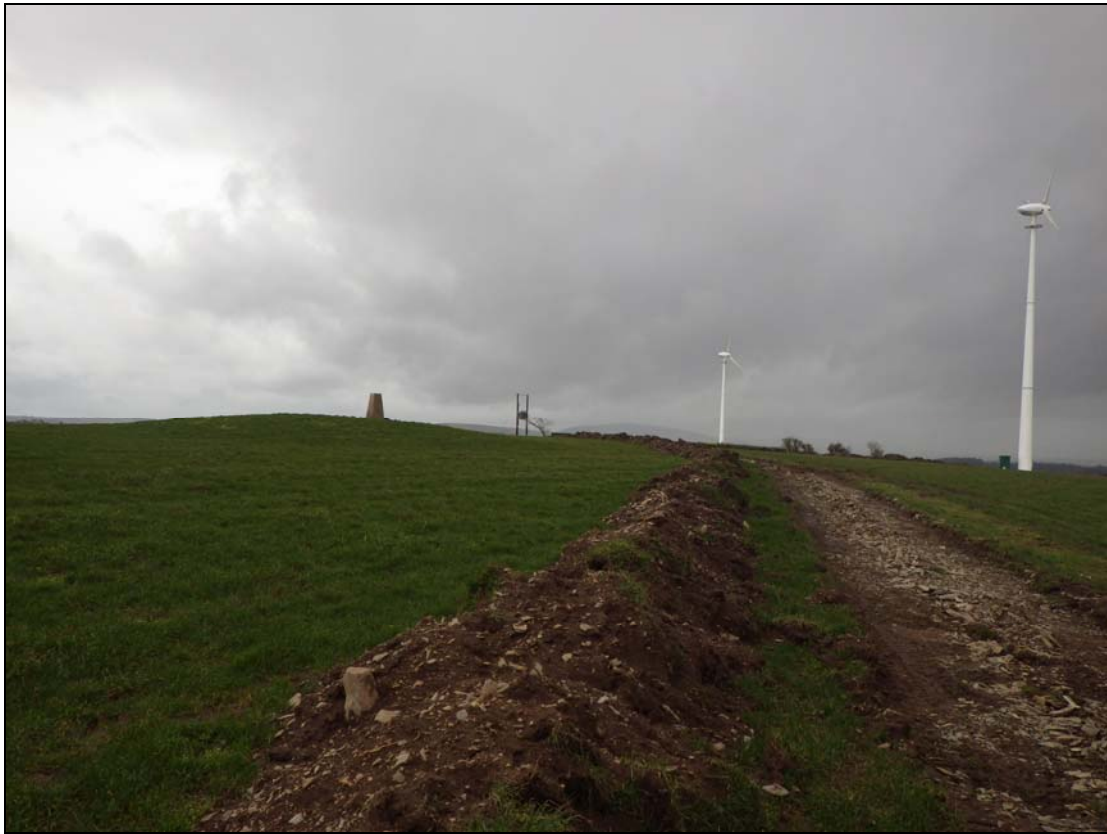
PGI2014_105	Round barrow, PRN 100717, with a concrete triangulation pillar on top of it with the cable trench running to the north of it.	24/02/2014	Looking southwest.

Plate 5: PGI2014_105, Round barrow, PRN 100717, with a concrete triangulation pillar on top of it with the cable trench running to the north of it.
