Archaeological Building Recording
of the
**NORTH-EAST BUILDING AT
NEWPORT CATTLE MARKET SITE,
NEWPORT.**
for
ISG Pearce

Report No. 2058/2009

Archaeological Building Recording
at
**NORTH-EAST BUILDING AT
NEWPORT CATTLE MARKET SITE,
NEWPORT.**

The surviving part of one range of the mid-19th century Cattle Market at Newport, in the north-east corner, was recorded to Level 3 standard before its removal as part of a scheme to redevelop the site as a supermarket. Some of the building had already been recorded in 2004. The remainder of buildings on the site will be recorded later.

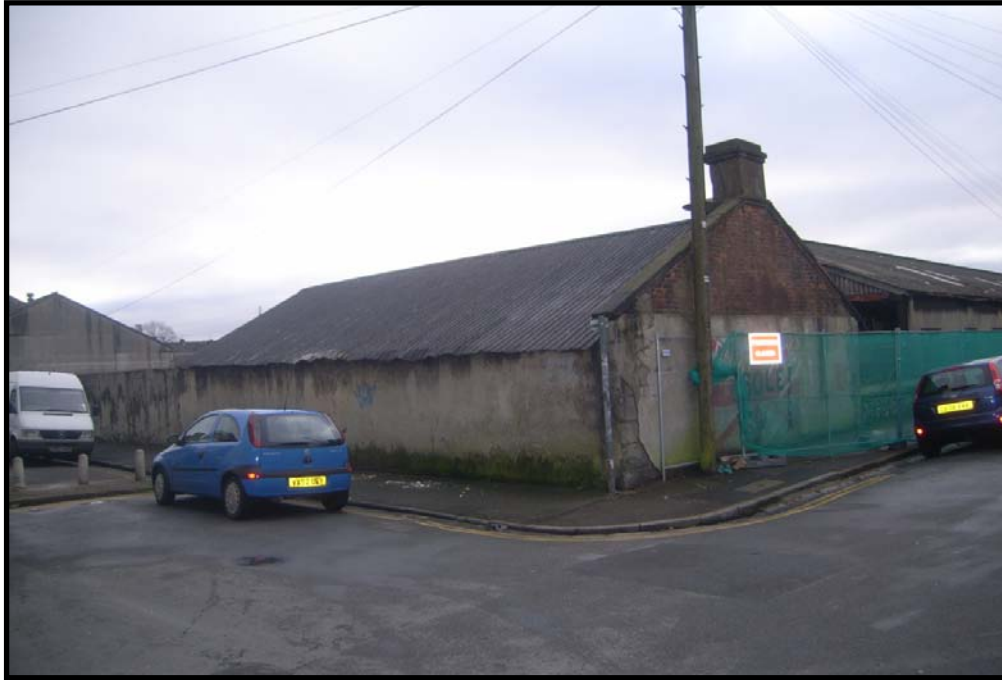
- Cover General view of building from north-east
- Plate 1 North elevation
- Plate 2 East elevation
- Plate 3 South elevation
- Plate 4 West elevation (N)
- Plate 5 West elevation (S)
- Plate 6 General view of interior, looking north-east
- Plate 7 Inside of north wall: centre, showing blocked fireplace, also gas burner
- Plate 8 Inside of north wall: west end with blocked alcove
- Plate 9 Iron column and portions of perforated lintel

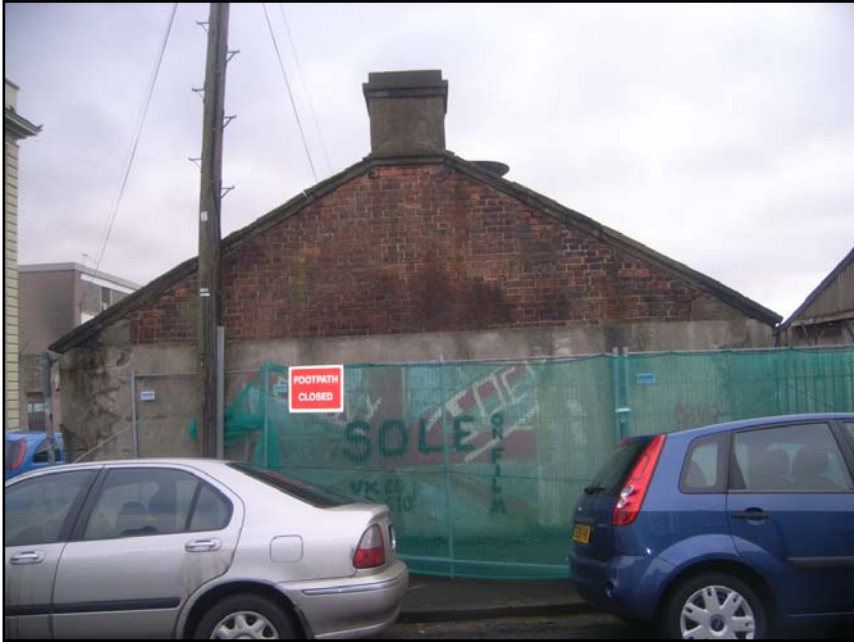
- 4.2 Both of the north and east external walls, to Ruperra Street and East Market Street respectively, are constructed of limestone rubble and about 650mm thick, and are rendered externally (**Plates 1 & 2**). There are ashlar quoins at the junction of the two walls. The exterior of the north end wall is rendered below eaves level, above which the exterior face is brick-built with a single ashlar block at the bottom of the western pitch of the gable and another near the bottom of the eastern pitch: the eastern eaves of this building are lower than along the western side. A rendered chimney stack finishes the top of the gable end, with coping stones along the angles down to the eaves. Inside the north wall is a central fireplace with a shallow brick arch supported by a shaped wrought iron plate, the opening now infilled with blockwork; there is brickwork visible in the wall above (**Plate 7**). To the west is a narrow arched recess, now also blocked in (**Plate 8**).

Plate 1
North elevation

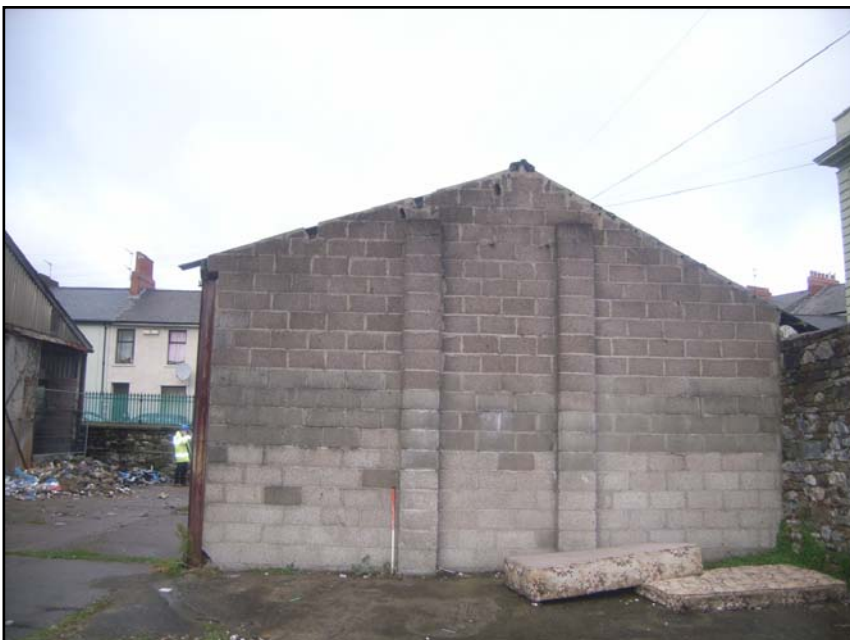
- 4.5 It is clear that the building was open-fronted from the beginning, but modern usage has dictated enclosure, achieved by the addition of two walls of concrete blockwork, one including double doors (**Plates 3-5**). Two external buttresses and one internal were built into the south wall. The west wall is unbuttressed for the north and south bays with large metal double doors closing the central bay (one leaf including a smaller wicket door).

Plate 3
South elevation

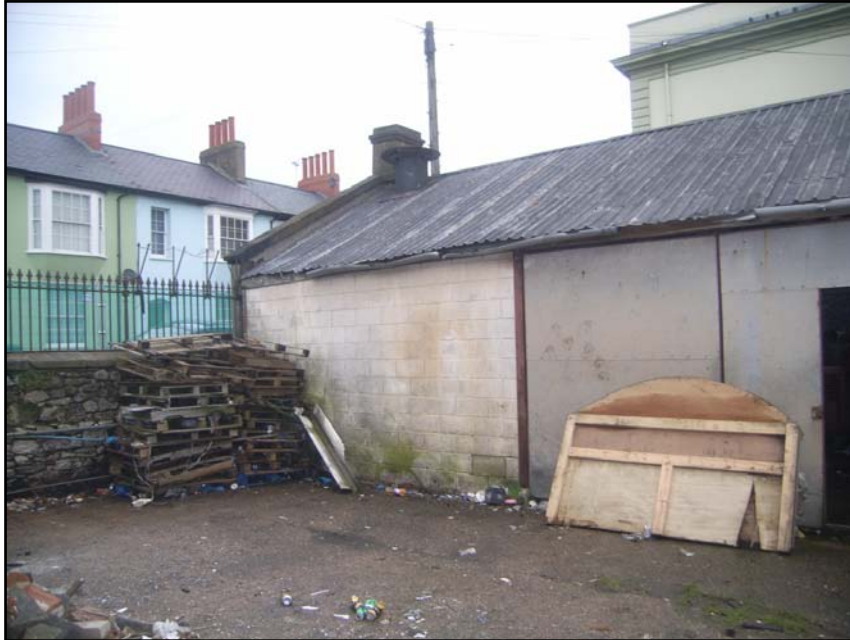
Plate 4
West elevation (N)

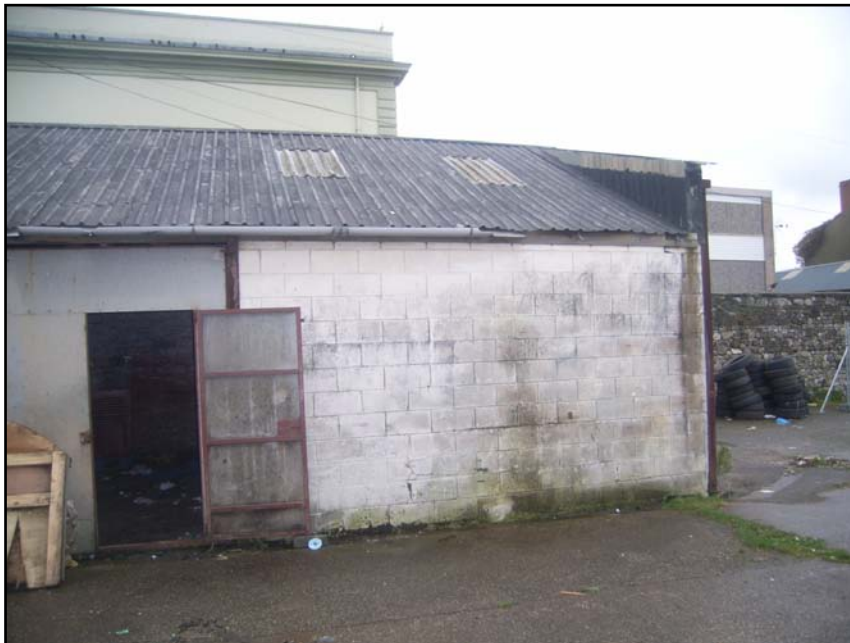
Plate 5
West elevation (S)

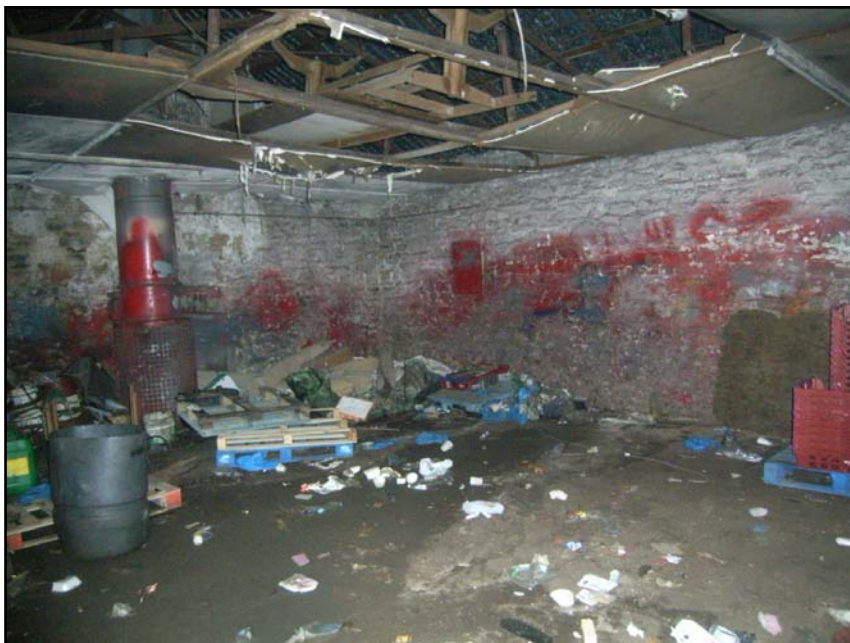
Plate 6
General view of interior,
looking north-east

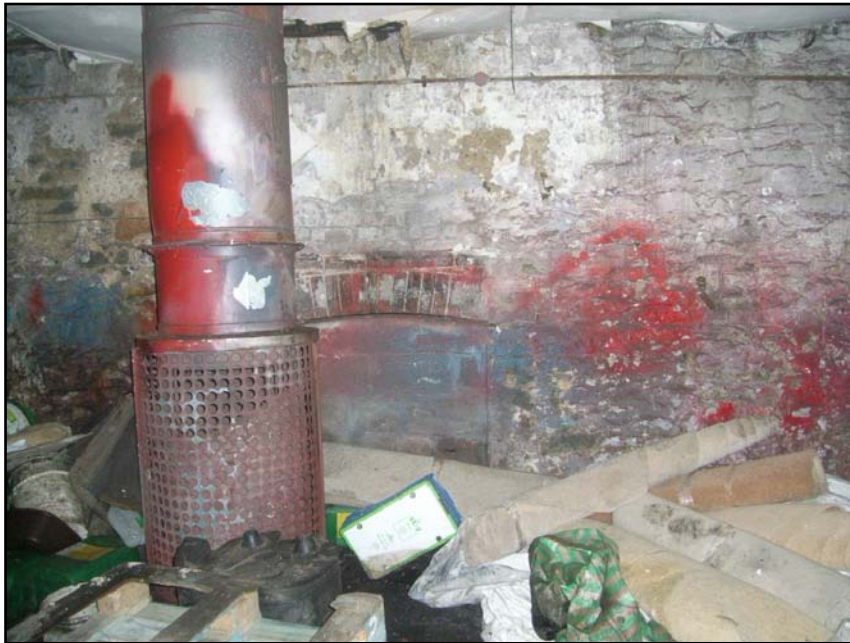
- 4.4 Flagstone flooring has been provided, each slab measuring approximately 870mm x 450mm. A modern gas burner of unidentified use has been placed inside the building, close to the north wall, with a flue emerging through the roof.

Plate 7
Inside of north wall:
centre, showing blocked
fireplace, also gas
burner

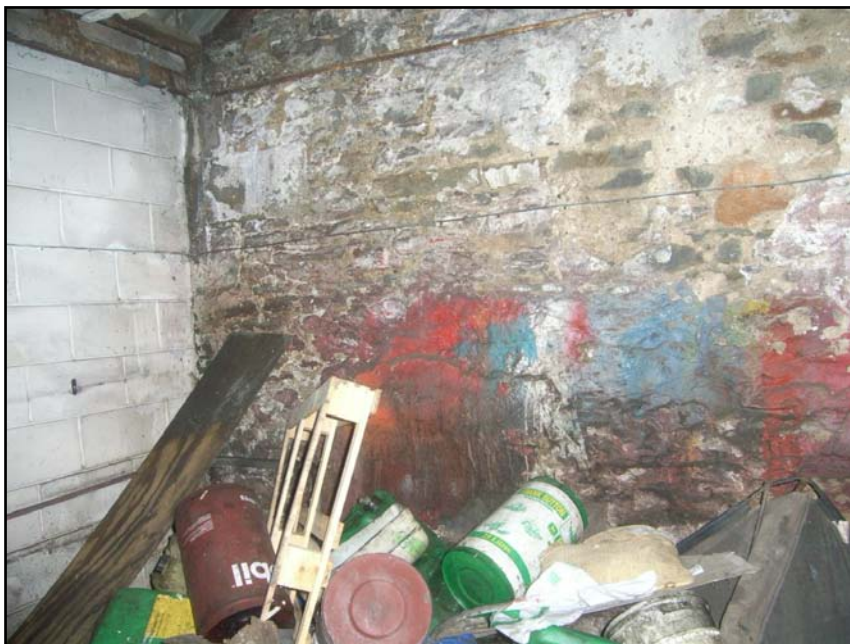
Plate 8
Inside of north wall: west
end with blocked alcove

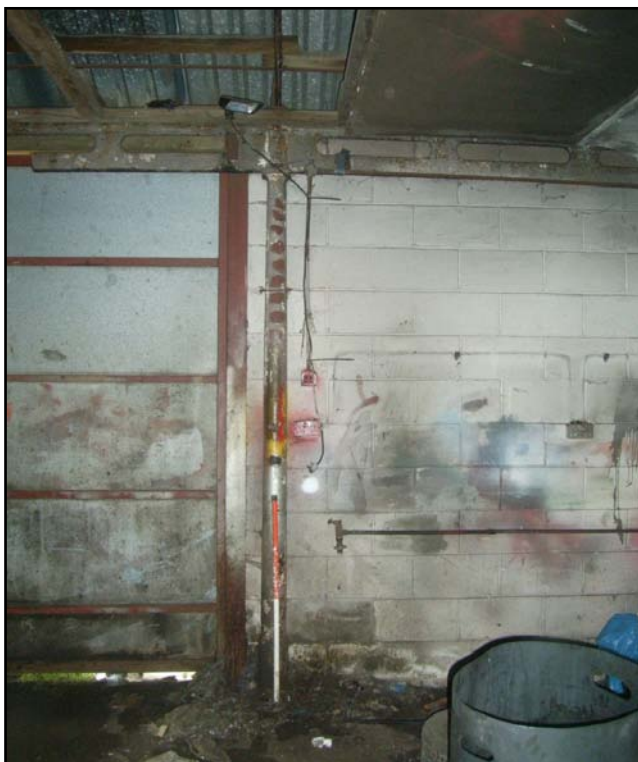
- 4.3 Each bay along the western side is defined by a cast-iron column (**Plate 9**), similar to those found elsewhere on site that date from the 1840s. Spanning each bay is a perforated cast-iron girder, or lintel, as also seen in other buildings on the site. The roof structure comprises a series of wrought iron scissor trusses complete with tie rods, with three trusses per bay. On its east side the roof sits directly on the top of the wall. Modern corrugated metal sheets have been used for roofing, with two clear panels in the southern part of the west pitch.

Plate 9
Iron column and portions of perforated lintel

- 1.5 This report will be complemented by a watching brief during demolition of the structure, at which point any additional information will be recorded. The iron columns and lintels are to be salvaged and stored, with the intention that they are reused at Big Pit at Blaenavon.
