Archaeological Evaluation
of land at
LLYNFI ROAD,
MAESTEG, SOUTH WALES
for
Morbaine Ltd.

Report No.1299/2005

Archaeological Evaluation
of land at
**LLYNFI ROAD,
MAESTEG, SOUTH WALES.**

Centred on
N.G.R. SS8500 9160

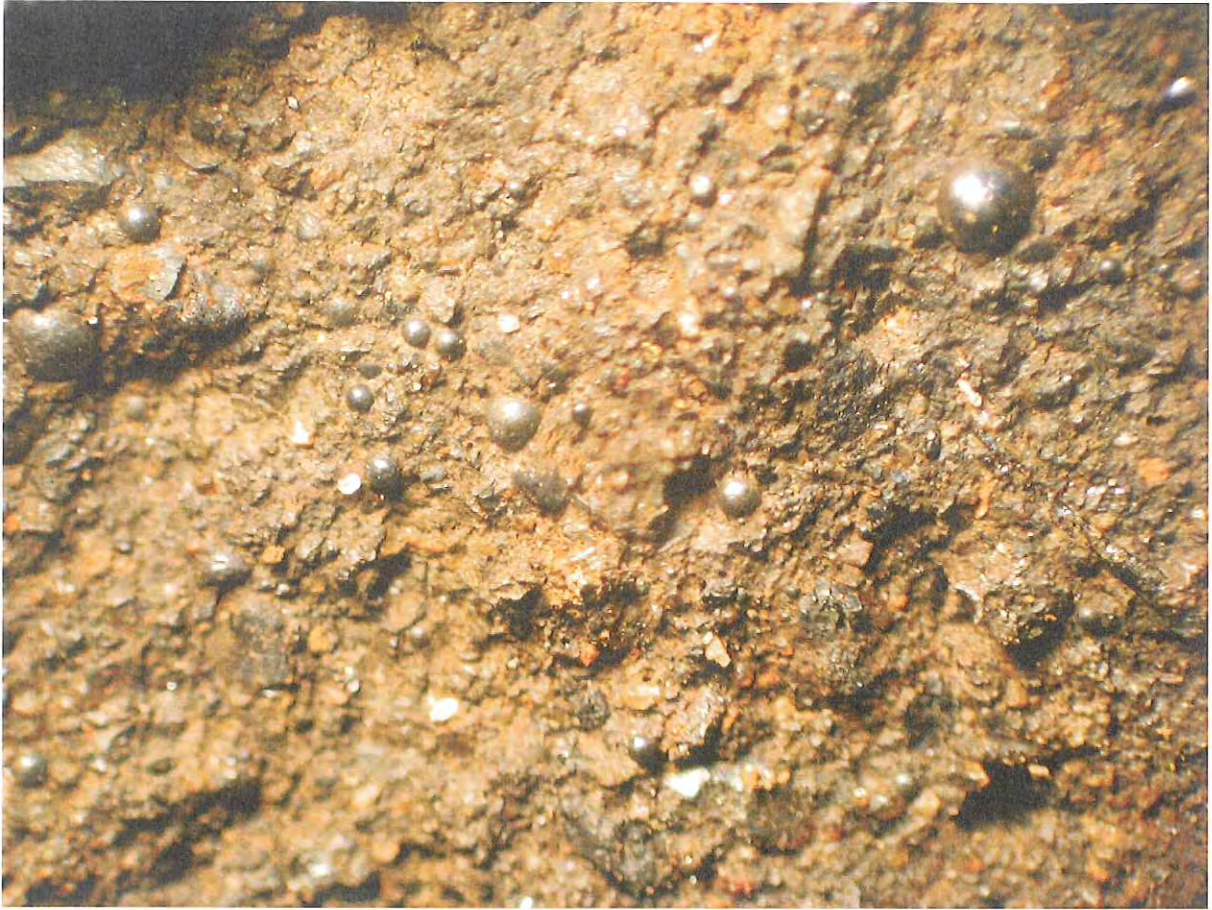
Figure Caption

Figure 1. Photomicrograph of an area of approximately 8mm x 11mm of a sample of concretionary material from context 305. The photograph shows the abundance of spheroidal hammer scale.

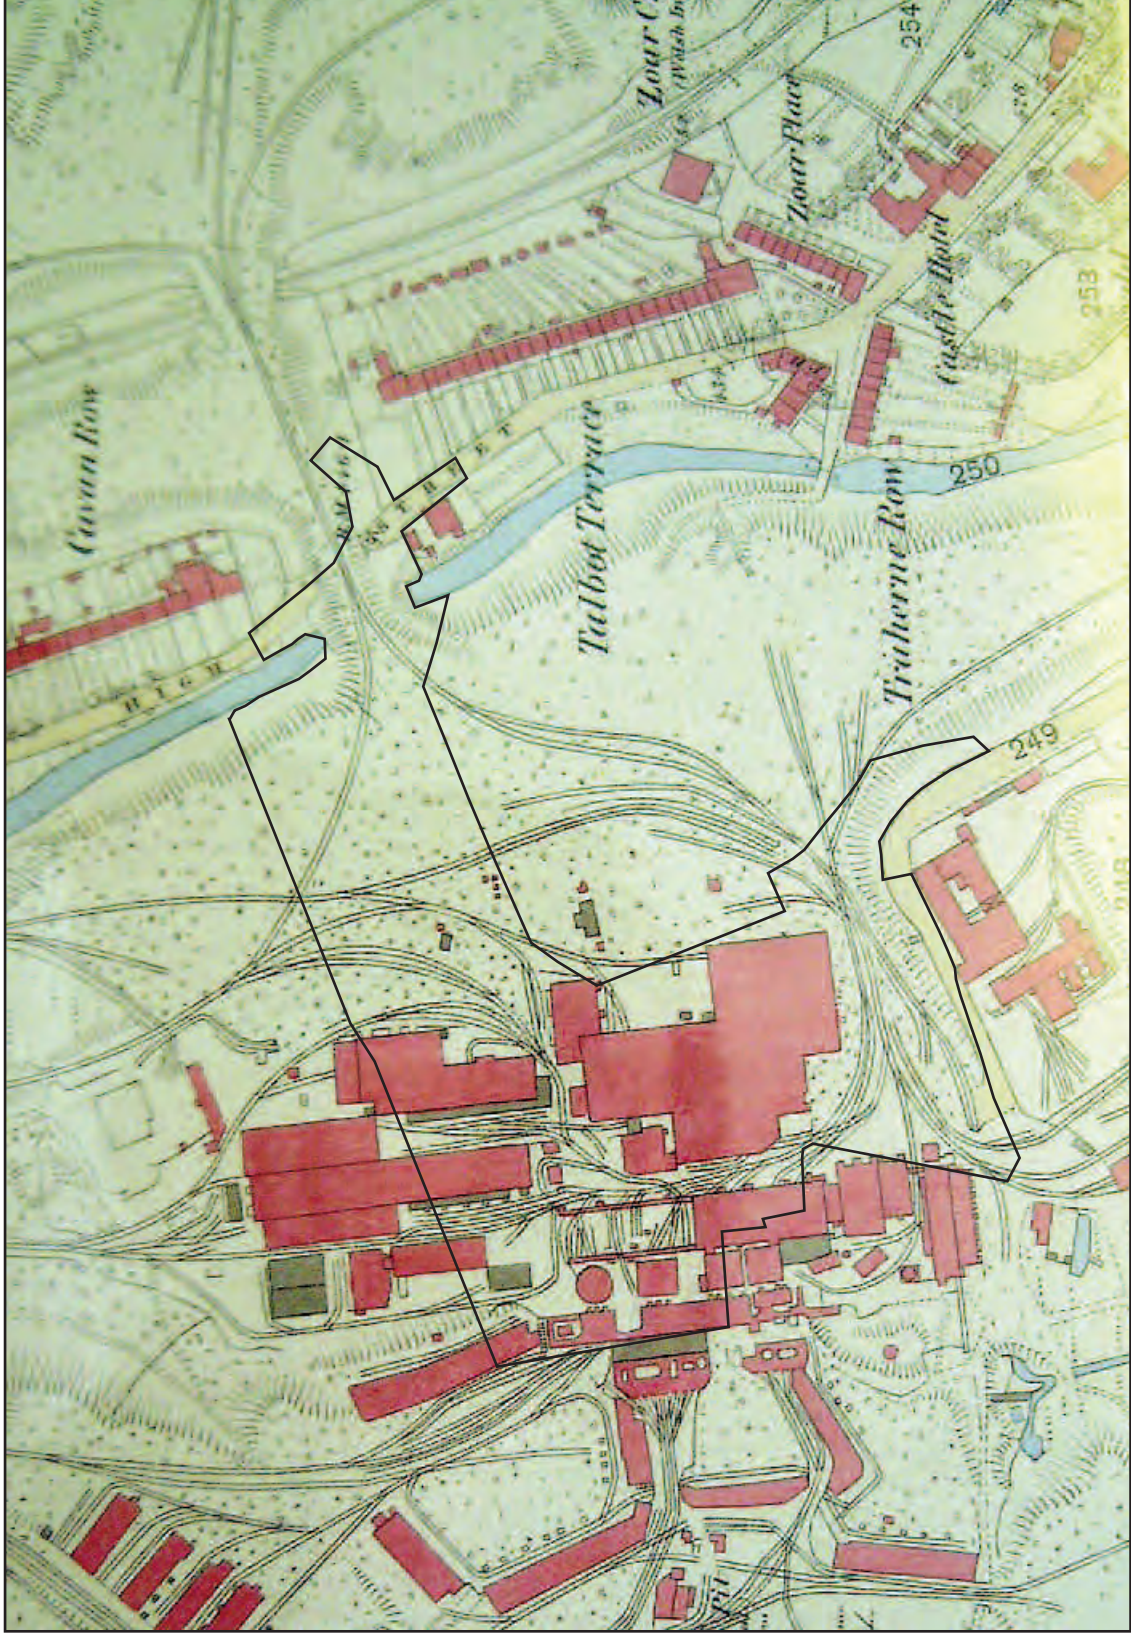
Fig. 6 Ordnance Survey 1:2500 (reduced), surveyed 1876

- 3.6 The alteration of the northern blast furnace is clearly visible in the Ordnance survey map surveyed in 1876 (Fig.6). Also of interest is the casting house to the east of the blast furnaces, which would seem to have been altered. In earlier plans the structure is given as solid and thus presumably covered. However in the 1876 plan its northern end shows only two walls with tramways protruding through or over them.

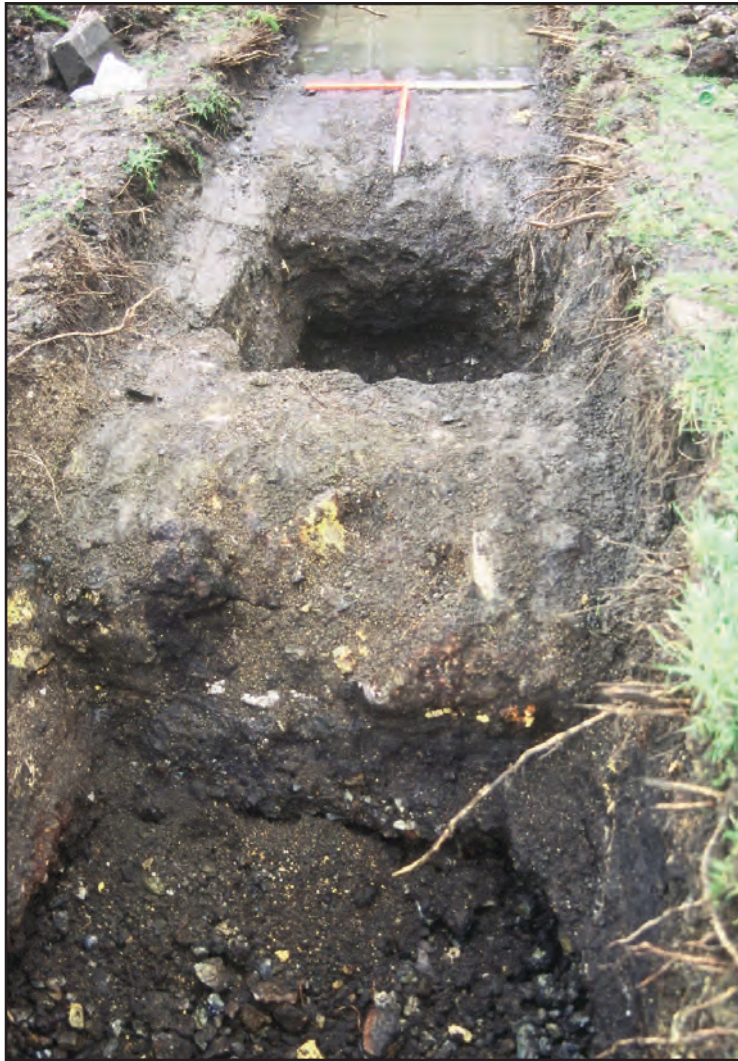
- 5.1.3 The indurated surface (103) was truncated by two regular steep-sided cuts which, although not fully exposed, would seem to have been either square or rectangular in plan (105 & 107). The cuts contained a friable mixture of building rubble and mortar and coal debris in their uppermost fills and a layer comprising hot blast furnace slags varying from a pale mid grey to dark green at their base (104,106 & 108). Neither cut was excavated to its maximum depth owing to health and safety considerations. The purpose of the two regular cuts is uncertain owing to the limited exposure in the trench. However, a possible function is that they acted as substantial bases for structures which were once sited in the area.

Plate 1 Trench 1, cuts 105 and 107 at eastern limit of trench

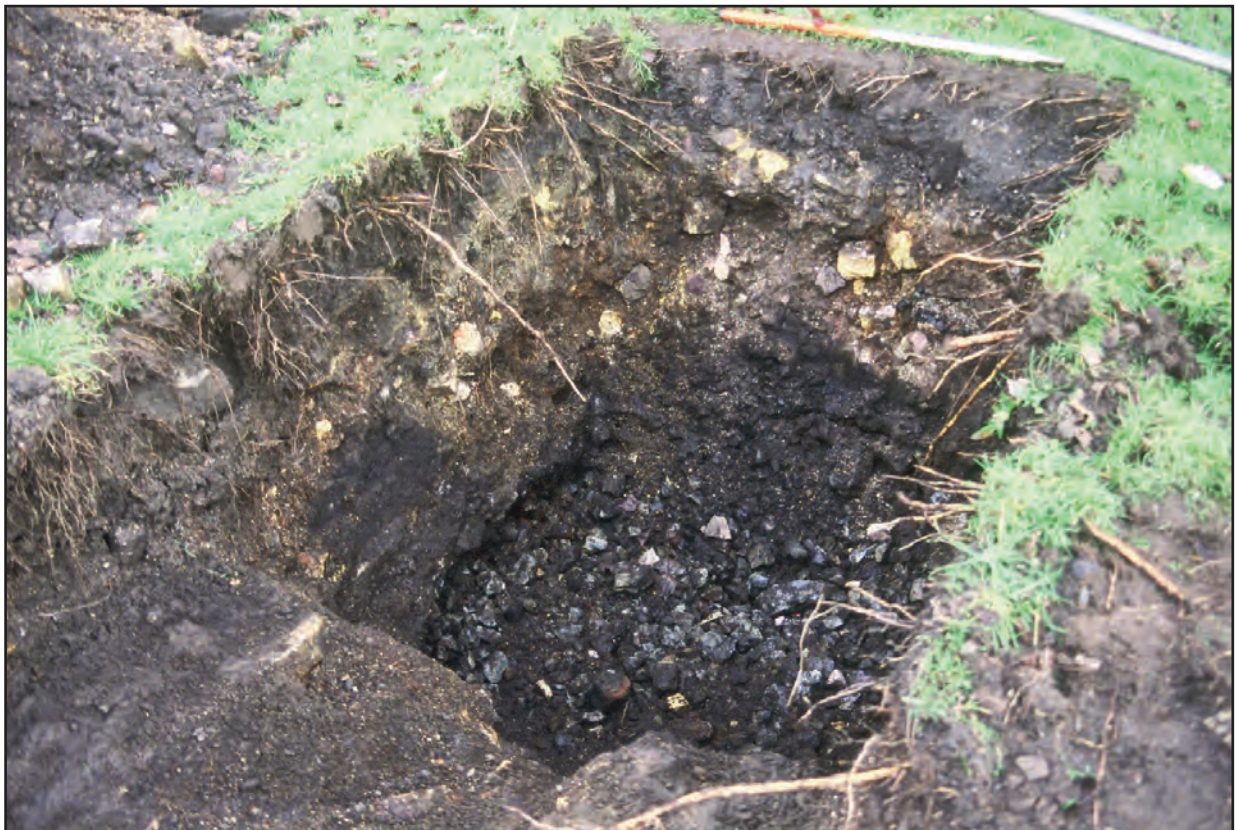
Plate 2 Trench 1, cut feature 107 and fills 106 and 108

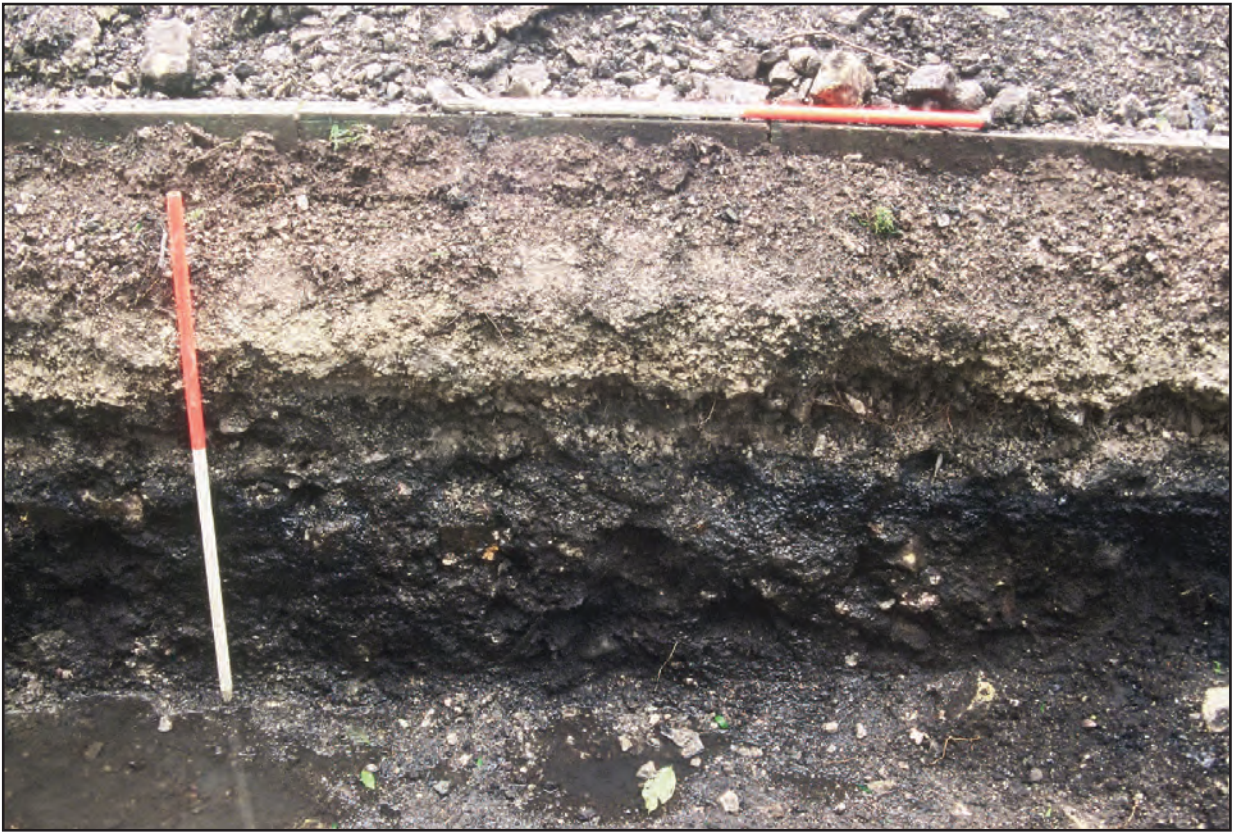
Plate 3 Trench 2, north-facing section

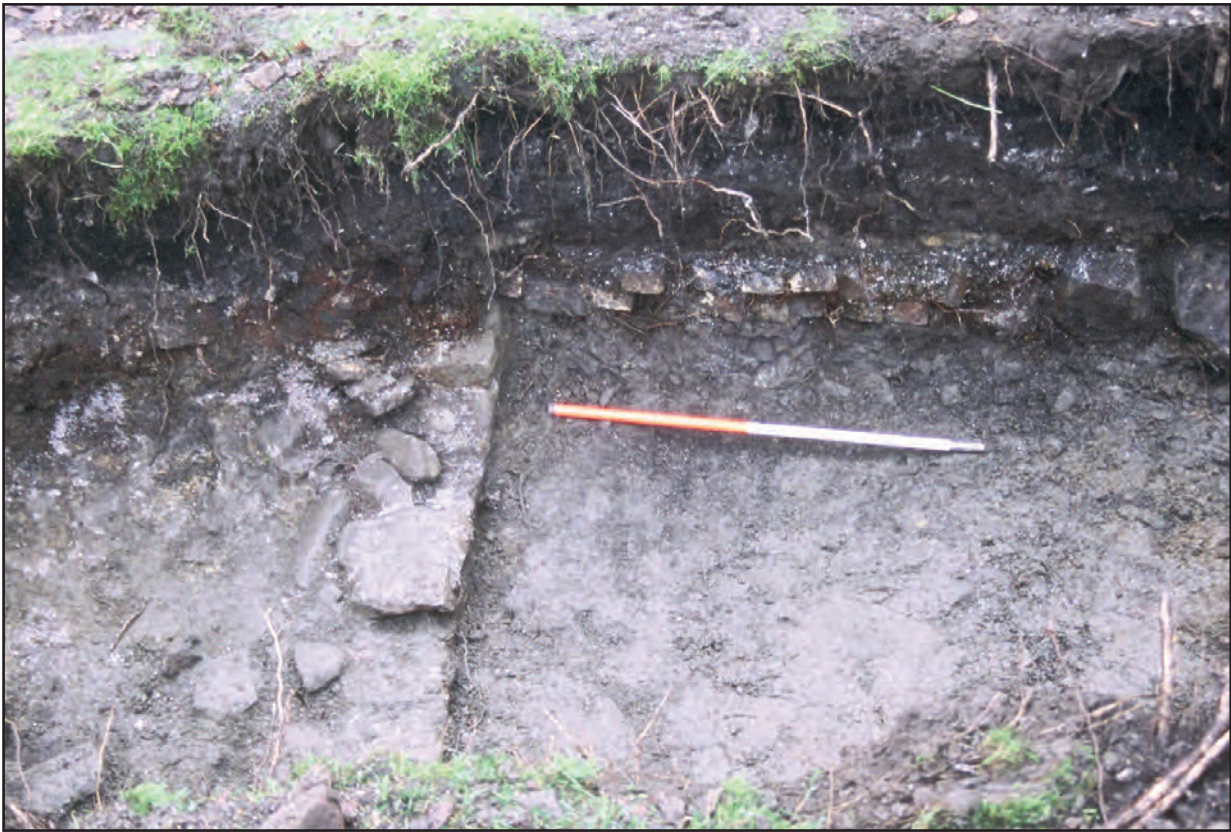
- 5.3.3 Wall 302 ran in a W-E direction and consisted of both brick and pennant sandstone bonded by a light whitish/grey mortar containing lime and charcoal flecks. It was less substantial than wall 304 with its eastern extent disturbed by machining. Walls 302 and 304 were bonded together with the smaller, 302, seemingly abutting 304. The walls are thus likely to be broadly contemporary and are thought to represent the main eastern wall of the casting house and an internal partition wall.

Plate 4 Trench 3, walls 302 and 304 and north-facing section

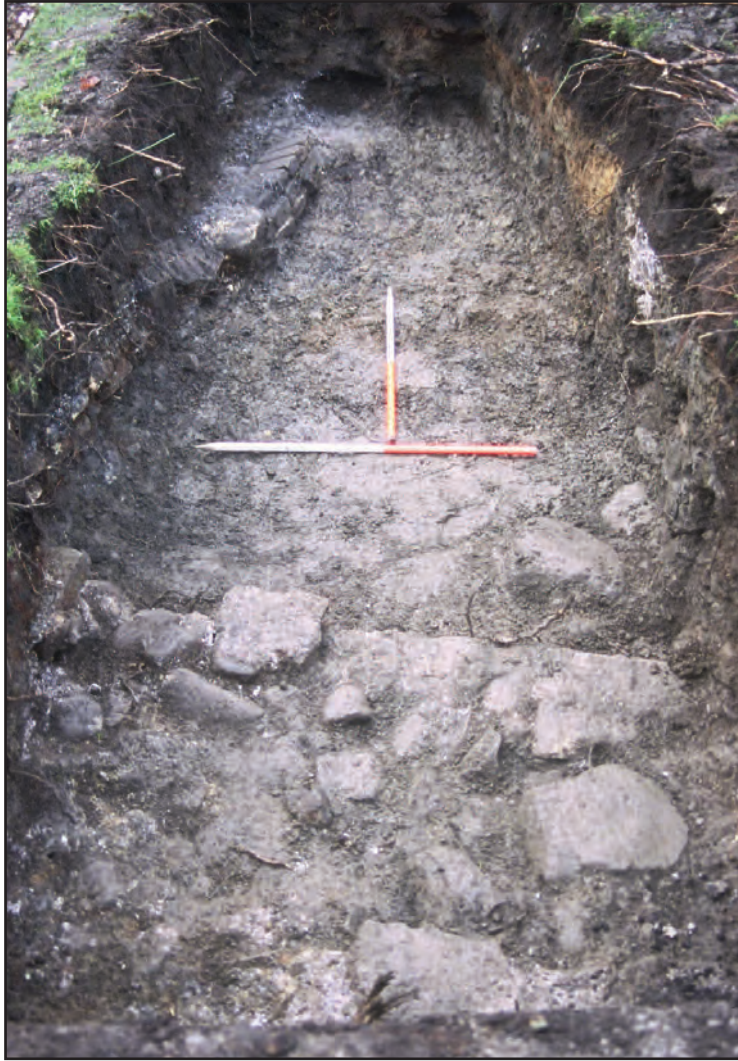
Plate 5 Trench 3, looking west

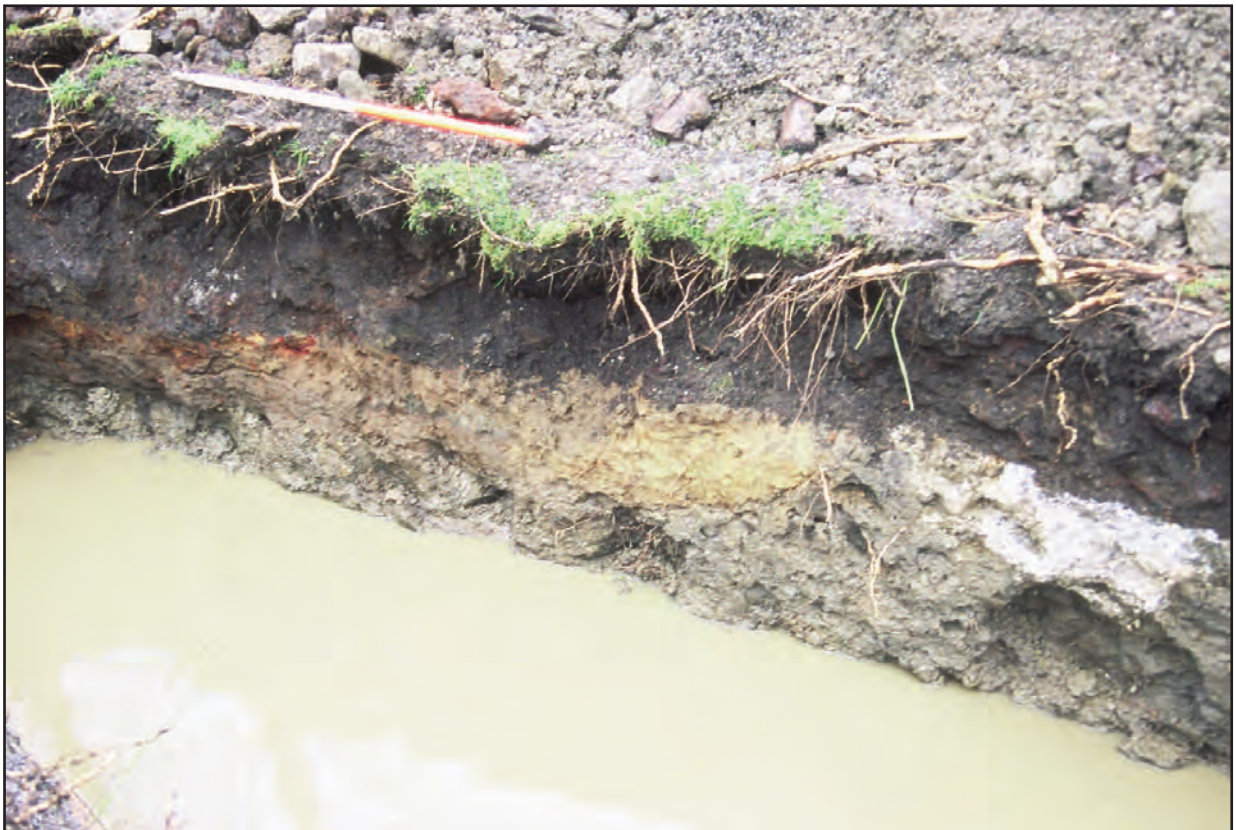
- 5.3.4 Evidence for the in-situ casting room floor was also present within the trench in the form of a layer of sand (310) contained within cut (309). The sand was mixed with ferrous material at the south-west corner of the trench which is possibly debris associated with the casting process (Dr. T. Young per comm.). A further oval cut and fill was encountered to the east of the casting room floor (307 & 308) with the fill consisting of a friable light greyish white mortar containing lime and charcoal flecks. The exact function of this feature is uncertain but it is stratigraphically contemporary with the casting room floor and is probably related to the casting process.

Plate 6 Trench 3, Casting House floor at western extent of trench

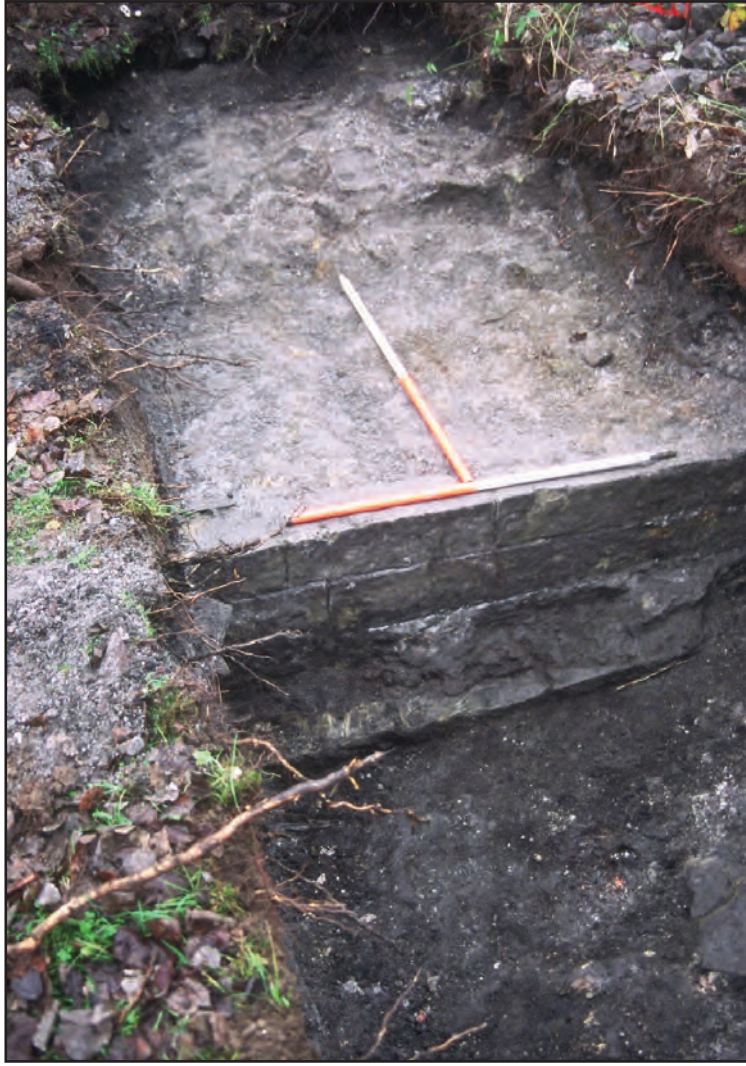
- 5.4.4 Wall 405 consisted of 3 courses of dressed pennant sandstone blocks above a faced protruding footing. The wall was bonded by a light whitish/grey lime mortar containing occasional charcoal and slag inclusions. The wall retained a rubble infill (406) consisting of roughly hewn pennant sandstone rubble bonded by an identical mortar to that within wall 405. The rubble layer continued southwards to the edge of the trench so was at least 2.6m in length. Wall 405 and rubble infill 406 are thought to represent the in-situ remains of the northern face of the third blast furnace.

Plate 7 Trench 4, Wall 405 and rubble infill 406

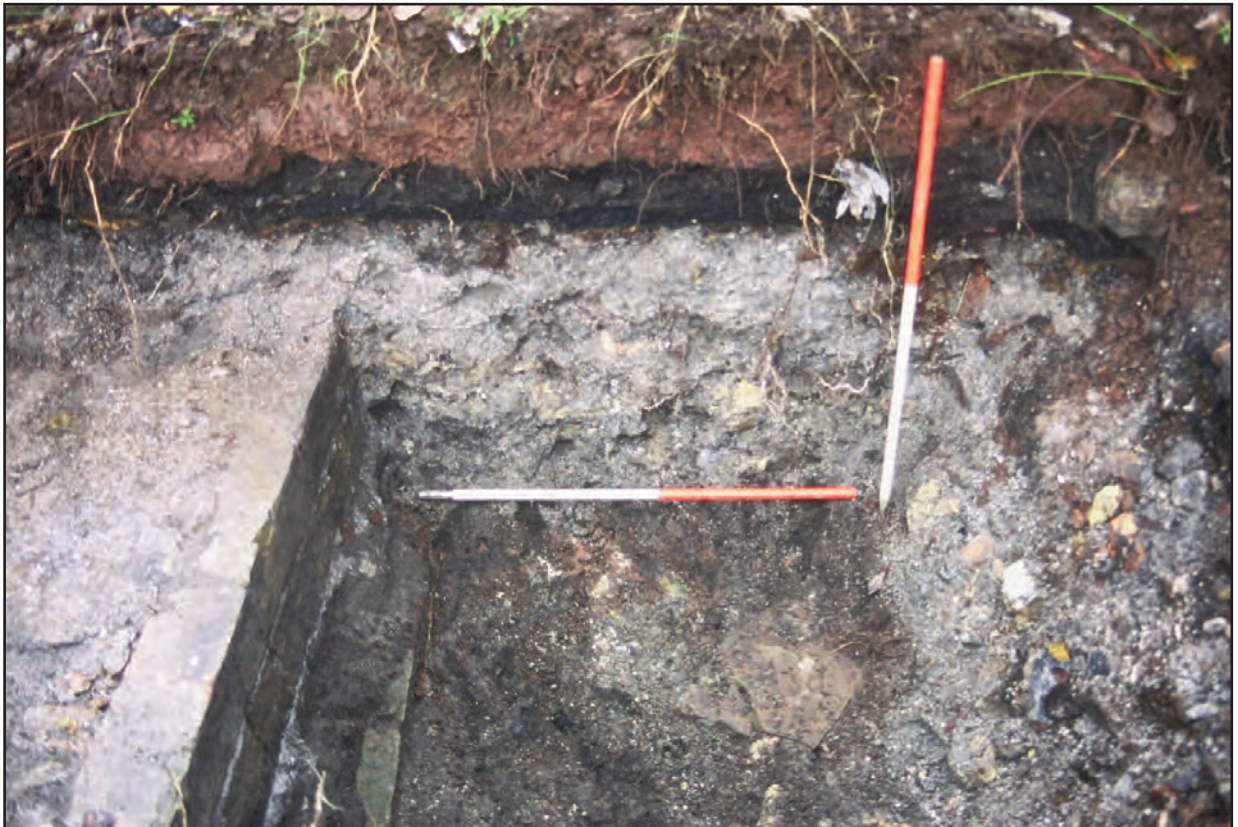
- 5.4.5 Physically abutting and overlying wall 405 and infill 406 was a substantial demolition deposit (404) consisting of sandstone rubble and mortar. Overlying layer 404 was a mid reddish/brown deposit containing frequent slag and ferrous material that had formed a firm surface (403). Above this layer, a friable dark blackish grey clayey silt containing frequent slag and coal fragments was present (402), above which lay a redeposited landscaping horizon (401) consisting of heavily bioturbated mercia mustone.

Plate 8 Trench 4, Wall 405 and associated demolition debris and landscaping horizons

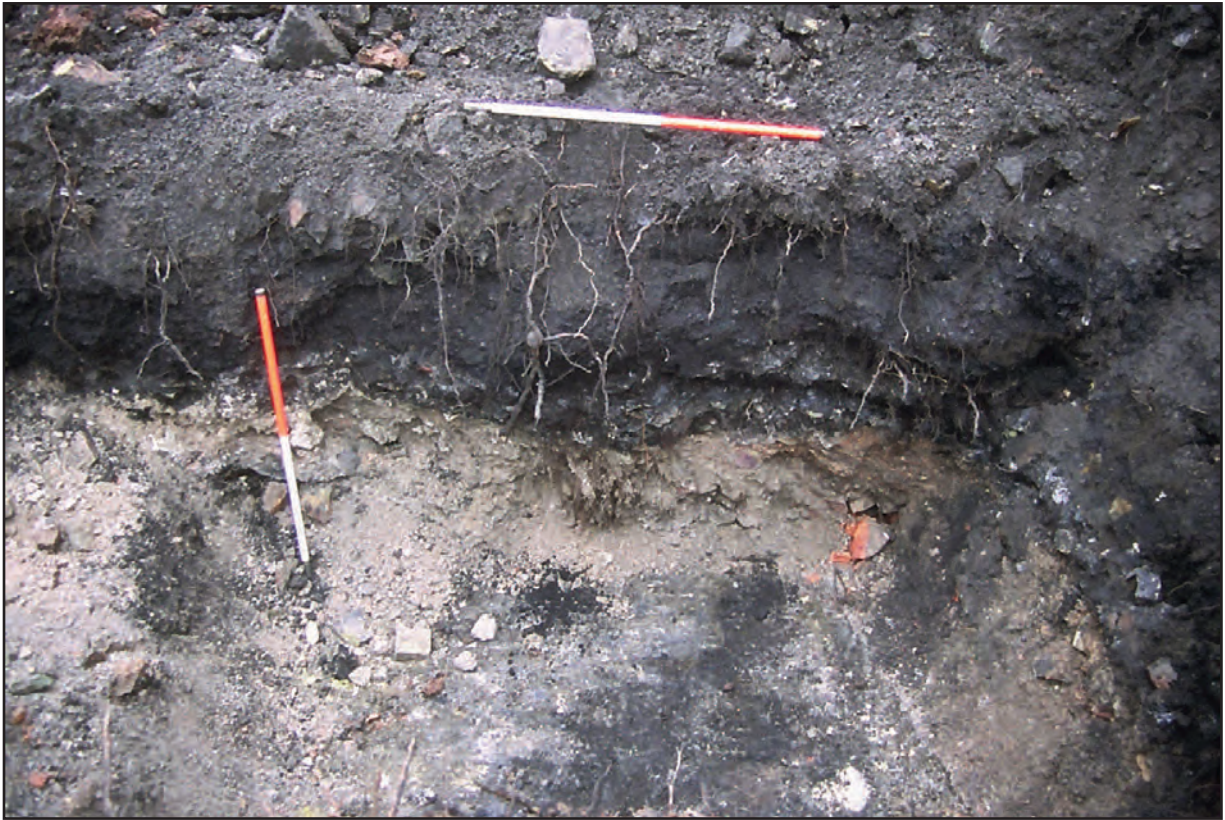
- 5.5.1 Trench 5 measured 5m x 1.5m and was sited 2m to the north-west of Trench 4 (see **Fig.16 & Plate 9**). It was excavated to a maximum depth of 1.9m. The trench contained successive layers of demolition debris stratified within differing deposits being either mortar or slag rich (505,504,503,502).
- 5.5.2 No structural remains of the northernmost blast furnace were apparent within the trench although the bottommost deposits (504 & 505) contained heat affected fire bricks associated with the inner core of the structure. Given health and safety guidelines it was not possible to further excavate the trench so it could not be ascertained if the blast furnace was located beneath the successive deposits of demolition debris.

Plate 9 Trench 5, east-facing section

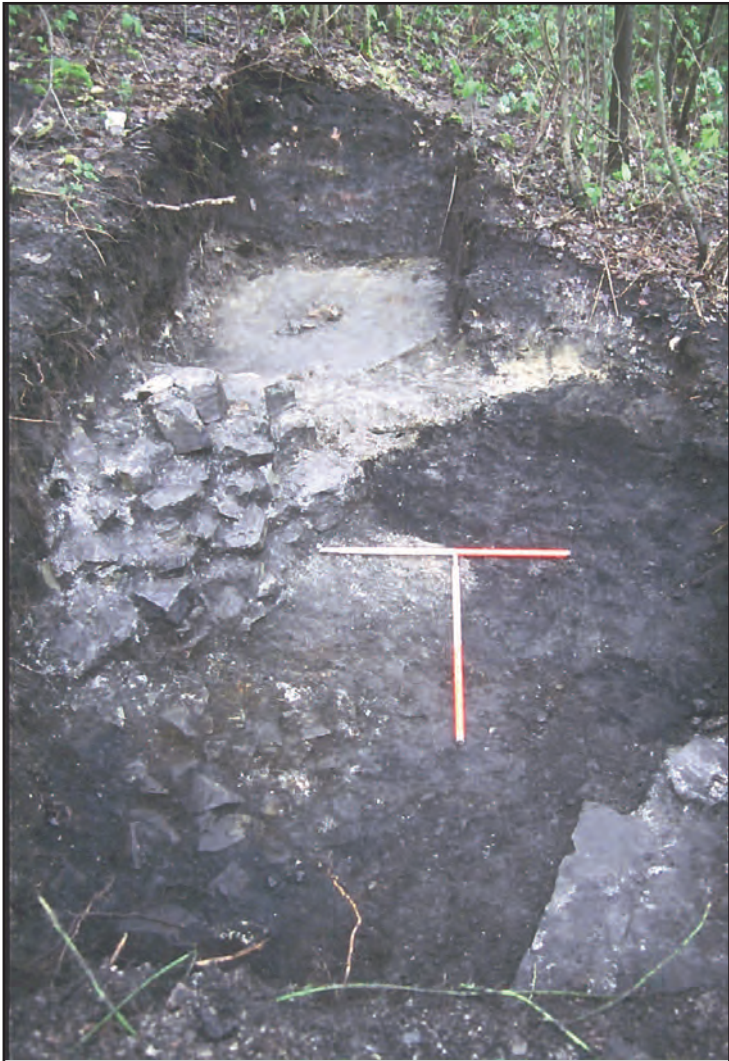
Plate 10 Trench 6, looking north

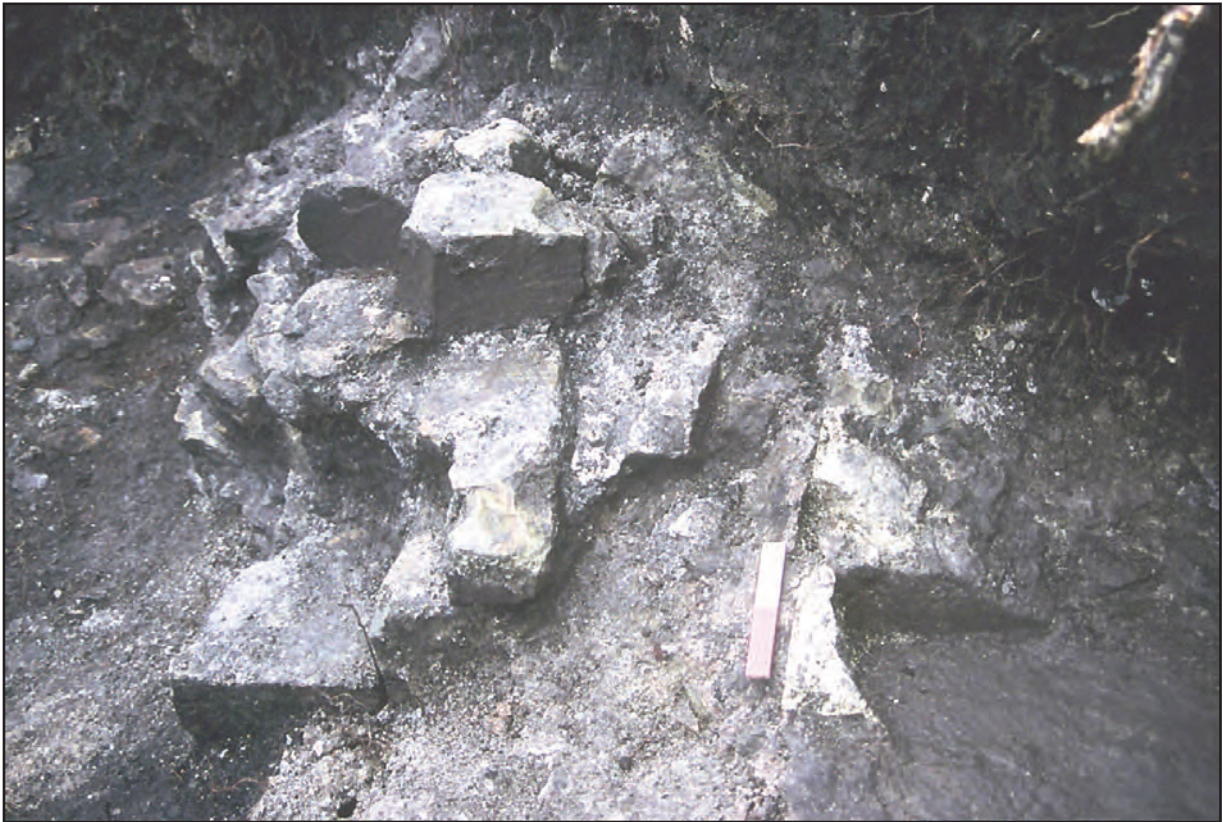
- 5.6.2 The remains of a wall (608) was identified within the western limit of trench 6. The wall fragment was constructed of roughly hewn pennant sandstone bonded by a light whitish grey limestone mortar. The main body of the wall was heavily disturbed and consisted of mortar bonded rubble reaching a maximum height of 0.6m above the base of the excavated trench. The eastern limit of the wall exhibited a definite face and is most likely to be the base of the tapping arch which would have led from the main base of the blast furnace. This is supported by the presence of heat affected fire bricks to the rear of the arch which are likely to have formed the internal superstructure of the blast furnace itself.

Plate 11 Trench 6, Wall 508 and internal fire bricks

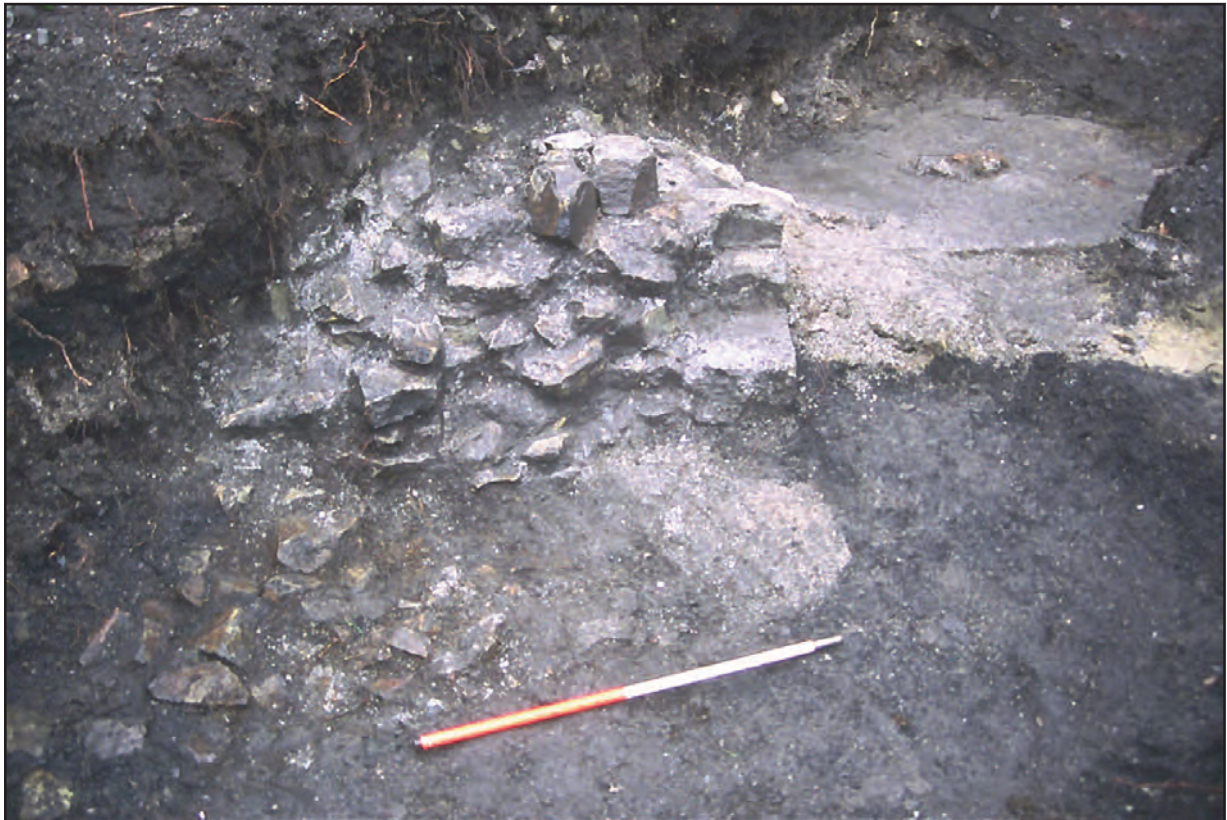
- 5.6.7 Deposits 616,617 and 614 had been truncated by a substantial linear cut feature (612). The amount of bioturbation and disturbance witnessed within deposit 616 had obscured the uppermost reaches of the cut but it was clear within the lower reaches of 616 and the whole of 617. The cut was interpreted as a robber trench dug to remove the facing stones from wall 608, presumably in the 1950's so as to construct St. Michael's Church tower.

Plate 12 Trench 6, view of structural features and robber trench to north-west of trench

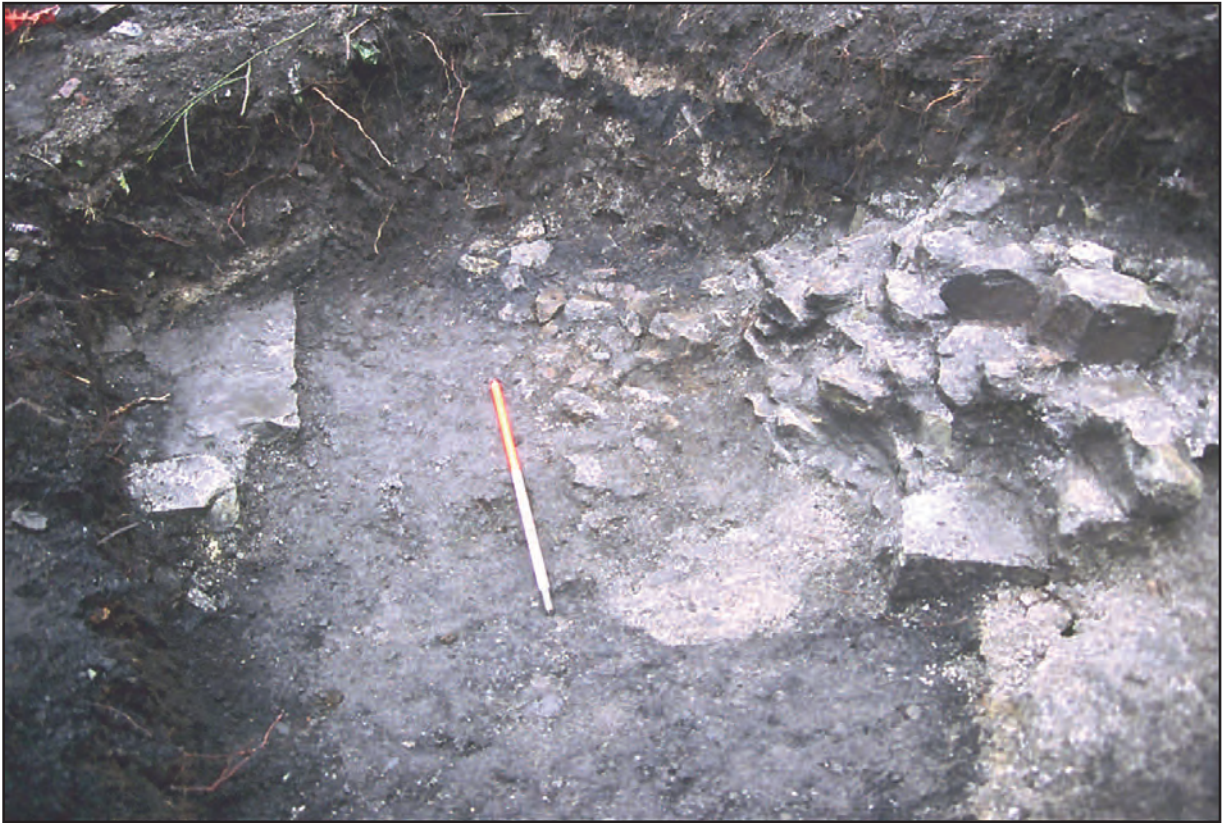
- 5.6.4 To the south-east of wall 608 and base 609 lay wall 615. Again this was constructed of pennant sandstone and bonded by a whitish grey mortar. It was faced to the north and west. Wall 615 lay broadly parallel to wall 608 and may be part of the same blast furnace structure, perhaps being a subsidiary wall supporting the chimney of the blast furnace (see conclusion & fig.4).

Plate 13 Trench 6, wall 508 and 515 and robber trench
