Conservation Management Plan

Llanelly House

Revised February 2009

Prepared for Carmarthenshire Heritage Regeneration Trust

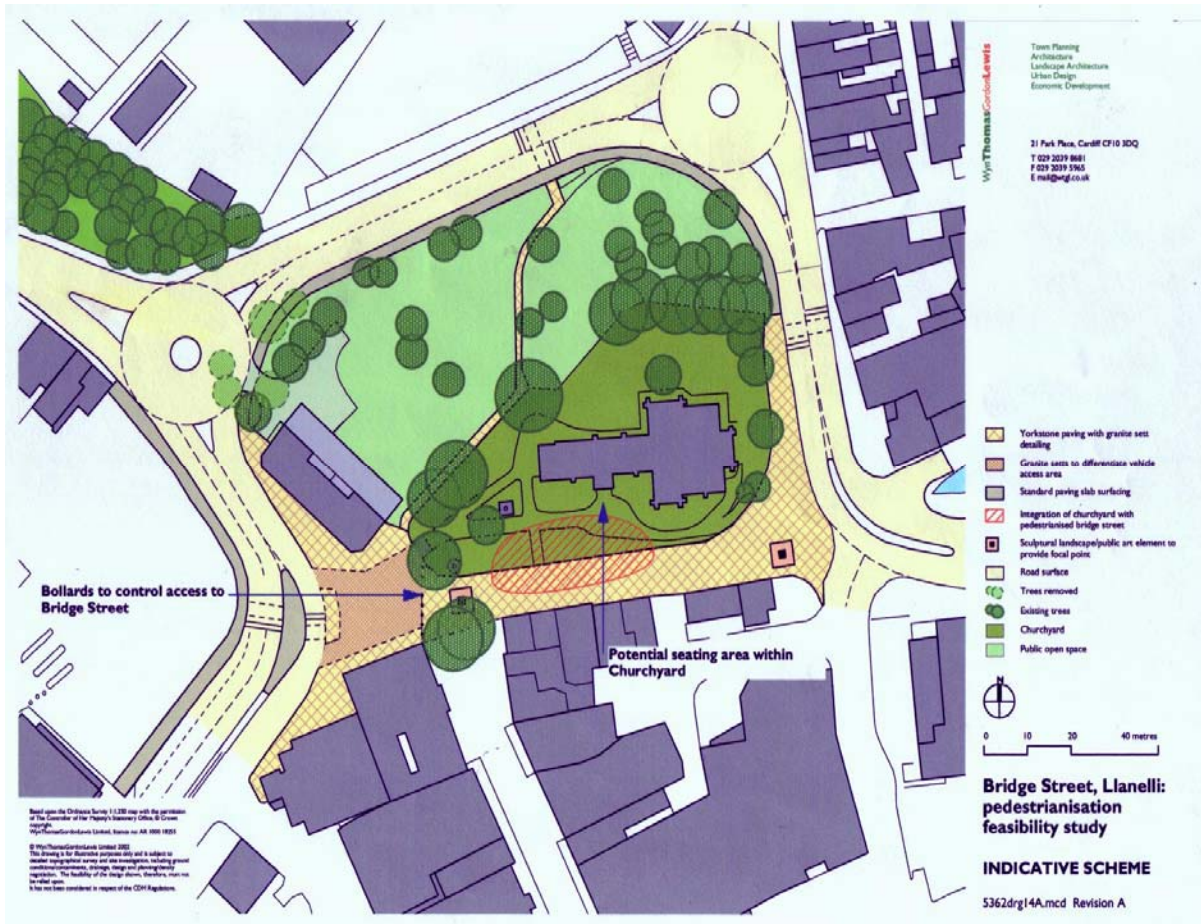
Bridge Street, Llanelli; pedestrianisation feasibility study.
