Report by: Trysor

### Trysor Project No. 2017/574

Land opposite Tithebarn Cottage, Tregynon, PowysHistoric Environment Desk-based Assessment

## Outline Planning Application P/2017/0621 (Powys)

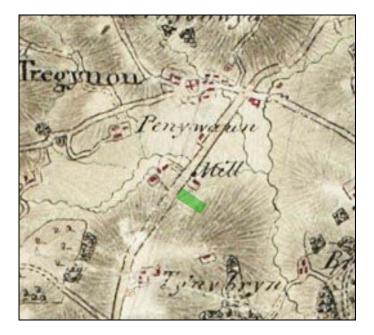
Figure 3; The Tregynon Parish Tithe Map of 1840. The proposed development site is located within field B.363, named by the tithe survey as Tithebarn Piece. The building in field B.365 is the School, now known as Tithebarn Cottages. The B4389 road to Bettws Cedewain, which passes between Tithebarn Cottages and the development site was not built until some 20 years after this map was produced.

- 8.3 Historical sources show us that the land was formerly part of Ty'n y Bryn Farm, which lies to the south of the development site. The parish tithe map (1840) and tithe apportionment (1841) record that the development fell within an arable field belonging to Ty'n y Bryn farm. The field name was recorded as Tithebarn Piece, a reference to the former tithe barn (ID number 2) which stands just to the north and was in use as a school in the 1840s. At the time of the tithe survey, Ty'n y Bryn Farm was owned and occupied by Charles Hanbury-Tracy, Lord Sudeley of Gregynog, possibly during a period when Gregynog Hall was undergoing refurbishment.

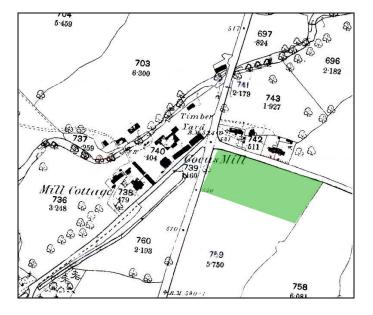
Figure 4; The 1886 1:2500 Ordnance Survey map with the approximate area of the development site shaded in green. By this time the B4389 road to Bettws Cedewain had appeared, Concrete Cottages had been built (ID numbers 10 & 18) and the field had been laid out in approximately its present form.

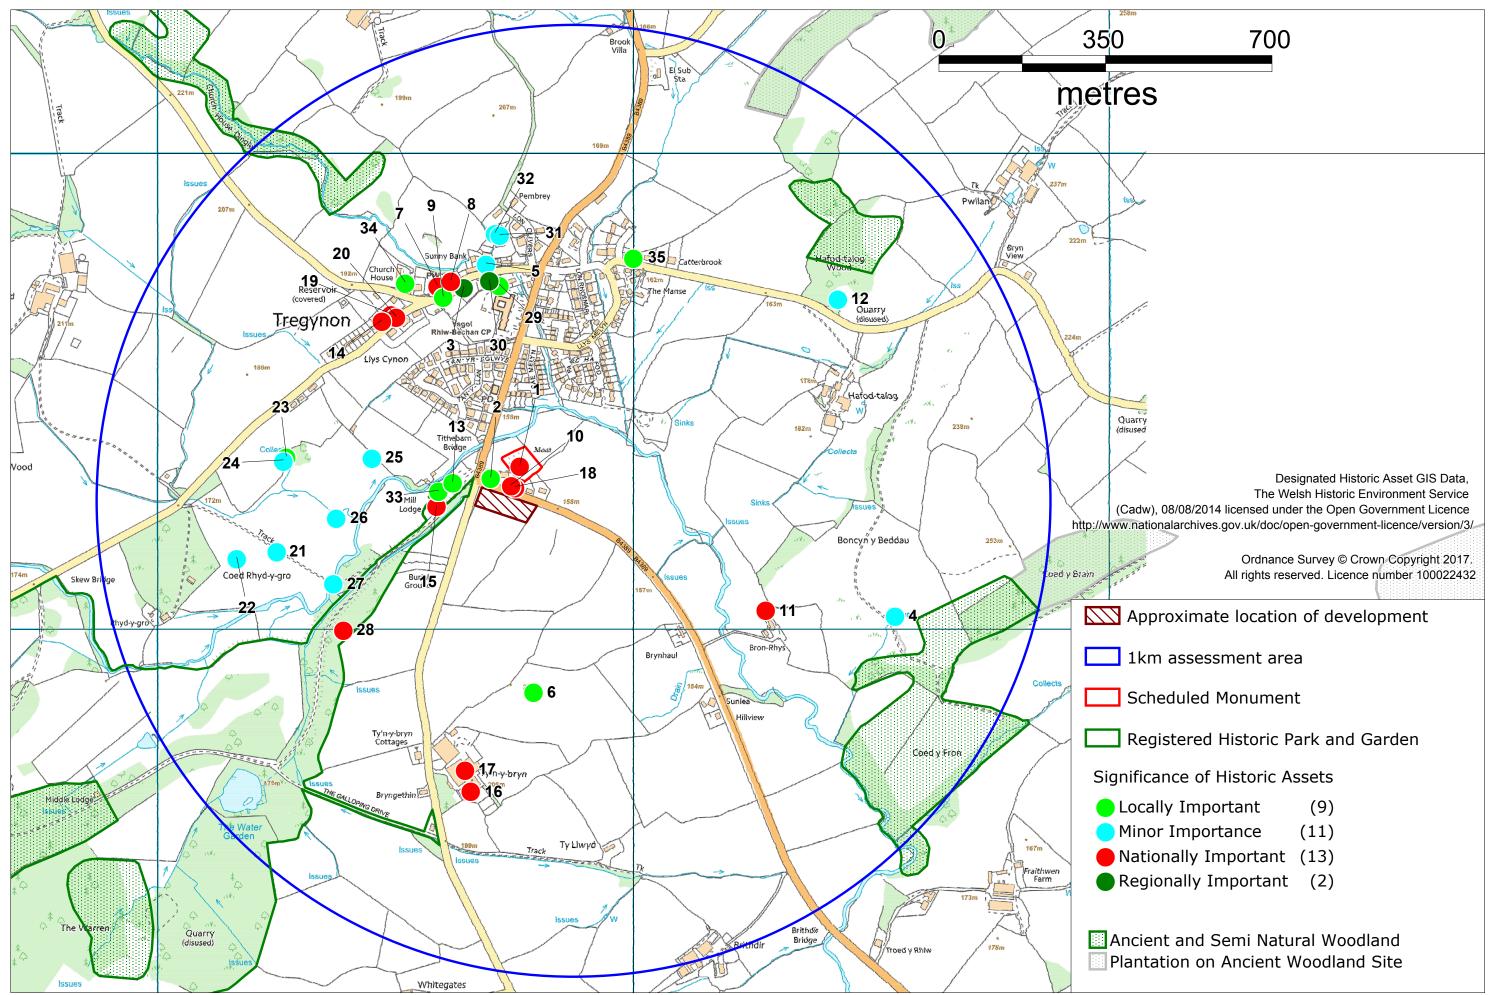
*Figure 5: The 1km assessment area showing significance of historic assets, labelled with Project ID number*

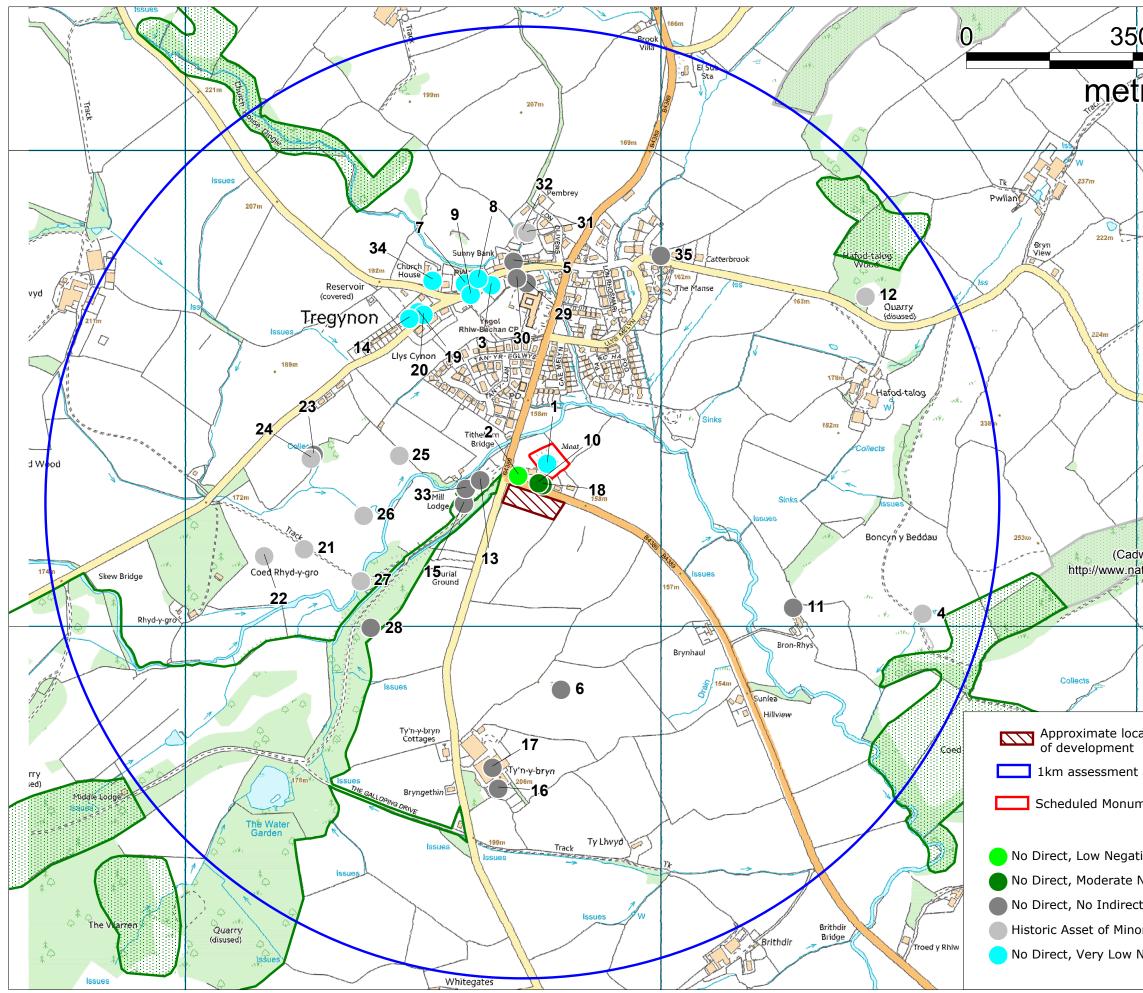
Figure 6: The 1km assessment area showing the level of impact on historic assets, labelled with Project ID number

11.1 The Direct and Indirect impact on each historic asset was assessed taking into account both physical and non-physical impacts, and whether the impact was Positive, Negative or Neutral. Each impact was assessed within the scale Very Low, Low, Moderate, High and Very High, taken into account the significance of the historic asset and the nature of the impact. A full table is found in Appendix B but a summary is tabulated in Table 2 below and illustrated in Figure 6.

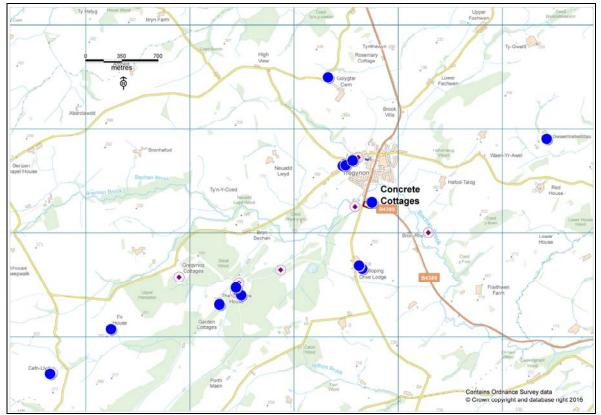
*Figure 9; The distribution of recorded concrete buildings and structures in the Tregynon area.*

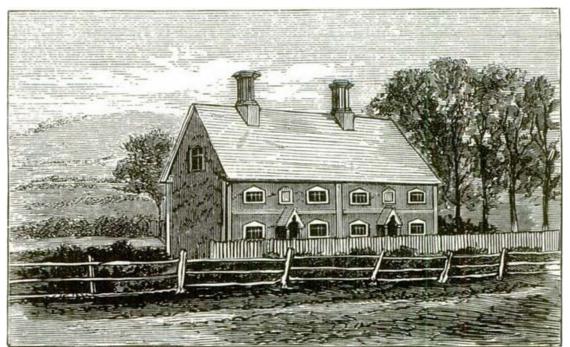
Figure 10; The Concrete Cottages as depicted in Thomas Nicholas's "County Families of Wales" in 1872. The view is from the field on the opposite side of the Bettws Cedewain road, within the proposed development site.

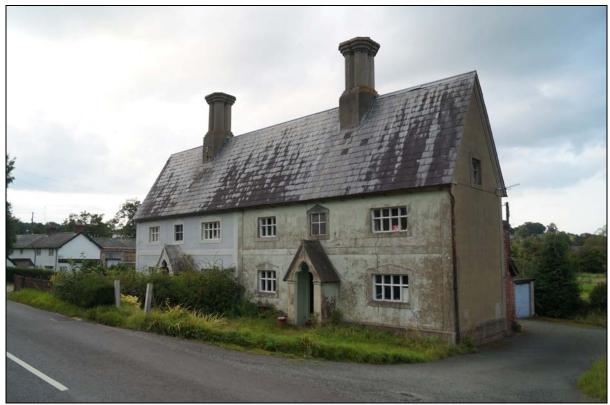
Plate 1; A key view of the Concrete Cottages, looking northwest, from the opposite side of the B4389 where its architectural detail can be understood.

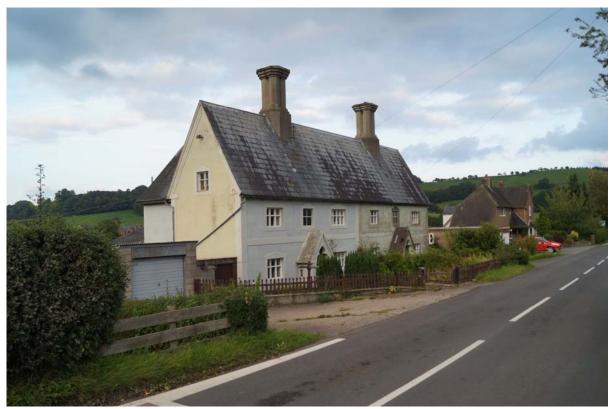
*Plate 2; A key view of the Concrete Cottages looking east from the opposite side of the B4389. The late 20<sup>th</sup> century house, Minffordd, stands to the right in the photograph.*

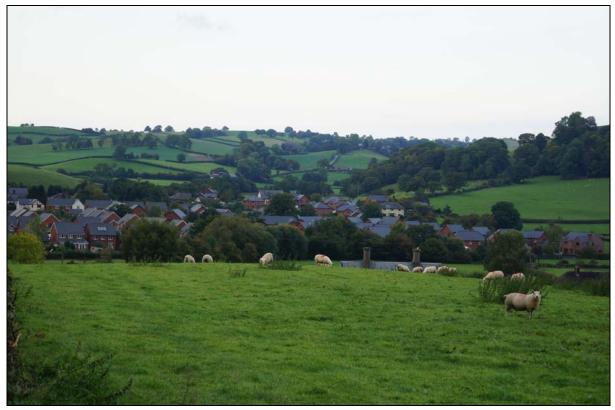
Plate 3; A view from the field gate at SO0961098090 shows the impact of modern development on the modern setting of Concrete Cottages, although only the chimneys of the listed building are in view here.

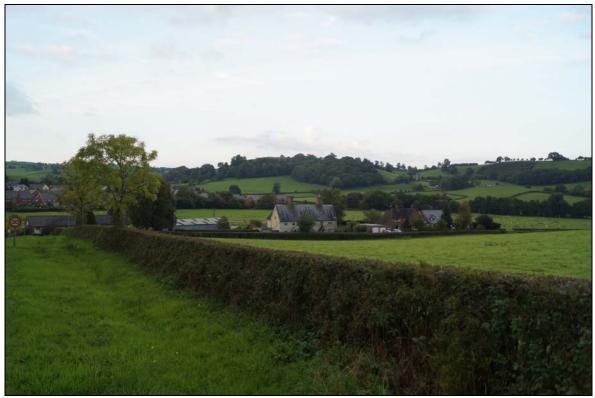
Plate 4; A view from the modern roadside verge along the former Newtown turnpike road which approaches Tregynon from the south shows that the Concrete Cottages stand amongst modern buildings.

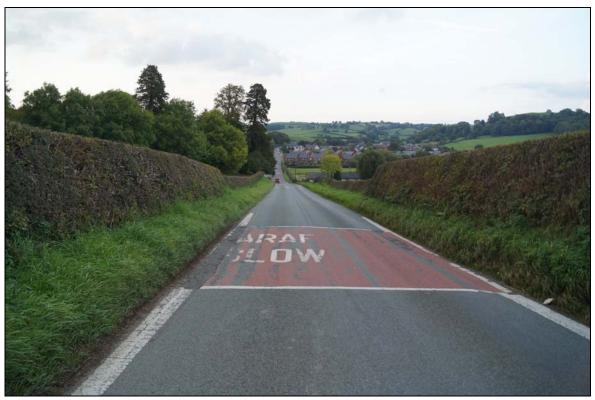
Plate 5; The view looking north along the former Newtown turnpike road which approaches Tregynon from the south also shows that the Concrete Cottages are not a landmark building from this direction, as it is hidden behind the hedge to the right and cannot be seen from the road.

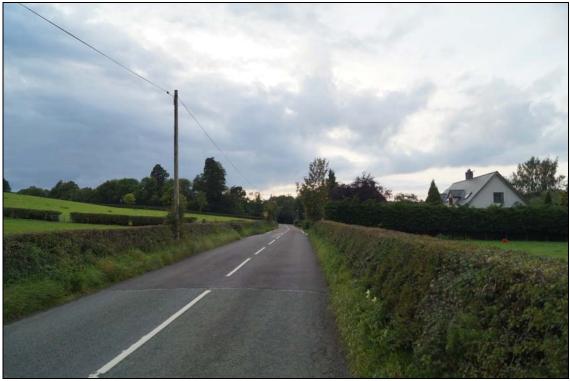
Plate 6; Looking west towards the Concrete Cottages from the B4389, now hidden behind modern houses such as Ty'n y Ddol to the right. The development site is in the field in the background to the left of the road.

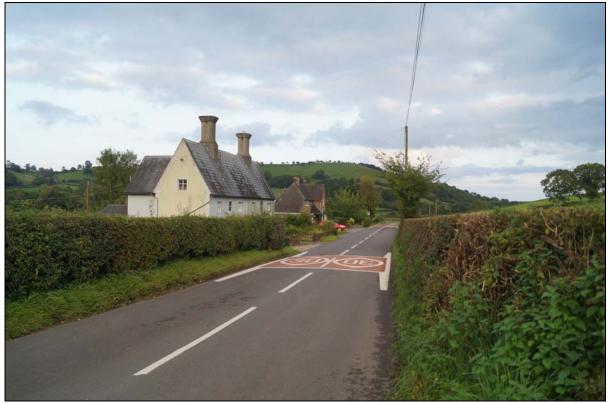
Plate 7; The Concrete Cottages are not an imposing site in the modern landscape as modern buildings and trees have already affected their setting. Even when newly built, their position below the road meant that they were set down in the landscape and not as dominant as they could have been.

This is a moot point in many respects, as the Concrete Cottages were built on ground terraced into the slope leading down to the meadow of the Bechan Brook, see Plate 7. The siting of the building below the road means that they were put in a roadside position, but not an "imposing" position. As the key views of Concrete Cottages are those looking generally northward, or northwest or northeast at short range along the B4389, the proportions of the building are perfectly visible when the viewer has their back turned to the proposed development site. The proposed buildings would themselves be terraced into the hillslope and also set back from the B4389, which would not make them overbearing to buildings on the opposite side of the road.

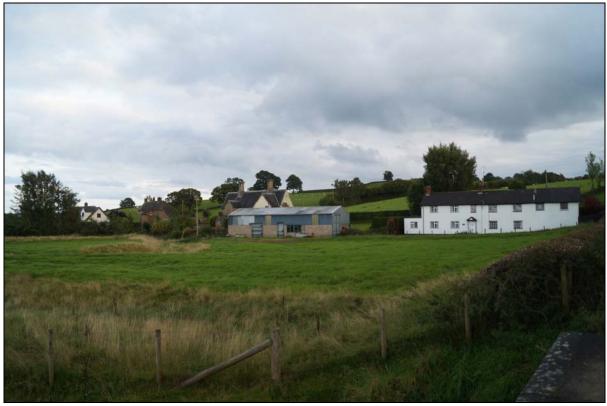
Plate 8; The view of Concrete Cottages from the B4389 to the north is largely blocked by a modern agricultural shed. Another building stood on the site of the shed as early as the time of the 1886 Ordnance Survey map, indicating that his has never been a key view of the Concrete Cottages.

Although this is true to some extent, the presence of the modern agricultural shed to the rear of Concrete Cottages largely blocks views of the listed building and means that this is not a key view of the building and from this direction it is not possible to fully understand or appreciate its character, see Plate 8.

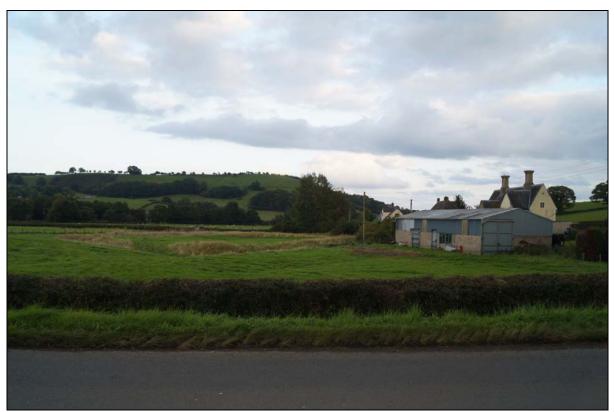
Plate 9; The Tithebarn Moated Site is best viewed looking east from this slightly elevated position on the B4389, which gives a good view of its rural setting. The Concrete Cottages are to the right, the development site just visible to the right of them.

Trysor's field visit established that the key view of the scheduled monument (ID number 1, Scheduled Monument number MG204) is gained from the B4389, just to the north of Tithebarn Cottages, looking eastwards towards the earthwork, see Plate 9. From this part of the road a clear view of the monument is gained against the backdrop of the Bechan Brook valley floor, with the hills to the east of Tregynon as a backdrop. Views of the monument from further north along the B4389 do not give a clear view of the earthworks and the backdrop is already compromised by the presence of the line of buildings along the B4389 which include Tithebarn Cottages and Concrete Cottages. The addition of the proposed development behind the existing buildings seen in this view would not, in the opinion of Trysor, constitute a significant additional impact on this already compromised view. The new buildings would be partially screened by the existing buildings.

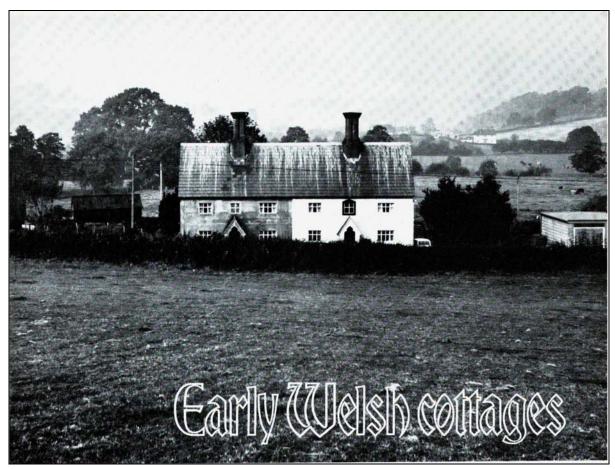
Plate 10; Taken from Concrete Quarterly, Volume 95, December 1972, p.26. A key view of the Concrete Cottages viewed as seen looking northwards from the heart of the proposed development site. The hedgerow at the northern side of the development site partially blocks the view. This hedgerow was not created until after the new road was built to Bettws Cedewain in 1861-1863. The access road into the development site would cause the removal of this section of hedgerow, allowing for a much clearer view of the whole building. Since this photograph was taken a garage has added to Number 1, to the left in the photograph. The trees in the background to the left have been removed and the modern housing developments in Tregynon village are now in view.
