**Excavations at Whitewall Brake
Romano-British Site.
Caerwent Training Area
Defence Training Estate Wales & West
NGR: ST 4753 9114**

ULAS Report No 2017-071

For: Landmarc Support Services Limited

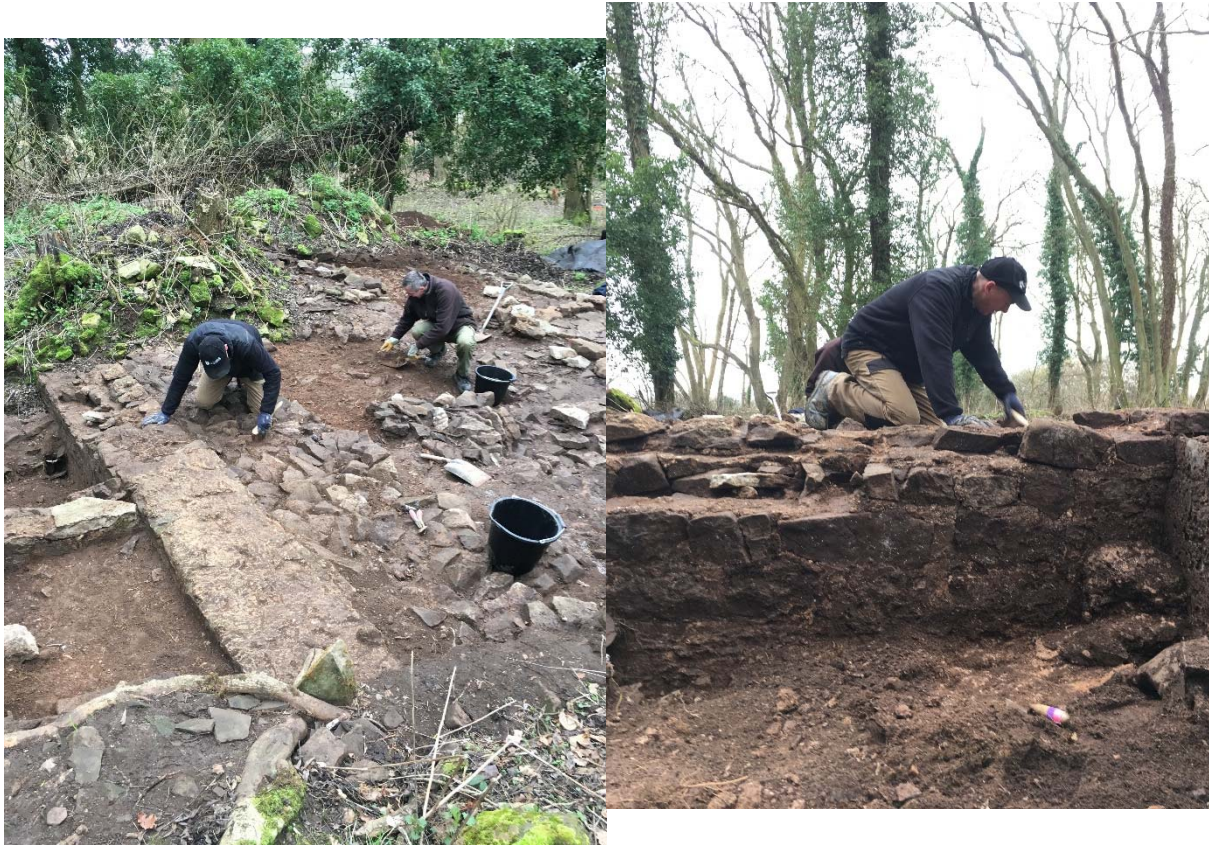
Figure 16: Western wall [113] being cleaned in 2017 looking south-west (left) and at the east facing section which shows traces of plaster.

In 2011-12 a very well built masonry foundation [113] was encountered on a north-south orientation, on the expected line of a wall. It measured 0.6m in width with limestone bonding; there also appeared to be a plaster facade remaining on some areas of the wall (Fig. 16). The trench was extended to the east which encountered large amounts of rubble debris including stone roof tiles. Wall [113] appears to be solid made from faced stones bonded with lime mortar.

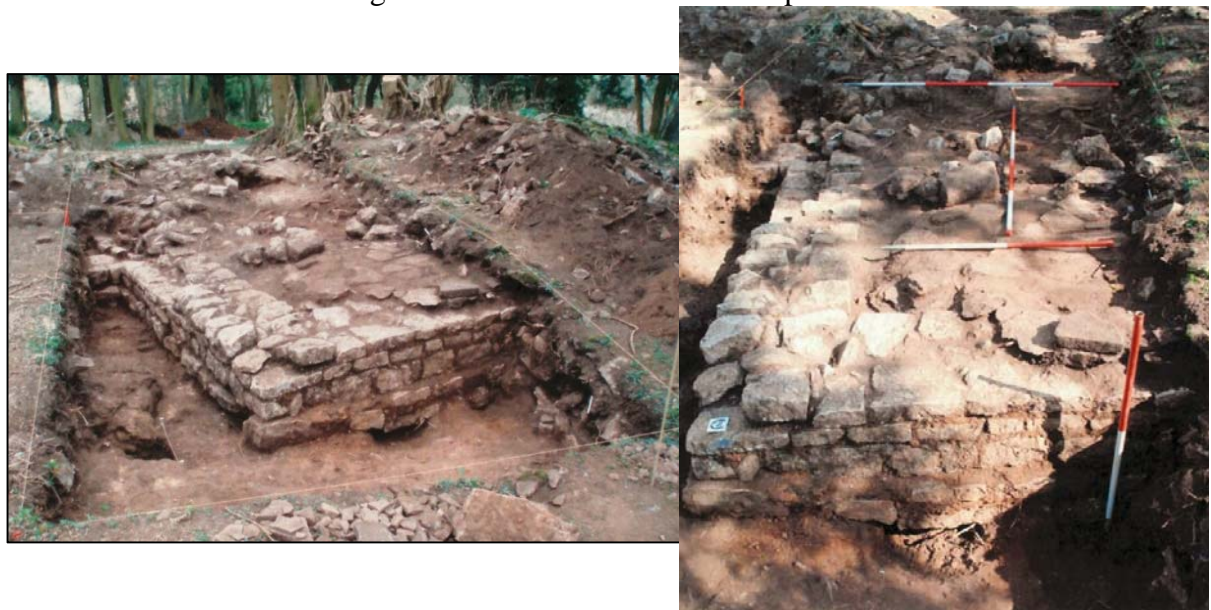
Figure 17: Walls [117] and [122] forming the north-west corner in 2012 looking east (left) and detail of the foundations of [122] laid onto the earth and the crack in the foundation plinth (right).

It was anticipated that, if there was a range of rooms along the east side of the complex, these would lie to the west of [113]. The western extension found the northern and western walls [117] and [122] of a room standing to a height of 0.7m with at least four courses of stonework surviving (Fig 17). The first course of the structure was a foundation course laid directly onto natural earth (111) sat overlying the bedrock which was a further 0.2m lower. This appears to have been the reason for a crack in the foundations of the west wall [122]. An attempt to repair the foundations using mortar as reinforcement suggest this happened in an early phase (Fig. 17). The walls appear to be bonded with lime mortar with small inclusions.

The stone appears to be locally sourced limestone with blocks approximately 0.2m x 0.1m x 0.3m to 0.3m x 0.2m x 0.3m. The reason that the building foundations were built on the earth rather than bedrock is unknown. It could be evidence of a lack of understanding of construction techniques, sub-standard working practices or attempts to cut costs or time although the use of good quality building stone and the actual wall construction would suggest this was not the case.

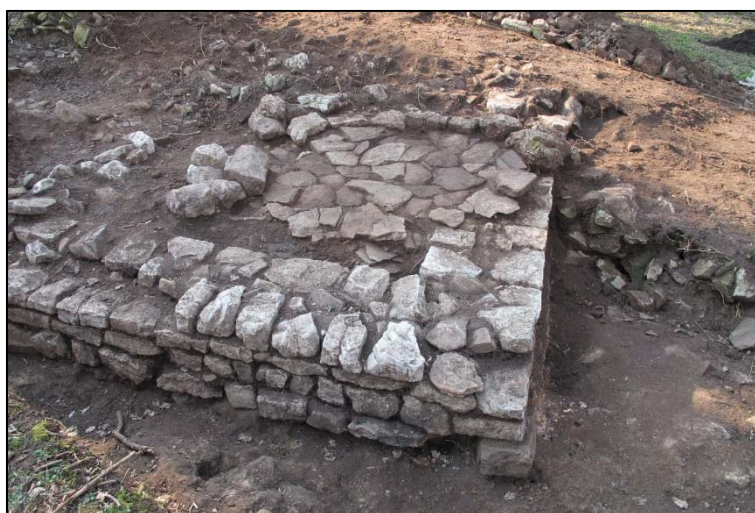
Figure 18: Flat stones (130) and larger stones (131) overlaying wall [122] looking south

Walls [117] and [122] and all features described above had been overlain by a deposit of moderately sized limestone rubble within a matrix of dark soil (110) and (132), interpreted as abandonment or demolition horizon. Beneath this in the north-west corner of the interpreted room and partially overlying the top course of a wall [122] was a spread of flat stones (130) bounded by a ring of larger stones (131) to creating a sub-circular feature measuring c. 1.4m north-south and 1.2m east-west (Fig 18). There was a gap in the eastern quadrant of the feature with a noticeably larger stone set on either side of the gap. It was suggested that because of the circular shape, consisting of reused Roman building material and the flat stone base that this could be a later hearth or oven base. Traces of red staining on some stones possibly as a result of intense heat are consistent with this suggestion but are inconclusive. Another possibility for its function is that the construction represents a small dry-stone building or cell. No dating evidence was recovered in relation to this feature, although it was evidently created only after the Roman walls [117] and [122] had already been reduced to their current height.

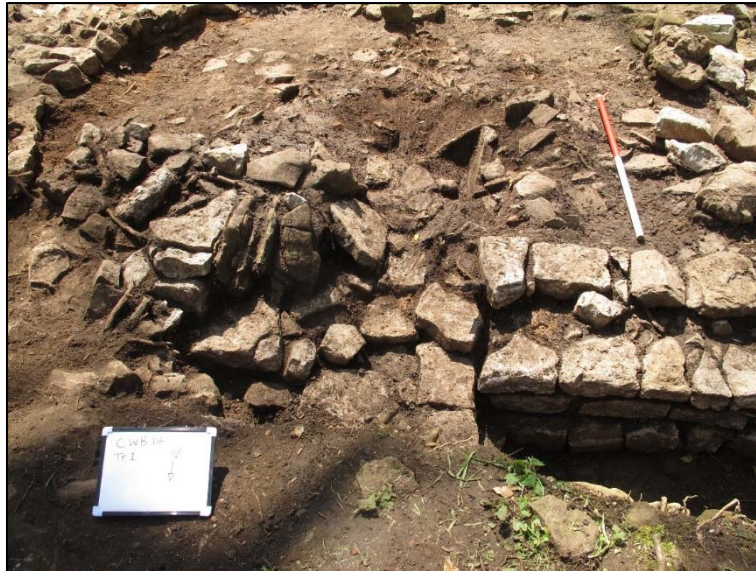
Figure 19: Structure [135] truncating wall [117] looking south

post-dates the demolition of the Roman structure. This feature was excavated in 2014 to provide a window into the stratigraphy and possibly Roman floor levels and to investigate whether it might be a grave. In the event no diagnostic finds or human remains were recovered and the feature appears to be cut through a series of rubble deposits, suggesting any floor layers has either been disturbed or lie at a deeper level.

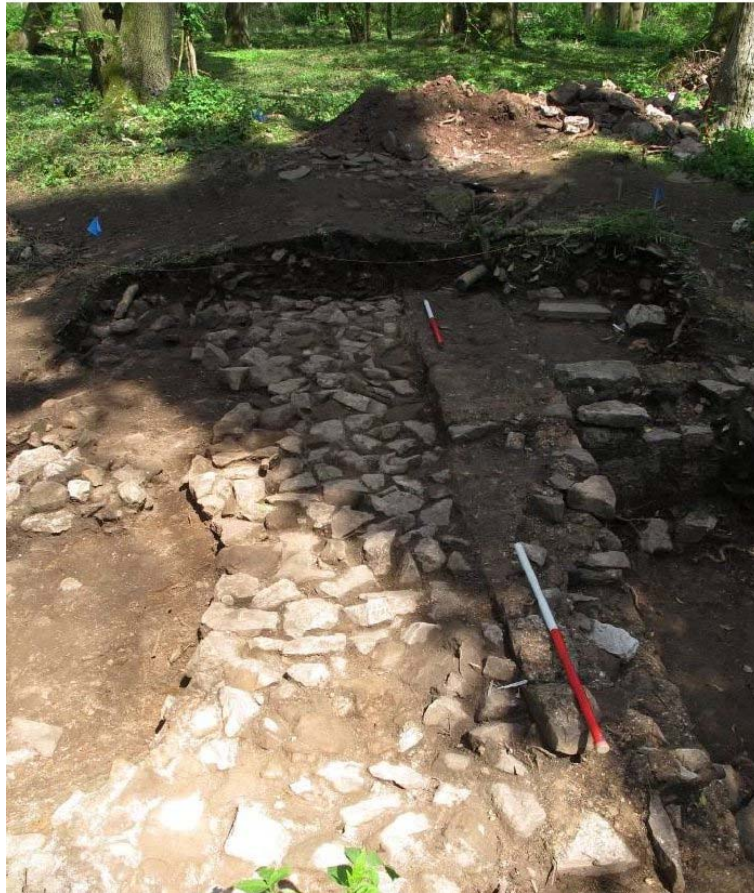
Figure 20: Roughly laid surface (146) adjacent to wall [113].

After the removal of the uppermost deposits of topsoil and jumbled rubble (139) just west of wall [113] in 2014, a substantial but discontinuous deposit of mortar (143), averaging 0.05m in depth but in places thicker, was found in a band roughly 1m wide. The excavators suggested that the layer of mortar may represent demolition of the Roman wall; as the stones were levered out, adhering mortar was knocked off and accumulated as a trampled deposit along its line. Alternatively it could be deliberately laid floor surface as a second layer of tightly packed stones (146) forming a rough surface was revealed beneath the mortar. No dating evidence was recovered for these phases. Excavation in this area also revealed wall plaster still in situ at points on the west face of wall [113].

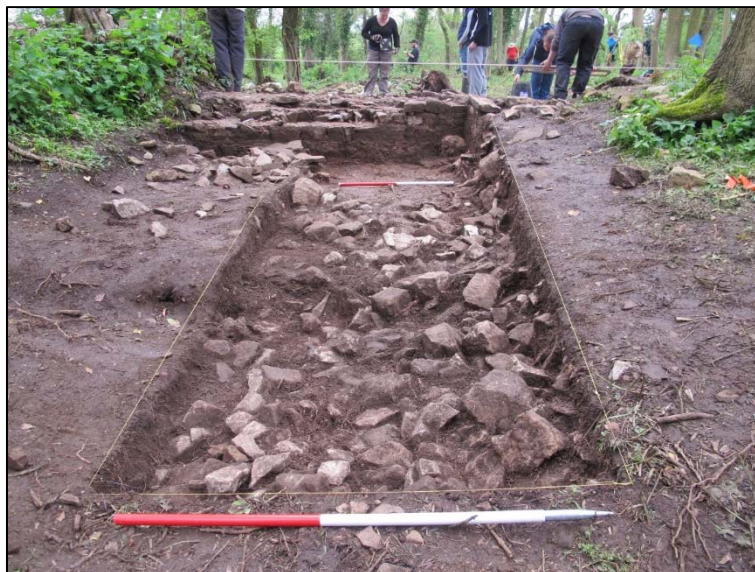
Figure 21: Extension of Trench 1 east of wall [113] looking west

Further work was also undertaken on the extension east of wall [113], downslope into the hollowway (Fig. 21). The area, initially opened in 2012 and continued in 2013 and 2014 hoped to inspect the elevation and foundations of [113] to gain further chronological data and to confirm the limits of the Roman site. The excavations found another wall [166] running east from [113]. This wall clearly abuts [113] suggesting at least two phases of construction in this area and indicates that there were rooms on both sides of wall [113]. Unfortunately this wall runs beneath a large mature tree preventing further excavation and excavations to the east of [113] revealed only apparent demolition deposits (Fig. 21), although traces of a possible mortar surface could be seen in the north-west corner of the walls.

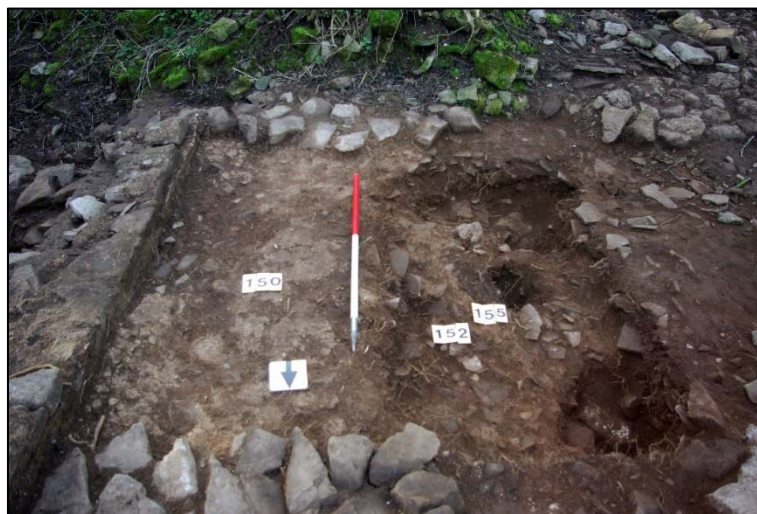
Figure 23: Mortar surfaces (150) (152) and posthole [155] looking south

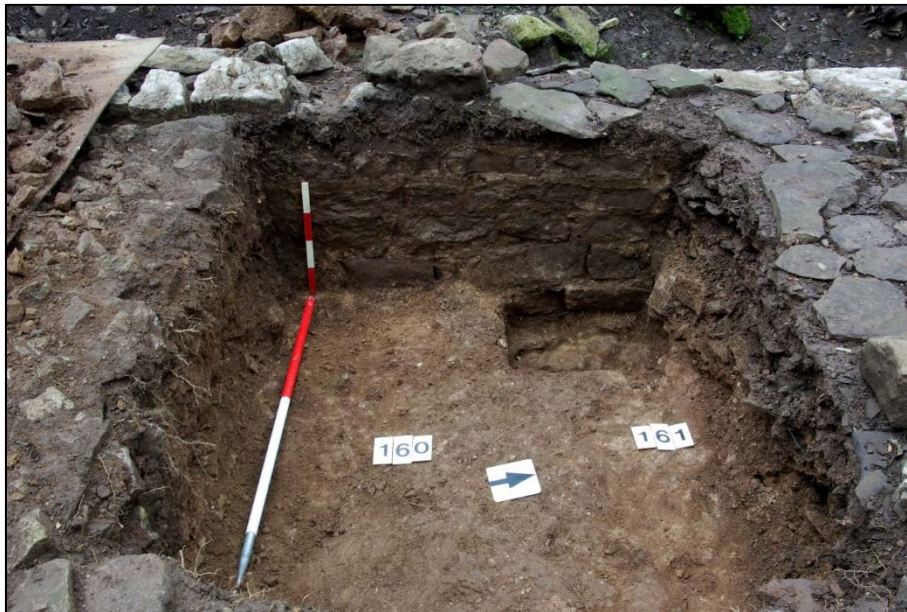
Figure 27: Internal face of wall [122] along with mortar surface (161) and layer (160). Also note the flat stones (130) interpreted as a hearth structure post-dating the wall to the right.

Surviving in the northern half of Sondage 2 below demolition layer (162) a lime mortar floor surface was recorded (161) surviving at a depth of 0.06m, although this appears to have been badly damaged by the collapse of the building. Beneath this was an interface layer (160) laid onto the natural bedrock. This was 0.15m in depth and consisted of a dark reddish-brown fine sand, similar to (158) seen in Sondage 1 (Fig. 27).

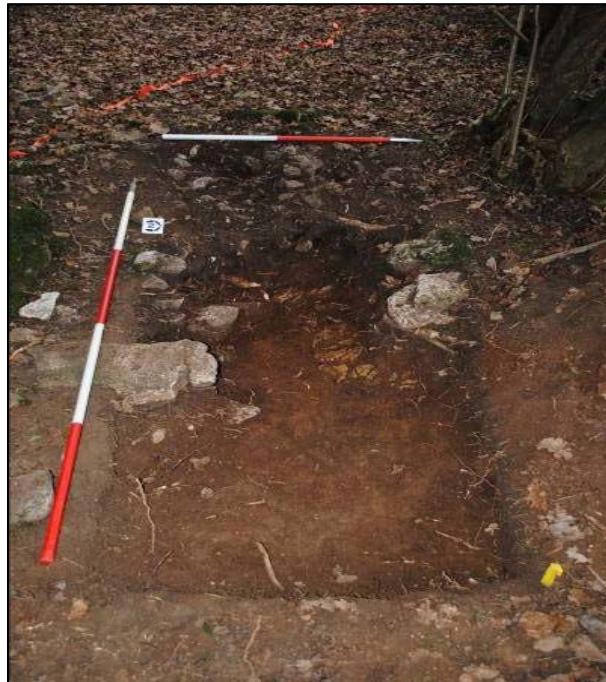
Figure 29: Trench 2 looking west

On investigation the interpreted wall appeared to be a scatter of stones (202) dumped against a natural outcrop of bedrock, and not an architectural feature (Fig. 29). This could be attributed to field clearance. Further excavation down to bedrock found no other archaeological deposits or finds.

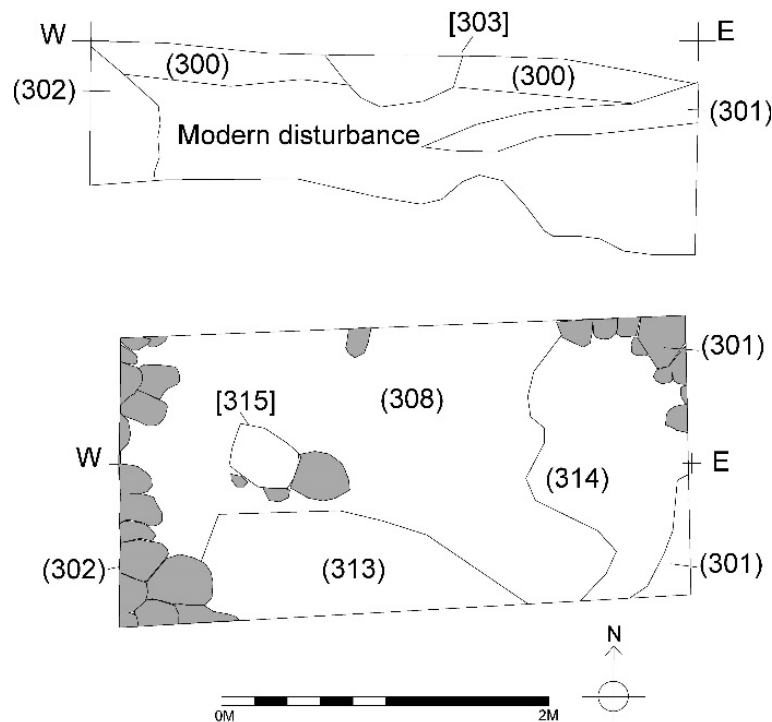
Figure 30: Trench 3 plan and south facing section.

The trench was excavated to bedrock through multiple layers of modern disturbance (to a depth of 1.4m) down to bedrock. Two features were recorded at the base of the trench. The first feature appeared to be a large irregular cut measuring 1.6m by 1m (314). No finds were found and it could either be disturbance from previous excavations or more likely a result of the natural geology. The second feature appeared to be a posthole of a roughly square shape with fill [315] yielding pig bones but no other features. There is no dating for this feature and it could be modern.

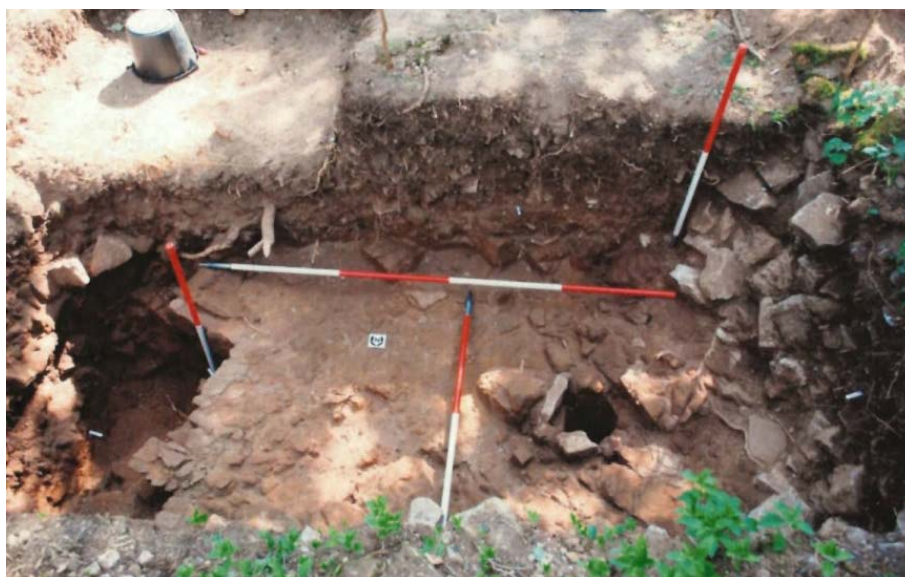
Figure 31: Trench 3 looking south with (314) to the left of the picture.

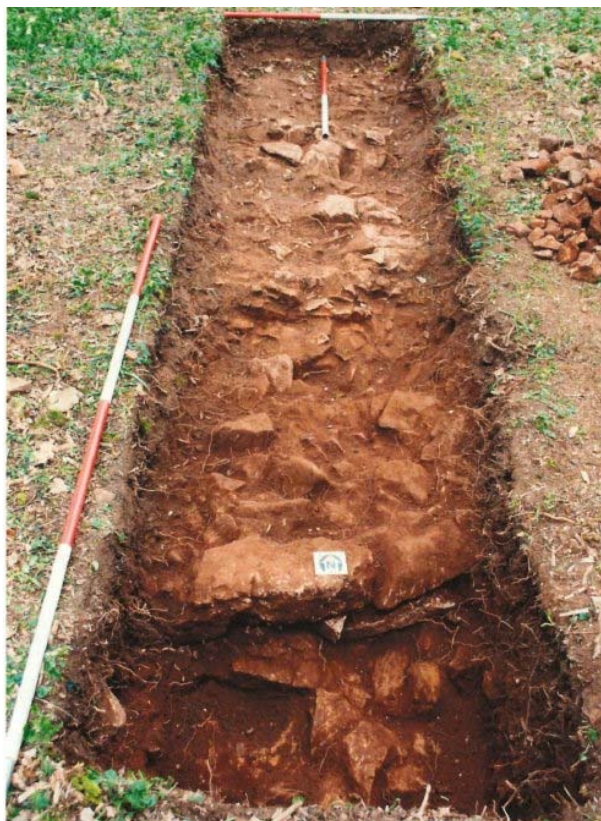
Figure 33: Trench 4 looking north with wall section 503.

Topsoil (501) was removed to a depth of 0.28m down onto natural bedrock. At the southern end of the trench a rubble and soil layer (506) was recorded, continuing to a depth of 0.49m below ground level with no finds. This lay either side of a wide dry stone wall of rough construction (503) and 2 to 3 courses high and 2 courses wide. To the south of (503) rubble and soil layer (506) appeared to continue down to natural bedrock. No finds were recovered from the trench and the original excavators suggested that the wall could represent landscaping outside the main building complex.

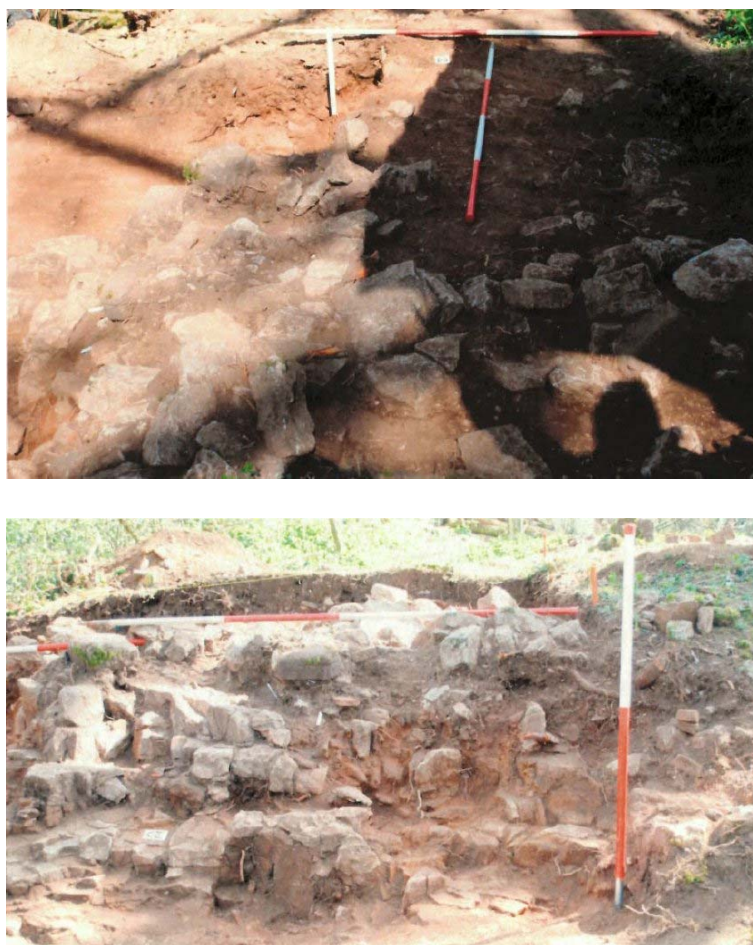
Figure 34: Trench 6, plan looking north (top) and north facing section of trench.

Alongside (601) a robbed-out wall was recorded running east-west [602]. A foundation cut [603] for the wall was identified, filled by (604) a red sandy soil presumably dating to after the robbing of the wall (Fig. 34).

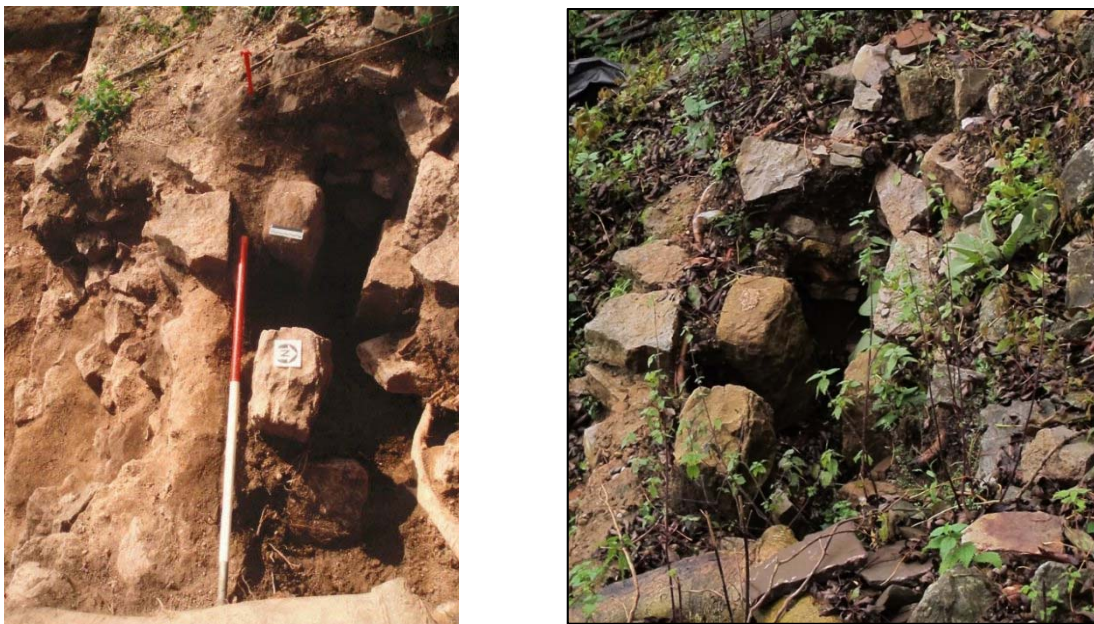
Figure 36: Trench 8 looking west during excavation (left) and in 2017 (right).

Trench 8 was a small area largely comprising of cleaning and recording of a small section of the south facing façade wall of the complex, situated just to the south of Trench 12. Beneath the topsoil three horizontal stone pillars were recorded immediately to north of the standing wall. These were interpreted as pilae, the remains of hypocaust system relating to the same system as explored in Trench 9 and 12 (see below for details).

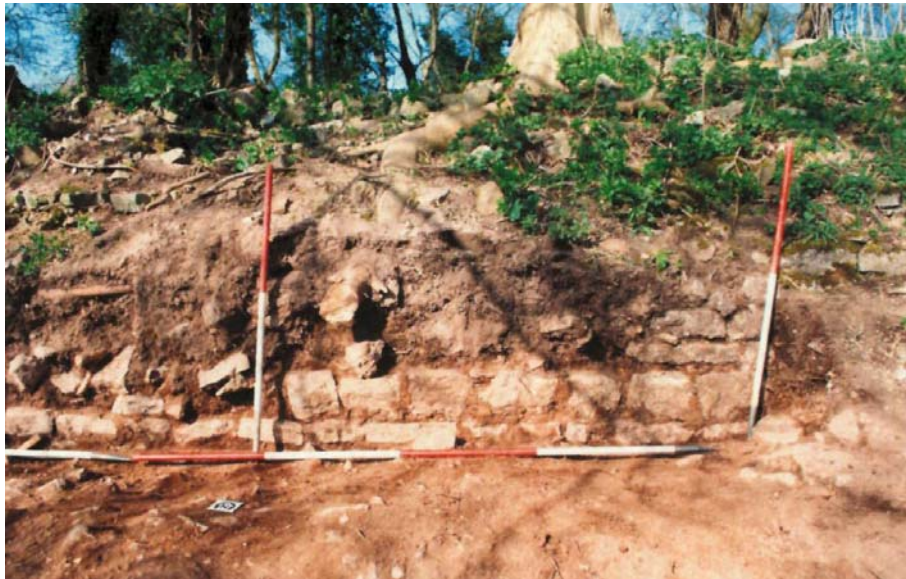
Figure 37: Trench 10 south facing section showing wall [167] following excavation

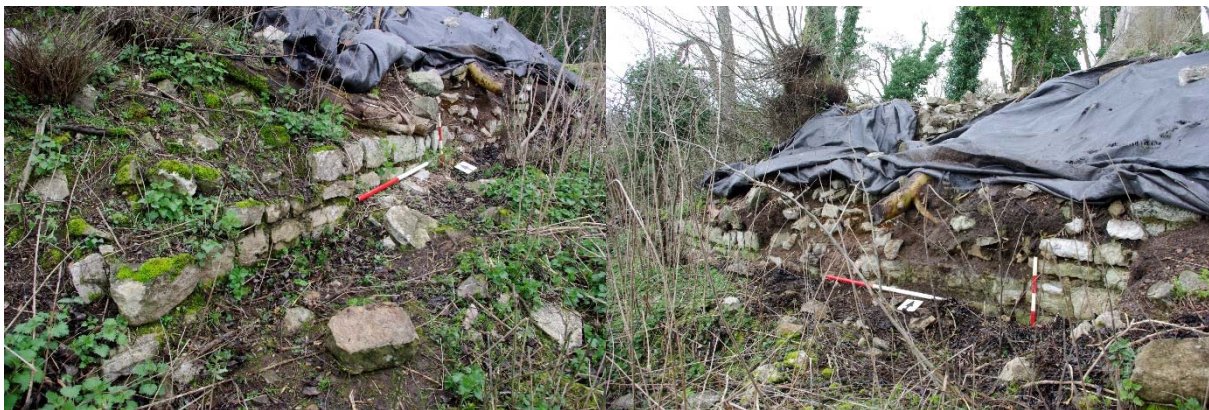
Figure 38: Trench 10 wall [167] in 2017

The wall was initially thought to form a corner with the perpendicular wall [804] in Trenches 9/12. Observations during the 2017 excavations however, indicated that the southern boundary wall of the Roman complex, extends westwards beyond Trench 9/12. During excavation in 2017 it was noted that the angle with the wall in Trench 9 was not 90o and further investigation showed that the wall continued westwards up to 3m beyond the interpreted south-west corner of the site where the hypocaust room in Trenches 8, 9 and 12 is located (Fig. 39).

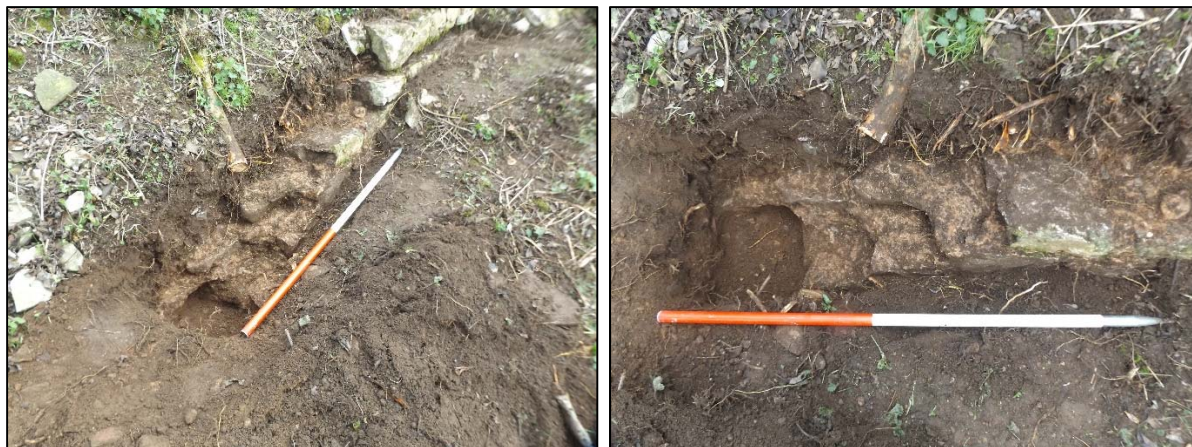
Figure 40: Southern wall extending west beyond the interpreted south-west corner of the complex

The extent of the wall beyond this point is unknown, though the site topography drops away at this point possibly due to quarrying in the 19th century, hinting that further Roman structures may now be lost. Further excavation also found a small, square post-hole at the western end (Fig. 40).

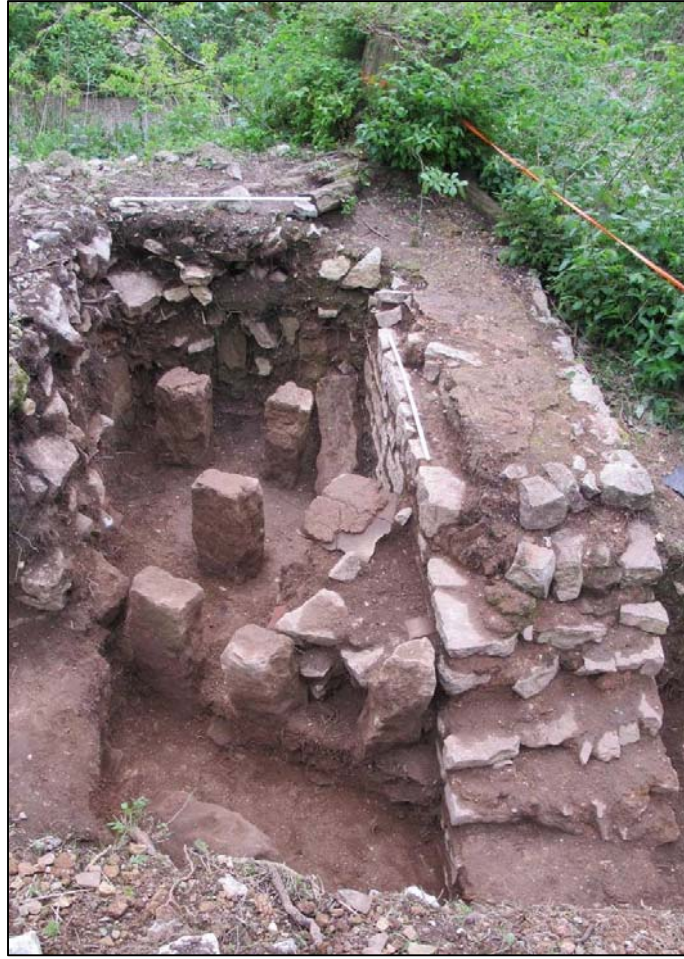
Figure 42: The conjoined Trenches 9 and 12 in 2014 looking south

In 2013 the baulk between Trenches 9 and 12 was removed and treated as an extension of Trench 12 (Trench 9/12; Fig 42). This revealed a small amount of hypocaust structure still in situ, comprising of a broken stone slab sitting on top of one of the pilae, bearing mortar bedding for the presumed mosaic floor. Along with hundreds of loose white, grey and red tesserae several small fragments of mosaic, comprising of mosaic cubes still embedded in fine mortar, attached to a coarser mortar subfloor were also found (Fig 43). Pottery sherds were recovered from the two trenches indicate a date spanning the 3rd and 4th centuries.

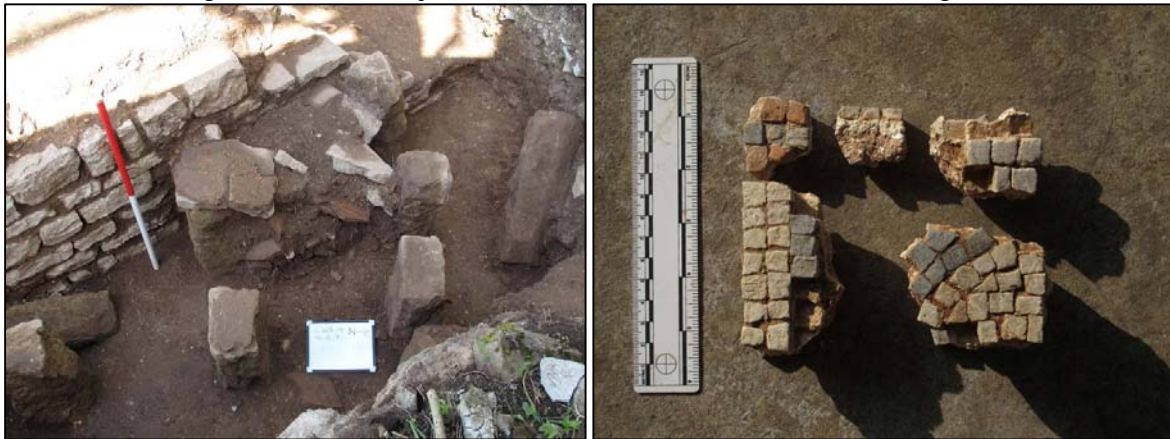
Figure 43: Detail of floor slab in situ on pila looking west (left) and fragments of polychrome mosaic from Trench 12 (right)

The tile fragments from Trenches 9 and 12 were at first thought to have been tegulae used on the roof of the hypocaust building. On closer examination it was observed that the flanges of the tegulae, rather than being straight, appeared to have been purposefully fashioned to create a series of crests or peaks. It has been suggested that these types of tile were fixed to the wall of the hypocaust and acted as an alternative to the box flue tiles normally used to vent the hot air up the walls of the room. As well as significant quantities of wall plaster and tesserae, several large broken stone flags were recovered, interpreted as remains of the floor which were supported by the pilae and upon which the mosaic floor would have been laid.

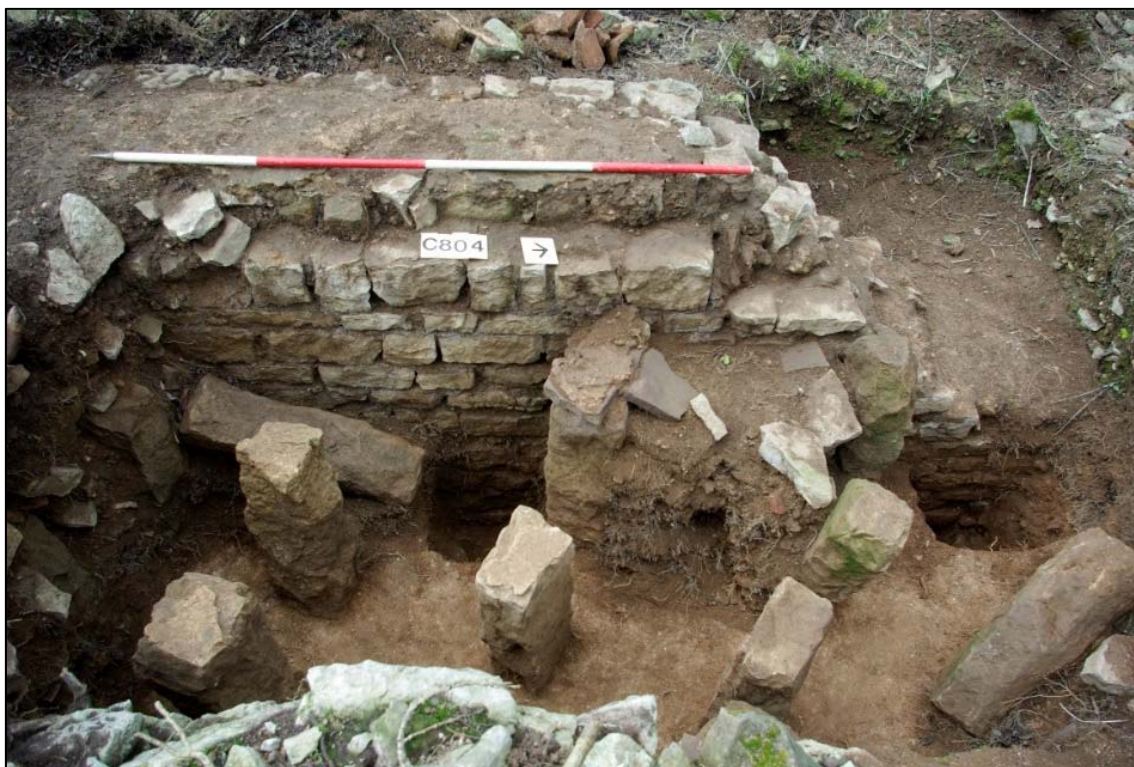
Figure 45: Wall [804]. Also note the antiquarian truncation (top right) and pilae in the foreground

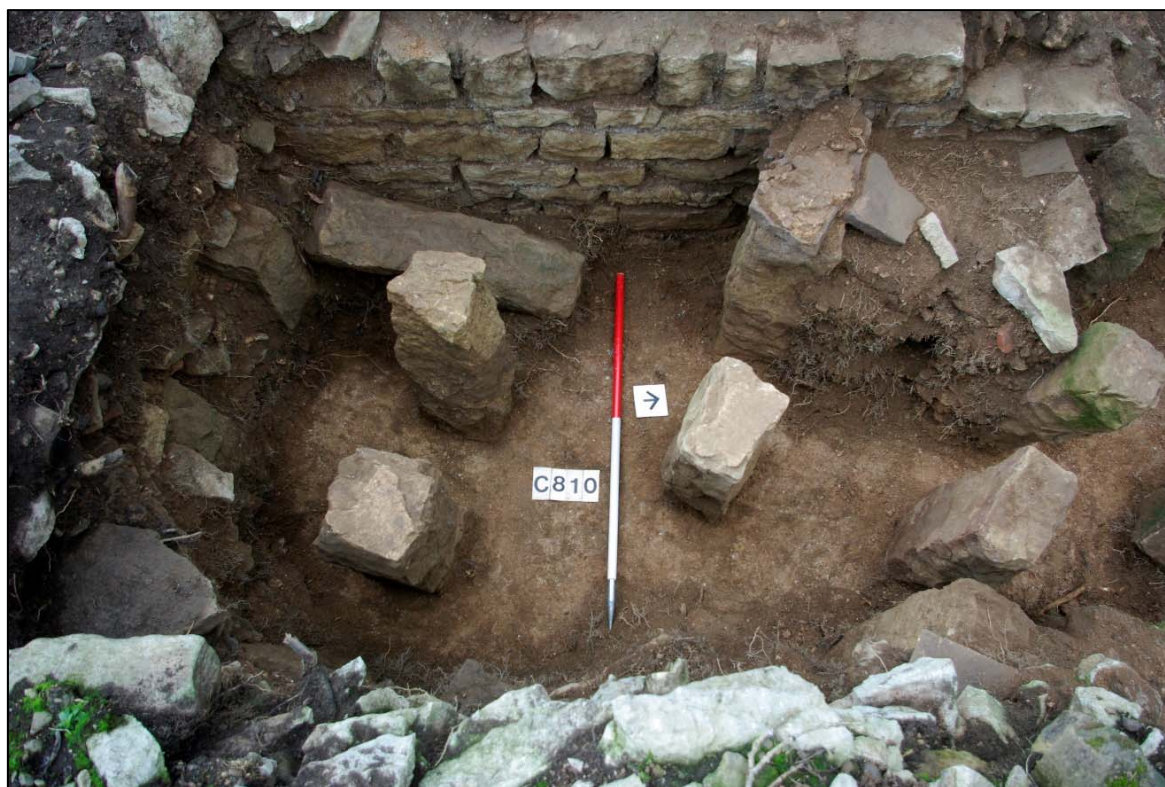
Figure 47: Dry mortar mix (810) in Trench 9/12

Beneath (810) a makeup layer (811) consisting of a reddish-brown silty-clays with occasional small-larger angular stones was seen, this was apparent in the initial sondage against [804] and confirmed in a second sondage against [804] to the north. This measured 0.5m in depth and abutted wall [804] perhaps indicating a foundation level on which (810) and the pilae were constructed. Two sherds of pottery were recovered from this layer dating to the mid third century onwards, along with 4 small sherds of animal bone. Under this natural bedrock was reached on which [804] appears to have been built (Figs 48 - 49).

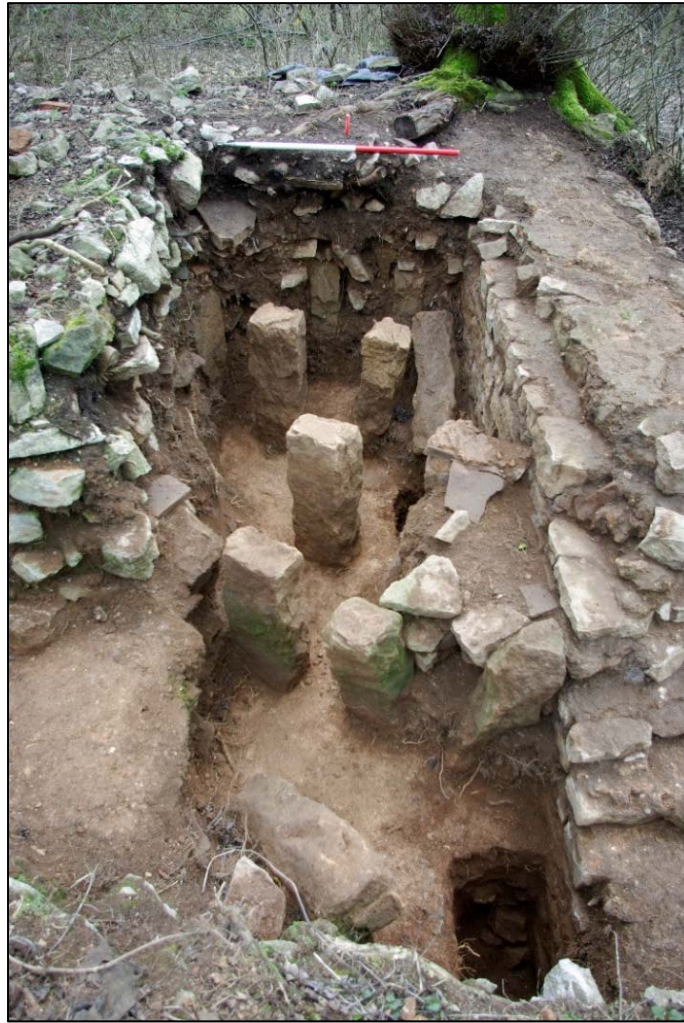
Figure 49: Trench 9/12 looking south

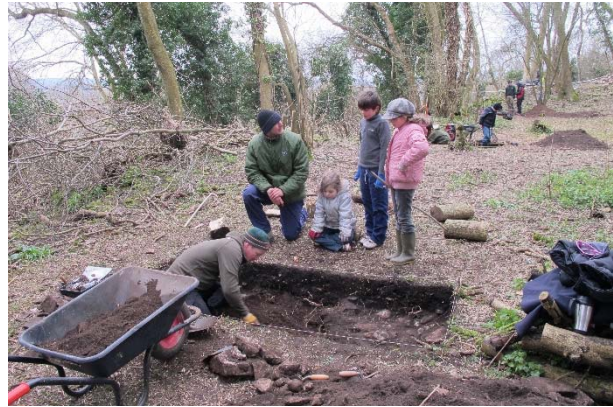
Figure 51: West facing section of Trench 13 (left) and trench under excavation (right)

Flat bedrock was encountered at the base of this trench at a depth of 0.8m. This was overlain by a succession of stone rubble deposits (901-902) consisting of small-medium sized angular stones within a moderately loose silty-sand matrix with mortar inclusions (Fig. 51).

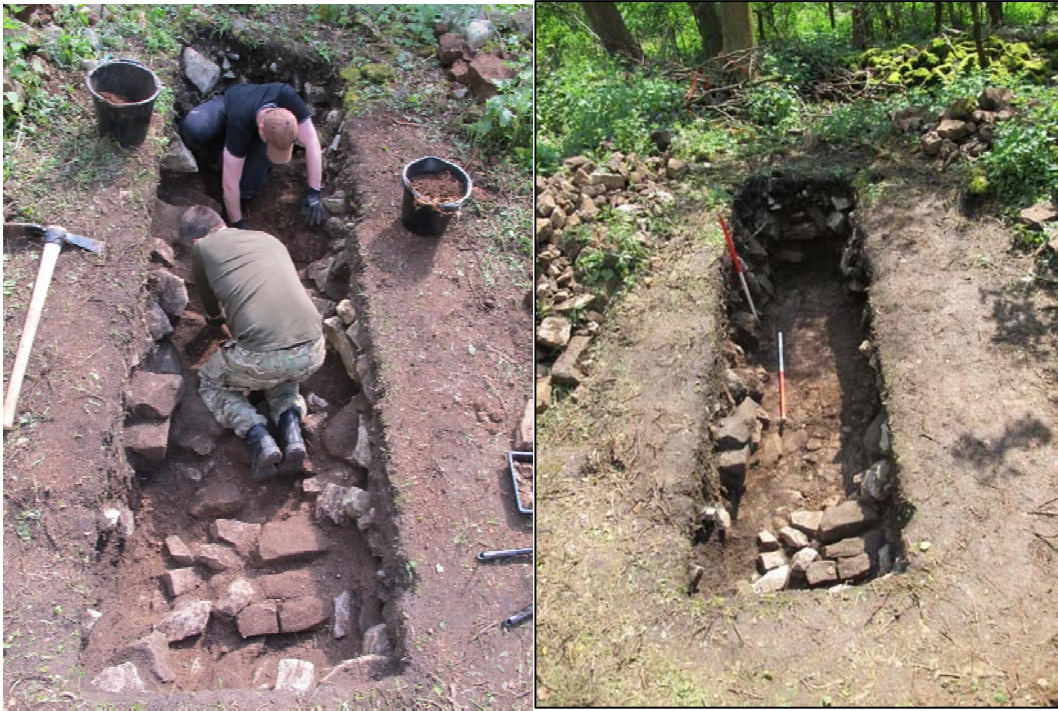
Figure 52: Trench 14 being excavated (left) and excavated (right) looking south

Loose large angular stones were recorded (931) immediately below the topsoil (930). The stones were distributed fairly evenly throughout the trench and as with Trench 13, could be indicative of a structure close by. Under this at the north end of the trench was a line of stones that could possibly be a toppled dry stone wall, overlying what appeared to be a rough surface of stones and cobbles (933). Beneath this was a mortar layer – possibly bedding for the rough surface (934) (Fig 52).

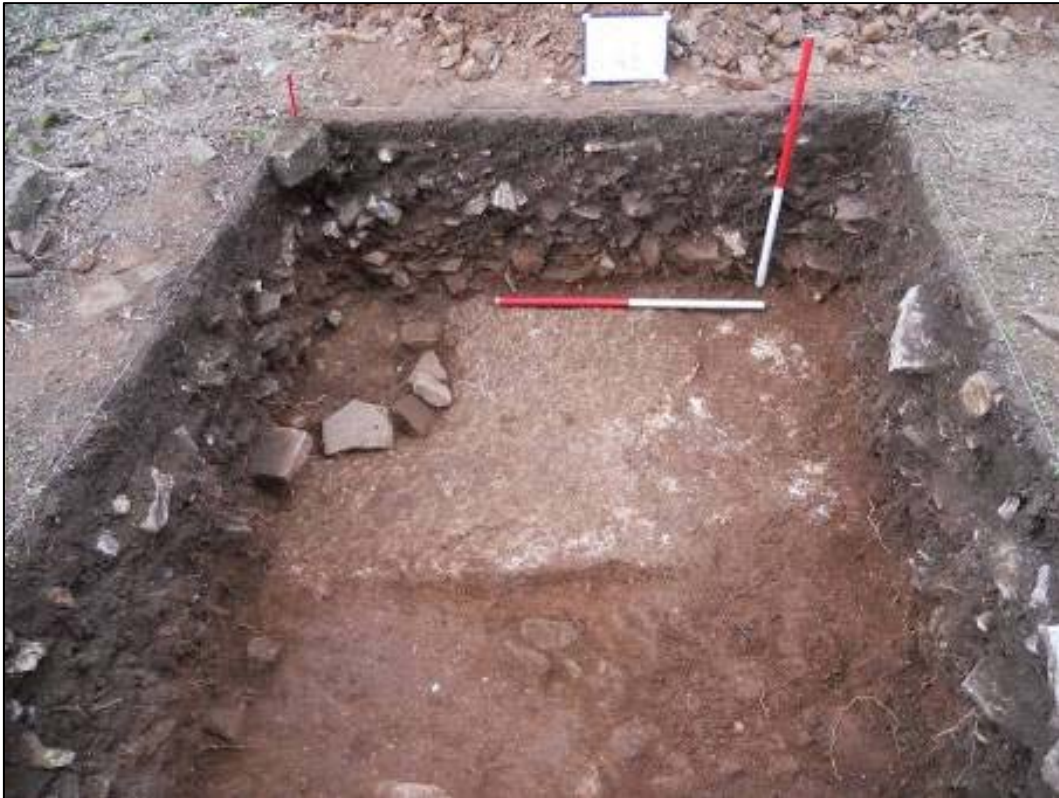
Figure 53: Trench 15 in 2013 showing mortar surface in the northern half of the trench and a probable robbed wall to its south. Posthole [964] is in the northwest corner of the trench (looking north)

At a depth of 0.8m a mortar surface (963) immediately adjacent to, and to the north of, a possible wall trench [967] was recorded. A posthole [964] could be seen truncating the mortar surface in the northwest corner of the trench. These deposits were sealed by a loosely compacted dark brown sandy-soil (962) and a relatively deep deposit of limestone rubble (960) and (961) beneath the topsoil (Figs 53-54). Deposits (960) and (962) overlaying the mortar surface produced pottery dating to the 3rd-4th century.

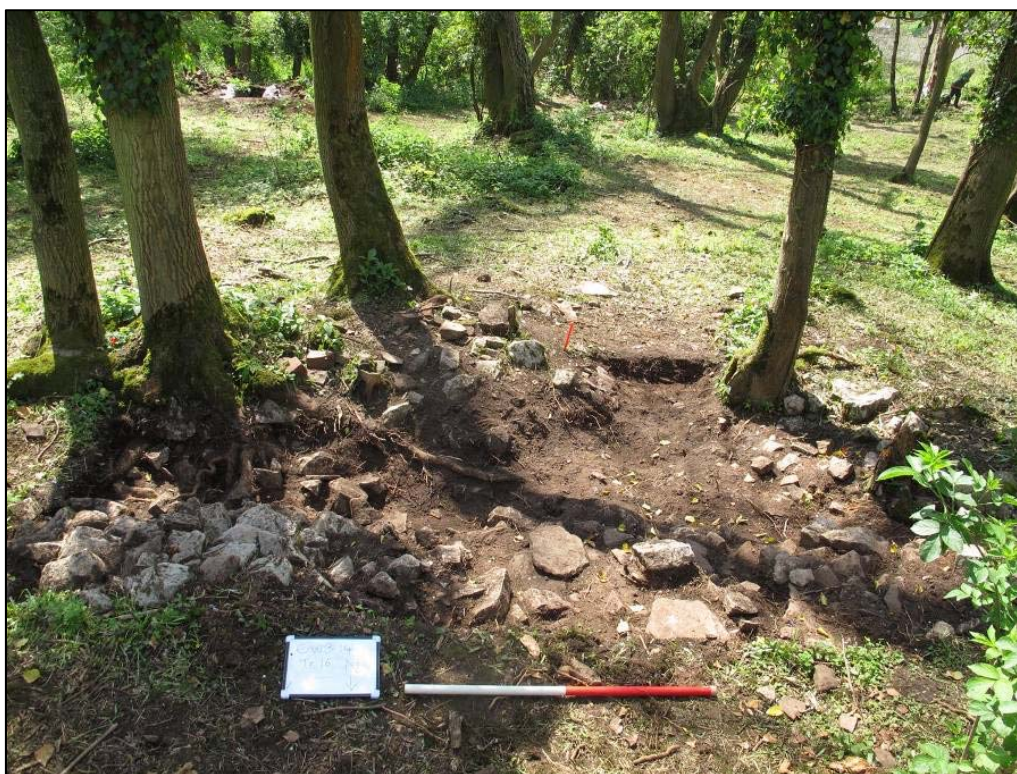
Figure 55: Trench 16 looking south

Topsoil (1001) was removed from the depression and produced quantities of modern material including metal fittings and broken glass, perhaps suggesting the presence of a military ‘fire’ trench, taking advantage of previous truncation by antiquarians and subsequently used as a rubbish dump. Below these modern deposits the piles of stones visible on the surface continued (Fig. 55). This material (1001) produced several sherds of Romano-British pottery and was suggested by the excavators to represent demolition material possibly from walls although the truncation from the tree root activity in this area made it difficult to identify the nature of the rubble.

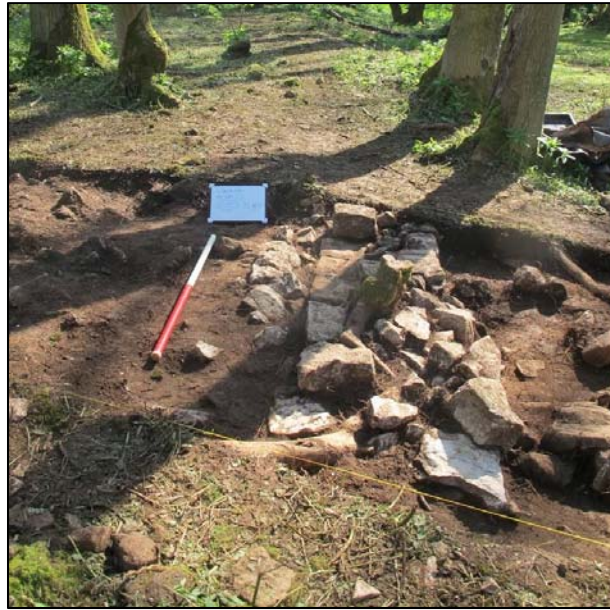
Figure 56: Trench 17 in 2014 looking east

Trench 17 was opened in 2014 and continued in 2017 measuring 6m by 2 m. It was positioned to the north of Trench 7 and Trench 16 over another apparent collapsed wall line showing on the ground surface as a slightly raised ridge. This appears to be on an alignment slightly different to that of the interpreted regular orthogonal main Roman complex. The aim of the trench was to establish the nature and date of this feature which it was thought could post date the Roman occupation on site (Fig 56).

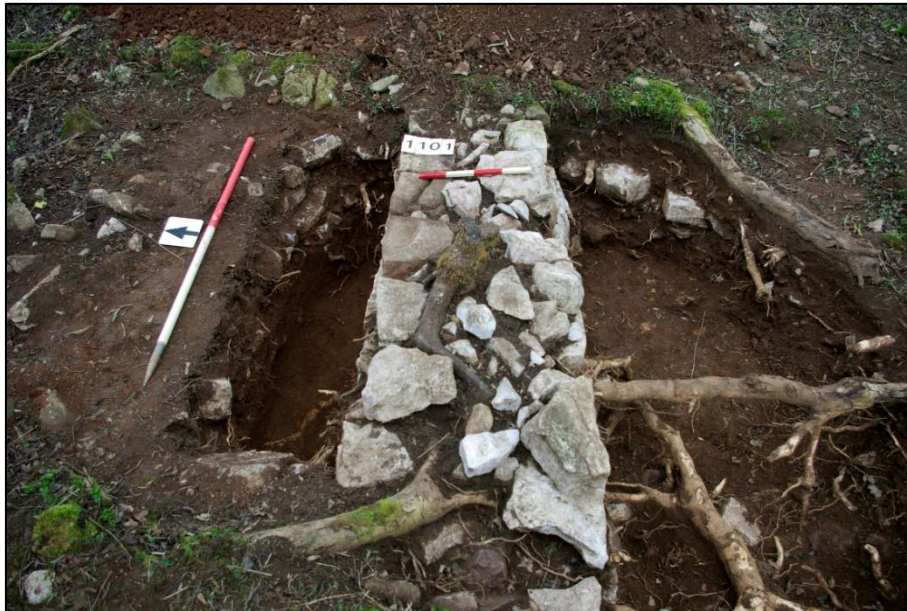
Figure 59: Trench 17 showing wall (1101) looking east

Topsoil and surface rubble (1100) was removed to reveal a wall of dry stone construction (1101) approximately 0.7m wide and extending north-east for approximately 50m on the line of the linear mound. The wall appeared to be made up of re-used stone of variable size surviving 4 courses in high, crudely constructed with no visible dressing (Figs 57-58). Deposit (1100) appears to surround both sides of the wall and also continues beneath it. Presumably the wall cuts through this deposit although no wall cut was visible (Fig. 59).

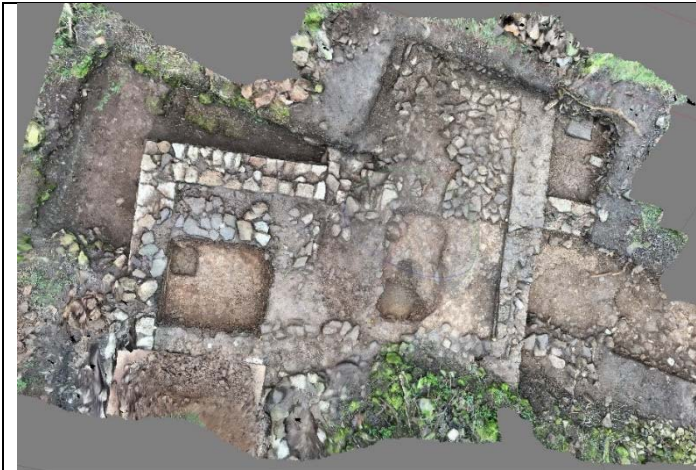
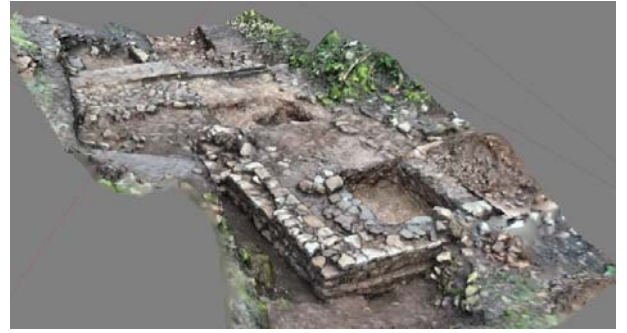
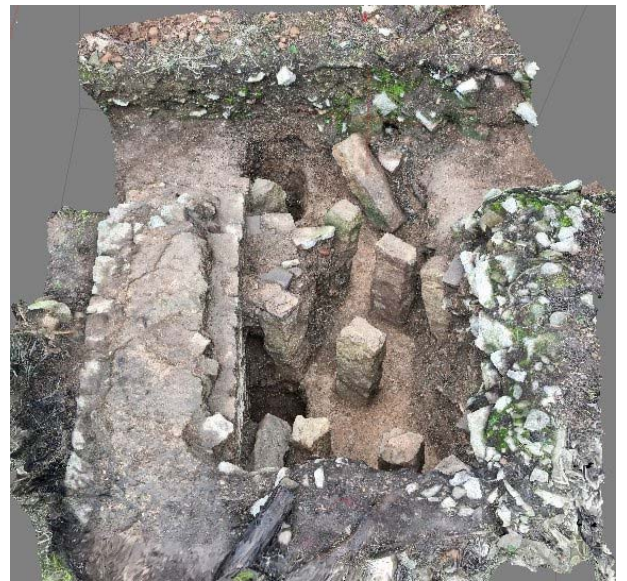
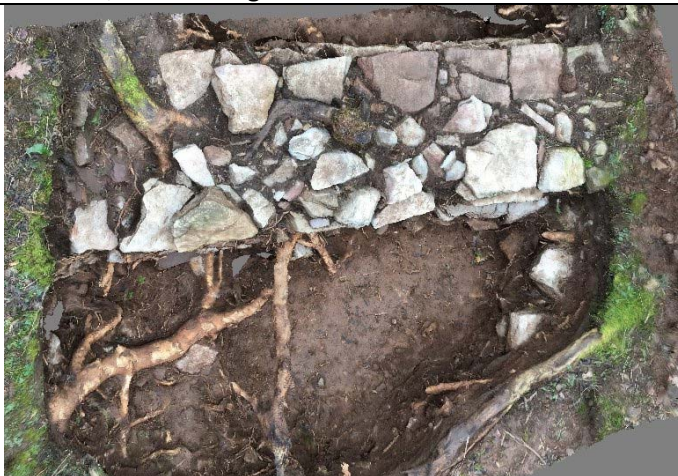
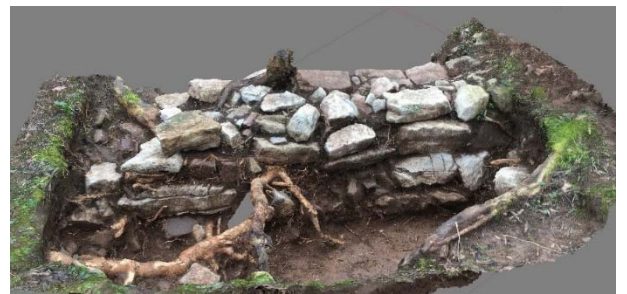
Figure 60: 3D imagery of the 2017 trenches created using Agisoft Photoscan Photogrammetry software.
