**Excavations at Whitewall Brake
Romano-British Site.
Caerwent Training Area
Defence Training Estate Wales & West
NGR: ST 4753 9114**

ULAS Report No 2017-071

For: Landmarc Support Services Limited

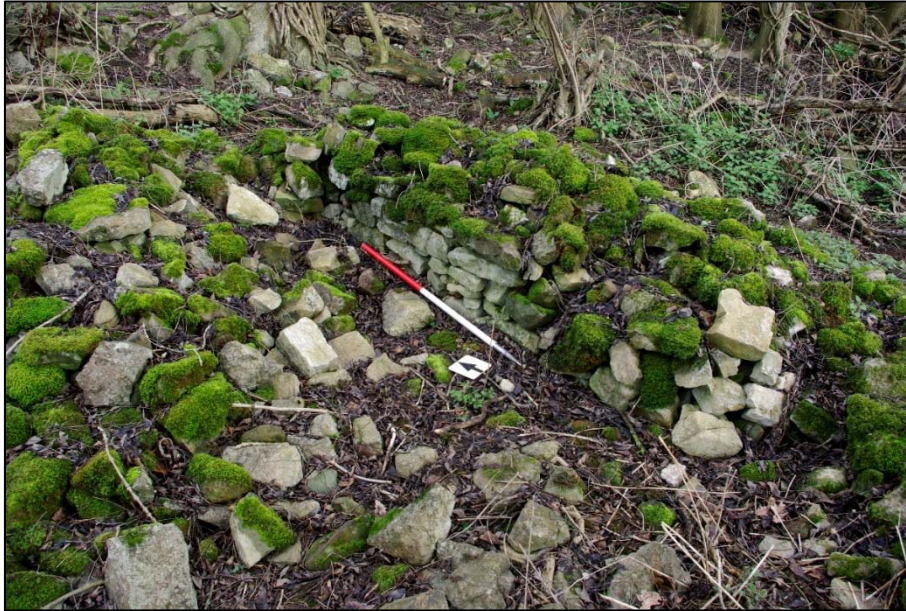
Figure 61: Dry stone structure south of the Roman complex looking north-east

Flanking the southern boundary of the site to the south of the projected Roman complex several visible dry stone structures can be seen (Figs 61-62). These appear to be constructed of reclaimed stone, similar to the wall seen in Trench 17. Mounds or cairns of stone tumble, probably re-used stone from the Roman complex are also visible in this area.

The nature of these structures appear to suggest these are post-medieval in date, most likely of an agricultural nature perhaps for livestock control and management of the land.

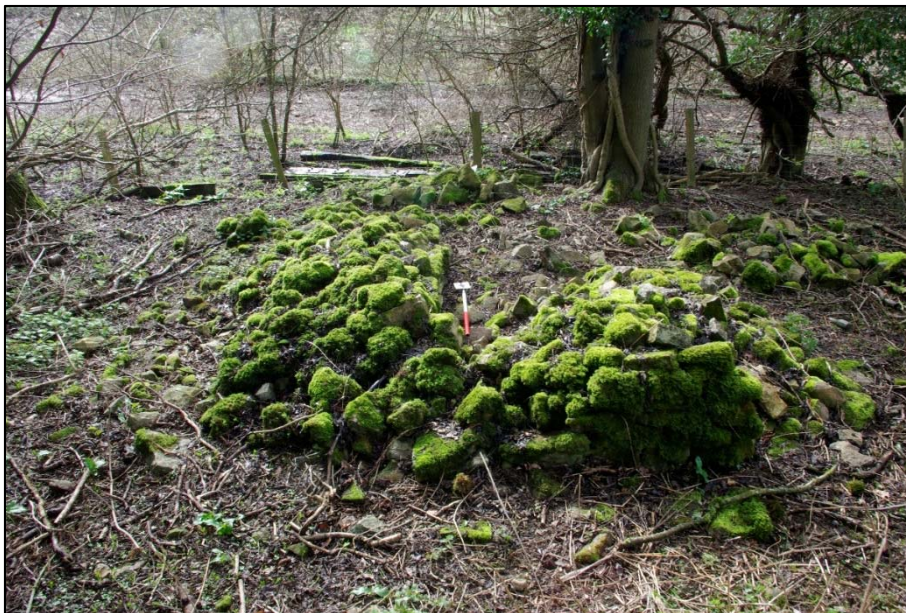
Figure 62: Mounds of stone tumble looking south

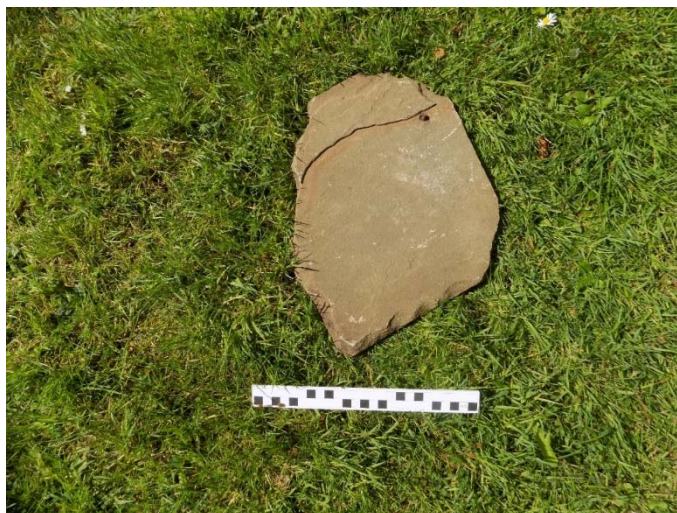
Figure 65: retained slate sample with nail still intact from CRWB12 (25). Photo: Heidi Addison ULAS

The stone roofing slates have been discussed in detail in the interim reports (Brown and Walshe 2012; Appendix 1). This suggested that the Whitewall Brake limestone roof slabs were held in place by a nail through one corner with each row of slabs overlapping the one below like the scales of a fish (Fig. 65). Roof slates of this type were inconsistent in size and the largest stones were used along the edge of the roof to project rain water away from the building with smaller pieces used in courses towards the ridge.

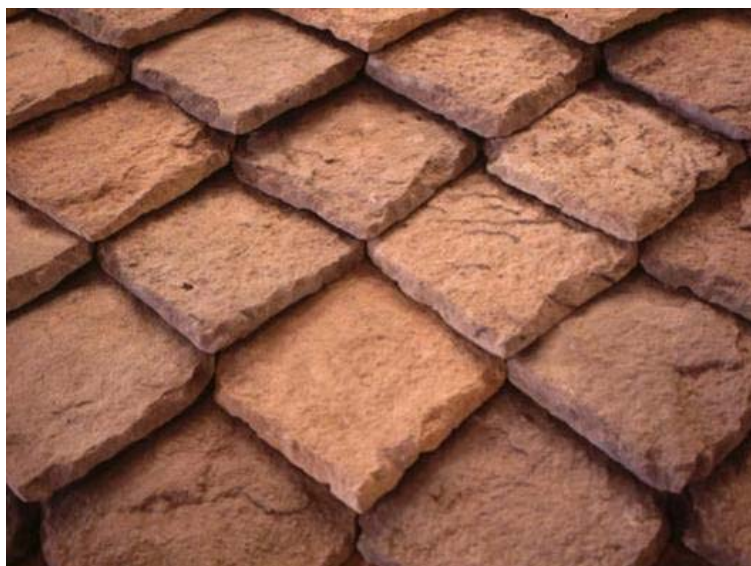
Figure 66: Reconstruction of stone slates from Brading Roman Villa (Isle of Wight). Image Simon I Hill, Oglander Roman Trust. From Brown and Walshe 2012.

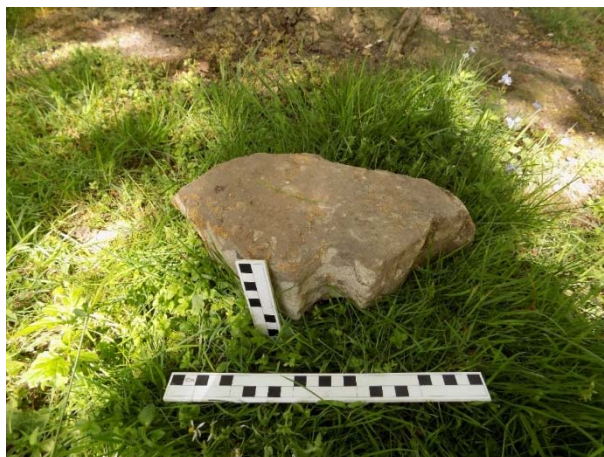
Figure 68: Quern stone frag from CRWB12 (100). Photo: Heidi Addison ULAS

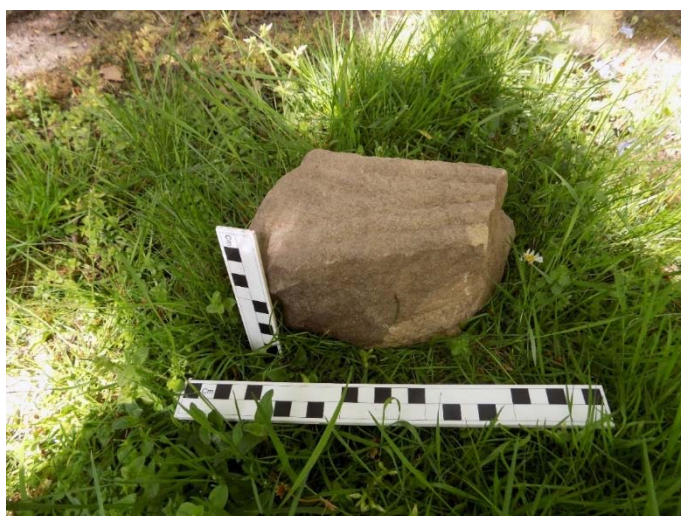
Figure 69: Quern stone frag from CRWB12 (100). Photo: Heidi Addison ULAS

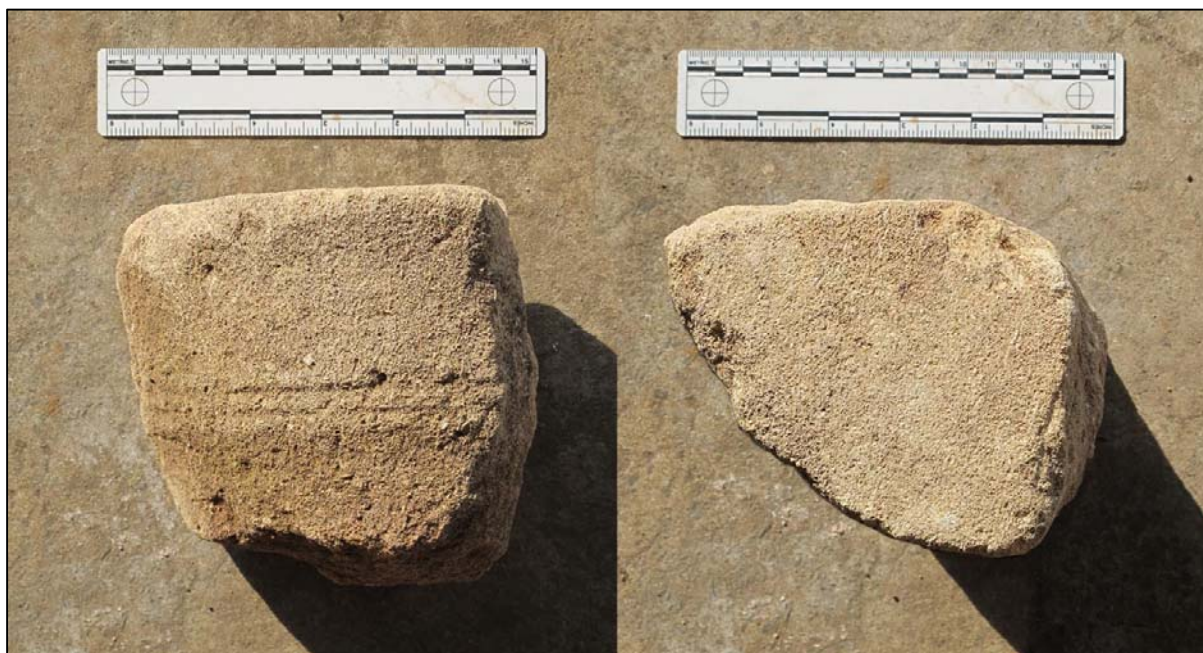
Figure 72: Fragment of probable column capital or base, original diameter c. 0.3 m

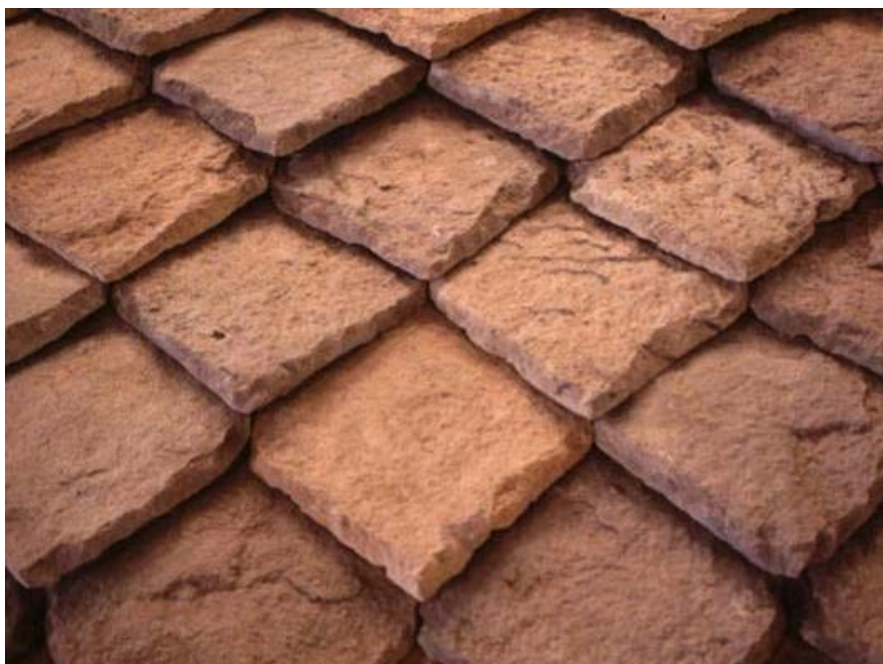
Rectangular stone slabs used on roofs were often held in place by a nail through one corner and each row of slabs overlapped the one below. This meant that the whole roof looked rather like the scales of a fish (see below)

Figure 73: Reconstruction of stone slates from Brading Roman Villa (Isle of Wight). Image Simon I Hill, Oglander Roman Trust

To prepare a building with a stone roof it would require wooden purlins to be fixed along the roof from which the slates will be hung. The slant of a stone roof would be between 48° and 55°, against 65° for thatch. Each slate had a hole or holes cut through near the top to enable its fixing to the purlins by nails or pegs.

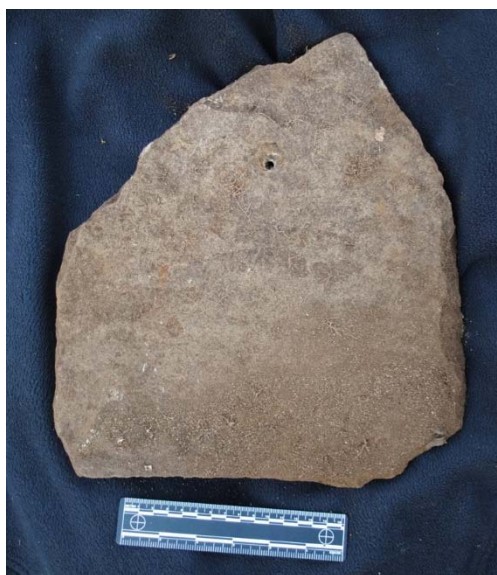
Figure 74: Limestone roof slate
