**CPAT Report No. 1355**

**52 – 54 Vale Street, Denbigh**

**Archaeological Watching Brief 2015**

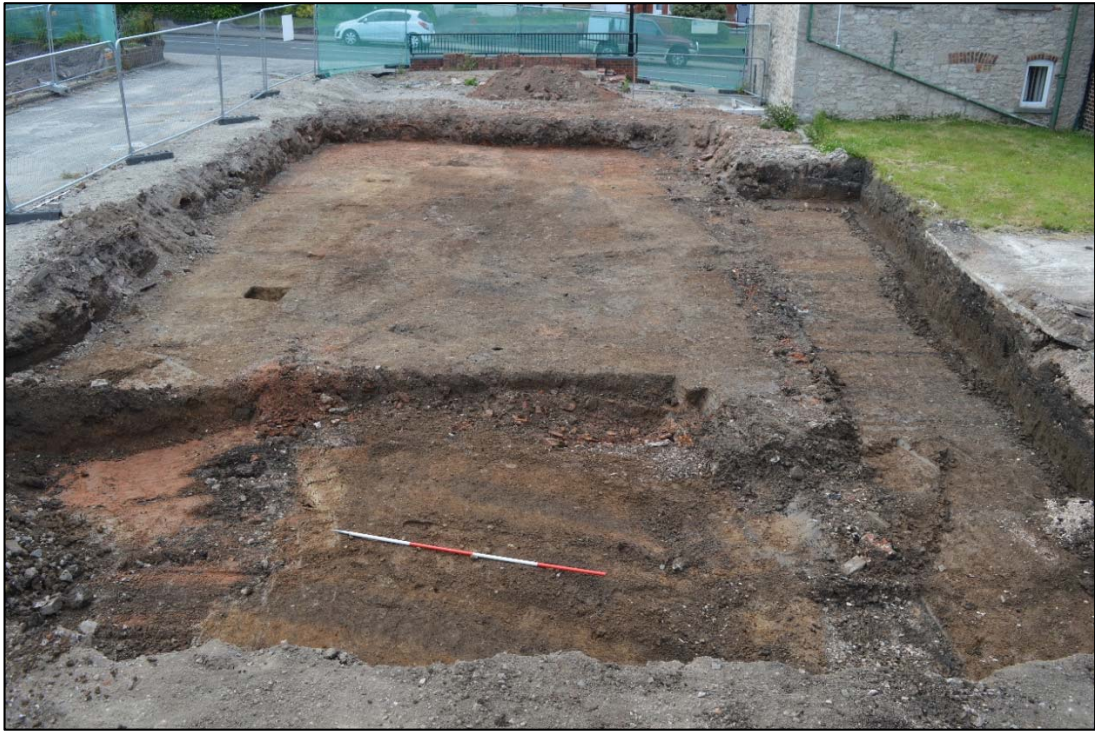
CPAT Photo 4030-0021

Fig. 4. Overview of the excavations (facing north) in the eastern area of the site showing the numerous gullies and area of disturbance in the centre of the site.

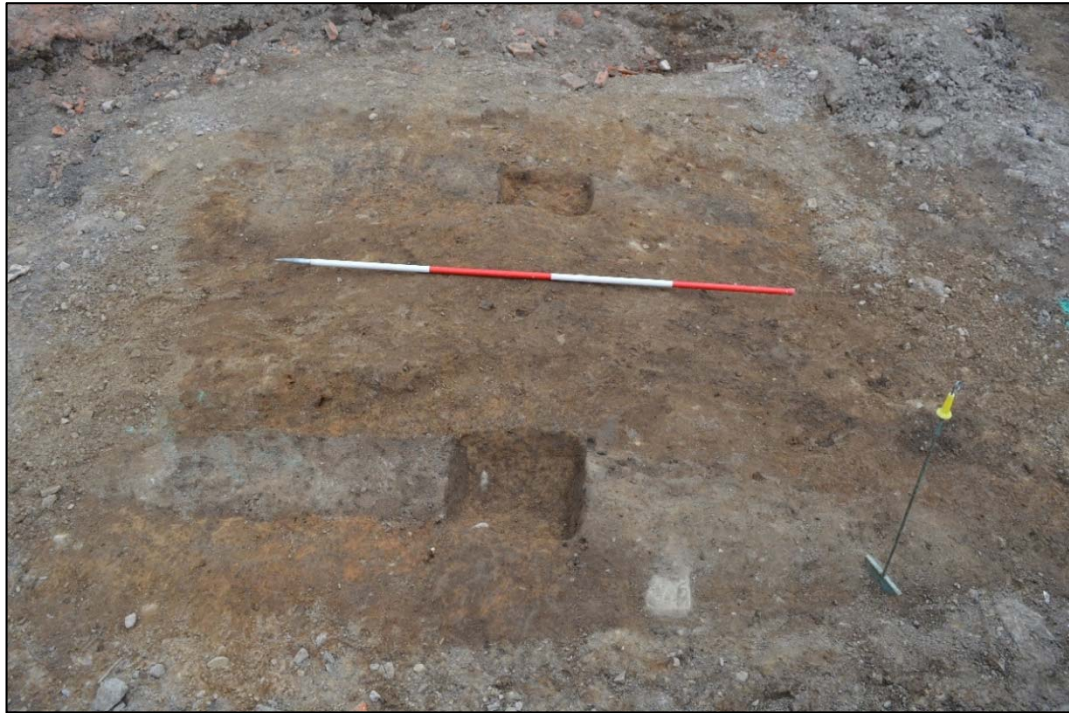
- 3.5. These gullies (26) and (28) were orientated east-west, measured 0.3m wide, 1.6m and 4m in length respectively, and were 1.4m apart (Fig. 5). Gully (26) had a steep-sided cut with a flat bottom and a shallow fill up to 70mm thick. Gully (28) was round-bottomed, with a deeper fill, up to 170mm thick. Each contained a dark brown silt fill containing frequent pieces of red brick, coal, some animal bone and two pieces of pot potentially medieval in age, but which are most likely to be residual in origin.

Fig. 5. Gullies (26) and (28) at the south-western corner of the site. CPAT Photo 4030-0059

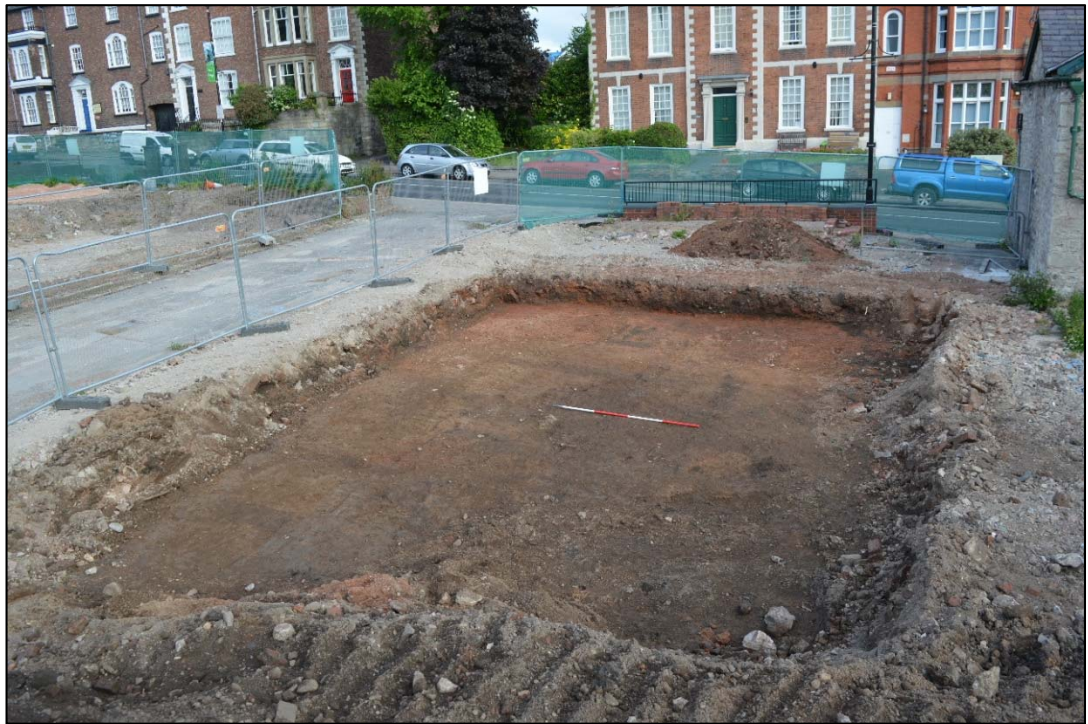
Fig. 6. Overview of the linear features in the western and northern area of the site, truncated by a large pit and later disturbance in the centre of the area. CPAT Photo 4030-0020

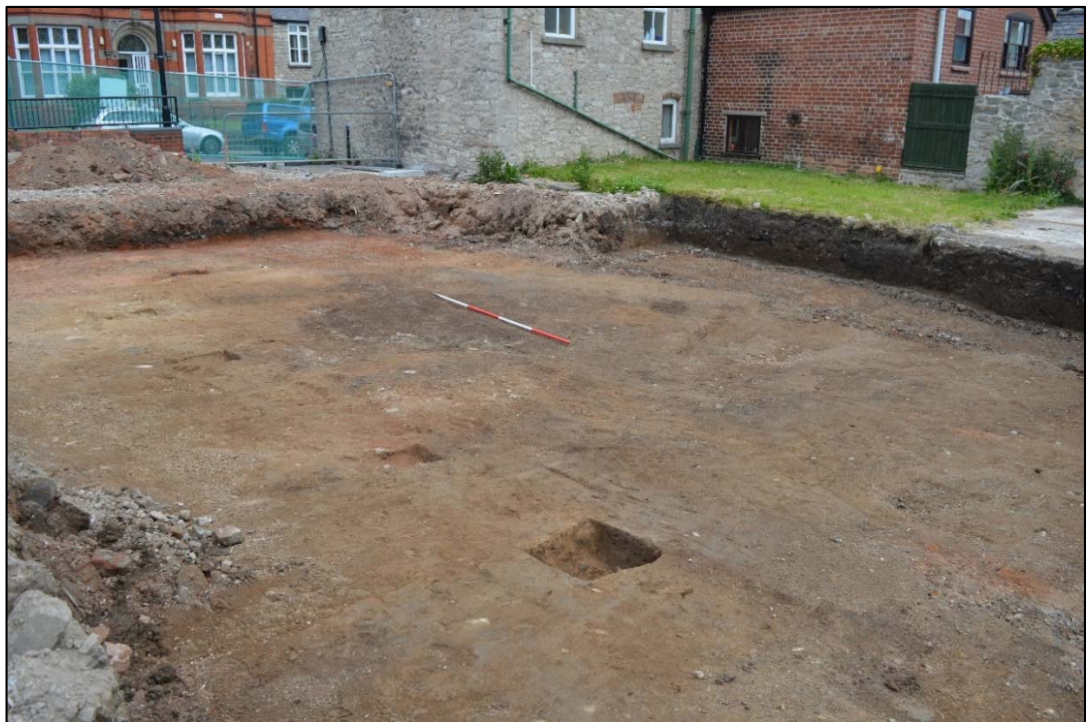
- 3.9. Six of the gullies (05, 07, 09, 39, 41 and 58) revealed shallow, steep-sided, flat-bottomed cuts with fills between 50mm and 80mm thick. These fills contained late medieval to early post-medieval pottery, along with frequent pieces of animal bone, coal/coke and occasional, limestone and slate. Elsewhere, four gullies (11, 13, 51 and 53) displayed, steep cuts with rounded bottoms and fills between 0.13 -0.35 thick (Fig. 7).

Fig. 7. The sampled sections of the gullies in the western and northern area of the site. CPAT Photo 4030-0025

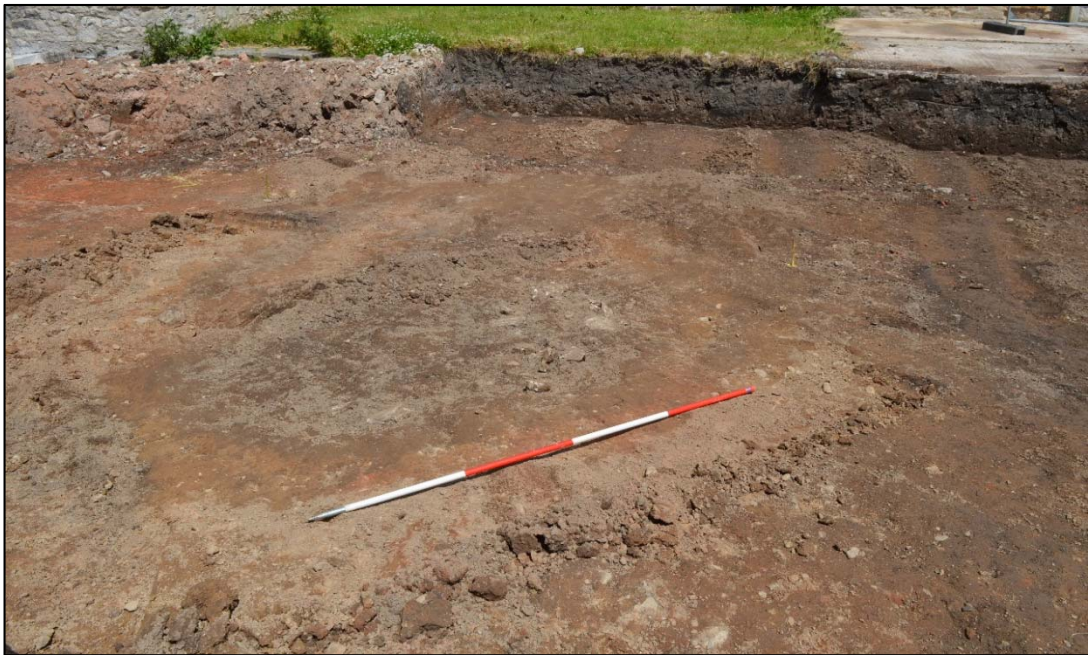
- 3.11. The post-medieval pit (37) truncating the gullies, measured 3.4m long, 2.2m wide and 0.7m deep (see Figs 8 - 9). It contained three layers. The primary fill consisted of a light brown-yellow clay silt (38), followed by a limestone rubble layer (16) containing frequent animal bone, post-medieval ridge tiles, an oyster shell and sherds of a late medieval storage pot, and was overlain by a loose, dark grey silt (17) containing frequent animal bone, red brick, a sherd of possible early post-medieval pot and clay pipe.

Fig. 8. The post-medieval pit (37) in the eastern area of the site. CPAT Photo 4030-0035

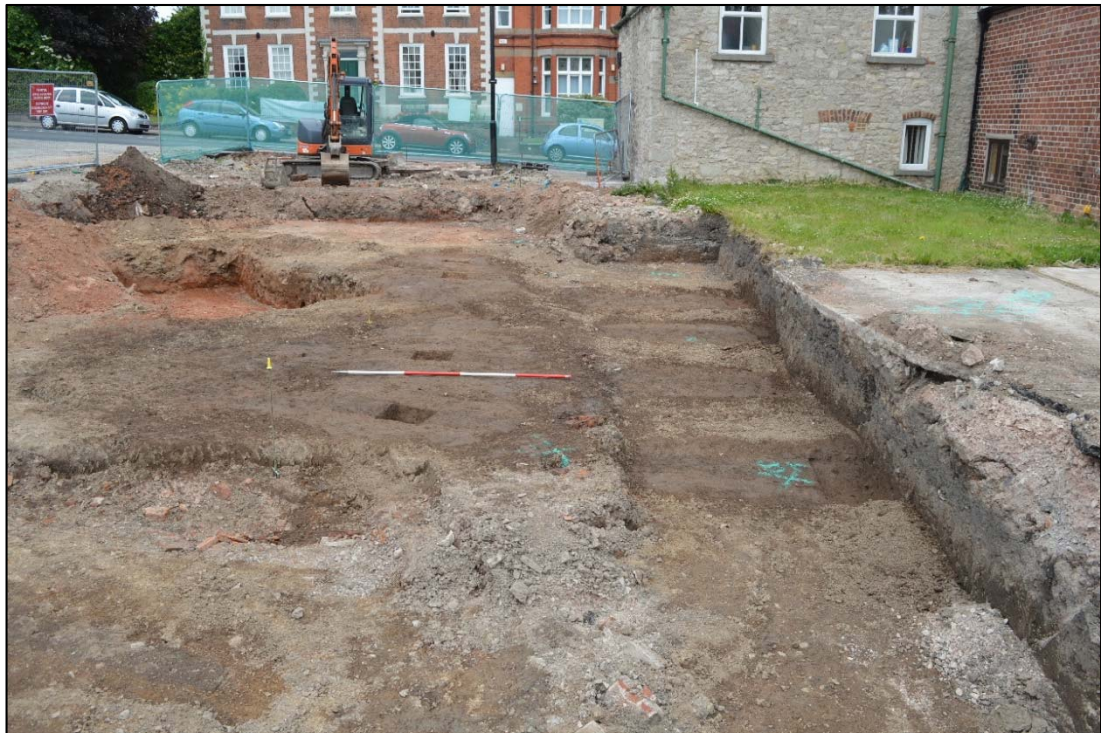
Fig. 10. The linear features along the eastern edge of the excavation area. CPAT Photo 4030-0043

- 3.13. These features were more reminiscent of plough furrows than the defined gullies seen elsewhere on the site. Each feature displayed shallow, irregular and broad cuts which were filled by the overlying cultivation soil (30). This comprised a dark brown silt containing frequent flecks of charcoal, coal, late post-medieval pot, red brick and frequent animal bone.
- 3.14. Owing to the intrusion of the modern wall (21) it was not possible to infer a direct relationship between the gullies and the probable plough features. However, the late post-medieval fills of the plough features attests them post-dating the gullies and suggests a later change of use or intensification of cultivation in particular areas of the plot.

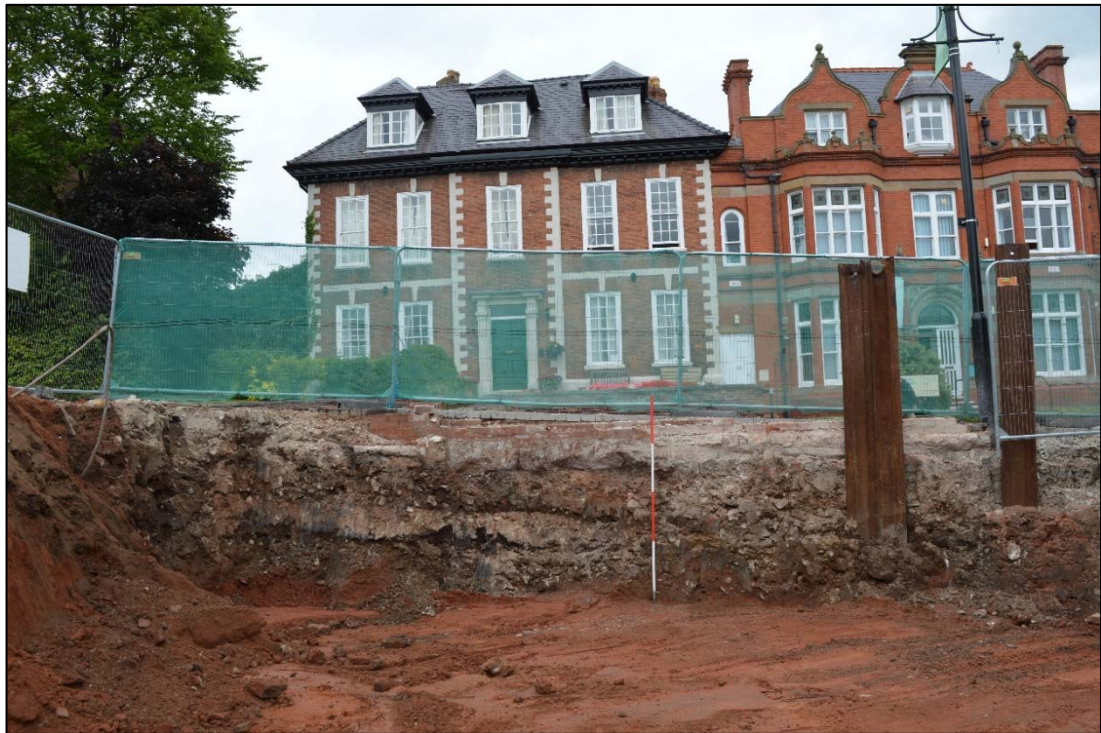
- 3.15. Following the initial phase of works, monitoring was undertaken during the deep excavation along the street frontage in the north-eastern area of the site, immediately west of and adjacent to No.56. Here, the level was reduced to 1.6m below ground level on to sandstone bedrock with the overburden being removed by machine. This excavation revealed the full depth of deposits at the street frontage and demonstrated a sequence of imported, levelling material comprising a dark grey/brown charcoal-rich silt (66) limestone rubble (71), sand, brick, demolition material (72 cumulatively) overlain by around 100mm of modern paving (73). These layers amounted to a total thickness of 1.5m above bedrock (Fig. 11). The earliest layer (66) contained frequent fragments of coal, smears of brick and occasional sherds of late, post-medieval pottery. The depths of these deposits are somewhat surprising given the level of the undisturbed natural subsoil just south of this area was only 0.4m below ground level. Such a significant discrepancy in levels suggests that the area along the street frontage has undergone substantial terracing and importing of material to level what is likely to have been a fairly undulating gradient.

Fig. 11. South-facing section showing the layers of post-medieval deposits making up the street frontage with “Y Gelli” house in the background. CPAT Photo 4030-0071

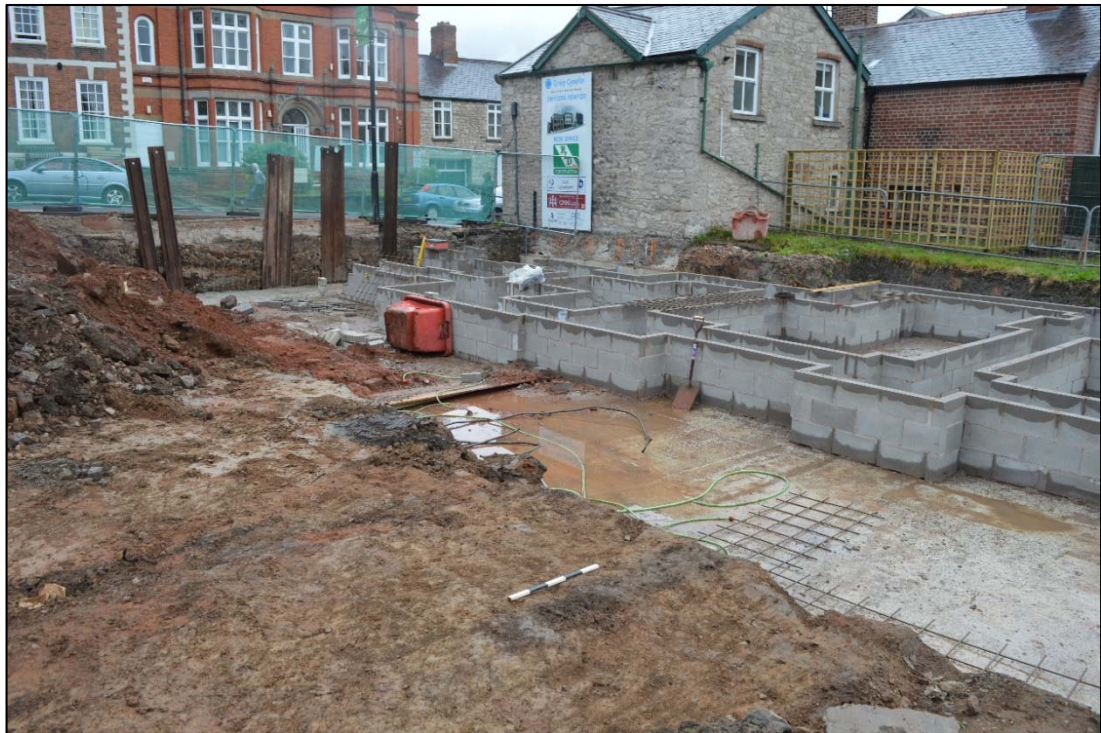
edge of the former access route (Fig. 12) This feature was cut into the buff-coloured sand (04) and contained a dark grey/brown silty fill (64) containing frequent pieces of charcoal/coke, red brick and animal bone. This was exposed at 0.38m below ground level but was probably cut from the top of the sandy silt (04), its fill may have been up to 0.27m thick. It was truncated at its eastern end by modern intrusions at the edge of the access route (70). This feature was identical in character to the gullies revealed during the excavation on the eastern side of the site and given its orientation, is likely to have been associated and contemporary with these features.

Fig. 12. The shallow gully (63) revealed beneath the former access road. Photo CPAT 4030-0082

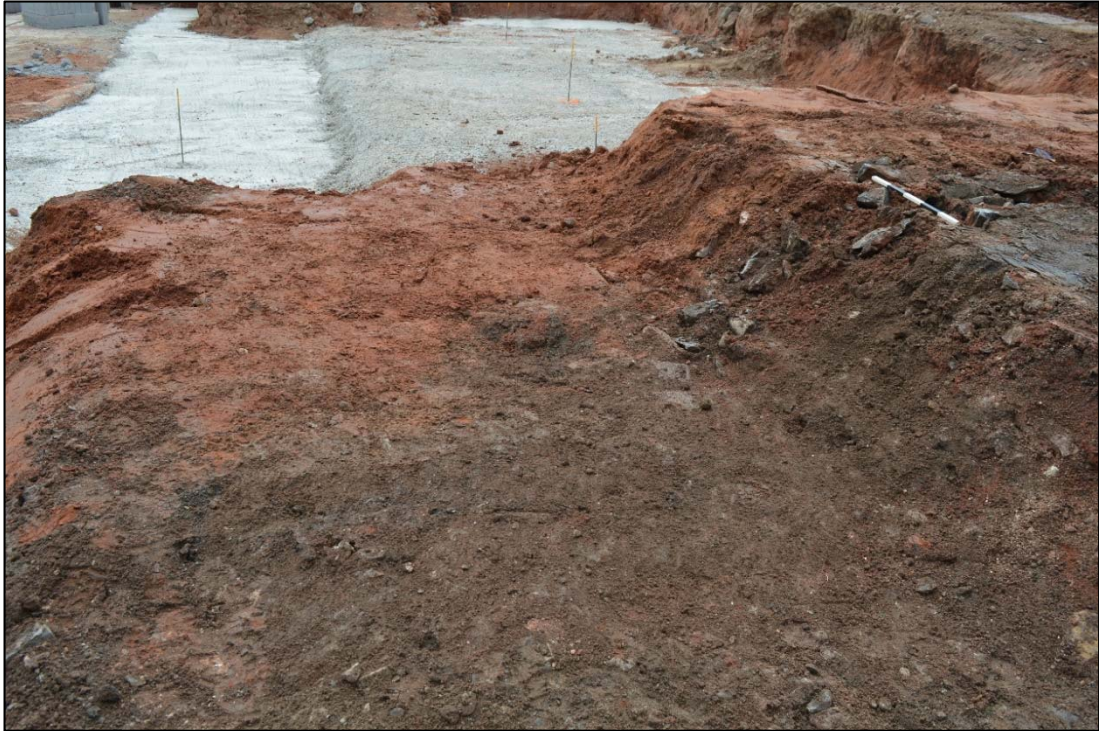
- 3.17. Ground reductions immediately west of the former access route revealed a limestone rubble wall (65), terminated by a large posthole (67) at its eastern end and a layer of dark grey/brown charcoal-rich silt (66) all within 3m of the street frontage (Fig. 13). These features was overlain by around 0.46m of modern disturbance and overburden (72).

Fig. 13. The limestone wall (65), posthole (67) and garden soil (66) revealed along the street frontage. CPAT Photo 4030-0096

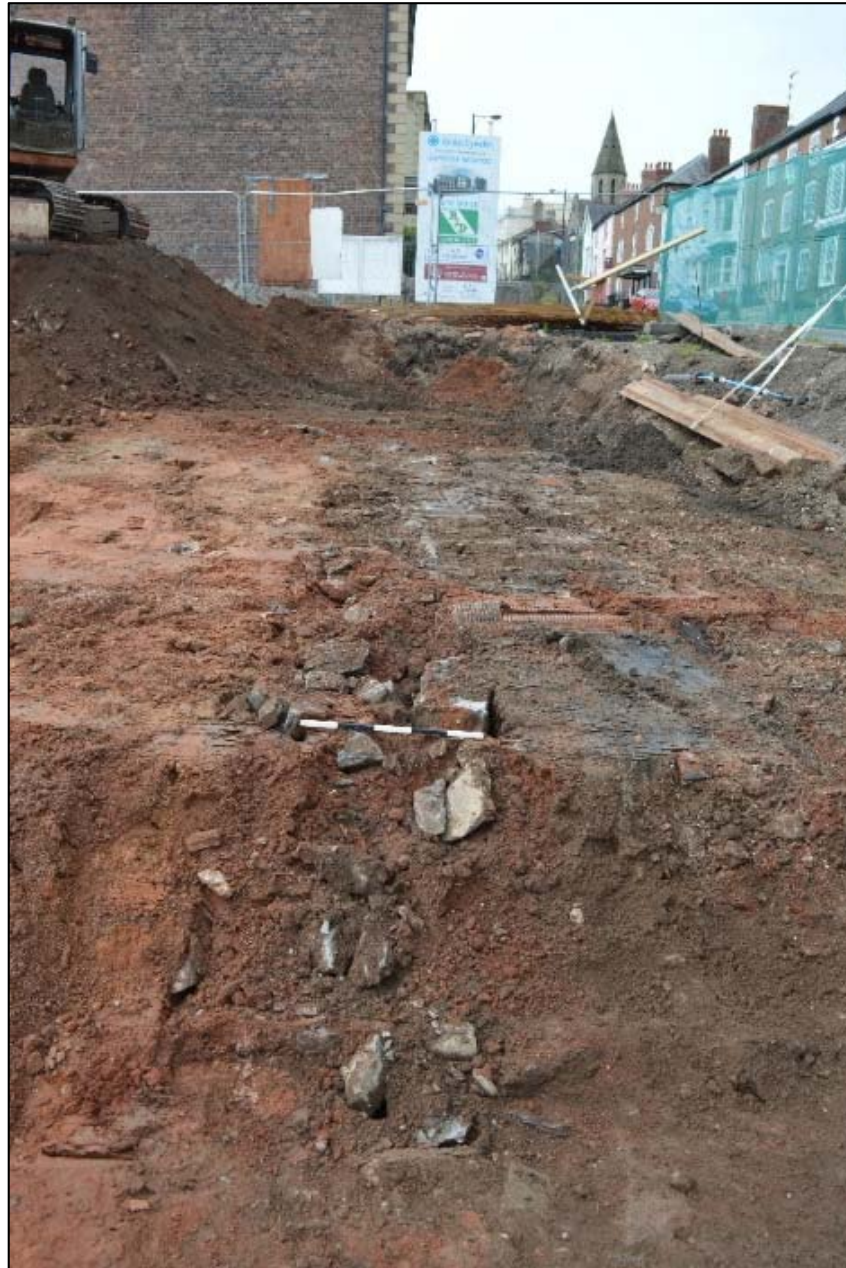
- 3.18. The wall (65) was parallel to the street front, orientated north-east – south-west and comprised limestone blocks, some of which were faced and retained evidence of a lime mortar (Fig. 14). A chamfered block with a longitudinal hole was recovered from the rubble (Fig. 15). The wall measured 0.65m wide and extended 10m westwards as revealed by the limits of the ground reduction. This wall was truncated by modern services, orientated north-south, some 1.2m west from the end of the wall. Its full length could not be established but the extent of the excavations demonstrated that the wall was cut into red sand (03), 1.34m below ground level. This wall was punctuated at its eastern end by a sub-angular posthole (67) (Fig. 16). The posthole measured 0.6m by 0.63m and 0.4m deep. This posthole contained a fill comprising a dark grey/black silt (68) which contained frequent pieces of coal, brick, animal bone, possible bits of lime and a slate roof tile. This wall appeared to be butted by a dark grey/brown charcoal-rich silt (66) which contained frequent animal bone, brick, coal and occasional sherds of post-medieval pottery and was reminiscent of a cultivation/ garden soil (see Fig. 14). This layer was also visible in the section of the street frontage, revealing a thickness of up to 0.13m and was overlain by a thick layer of limestone rubble (71) as seen previously in the street section (Fig. 17).

Fig. 14. The limestone wall (65) running parallel with the street frontage, truncated by modern services, with the front of the Old Police Station on the background. CPAT Photo 4030-0093

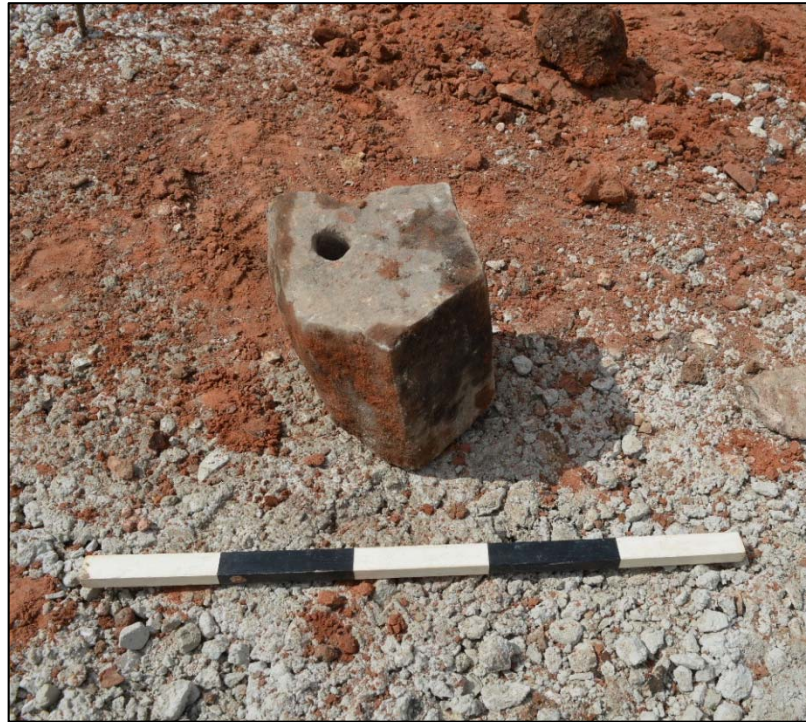
Fig. 15. The chamfered limestone block retrieved from the wall (65) rubble. CPAT Photo 4030-106

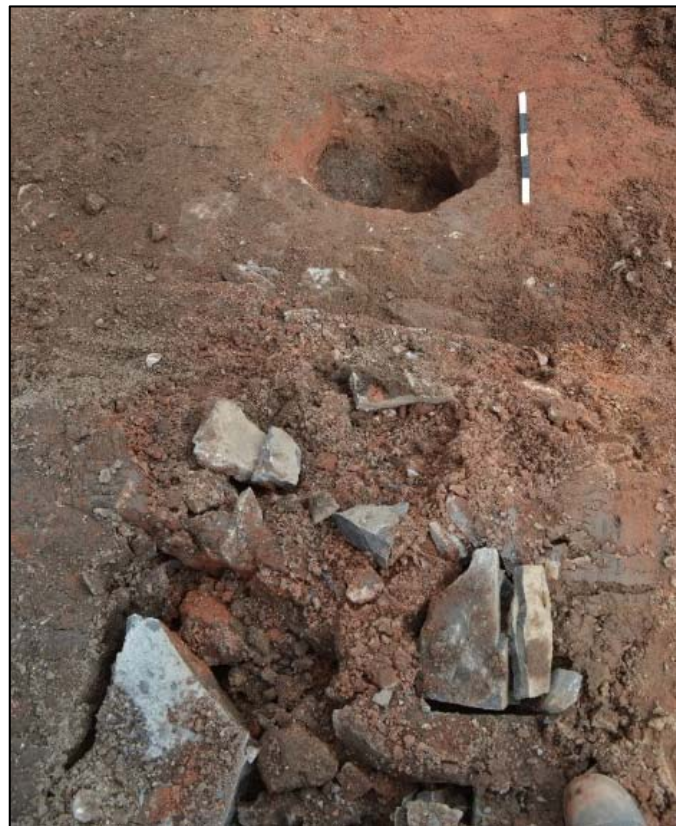
Fig. 17. Posthole 67 terminating the eastern end of wall (65). CPAT Photo 4030 -0102

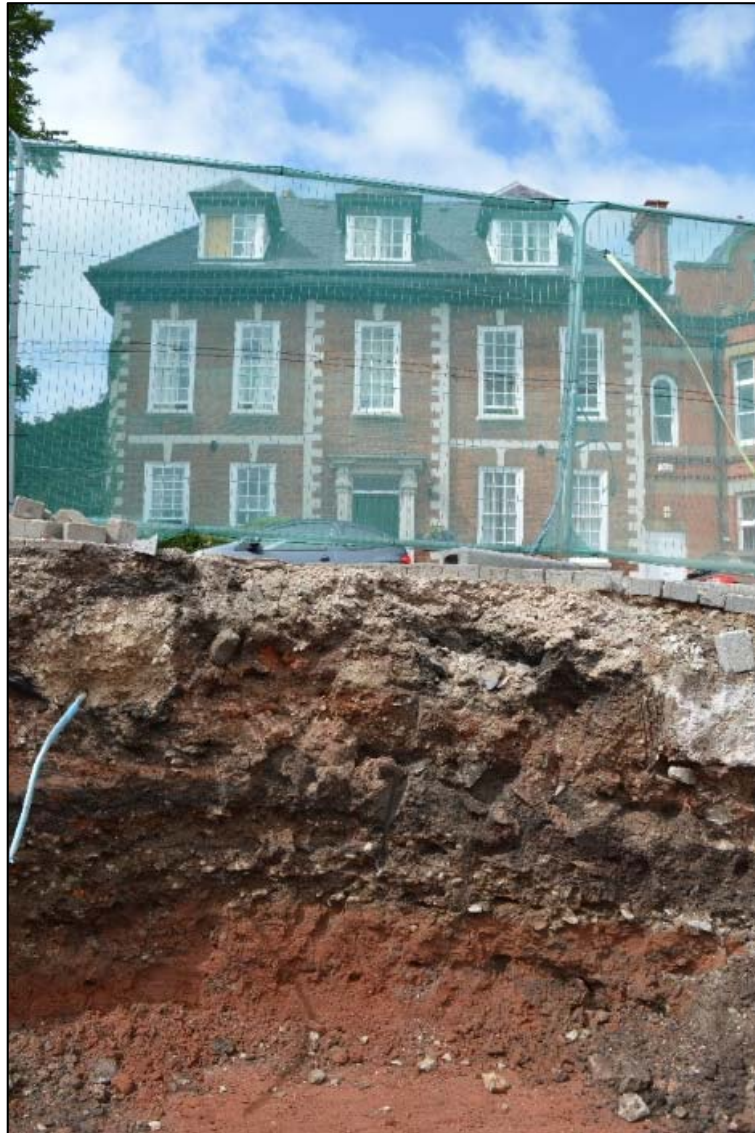
Fig. 18. The street front section showing a thin lens of garden soil (66) overlying the natural sand (03) and overlain by a thick limestone layer (71) and cumulative post-medieval deposits (72) beneath the modern paving (73). CPAT Photo 4030-0105

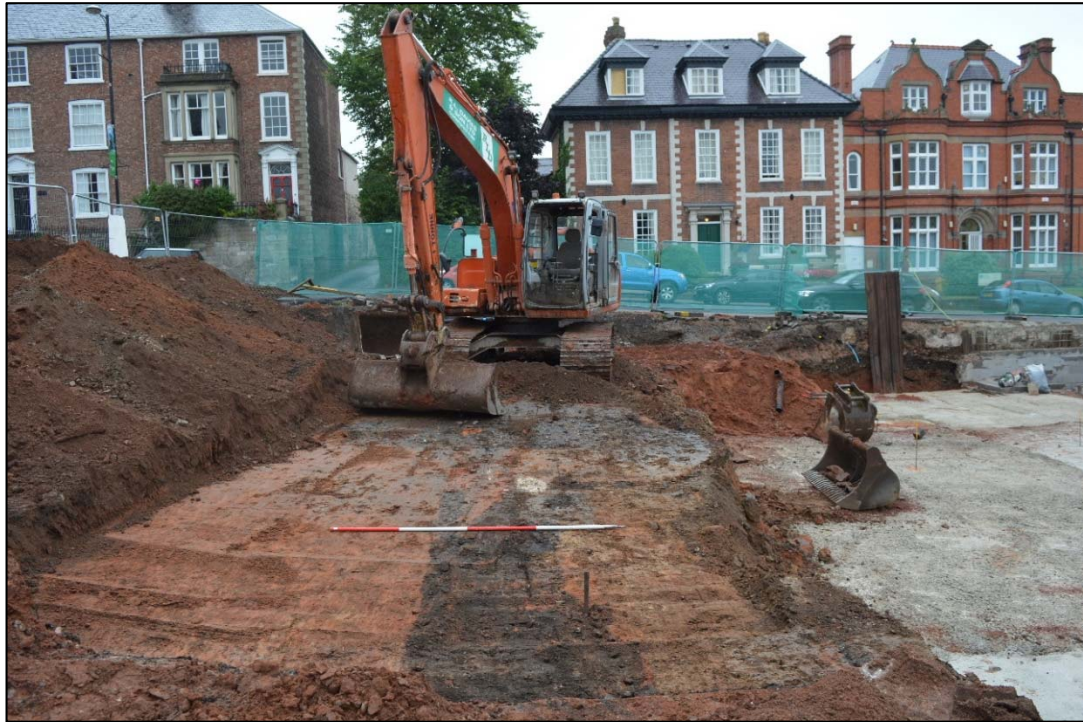
- 3.19. Consultation of the historic mapping shows that this wall corresponds with the retaining garden wall as discussed earlier in this report and it aligns with the limestone wall revealed during the 2014 watching brief. Further still, the posthole (67) most likely supported the western stone pillar or gatepost framing the entrance to the former Grove. The post-medieval nature of the deposits and pottery evidence are suggestive of eighteenth-century origins.
- 3.20. The final phase of the watching brief monitored the excavation of a narrow strip of ground undisturbed during the previous ground reductions, west of the former access route and immediately east of the modern services previously seen truncating the limestone wall (65). These were the remnants of an eighteenth to nineteenth-century garden soil (69) and overlay the buff-coloured sand (04) (Fig. 19).

Fig. 19. The modern service trench truncating the remnants of an 18<sup>th</sup>- or 19<sup>th</sup>- century soil (69) along the eastern edge of the excavation area. CPAT Photo 4030-0110
