A Report on Field Survey, Excavation and Historical Research at Ty Mawr, Llangasty Talyllyn, Powys: 1993 - 2001

NGR SO 1245 2603

Report prepared by Peter Dorling for the Brecon Beacons National Park Authority
June 2018

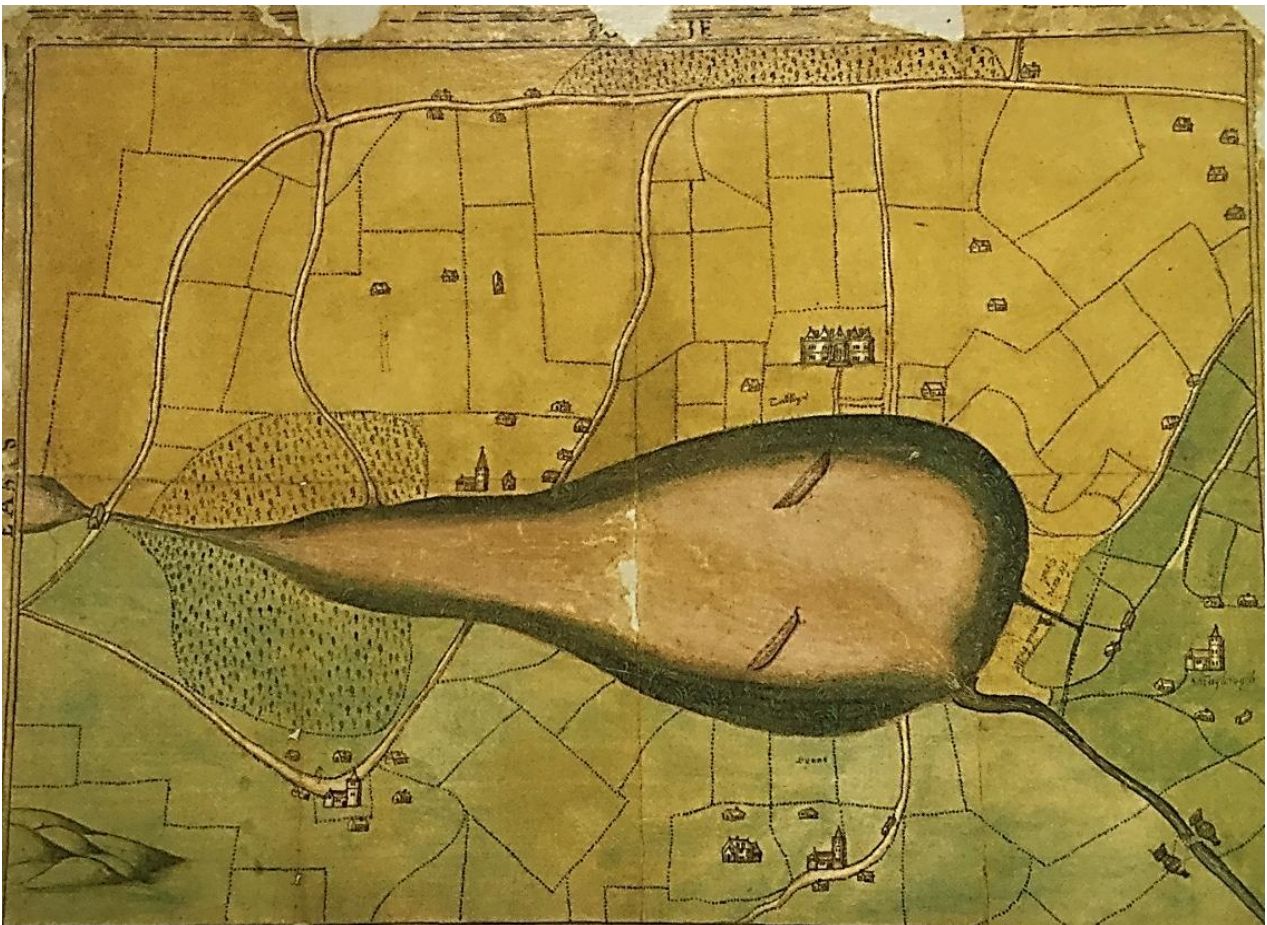
Figure 2: The 1584 Enquiry map, south is at the top of the map. (© Public Record Office)

- 3.4 We are also very fortunate that Talyllyn House is depicted in the 1584 enquiry map from a dispute into fishing rights on Llangors Lake (figure 2)(PRO E 178/3323). This key piece of evidence shows what appears to be a large fine house of Elizabethan style on the site. It is depicted with five bays and three stories, gabled over each bay and with four large stacks rising from the valleys between. An impressive two storied entrance occupies the central bay, flanked by columns or pairs of columns with two or three steps leading up to the entrance. The windows on the façade all appear to be of three lights with stone mullions (Addyman, 1997).

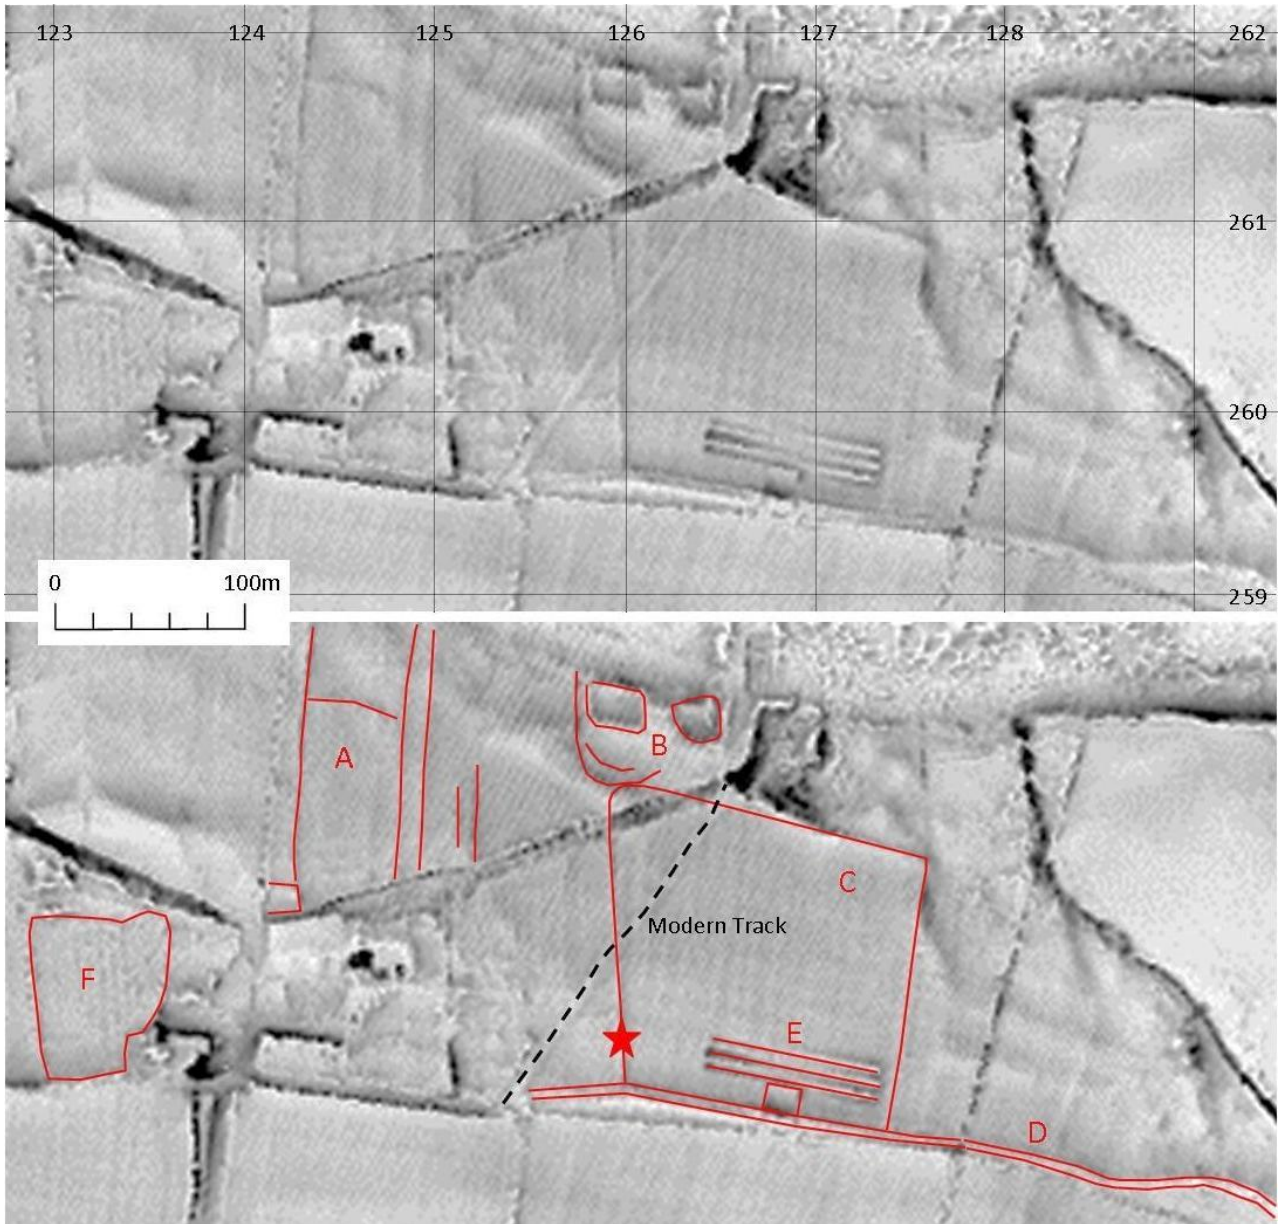
Figure 3: Lidar image and location of earthworks recorded in the survey of 1996. The star indicates the location of excavation Trench E. Grid at 100m intervals. (NRW 2mRes DTM, Sky View Factor Visualisation) Contains Natural Resources Wales information © Natural Resources Wales and database right

- 4.1 The extent of the earthworks in the immediate vicinity of the former house is shown in outline in figure 3. These were surveyed by archaeology students from University College Cardiff in 1996 but Lidar data has allowed some enhancement of the field survey results and shows some potential additional features (see especially figure 4). However it has not been possible to check the nature or character of these in the field. Information from mapped data and natural features such as trees are also included in this section.

- 4.3 A number of earthworks survive in this area to the south of the house (figure 3) and those representing the drives or tracks are relatively clear (A). In the south-western corner of this area a low platform is recorded where a building is shown on the 1840 Tithe map (figure 6). The earthworks to the east within the same field (B) are the remains of ponds and short lengths of associated surviving feeder channels. The ponds were clearly at one time significant features, a trial pit through deposits in the western most pond in the late 1990s

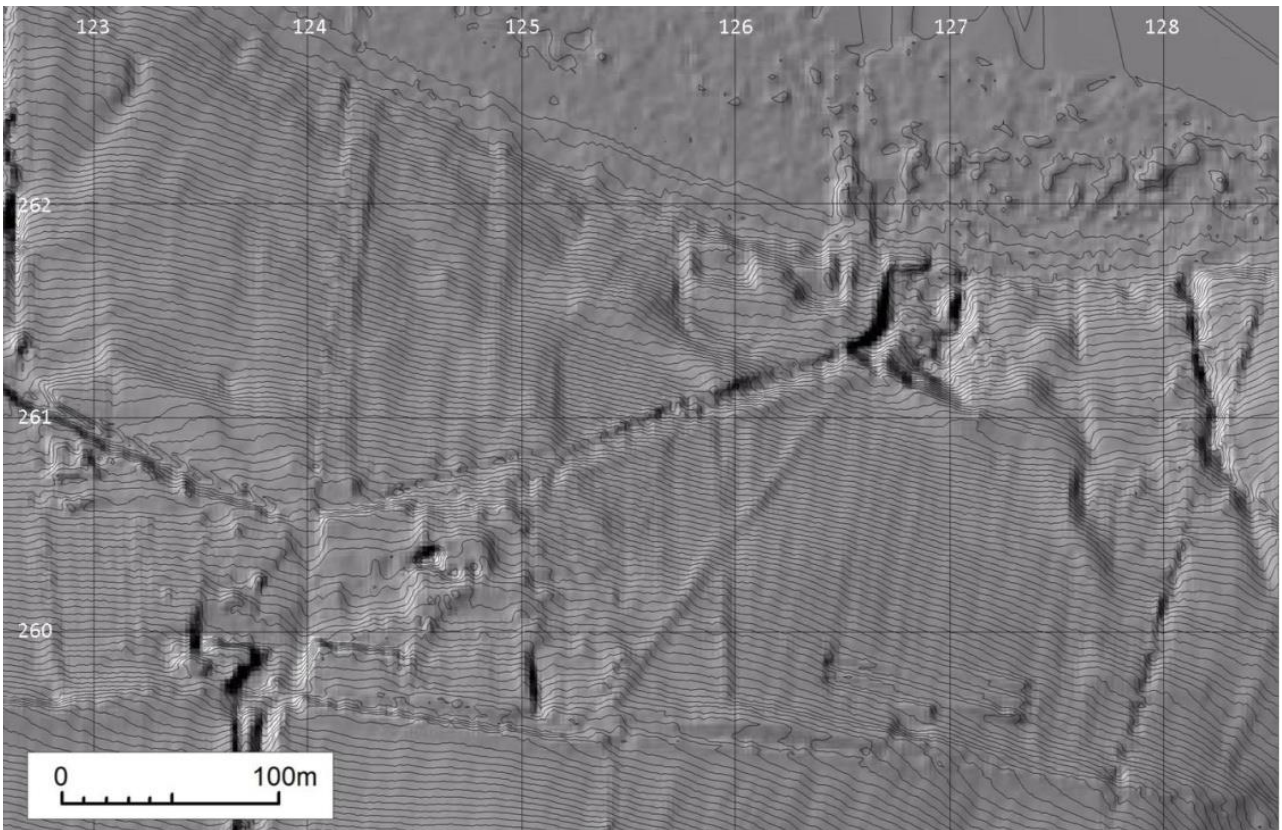
Figure 4: Lidar image enhanced by overlaying contours at 25cm intervals. Grid at 100m intervals. (NRW 2mRes DTM, Sky View Factor Visualisation) Contains Natural Resources Wales information © Natural Resources Wales and database right

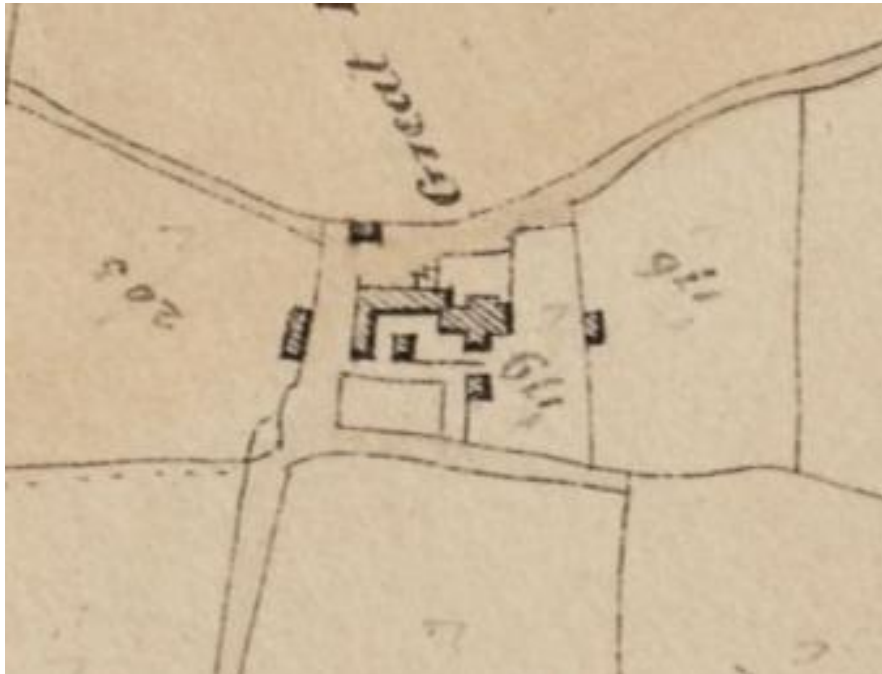
Figure 6: Detail of the 1840 Tithe Award map showing the main house

- 6.11 Trench C was located adjacent to and to the north-west of the only known well on the property and measured 5m north-south by a maximum of 4.3m east-west (figure 11). It proved to be a very busy area with a number of different stone surfaces and structures recorded in a small area. The configuration of the drainage features in particular and the possibility of some wall remnants suggests that these features were located within a building and there is a building shown on the 1840 tithe map in this location due south of the main house (figure 6).

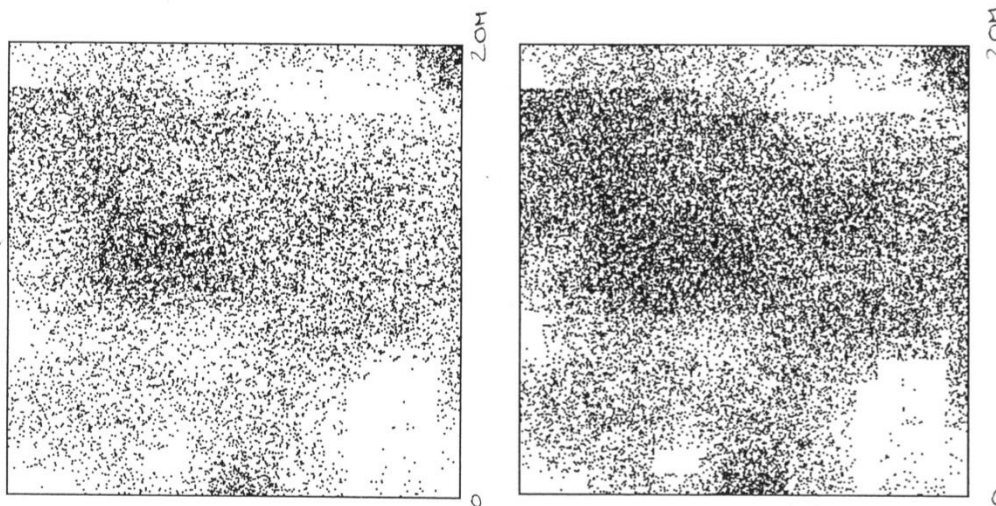
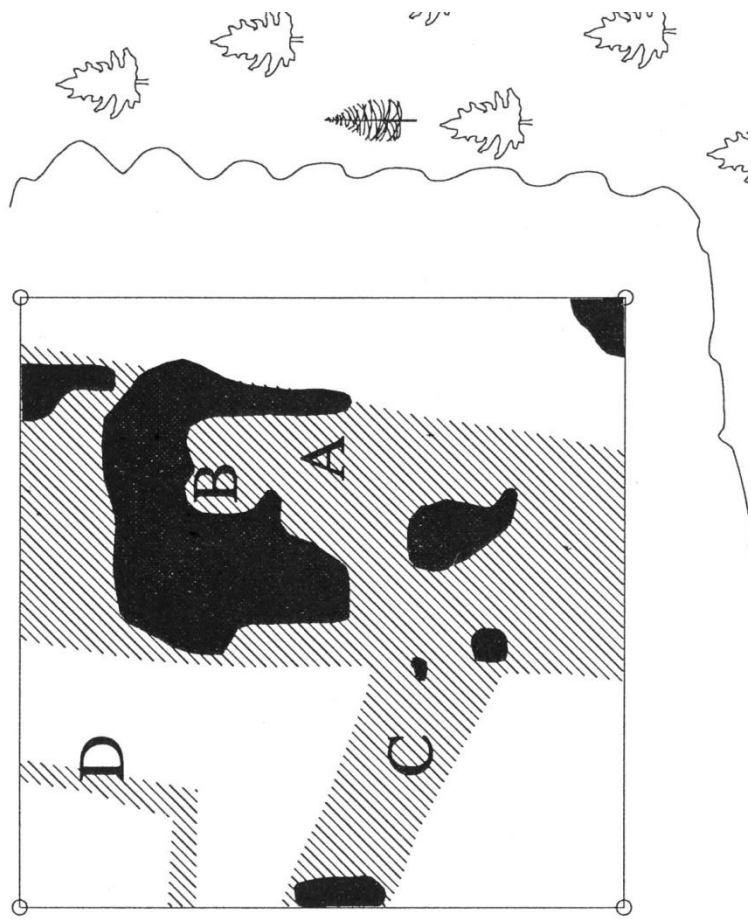
Figure 10: Data print outs and interpretation of the geophysical survey carried out in 1993, north is to the top

- 5.2 Within the 20m by 20m survey area there is a broad area of high resistance (A) which would suggest the presence of stone/building material. Within this band there are discrete areas of higher resistance (B) which may be significant. There is no suggestion of walls although this does not rule out the possibility of them being present. If there is a lot of rubble spread across the site it would not be possible to “see” or detect individual walls. Alternatively it is possible that the areas of higher resistance indicate stone floors.

- 5.3 The area of high resistance (C) may be of interest
- 5.4 There are suggestions of a rectilinear high resistance anomaly (D) which may represent a wall, but it is a very weak anomaly. However it could be associated with the floor you found when building your new toilet.

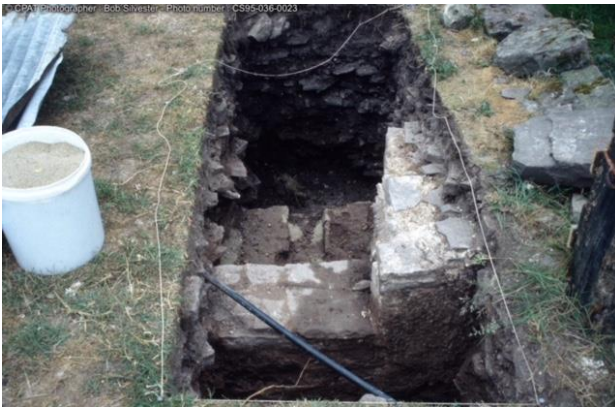
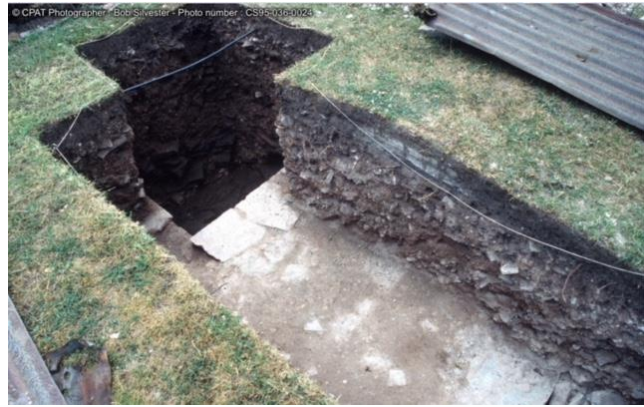
Figures 12 and 13: Trial trenches 1 and 3 viewed from the north and from the north-east respectively. 12 shows the front wall of the building with a window reveal and 13 a wide two-phase internal wall with another joining from the south. In Trench 3 the nature of the overburden can be clearly seen. © CPAT Photo Nos. CS95-036-0023 & CS95-036-0024

6.2 The trial work was successful in locating the remains of a number of walls (figures 12 and 13). The work carried out from 1997 onwards allowed these to be identified as; in Trench 1 the front wall of the building, in Trench 2 the inner revetment wall of a raised terrace in front of the house and in Trench 3 a two-phase wall, with clay bonded and lime mortared elements. Another wall joined from the south (figure 13) and the small area of exposed floor was cobbled.

6.3 Although we don't have a surviving record of excavated contexts the material removed to expose the masonry remains was all demolition and later material (see figure 13), some of which was possibly brought onto the site for landscaping purposes. Numerous finds came

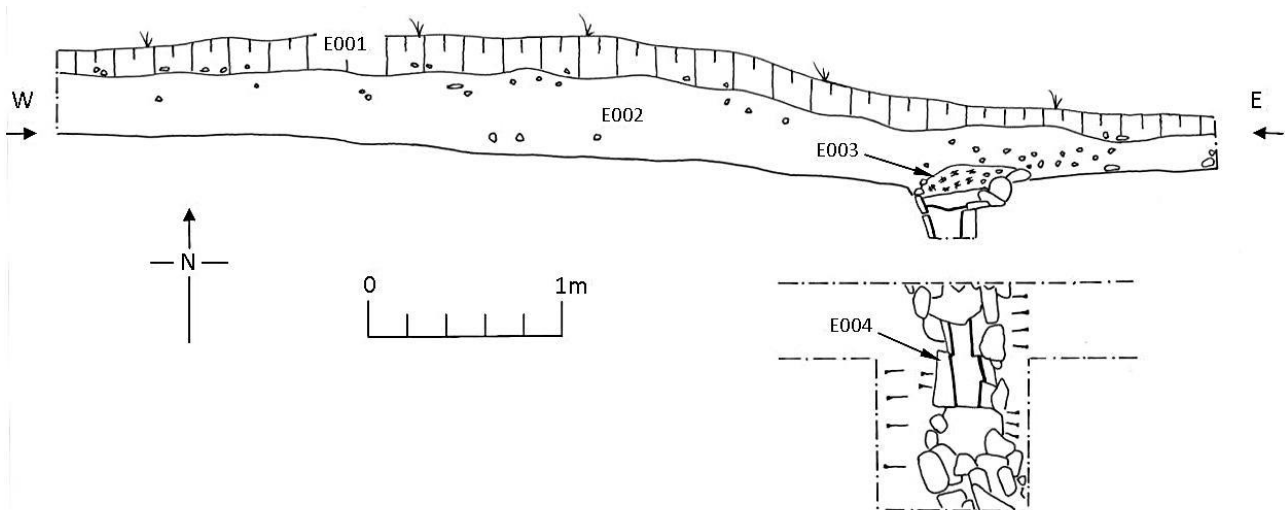
Figure 16: Section of Trench E and plan of the exposed stone culvert

6.16 Trench E was located over the western bank of the earthwork enclosure in the field to the east of the site of the manor house at approximately SO 1259 2599 (figure 3) (see section 4.4 above for a description of the earthwork). The trench measured 6.3m east-west by 0.40m north-south and was placed to examine a section through the earthwork bank at this point. An extension 0.75m east-west and 0.80m north-south was excavated towards the eastern end of the trench to expose and investigate a 1.20m length of a stone lined drain or culvert (figure 16).

6.17 The stone structure (E004) was the earliest feature in the sequence of construction. Cut into the natural clay subsoil it took the form of a stone lined and capped channel with an internal width of between 12cm and 16cm at this point and a depth of 15cm (the base was not exposed but it was probably also stone). The feature was overlain and sealed with a deposit of stiff purple-red stony clay (E003), redeposited natural with a maximum depth of 15cm.

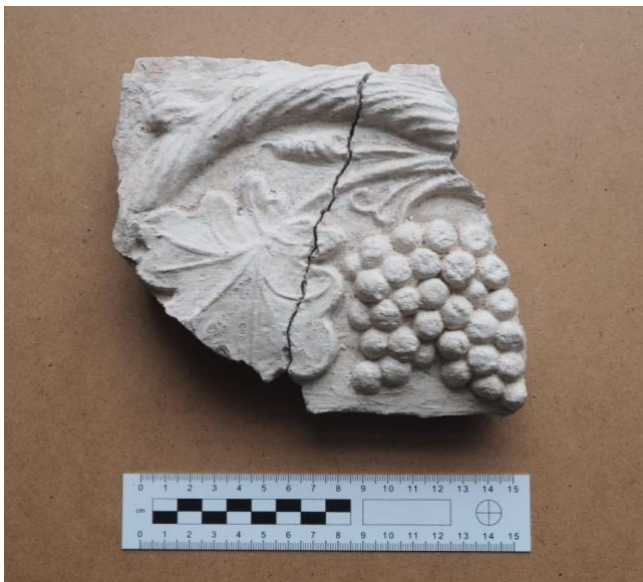
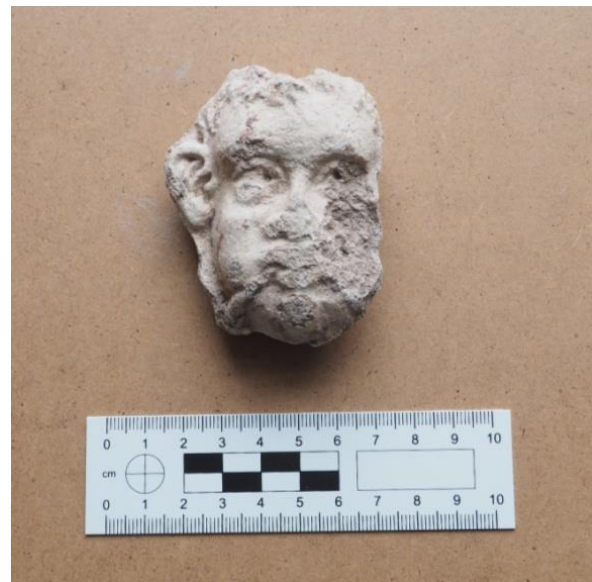
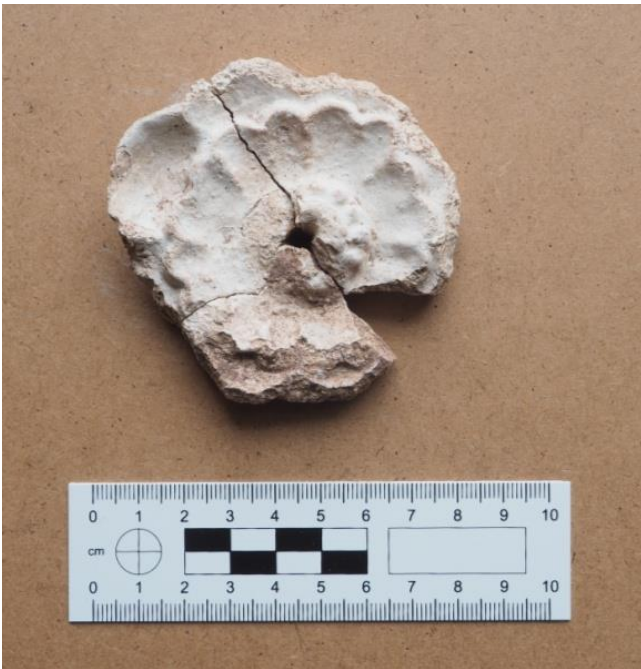
Figure 19: Vine and grapes cornice fragment

Figure 20: Moulded plaster head. The vines trailing from the mouth are suggestive of a Green Man

Figure 21: A flower (perhaps a Rose) ceiling boss

7.7 Significant quantities of decorated plaster have come from Trenches A and D. These include egg and dart cornices or dados and parts of a vine and grapes cornice, a moulded head with vines trailing from the mouth and a flower ceiling boss (figures 19, 20 and 21).
