CPAT Report No. 1585

Montgomery 11kV Overhead line rebuild

Archaeological Watching Brief

Project Name: Montgomery 11kV Overhead line rebuild

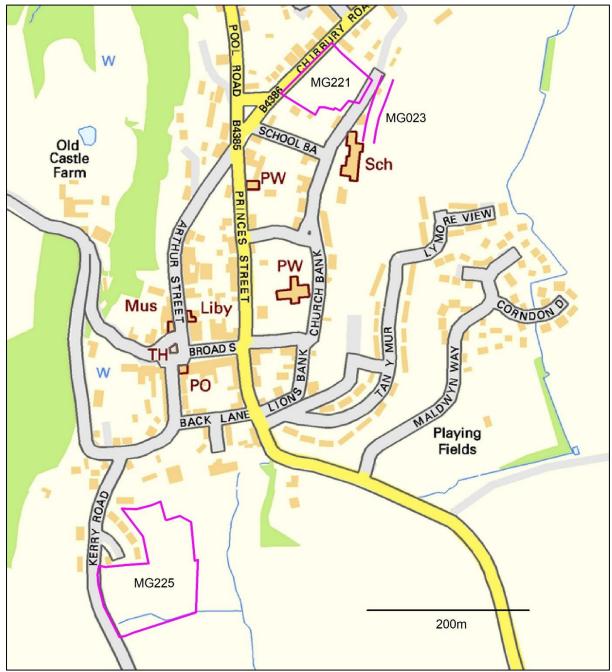
Fig. 1 Location of the scheduled areas (marked in purple) impacted upon by the overhead line rebuilding scheme

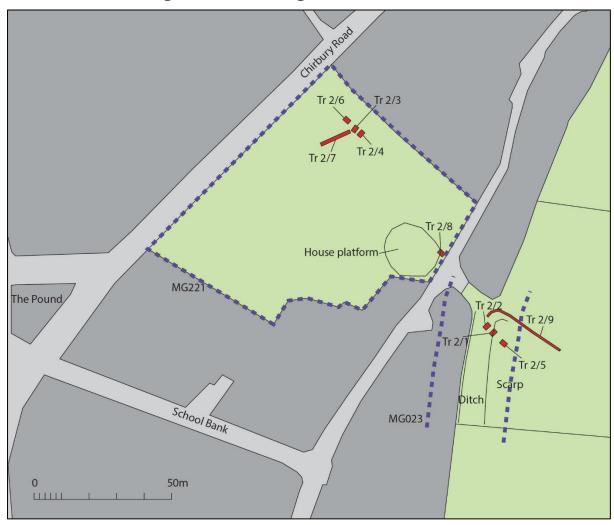
Fig. 2 Plan showing locations of groundworks in Scheduled Areas MG221 and MG023

2.1. This section of the medieval town defences was located on the crest of ridge running to the east of the town (Fig. 2). It was separated from the section running through the field (MG221) by the associated defensive bank and a narrow lane running parallel to it. The defences had previously been cut through at the point where the groundworks had been carried out to allow access to the farmland to the south-east via the lane. A watching brief was carried out on the 29th and 30th of May 2018, concurrently with that carried in the adjacent area (MG221).

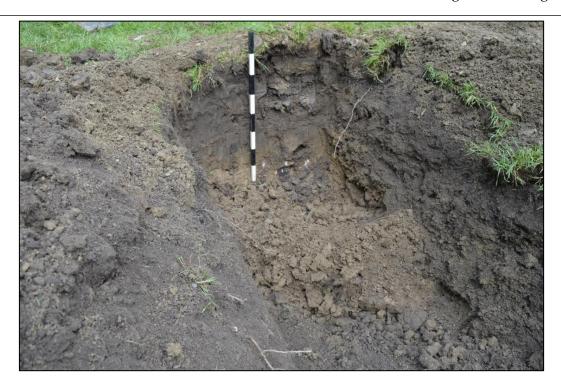
Fig. 3 South facing section through medieval ditch in Trench 2/2 Photo CPAT 4499- $\,\,$ 0022

2.2. Soil deposits outside of the ditch comprised a topsoil deposit, 0.3m thick, overlying a stony subsoil, >1.5m thick. Underlying the topsoil within the ditch was a reddish brown silt deposit, 0.3m thick, comprising a disuse or silting fill, rather than a deliberate backfill deposit. Two undiagnostic iron fastenings were recovered from this fill, which contained no obviously later artefacts, as were recovered from the overlying topsoil.

- 3.2. Archaeological remains recorded within the town ditch forming part of the eastern defensive circuit comprised a distinct fill, underlying the topsoil. Finds recovered from this deposit were undiagnostic and unhelpful in dating the fill, which was believed to have occurred by silting rather than deliberate dumping or backfill.

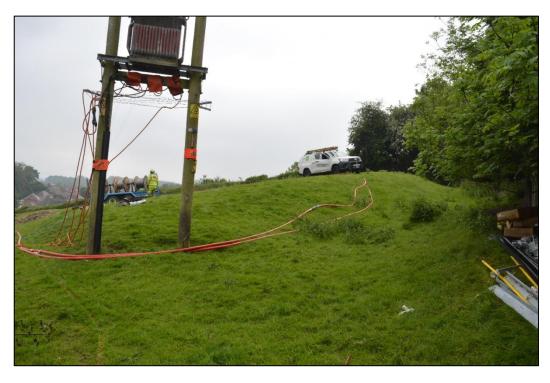
Fig. 4 View from the north showing the existing overhead line installation, defensive ditch and scarp Photo CPAT 4499-0014

- 3.3. Groundworks in this area were excavated through the existing field entrance cut through the bank and scarp. The new pole installation was located in this entrance in a similar position as the existing H-shaped pole within the ditch, causing minimal disturbance to the structure and fill of the ditch. No significant damage was caused to the ditch or the scarp during the course of this work.

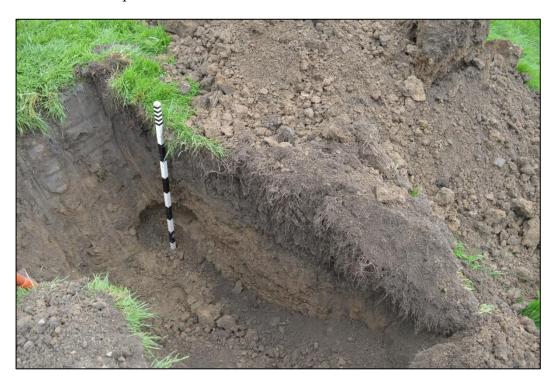
- 2.3. The watching brief on groundworks within an open field to the south of Chirbury Road (MG225) was carried out on the 29th and 30th of May 2018. Three pole trenches and a trench for a stay were excavated within this area, in addition to open-cut trenching to install an earth cable and connect the overhead lines an existing underground powerline (Fig. 2).
- 2.4. Two soil deposits were identified, extending across the entire area. The topsoil was 0.5m in thickness at the top of the bank to the south-east of the area, and 0.3m at the base of the slope. The subsoil was excavated to >1.4m.

Fig. 5 North-east facing section of Trench 2/6 Photo CPAT 4499-0028

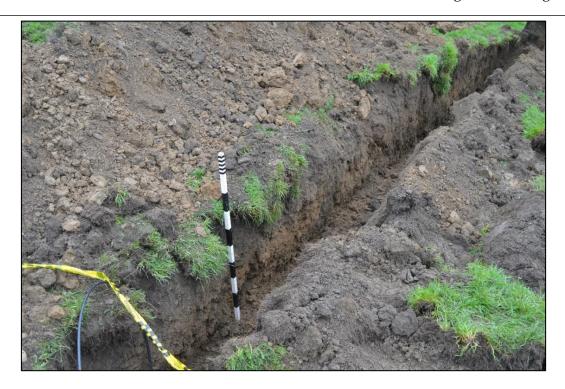
Fig. 6 View from the north along cable Trench 2/7 Photo CPAT 4499-0032

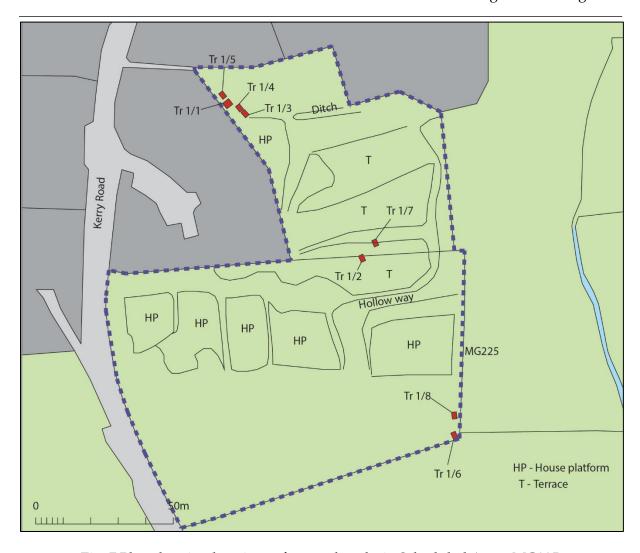
Fig. 7 Plan showing locations of groundworks in Scheduled Areas MG225

- 2.5. The watching brief on groundworks within the area of farmland to the south of Kerry Gate (Fig. 7) was carried out on the 15th of May 2018. The groundworks comprised open area trenching at the north end of the area to reveal the buried cables supplying the overhead lines, and a series of small trenches to install 4 new wooden poles and stays.
- 2.6. Trenching at the northernmost end of the area revealed topsoil deposition, 0.35m thick. Underlying this was a clayey silt subsoil deposition 0.7m overlying weathered bedrock deposition to >0.75m.

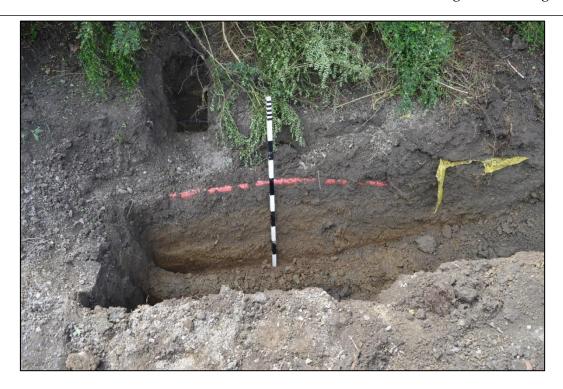
Fig. 8 East-facing section of Trench 1/5 Photo CPAT 4499-0011

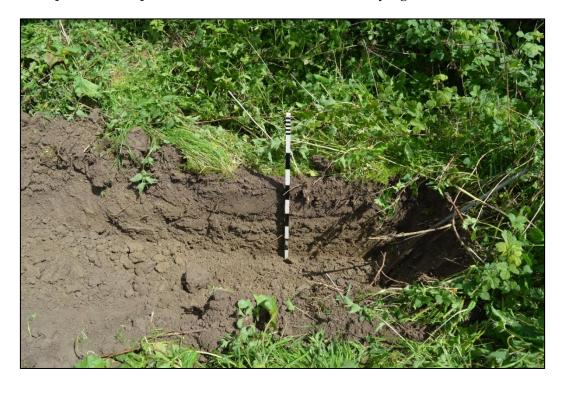
- 2.7. Around 75m to the south of this a pole and stay were removed on an old hedgeline that had reverted to mature trees. Excavations here revealed very deep topsoil deposition, 0.75m thick, overlying subsoil, 0.55m thick, on top of the bedrock 0.55m thick.
- 2.8. Around 70m to the south a second pole was removed on a field boundary. Topsoil deposits in this part of the site were 0.3m thick, overlying subsoil >1.5m in thickness.

Fig. 9 East facing section of trench 1-8 Photo CPAT 4499-0013
