# Pont y Pairl Betws y Coed

## Archaeological Watching Brief

Prosiect Rhif / Project No. G2587

Adroddiad Rhif / Report No.1460

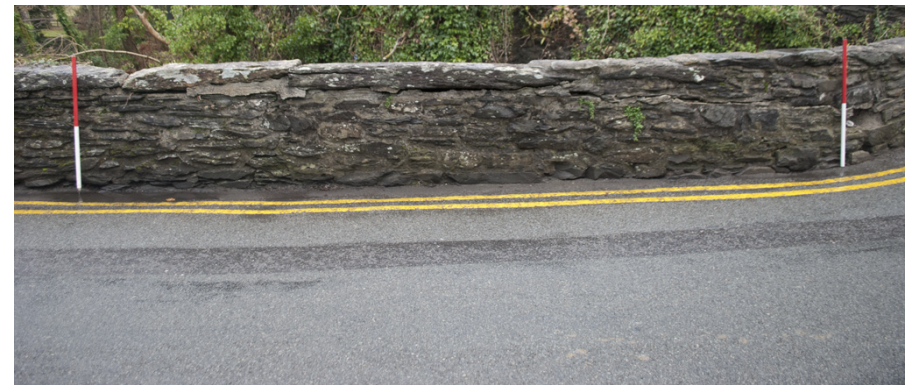
Figure 02: Southeast facing elevation of Pont-y-Pair Bridge detailing damage and existing repair. Scale as shown

An initial pre-works site visit was carried out on 11<sup>th</sup> January 2019, when the damaged areas of the bridge parapet on the northwest facing side of the southeast corner, and the area at the northwest corner of the site were examined. The parapet wall was repaired under watching brief conditions on 14<sup>th</sup> and 15<sup>th</sup> January 2019. In the case of the southeast corner of the parapet, damage along a 5m length was observed, a diagonal crack having been created in the mortar running top left to bottom right caused by a vehicle strike on the bridge (Plates 2-3, 5-6) along with one large stone having become detached from the parapet walling (Plate 7). Much evidence for the previous repair and reconstruction of the parapet in this area was noted, with the use of modern cement mortar in the previous repairs, and the presence of drainage pipes through the parapet were noted on the riverward side (Plate 6). The parapet was noted to be about 0.9m high above the current carriageway, and to consist of larger stones, up to 0.5m by 0.15m in the lower courses towards the base. The coping stones, of local grey schist, were up to 3.4m in length, and 0.15m thick. The width of the parapet varies between 0.38m and 0.5m, and is at its narrowest at the southeast corner where the damage had taken place. A drawing was produced of the damaged section of walling (Figure 02).

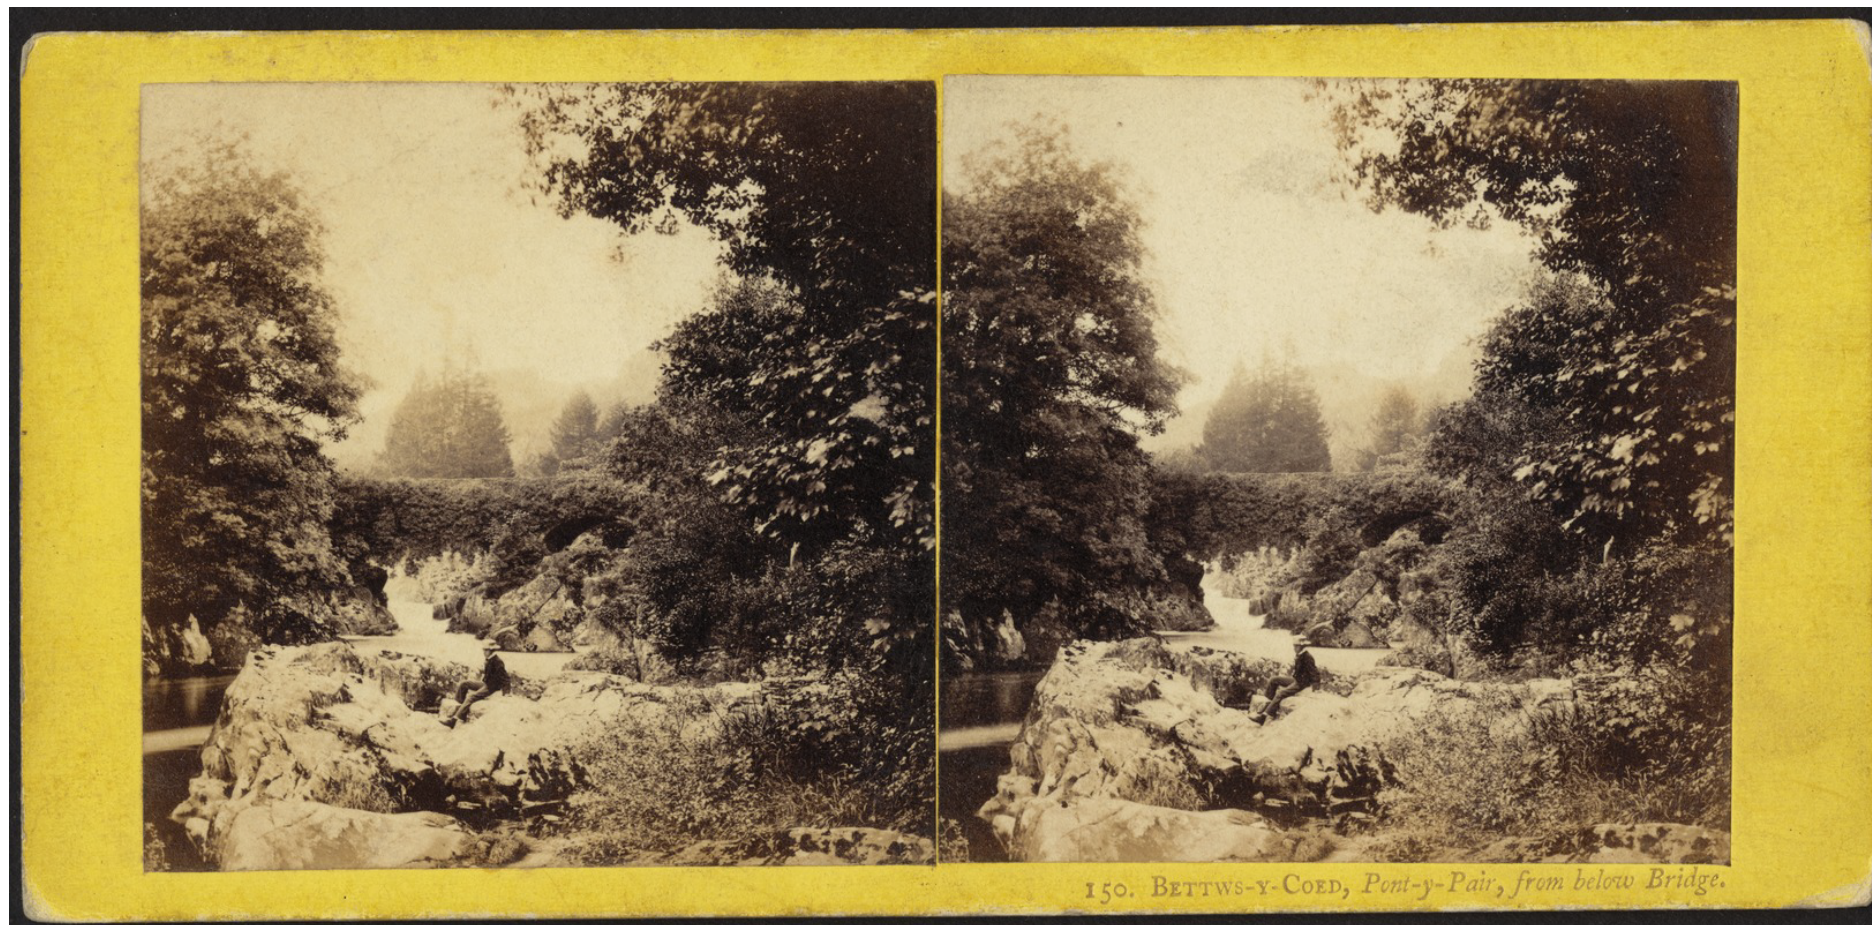
150. BETWS-Y-COED, Pont-y-Pair, from below Bridge.

Figure 03: Late 19th century stereographic Image of Pont-y-Pair, Betws-y-Coed showing the Bridge covered in Ivy in the middle ground.

walling was of irregular local fieldstone masonry, including some large blocks to the lower courses (Plate 8). The coping stone was reset and the wall repointed in this area on 15<sup>th</sup> January 2019, with a number of the stones below the coping stone having to be reset due to the lack of bonding with other stones (Plate 17), the bonding material having been pushed out by the expanding ivy, which was dominant on the riverward side (Plate 19). This dominance of ivy over the parapet has clearly been an issue in historic times, and may help to explain the repeated re-mortaring of the parapet that has been noted. The bridge is shown enveloped with ivy on a late 19<sup>th</sup> century stereograph (Figure 03).

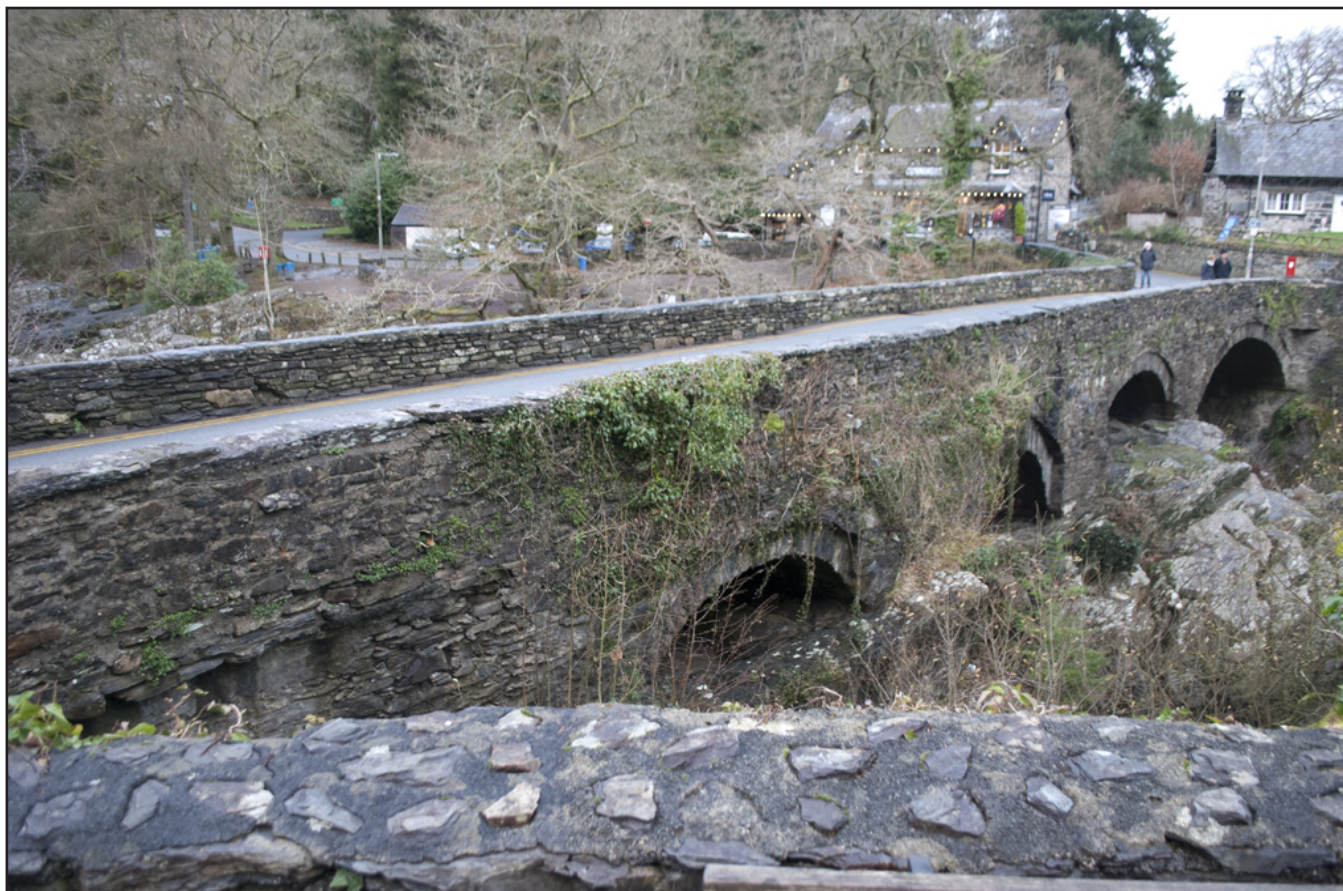
Plate 1: General view of Pont y Pair showing the side elevation with arches, reveals and voussoirs; scale: not used (archive reference: G2587\_006).

Pont-y-Pair Bridge carries the old road to Llanrwst and Conwy across the Afon Llugwy at Betws-y-Coed and is thought to date to the late 15<sup>th</sup> century. It is approximately 45m long and 5m wide. The bridge is constructed with five irregular segmental arches, some of which are built directly onto exposed bedrock (Plates 1, 6, 20). The middle arch, the widest of the five, spans the Afon Llugwy (RCAHMW 1956, 22). The section of the river over which Pont y Pair crosses was described by Edmund Hyde-Hall in 1811 as *'the Llugwy displays itself both above and below the bridge, either circling in boiling basins or dashing itself down from rock to rock in frequent leaps'* (Hyde-Hall 1952, 131; Figure 03). Samuel Lewis in 1833 described the area thus *'and over the latter is a bridge of singular construction, called Pont y Pair, consisting of four arches resting upon masses of rugged precipitous rocks of romantic appearance, which in high floods exhibit below the bridge several beautiful cataracts of striking magnificence. This picturesque structure was projected and partly raised by one Howel, a mason from Penllyn, who, about the year 1468, had previously erected a bridge over the Lleder, at a spot where his passage had been obstructed by a flood, whilst on his journey to Aberconway, to attend the Merionethshire assizes, to which place he removed, and, having built the bridge at his own expense, received no other remuneration than the voluntary donations of travellers : he then removed to this place, where he commenced Pont y Pair bridge, but died before its completion. The scenery around this spot consists of rocky mountains fringed with wood, in the fissures of which are found trees of stately growth, and the whole neighbourhood abounds with strikingly magnificent and finely contrasted features'* (Lewis 1833, 81-88; Plates 20-21).

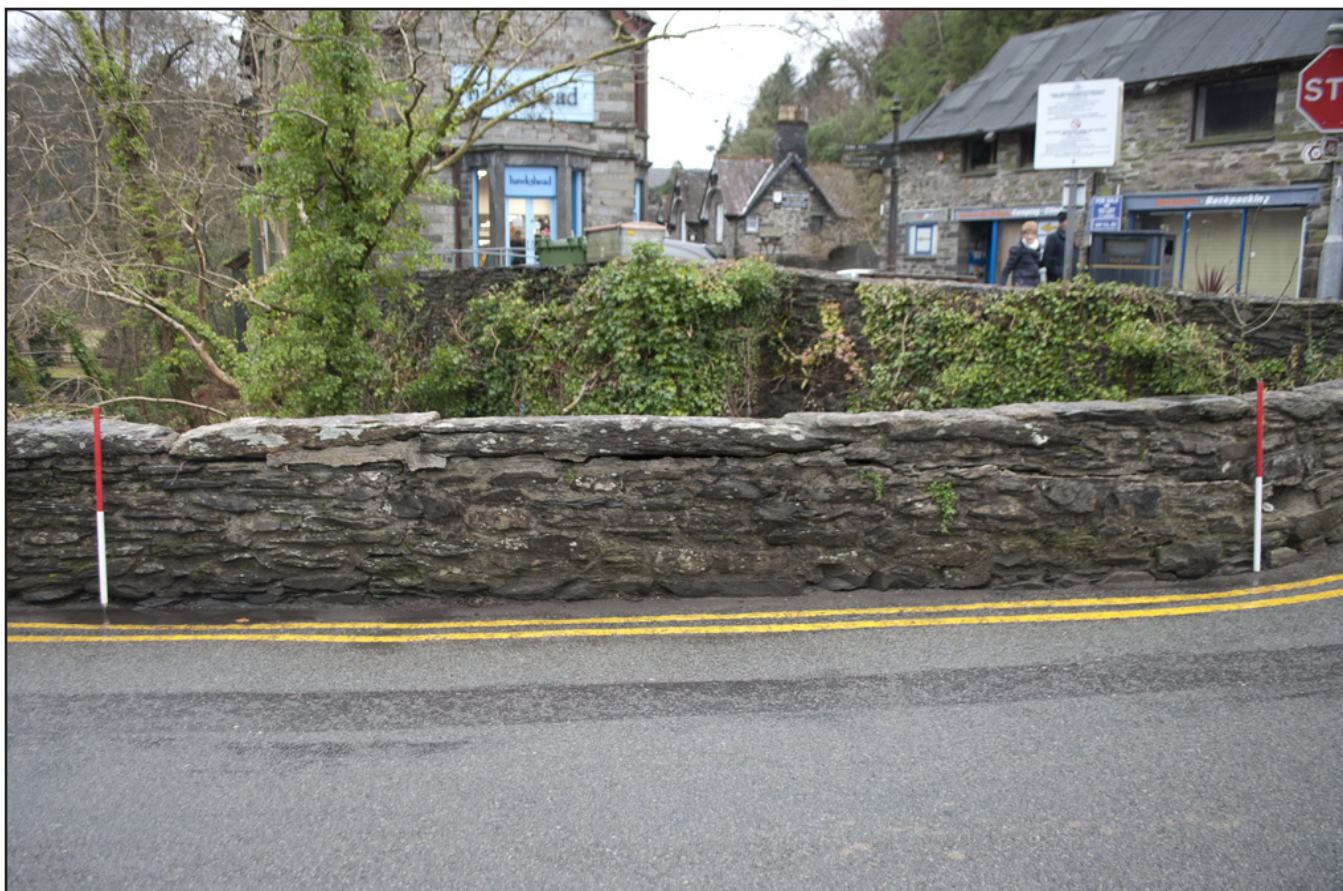
Plate 2: General view of damaged section of walling at southeast corner of Pont y Pair; scale: 2x1m (archive reference: G2587\_003).

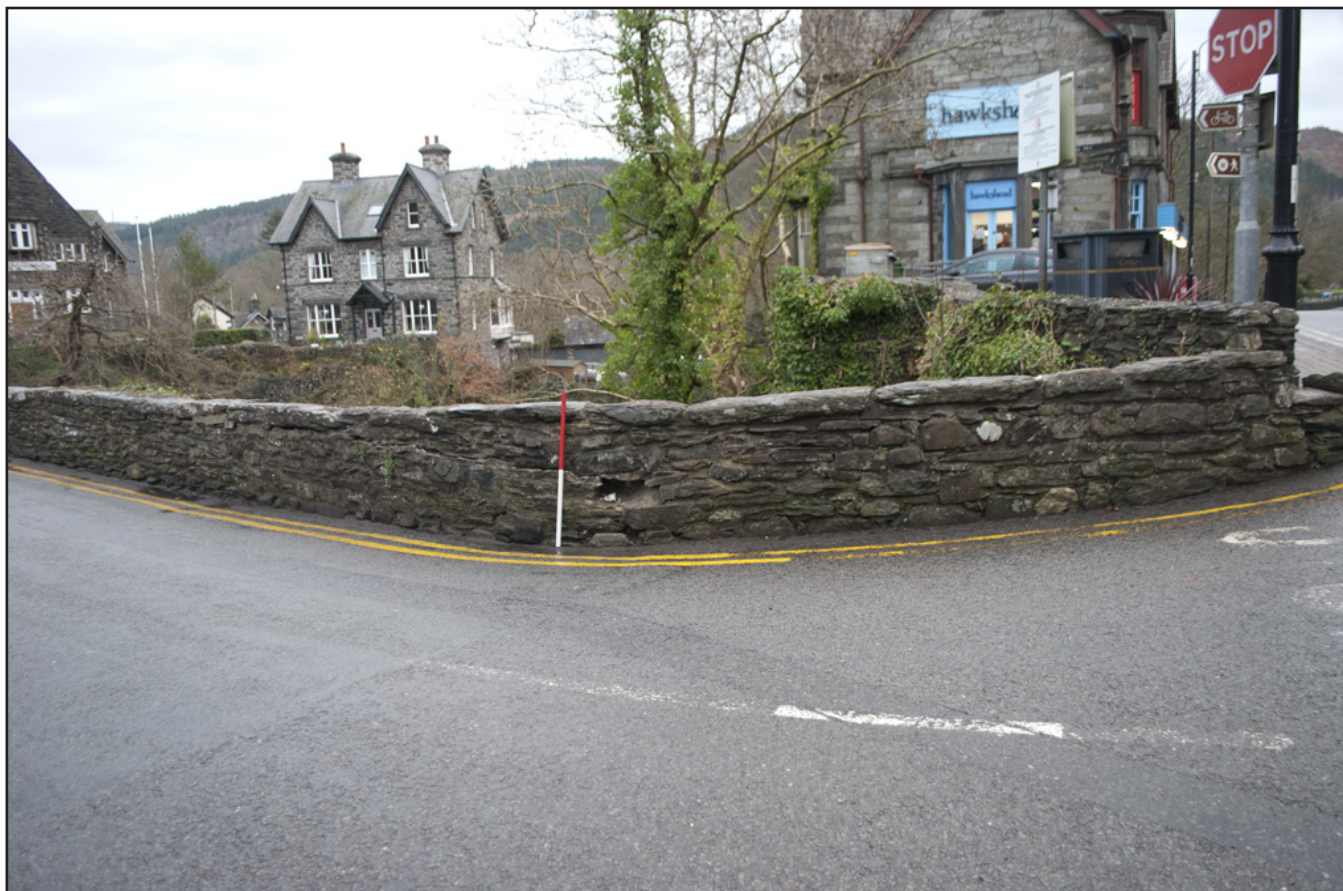
Plate 3: General view of damaged section of walling at southeast corner of Pont y Pair showing the splaying parapet from the A5 junction; scale: 2x1m (archive reference: G2587\_004).

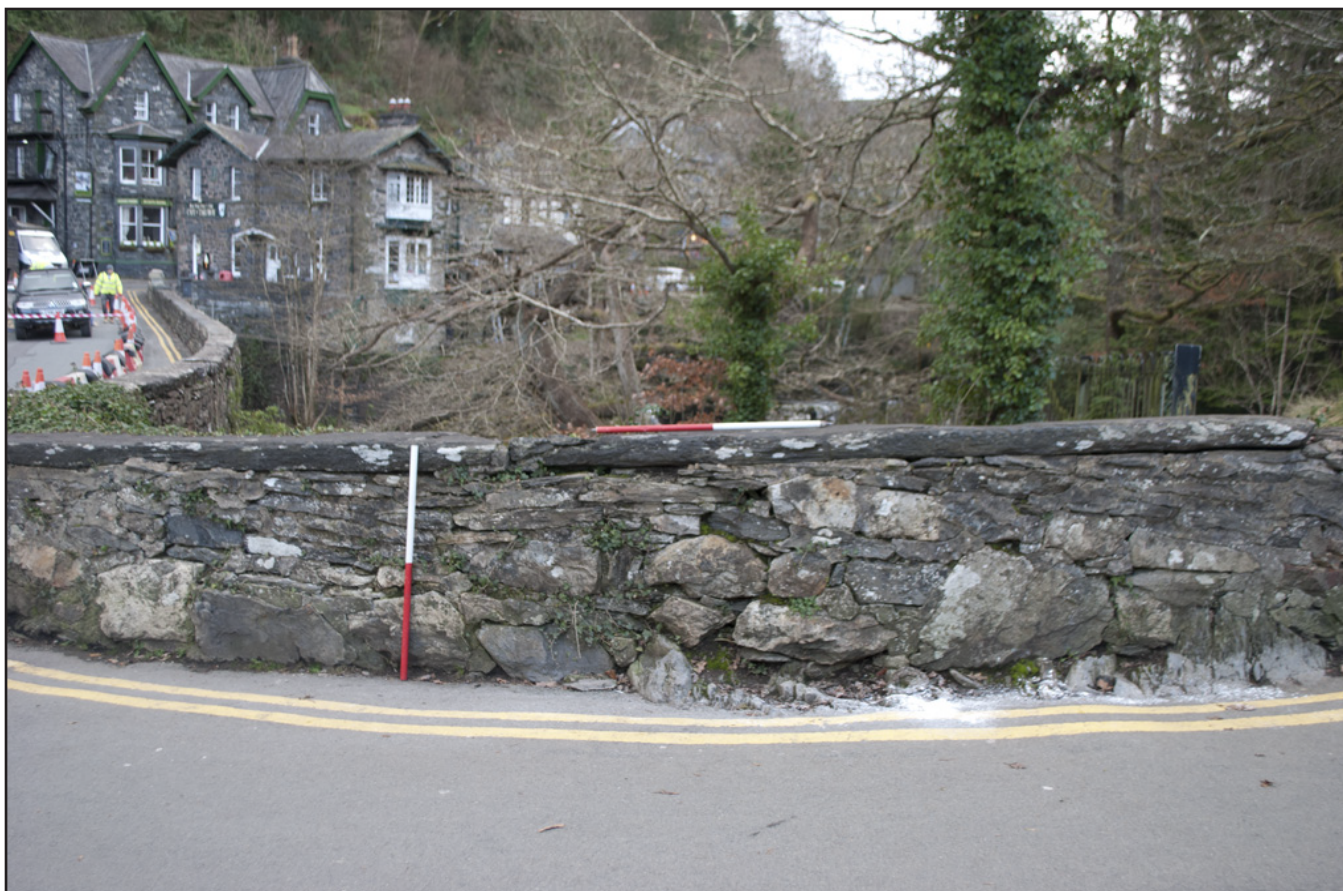
Plate 4: View of the northwest damaged coping stone area; scale: 2x1m (archive reference: G2587\_027).

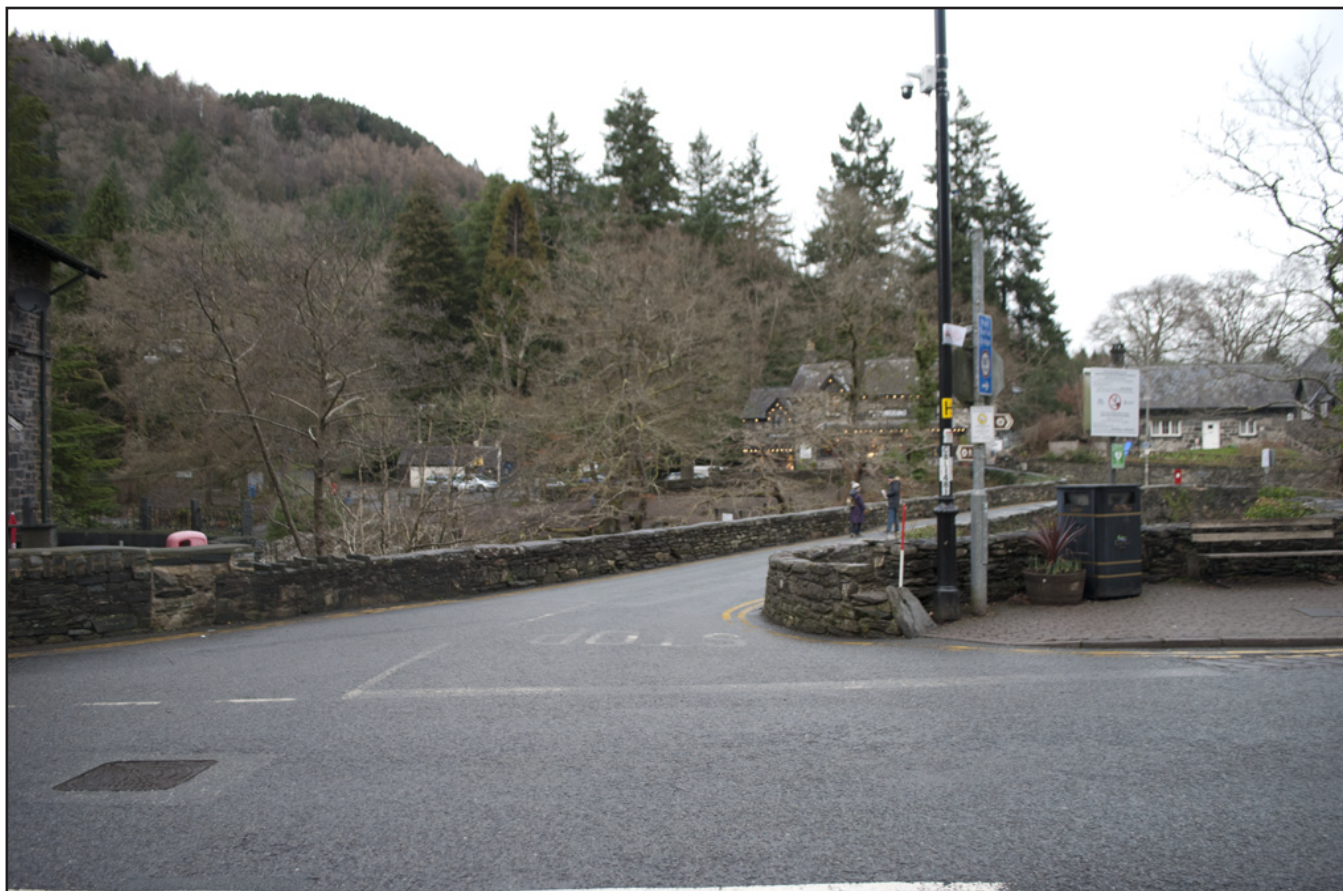
Plate 5: General view of Pont y Pair along the B5106 road from the A5 road, at the junction; scale: 1x1m (archive reference: G2587\_007).

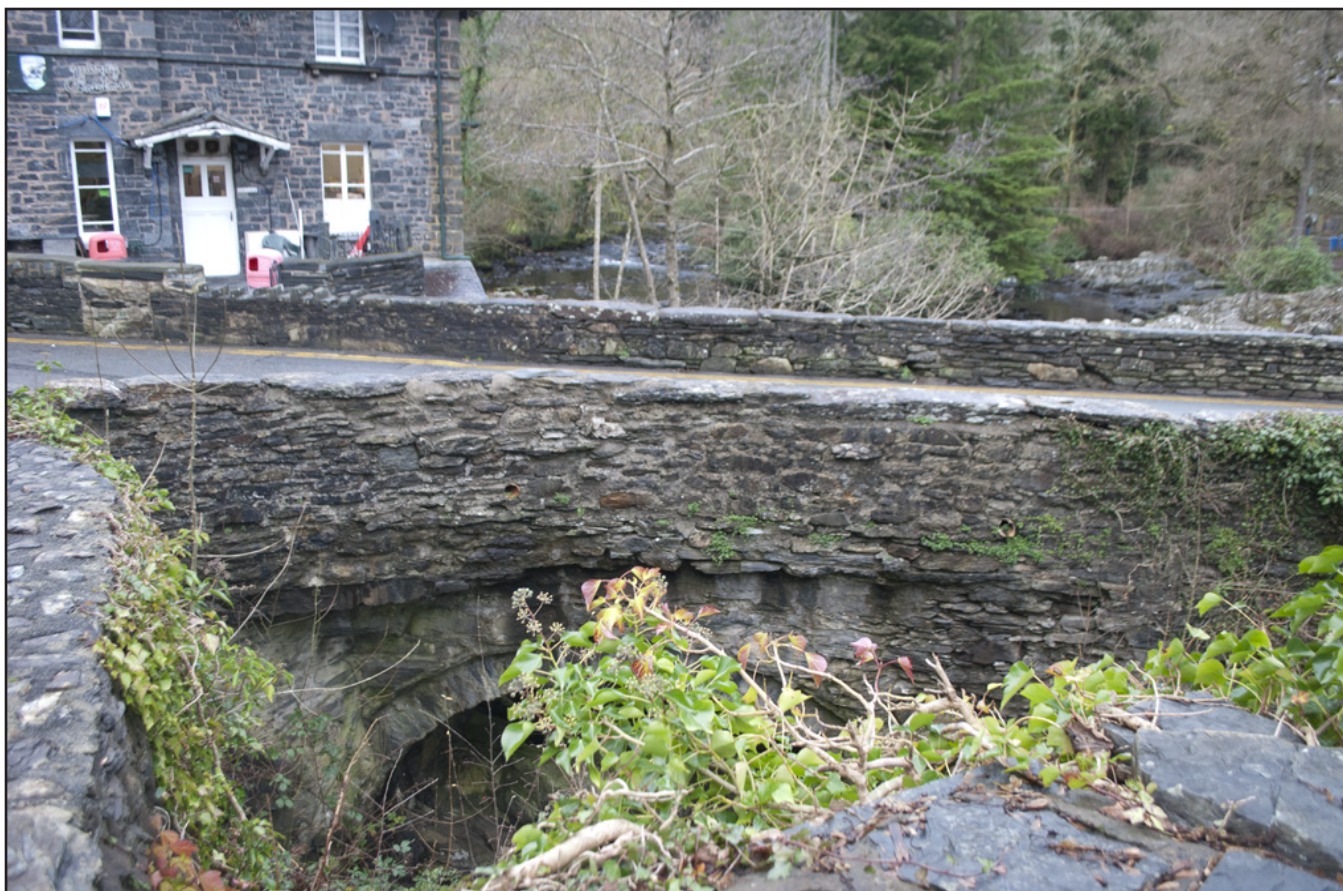
Plate 6: General view of damaged section of parapet wall; scale: not used (archive reference: G2587\_005).

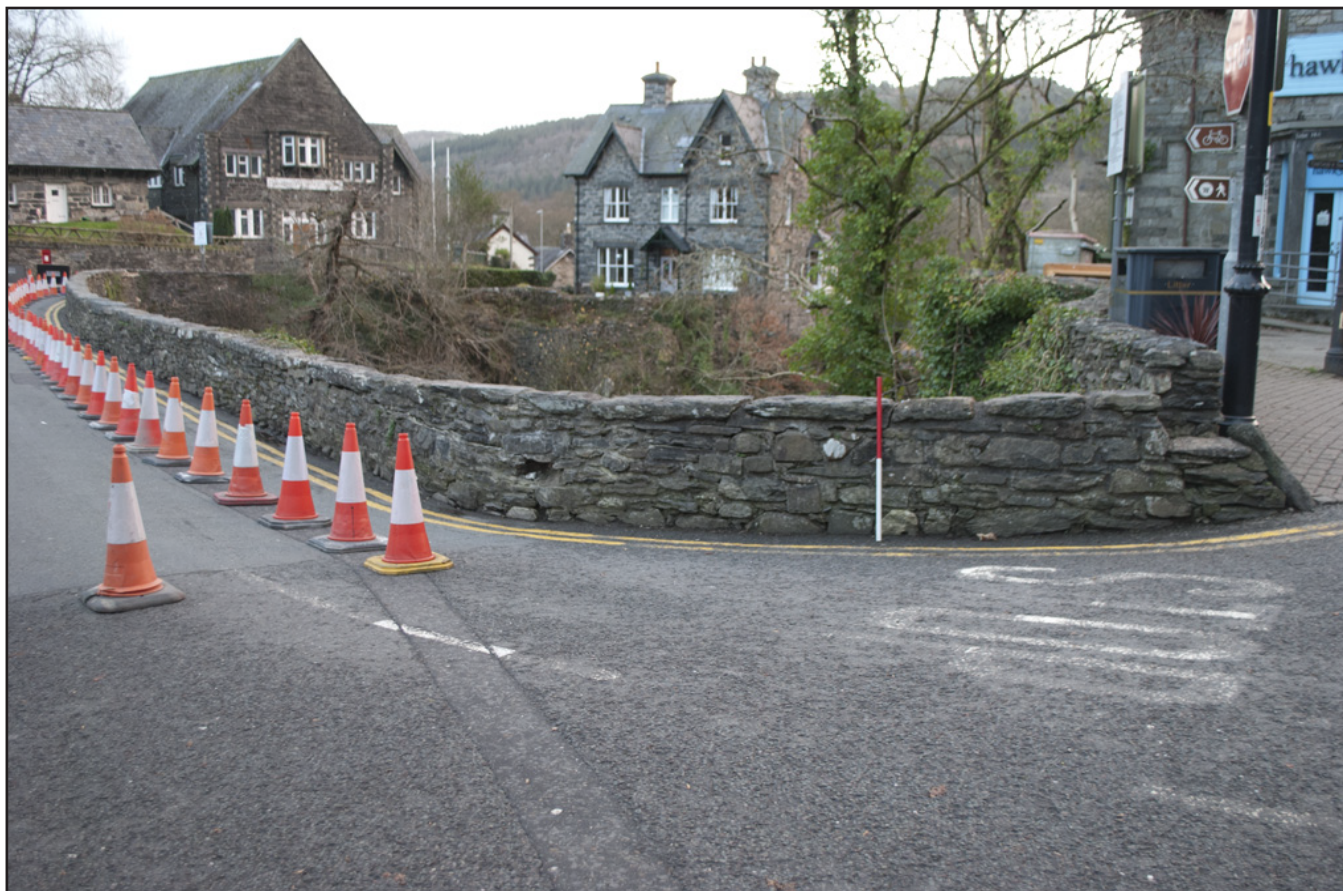
Plate 7: View of damage on splayed corner of the parapet walling to the southeast near junction with the A5 road; scale:1x1m (archive reference: G2587\_012).

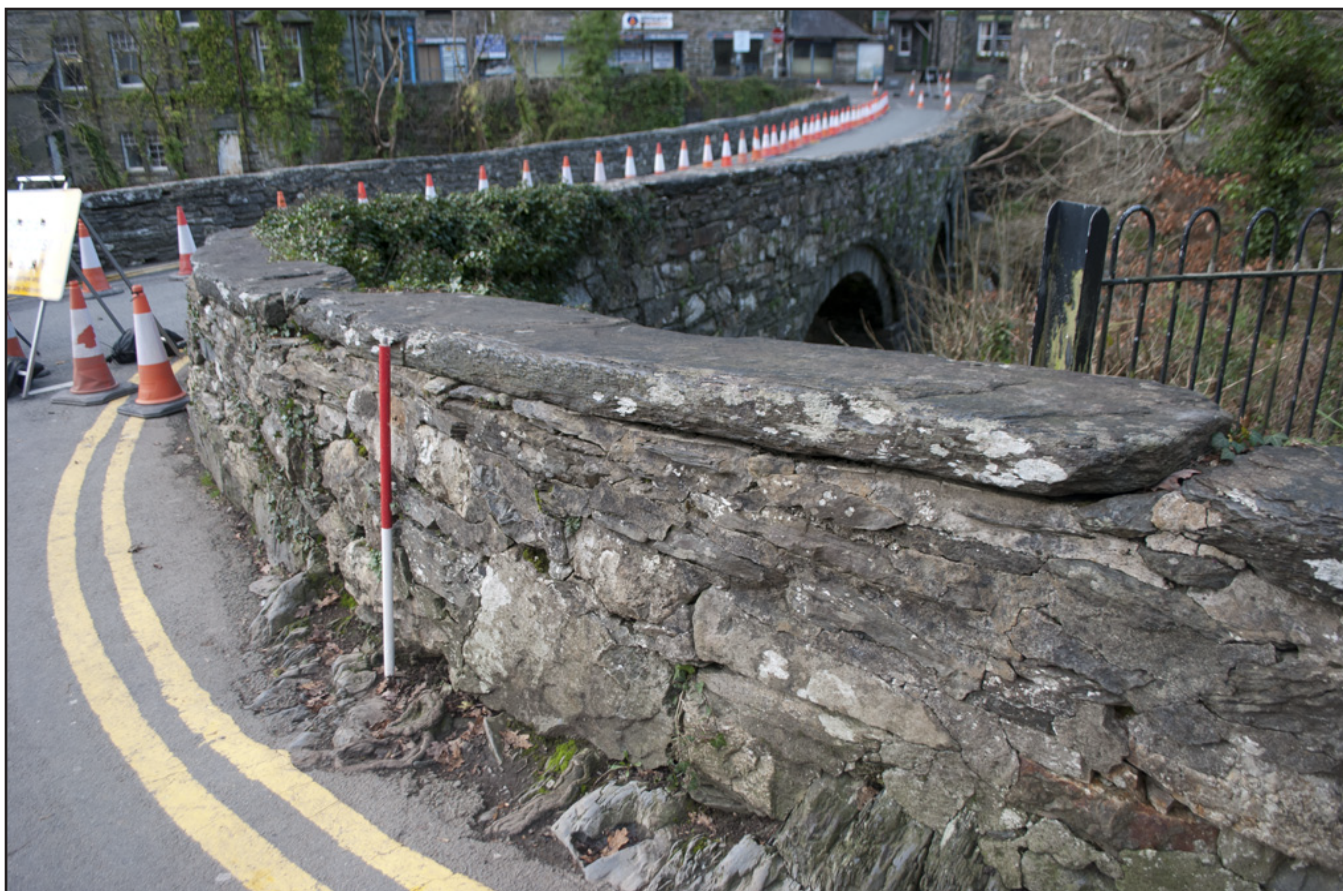
At the northwest corner of the site the coping had slipped and pushed over towards the river (Plate 8). The coping stone was of a very large size, was curved to the right, having been worked to fit it for its particular position on the curving of the parapet as it approaches the bridge crossing. It was 3.2m long, 0.5m wide and 0.12m thick (Plate 8). The roadside of the parapet in this location showed considerable evidence of previous repair, along with the use of modern cement mortar, and was in addition set on an outcrop of bedrock (Plate 4). On the riverward side the parapet was overgrown with ivy so details were hard to make out. The

Plate 8: View of slipped coping stone at the northwest corner of the bridge parapet walling; scale: 1x1m (archive reference: G2587\_016).

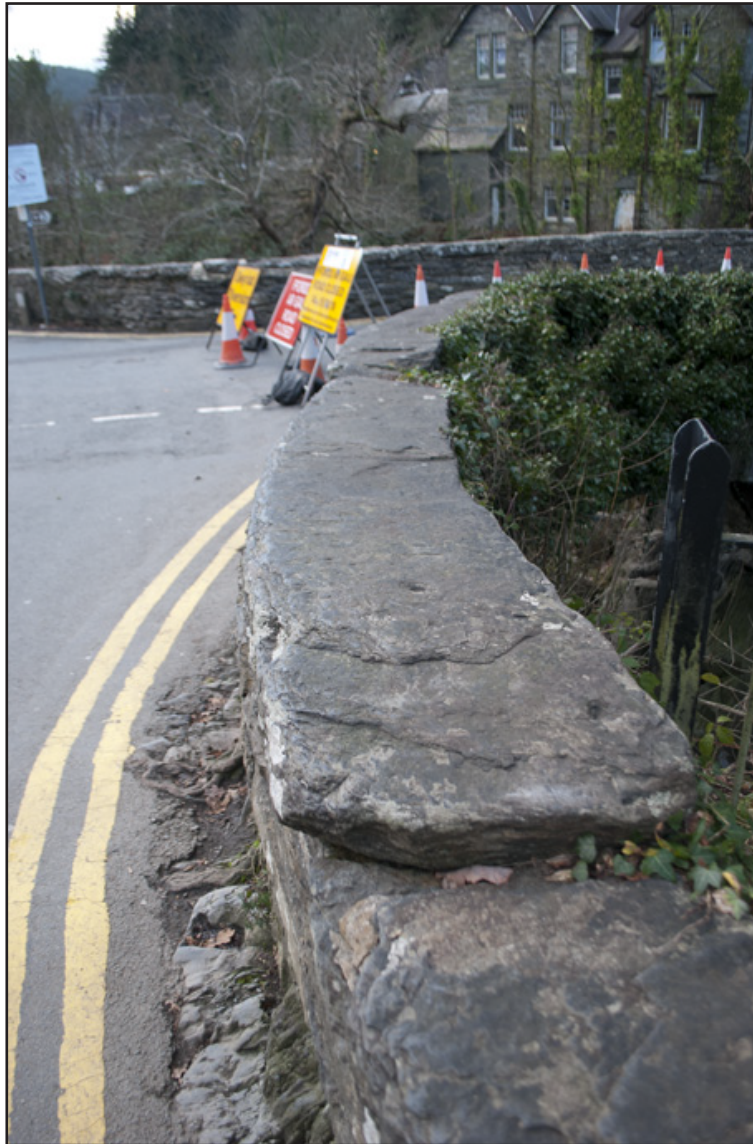
Plate 9: Detail of very large (3.2m long by 0.1m high) slipped coping stone; scale: not used (archive reference: G2587\_017).

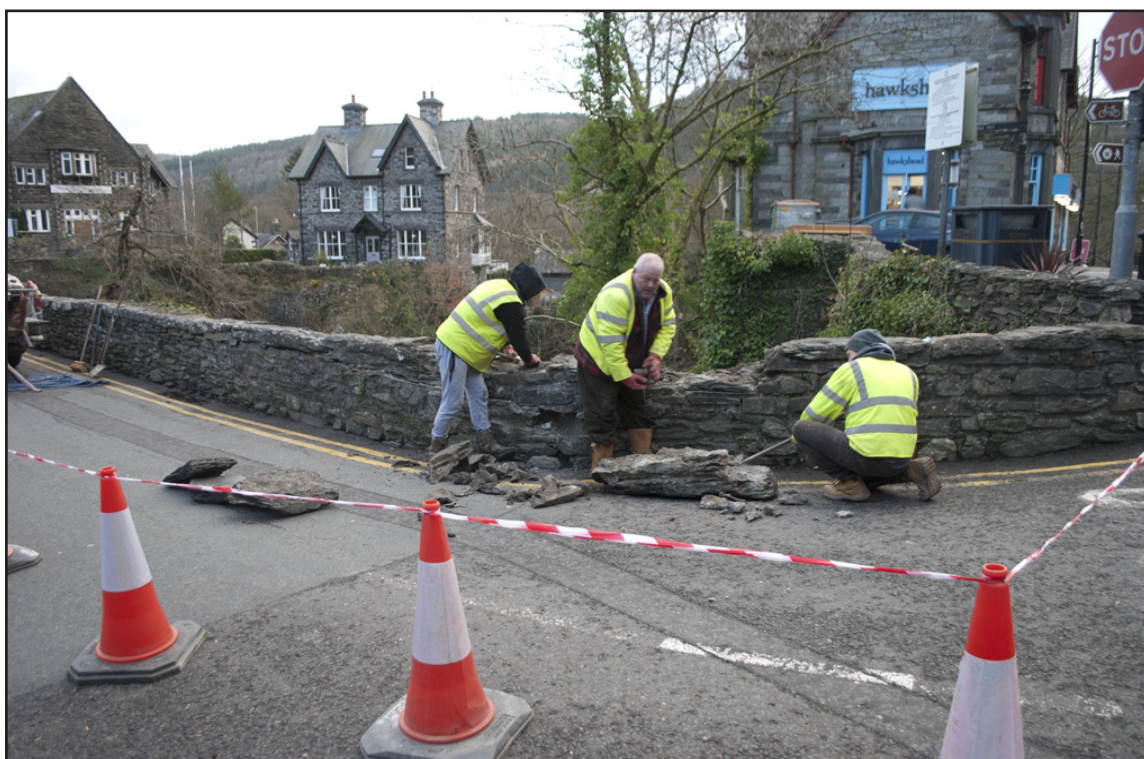
Plate 10: Action shot showing demolition work (by hand) taking place at the southeast corner of the parapet; scale: not used (archive reference: G2587\_020).

The demolition and rebuilding of this section of the parapet walling at the southeast corner (Plate 10), carried out on 14<sup>th</sup> January 2019, revealed elements of friable mortar in the core of the wall construction, but was mainly of modern cement render, indicative of significant modern repairs to the walling (Plate 11). Between the facing stones there was a rubble core of small stones and a very gritty lime mortar which was much more friable than that seen on the wall facings and contained a crushed coal/coke element within the matrix (Plate 16). The wall was rebuilt in a similar form to its previous appearance, using the agreed bonding mix and no stones were imported in its use, with the coping stones placed as close as possible to their original positions (Plates 12-15).

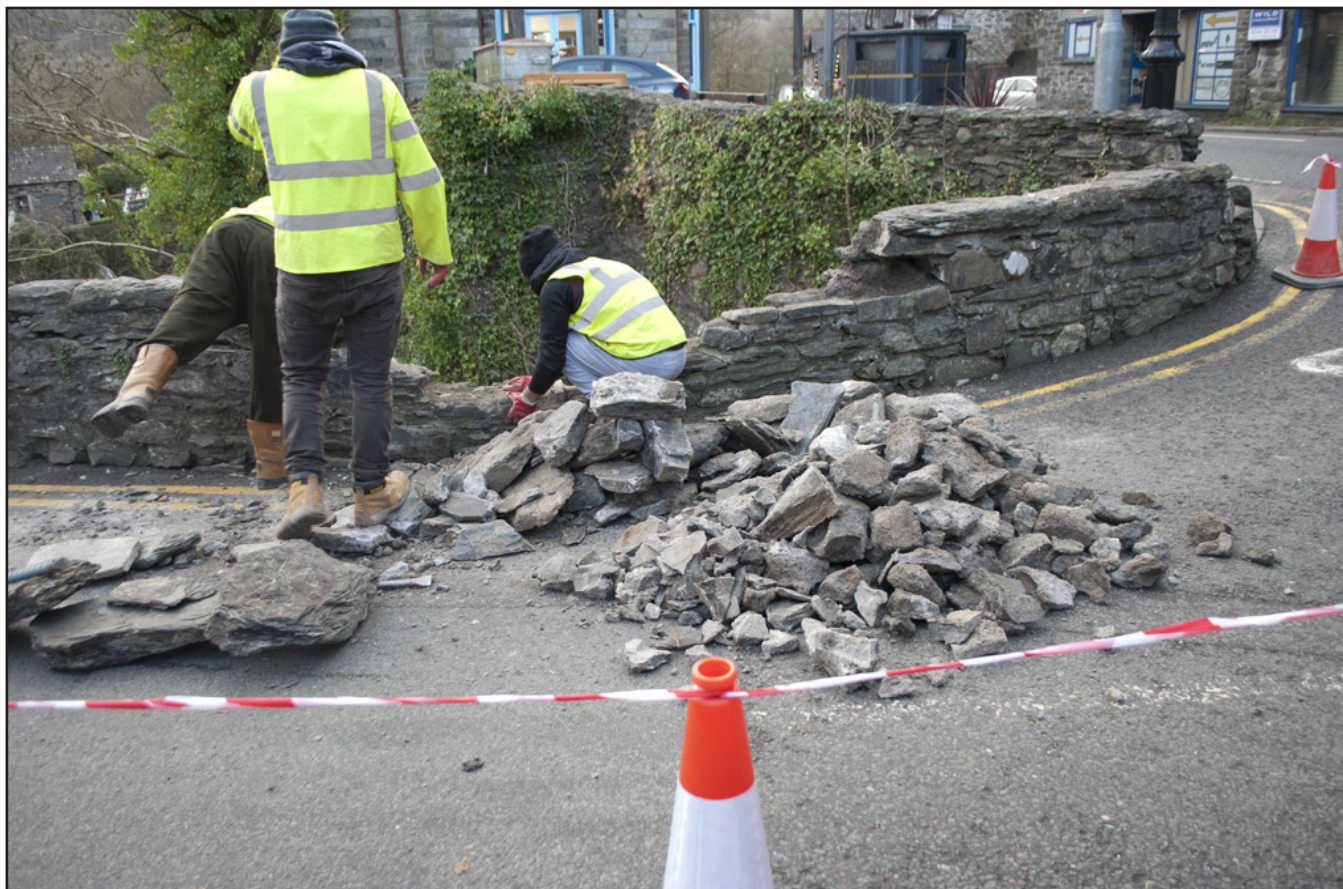
The parapet has clearly been substantially rebuilt on a number of occasions; in both the damaged areas examined this has involved the use of a hard cement mortar between the facing stones. There is also evidence of patch rebuilding, with the north western part of the parapet having a greater variety and mix of stones suggesting more frequent repair, although the limited amount of work carried out has meant that this has been only partially examined. The rebuilding work was carried out in accordance with the Cadw Scheduled Monument specification, with the correct bonding mix used, no imported stone used and the parapet coping replaced exactly as seen prior to the repair work. The coping stones, although reset numerous times, do appear to be an original feature.

Plate 11: General view during wall demolition showing the hard mortar (in a pile); scale: not used (archive reference: G2587\_023).

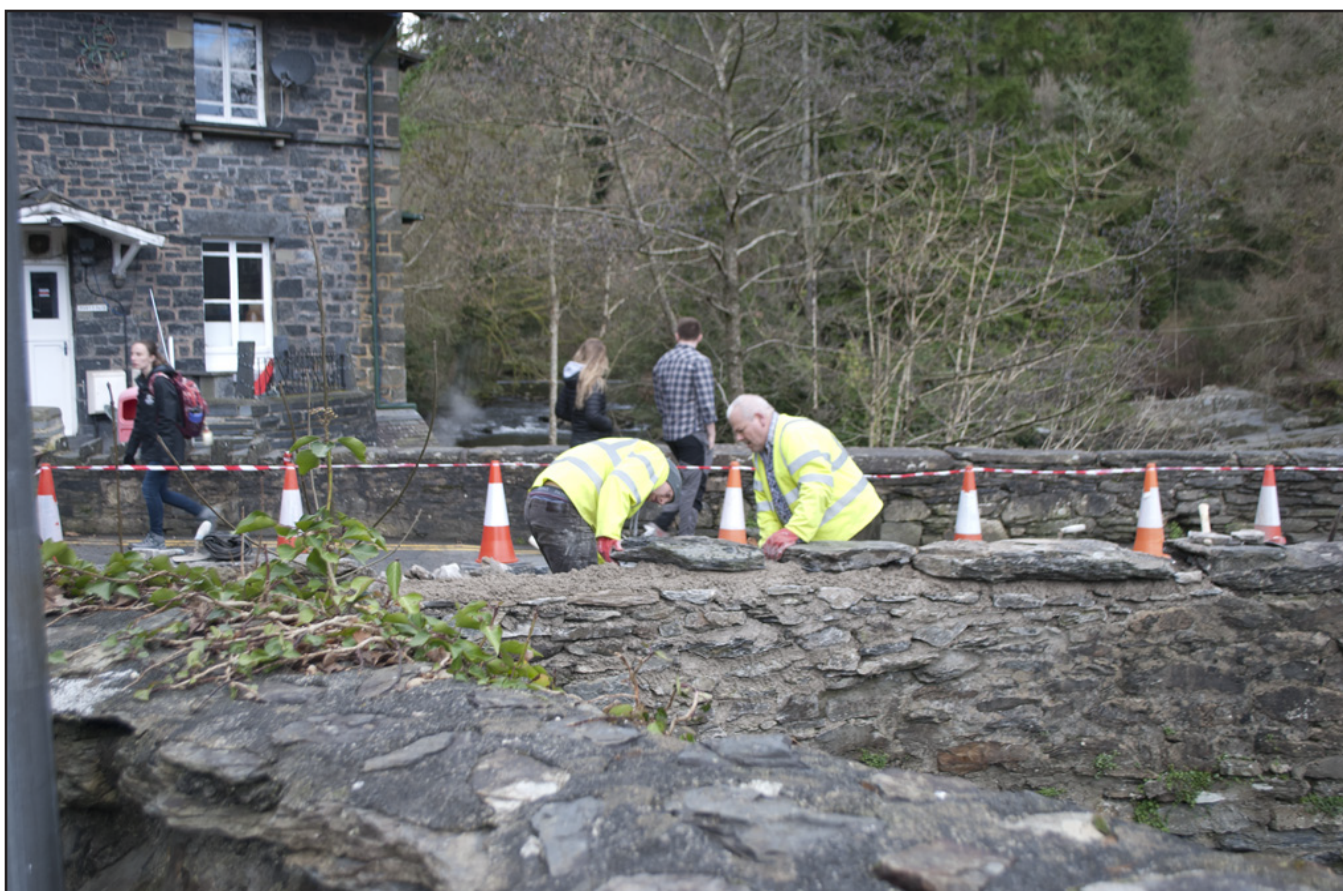
Plate 12: Placing capping stones; scale: not used (archive reference: G2587\_029).

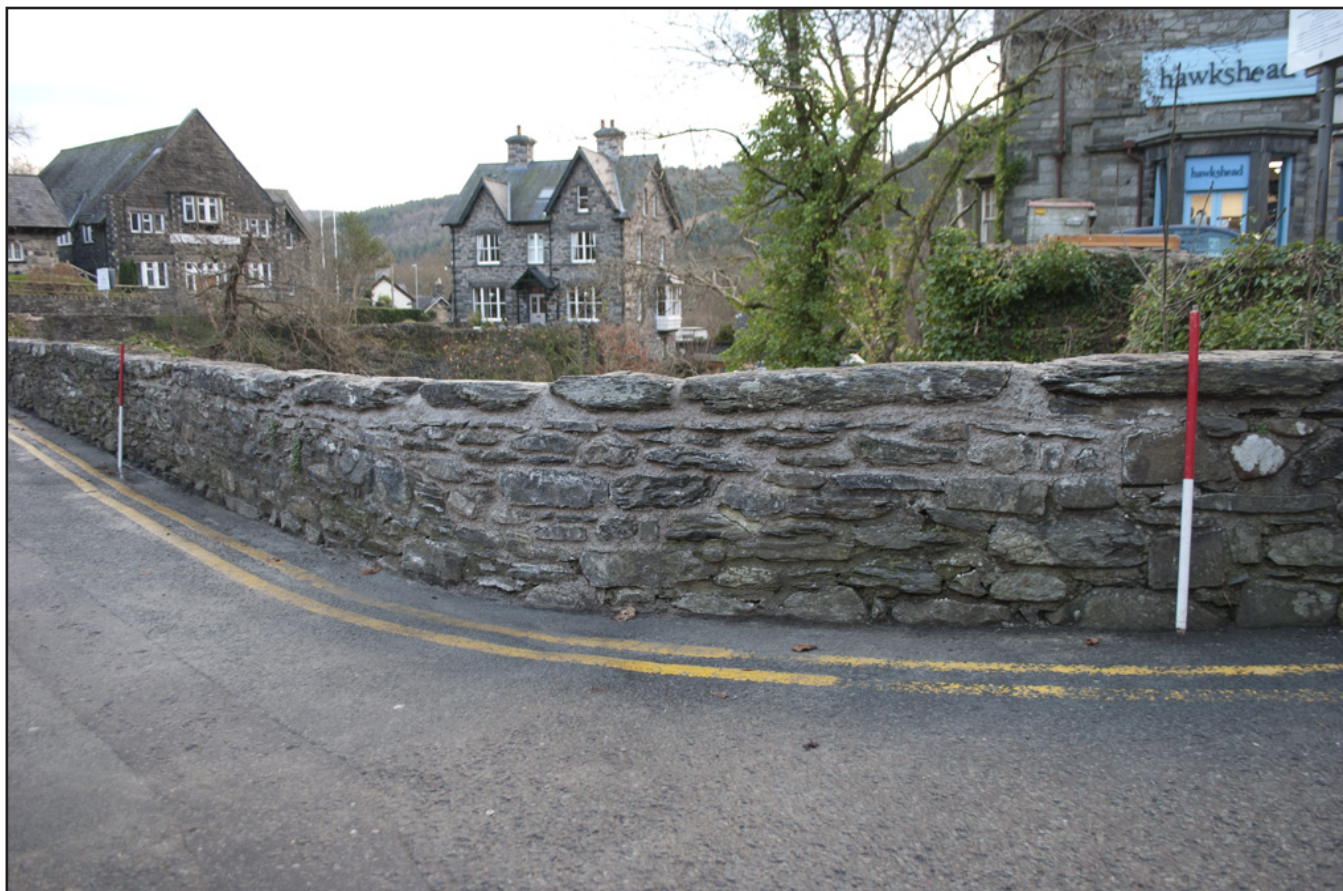
Plate 13: View of repaired southeast corner of the bridge parapet; scale: 2x1m (archive reference: G2587\_031).

With the parapet stones and copings replaced, the former appearance of the parapet was closely matched.

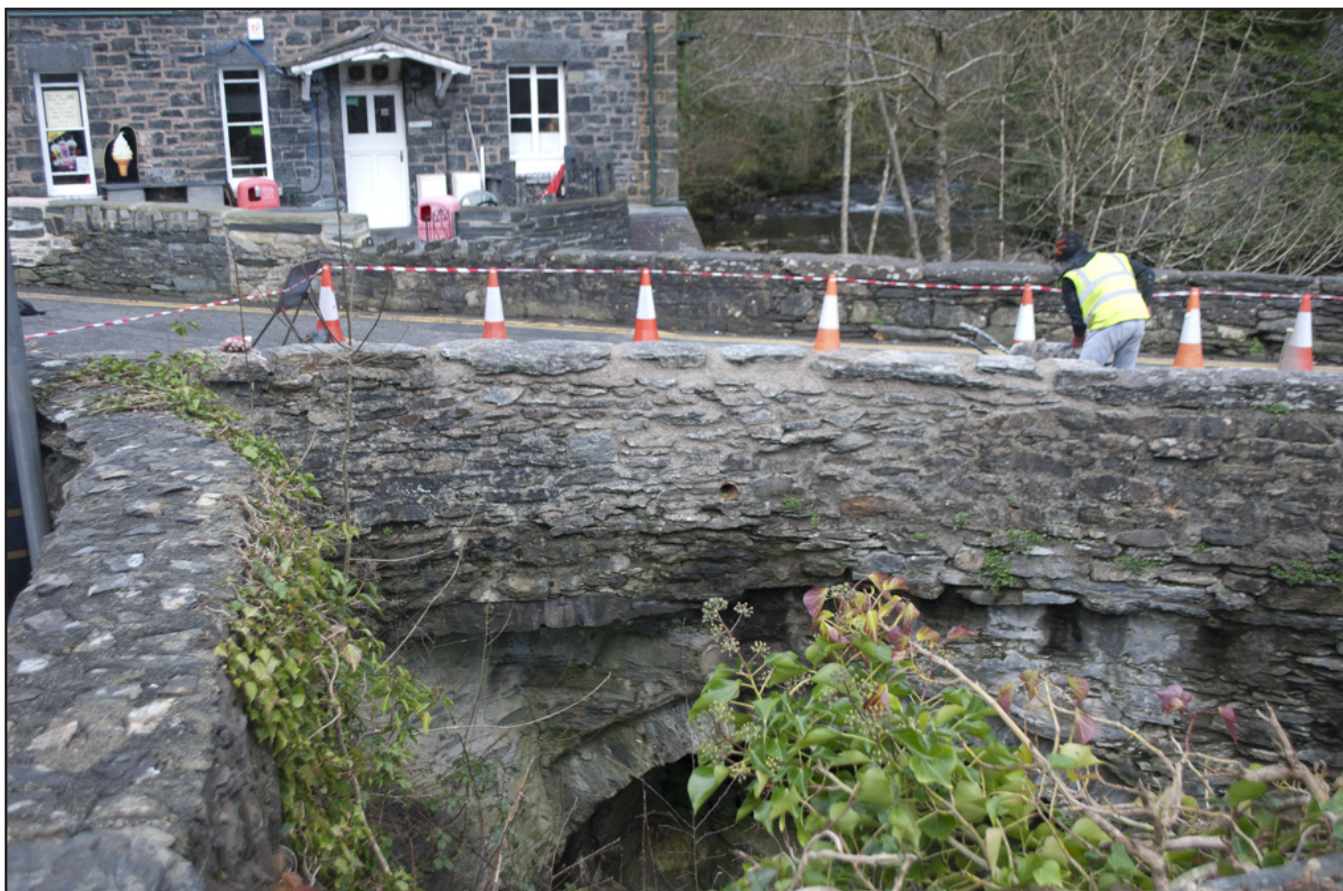
Plate 14: View of completed work to the southeast portion of the parapet from the riverside; scale: not used (archive reference: G2587\_030).

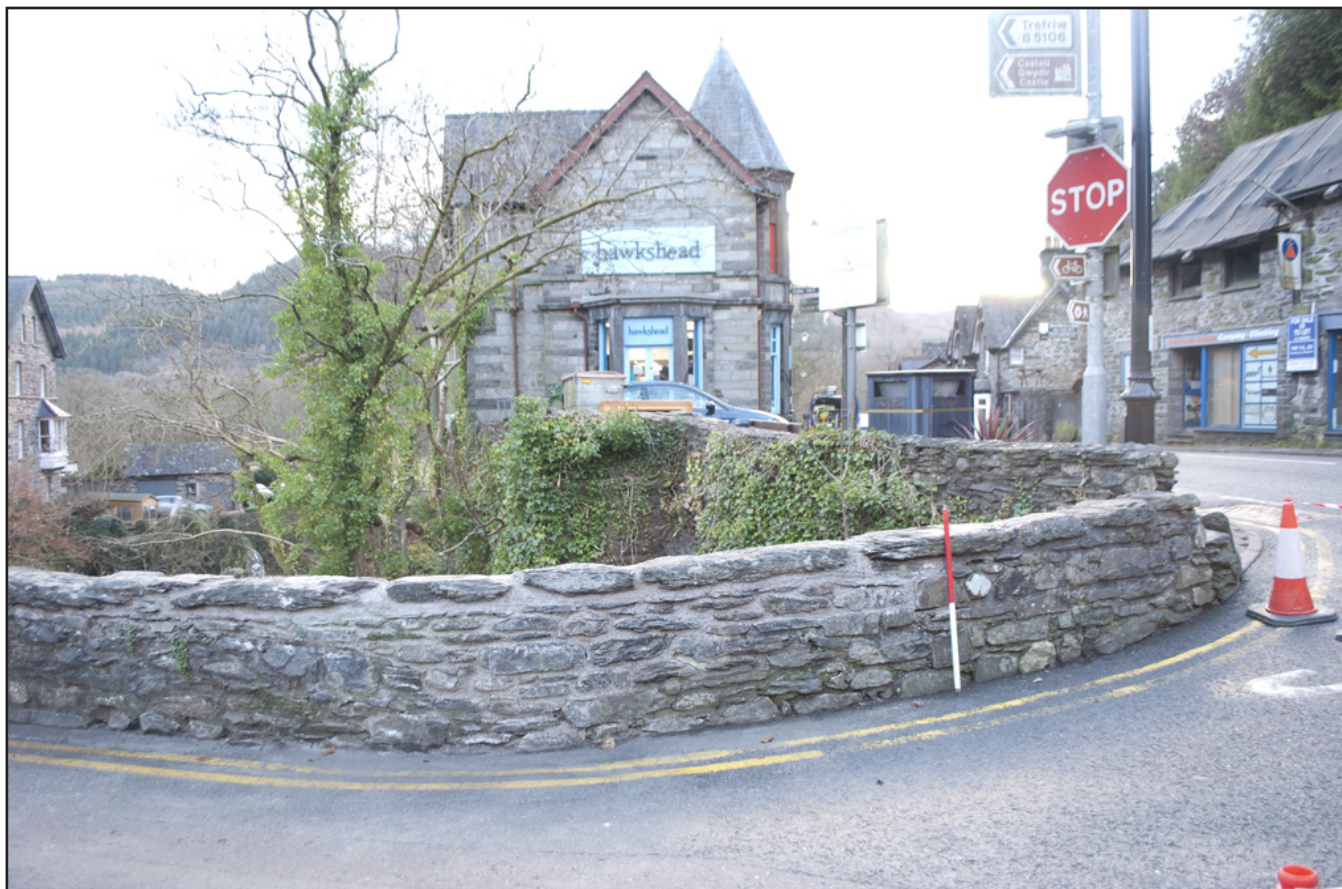
Plate 15: View of repaired southeast corner of the bridge parapet; scale: 1x1m (archive reference: G2587\_033).

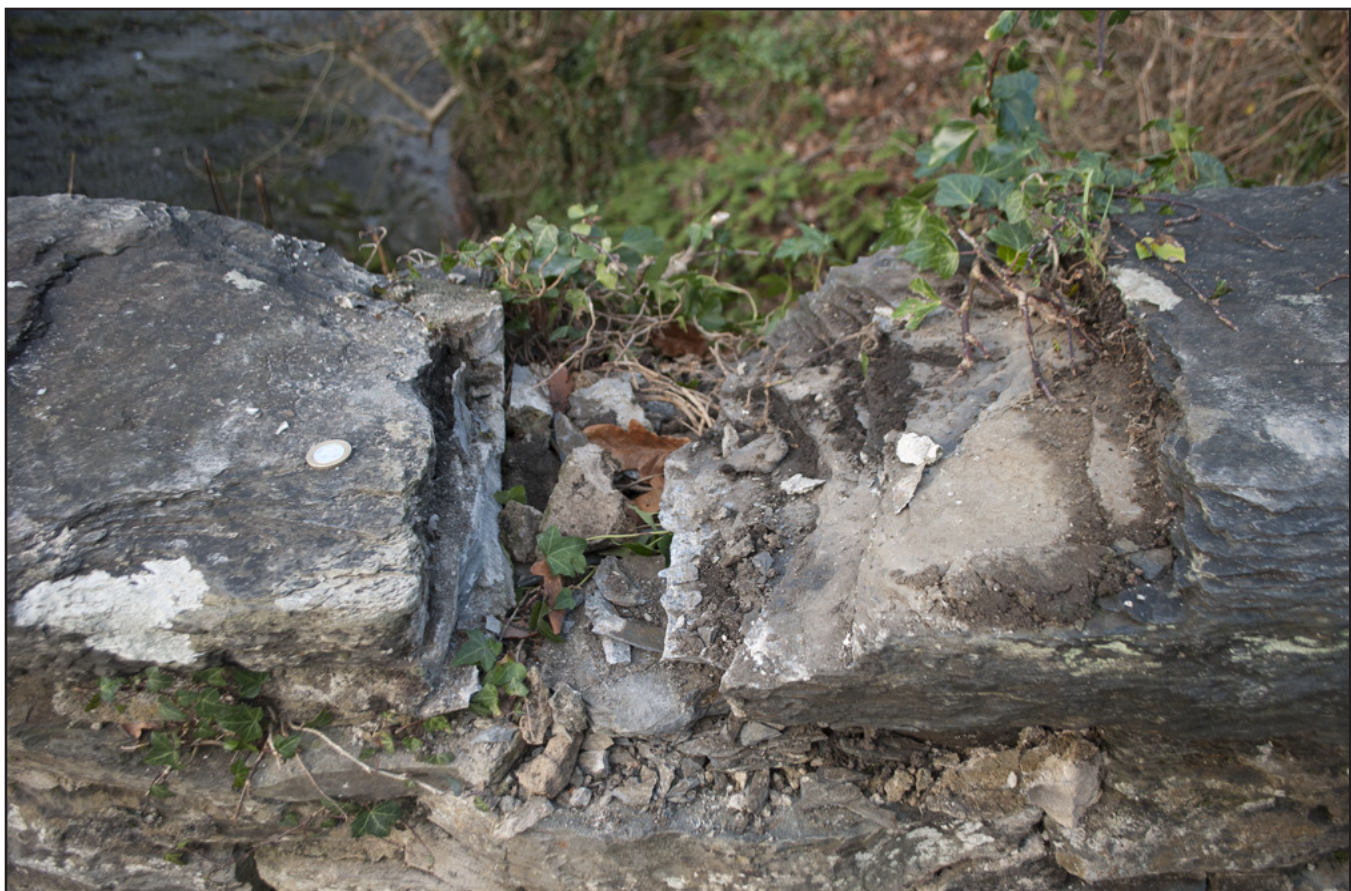
Plate 16: Area of damaged coping at the northwest end of the parapet; scale: not used (archive reference: G2587\_034).
