# Pont y Pairl Betws y Coed

## Archaeological Watching Brief

Prosiect Rhif / Project No. G2587

Adroddiad Rhif / Report No.1460

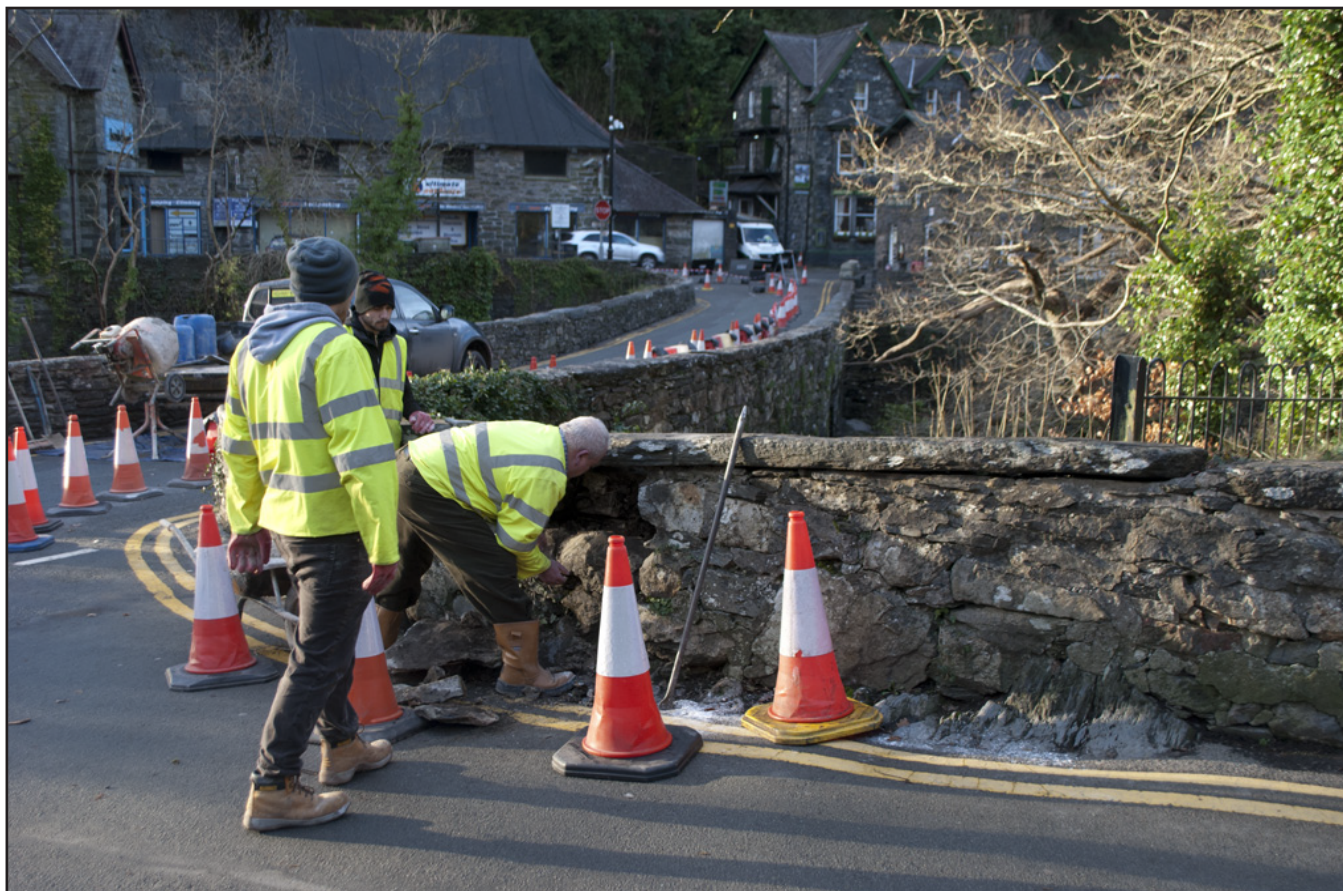
Plate 17: General shot of repair work to stones below the large coping stone at the northwestern end of the parapet; scale: not used (archive reference: G2587\_037).

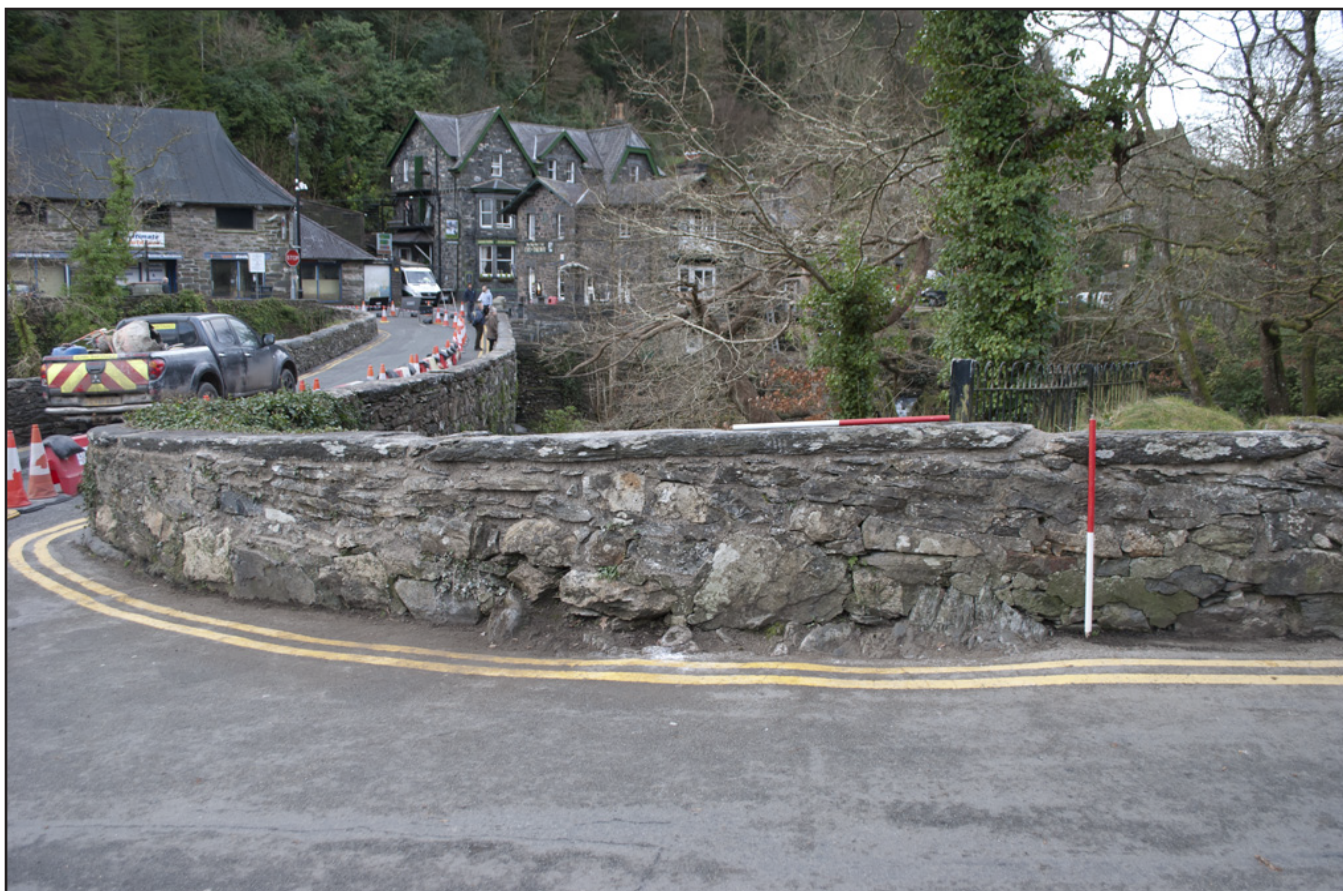
Plate 18: View of the carriageway side of the northwest parapet repair work; scale: 2x1m (archive reference: G2587\_041).

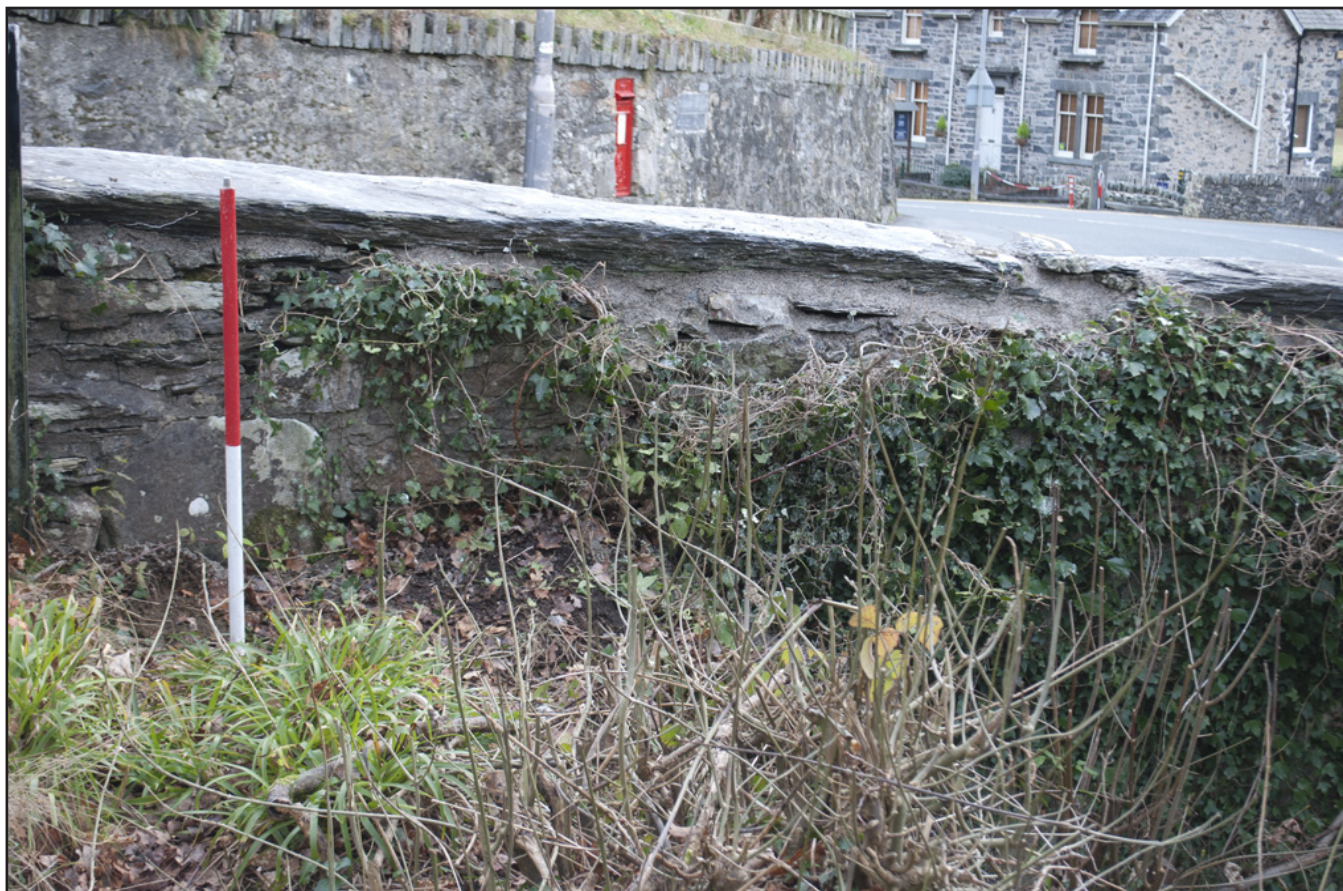
Plate 19: View of riverward side of the repaired northwest section of Pont y Pair parapet; scale: 1x1m (archive reference: G2587\_039).

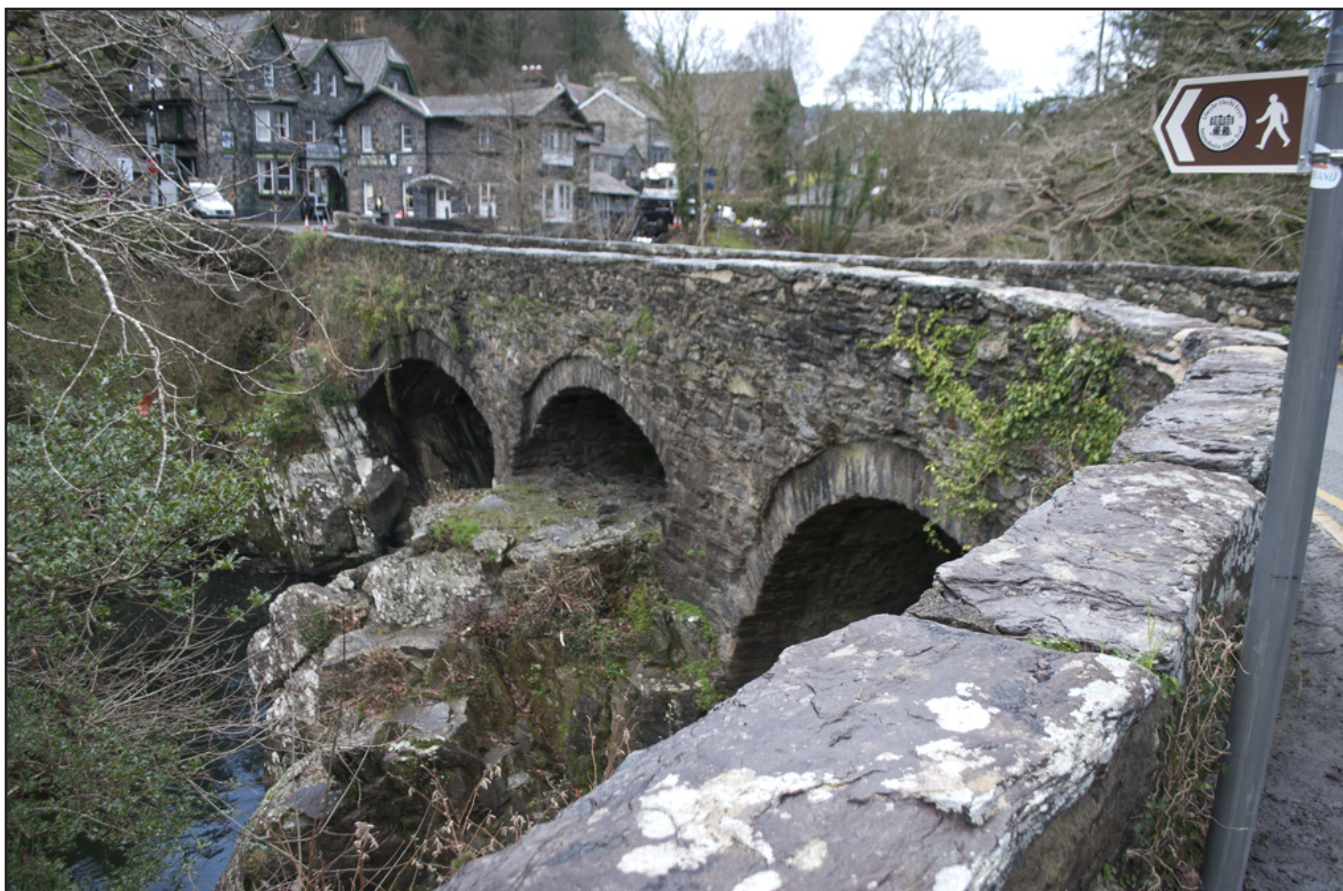
Plate 20: General view of Pont y Pair; scale: not used (archive reference: G2587\_009).

Pont-y-Pair Bridge carries the old road to Llanrwst and Conwy across the Afon Llugwy at Betws-y-Coed and is thought to date to the late 15<sup>th</sup> century. It is approximately 45m long and 5m wide. The bridge is constructed with five irregular segmental arches, some of which are built directly onto exposed bedrock (Plates 1, 6, 20). The middle arch, the widest of the five, spans the Afon Llugwy (RCAHMW 1956, 22). The section of the river over which Pont y Pair crosses was described by Edmund Hyde-Hall in 1811 as *'the Llugwy displays itself both above and below the bridge, either circling in boiling basins or dashing itself down from rock to rock in frequent leaps'* (Hyde-Hall 1952, 131; Figure 03). Samuel Lewis in 1833 described the area thus *'and over the latter is a bridge of singular construction, called Pont y Pair, consisting of four arches resting upon masses of rugged precipitous rocks of romantic appearance, which in high floods exhibit below the bridge several beautiful cataracts of striking magnificence. This picturesque structure was projected and partly raised by one Howel, a mason from Penllyn, who, about the year 1468, had previously erected a bridge over the Lleder, at a spot where his passage had been obstructed by a flood, whilst on his journey to Aberconway, to attend the Merionethshire assizes, to which place he removed, and, having built the bridge at his own expense, received no other remuneration than the voluntary donations of travellers : he then removed to this place, where he commenced Pont y Pair bridge, but died before its completion. The scenery around this spot consists of rocky mountains fringed with wood, in the fissures of which are found trees of stately growth, and the whole neighbourhood abounds with strikingly magnificent and finely contrasted features'* (Lewis 1833, 81-88; Plates 20-21).

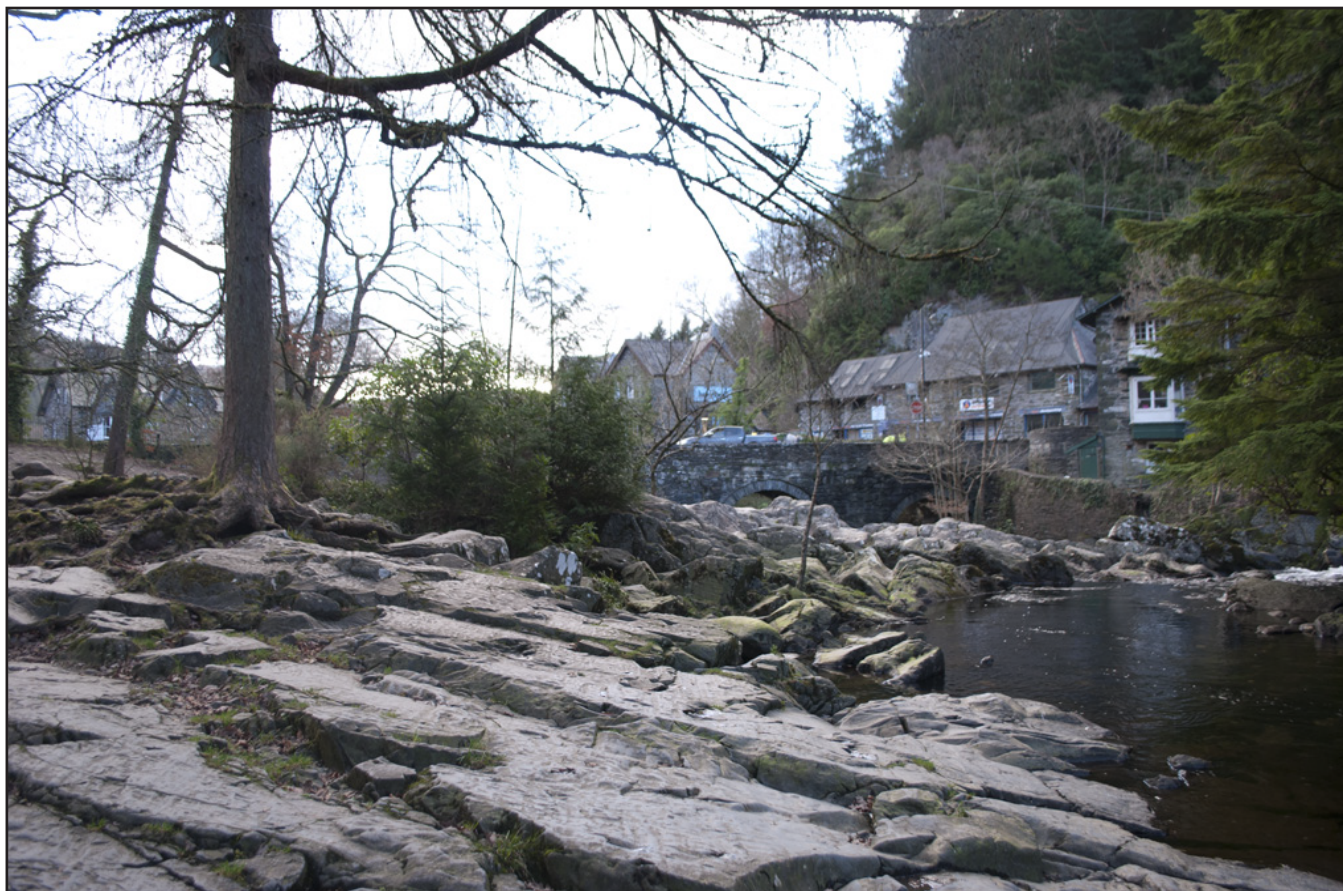
Plate 21: General view of Pont y Pair bridge from the riverbank and waterfall; scale: not used (archive reference: G2587\_019).
