Tabernacle Church & Town Wall, Pembroke

Building Recording

Report No. 1383

Prepared For: Pembroke 21C

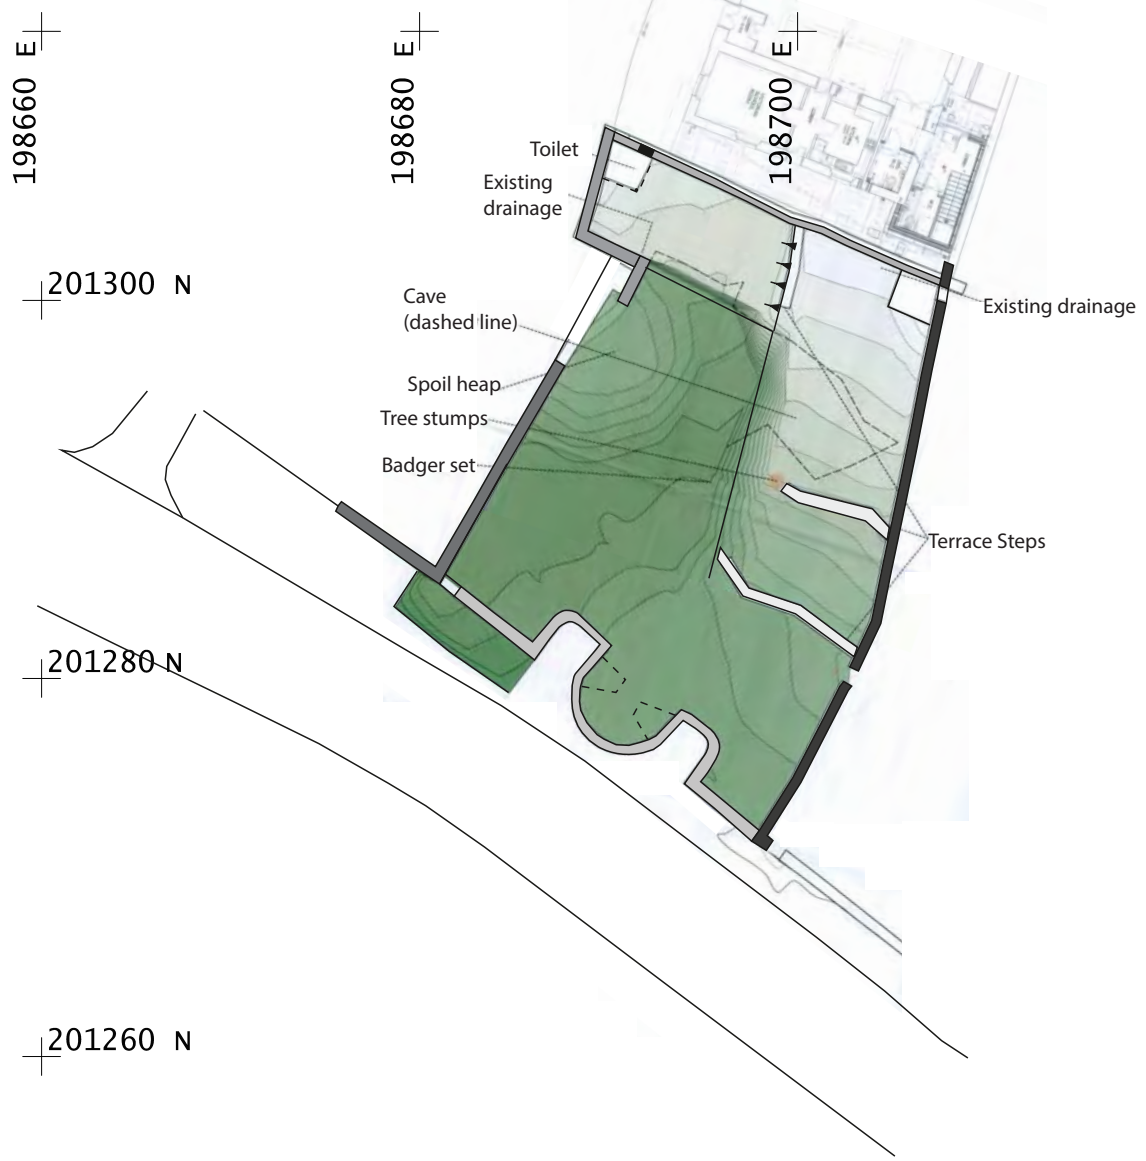
Fig 3: Site Plan

5.1.2 Figure 3 shows the existing plan of the former garden grounds. Figures 11-13 show the existing elevations of the southern, western and eastern walls. Figure 15 shows the location and direction from which the photographic plates were taken. The number after each red arrow corresponds to the plate on which the photograph appears. Plates 1-16 show views of the southern wall. Plates 17-23 shows views of the western wall. Plates 24-30 show views of the northern wall. Plates 31-36 show views of the eastern wall.

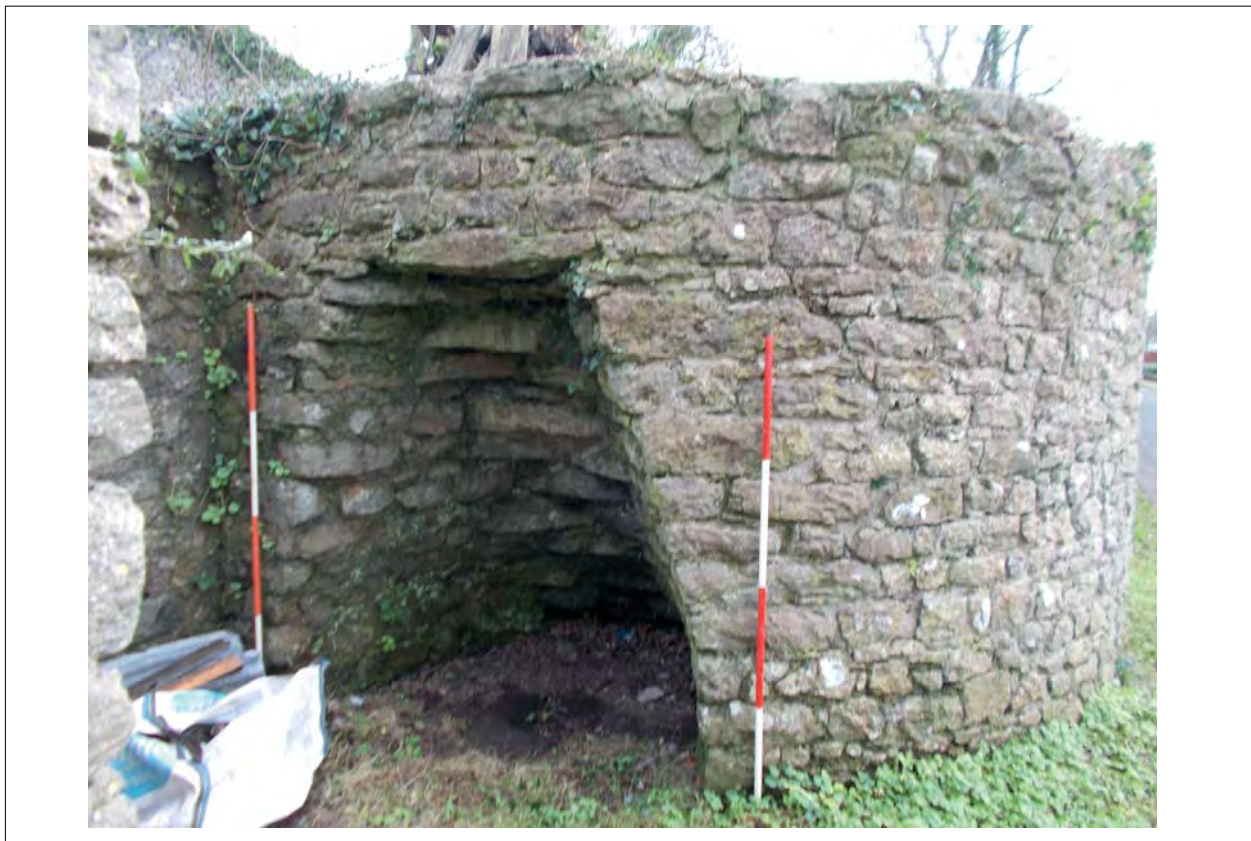
Plate 6: View east toward lime kiln

- 6.2.5 The lime kiln appears to be relatively intact and a good example of a large industrial D-Shaped lime kiln of late-18th century date. The attached walls along the southern section appear contemporaneous and so date the entire South Wall to the same period. The later addition of an entrance is noted at the far western end of this wall, but this may well be a rebuild of an earlier doorway contemporary with the South Wall. The addition of a retaining wall adjacent to the entrance way to accommodate an earth ramp is presumably of a similar date to the lime kiln itself, although of a later phase. It is tempting to see the quarrying activity within the western part of the plot as contemporary with the establishment of the limekiln. A nearby cave, which could not be closely examined due to the presence of a bat roost, may be associated with the quarrying and lime burning activity. Chisel marks and drill holes noted around the cave's entrance, and also possibly on the roof,

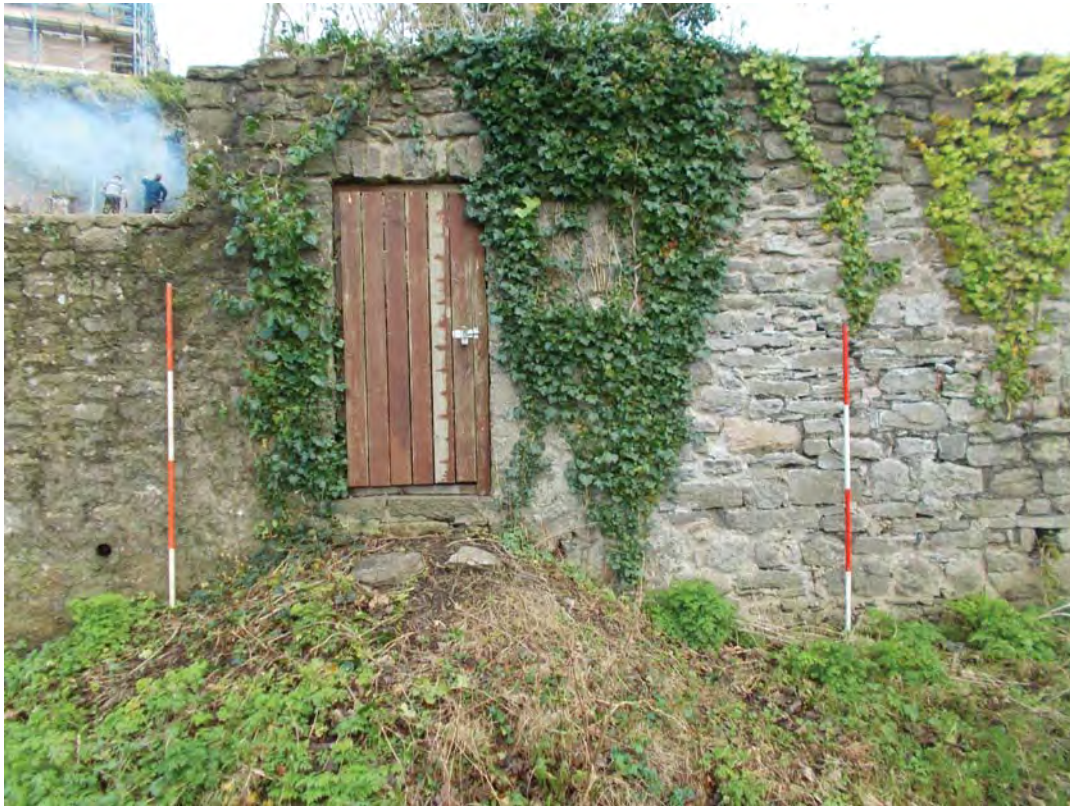
Plate 17: View north east toward south external wall, showing transition from medieval wall to the right (medieval arrow loop visible in bottom right), to 18th/19th century wall to left of ivy.

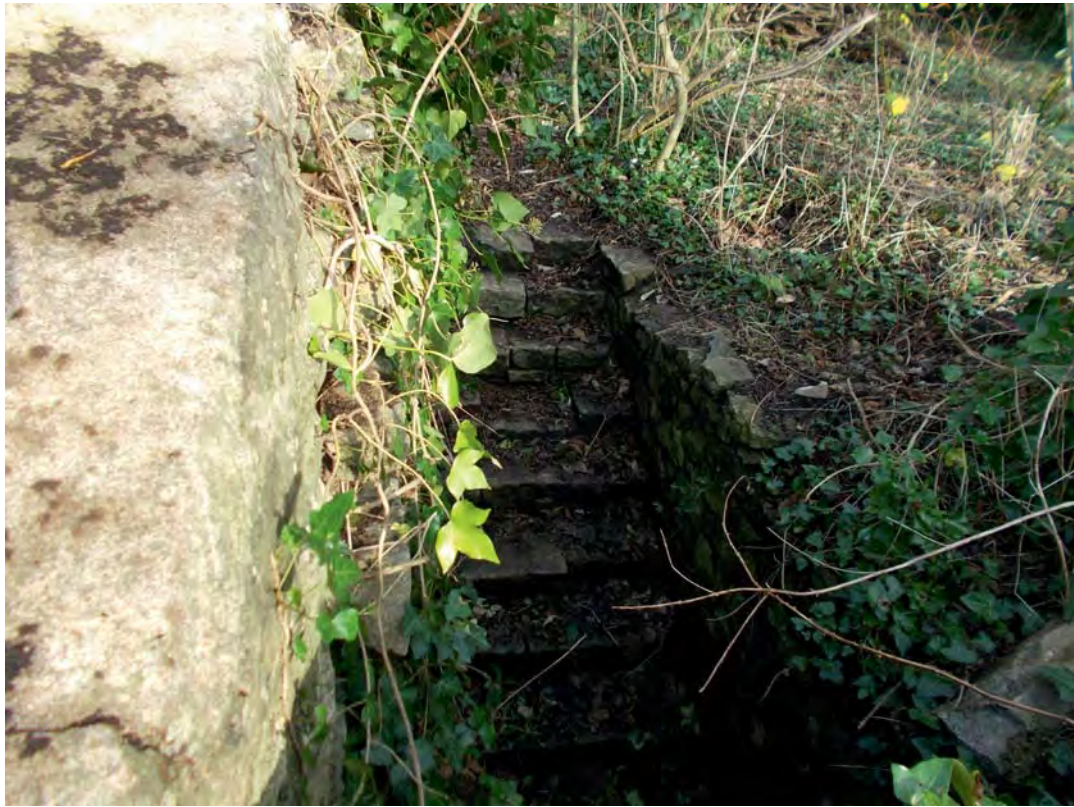
Plate 23: Stairs built in the adjacent property to the east, built against the burgage plot boundary wall, illustrated as a comparison to the stairs revealed in the north west buttress wall

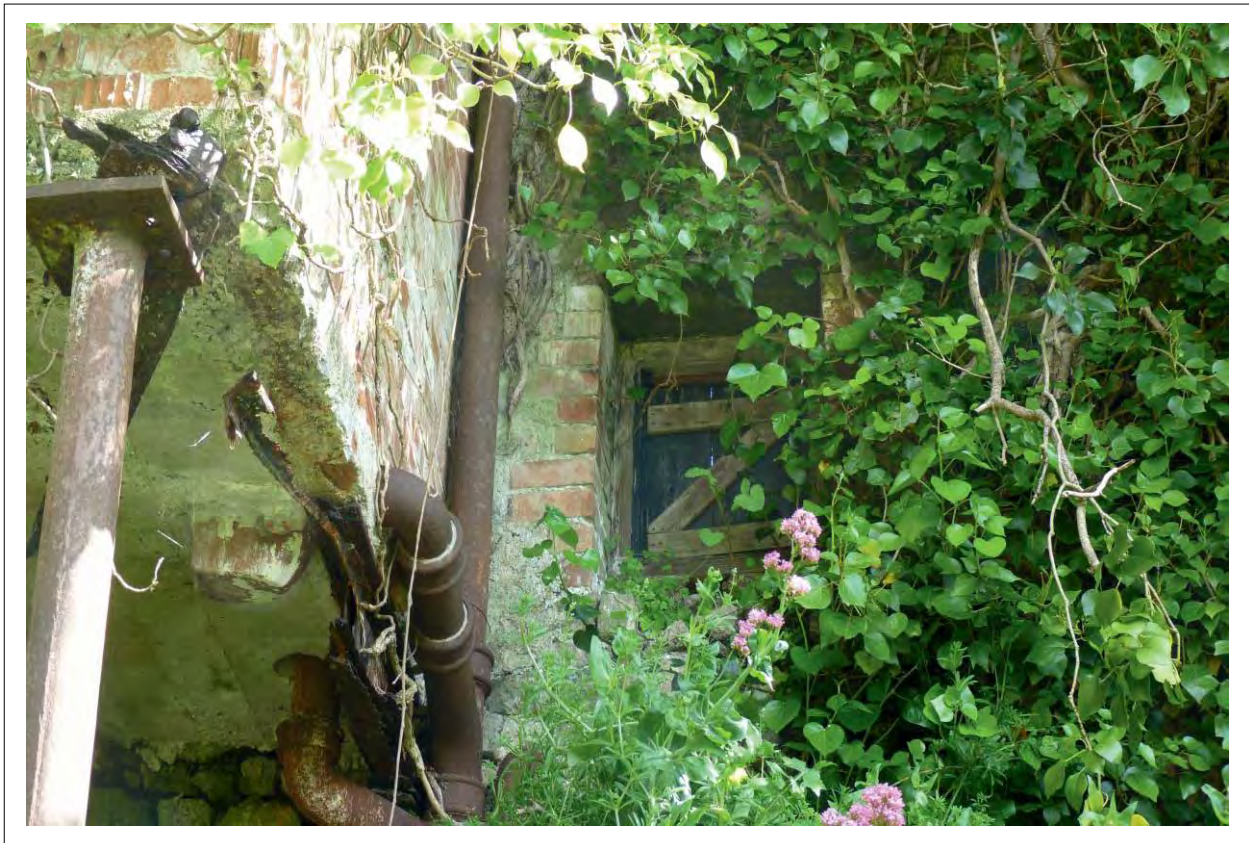
5.4.1 Due to Health and Safety concerns the north wall could not be closely recorded, and detailed elevation were not possible. Photographs were taken, but these were obscured with vegetation cover, although an initial visual inspection of the wall was made. The north wall is orientated approximately northwest to southeast and is 18m in length by approximately 5m in height. The wall is constructed of coursed irregular rubble with a buff lime mortar bonding. It is constructed on top of the bedrock outcrop and shows signs of having been constructed in vertical sections; putlog niches were noted but could not be photographed. The vast majority of the wall was covered in vegetation, but a mortar screed was noted covering much of its surface. A small square opening was apparent at the western end of the wall, which had been later blocked. This may represent a later addition to the red brick stilted structure located above (Plate 25). A redbrick window was also inserted at the western end, which dates to the same phase as the construction of the stilted structure (Plate 29).

Plate 29: View north east toward brick window in north wall

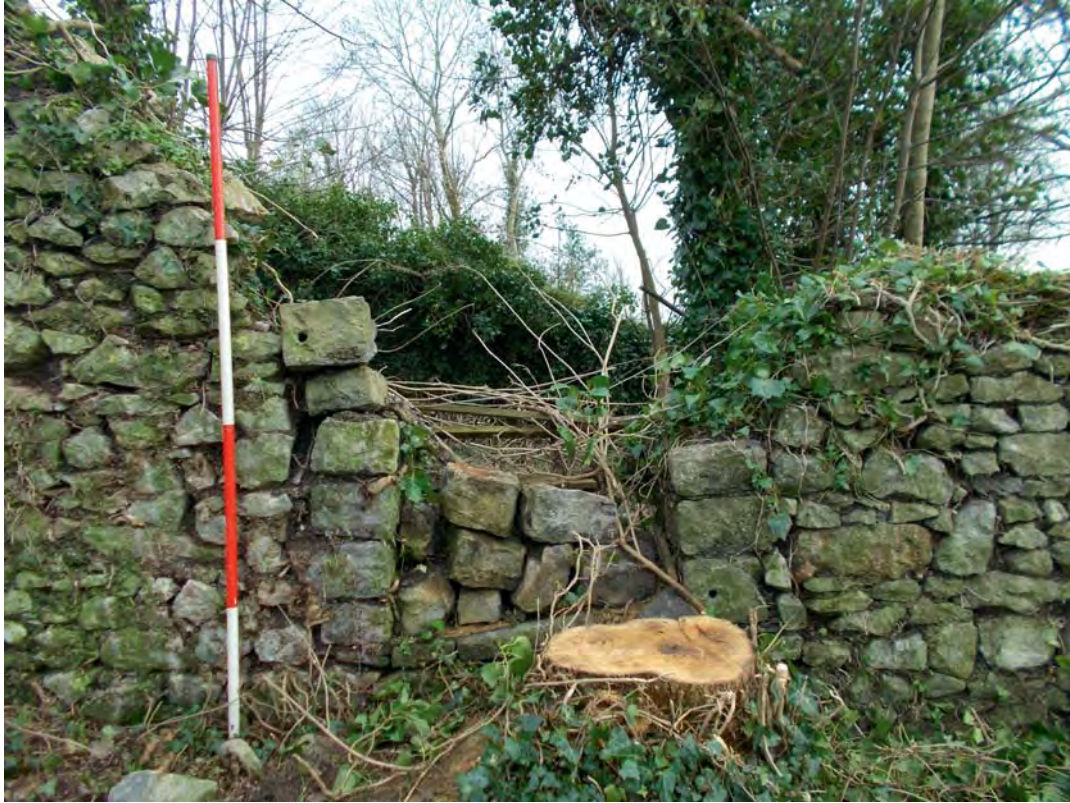
Plate 47: View south east toward east wall, showing detail of blocked entrance

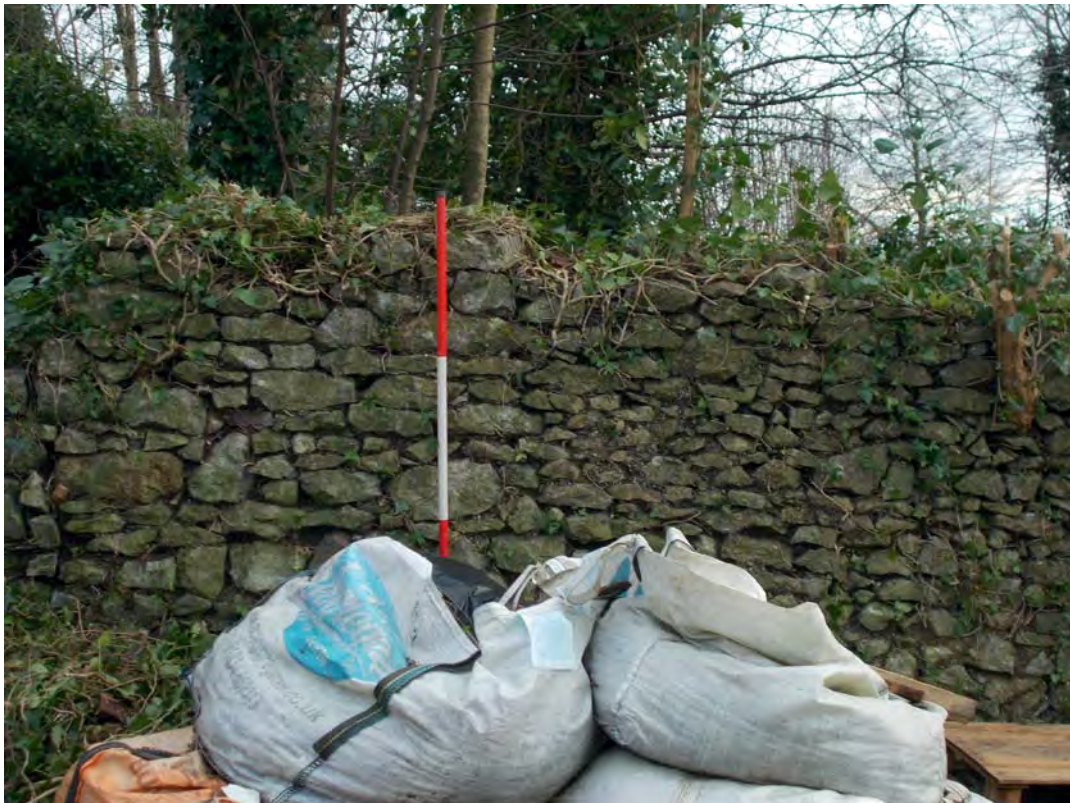
Plate 48: View south east toward east wall, showing detail of possible rebuilt section

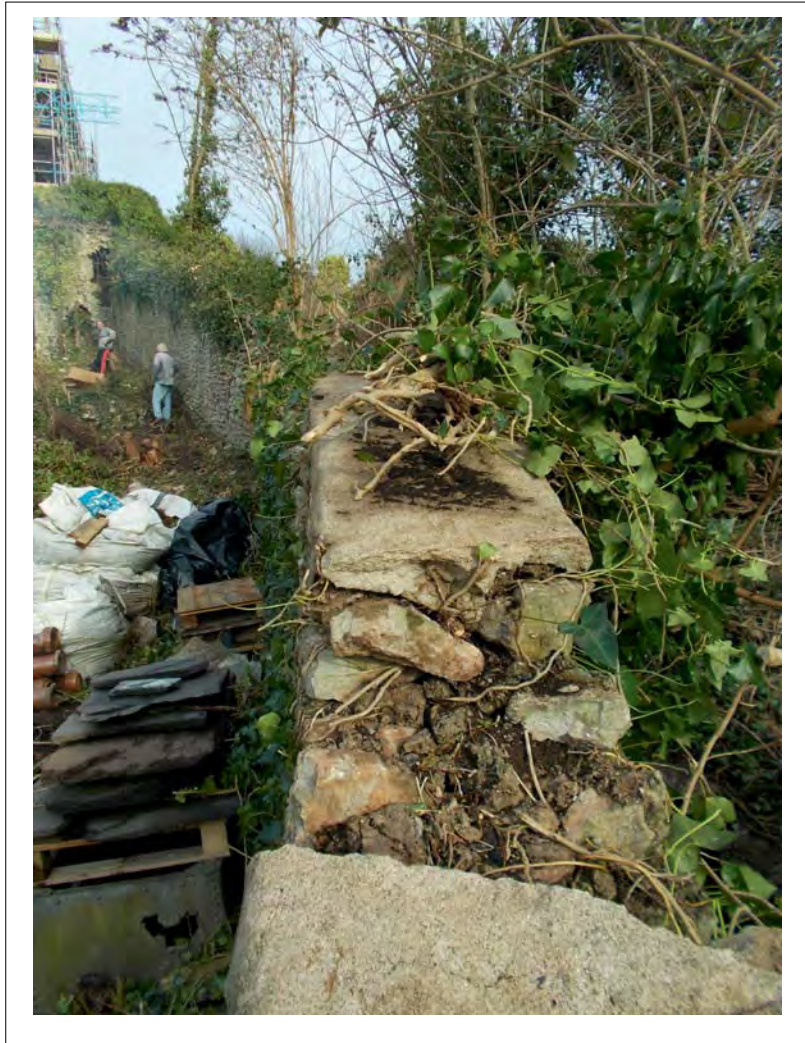
Plate 49: View north east along east wall, showing detail of alignment change
