ARCHAEOLOGICAL

WATCHING BRIEF

WB04/AONB1/07

Angidy Ironworks, Tintern.

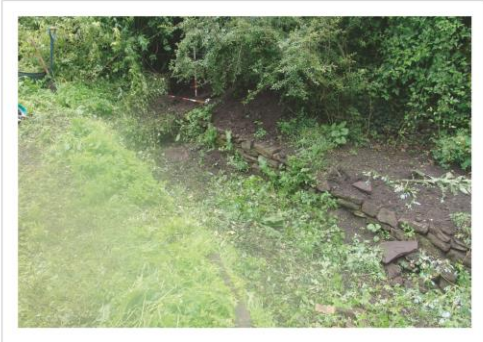
Plate 01: Predicted drain position

Work was concentrated here because ground features and topography suggested that the expected outfall of the drain from the ironworks wheel pit would open adjacent to the road in this area, plate 01. Trial pitting was employed to search for the drain but without success plate 02. A new test strategy was then employed using a representation of the drain on an early map, *fig 2*. The drain is depicted as an open channel running from the north east corner a cottage plot; south of the road.

Initial work included the clearance of vegetation from a dry stone lined ditch, identified as an old watercourse, plate 01.

The location for test pit one was proposed due to the existing stone lined channel and its direction of fall within the topography. It was later discovered, that its line of fall took it under the floor of a known cottage thereby, necessitating a channel depth too deep for practical drainage purposes. Clearance of the channel revealed that the dry stone wall linings were quite shallow, approximately 0.4m and probably aesthetic features rather than structural. The excavation showed that the walls rested on a sediment lens [002] under which was back fill containing 19th/20th century, domestic debitage. This area does not form part of the drainage channel from the furnace.

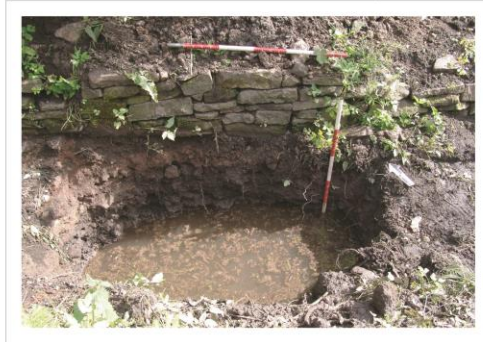
Plate 02: Test pit 1

Test pit 1, plate 02, was excavated by mechanical digger to a depth of 1.4 m below ground level. The excavation was undertaken with a non-toothed bucket, and produced a trench 0.8m x 1.4m.

Water was encountered at a depth of 0.35m beneath the ground level and filled the trench quite rapidly. It was not possible to investigate the resultant excavation with any accuracy due to the water level.

Stratigraphic layers that were observed consisted of the topsoil [001], a variable lens of red sandy sediment [002] followed by dark brown soil with lenses of powdered plaster, sherds of glass, ceramics and lumps of furnace slag [003].

The ceramic and glass finds within [003] were non abraded and dated to the 19th and early 20th century.

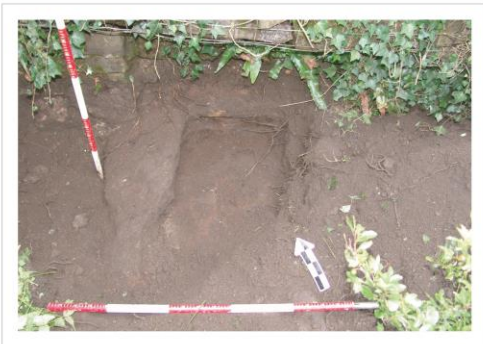
Plate 03: Test pit 2

Test pit 2 was excavated alongside the road retaining wall, just to the north east of test pit 1. Its excavation was in response to an eyewitness account of an archway in the vicinity, Saunders B., *pers com*. A vertical line of masonry was the initial focus of interest, plate 03.

The trench measured 0.8 x 1m and revealed a compacted floor with high iron content [004] just below the surface.

The floor surface was trowelled for recording and remains in need of further investigation.

No brick arch was found and there were no finds in this area.

The location of test pit 2, to find a reported arch position through the road revetment was unsuccessful in achieving its purpose but has provided an interesting area for further investigation. The feature, partially revealed within test pit 2 is a heavily compacted surface with a high visible ferrous content. It appears to be either a flow formation, or the remnants of a deposition episode. It has a rectangular break of surface which may be the ghost impression of an associated object; now gone. The surface appears to be contained along the northern edge by vertical edges of masonry now incorporated into the road revetment.

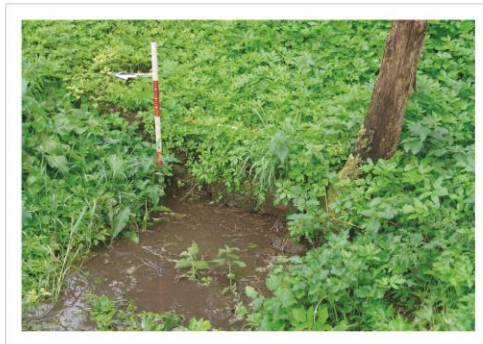
Plate 04: Test pit 3

The excavation of test pit 3 was initially carried out by mechanical digger fitted with a narrow grading bucket. Unfortunately, the surface water present did not allow for any investigation of the sub-surface archaeology.

The excavation was stopped after a few buckets of soil were removed and a rod was used to test the depth. The rod struck a solid bottom at around 1.8m beneath the surface.

Test pit 3 was abandoned quite quickly as a search location, highlighting as it did the existence of the cottage remains and the records of its previous excavation by Mrs J Saunders, *pers com*. It did however, lead to further credence of the early map which led to the position of test pit 4.

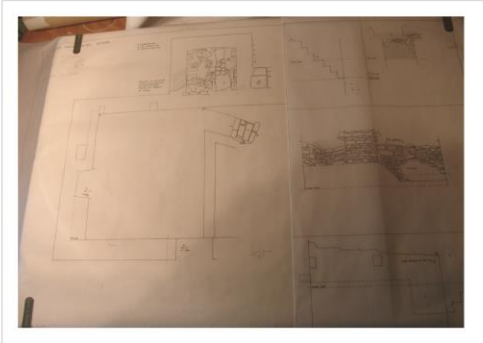
Plate 05: Excavation plan (Mrs J Saunders)

The hard surface was revealed to be the cellar of a cottage previously excavated by the owners of the site; Mr & Mrs Saunders, plate 05.

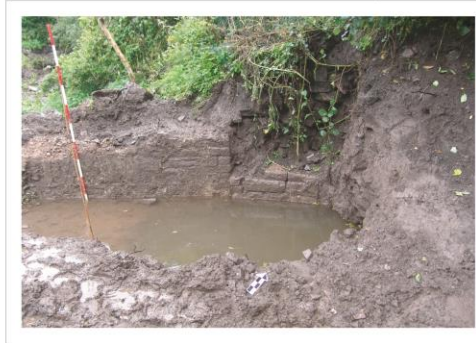
Plate 06: Test pit 4, road revetment

The line of the west edge of the trench followed the line of the surviving cottage wall as shown on fig 02. The northern edge was restricted by the proximity of the road which, at this point appeared to be supported by a poorly constructed dry stone revetment, plate 06. Both the width and length of test pit 5 were largely dictated by the manoeuvrability of the mechanical digger and health and safety issues resulting from the poor ground conditions. Fully extended, the digger arm reached a depth of about 1.5m below ground surface but was unable to locate any opening for the drain.

As with test pit 3, the ingress of water seriously prevented any detail recording of the excavation and also made it impossible to assess the success of the search to locate the drain out flow.

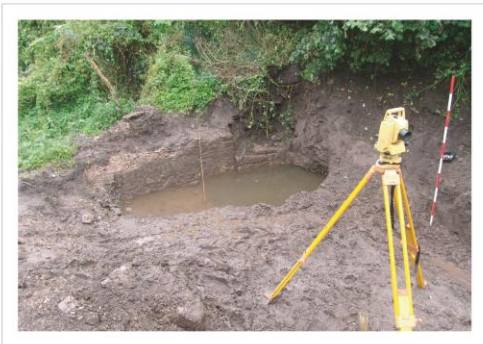
Plate 07: Test pit 4, cottage & drain

At the end of the present excavation of test pit 4, a length of the south eastern cottage wall had been uncovered revealing a plastered or rendered surface. A section of masonry, at a slightly different alignment and build runs from the northeast corner of the cottage into the bank of the road.

At close of excavations on the 20th July 2007, the masonry wall, to the north east of the cottage wall in test pit 4, would appear to be associated with the drain outfall from the furnace floor. This interpretation cannot be shown archaeologically at present but has been arrived at through documentation, survey and observation. In keeping with the cartographic history mentioned above, 2.3, the ground between the stream and the cottage consists entirely of made up ground. Arguably, a lot of the fill equates to the modern pie trench but there is no discernable stratigraphic separation between its cut and the background fill.

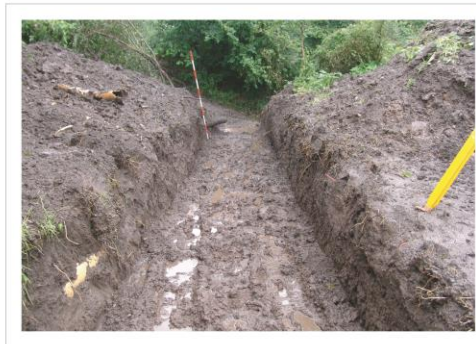
Plate 08: Pipe trench

In order to remove the water from test pit 4, it was decided to dig a channel to the stream. The position for the trench was the line of a modern road drain which can be seen in plate 08.

The ground through which the trench was excavated consisted of modern backfill associated with the road drain.
