# Penygraig Uchaf, Ystrad Meurig, Ceredigion Watching Brief

Report by: Trysor

Trysor Project No. 2015/424

1.1 In May 2015, Trydor undertook a watching brief on groundworks for a single turbine at SN7075668193 at Penygraig Uchaf, Ystrad Meurig, planning application A140201.

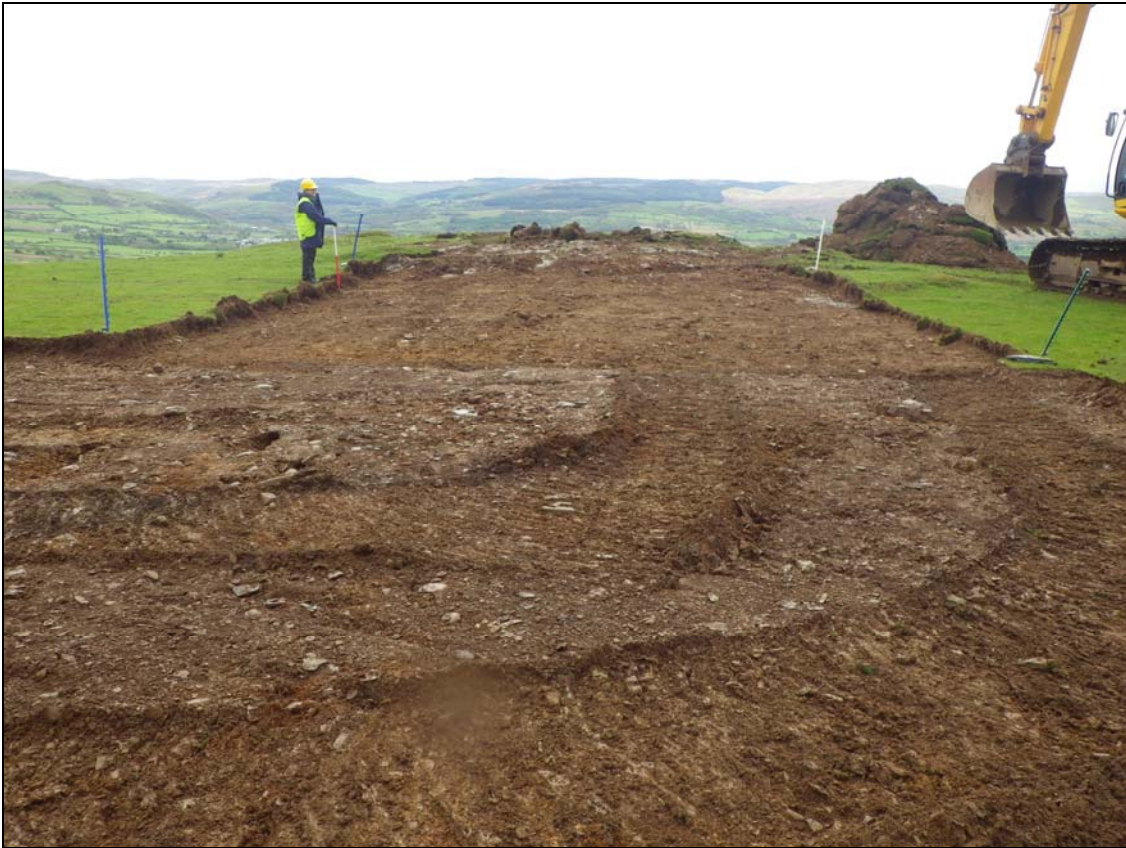
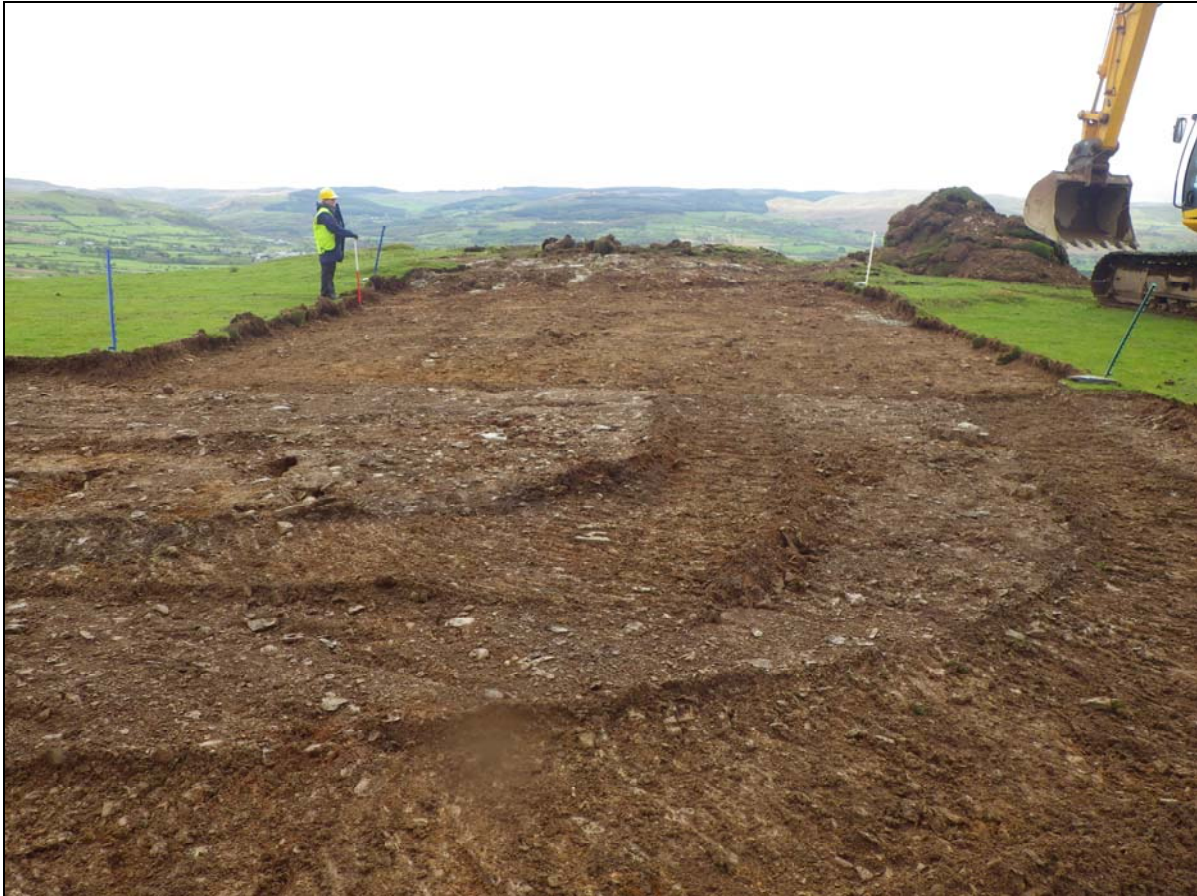
*Cover photograph: Topsoil removed from the hardstanding area, looking southwest.*

*Plate 1: PGU2015\_101, After the topsoil, 001, removed from the hardstanding area, looking southwest.*

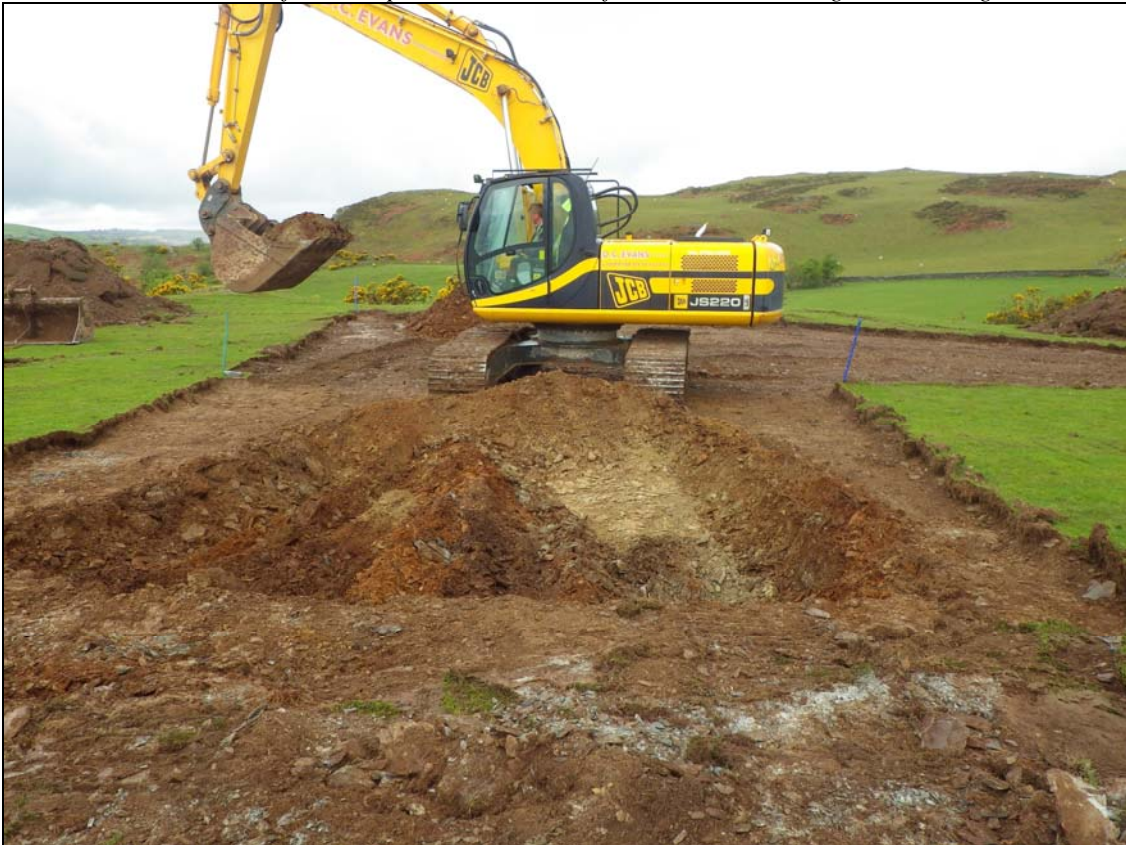
*Plate 2: PGU2015\_102, the area of the turbine foundation, looking northwest. The natural rock surface can be seen in the foreground.*

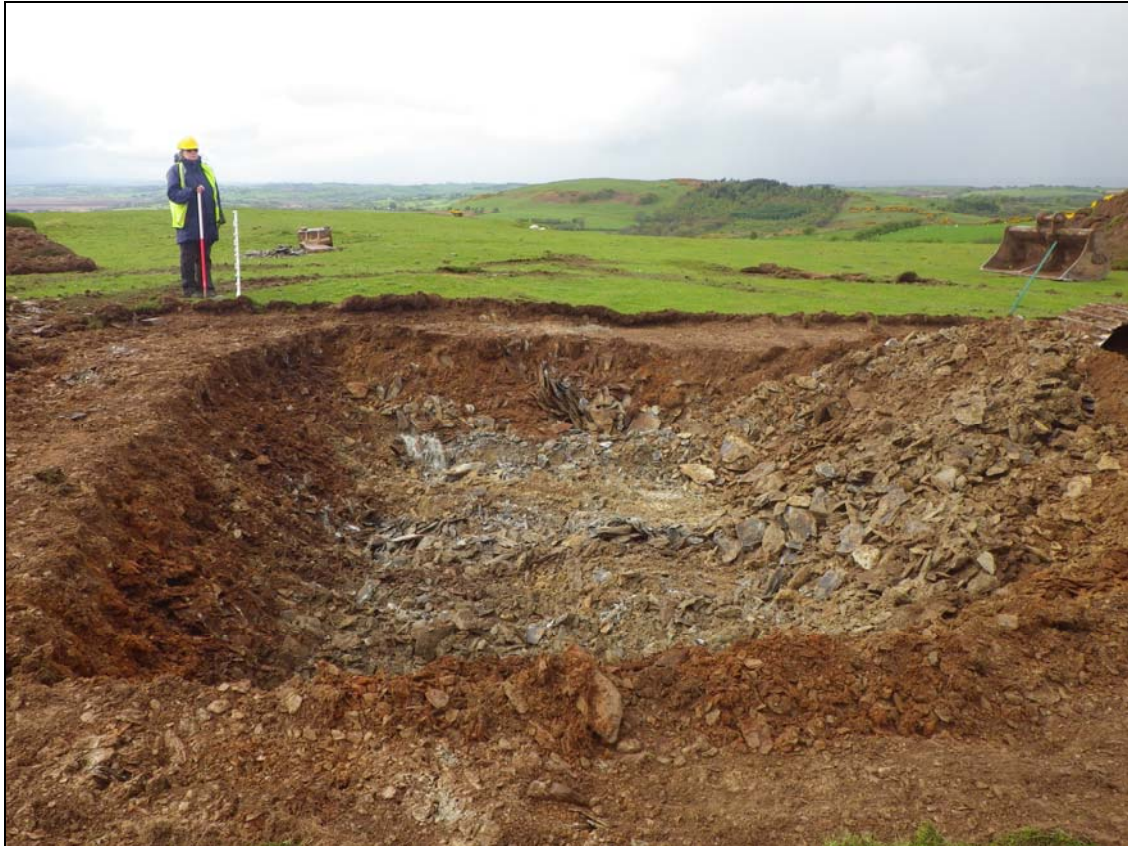
Plate 3: PGU2015\_103, the area of the turbine foundation, looking southwest. The natural rock can be seen in the far section, showing how it has been folded and has an uneven interface with subsoil above.

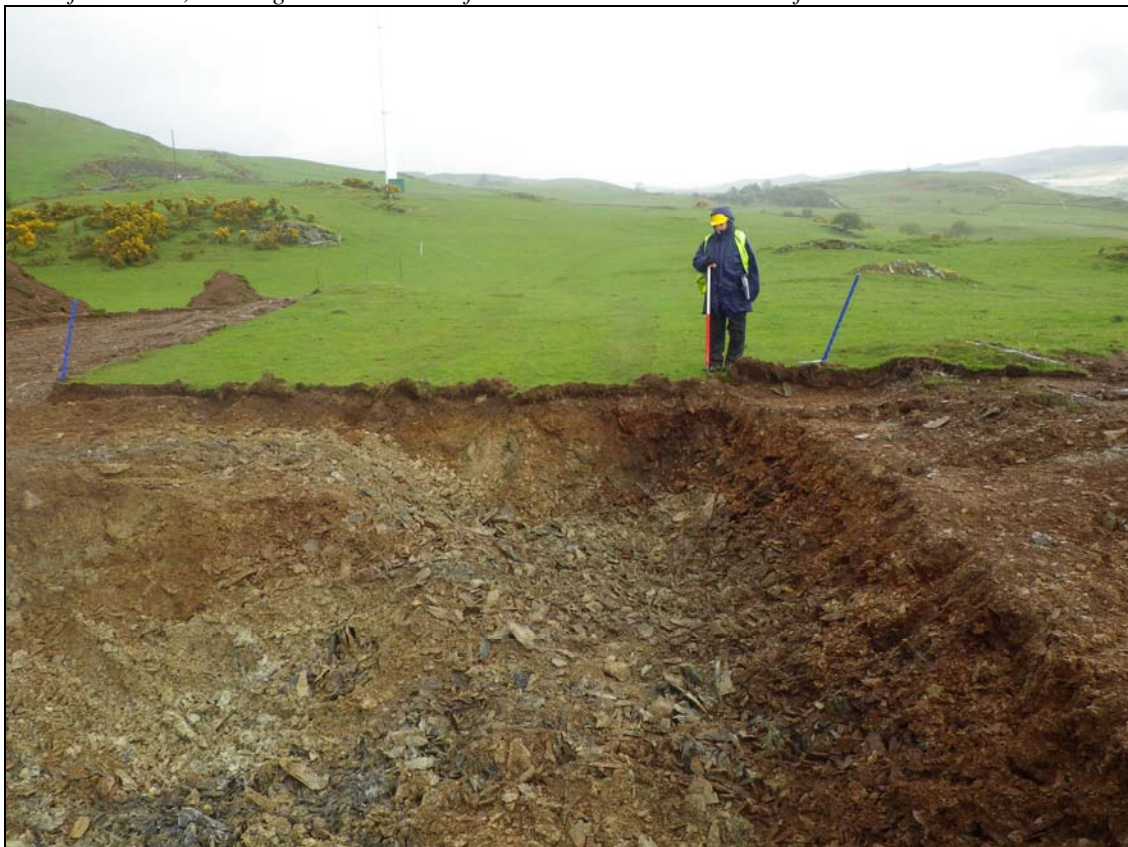
Plate 4: PGU2015\_104, the area of the turbine foundation, looking northeast. Again the uneven natural rock surface can be seen in the far section, here it gives a deeper depth of mixed subsoil. This is a natural feature and not created by human interaction
