Archaeological Evaluation  
of land adjacent to  
**THE VILLAGE COMMUNITY CENTRE,  
TINTERN, MONMOUTHSHIRE.**  
for  
Tintern Community Council

Report No. 1942/2008

Archaeological Evaluation  
of land adjacent to  
**THE VILLAGE COMMUNITY CENTRE,  
TINTERN, MONMOUTHSHIRE.**

Centred on  
N.G.R. SO 5306 0017

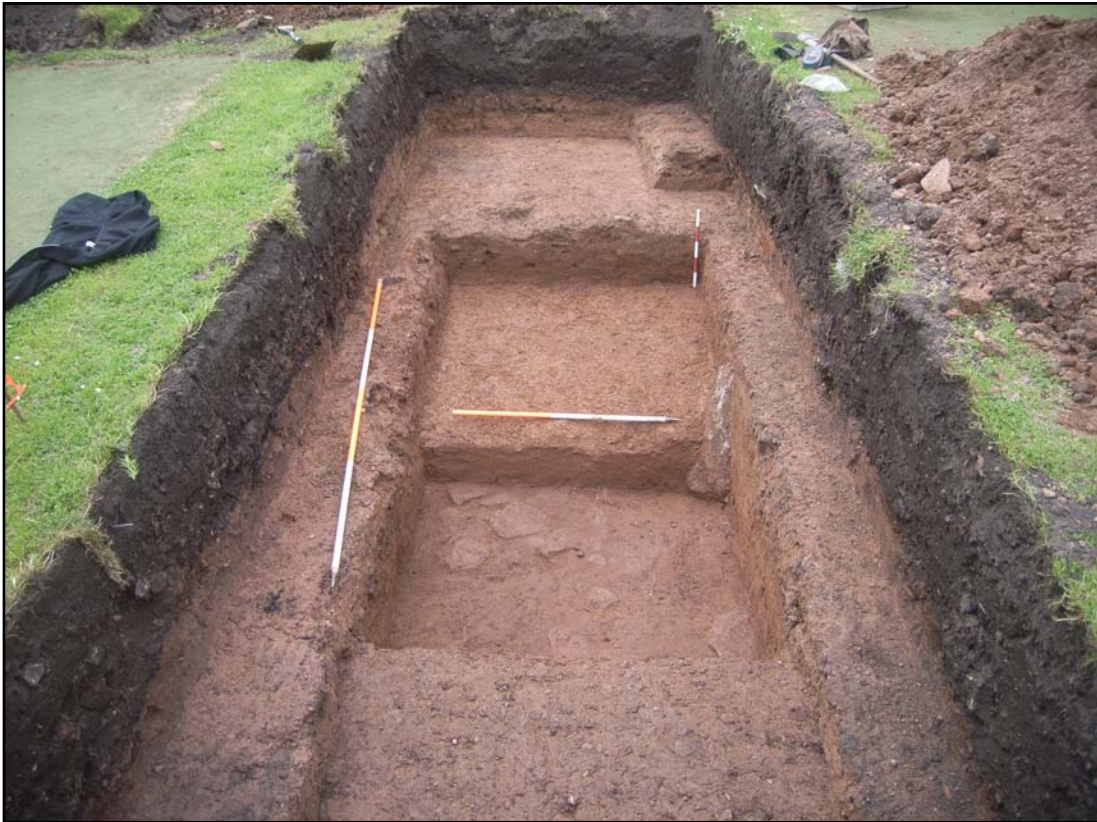
Plate 1 Trench 1, looking west

- 5.1 Trench 1 measured 6m x 2m and was located at NGR SO 53056 00142 to the south-east of the Village Community Centre (**Plate 1**). A hand-dug sondage (**Plate 2**) was excavated to a height of 8.15m aOD into the undisturbed, compact, reddish-brown, natural sandy clay and gravel containing medium-sized stones up to 200mm in width (Context 110).

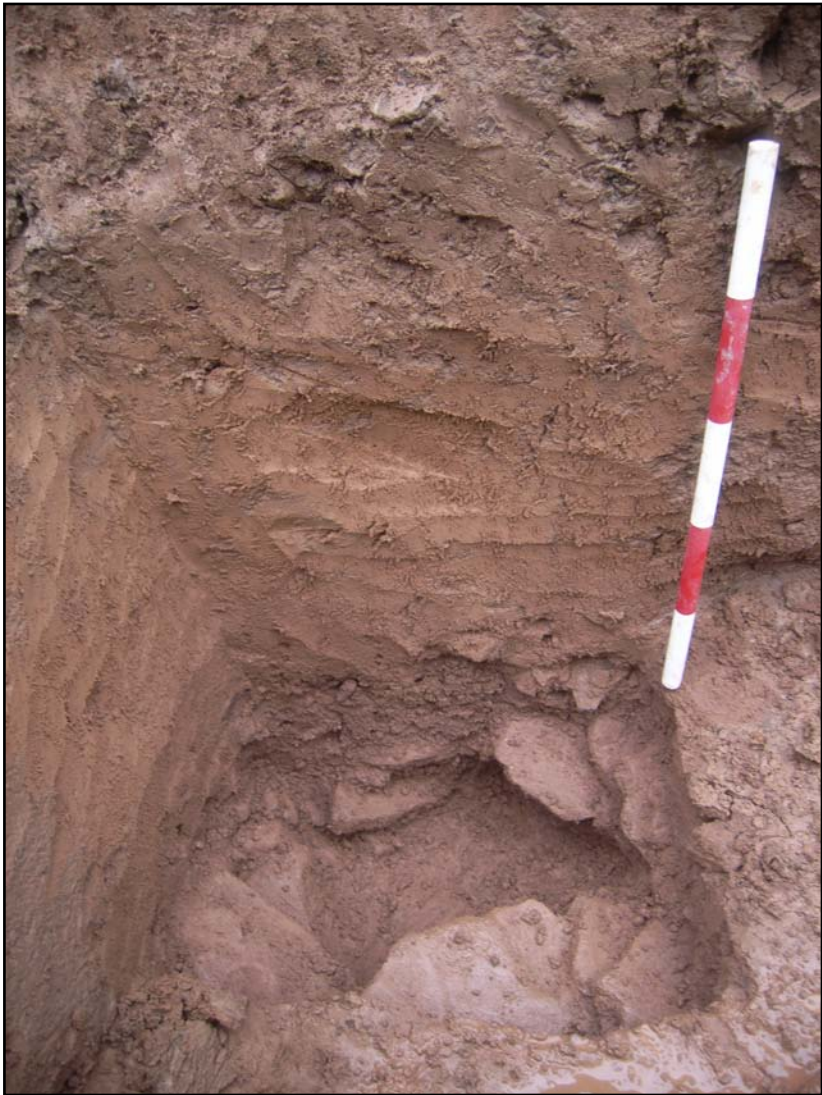
Plate 1 Sondage through deposits 105-107 showing natural 110, looking south

- 5.2 Immediately overlying 110 was a softer, reddish-brown, sandy clay (107) possibly representing eroded natural. Associated with 107 was a thin layer of flattish, angular stones less than 150mm in size (106). Above 106 was a colluvial deposit of yellowish-brown, sandy clay (105), up to 350mm in depth.

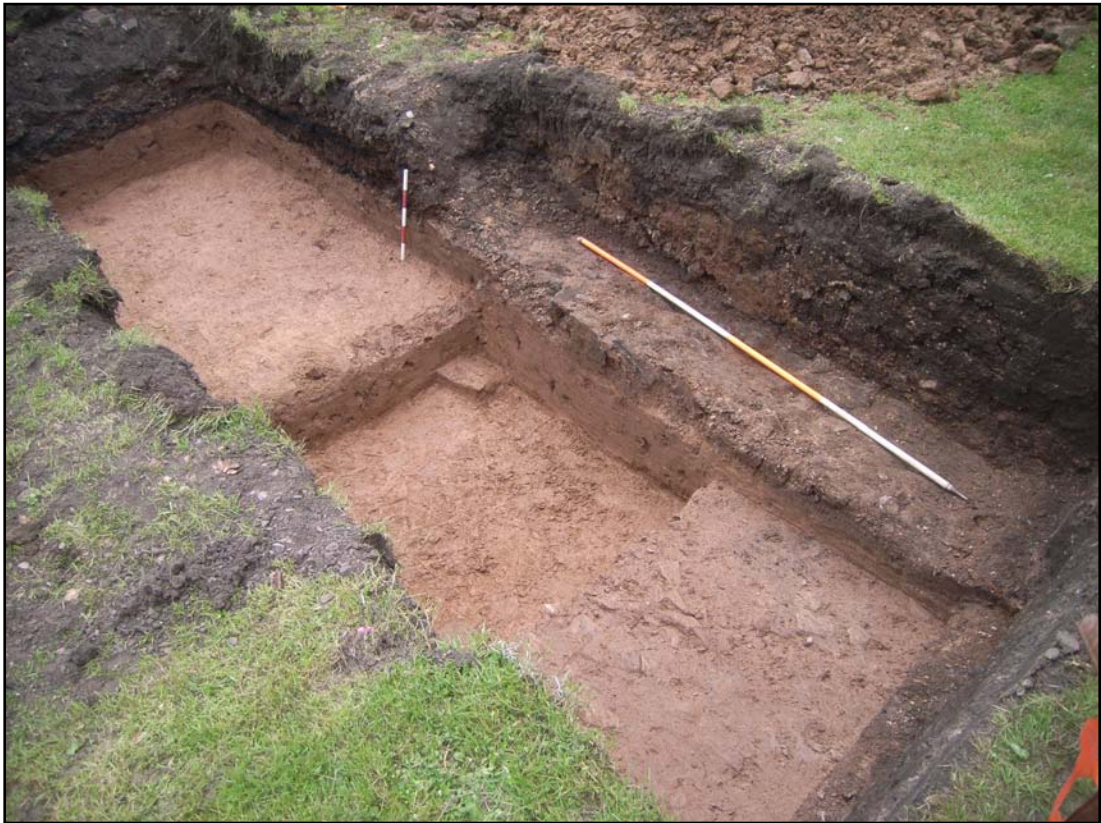
Plate 3 Trench 2, looking south-west

- 5.7 Trench 2 measured 6m x 2m and was located at NGR SO 53048 00141 to the south of the Community Centre (**Plate 3**). The top of the undisturbed, natural reddish-brown, sandy clay (208) was reached at a height of 8.57m aOD.
