CPAT Report No.1379

6-8 Beacons Hill, Denbigh

Archaeological Watching Brief

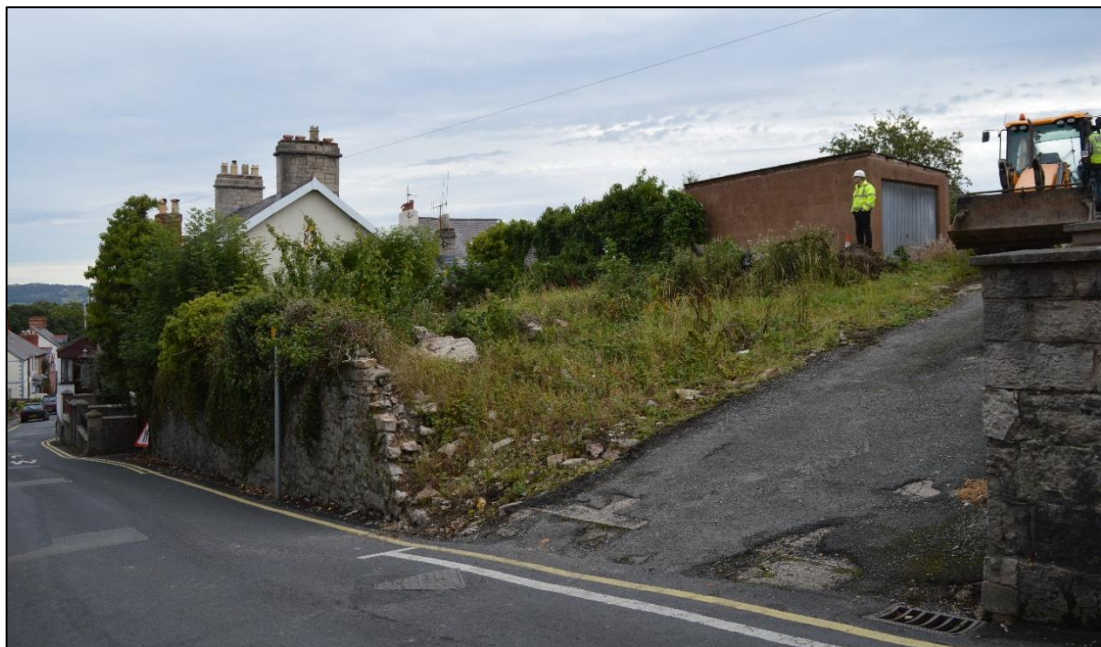
Photo 1. The development plot prior to ground reductions showing the area of rough ground retained by the limestone wall and the modern garage up slope towards the rear of the plot. CPAT Photo 4078-0004

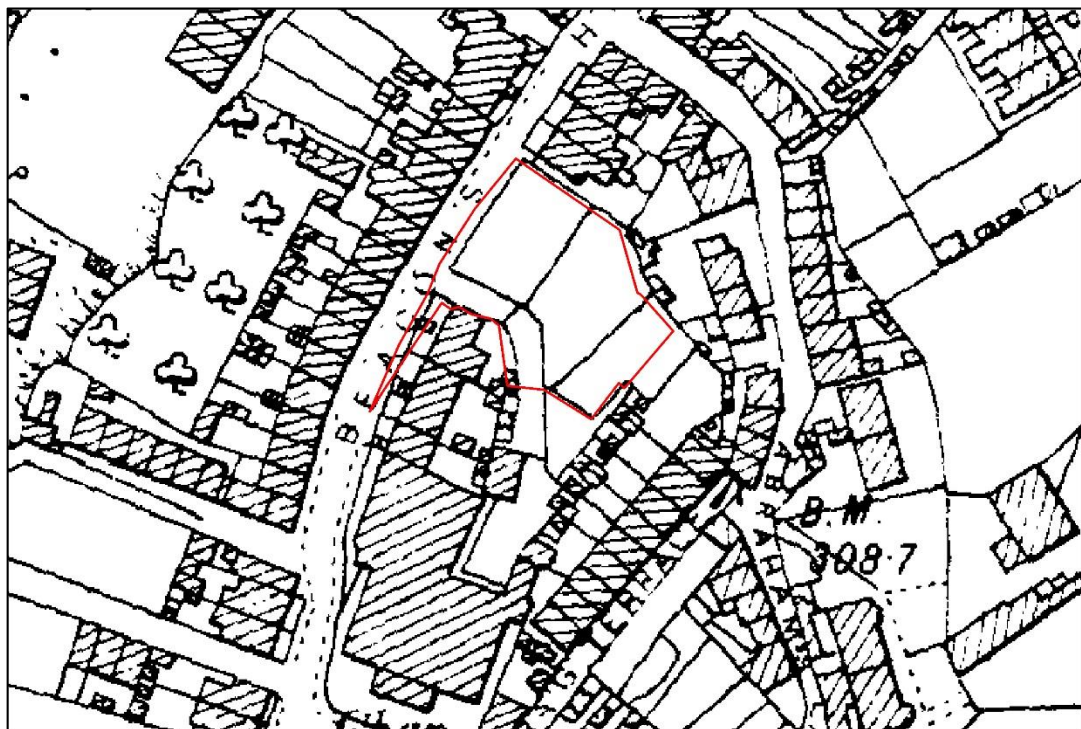
Fig. 4. The 2nd edition Ordnance Survey map of 1899 showing the development plot (as outlined in red) as an area devoid of dwellings.

- 3.2. Sometime after the tithe mapping the street name of “Pembrokes Hill” is replaced with the current street name of “Beacons Hill”. The 1st edition, 1:500 Ordnance Survey map of 1875 shows the development area as devoid of dwellings and occupied by a large walled garden parallel to the street front, along with open areas delimited by garden paths to the rear of the plot (Fig. 3). The 2nd edition 1:2500 Ordnance Survey map of 1899 although less detailed, also shows this area as plot devoid of buildings but divided into garden plots (Fig. 4).

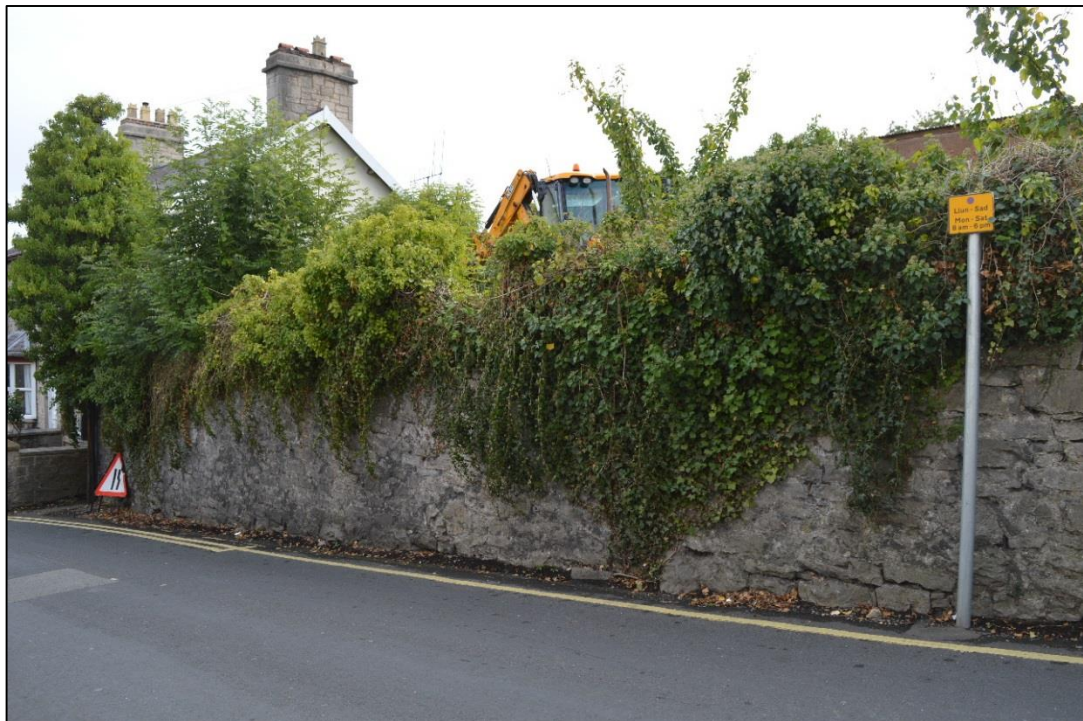
- 4.4. It is very likely that the western elevation of this wall is part of the original walled garden or at least has, 19th century or possibly earlier origins. It is lime mortared and heavily weathered (Photo 2). It was not possible to access the northern wall but given its position as both a boundary and retaining wall it is almost certainly the wall represented on the historic mapping. The southern return wall had been demolished prior to the development. The eastern elevation was extant but on closer inspection it was found to be a modern wall on concrete slab footings.

Photo 2. The western limestone wall, most likely to be part of the walled garden as depicted on the 1st edition Ordnance Survey map. CPAT Photo 4078-0011

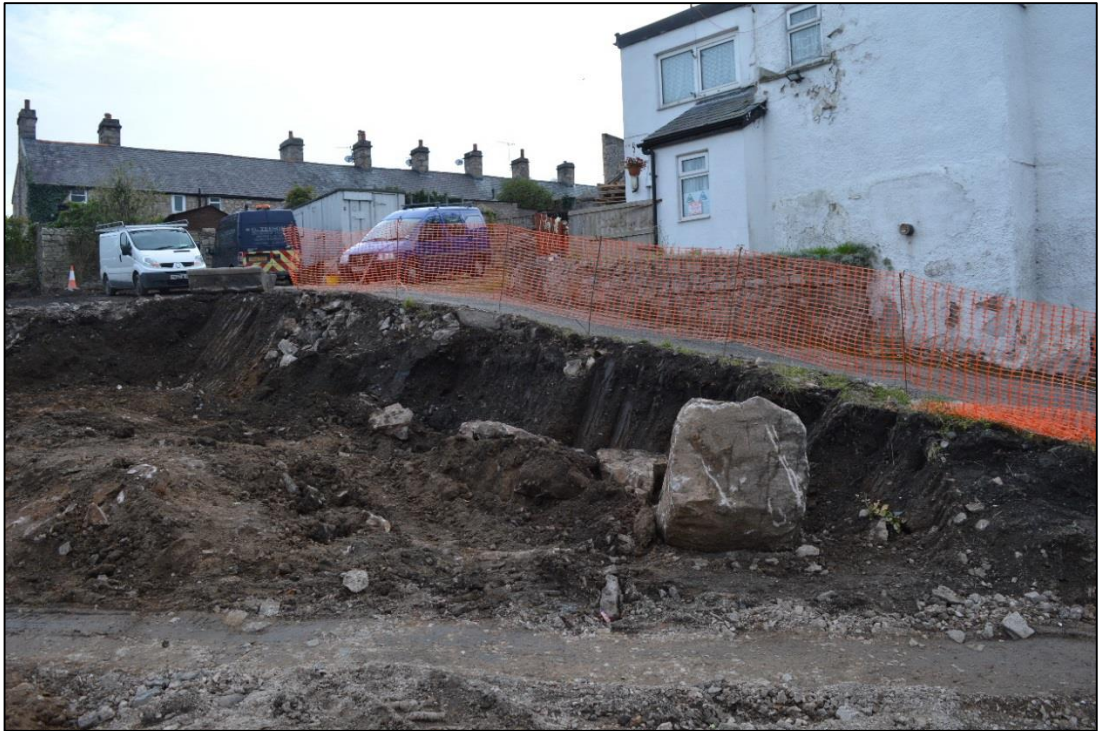
- 4.8. Ground reductions began within the bounds of the existing limestone wall. With the exception of the small area sampled by Test pit 2, up to 0.6m of a rich, dark grey/black silt garden soil was removed (01). This was underlain by an earlier light grey charcoal rich silt (02), between 0.3m and 0.4m thick and which contained frequent pieces of animal bone and 18th/19th-century pottery. The natural subsoil was revealed to be a mottled, bright orange sandy boulder clay with limestone rubble and large boulders (17) (Photo 3). This was reached at a depth of around 0.8m below ground level in the northern area end and 0.55m at the southern end of the site.

Photo 3. Ground reductions in the south-western area of the site revealed large limestone boulders in the sandy boulder clay subsoil. CPAT Photo 4078-0044

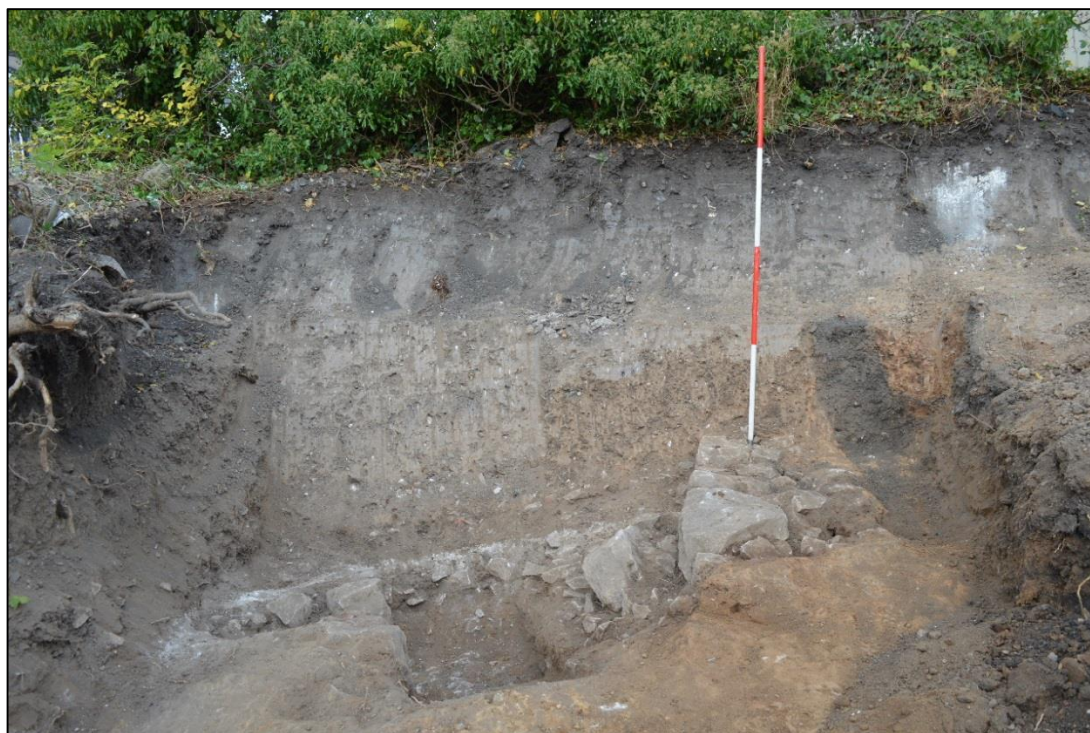
- 4.10. The light grey cultivation layer (02) was mechanically removed down to a depth of 1.5m where the surface of a dry stone limestone wall was encountered (Photo 4). Thereafter the excavation was conducted by hand. The wall (07) was orientated north-east/south-west, measured 1.4m long and 0.45m wide, and continued into the northern section of the trench (Photo 5). The wall was situated within a rubble-filled (08) foundation trench (06) which was had been cut into the natural subsoil (17) and appeared to turn east-west towards the western section. The rubble fill (08) consisted of angular limestone rubble with frequent pieces of animal bone, eighteenth/nineteenth-century pottery including porcelain, bottle glass and clay pipe. A small exploratory slot against the face of the wall revealed that the wall was built on top of the limestone bedrock (18) and the late, post-medieval artefacts were consistent down to this level (Photo 6).

Photo 4. The dry-stone wall (07) beneath the garden soils. Note also the cut of linear (15) to the right of the wall. CPAT Photo 4078-0028

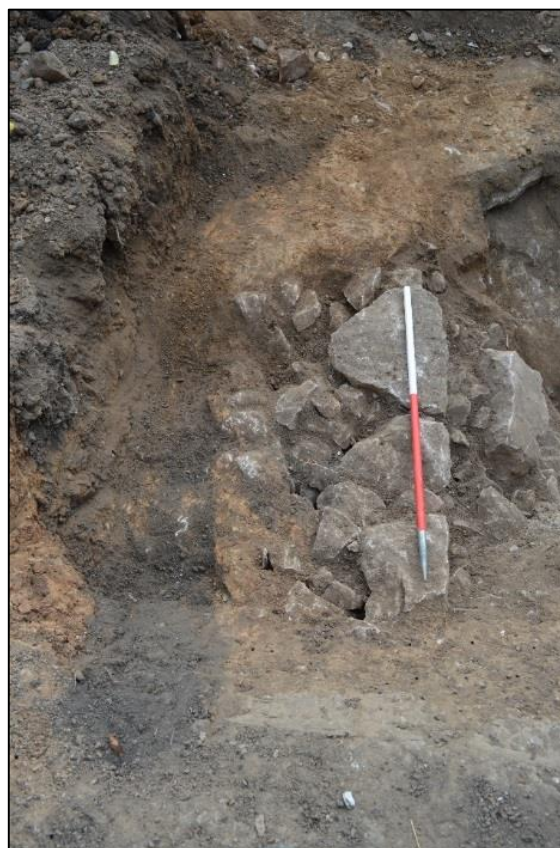
Photo 5. Plan view of the dry limestone wall (07), the wall trench cut (06) into the orange subsoil and the rubble fill (08). CPAT Photo 4078-0032

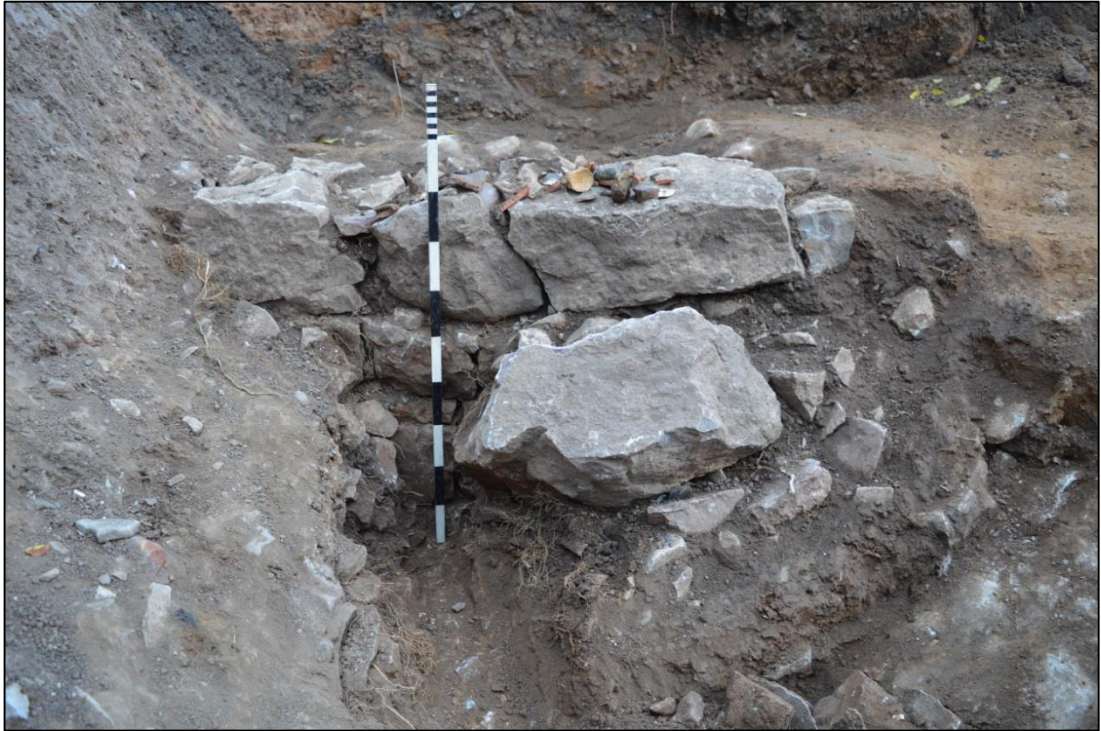
Photo 6. The exploratory slot through the rubble fill (08) against the face of the limestone wall (07). CPAT Photo 4078-0050

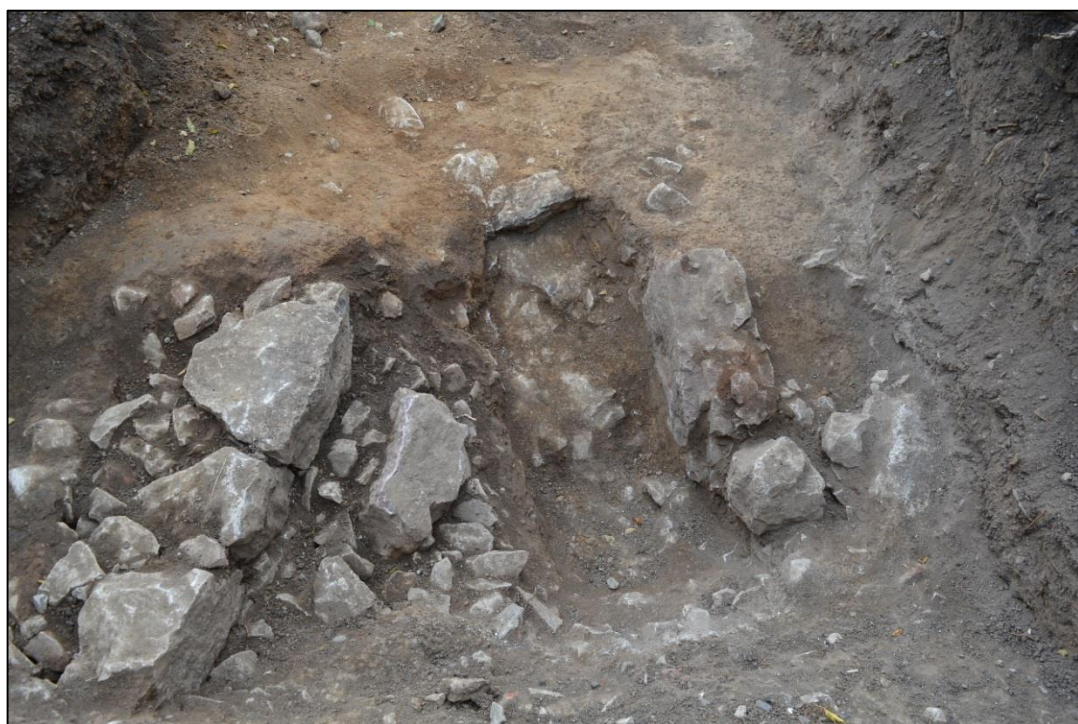
- 4.11. It appears that Test pit 2 had truncated a rubble filled void between wall (07) and the remains of a possible wall (09), truncating the wall trench cut (06) and revealing the east-west dipping limestone bedrock (18) in the process (Photo 7 and Fig. 6). The possible wall (09) comprised of two large limestone blocks, orientated north-east/south-west and was set into the natural subsoil (17). These blocks were butted by loose rubble fill (10), very similar to (08). Immediately south-west of this possible wall (09) and rubble (10) were two cut features (11) and (13) with late post-medieval fills (12) and (14) containing pieces of clay pipe and pottery. These were cut into the natural subsoil (17).

Photo 7. Overview of the limestone wall (07) and associated features showing the location of Test pit 2 truncating the rubble fill, revealing bedrock. CPAT Photo 4078-0041

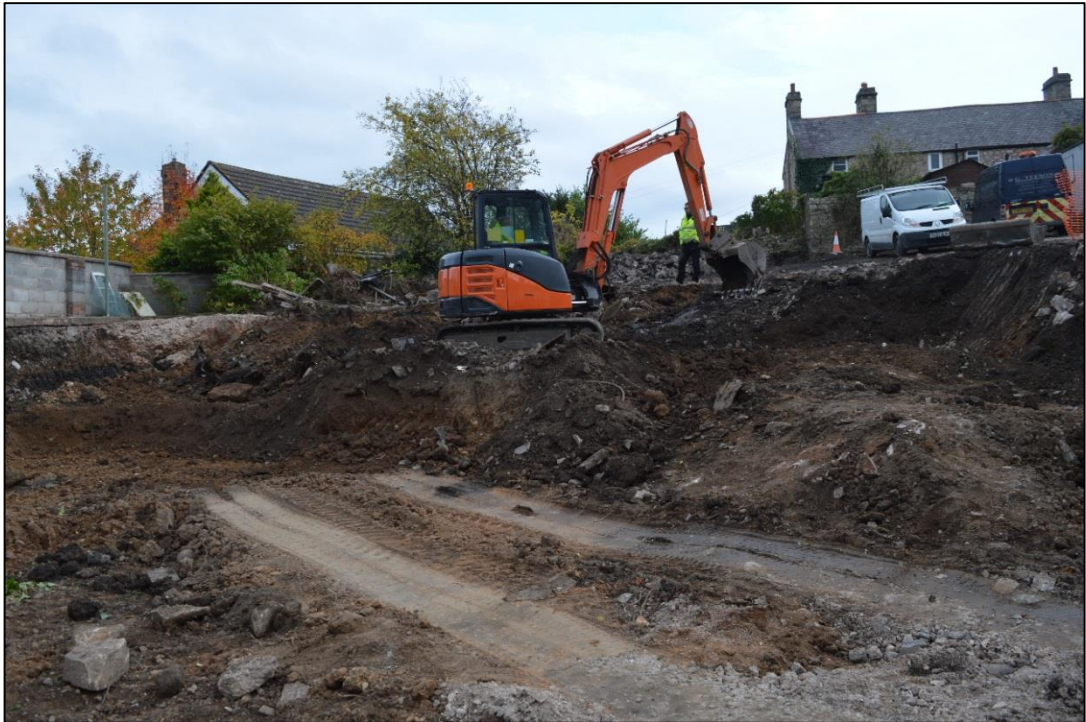
- 4.14. Ground reductions elsewhere on the site were limited to within the foot print of the demolished garage, and crucially beyond the modern north-east/south-west retaining wall. Here ground reductions revealed modern deposits overlying the boulder clays (17) (Photo 8).

Photo 8. Ground reductions in the eastern area of the site, beyond the (demolished) modern wall. Note the depths of modern deposits on the left side of the picture, at the north-eastern area of the site. CPAT Photo 4078-0045
