CPAT Report No. 1624

# Tremeirchion Churchyard Wall, Denbighshire

Archaeological Watching Brief

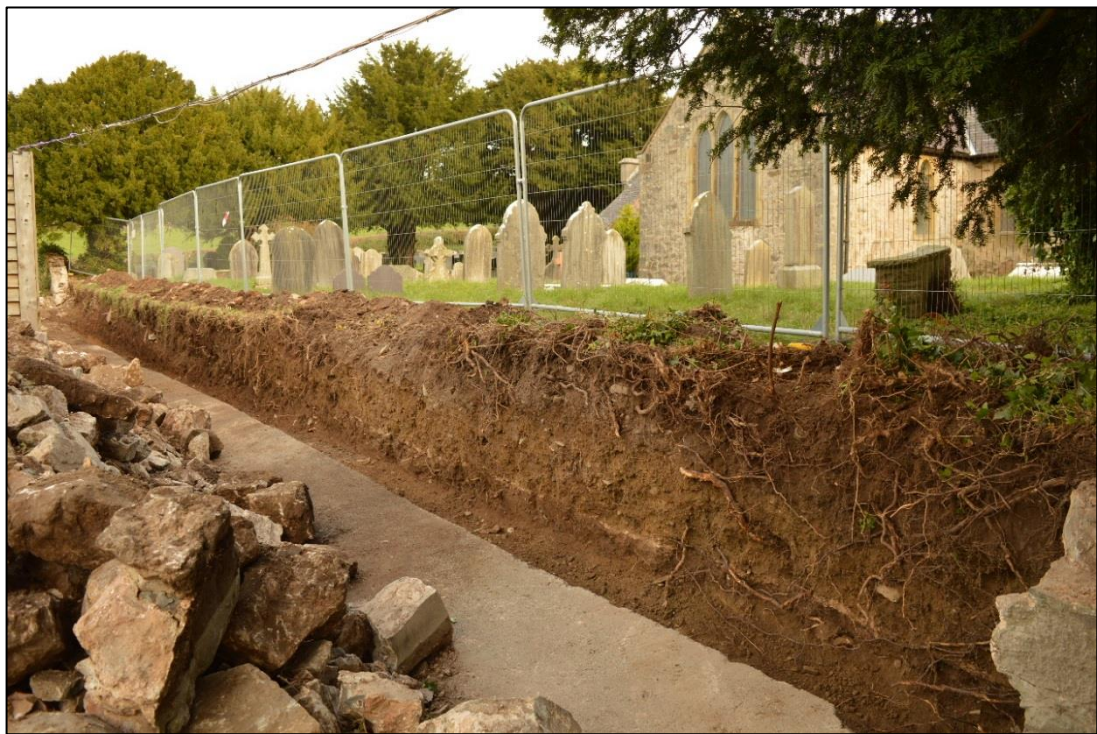
Fig. 3: The machine excavated trench for the new wall foundations, from the north-west. CPAT 4558-0009

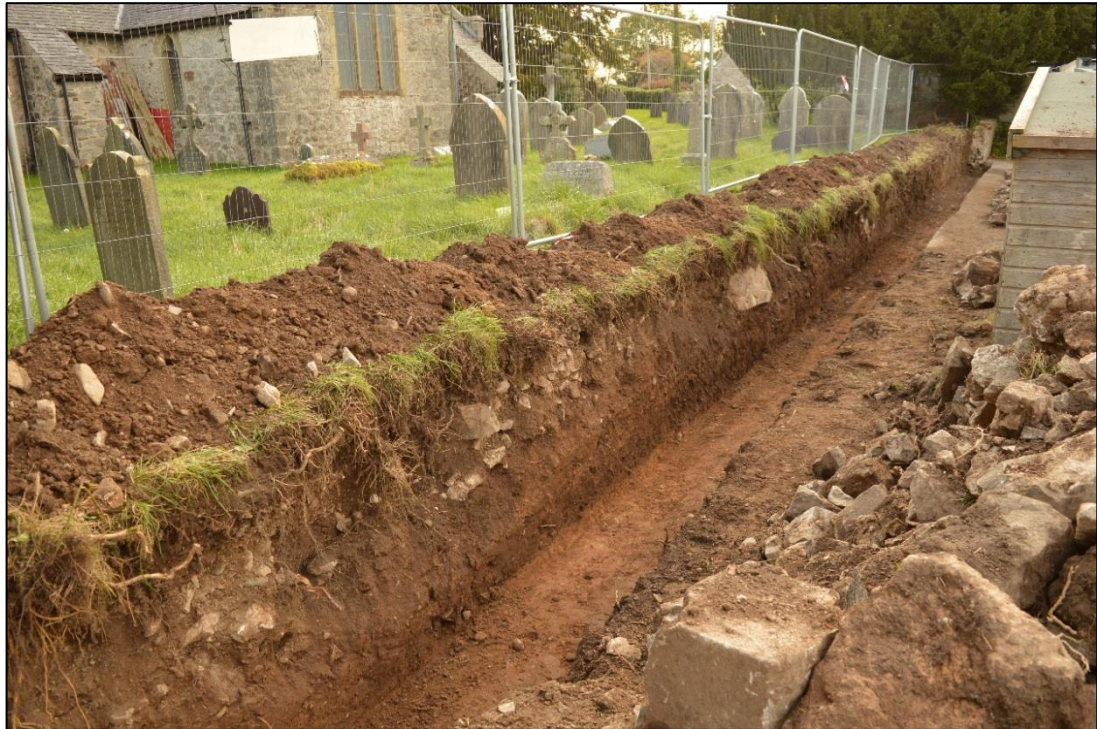
Fig. 4: The machine-excavated trench for the new wall foundations, from the north-east. CPAT 4558-0012

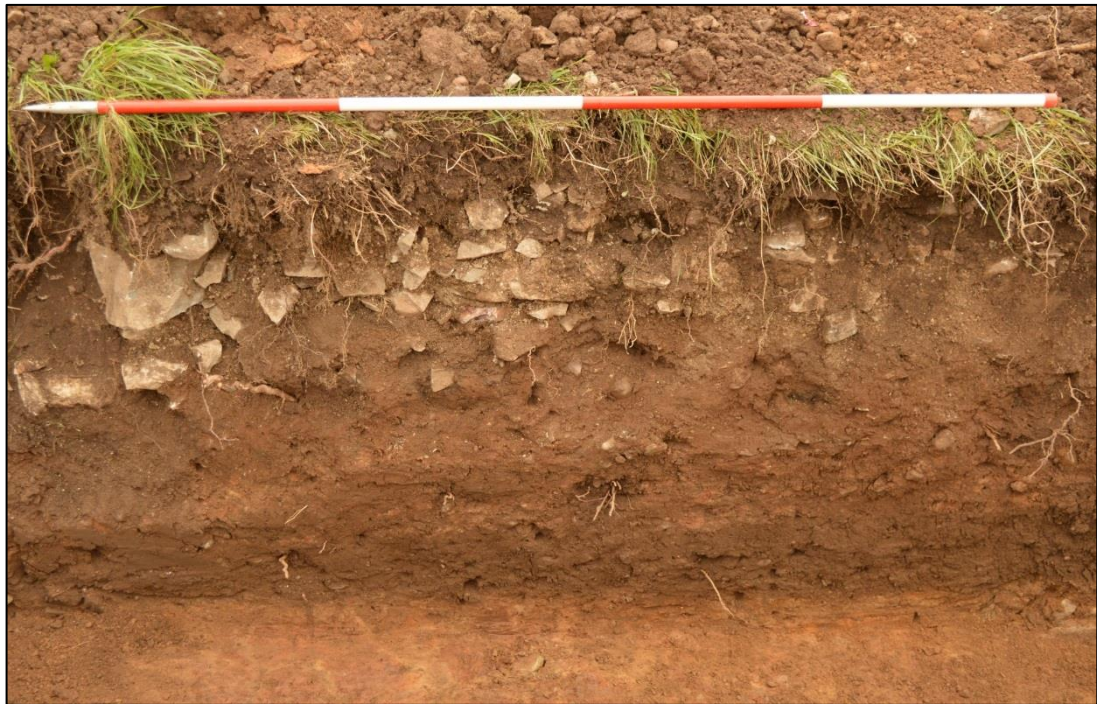
- 4.2. The section through the soils behind the churchyard wall revealed a sequence of deposits relating to the past history of that part of the churchyard and these are described in the following paragraphs and depicted on Figs 5 and 6. It should be noted that the thicknesses of the deposits vary and the maximum figures given do not all occur in one place; some are only present in part of the section.

- 4.5. Layer 5 was covered by layer of dark grey silt (4), which was up to 0.6m thick and contained a large amount of stone rubble and lime mortar fragments. A single fragment of purple slate was recorded, presumably from the quarries in north-west Wales, but this is not particularly helpful in dating the deposit as it is known that purple slate was being quarried there in the medieval period. One stone was 0.8m in length, but otherwise the stones were less than 0.3m in size. Some disarticulated skeletal material was also present within this layer and any that was disturbed was retained for later reburial.

Fig. 5: A section through the main churchyard deposits, with natural subsoil at the base and including the layer of demolition rubble (4). CPAT 4558-0007
