A.P.A.C. Ltd.

**ARCHAEOLOGICAL
PHOTOGRAPHIC SURVEY & WATCHING BRIEF
BSWB/BDH/18**

The Deadhouse, St. Cynog's Church, Boughrood, Powys

Boughrood Parochial Church Council

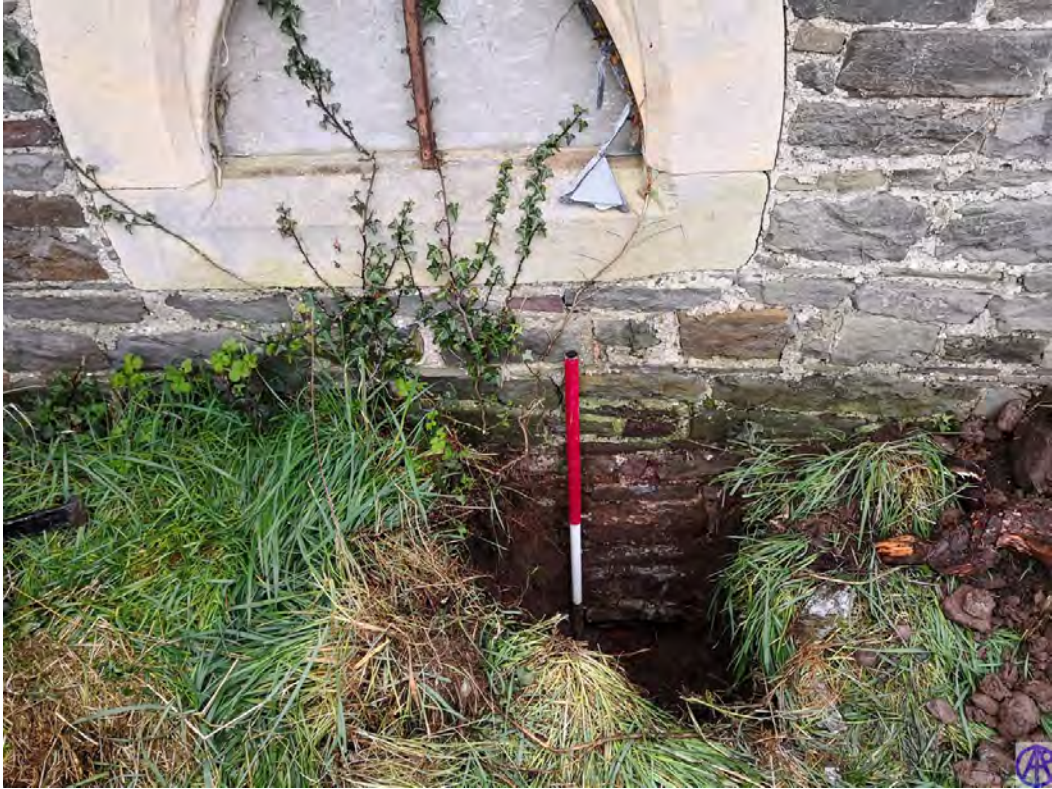
Plate 1: View of Trial Hole 1, Scale 1x1m

against the external face of the south-east facing wall (Fig 3, Plates 1 & 2).

The removal of 0.4m of turf and dark silt topsoil (001) revealed the top of a stoney red silt superficial natural deposit (002). This deposit continued in each trial hole to the final depth of 0.7m.

At a depth of between 0.65m and 0.7m the bottom of the structures foundation was encountered. The depth of foundations was deemed to be artificially deep owing to the raised ground level butting against the south-east facing wall. With the ground level of the churchyard at its original height in this location, a foundation depth of closer to 0.1m – 0.2m below the ground surface would be apparent.

The watching brief undertaken on the two trial holes has shown the structure to have a very shallow foundation depth, likely made to appear superficially deeper by the raised ground level in this area, seemingly associated with dumping of material at the base of the now removed tree adjacent to the south east facing wall.

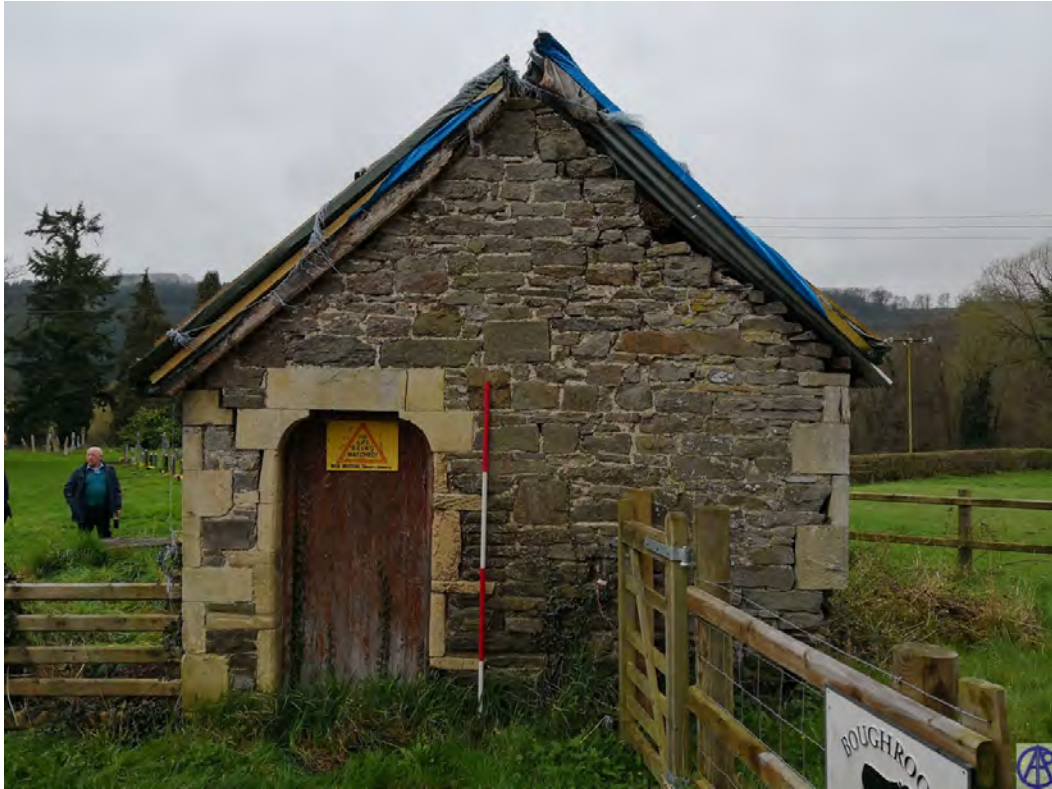
Plate 3: View of North-East Gable End External Elevation, Looking south-west
Scale 1x2m

The structure is aligned on a north-east to south-west orientation. The north-eastern wall has a single doorway offset from centre (Plate 3) whilst the south-western wall contains a single, central, doorway (Plate 4). Both doors are wooden and seem unlikely to be original.

The corners of the external wall faces, as well as window arches and door frame edges, are finished in a lighter, decorative, stone (Plates 3-8) mirroring that of the adjacent church and highlighting their contemporary construction dates.

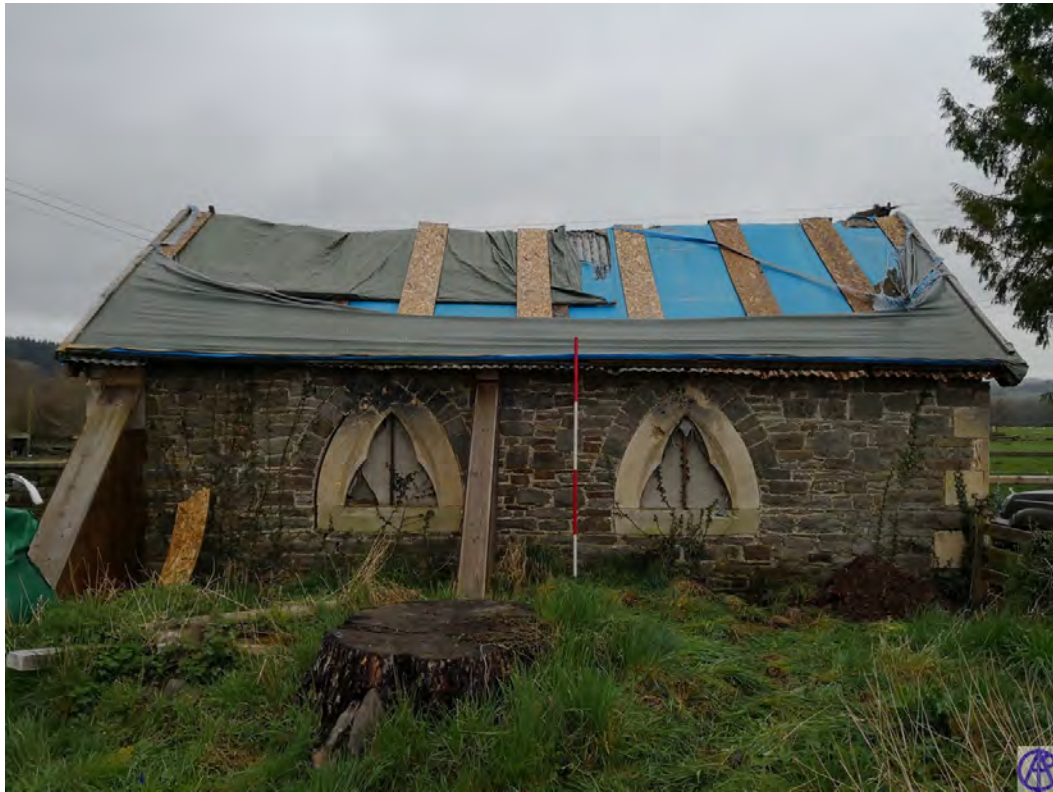
Plate 5: View of South-East External Elevation, Looking north-west
Scale 1x2m

The south-east facing wall contains two equally spaced arched windows (boarded, glass removed – Plates 5-7) of a very similar design to that on the adjacent church. The south-east facing wall also has two wooden buttress supports (Plate 7), modern additions to alleviate the evident structural cracking in the wall face. The north-west facing wall contains no features (Plate 8).

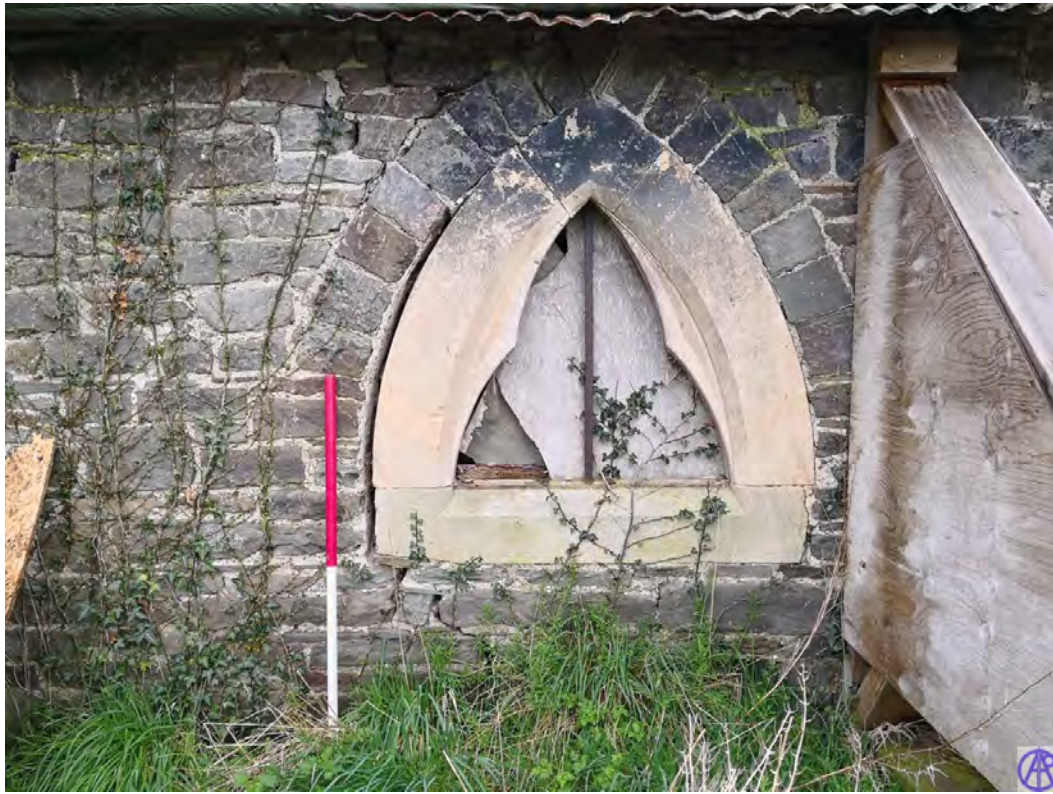
Plate 7: View of Second Decorative Window in South-East Elevation, Looking north-west
Scale 1x2m

The roof of the structure, likely originally tile or slate, has been replaced with corrugated sheet metal at some point which has since been patched with tarpaulin (Plates 7&8).

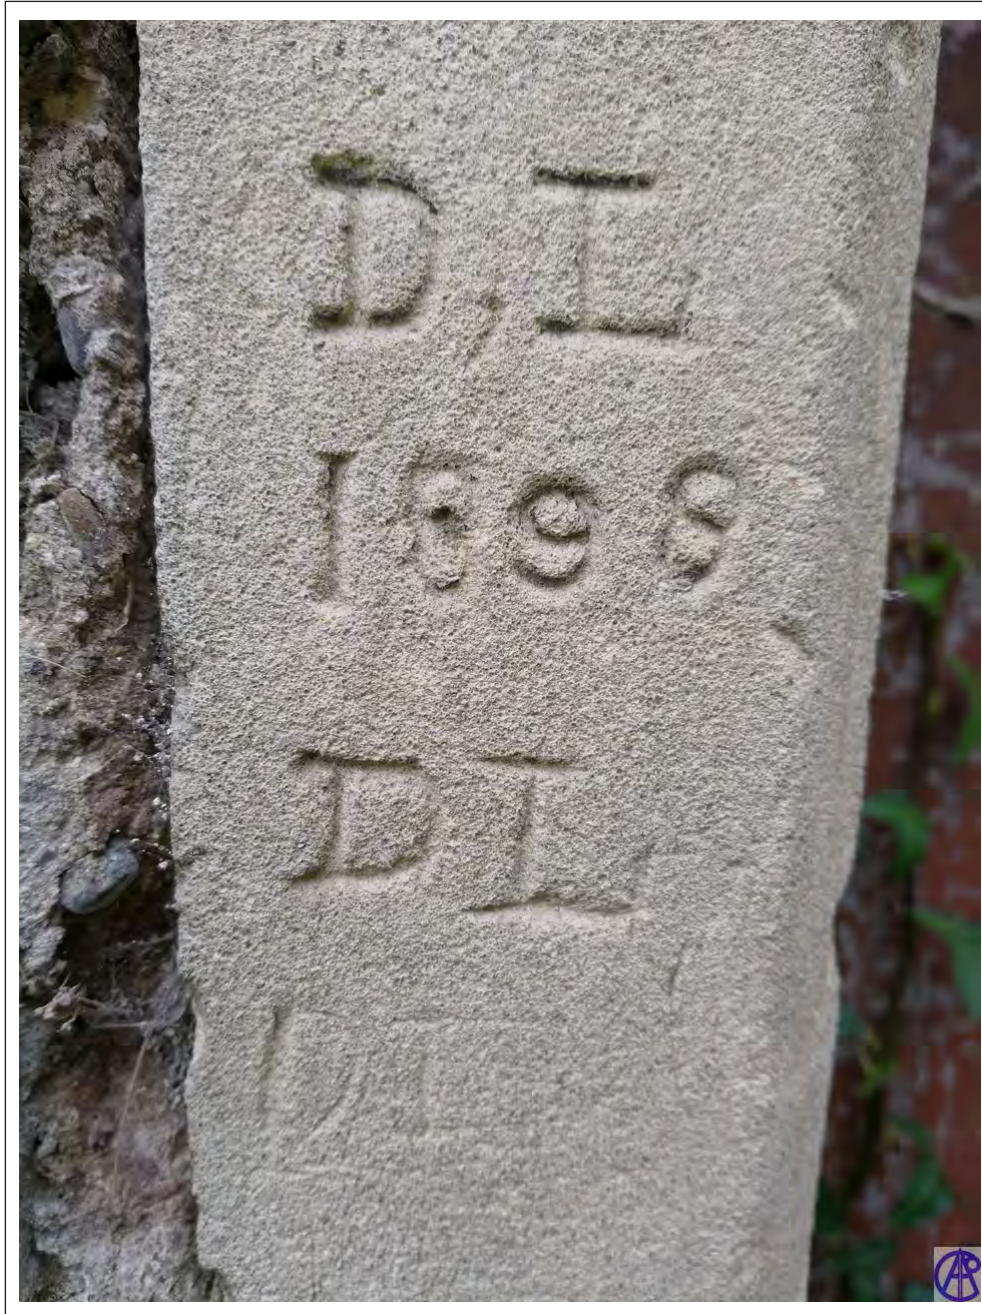
Plate 9: Detail view of 1898 External Graffiti

The north-eastern door and decorative stone surround shows a comparatively large amount of seemingly historic graffiti. Whilst much is faded beyond recognition two clear dates of 1898 and 1915 were identified (Plates 9&10).

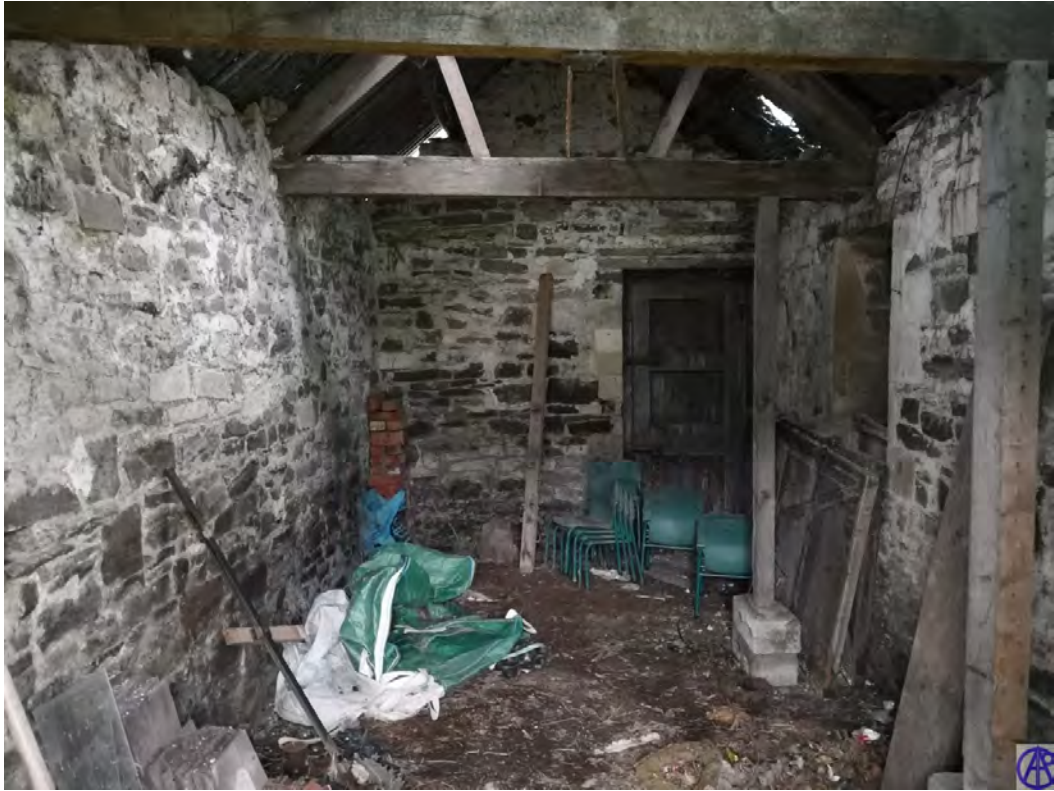
Plate 11: View of Internal Space within DeadHouse, Looking north-east

The internal space of the Deadhouse structure is a single open area with no internal partitions. The floor, where visible, appears to be earthen (Plate 11).

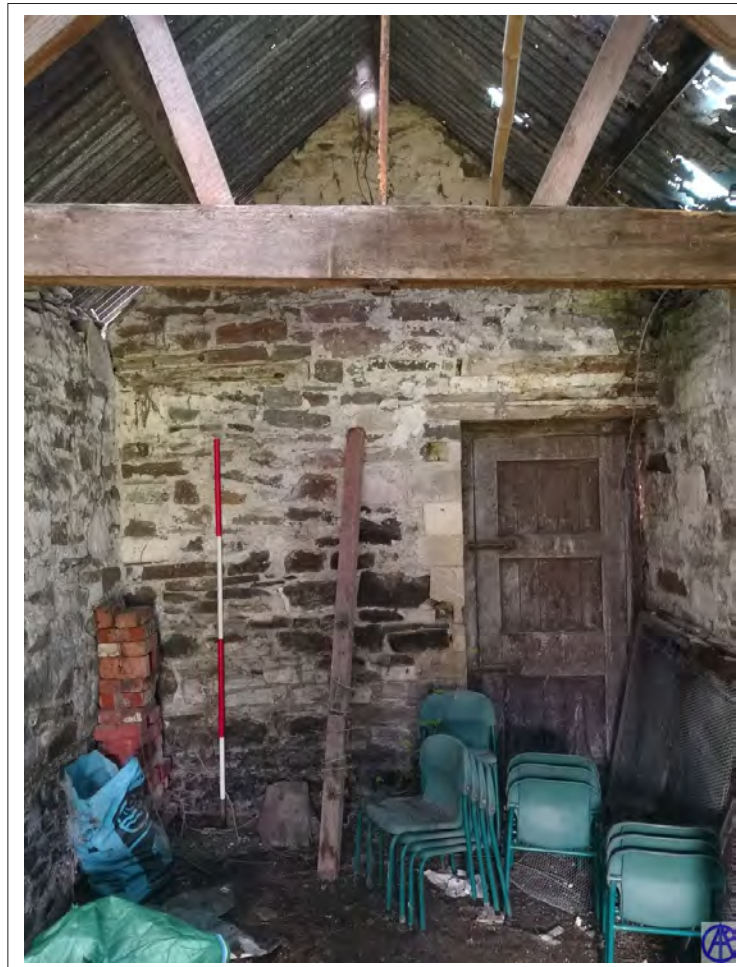
The internal faces of the end walls show no further features (Plates 12&13), likewise the internal face of the structures north-west wall (Plates 14&15). The two window openings set within the south-east wall have rectangular alcoves visible from the inside below timber lintels (Plates 16&17).

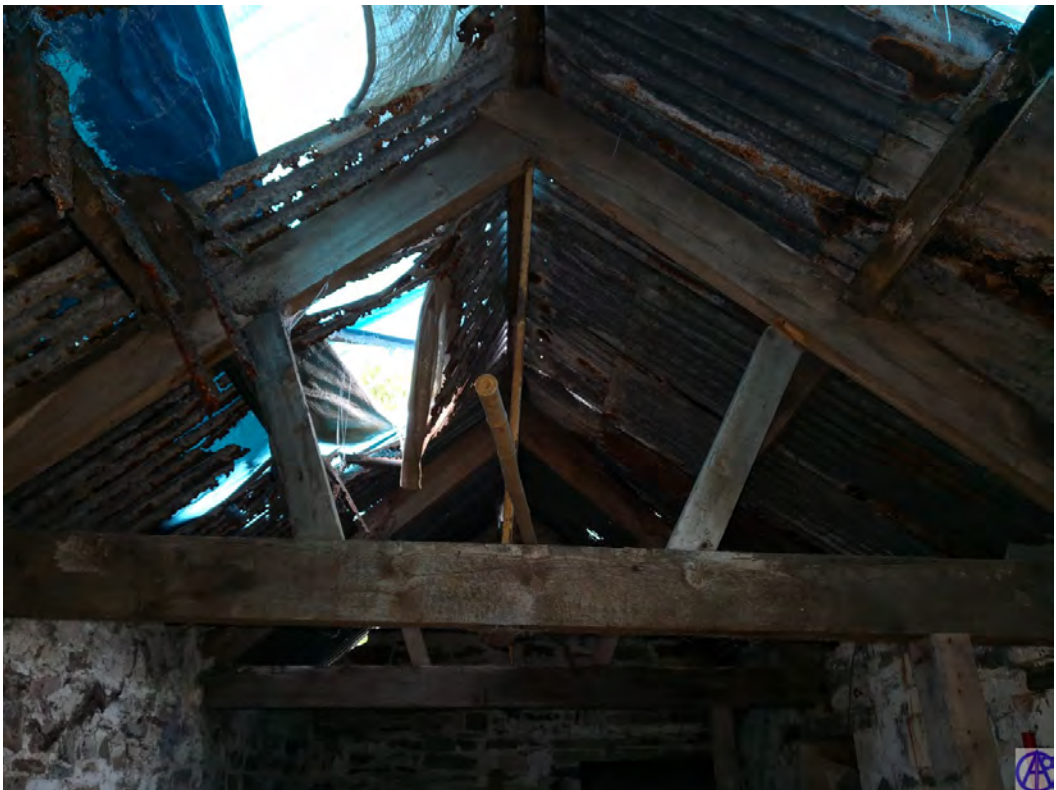
Plate 18: View of Roof Truss 1, Looking north-east

The roof is supported by both stone gable ends as well as two equally spaced timber roof trusses (Plates 18&19) sat within the top of the north-west and south-east walls. Both trusses are currently supported by additional, modern, props.
