## Plas Brynkir

Summer 2012 seasons, 12<sup>th</sup>- 30<sup>th</sup> August 2013 & Summer 2014.

Directors: Dr Mark Baker and Dr. Sarah K. Doherty  
School of History, Archaeology & Religion  
Cardiff University  
Humanities Building  
Cardiff  
CF10 3EU

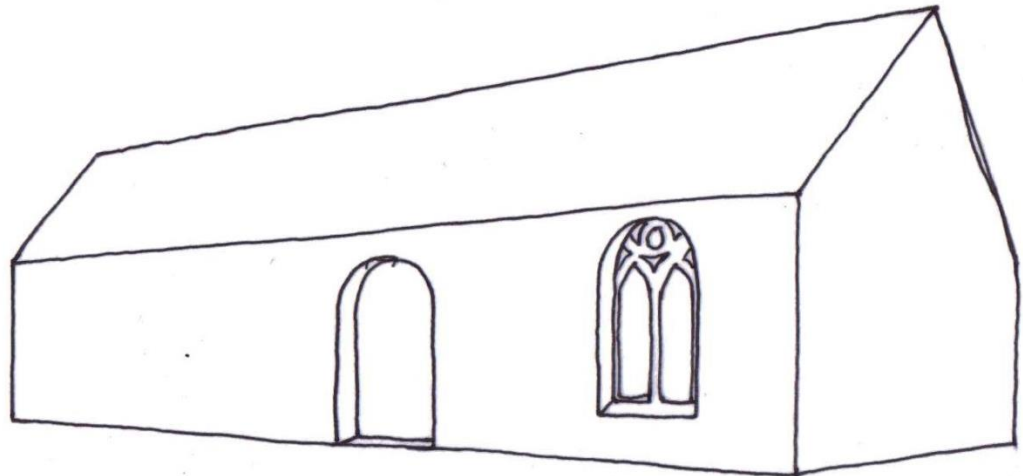
### **Phase 1**

A plinth of at least three courses, with shaped corners was constructed to create a platform onto which the hall was erected. This was graduated and the stones which were above ground level, and visible, support the argument that the front elevations, overlooking the gardens, were originally rendered. Medieval Welsh poetry refers to the houses in this area looking like lanterns in the hillsides. The earliest sections of the upper house are constructed out of dolerite boulders, most probably gathered from post-glacial scatter and roughly hewn to shape. There appeared to be very little evidence of tooling marks and it is likely that stones were chosen specifically due to their dimensions: larger boulders on the lower courses, decreasing in size as the wall height increases.

At roughly 2 metres from ground height, a ledge was observed internally, onto which a wooden roof or floor may have been supported. It was noted that all of the phase 1 building material stopped at this level.

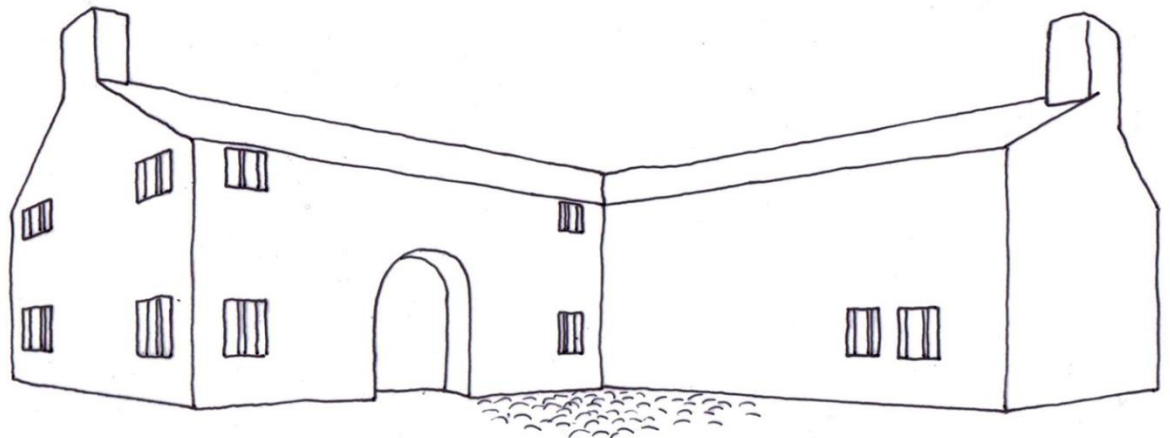
## Phase 2

At right angles to the hall house was constructed a large two-storey building with central doorway: parlour to the left and dining room to the right. On the garden gable-end, four small windows survive in their original size, and overlook the terrace gardens. The building of this 'Snowdonia Type' house is likely to have taken place during the last quarter of the sixteenth century.

The walls are constructed out of mudstone, identified by the Geology Department, National Museum of Wales, as being from the quarry site in Bryn Brain. The mudstone used cleaves naturally when quarried into rectangular blocks, easily moveable and usable for constructing walls of great height. Diagonal tooling marks were visible on all of the external mudstone. These marks may be part of the finishing process post-quarrying, or were used to create a surface onto which render/limewash could adhere. Some dolerite boulders were included in this building phase, but none were as large as those found in phase 1. Most appear to have been chosen specifically for their size, possibly being split. However, the markings found may be glacial marks, but it is likely that these were made more defined so that render could adhere more securely.

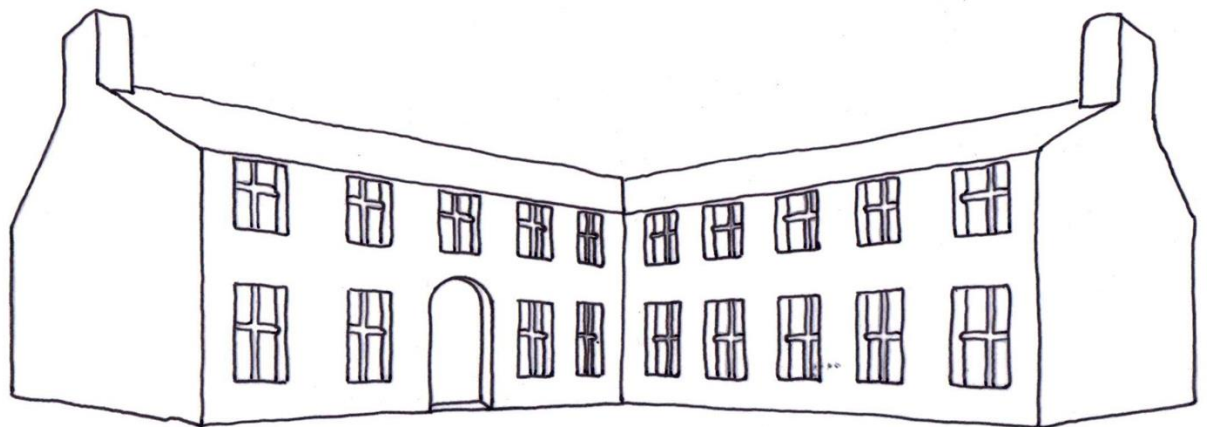
#### Phase 4

The staircase-tower was reconfigured and the entry blocked, indicating that it may have been an open-well stair, which was either filled in or was replaced with a dog-leg to fit into the altered space. Unfortunately, due to collapse, there is no evidence of window openings.

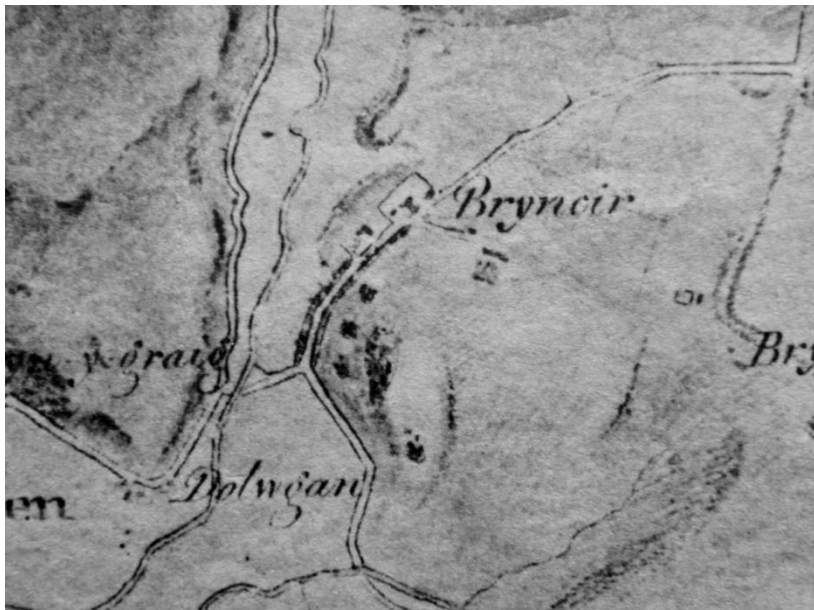
Figure 2 Surveyors' drawing of 1816 show an L-shaped building for the lower house with a circular turning area in front.

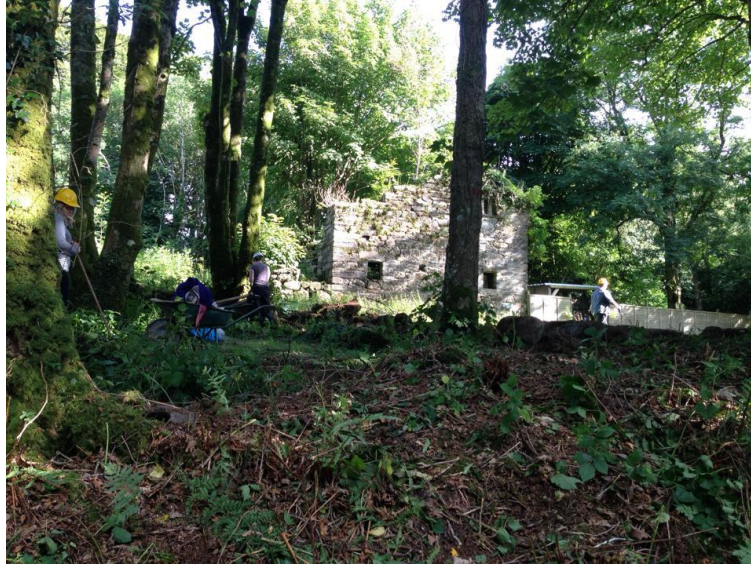
Figure 4: Clearing the terraces and ha-ha looking up to the Upper House from the lower terraces and possible bowling green.

However, being a ruin in varying degrees of collapse, with a lot of fallen rubble and potential for more, it had to be closely monitored for any changes or movement. All staff and students wore PPE at all times and were never allowed on the site alone. The site is also full of mature trees, laurel and rhododendron bushes making it in places quite hazardous and difficult to navigate. Much of the early 2012 season was taken up with the removal of as many plants, roots and immature trees as possible to make the site more accessible and to prevent further bioturbation (see Figures 4 & 5).

The survey close to the Upper House extended from the area in the angle of the two surviving wings, down the slope across the terraced path features, across a revetted ditch and bank and onto the present mini-football field (see Figure 4). The principle anomalies (see Figures 8 & 9) are interpreted as:

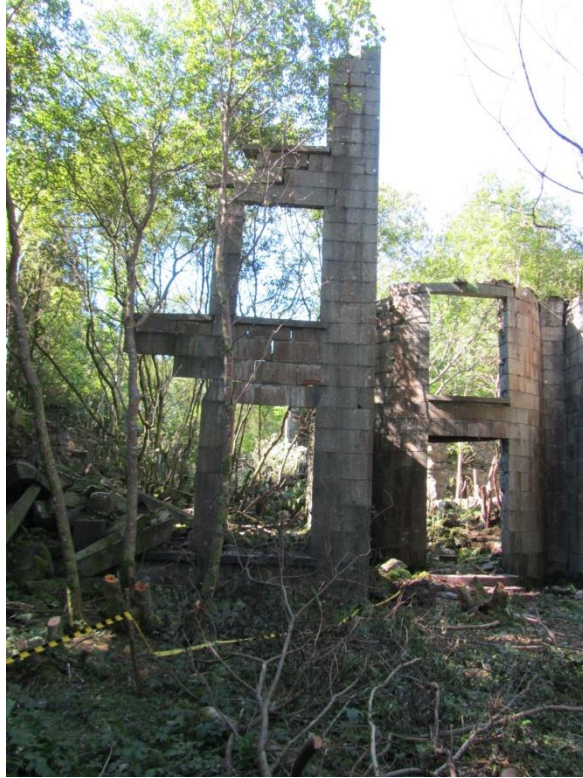
**Figure 5:** The Ashlar facing rear entrance of the Lower House under threat from young trees. Photo: S. Doherty

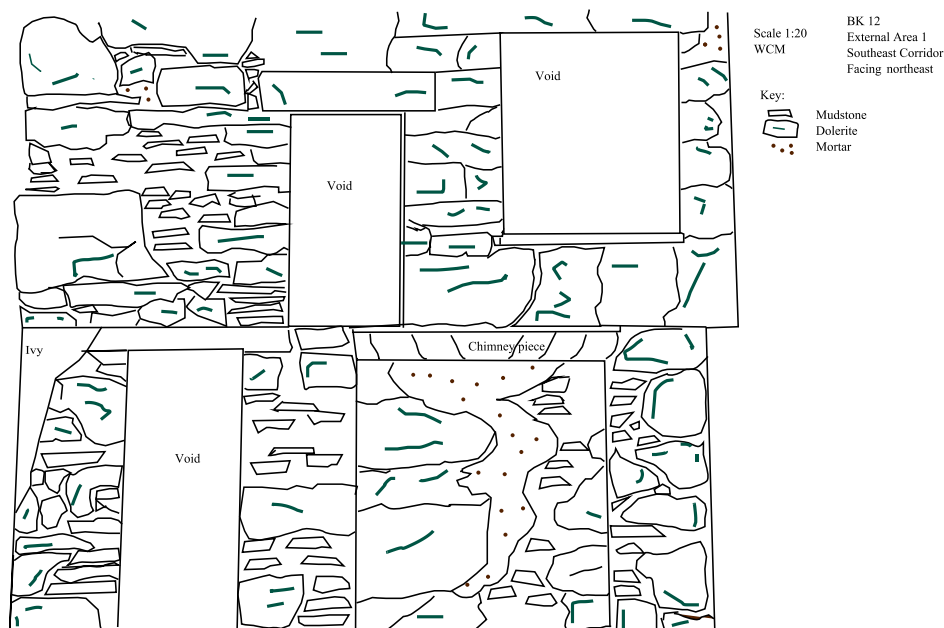
Figure 6: Elevation plan of External Area 1 of the Lower House showing two stories, window and doorways. Drawing: WCM and digitised by S. Doherty

the Napoleonic Wars<sup>14</sup>. The buildings survey of 2012 focused on the Lower House, with detailed scale plans, elevations and a stone-by-stone survey undertaken by each of the students who were designated a particular section of the house to work on in groups of three (see Figure 6). These revealed that the house was multi-phased with an initial regency villa, added to a wing at 45° (at same angle as the Upper House) and ashlar dolerite facing over the back of the house added during the 19<sup>th</sup> century, and a circular cellar was constructed, likely when Captain Joseph Huddart bought the house<sup>15</sup>. In the 20<sup>th</sup> Century Roman Cement was added to the front of the house, with three “day” marks visible. His son, Sir Joseph appears to have taken on the estate in 1816 and built the surrounding estate buildings, a bridge, the servants’ quarters and the tower (see Figure 1) to commemorate the visit of George IV who knighted him. In 1903 the estate was sold to the Greaves family who added a billiard room and added to the gardens. The estate was mostly used for hunting and shooting parties. In 1945 it was sold to local farmers who commenced asset stripping the estate, including removal of the roof.<sup>16</sup>

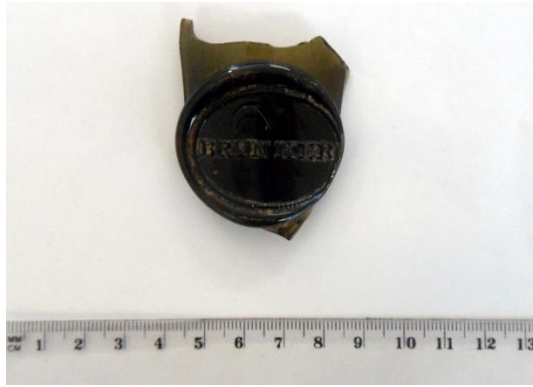
Figure 7: Bottle stamp with the “Brynker” family name detail. BK13/066. Photo: S. Doherty

All five trenches had two layers above the undisturbed archaeology: a layer of topsoil of up to 30 cm in place, which covered a layer of demolition and collapse material that was up to 1m in depth. Within the later were found large pieces of fallen masonry and roofing slate, which due to its compact nature, meant that removal took longer. Finds uncovered in the rubble layers probably related to the dwellings use as a garden feature in the 19th century according to the 1899 sales catalogue. Notable finds included a perfectly preserved clay pipe was found with the decorations and manufacturers mark intact, dating from 1860-1900, and a wide range of domestic glass and pottery finds also of similar periods. In the deposition levels, bottle stamps with the 'Brynker' family name intact on them were also found (see Figure 7).

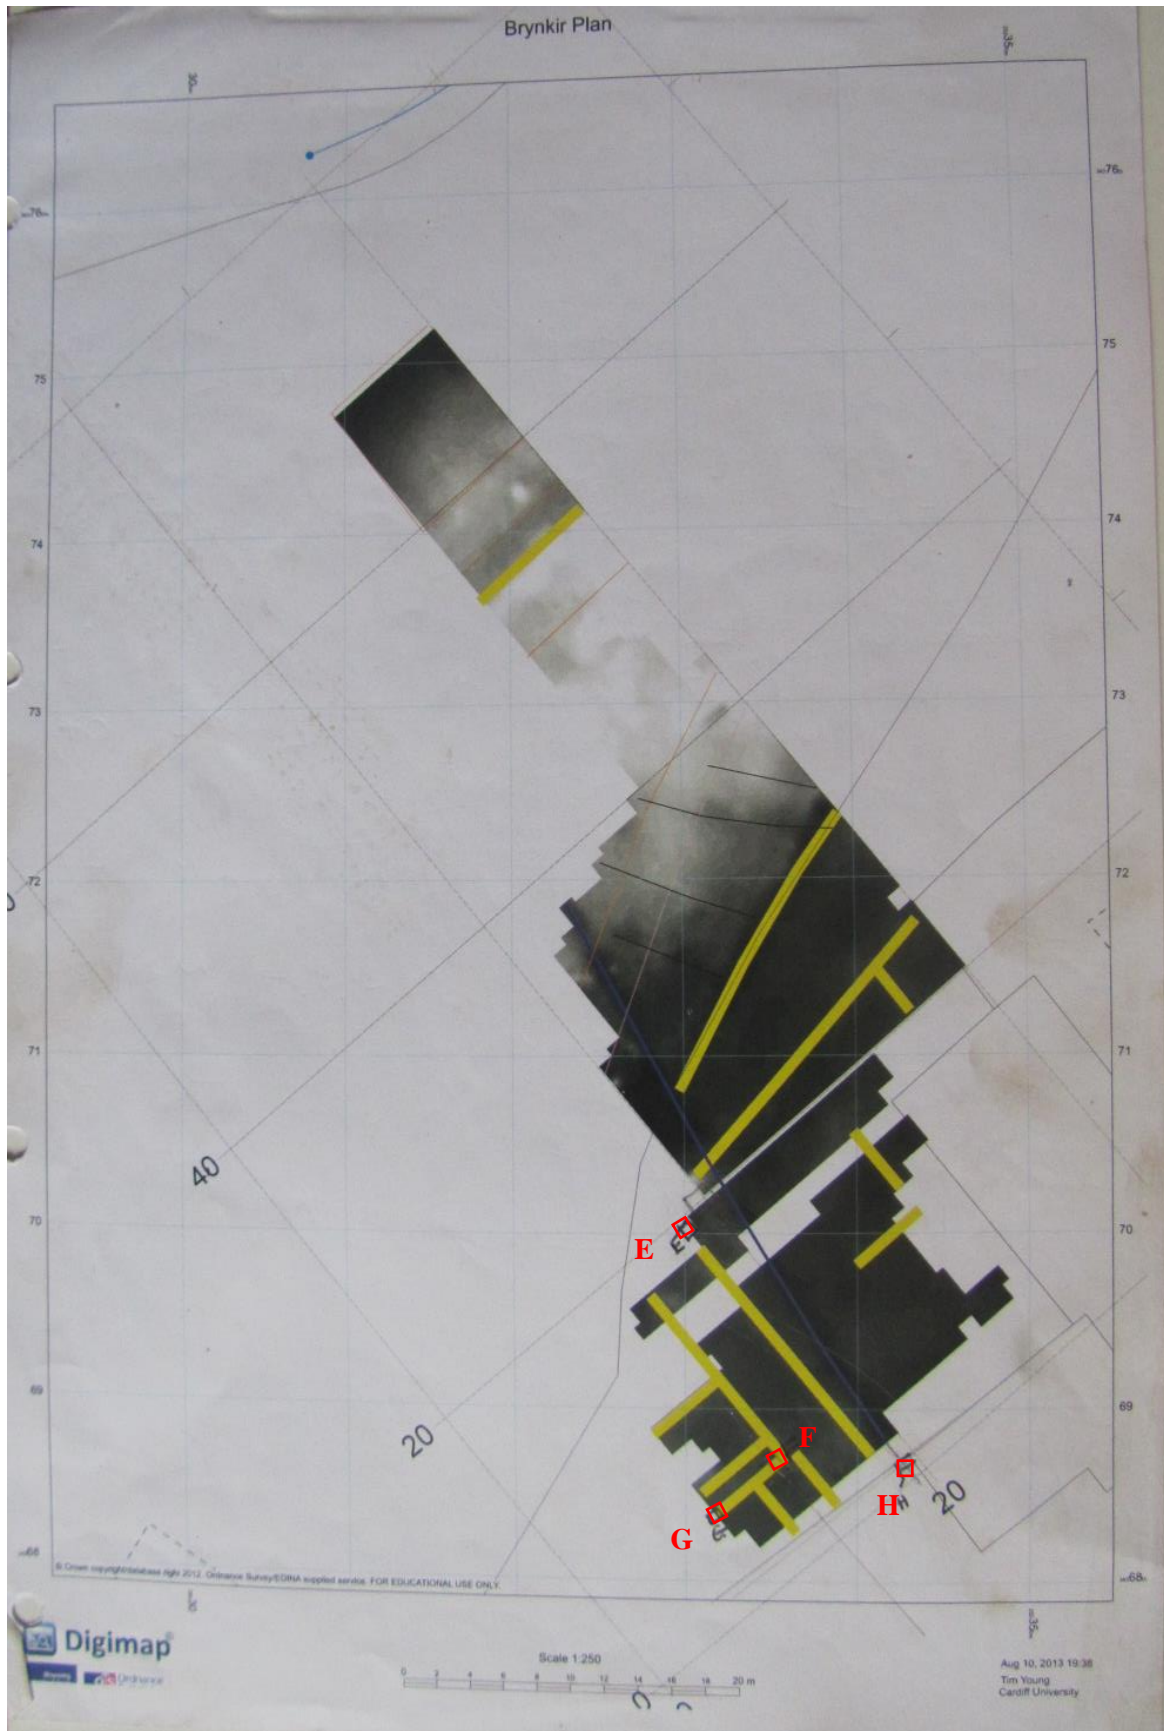
Figure 9: Plas Brynkir. Ground resistivity data as images from *Surfer*, 0.5m probe spacing, located on modern basemap. Upper House data shown with greyscale 180 ohm measured resistance (black) to 320 ohm (white). Yellow indicates possible walls underneath the surface. Trenches E- H are indicated in red squares. Basemap © Crown Copyright 2013, Ordnance Survey/EDINA supplied service. After Tim Young "Geophysical Surveys at Plas Brynkir, Gwynedd" GeoArch Report 2013/18 (unpublished report 2013).

Many show at both 0.5m and 1.0m probe spacings, but some do not appear on the wider spacing – either indicating they are relatively shallow features, or that they are less differentiated at depth (e.g. the wall of a room may be more differentiated from its surroundings above floor level and in the footings, then it is at floor level). Positive resistivity anomalies may be generated by, for instance, stone-built drains as well as by walls so some circumspection is required in assuming all these anomalies indicate walls<sup>10</sup>.

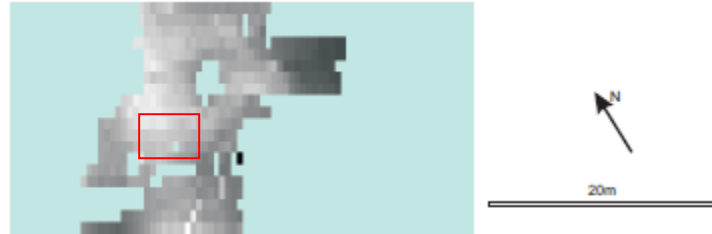
Figure 10: Plas Brynkir, Lower House. Ground resistivity data as a bitmapped images from *Geoplot:d*. 1.0m probe spacing, despiked data greyscales: 450 ohm measured resistance (black) to 50 ohm (white) for 0.5m probe spacing and 400 ohm measured resistance (black) to 600 ohm (white) for 1.0m probe spacing. After Tim Young “Geophysical Surveys at Plas Brynkir, Gywnedd” GeoArch Report 2013/18 (unpublished report 2013, fig 3d). The 45° anomaly is contained within the red box.

As outlined previously, the resistivity evidence for the Lower House was not as clear as the Upper House. The exception was a linear anomaly running at 45° to the standing range of the rear entrance of the house (see Figure 10), with surrounding garden features.

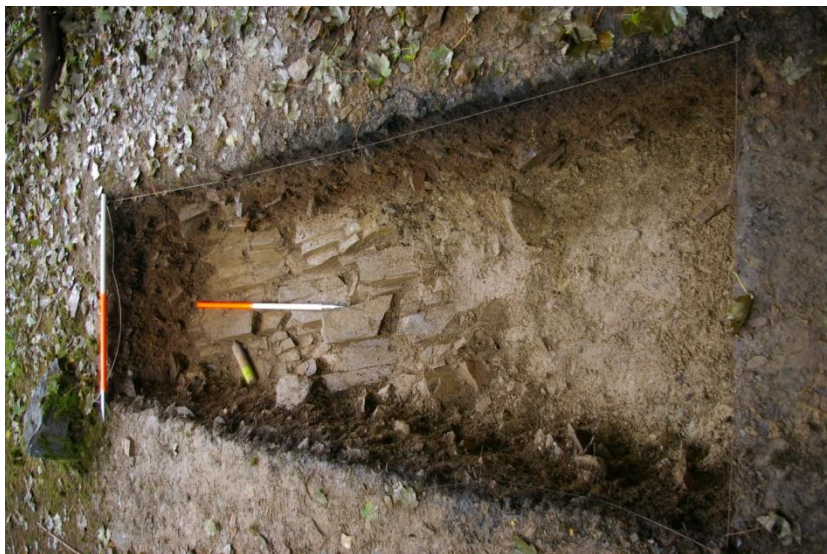
Figure 12: Trench C, showing the mudstone “quarry” layer [170]. Scale 2m.

Trench C was in a really soggy part of the site, under the lees of the standing buildings and heavy tree cover, devoid of sunlight, yet proved to contain the likely remains of a quarry for mudstone to the Northeastern end of the trench. The upper layers were extremely waterlogged, and no doubt the impermeable rock layer c40cm below was the cause. The soil contained various lenses of burning, and several large pieces of mudstone, probably the result of the partial collapse of the surrounding buildings. In the 1940s, the Lower House had been asset stripped, and most of the surrounding trees were felled. It is possible that these burning lenses represent this phase, as they were just below the topsoil layer at c10cm.

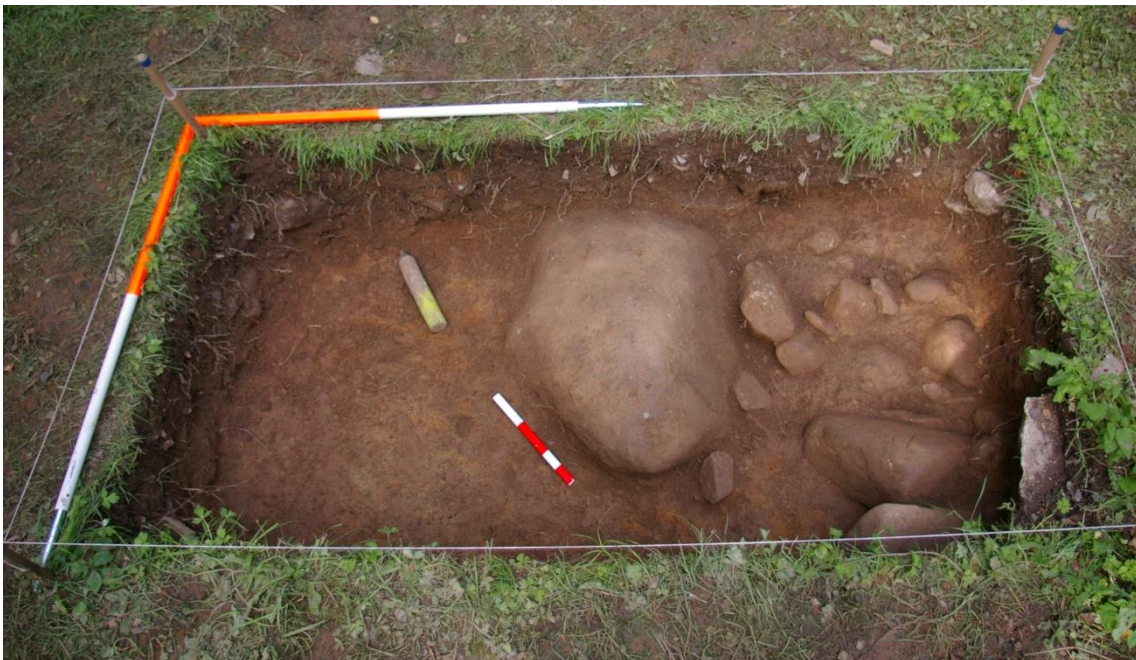
Figure 14: Showing large basal stone [132] with the mudstone and dolerite packing [135] of the wall [131] in Trench F. Scales 2m and 0.5m. Photo: S. Doherty

Trenches E-I were excavated in the Upper House within the archery range of Cwm Pennant Hostel, most at 1x2m, apart from G and H which were test pits at 1x1m. Trenches G and I were sterile, but like Trench B served to show the geology of the area. The natural again proved to be a thick orange clay interspersed with pebbles. Trenches E and F seem to confirm the existence of a wall, with a large dolerite basal stone [132] 0.5m wide and mudstone and dolerite rubble packing emerging in trench E

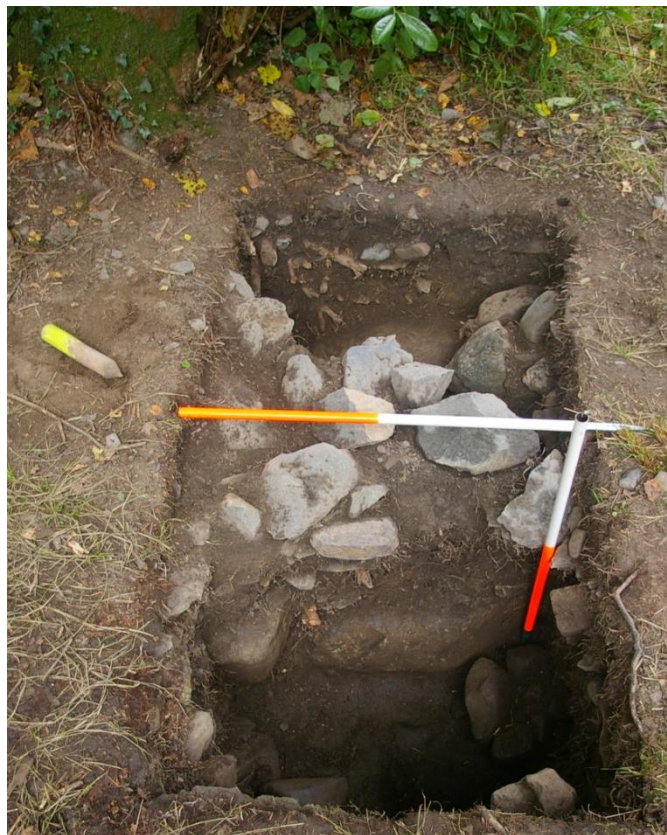
Figure 15: Showing wall [156] of trench F, contemporaneous with wall [131] of trench E as it appeared to run along the same lines.

Trench F demonstrated that rather unusually, the walls of the gatehouse and courtyard must have formed a parallelogram rather than a rectangle (which was generally the preferred choice e.g. at Dolbenmaen). The wall [156] like that of trench E's wall [131] contained large dolerite basal stones in

they would not have been easily moved. The mudstone rubble however, could easily be removed by hand. Indeed, most of it seems to have been reused for the rubble wall of the ha-ha and other 19<sup>th</sup> Century walled features contemporary to the Lower House.

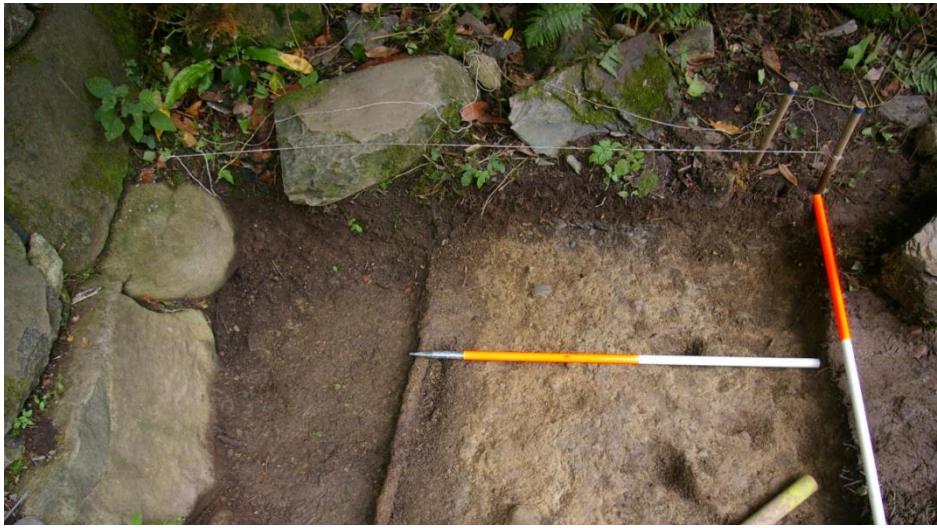
Figure 17: Detail of the gravelled surface [147] overlying orange clay [140]. Photo: S. Doherty

Figure 16: Plan of Trench H, showing modern water pipe [151] next to the basal stones of the 15<sup>th</sup> Century Hall and the orange clay [140] underneath the gravelled surface [147] containing post holes or more likely “stone hollows” from the gravelled path. Photo: S. Doherty

Trench H abutted the corner of the 14<sup>th</sup> Century core “hall” house. It proved to contain the 1945 water pipe apparently used by semi-permanent squatters at the site, so the trench was somewhat disturbed. However, just beneath the topsoil, the remains of a gravelled surface were revealed just over 1m away from the corner of the hall. It appeared firstly in section overlying the natural orange clay, but a small sondage to the southeast revealed the detail (see Figures 16 and 17).

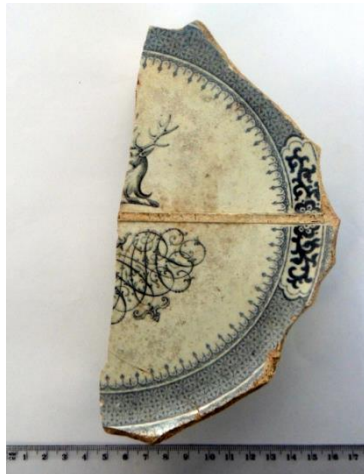
Figure 18: Pottery dish detailing the Brynkir Crest from the underneath the door threshold slate in trench I

Trench I focused on clearing and cleaning the main “Renaissance” period doorway of the house in order to ascertain the different phases of the household and the various improvements on doorway indicated by the estate records. The doorway was apparently narrowed in the 17<sup>th</sup> Century and new windows put in. This proved to be the case, a building break was discovered in the doorway, and an earlier threshold stone was revealed containing a dolerite foundation. By contrast, the 17<sup>th</sup> Century doorway was covered by a threshold stone of slate. During the 2012 season, a 17<sup>th</sup> Century pottery plate with the Brynkir Crest had been uncovered underneath this threshold, giving a useful terminus post quem for the entranceway.

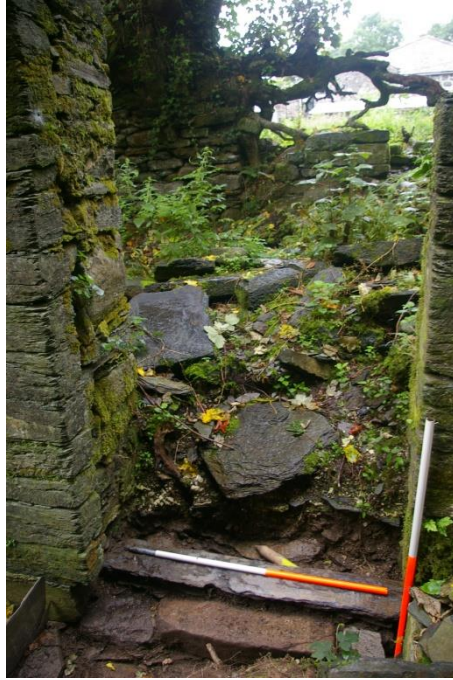
Figure 19: Trench I. The Doorway of the 17<sup>th</sup> Century hall, showing the slate threshold (where the ranging pole is resting) sitting on top of the earlier dolerite threshold stone. Notice the squared mudstone “Renaissance” wall in front of the earlier uneven wall. Photo: S.Doherty.

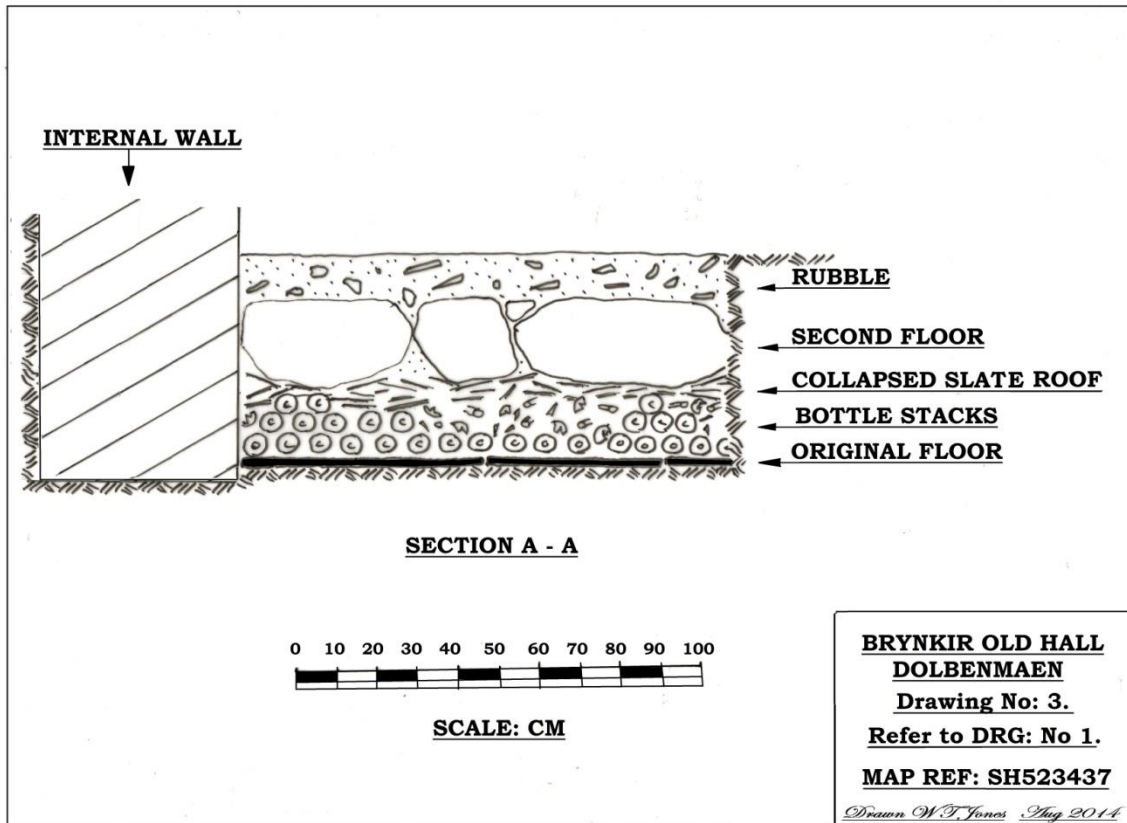
Figure 20: Section of the Upper House Trench during the 2014 season showing the original floor, stacks of bottles and the collapsed floor slate roof with second floor blocks overlaying it.

The 2014 season consisted mainly of one trench 5m long and 1m wide from NW to SE in front of the inglenook fireplace, see Figure 2. The only difference between the Royal commissions survey and ours was that a spiral staircase had been found, which had been built during the original construction of the fireplace. Also a second floor, very roughly constructed had been laid on top of a fallen roof which had fallen on top of rubble and stacked bottles. This floor may have been made to house animals due to the rough way they had been laid, and because large gaps in the floor this suggests that it may never been completed. The original floor needs more excavation to determine its date (see Figure 20).

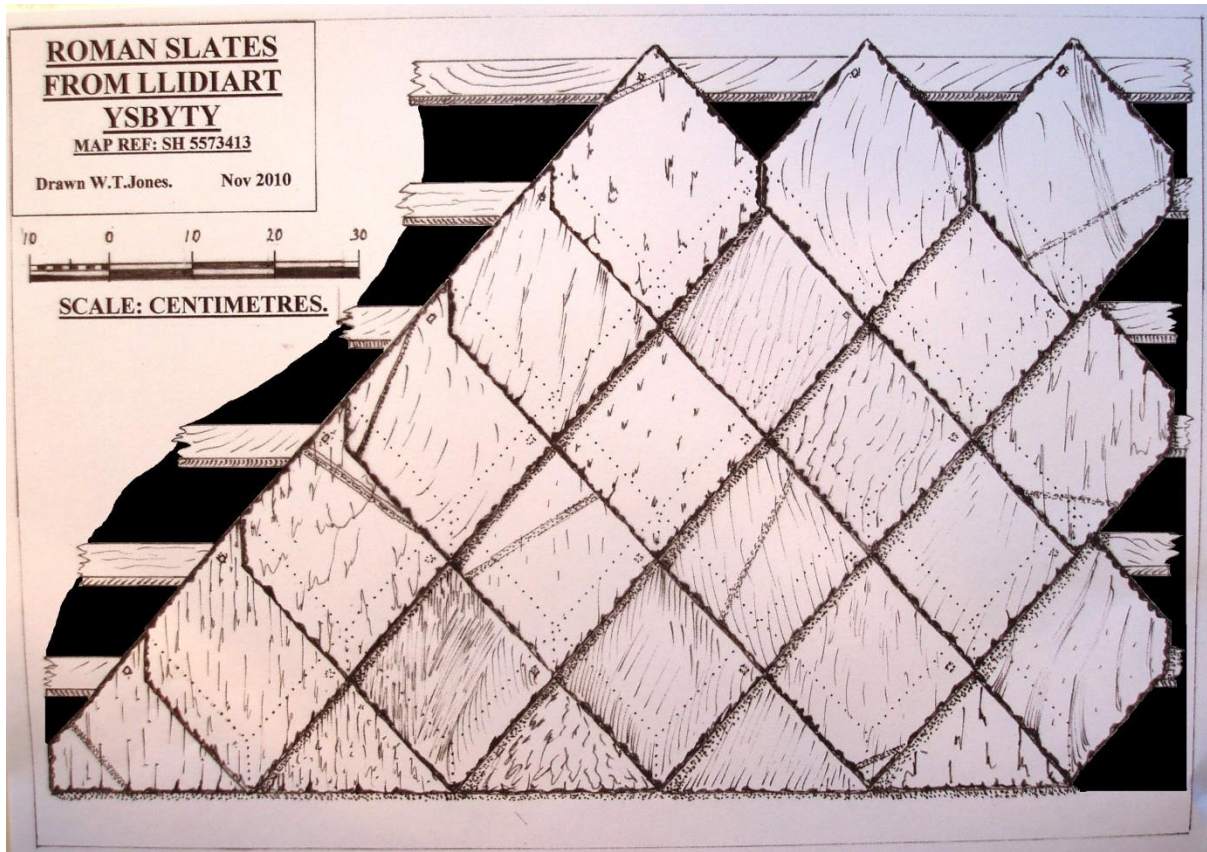
Figure 20: Roman Slates aligned on the roof of the Llidiart Ysbyty. Drawn by W. T. Jones

Slates have been quarried in North Wales at least since the Roman period and probably much earlier. Hundreds of these slates have been found at Tremadog, during the construction of the Porthmadog bypass. All are of a uniform hexagonal shape, with a square hole for the hand-made nail, off-centred at the top; from the pointed bottom to the hole is nearly one foot, equivalent to a Roman *pes* (see Figures 20 and 21).

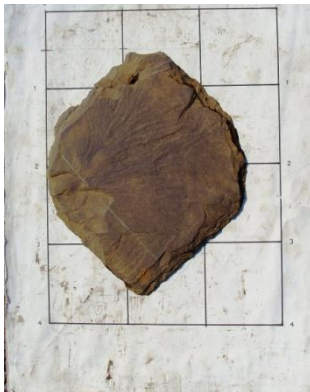
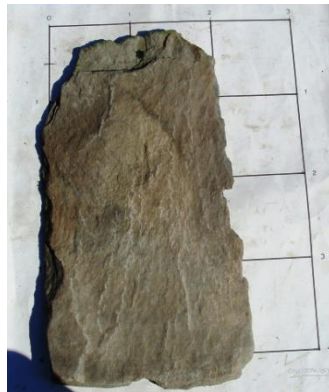
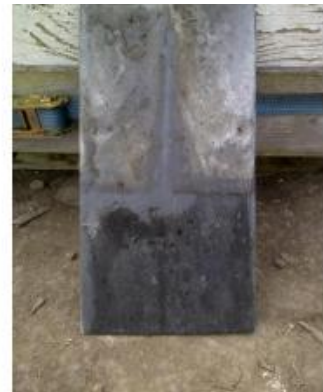
Roman slate

Welsh Moss slate

Modern slate

Figure 21: The Different types of slate found in North Wales. Photos: W. T. Jones

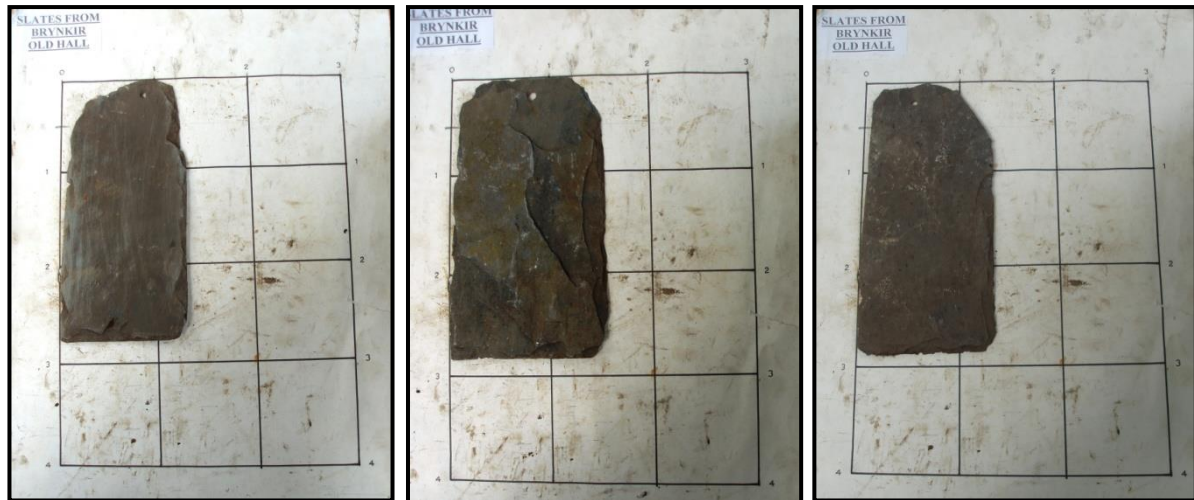
Brynkir slate from the left hand side of the roof

Brynkir slate from the centre of the roof.

Figure 22: The slates found from Brynkir Upper House showing the positions on the roof. Photos: W. T. Jones

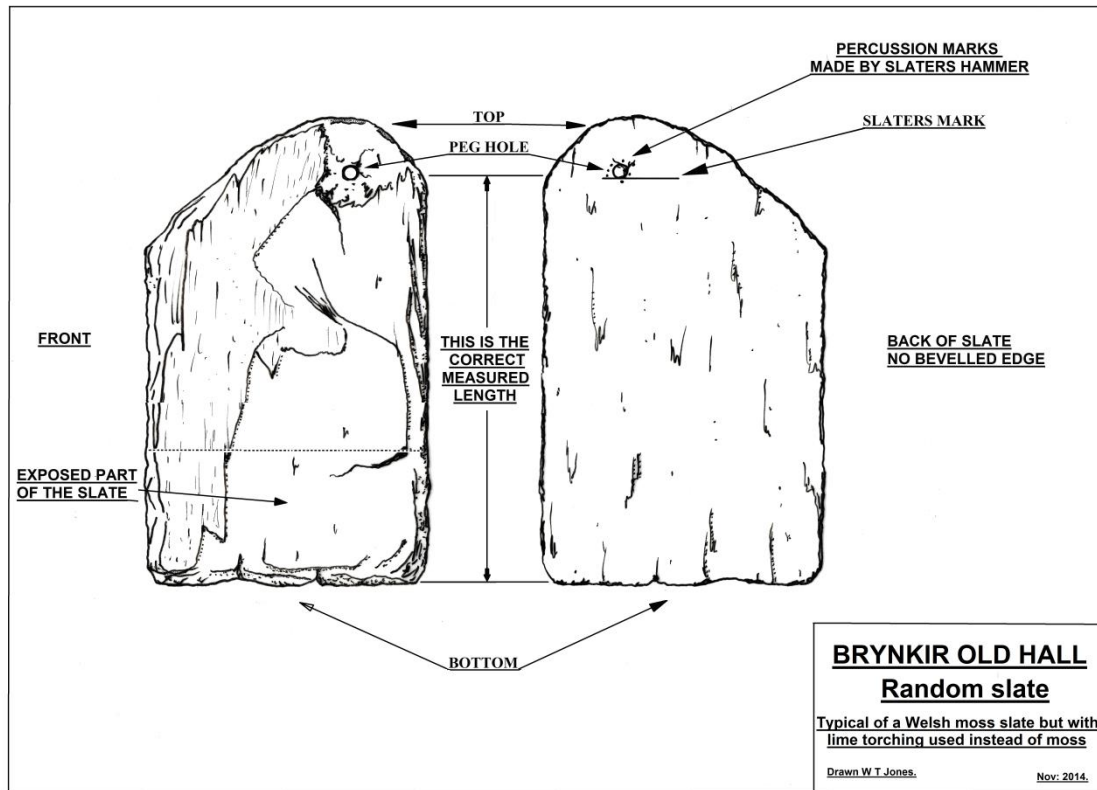
Figure 23: A random slate selected from the 2014 excavations at Brynkir, similar in shape to a “Moss” slate, but using lime torching instead of moss. Drawing: W. T. Jones

The majority of the early roofing materials were hewed from local mudstone tuffs at first, and then from slate outcrops. The slates would have been hewed roughly where they were, before being hauled to the site. The next process would have been to grade them by size and thickness. The biggest ones would have gone on to the eaves and then diminishing in size towards the ridge. All the slates that were found at the site were of the sort known as moss slates or, *Llechi mwsog*, sometimes referred to as ‘diminishing courses’, ‘peggies’ or ‘randoms’ (see Figure 21). On closer examination, they were found to be anything but random, as they had a specific pattern and purpose. These roughly hewed slabs of stone make for an aesthetically pleasing roof, though this involved more work than meets the eye. Once on site, the slates were treated differently, depending on whether they were to hang on the left, in the middle, or on the right hand side of the roof. The slates on the left hand side of the roof would have had the upper left hand corner chopped off, (see Figures 22 and 23), and then the exact measurement from the bottom of the slate to the peg hole would have been marked with a slater’s rule, *pric mesur* (Figure 24), and a hole made on the top right hand corner of the slate. This hole was driven from the underside of the slate with the spike on a slater’s hand trimmer, a *cylllell bach*. (See Figure 25). Pock marks made by this hand tool can be seen at the back of the slate around

the peg hole, also the scratch mark made by the slater's rule (a pric mesur) denoting the exact location of the peg hole. More research has allowed us to follow up this scratch mark, back to the Roman times 2000 years ago, when it was used by their Slater to mark the position of the nail hole<sup>24</sup>.

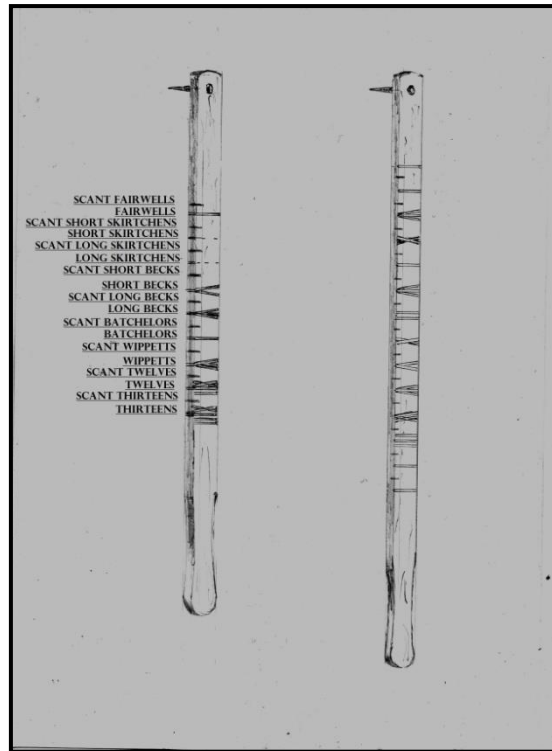
Figure 24: The slater's rule or pric mesur, the tool that gave the finished roof its aesthetic qualities. The exact location of every slate was determined to within a half an inch. Drawn by W. T. Jones.

The position of the peg hole would be determined and marked with the slater's rule, the *pric mesur*, within a half inch accuracy, then using a knife-like tool, the *cyllell bach*, for hand trimming on a metal traverse *trafal*. The wooden pegs were made by the hundreds by tying a piece of string loosely around a square block of wood 2½" x 2½" x 2½" and then splitting it up into ¼" square cross section pegs. The slater most probably started at the middle of the eaves working outwards towards the gable end, and after the first layer was hung with the wooden pegs the next layer was laid on a bed of sphagnum moss. Because of the coarseness of the slate this provided a cushion and insulated the roof. This was done on every course up to the apex of the ridge. Lime-mortar torching was used in high-status buildings, and traces of torching were found at Brynkir Upper House. Every now and then the moss underlay had to be renewed. This was done by a 'mosser' a craftsman who went around replenishing the moss under the slates using a mossing iron to force moss underneath the slates. Though the collapsed roof at Brynkir Upper House was not the original, as it included a selection of moss and lime torched slates. This roof was erected probably during the transition period between hung, and nailed slates.

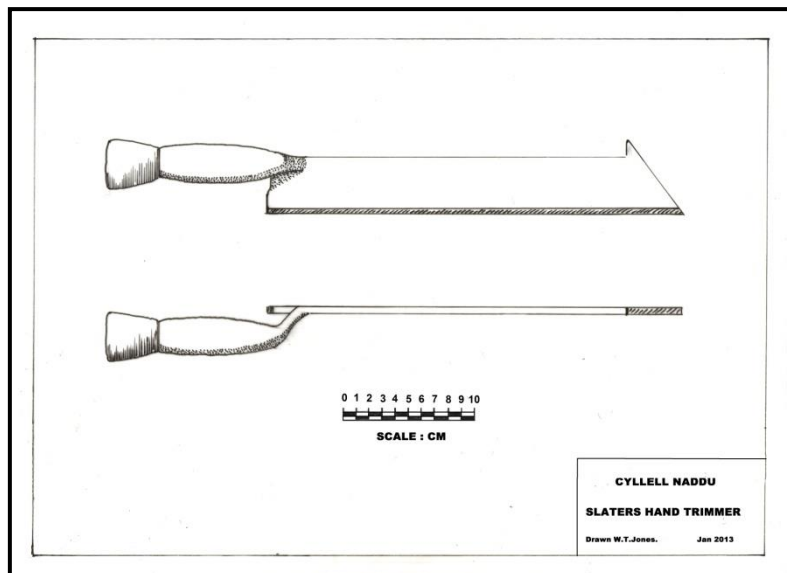
Figure 25: The main difference between a slater's hand trimmer, cylllell fach, and a slate quarryman's cylllell fach, is the piercing spike on the spine.
