Land Southwest of Bramble Lodge, Hill Mountain, Milford Haven, Pembrokeshire Watching Brief

February 2016

Trysor Project No. 2015/486

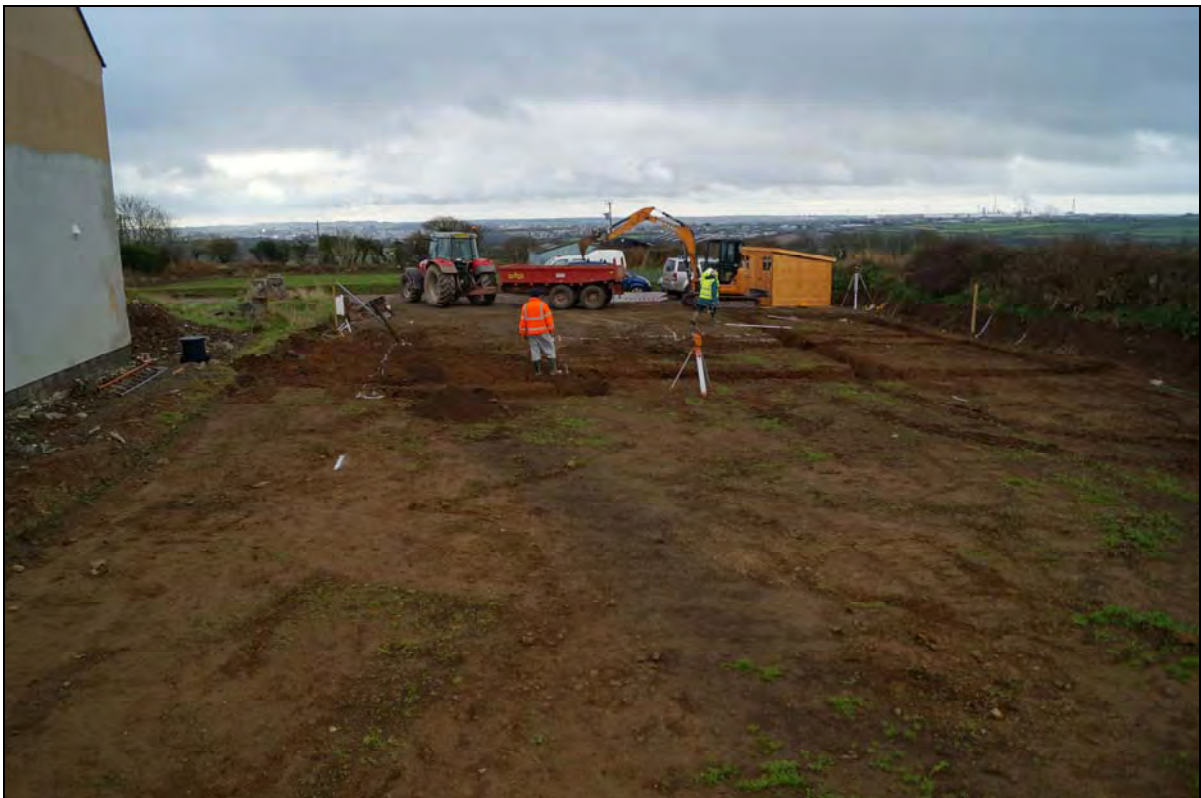
Cover photograph: The development plot, looking south, showing ditch 003

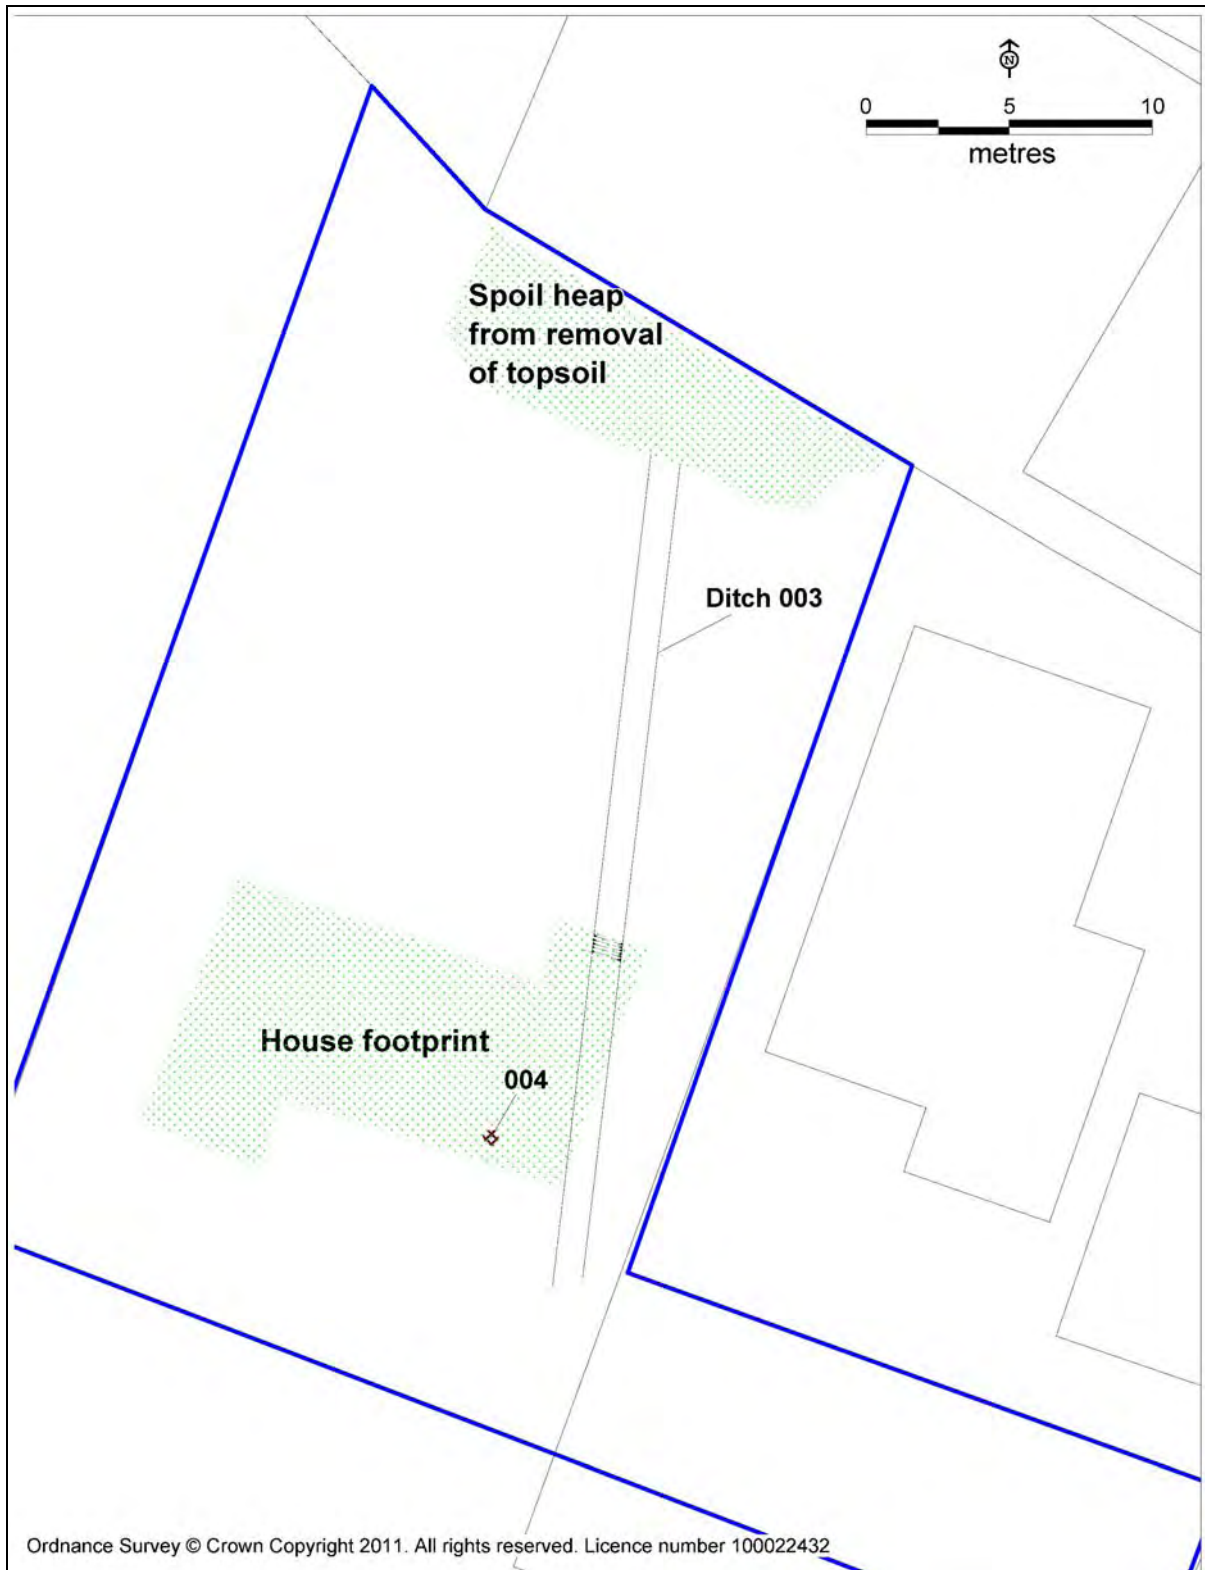
Figure 3: Features recorded

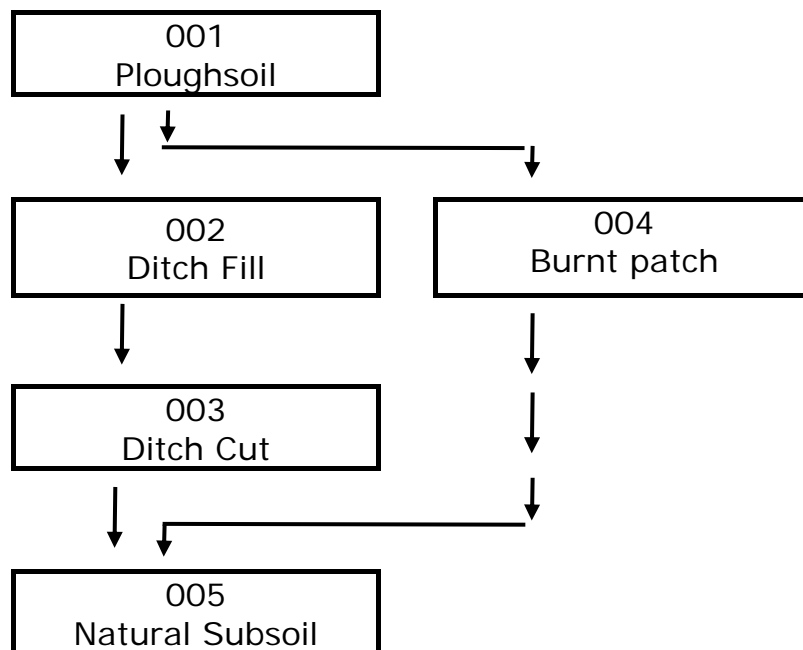
Figure 4: Section A to B through ditch 003

1.3 A ditch line was recorded running roughly north to south across the development. A section was excavated by hand where the house foundations would cut through it. The ditch was 1 metre wide and 0.45 metres deep below the natural subsoil interface with the topsoil. No dating material was recovered.

10.2 A ditch line was recorded running roughly north to south across the development plot. A section was excavated by hand where the house foundations would cut through it. The ditch was 1 metre wide and 0.45 metres deep below the natural subsoil interface with the topsoil. No dating material was recovered.

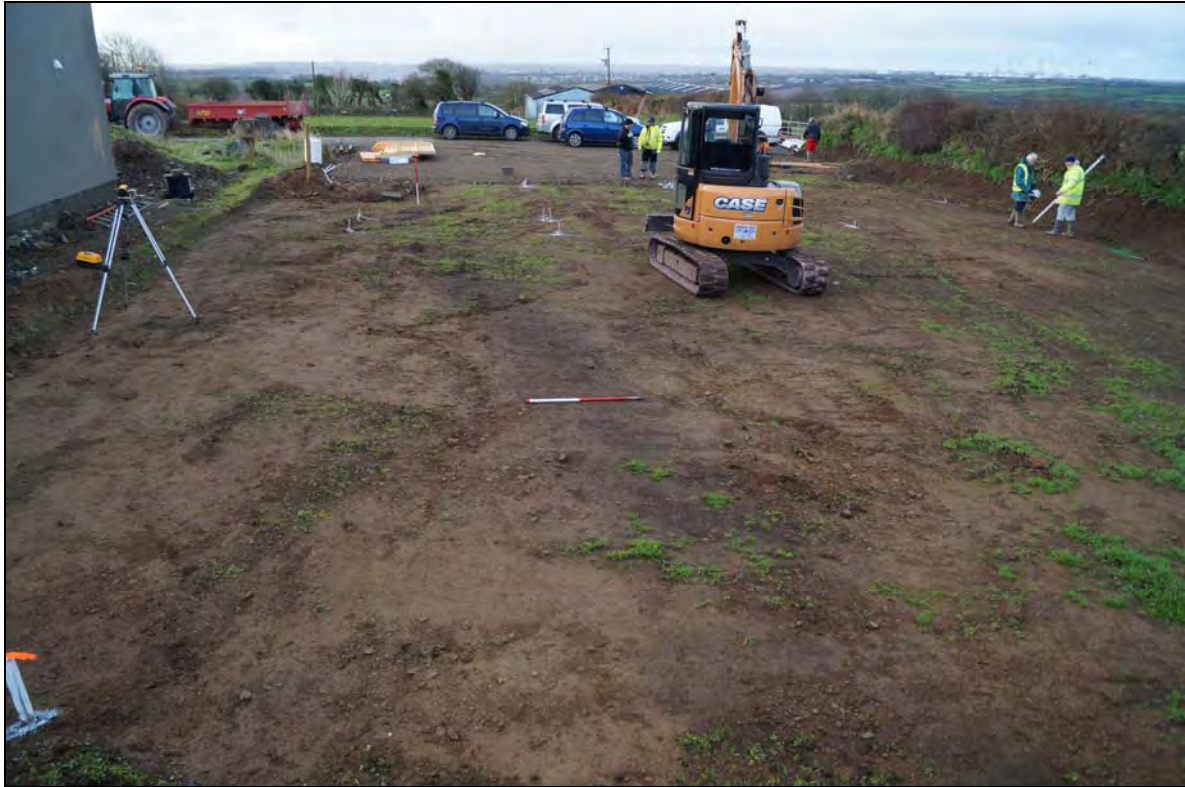
Plate 1: HMN2015_101, Site cleared of topsoil, with ditch HMN2015_003 clearly visible, taken from a pile of topsoil at the north end of the plot, looking south.

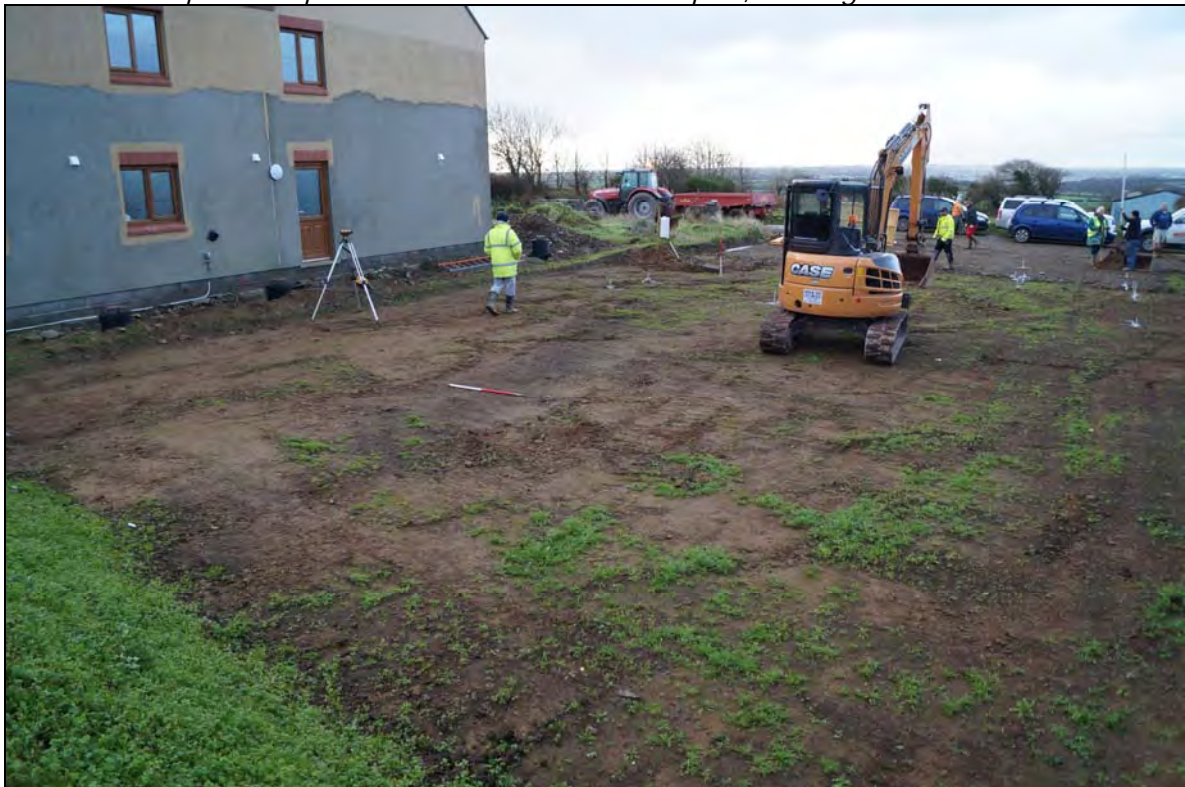
Plate 2: HMN2015_102, Site cleared of topsoil, with ditch HMN2015_003 clearly visible, taken from a pile of topsoil at the north end of the plot, looking south southeast.

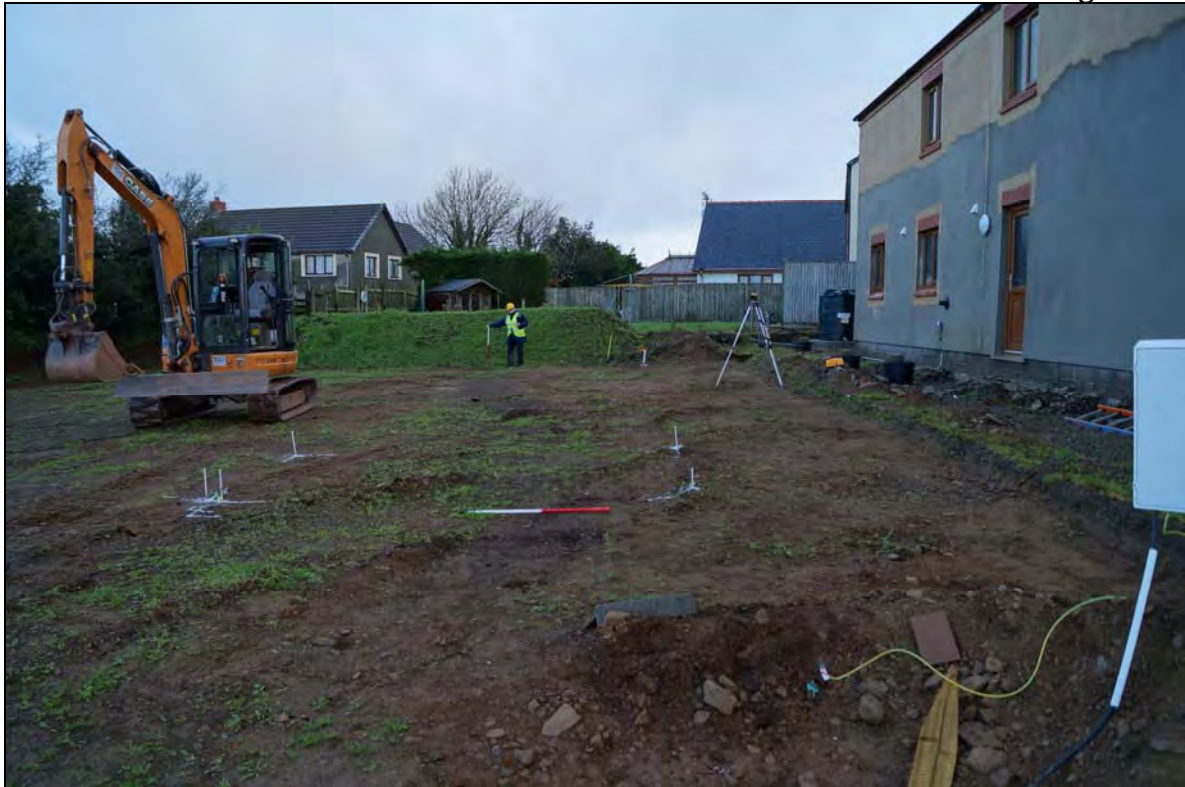
Plate 3: HMN2015_103, Site cleared of topsoil, with ditch HMN2015_003 clearly visible, taken from south end of the plot, looking north northeast.

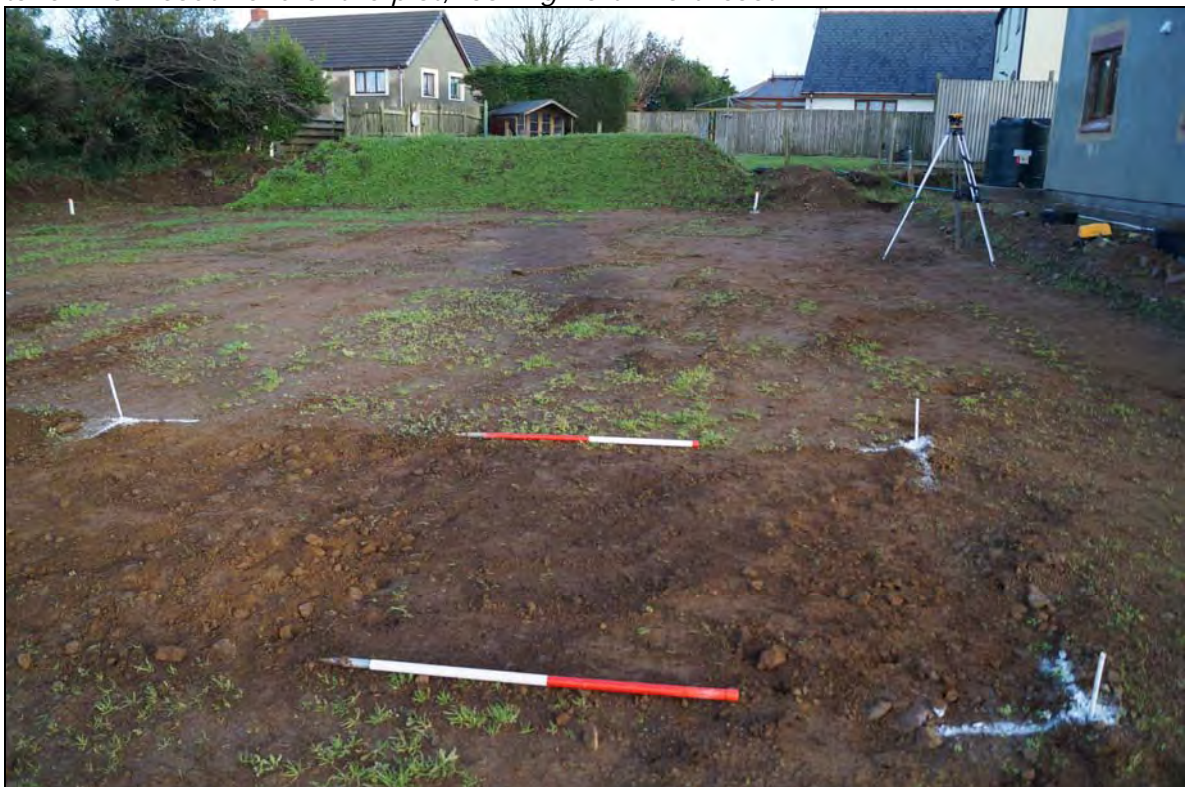
Plate 4: HMN2015_104, Site cleared of topsoil, with ditch HMN2015_003 clearly visible, taken from south end of the plot, section of ditch through which house foundations were be cut cleaned, looking north northeast.

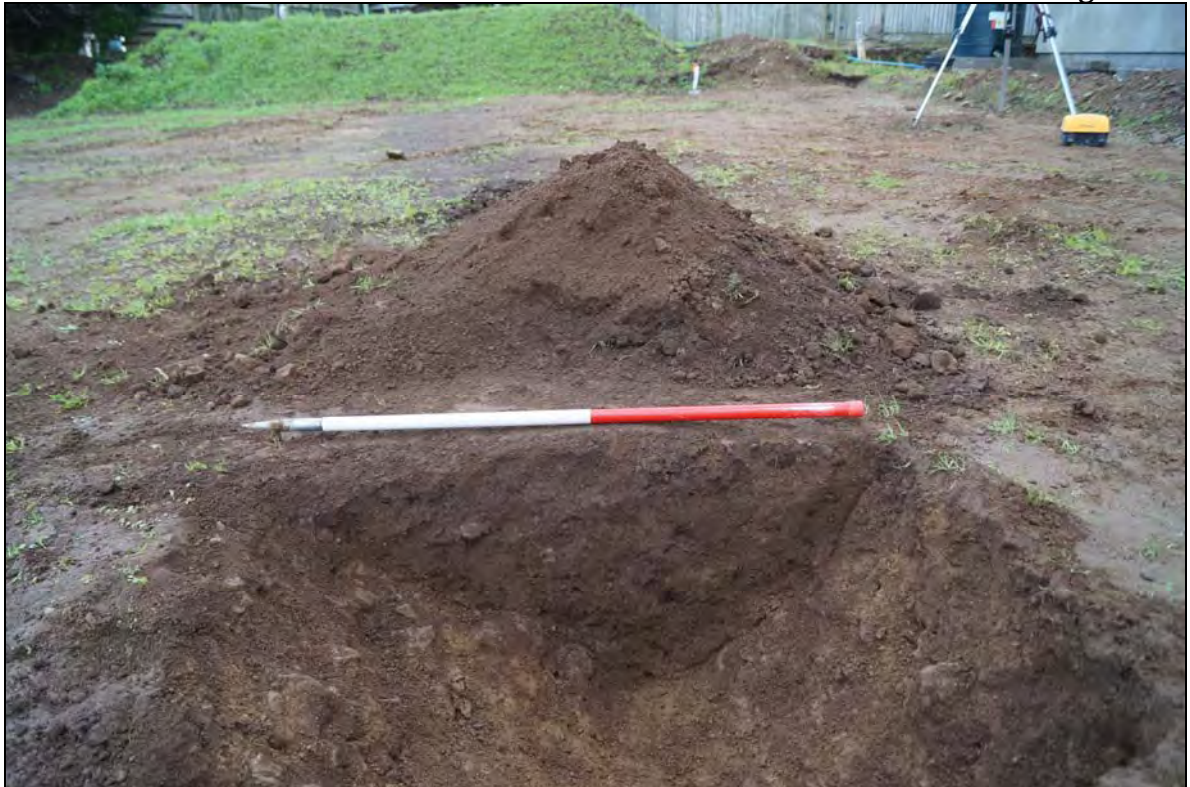
Plate 5: HMN2015_105, section across ditch where the northeasternmost wall foundation was to be placed, looking north northeast.

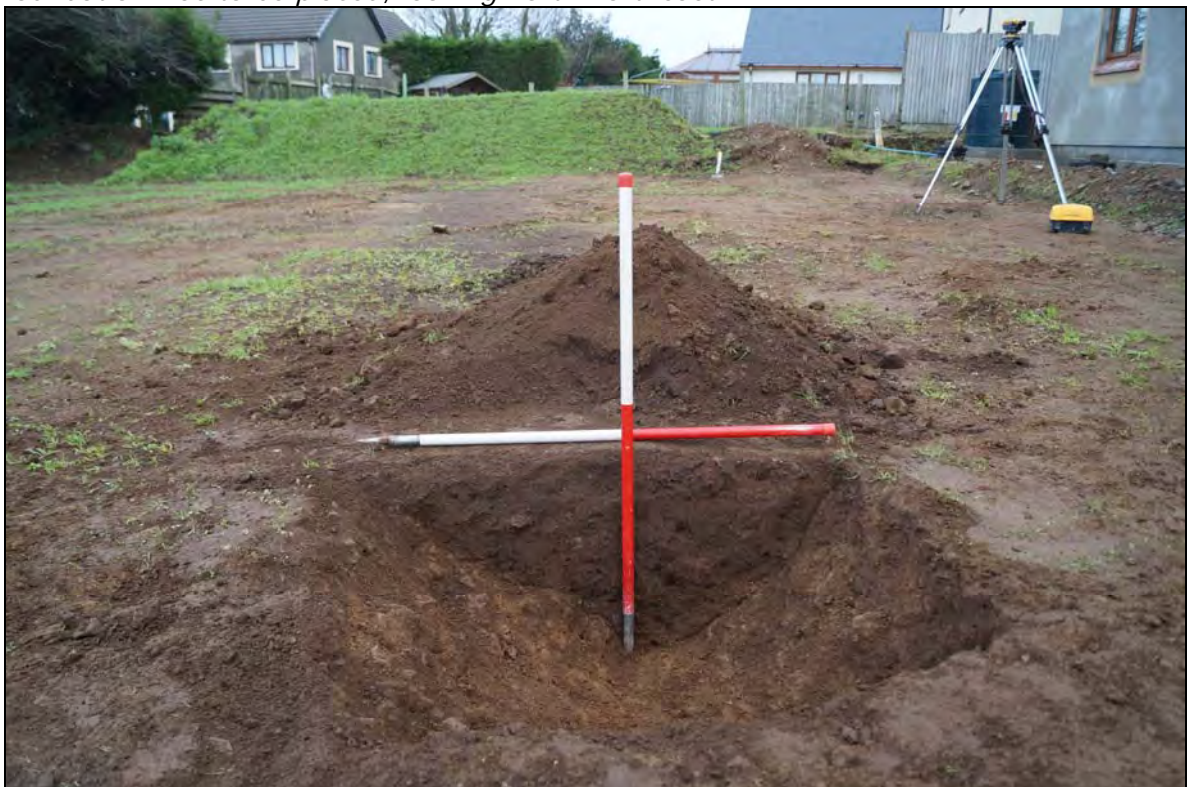
Plate 6: HMN2015_106, section across ditch where the northeasternmost wall foundation was to be placed, looking north northeast.

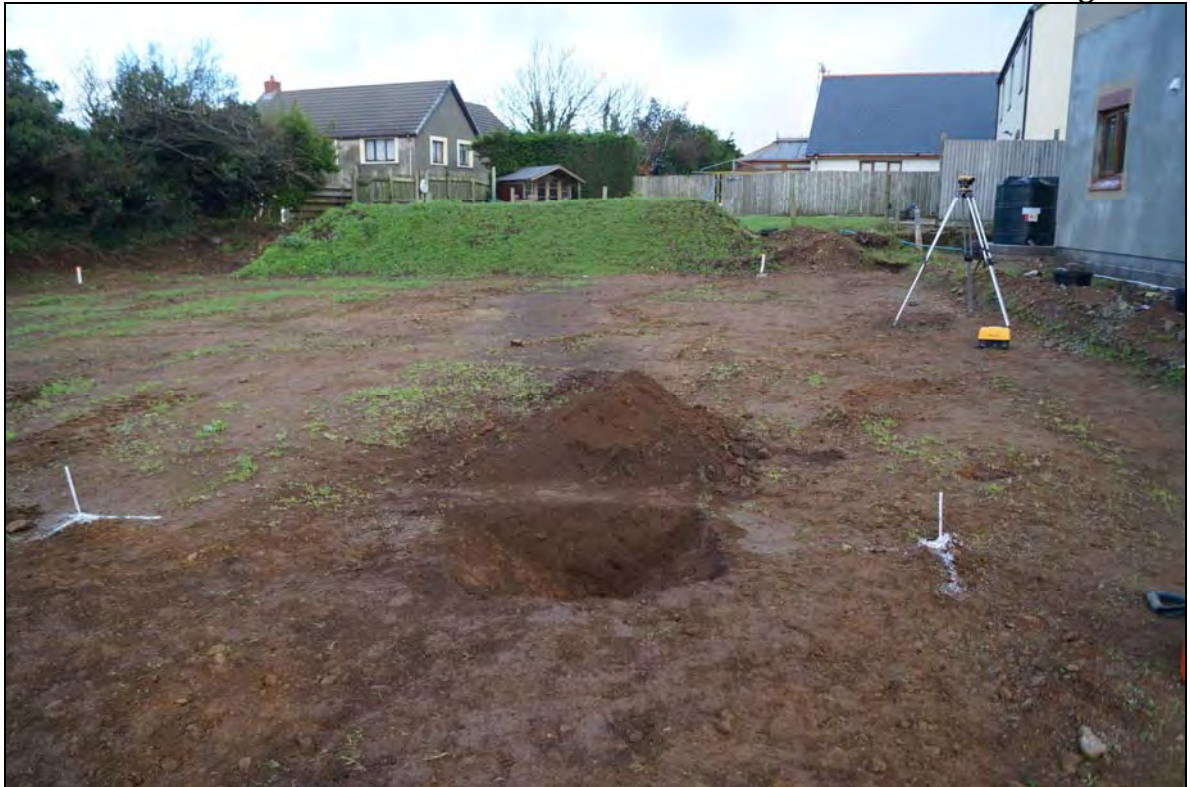
Plate 7: HMN2015_107, the excavated section of the ditch, without scales, looking north northeast.

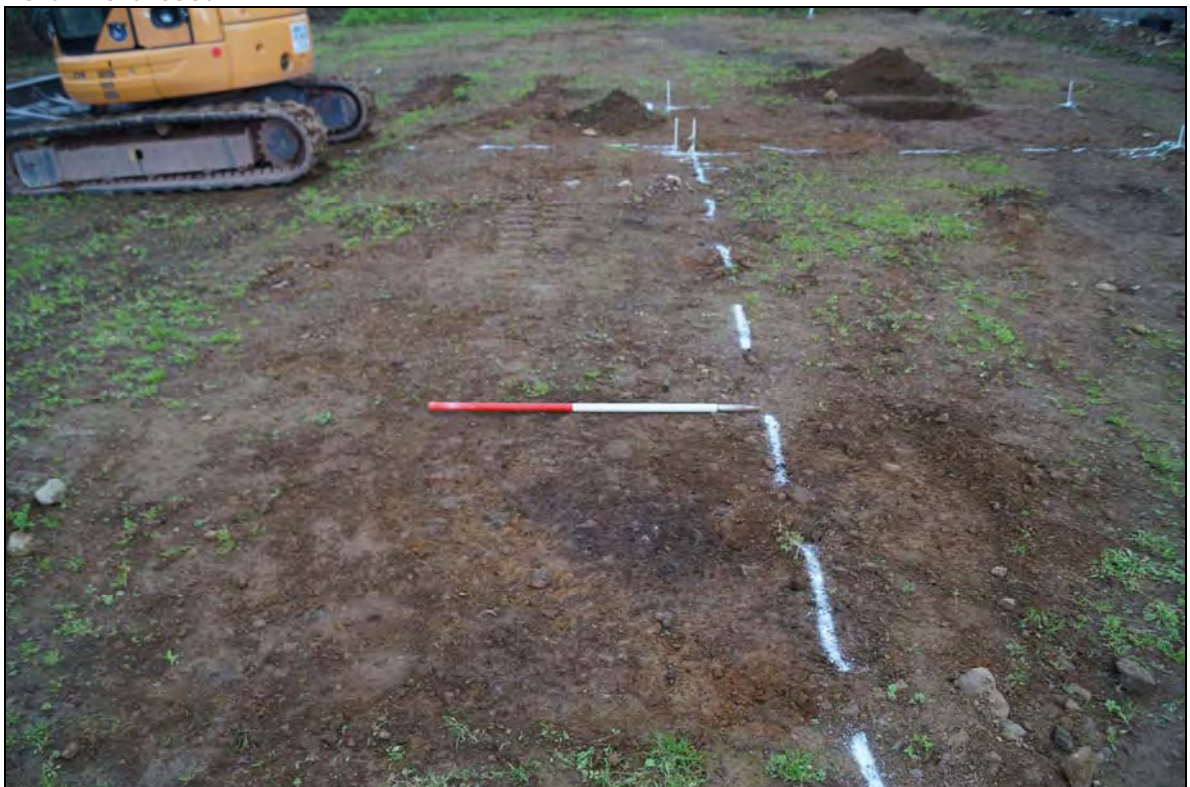
Plate 8: HMN2015_108, small patch of burnt material HMN2015_004, looking north northeast.

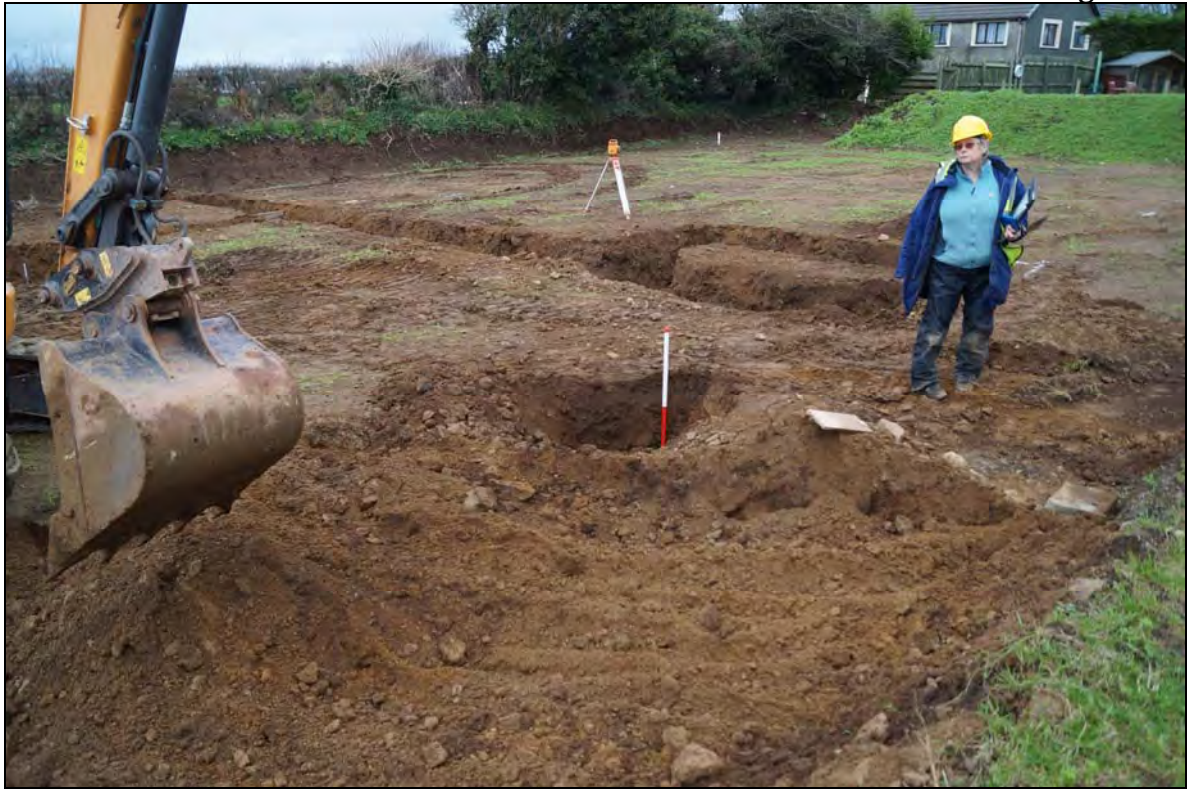
Plate 9: HMN2015_109, continuation of HMN2015_003, looking northwest

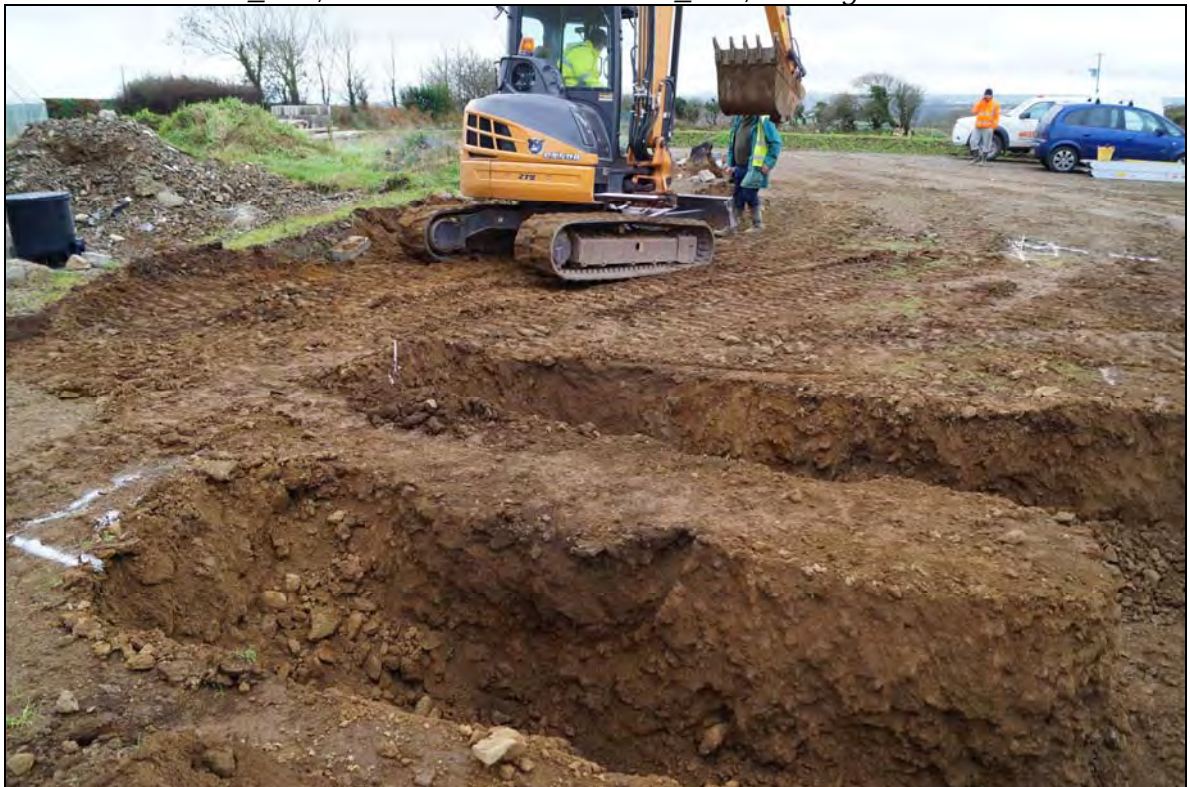
Plate10: HMN2015_110, HMN2015_003, in section after excavation of wall foundations, looking south southeast

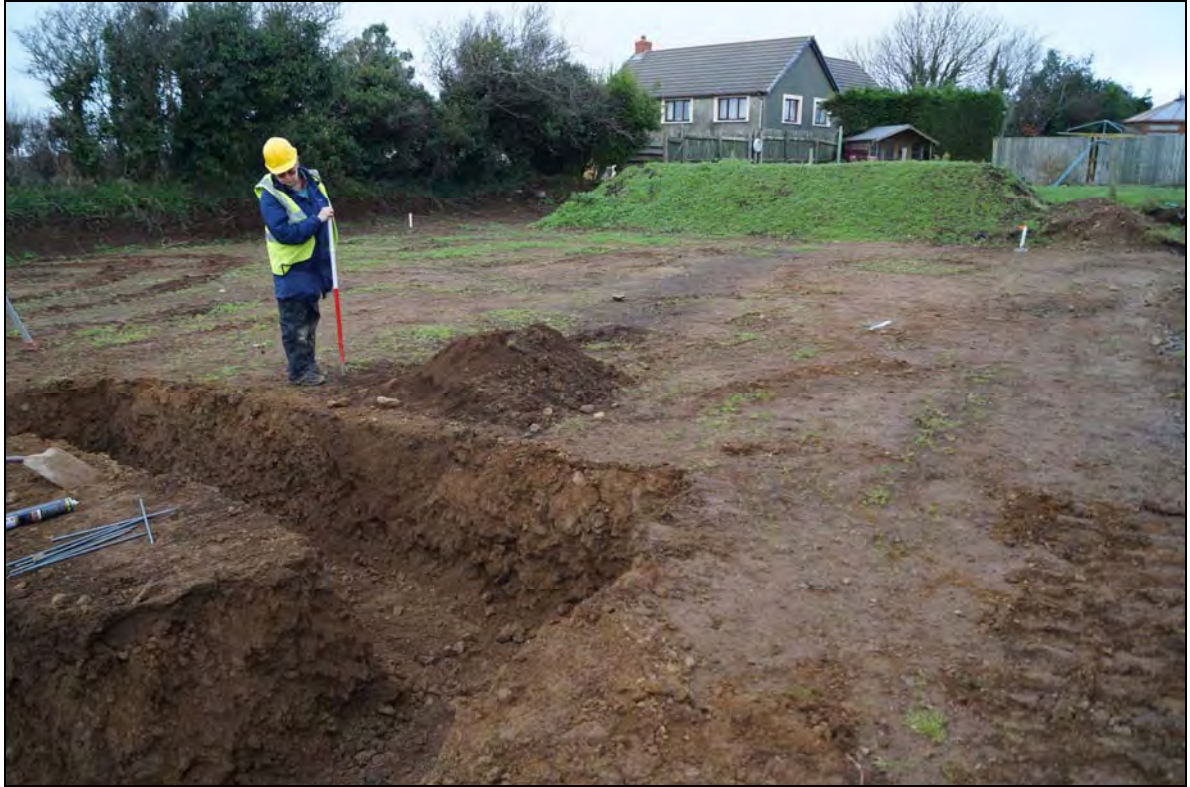
Plate 11: HMN2015_111, part of HMN2015_003, previously excavated by hand by Trydor, see Plates 5, 6 & 7, showing in section after mechanical excavation of wall foundations, looking northwest.
