**Archaeology Wales Ltd**

**Llanelly House, Llanelli,  
Carmarthenshire.**

Summary of Archaeological Results from  
Trial Trench in Room G1a/G1b

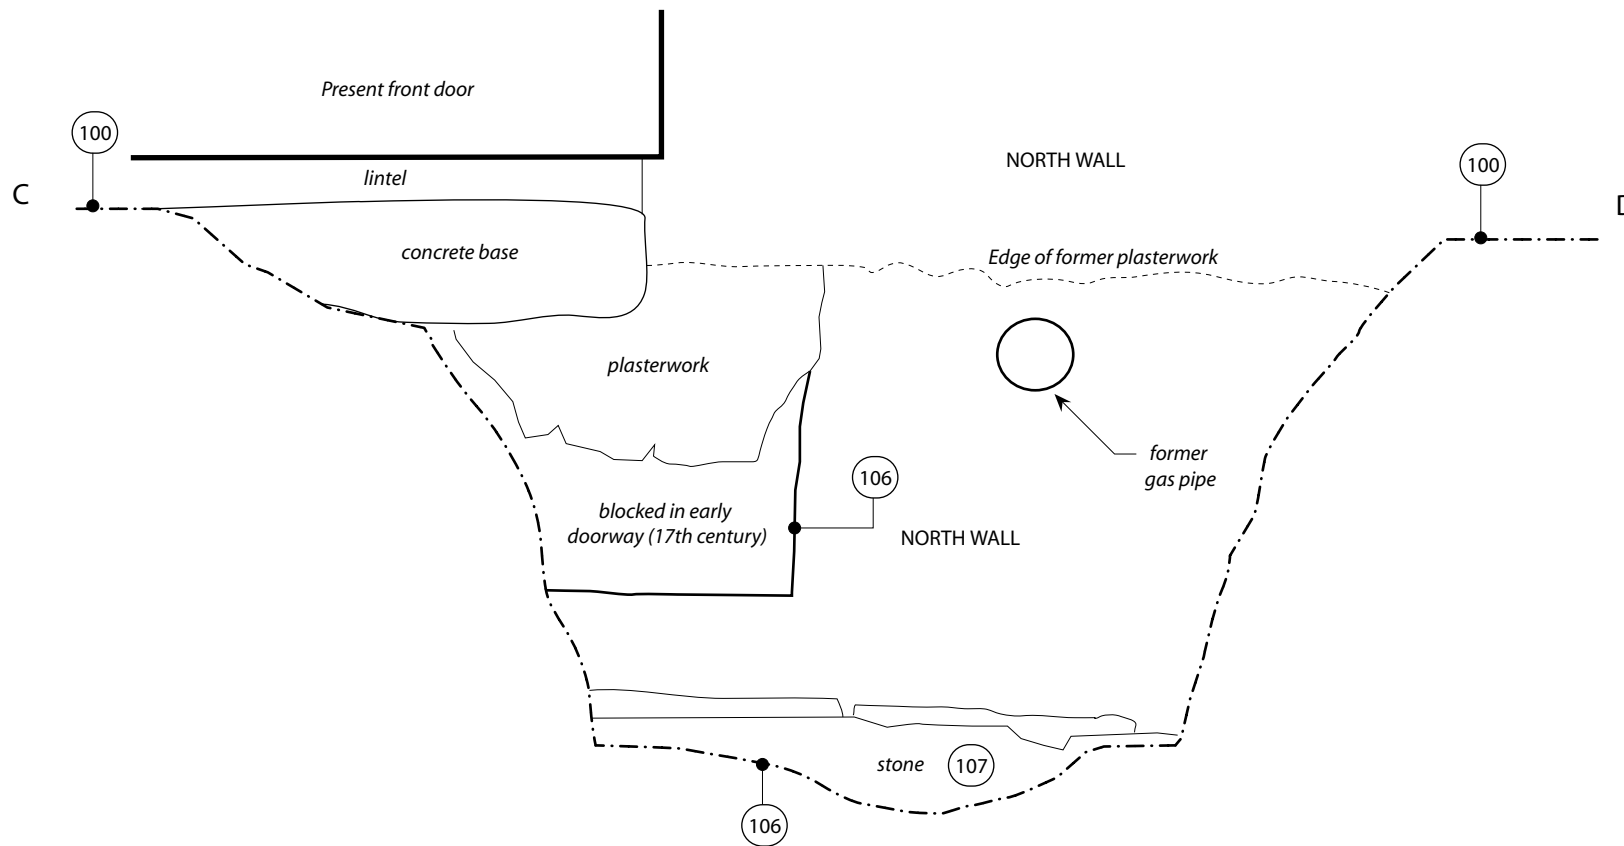
- 100 = Stone tile
- 101 = Oak beam floor joist (depth approx. 0.20m)
- 102 = Loose deposit consisting of soil, plaster fragments (small) and charcoal - depth approx. 0.20m (1710-1714)

- 103 = Compact deposit (Construction) (soil, plaster, lime, stones (small) - depth approx. 0.12m (1710-1714)
- 104 = Loose deposit (demolition), (stones (large), ceiling plaster (large fragments), soil, orange clay, charcoal fragments) - depth approx. 0.20m. (17th century)

- 105 = Loose deposit (demolition), consisting of clay, soil, plaster and charcoal fragments (17th century)
- 106 = Compact clay surface (grey/orange clay with charcoal flecks in upper regions of deposit) (17th century)

- 107 = Foundation stone of earlier house (17th century)
- 108 = Cut for foundation trench
- 109 = Fill of foundation stone cut 108 (orange clay with charcoal flecks).

- 110 = Blocked in early doorway (17th century house)

Figure 4. South Facing section of trial trench in Room G1a

- 2.4 This exposed section is represented by the north wall of the house. Significant features exposed here include the position of a former gas pipe, the footings for the former 17<sup>th</sup> century house north wall and the remains of a former doorway with threshold, blocked in with stonework and covered at its upper limit by a covering of wall plasterwork. This former doorway is positioned immediately below and to the right of the existing front door to the house, which was formerly, in the 1714 rebuild, utilised as one in a series of windows in the house's front façade.

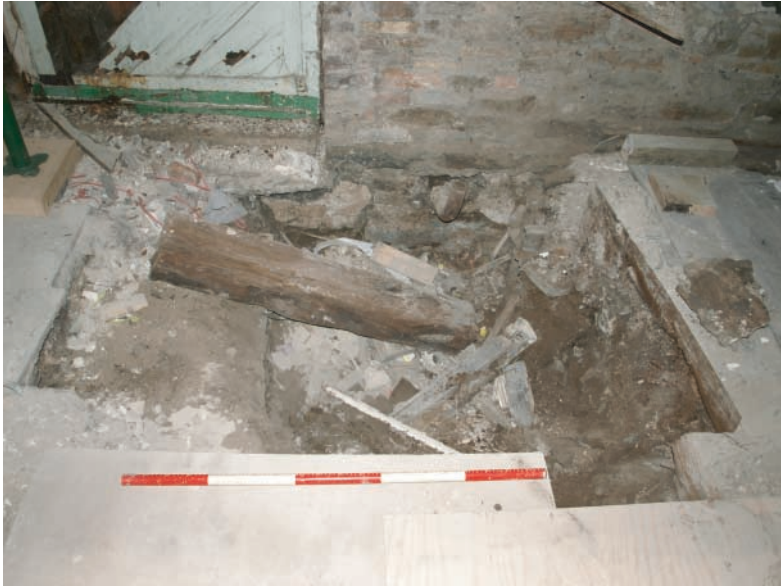
Plate 1. Trial Trench in Room G1a/G1b prior to re-opening. Looking north.

- 1.1 The trial trench in Room G1a/G1b was dug several years ago by another party as part of earlier preliminary investigations. However, the results from the excavation were never recorded or fully interpreted archaeologically. The following is a record and interpretation of the results from this trench following its re-opening on 24<sup>th</sup> February 2011. Since its initial excavation the trench had been used subsequently as a 'rubbish' pit, being filled with a variety of building materials, including soil, cement, resin, newspaper, timber etc.

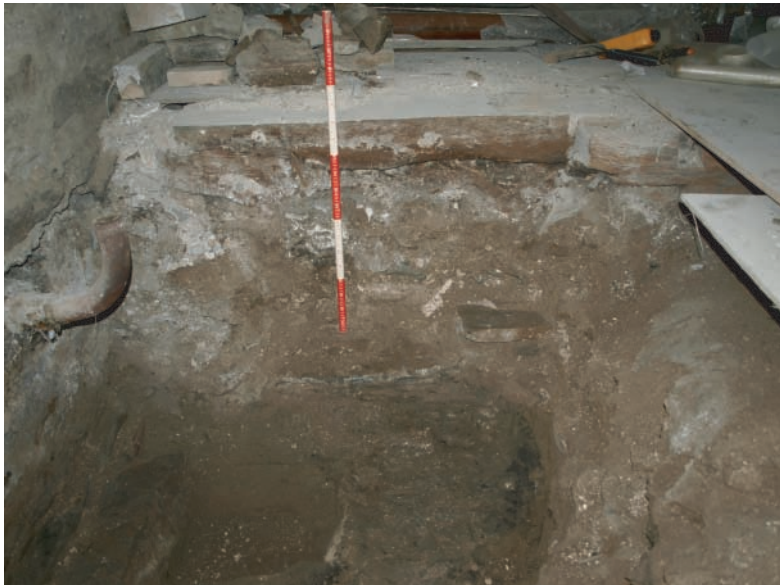
Plate 3. Trial Trench in Room G1a/G1b following removal of overburden cleaning. Looking east.

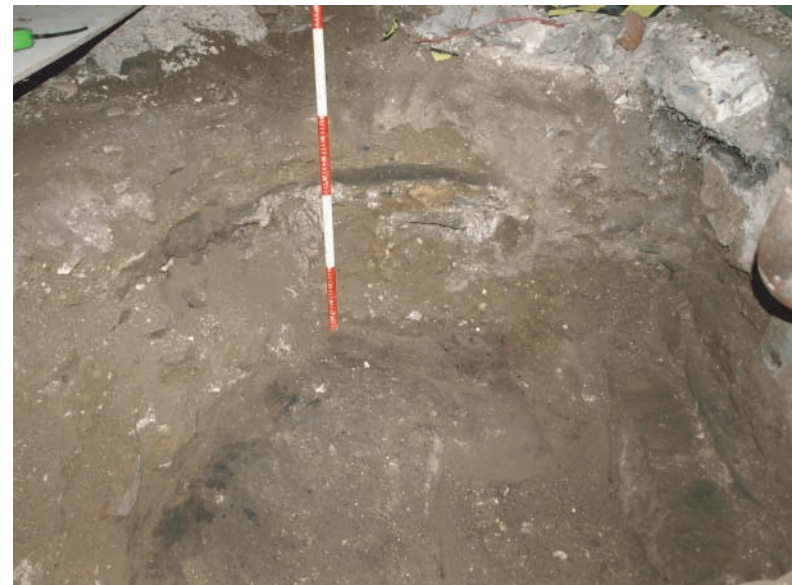
Plate 4. Trial Trench in Room G1a/G1b following removal of overburden and cleaning. Looking west.
