# Glebelands, Milford Haven Pembrokeshire

Desk Based Assessment

Report No. 566

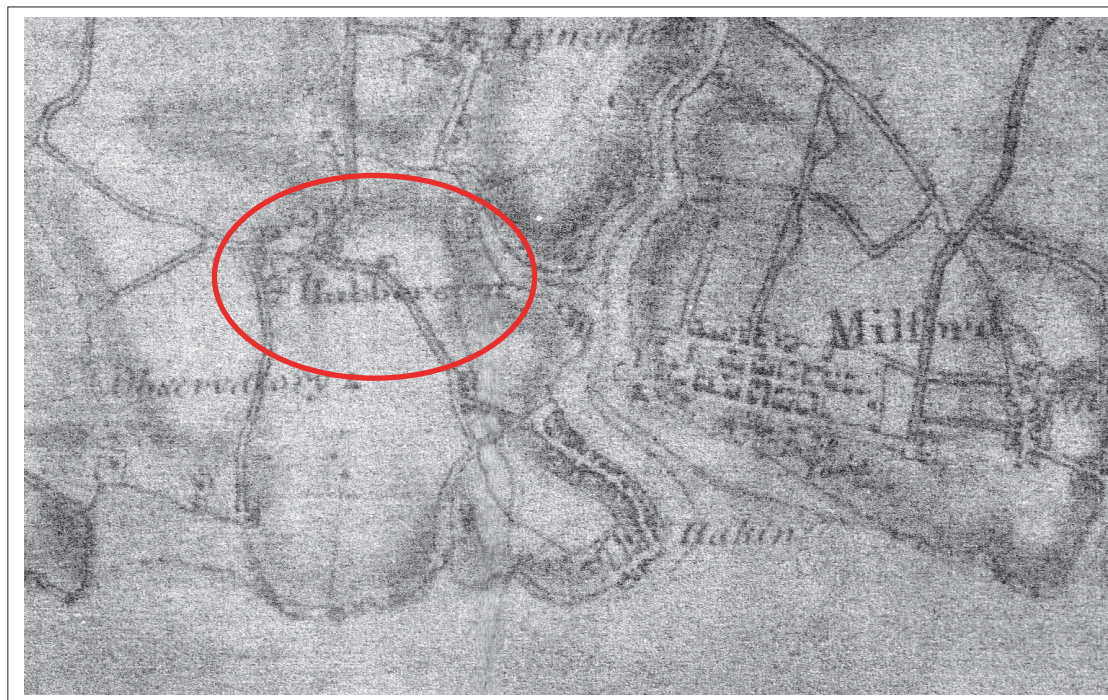
Fig 2: 1809-1834 2 Inch OS Surveyors Drawings showing assessment area

4.1.1 The 1809-34 2 Inch OS surveyors drawings (Fig 2) show the assessment area although not in any great detail. St. David's Church is faintly marked and the area is clearly not very built up. No other detail is shown.

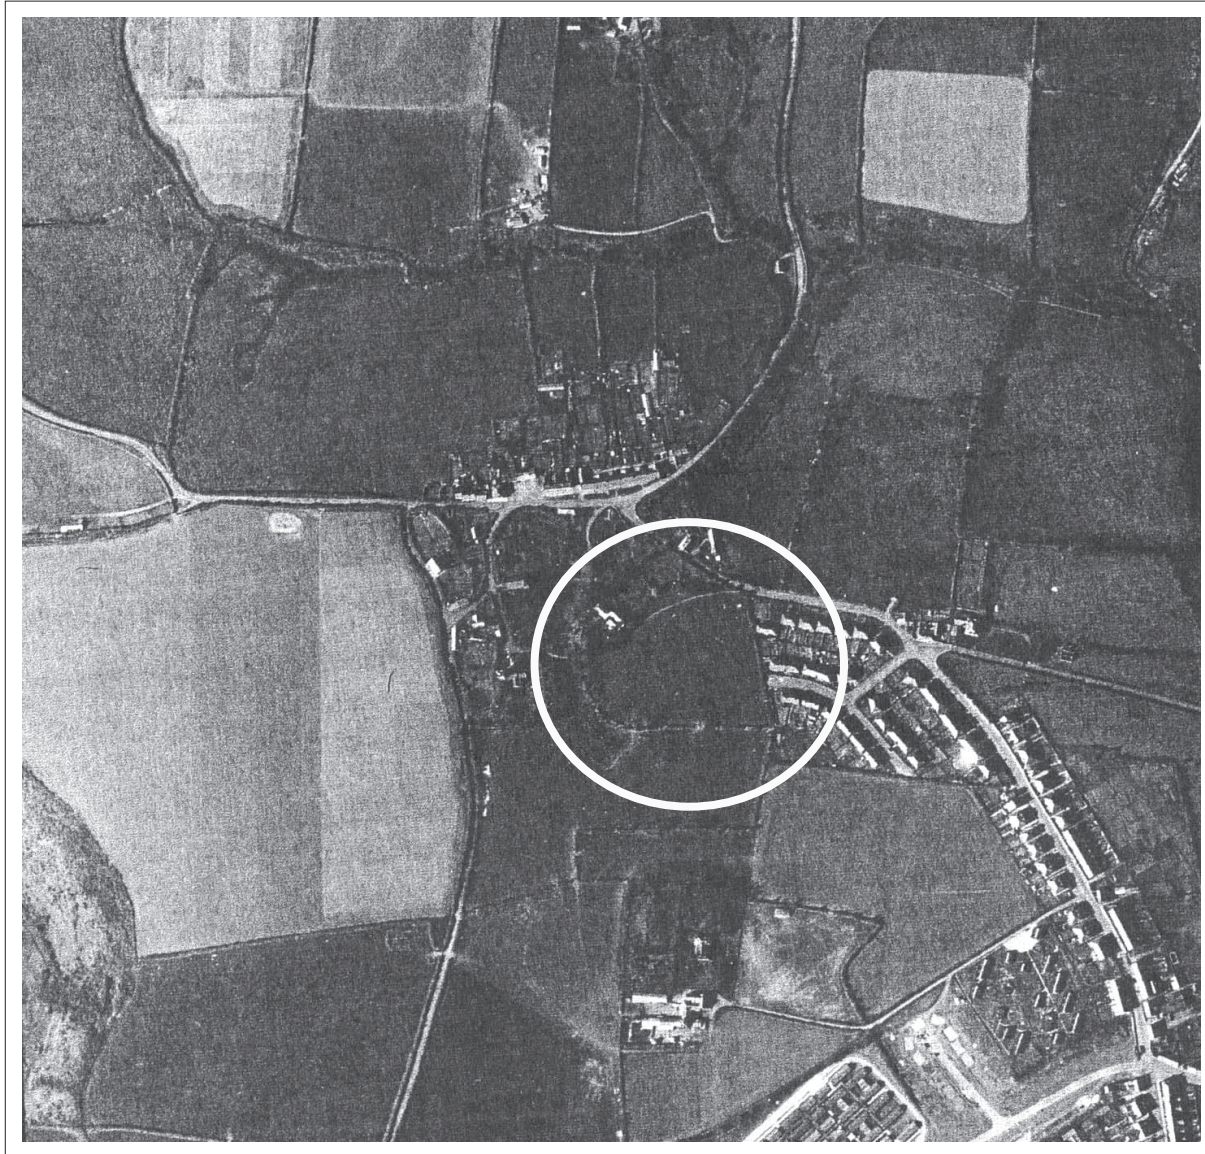
Plate 1: Aerial photograph of assessment area from April 1946

- 4.3.1 The first aerial photographs covering the assessment area date to 1946 with two sets from that year (Plates 1 and 2). Both sets of aerial photographs from 1946 appear to show the assessment area as having been divided in two by an east west boundary. A co-axial system of further, smaller, boundaries can be seen projecting at 90° from this main boundary at regularly spaced intervals. The area may have been divided up into allotment type garden plots during World War Two.

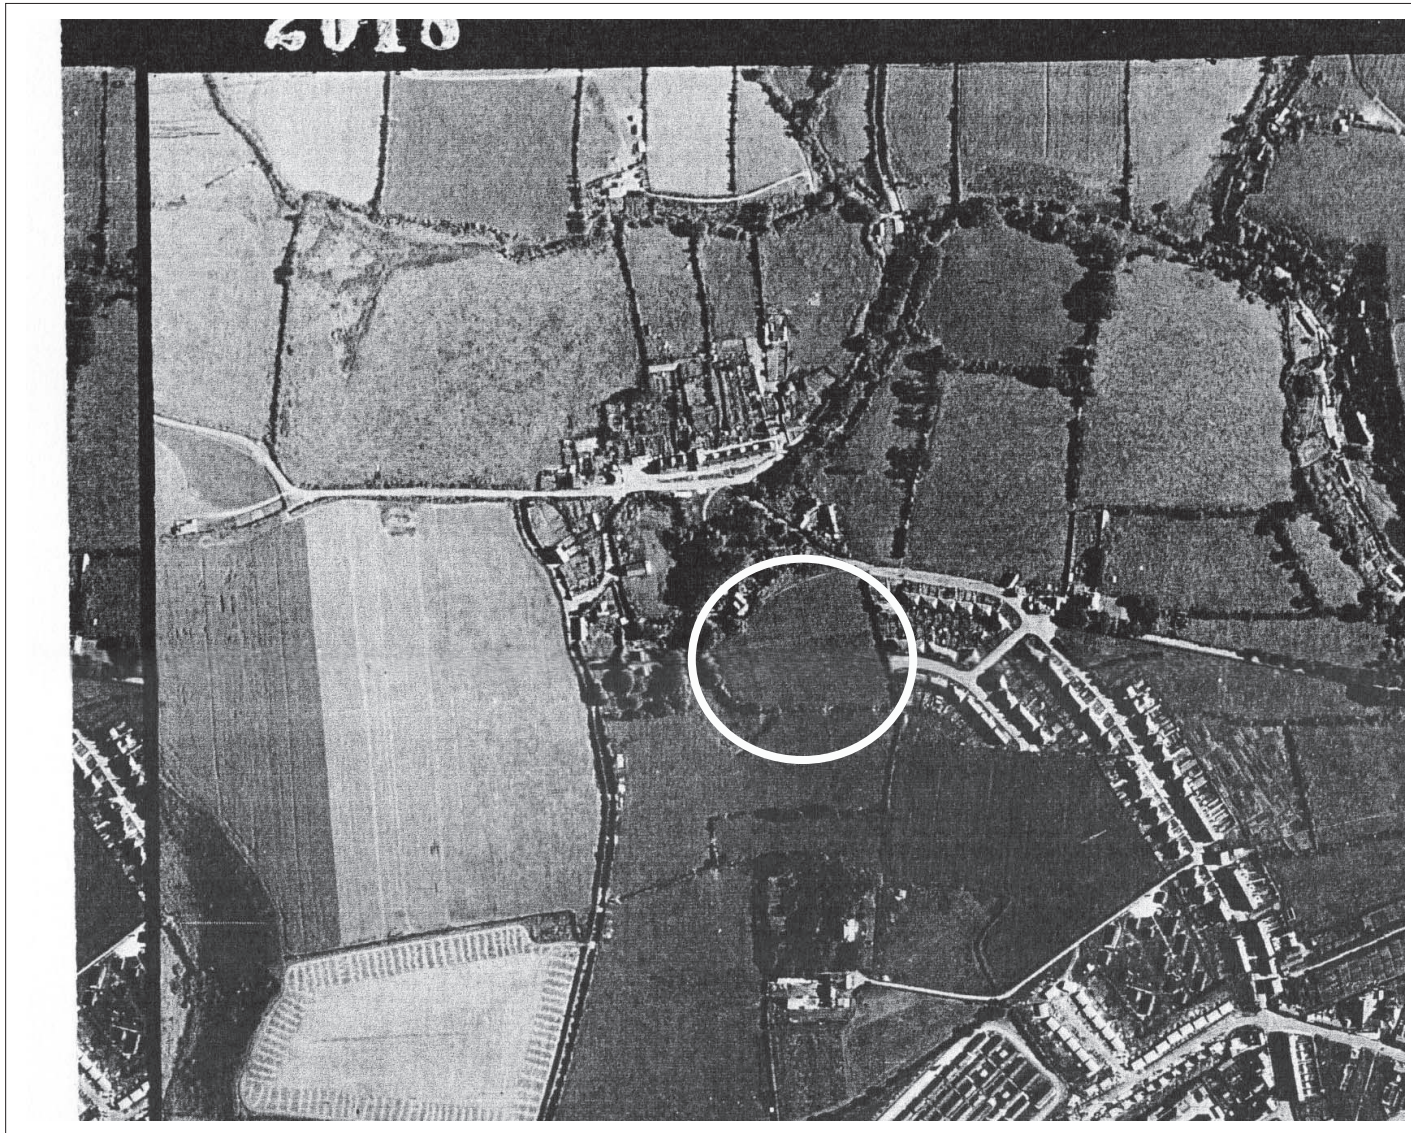
Plate 2: Aerial photograph showing assessment area in July 1946

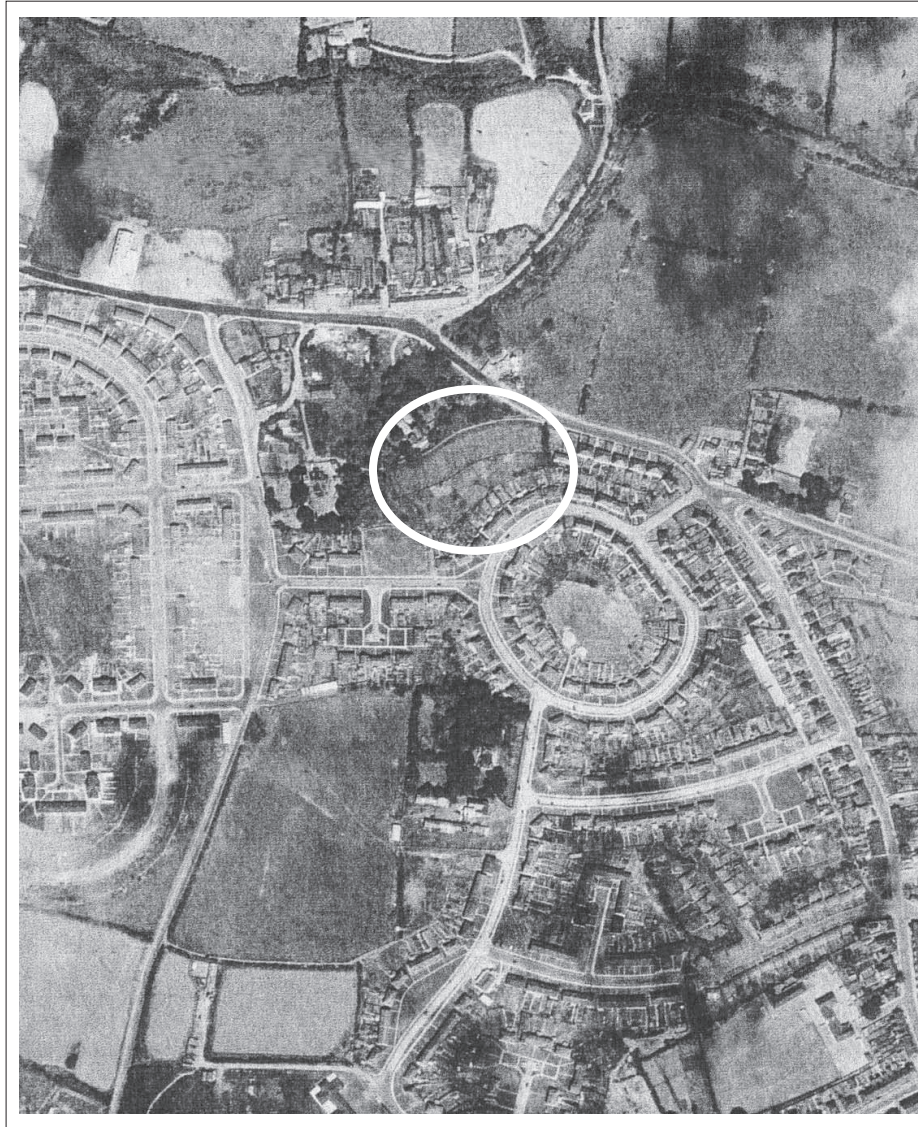
Plate 3: Aerial photograph showing assessment area from June 1959

- 4.3.2 By the time the next set of aerial photographs (Plate 3) were taken, June 1959, the areas to the south, east and west of the assessment area had seen considerable urban development. Houses are now seen to butt the assessment area to the south and east. The central dividing boundary is still in place although it no longer runs east west. With the reshaping of the southern boundary to the assessment area as a result of house building, the layout of the still visible 'allotment' type plots appears to have changed slightly. The central dividing boundary now appears to be 'S' shaped in plan.

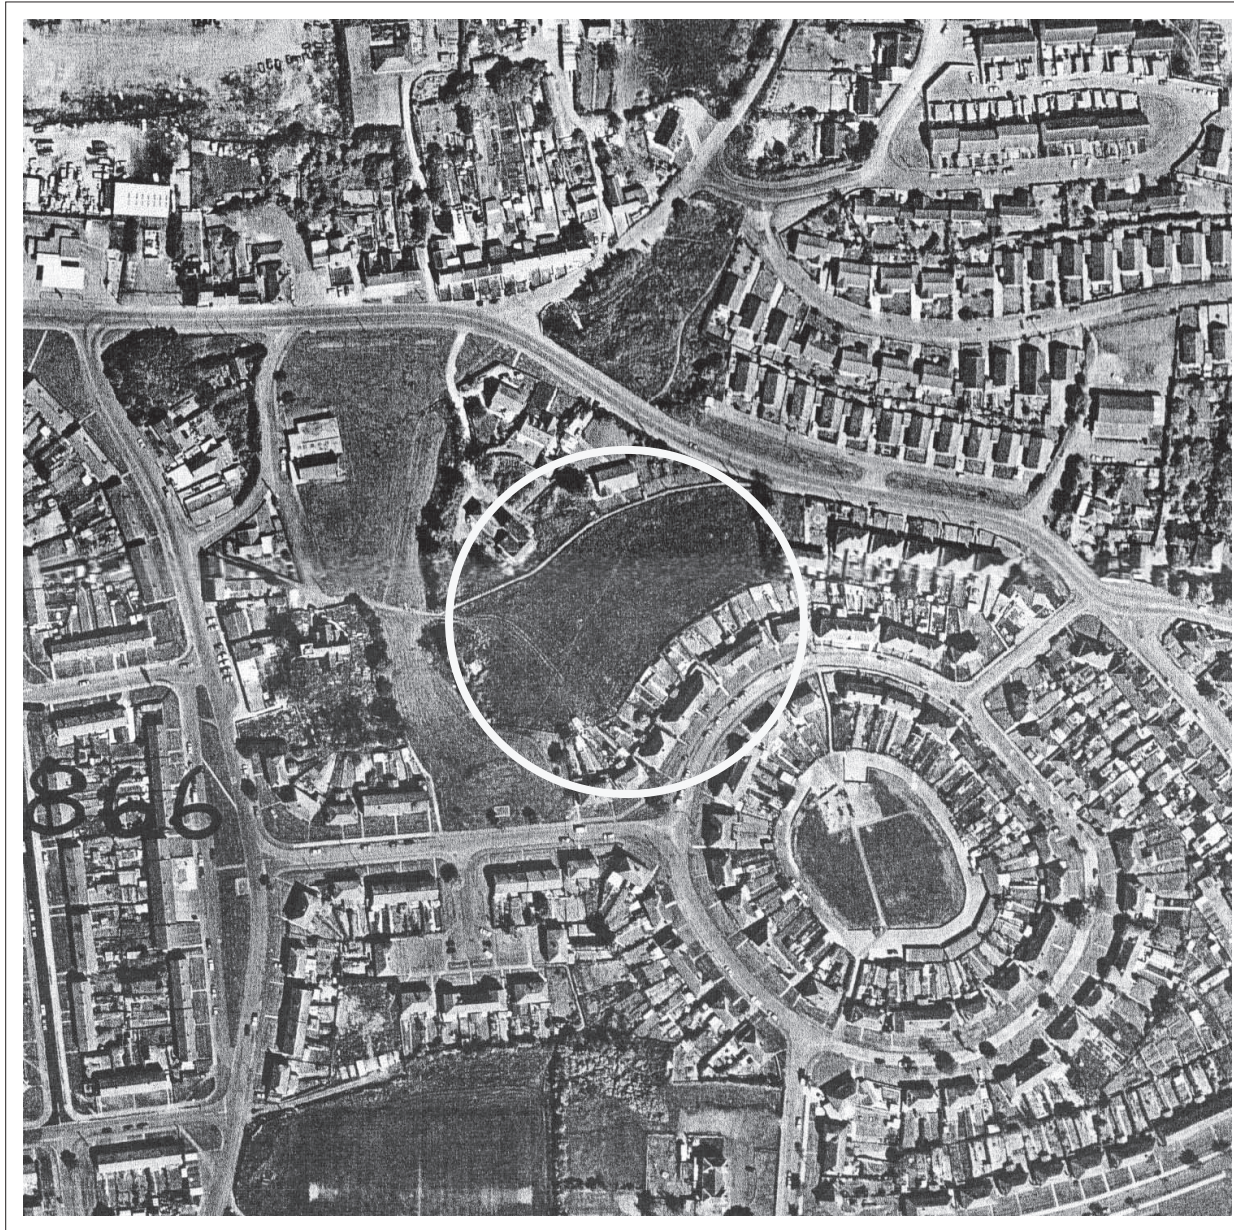
Plate 4: Aerial photograph showing assessment area from 1993

- 4.3.3 The 1993 aerial photograph (Plate 4) shows that further urban development has taken place all around the assessment area. The area itself has not been encroached onto however. The 1993 aerial photograph appears to show much thinner tree cover around the edges of the assessment area. The house to the east of The Rectory also appears to have been constructed by this point. All traces of the allotment type gardens appear to have been removed by this point also. The footpath, marked on the 1<sup>st</sup> Edition OS map, now appears to be laid out in tarmac. No further features are discernible.

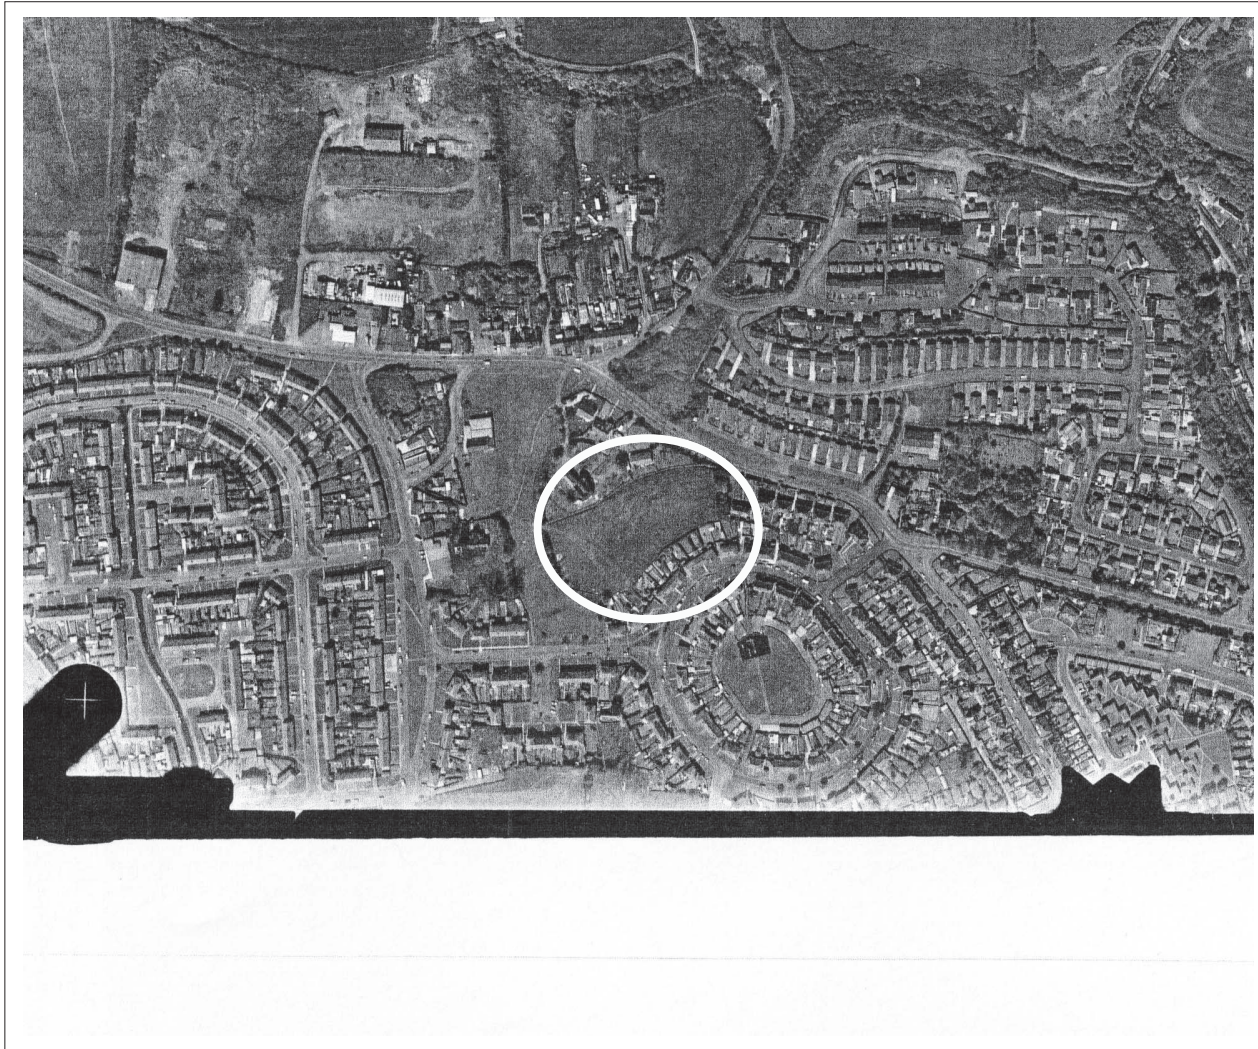
Plate 5: Aerial photograph of assessment area from 1995

- 4.3.4 The 1995 aerial photograph (Plate 5) shows the same detail as the previous 1993 photograph. No further features are discernible.
- 4.3.5 The 2008 satellite image (Google Earth) (Plate 6) shows much the same detail as the previous 1995 photograph. No further features are discernible.

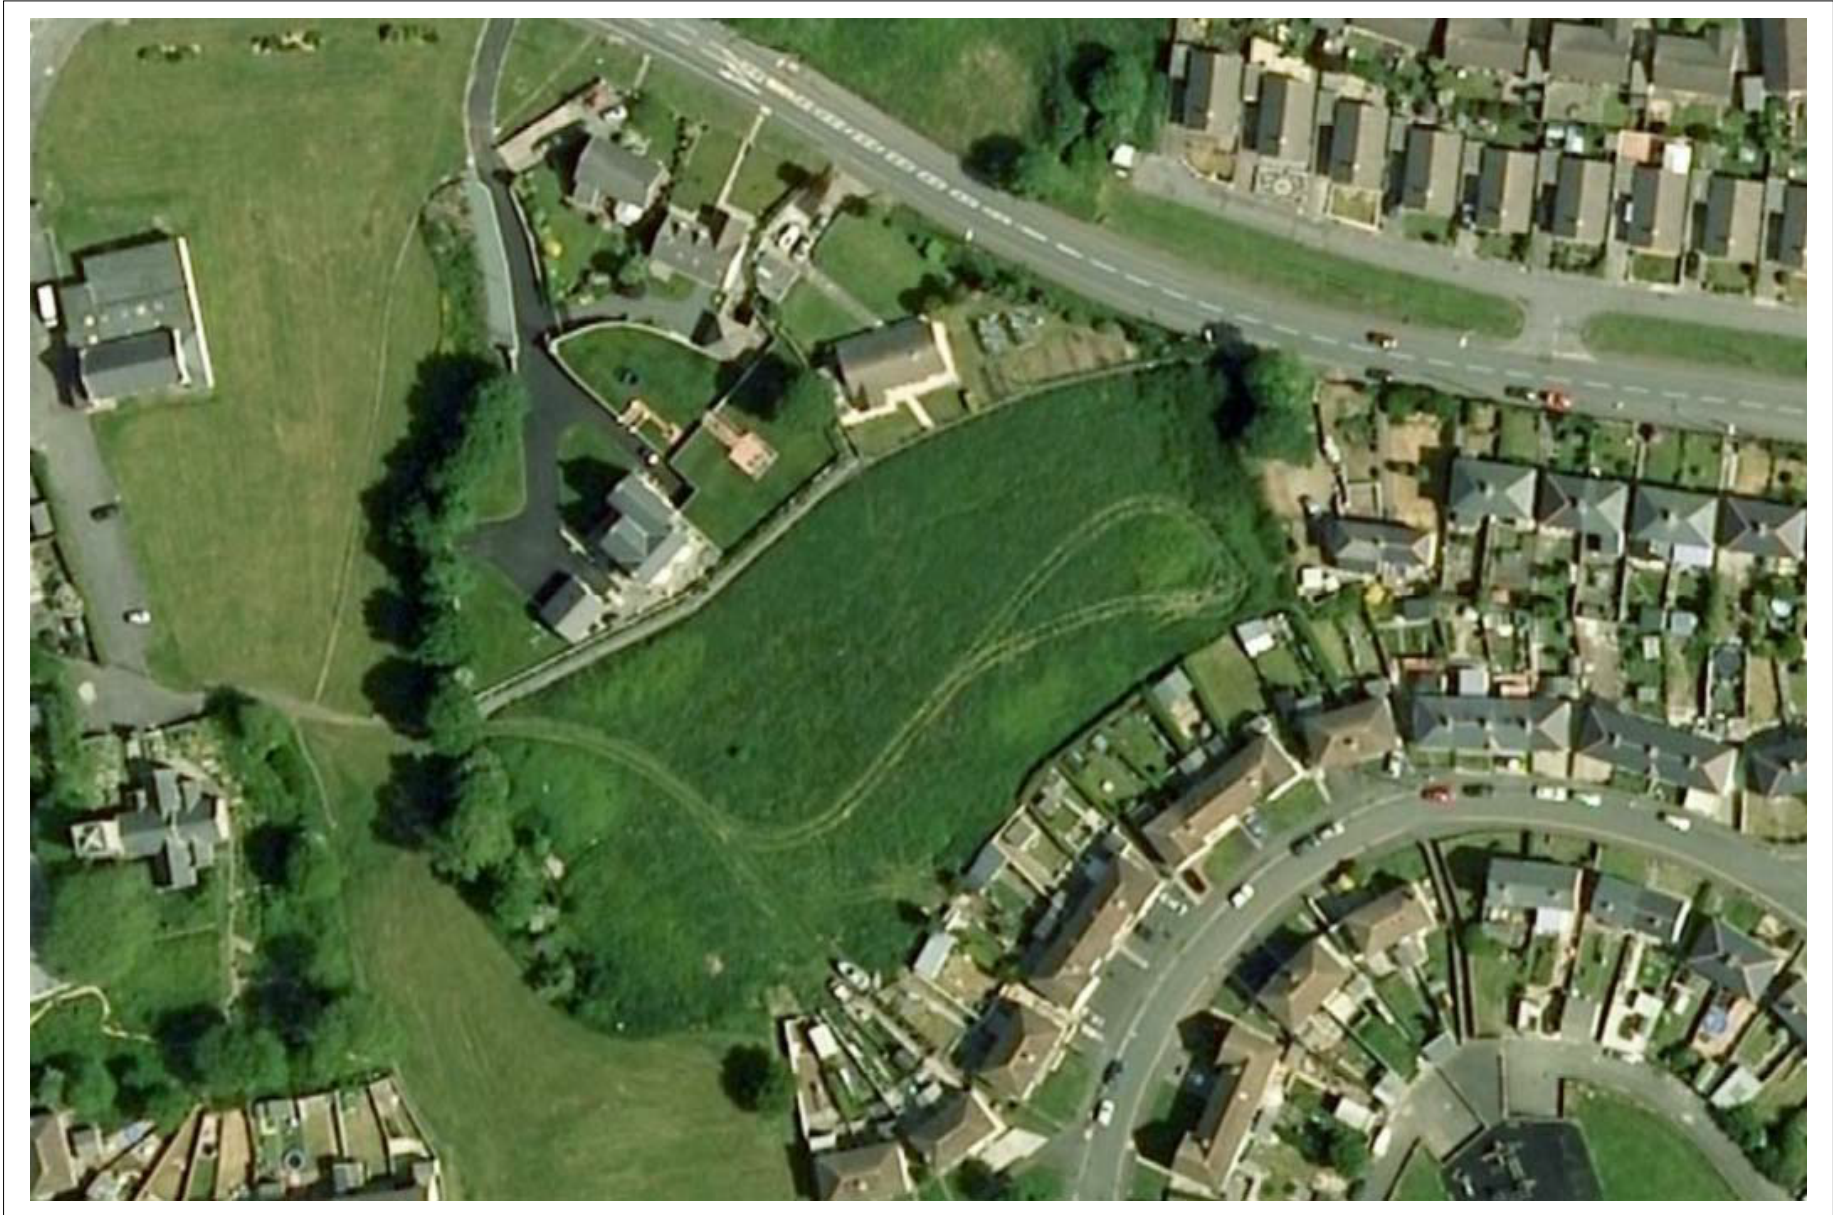
Plate 6: Satellite image showing assessment area as it appears today.
