Bute Park, North Lodge Cardiff

Archaeological Watching Brief

Report No. 655

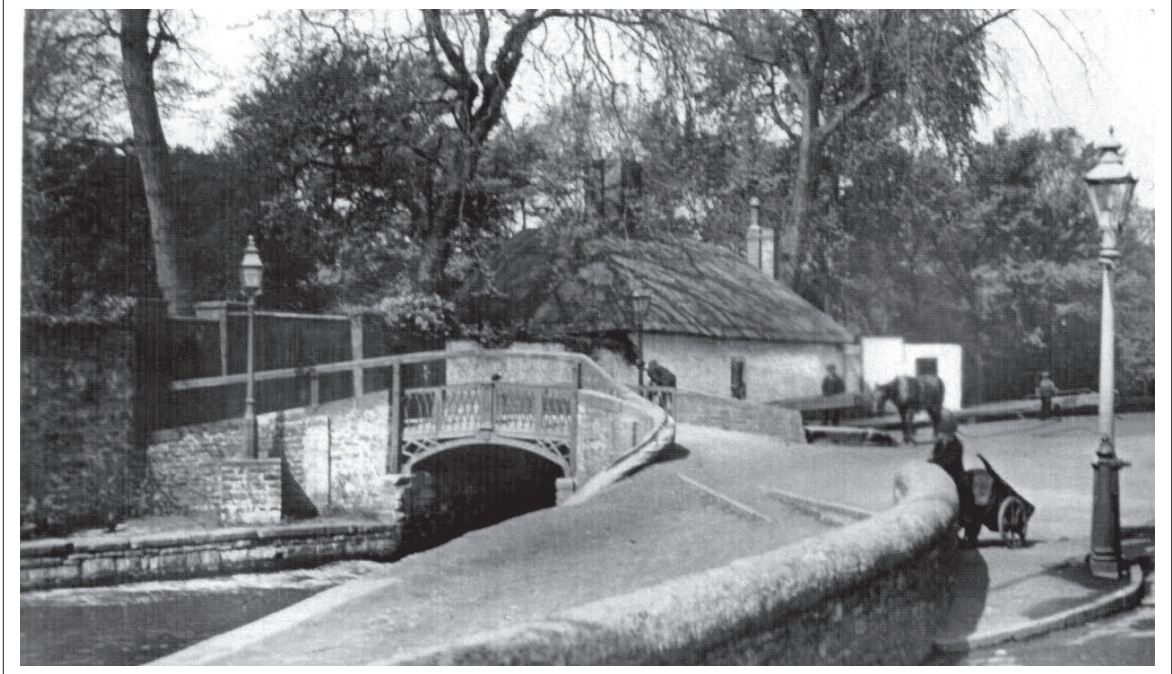
Plate 1: Early nineteenth century photograph of North Lodge. Note Canal wall in foreground

The watching brief was carried out on the excavation of small areas of service trench adjacent to the old Glamorganshire Canal wall (Plate 1). Excavation was carried out both by hand and mechanical excavator under close archaeological supervision.

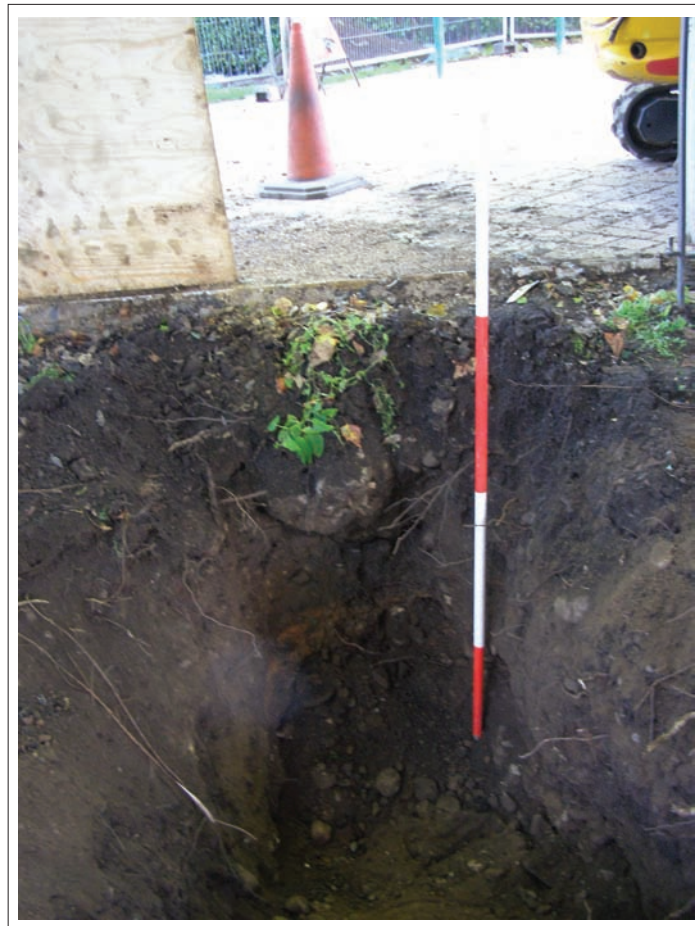
Trench 1 (1m x 1m x 1m, fig 2, Plate 2)

Trench 1 was located adjacent to the track leading into the underground passage beneath North Road. This trench measured 1m in length by 1m in width and depth and was excavated to accommodate bore hole drilling equipment. Removal of topsoil (a dark brown silt), revealed a subsoil level at around 0.2m deep. Removal of subsoil (a dark brown clay silt) revealed cobblestones within the context, their frequency increasing with depth. At a depth of 1m excavation ceased. No significant archaeological remains were encountered.

Plate 2: View of trench excavated for bore

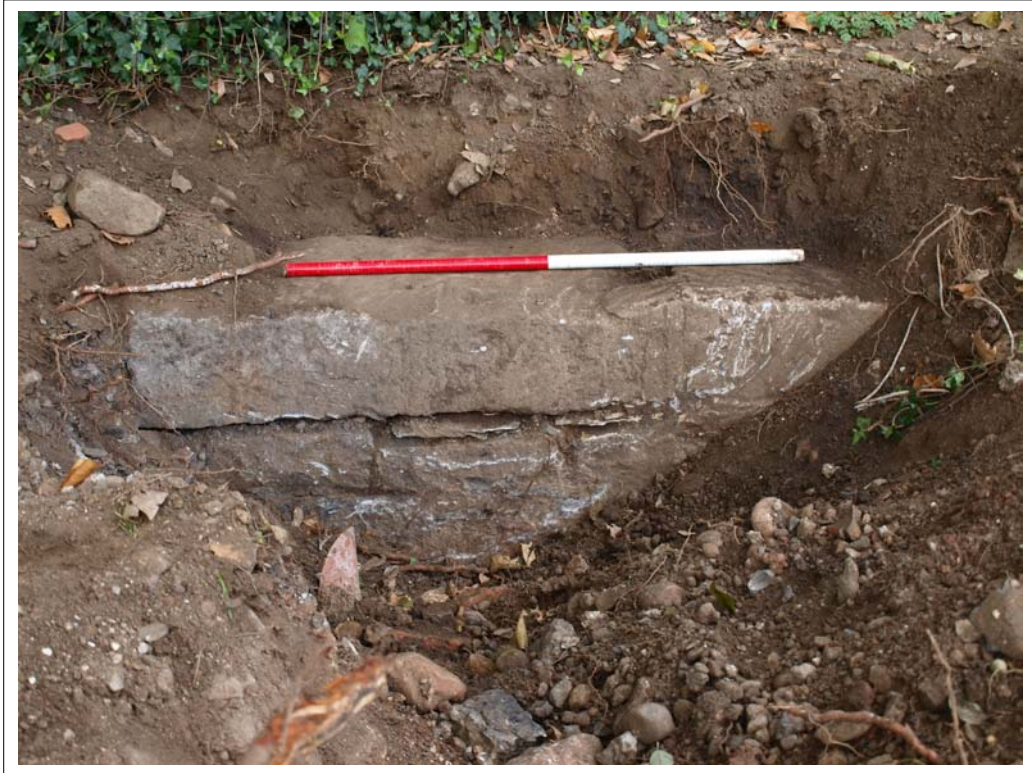
Trench 2 (1.4 x 0.8m x 0.7m, fig 2, Plate 3)

Trench 2 was positioned on an area of grass verge adjacent to North Road. Removal of topsoil revealed the surface of the old canal wall. Further excavation beside the wall revealed it to be made of dressed stones of differing sizes. Modern concrete repointing between the stones reveals that the wall was exposed until relatively recently. Excavation beside the wall ceased at a depth of 0.7m. The wall was recorded prior to being drilled through.

Plate 3: View of canal wall within trench 2, scale 1x1m

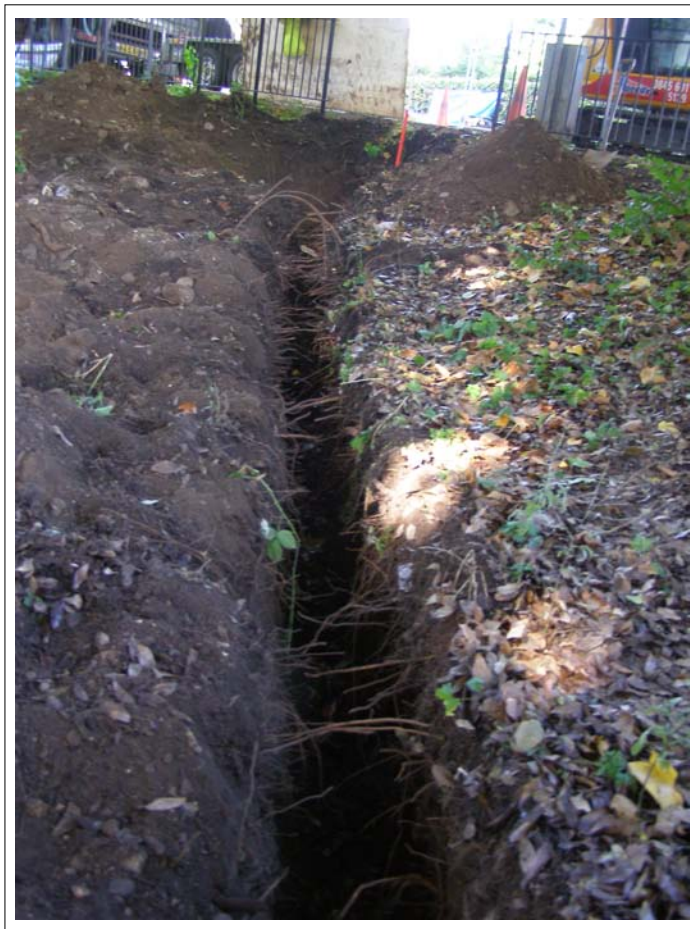
Trench 3 (10m x 0.8m x 0.5m, fig 2, Plate 4)

Trench 3 was a long thin trench excavated by mini-digger joining trenches 1 and 2. The trench was excavated to a maximum depth of 0.8m and was only 0.5m wide. No archaeological

remains were evident within the trench.

Plate 4: View along trench 3.
