CPAT Report No. 1341

Relict Landscapes of the Limestone in Flintshire

Assessment

Report for: Cadw

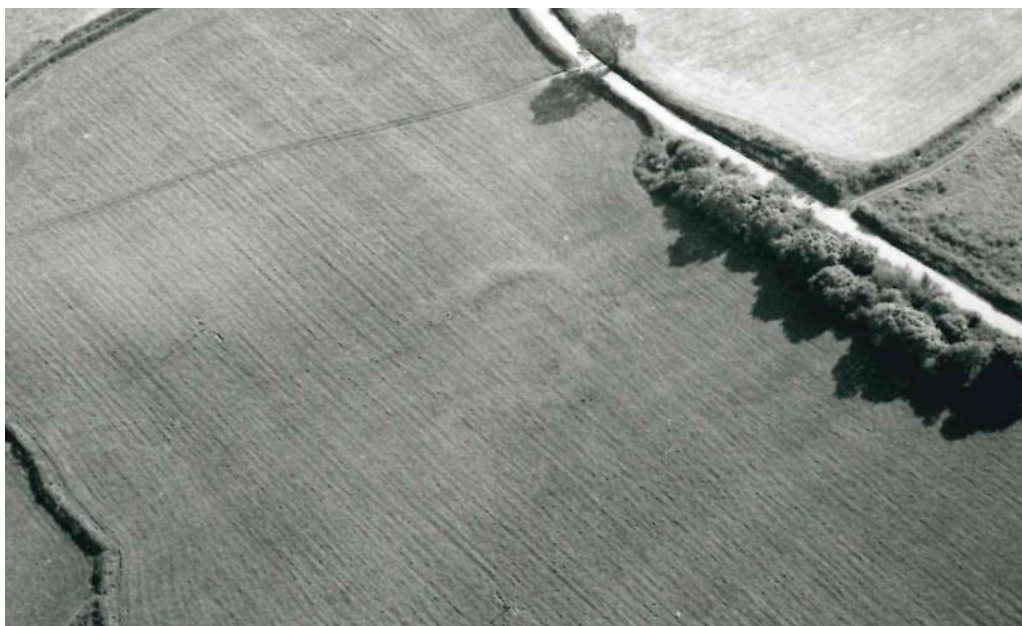
Bron Fadog enclosure: CPAT AP 89-mb-554

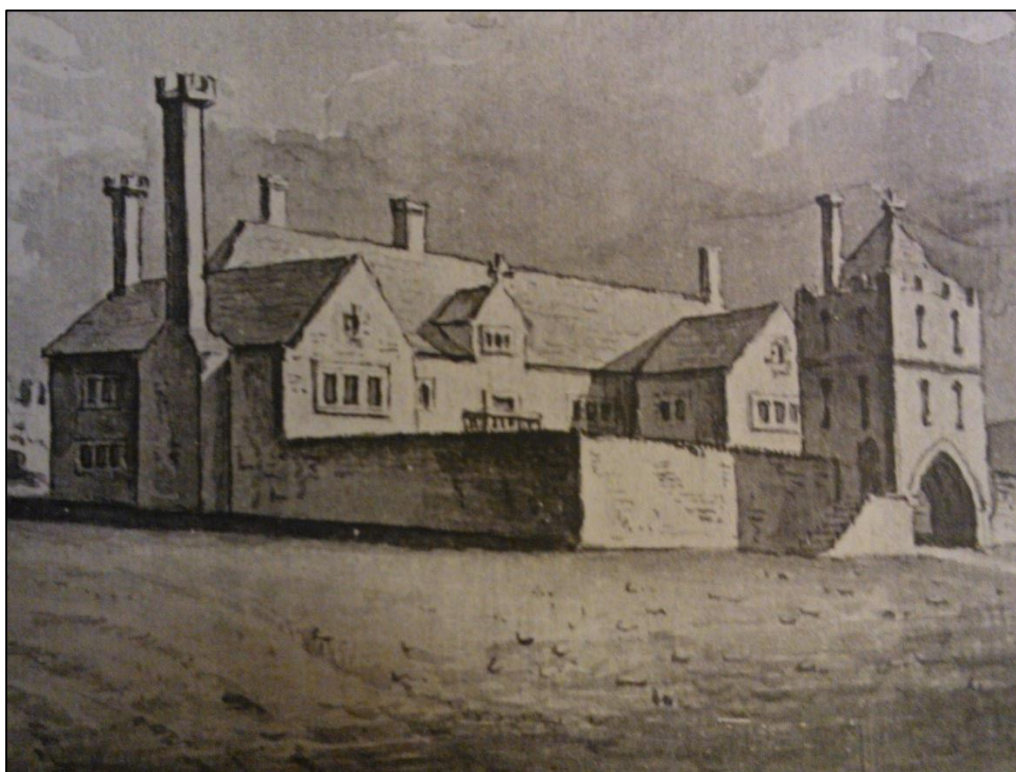
The Royal Commission noted the hall's surrounding features including a kitchen garden, orchard and a possible carriage drive as shown on the 2nd edition of the 1:2,500 Ordnance Survey map. Burnham's map shows the drive as a tree belt leading northwards towards the gatehouse from the lane to the south.

Clwyd County Council's records from 1979 refer to a rectangular earthen enclosure (98443) measuring 52m long by 20m wide; there was a break, 1.5m wide, on the north side at the north-east corner and evidence of stones being used here, and there was also a rough bank, 3m wide, running down the centre of the enclosure from north to south. This shows on early Ordnance Survey maps as a quadrilateral feature (at SJ 1317 7400) incorporated into the enclosure pattern around the hall. It is without doubt unusual and probably represents a park or garden feature.

Caerwys Hall has yet to be properly researched. Much altered, it is said to date to 1589 and comprises a two-storey stone farmhouse with a massive gabled chimneybreast, and with some stone-mullioned windows surviving. Peter Smith considered that it was built as a storeyed house with a first-floor room open to the roof (as reported by Edward Hubbard). Hubbard also referred to the massive two-storey gatehouse shown in a drawing of c.1800, presumably the work of Moses Griffith and this also appears on William Burnham's 1717 estate map of the area.

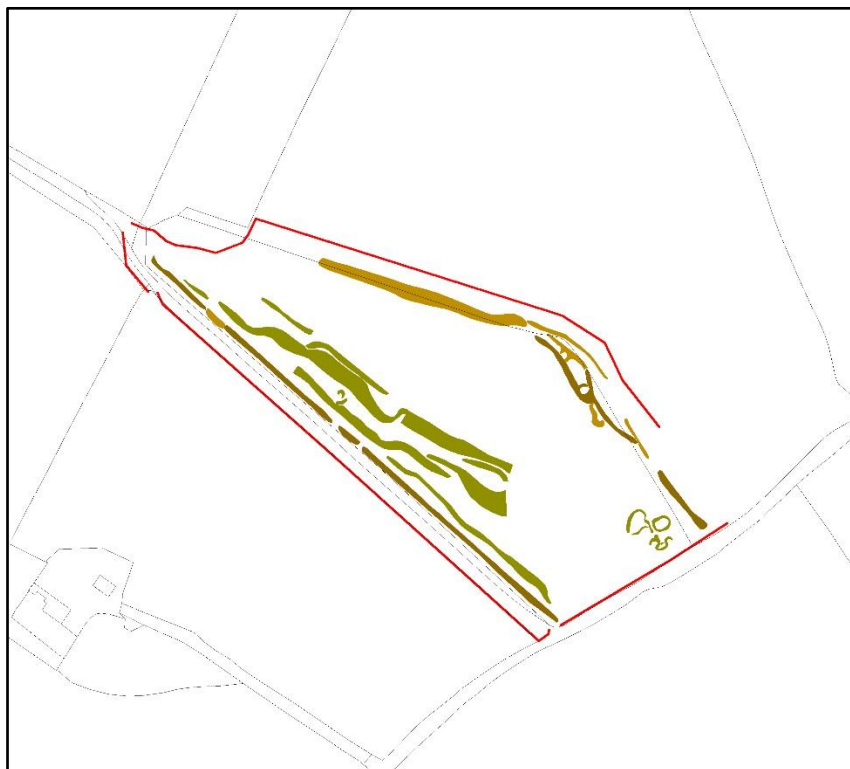
Earthworks in Coed Tan-y-plas, based on survey by Gwynedd Archaeological Trust

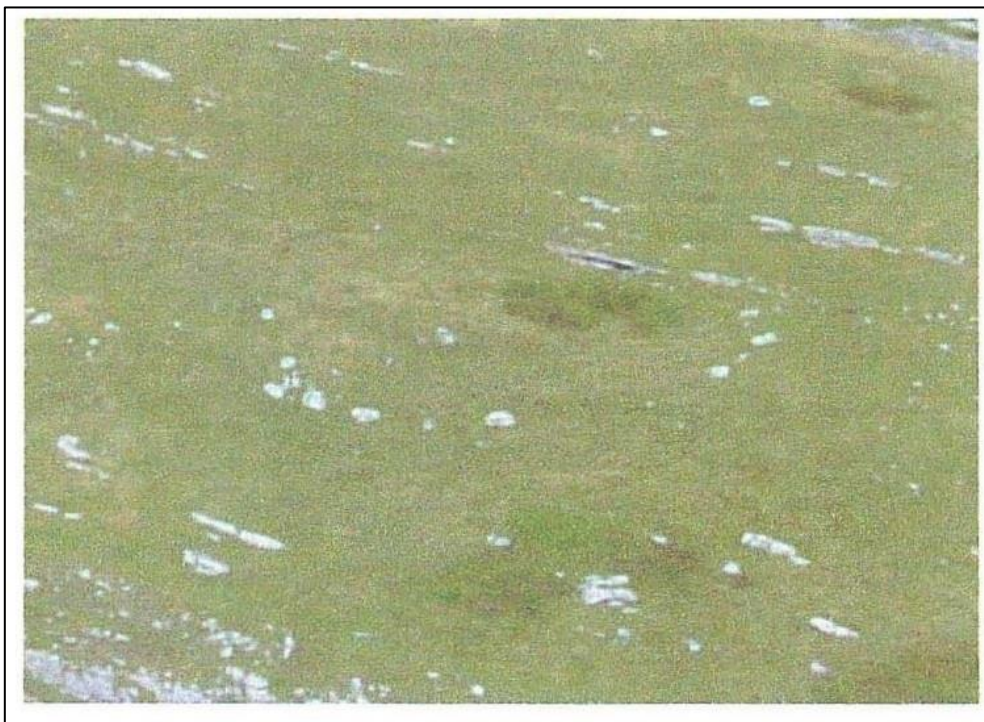
The Eryrys horseshoe (after John Blore)

John Blore has continued to study this putative site, surveying it and test pitting close to some of the stones. His current report, held within the HER, and in the general form of an on-going blog, runs to eighteen pages. He has not, I think yet managed to demonstrate conclusively that this is an authentic archaeological site, but he has found a pit beneath one stone which contained a collection of water-worn pebbles, suggestive of some human activity. And, on the other hand the evidence to support a natural origin for the stones is hardly indisputable.

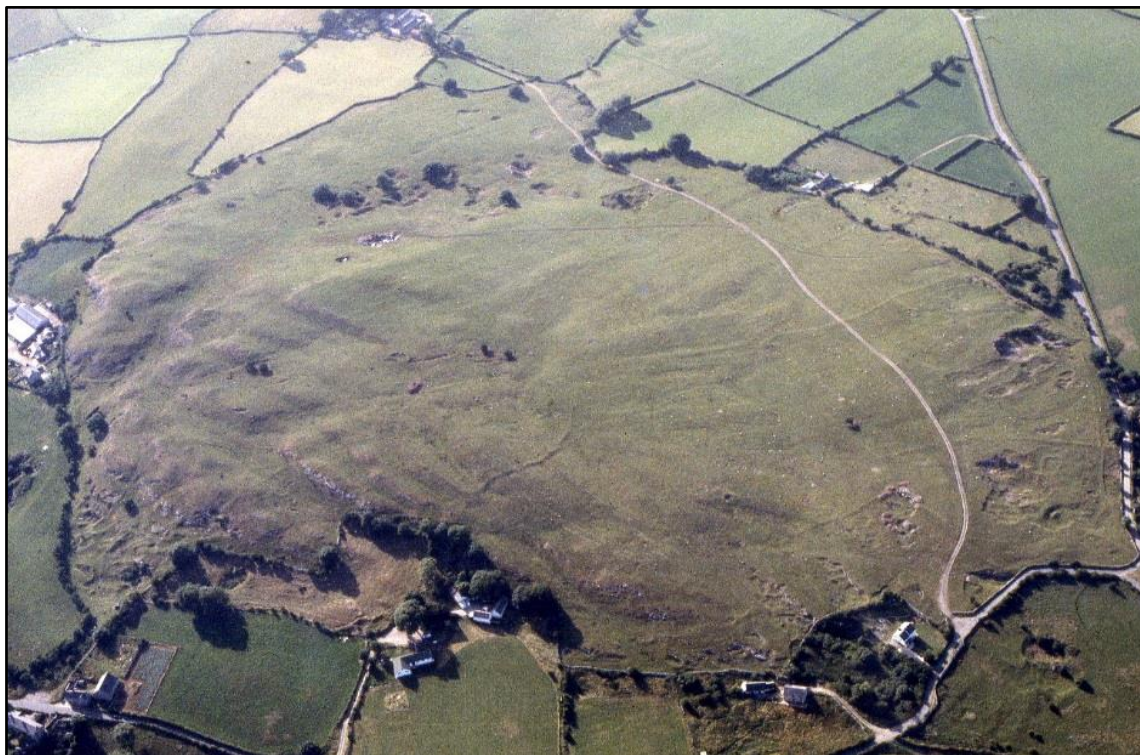
Marian Ffrith © CPAT 83-c-0238. The enclosure can be seen a little to the left of centre, the boundaries to the right of the image.

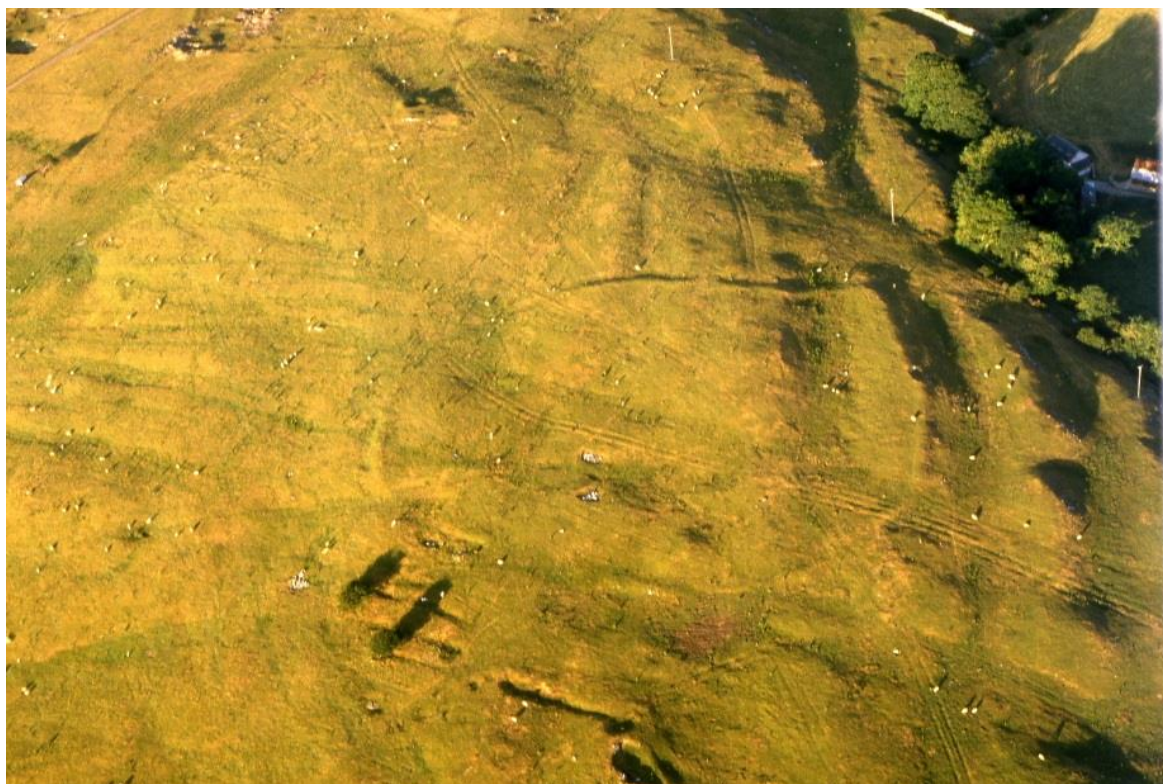
Marian Ffrith © CPAT 84-c-0261. The enclosure.

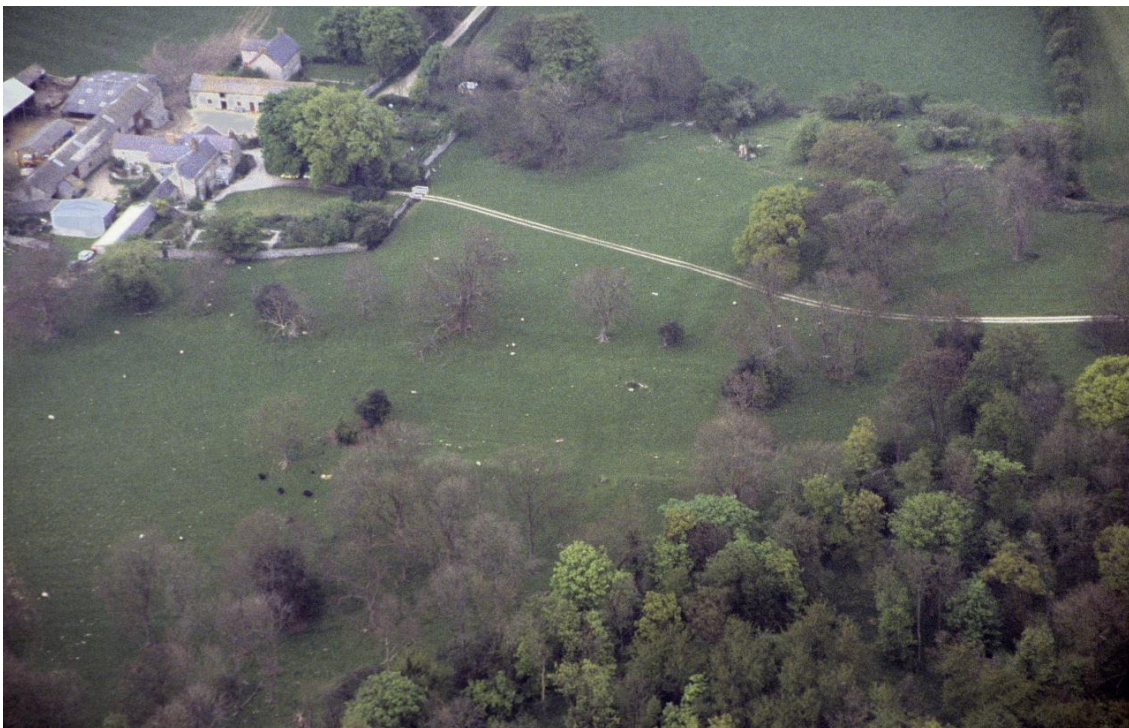
The Foxhall enclosure © Clwyd-Powys Archaeological Trust; CPAT-93-c-0298. Part of the enclosure bank is just apparent on the right of the aerial photograph immediately above the road, while the antenna banks are crossed by the same road, closer to the centre of the image.

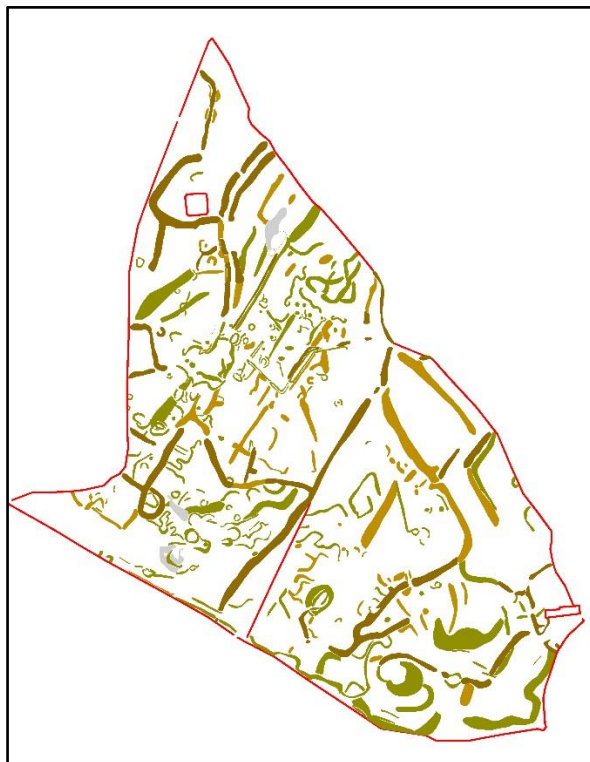
Earthworks at Pant (after GAT)

The Royal Commission calculated the area of the earthworks at around 6ha – the GAT survey indicates 6.85ha - and described the site as lying on uneven ground falling gently from the north-west to the south-east, from 205m OD to 190m OD. This is on the periphery of the parish of Caerwys, and this location is of significance in that it goes a part of the way to explaining why this area on the margin remained as common into the 18th and probably into the 19th century (for it appears from the damaged

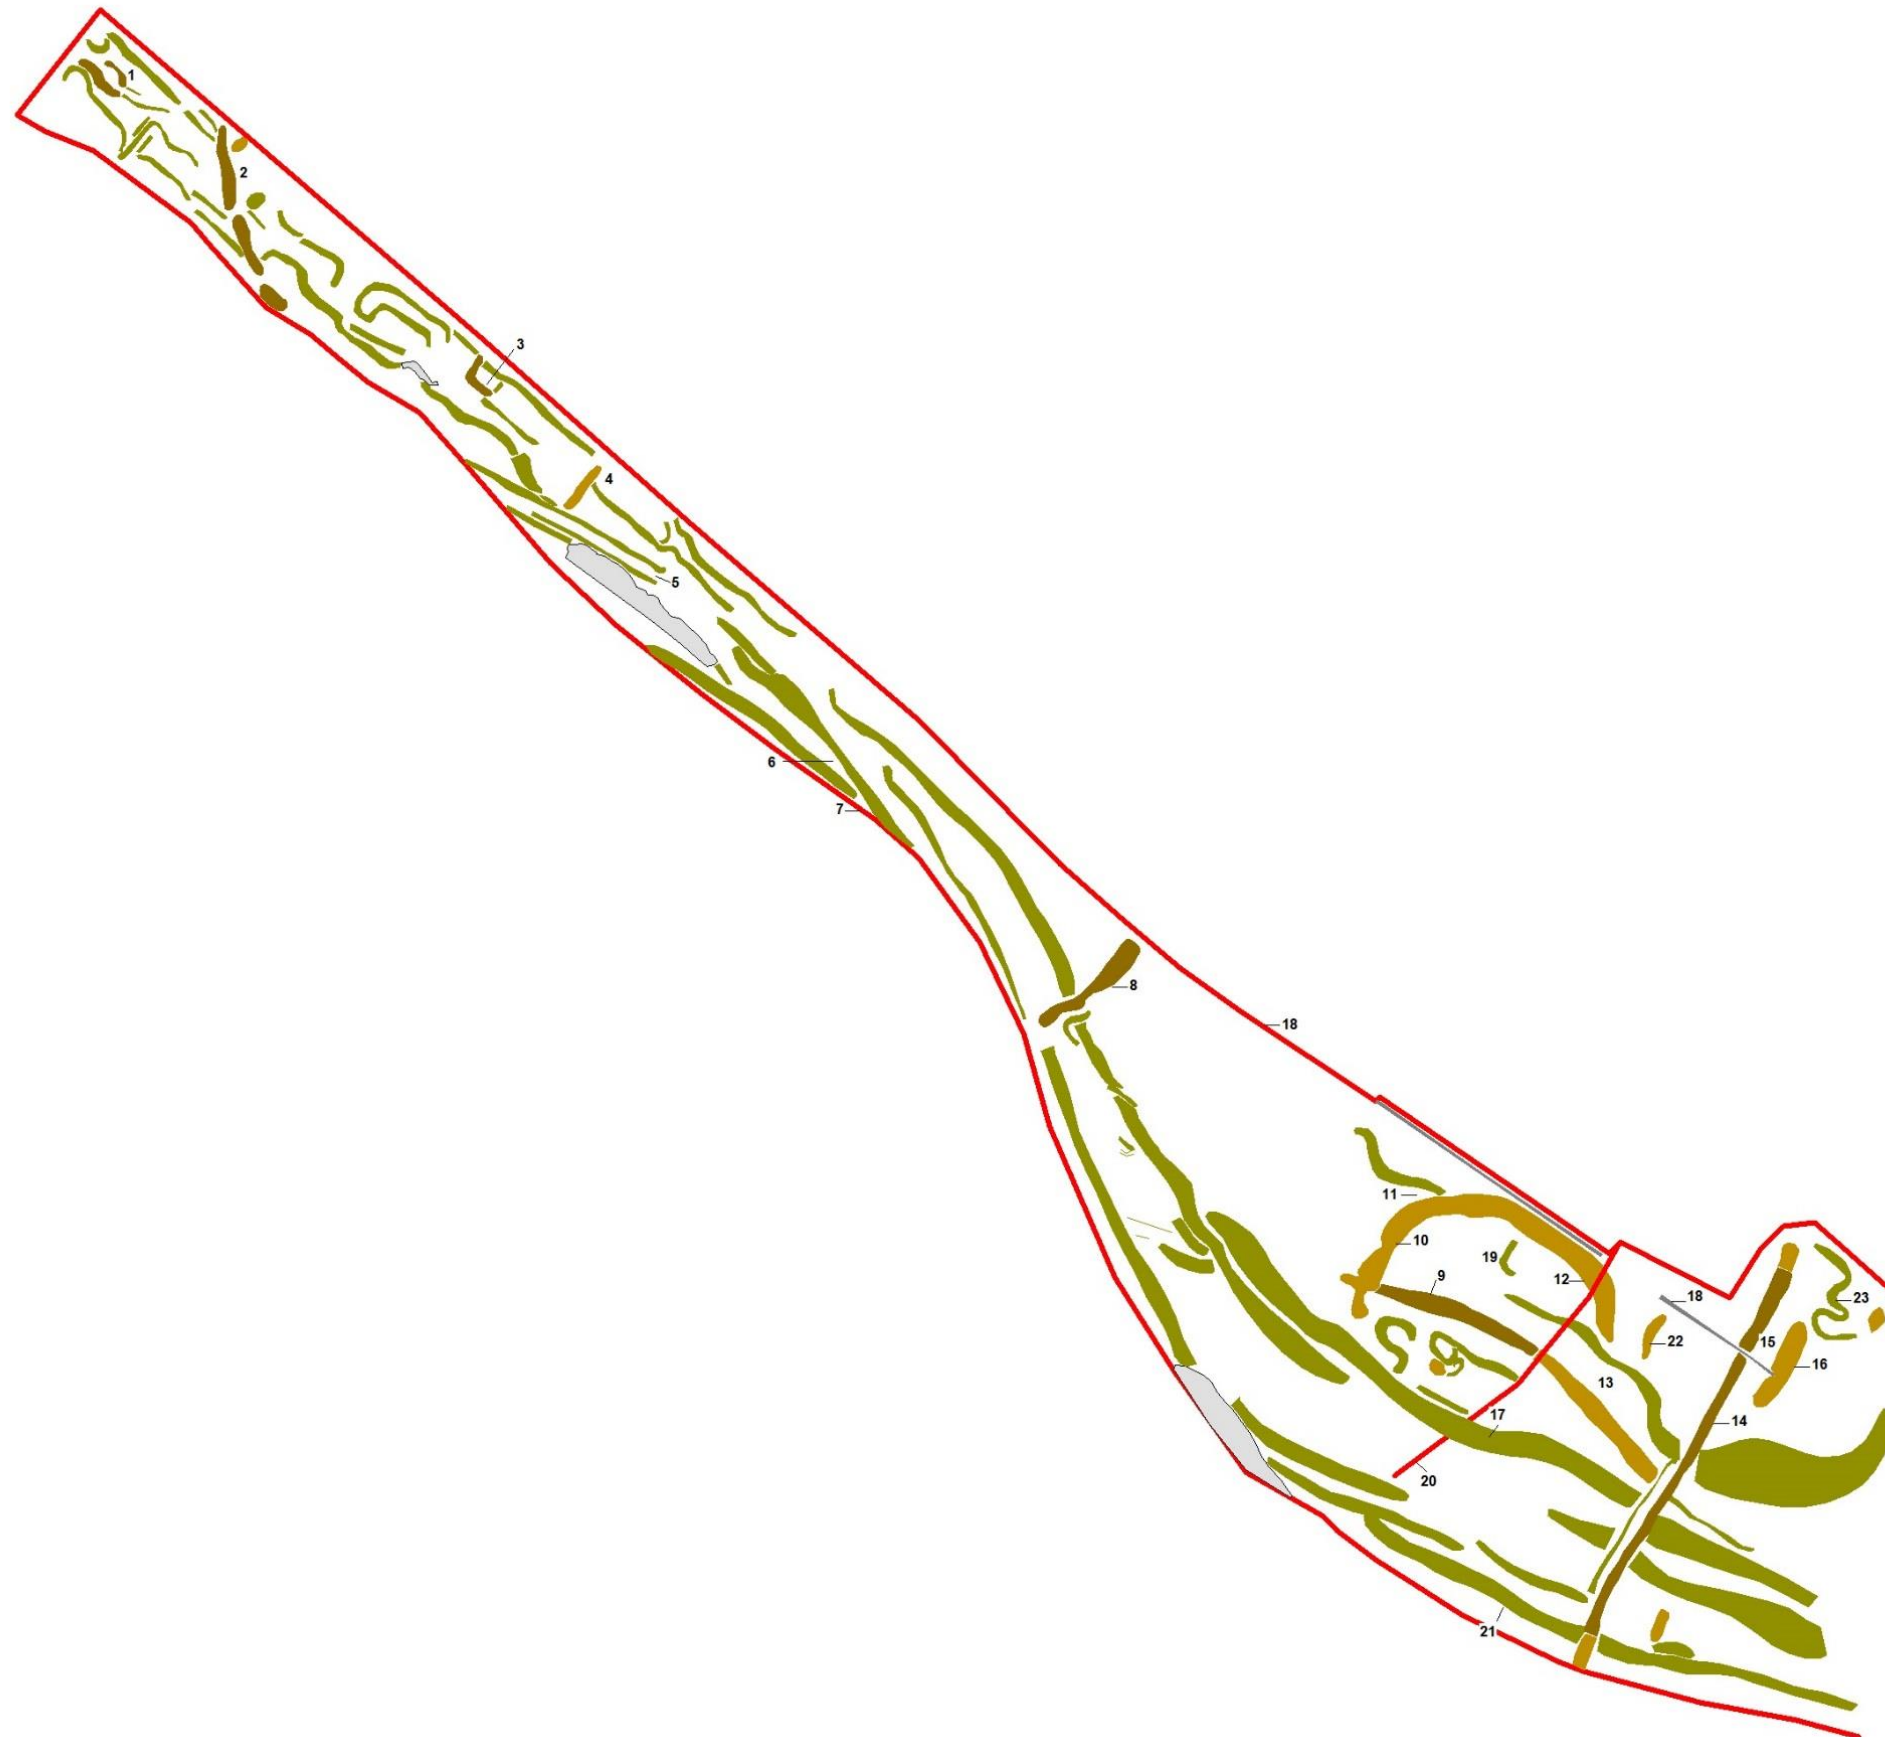
Coed Tan y Walk Earthwork: Plan

- 21 Possible base of wall cf (7).
- 22 Overgrown and not detected.
- 23 Area integrated into pasture field to N.

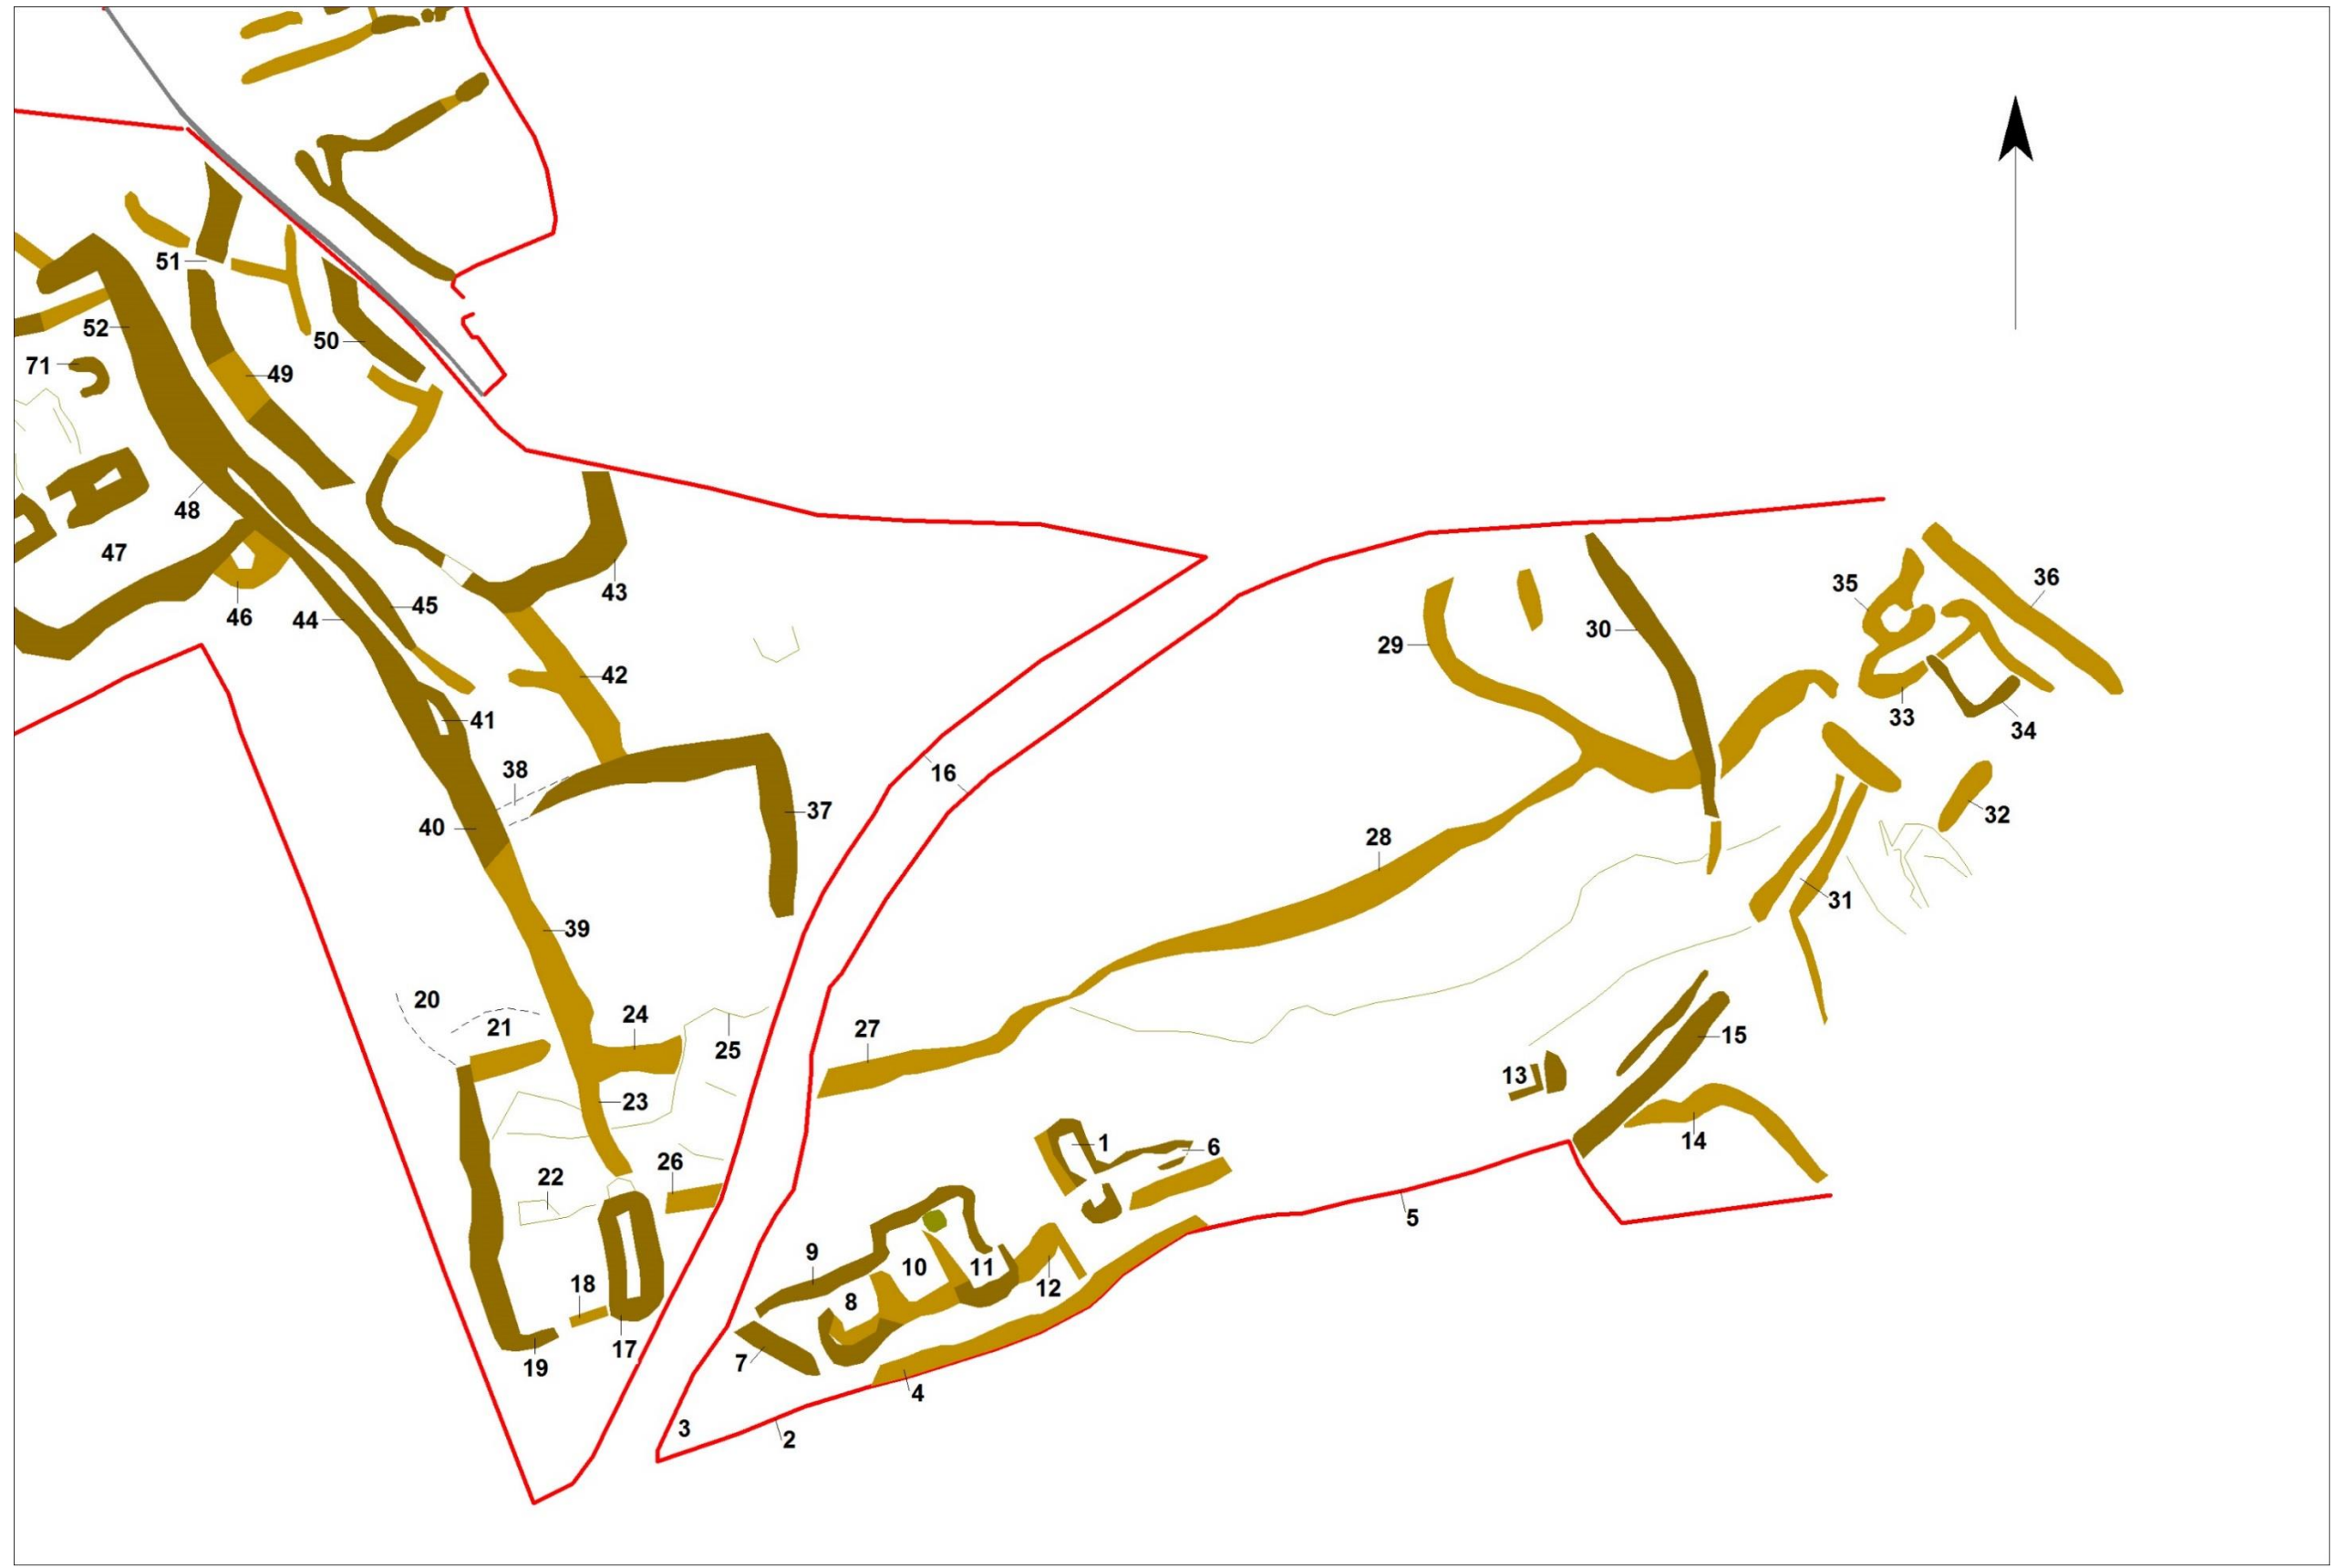
Hen Caerwys Earthworks: Plan 1

71 Horseshoe-shaped feature accurately depicted in 1993 survey. Bank no more than 0.3m high on both of its faces. A hint that the interior is higher than the surrounding ground level.

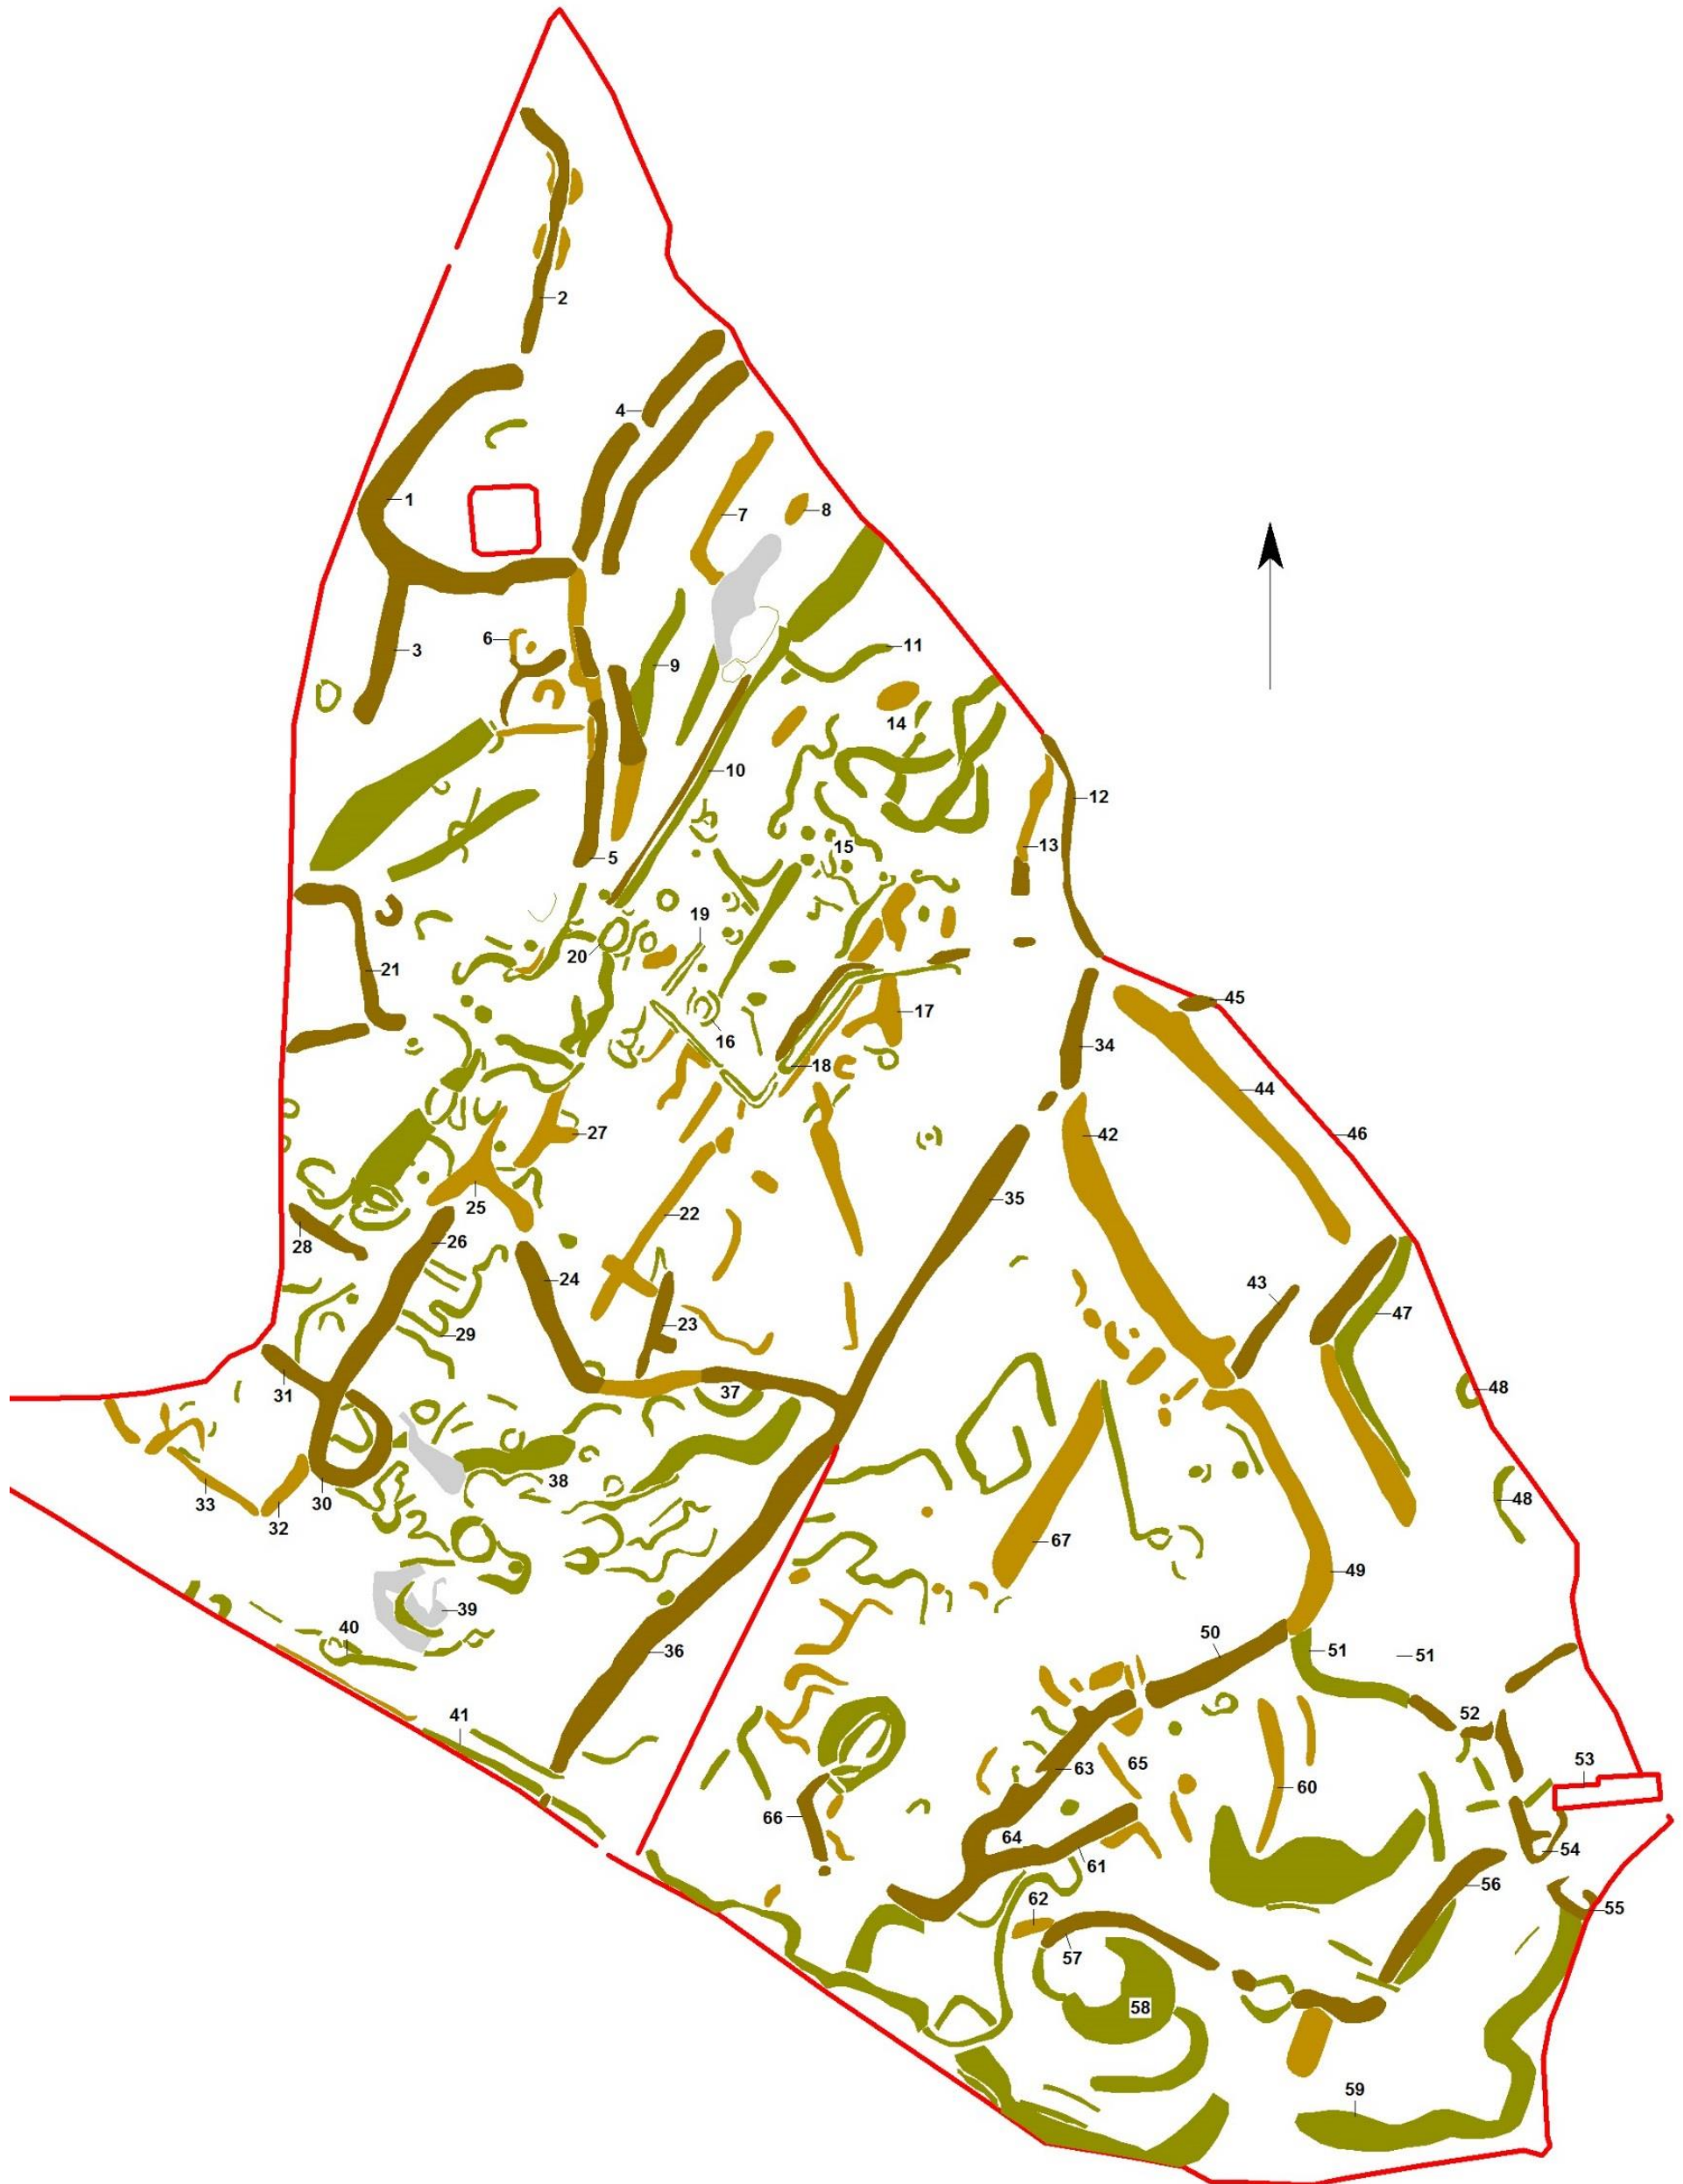
Pant, Caerwys Earthworks: Plan

(Note all measurements given were done by eye by the writer, or paced in the case of horizontal measurements). Visits were made on 27 January and 04 February 2015. Field notes written up 06 February 2015
