# The Tudor Mansion, Neath Abbey, Neath, Swansea, Glamorgan (Phase 3).

## Archaeological Geo-physics Survey

HRS Wales  
Report No: 223

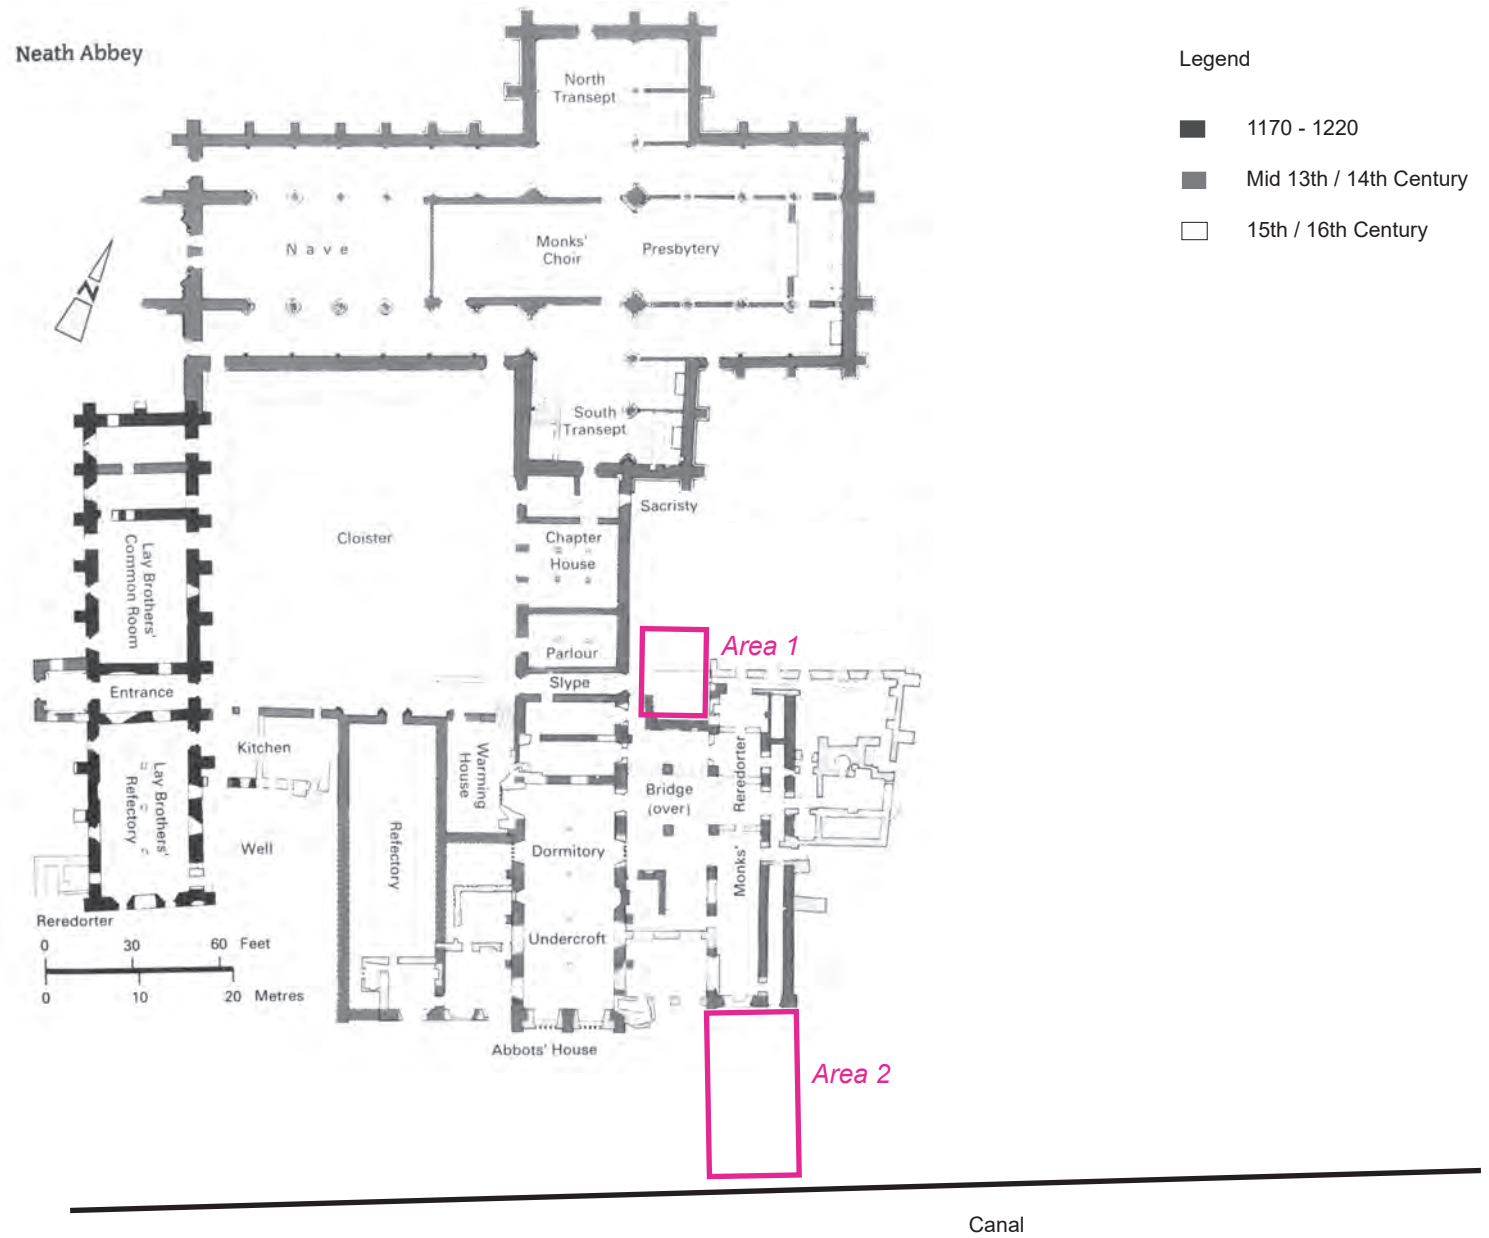
Ground Plan of Neath Abbey with areas of Gewophysics investigation highlighted.  
(after Cadw's Guide to Ancient and Historic Wales: Glamorgan and Gwent - 1992)

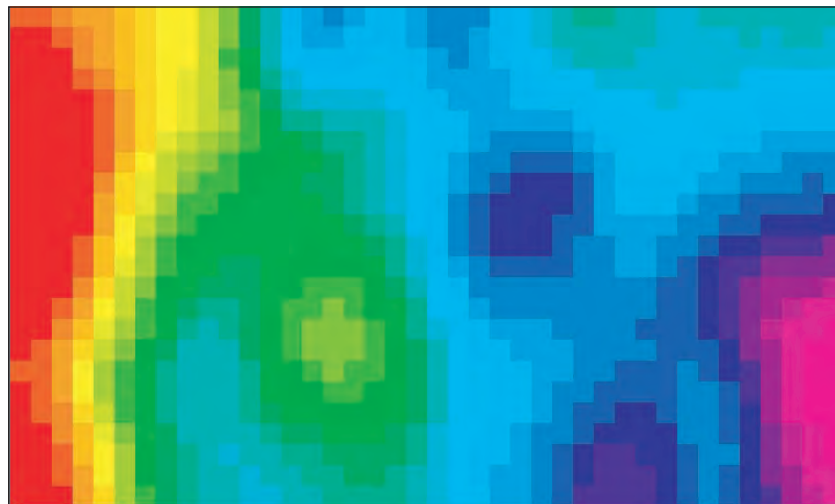
**Figure 6.**  
 Area 1 - Resistivity Survey results using 0.50 Meter array (Greyscale and colour mapping).

- 4.4 Analysis of the 0.50m wide array survey data results for Area 1 has not revealed any *obvious* channel or leat running across the surveyed area. However, it has revealed the character of the ground in a number of areas, such as in grid no's 4C through to 5F, where the survey shows areas of medium resistance, suggestive a loose rubble deposit, likely rubble filled overburden. An area of high resistance is also shown from grid no's 1A through to 1F. This area is the position of the partly exposed cross wall immediately north of the bridge.

- 4.5 Another interesting area is within grid no's 10C through to 10F, where an area of low resistance shows a very moist area of ground.
- 4.6 The results from the 1m wide array show a very similar pattern of results from the 0.50m wide array but give better delineation of resistance edges, Of particular interest is the larger extent of wet ground at the far north east end of the survey area (grid no's 5F, 6F, 7E, 7F, 8F, 9E, 9F, 10D –

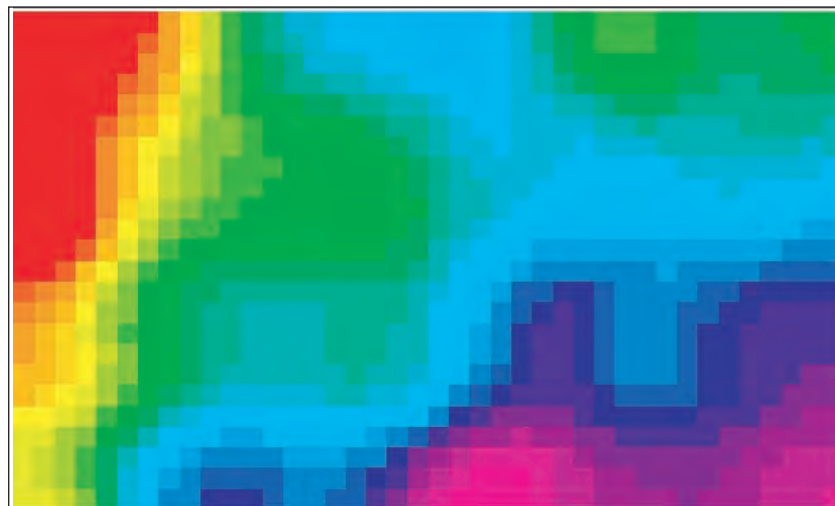
**Figure 7.**  
 Area 1 - Resistivity Survey results using 1 Meter array (Greyscale and colour mapping).

10F). Also more apparent is the extent of the rubble filled overburden at both the northwest and southwest ends of the survey grid.

- 4.7 The areas between the rubble filled overburden and the wet ground reveal areas of medium to low resistance, likely loose soil overburden.

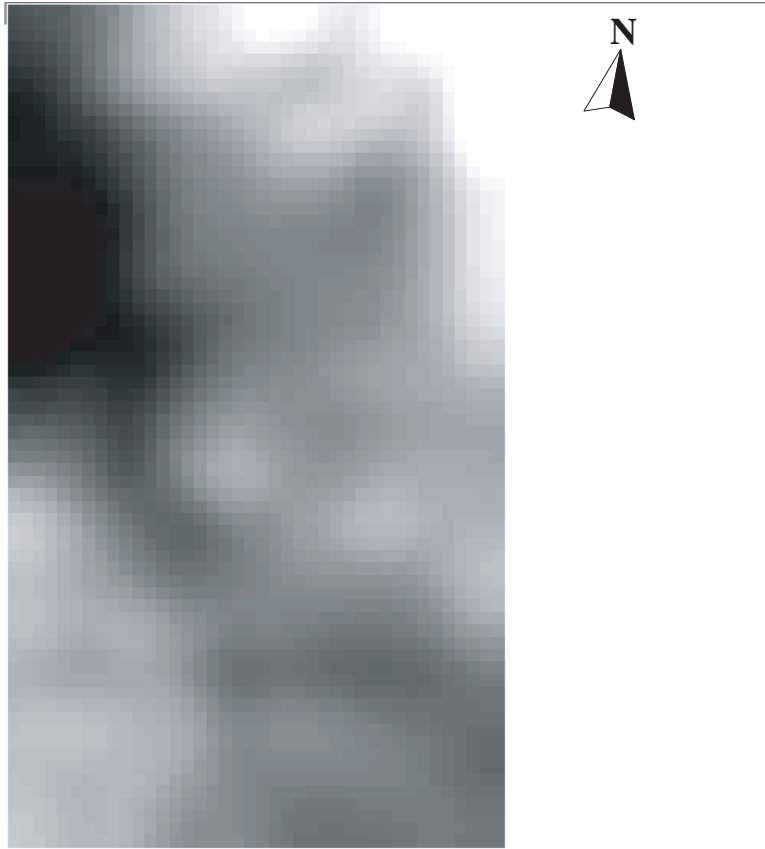
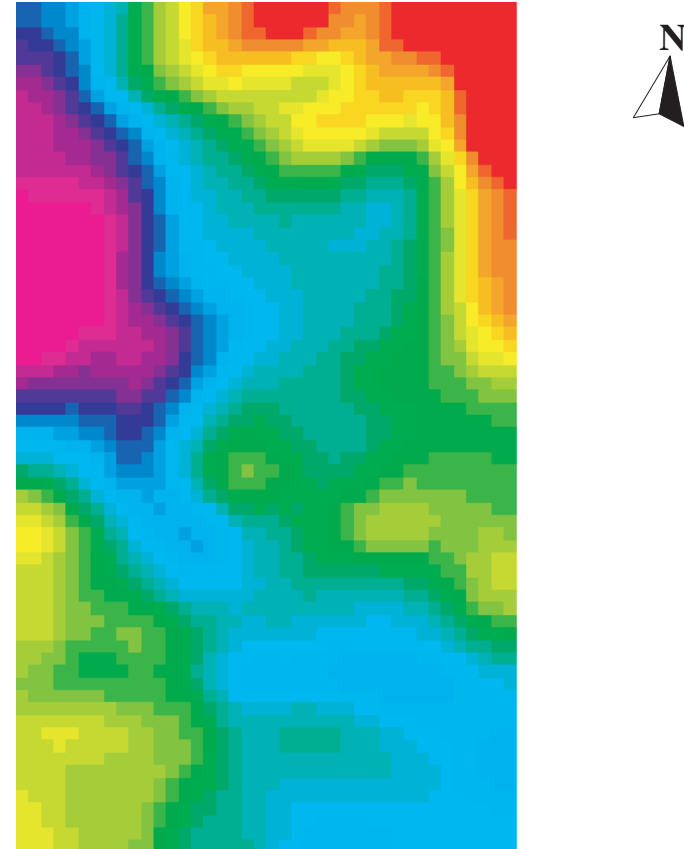
Document: Survey Area 2 (0.50m array)  
 Grid Width: 40 (10 m)  
 Grid Height: 72 (17 m)  
 Orig. Sample Size: 1.00 x 1.00m  
 New Sample Size: 0.25 x 0.25m

Area 2 - Resistivity Survey results using 0.50m array (Greyscale and colour mapping).

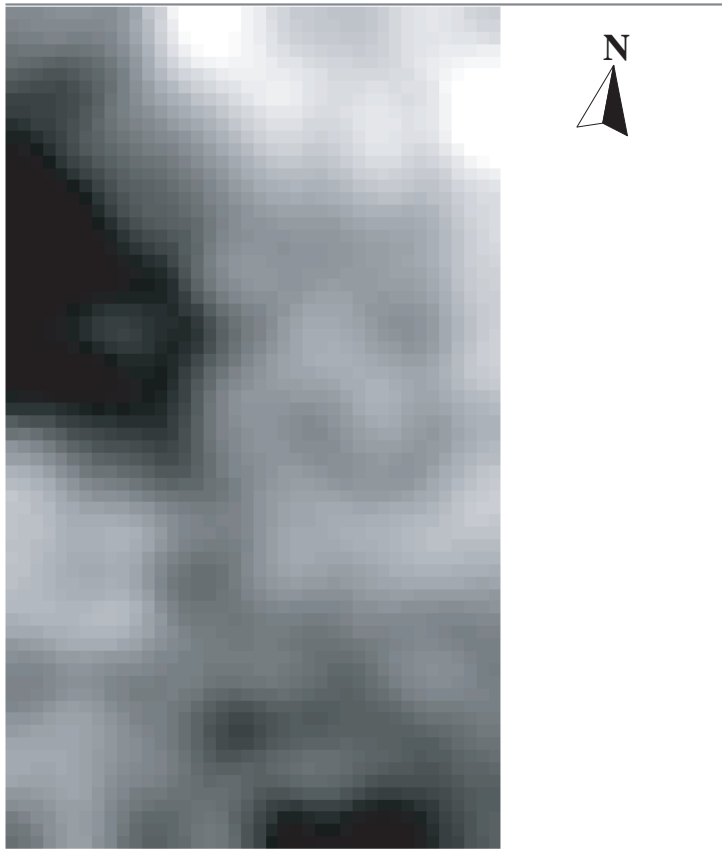
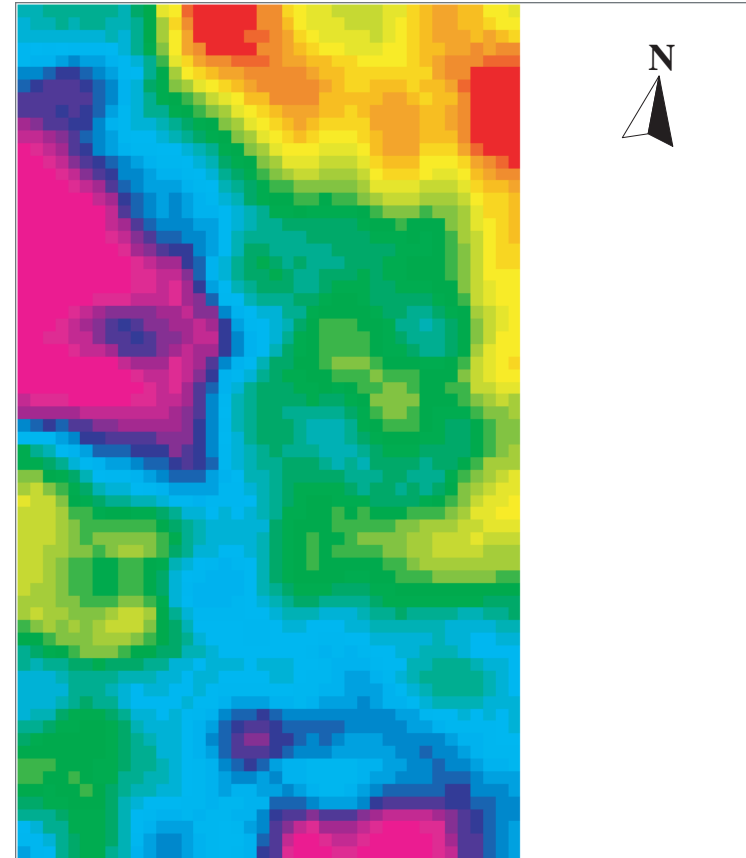
Document: Survey Area 2 (1m array)  
 Grid Width: 40 (10 m)  
 Grid Height: 68 (17 m)  
 Orig. Sample Size: 1.00 x 1.00m  
 New Sample Size: 0.25 x 0.25m

Area 2 - Resistivity Survey results using 1m array (Greyscale and colour mapping).

- 4.16 Again, although no obvious leat or channel has become revealed in the area associated with the outflow from the Latrine Range, use of the wider array has offered a more outlined view of the apparent structure in grid no's 1D through to 1J, 2D through to 2J, 3I – 3J, 4J, 5J, 6J and 7J, which suggest that in this position there is the foundation remains of a possible polygonal structure set up against the external elevation of the Latrine Range, seemingly with a hollow centre, suggestive of a possible former stair tower.

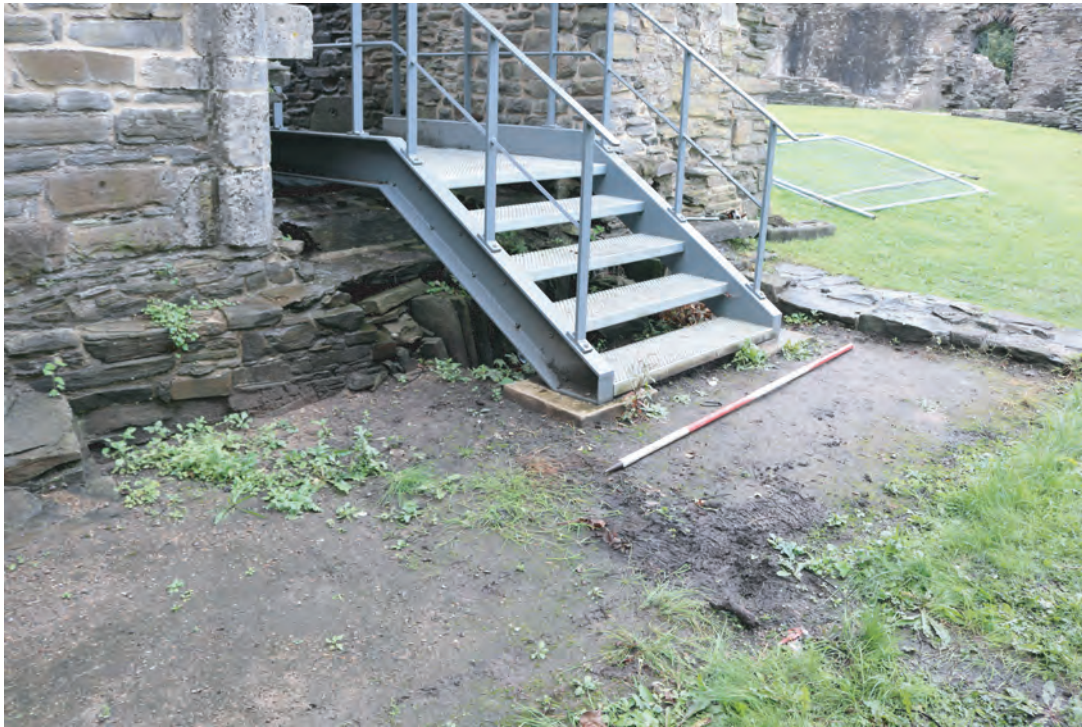
*Plate 03. Area 1 - Oblique view of modern steel steps covering former opening to cell or basement area below slype passage at northern end of Dorter / Undercroft. Looking northwest.*

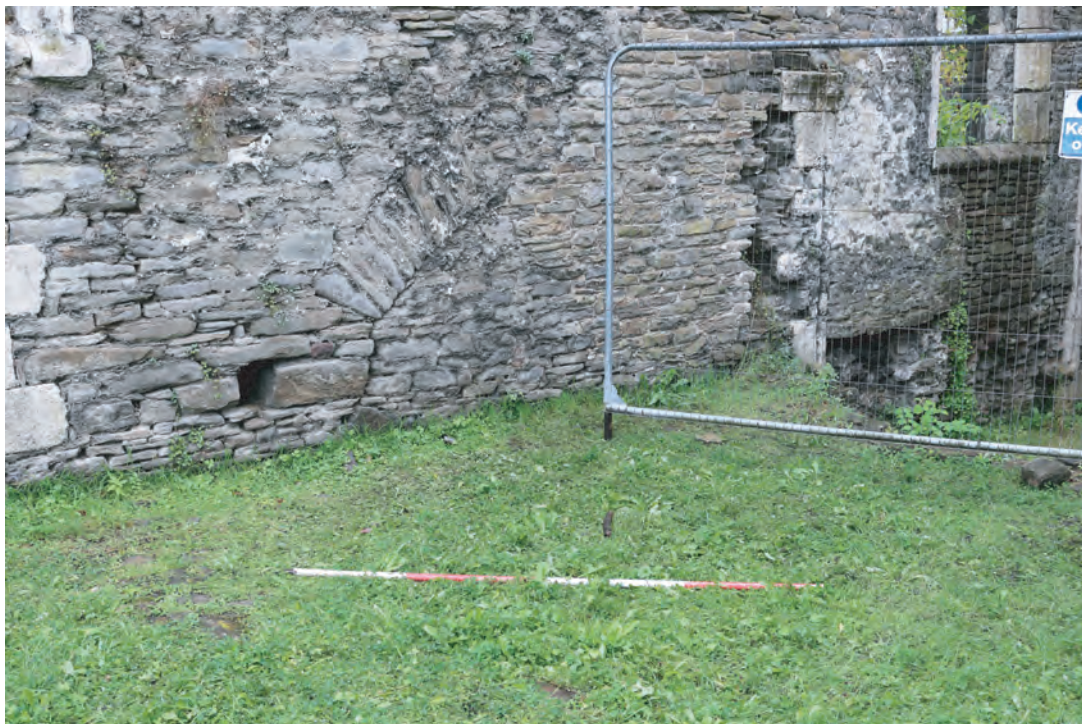
*Plate 04. Area 1 - Detail of blocked opening in north end of west facing external elevation of Reredorter (Latrine Range). Looking southeast.*

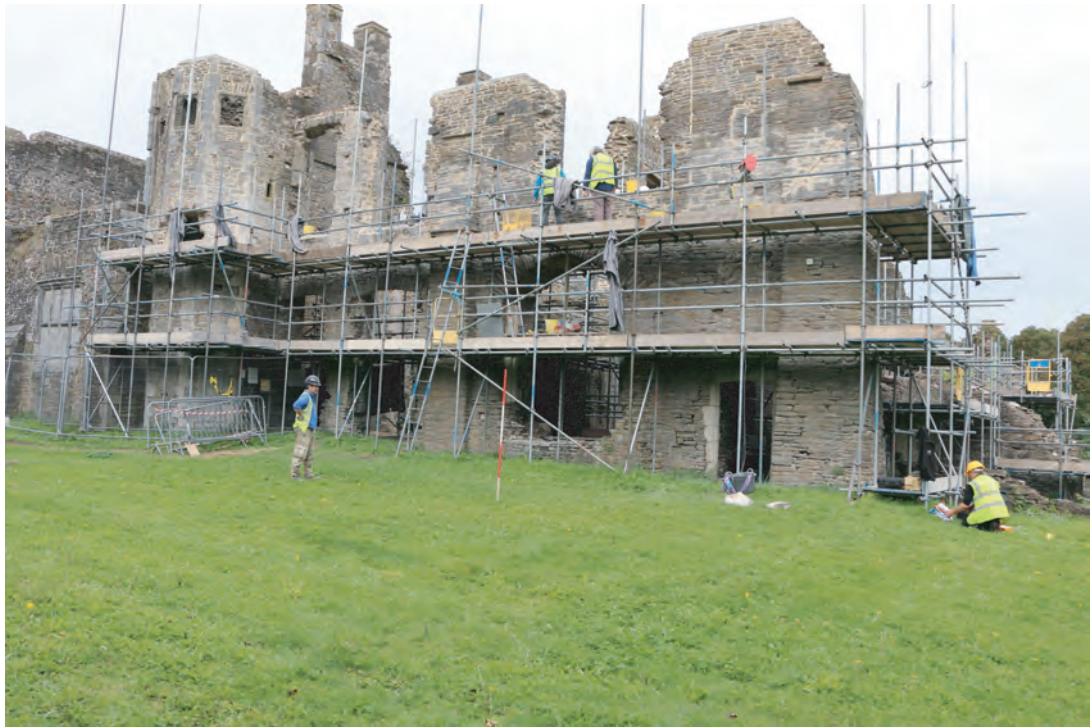
Plate 07. Area 2 - View of survey area at southern external side of Reredorter (Latrine Range). Looking north.
