# Blackpool Mill Minwear Pembrokeshire

## Level 4 Historic Building Record

July 2021

Level 4 Historic Building Record

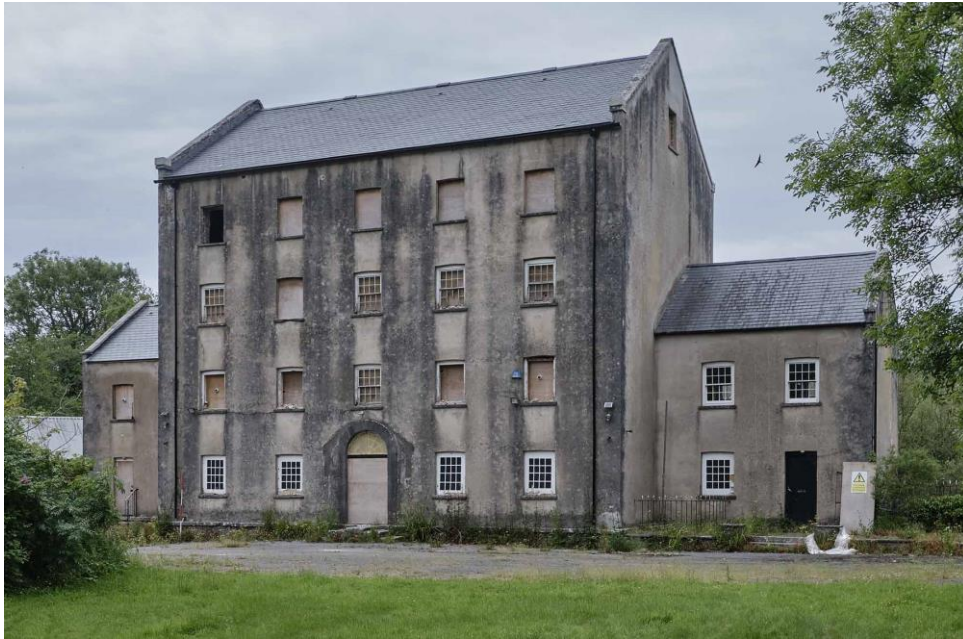
*Figure 6. South-east front of the Mill.*

The mill is a building of four storeys, with attic, and a basement housed within a deep plinth (fig 6). The main building which has walls of coursed stone that have been cement-rendered, under replacement slate roofs behind coped gables. The plinth is of hammer-dressed stone with freestone coping. The main range has five bays, with outer two-storey wings of two bays set back. The central entrance is round-headed and within a dressed limestone surround, with double doors under a radial-glazed overlight. Mid-twentieth century photographs show a gabled canopy over the entrance which this has been removed, but its shadow remains visible on the wall. Steps up to the door are in modern concrete. Original windows are 16-pane hornless sashes, of which four survive in the front of the main range, with some replacement twentieth-century horned sashes, while other windows are boarded over, and the sashes have been removed. In the north-east (right-hand) wing there is an inserted door, but otherwise it has windows similar to the main range. The angle between

the main range and the wing is not paved, leaving the watercourse to the secondary waterwheel exposed. Curved railings around the around protect from the fall in the ground. In the south-west (left-hand) wing are modern steps up to an inserted door, but otherwise the windows are also similar to the main range. In front of the south-west wing is a weighing machine by Pooley & Sons of Liverpool and Birmingham (fig 7). The attic of the main range is lit by small windows in the gable ends, both boarded over. In the gable end of the south-west wing is an arched opening to the basement and a single cast-iron mooring ring.

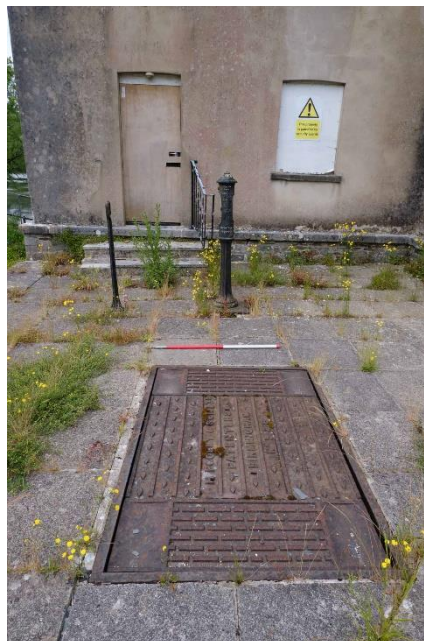
*Figure 7. Weighing machine in front of south-west wing.*

By 1907 the tenant, G.W. Pike, had installed a weighing machine (marked WM on the 1907 Ordnance Survey map), replaced one pair of stones, added a cake crusher, sawmill and corn rolls for rolling oats. In 1915 additional equipment was installed – a flour-dressing plant with automatic feeder, stone meal scalper, centrifugal dressing machine (or smutter) and grain separator, all by Joseph Armfield except for the smutter. The stones were used for grinding wheat and barley and shelling oats. Pike claimed, however, that demand for crushing barley

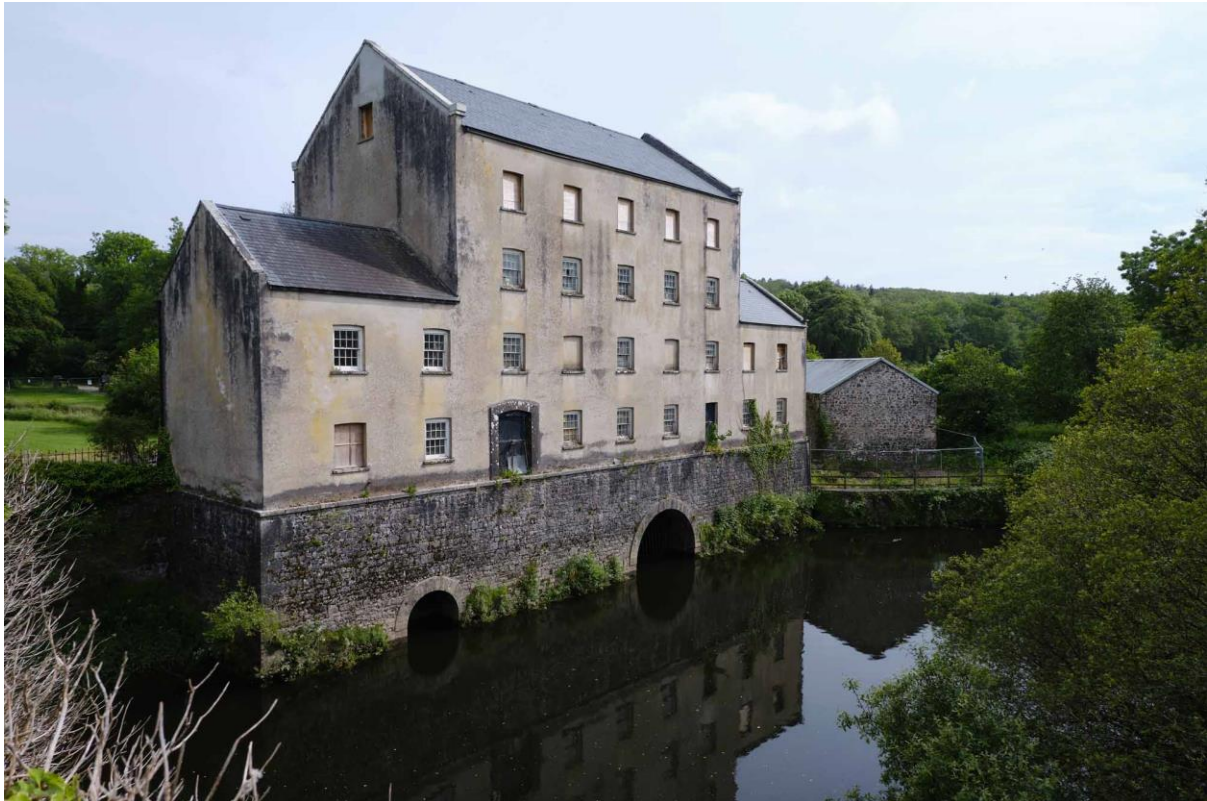
*Figure 8. Rear wall to river, with quay on the right-hand side.*

At the rear, the main range and wing form a continuous front to the river (fig 8). The deep plinth of hammer-dressed stone with projecting coping, is more clearly visible than it is at the front of the building. It has a central wide tail race under a round arch of dressed limestone, with a smaller tailrace to the left, under the north-east wing, for the secondary waterwheel. The left-hand bay of the main range has a ground-floor doorway in a projecting stone surround with cambered head, which has a split boarded door. It was used for raising and lowering sacks from river vessels. In the right-hand bay there is a simple ground-floor boarded split door.

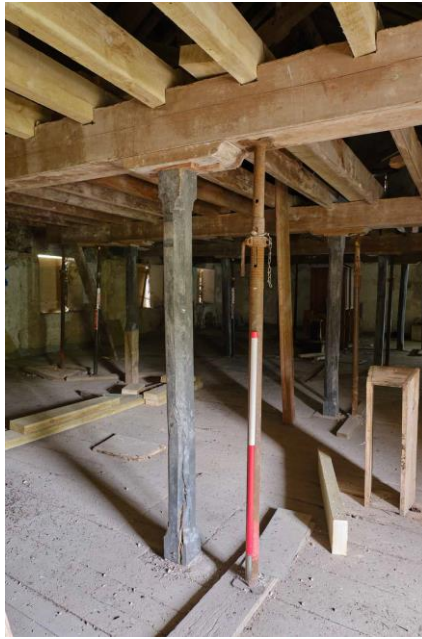
*Figure 9. Timber post on third floor.*

The main floors retain original pine floorboards, with significant areas of replacement. Walls are lime-plastered on the main floors. In the ground, first and second floors the cross beams are carried in two rows of cast iron columns. On the third floor they are carried on octagonal timber posts which have run-out stops (fig 9). The five-bay roof has trusses which have been restored and repaired by the addition of fish plates. They have tapering king posts with raking struts. Between the central two trusses are longitudinal beams that supported the sack hoist.

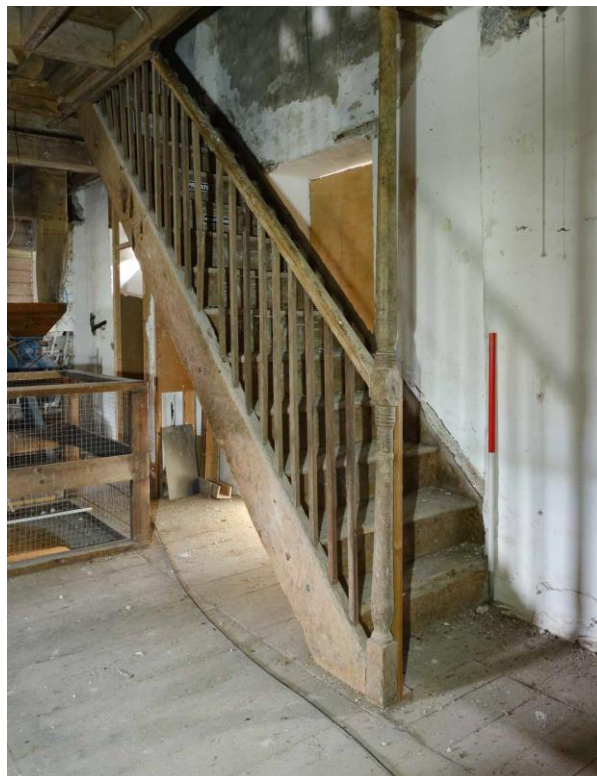
*Figure 10. Stairs from first to second floors.*

Stairs from ground to first floor, first floor to second and second to third are all set against the wall (fig 10). They have turned full-height newels, plain balusters (removed second-third floor) and moulded hand rail. The stair to the attic has lost its square balusters and retains only one moulded square newel. Other interior details are modern, including the doors to the outer wings and basement stairs.

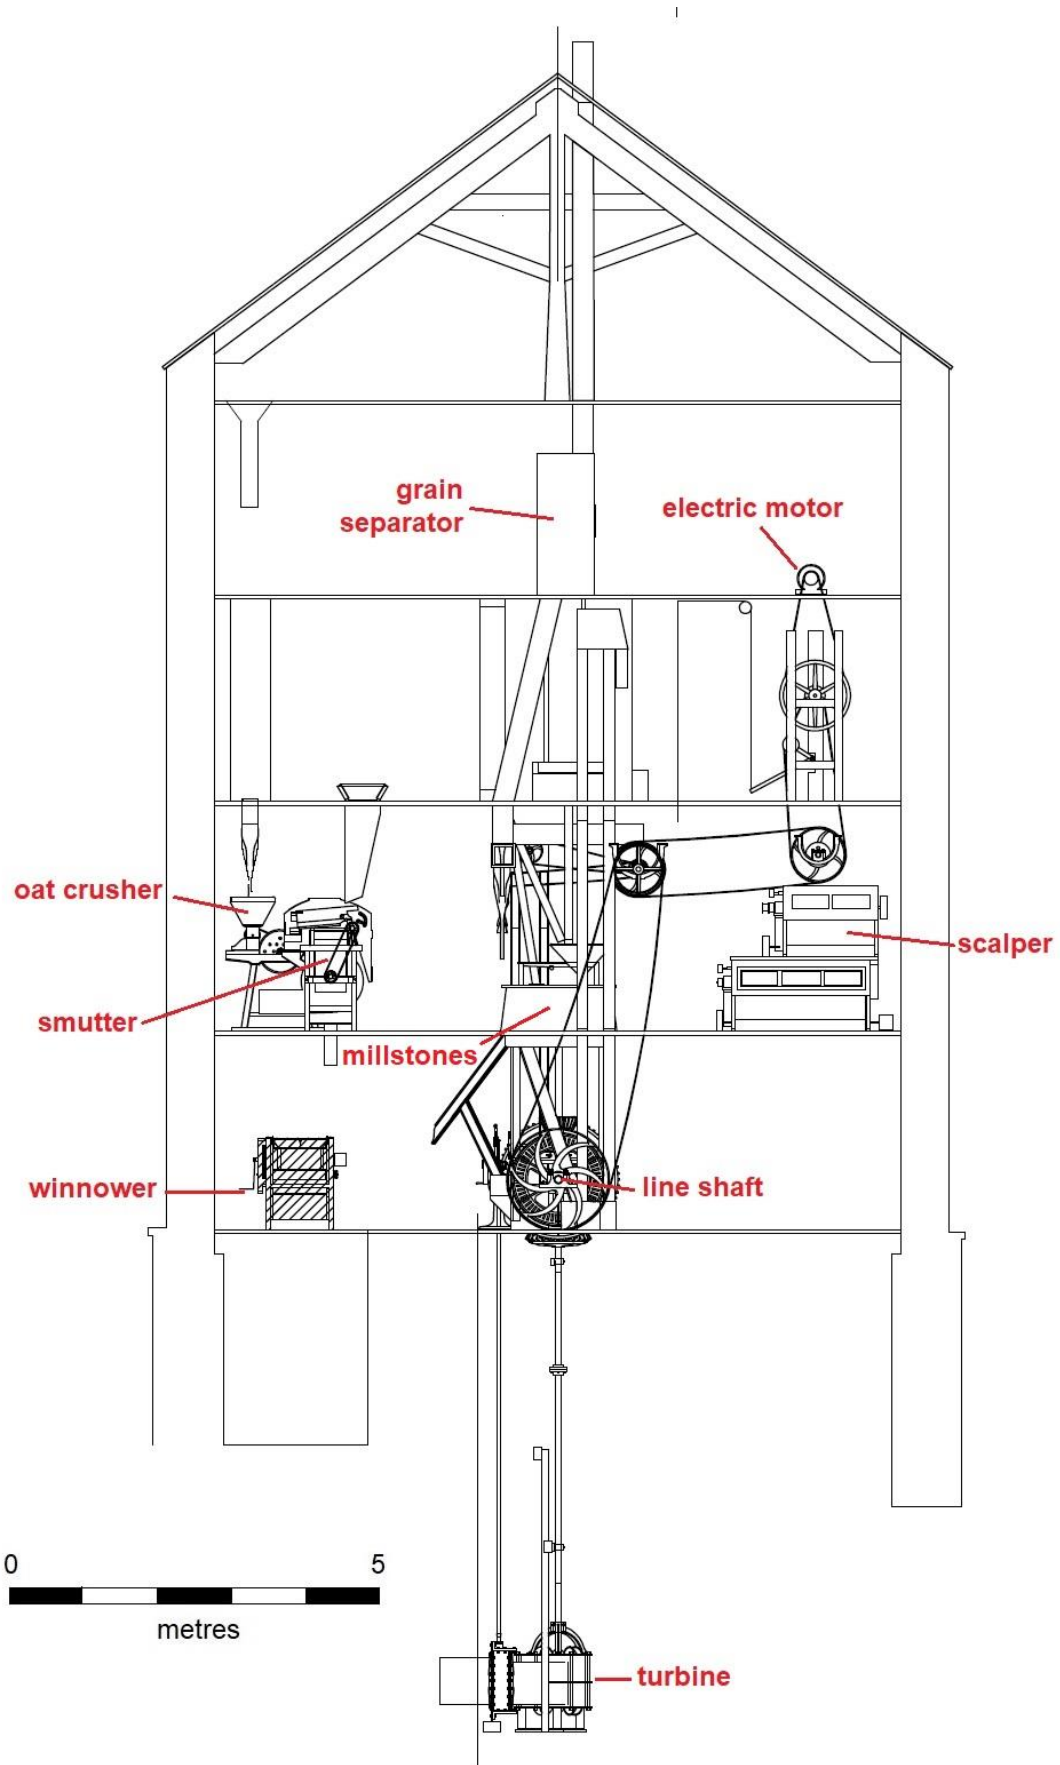
Figure 12. SW-NE section, showing turbine, motor and machinery.

There are three sources of motive power in the building: turbine, waterwheel and electric motor (figs 12, 13). The turbine is not visible, as it is set below the level of silt inside the old tailrace. The turbine shaft passes up to the ground floor, where the turbine controls are situated, and where its power is distributed to a lay shaft by means of a bevel gear (fig 14). Two subsidiary vertical shafts are for the turbine controls.

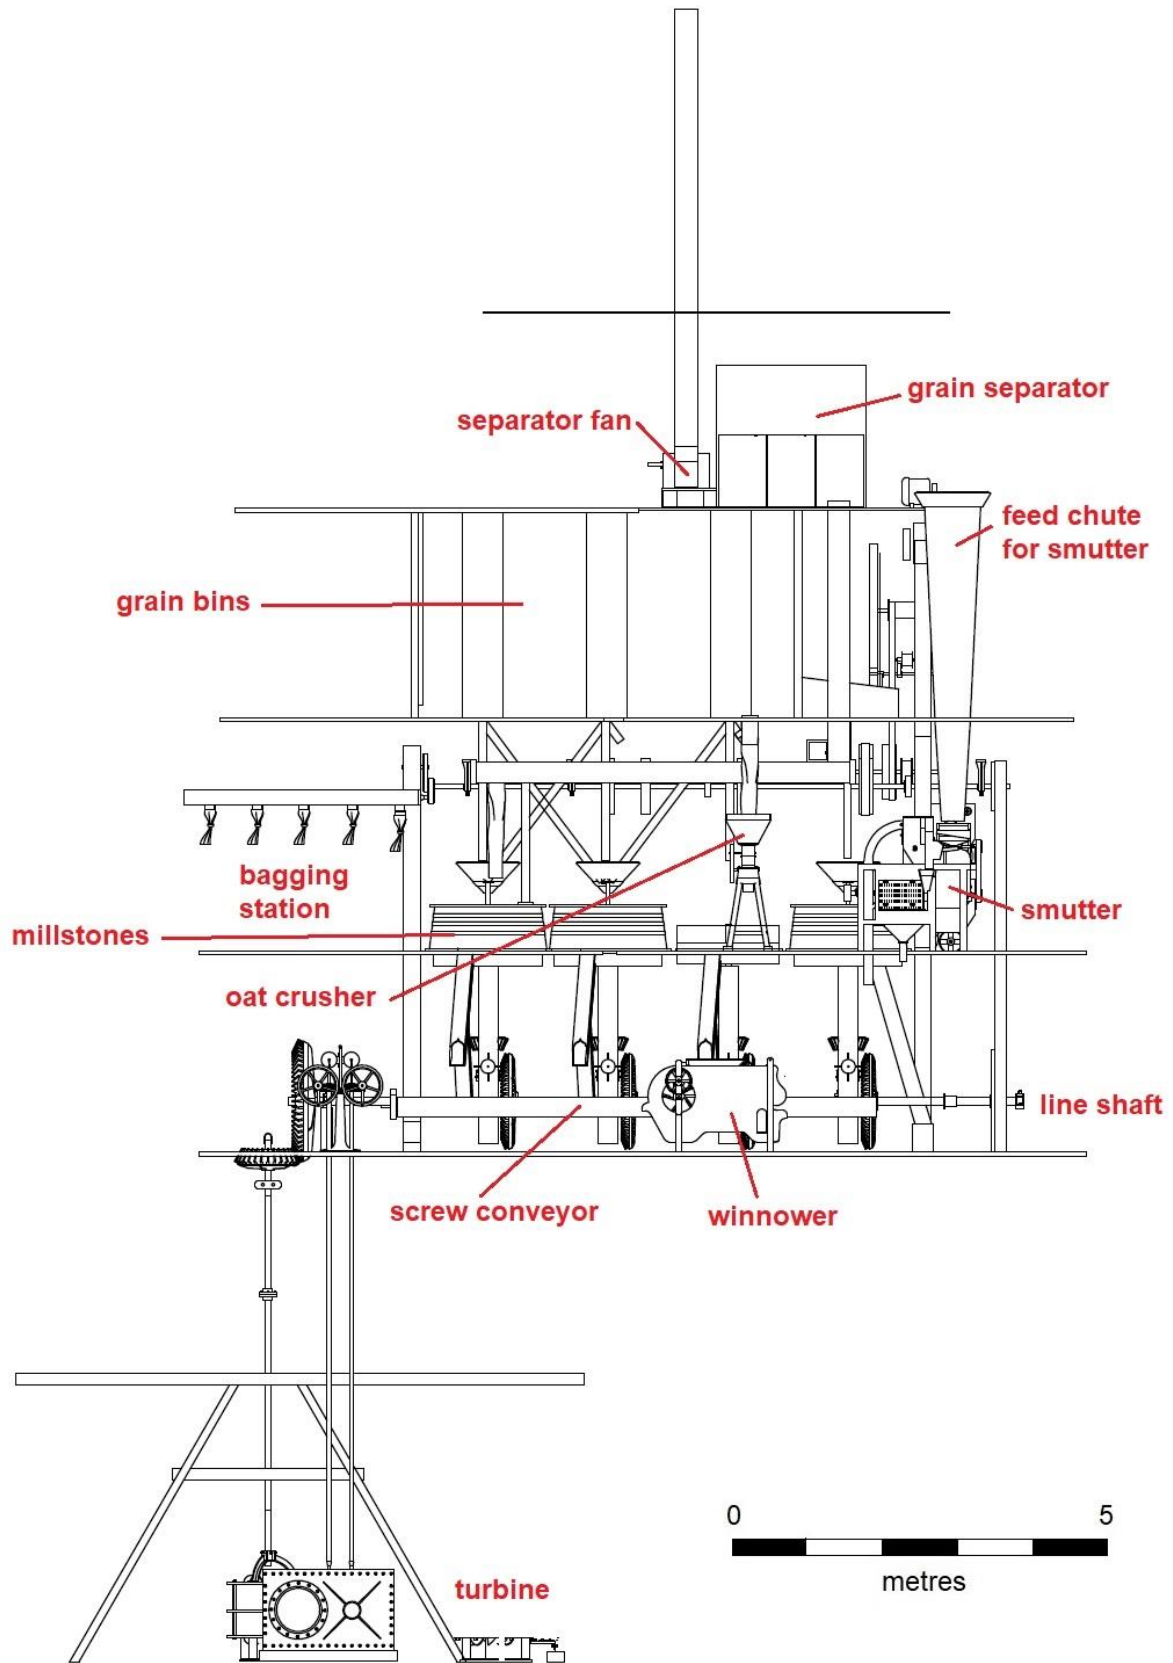
Figure 13. SW-NE section, showing turbine and machinery.

Grain was delivered from the grain bins on the second floor by means of chutes (fig 13, 20). The meal could be recirculated and could be bagged either on the first floor – by means of the screw conveyor and bucket elevators to the feed chutes toward the south-west end of the room (fig 19) – or (for stones 1-3) at ground floor level (fig 17).

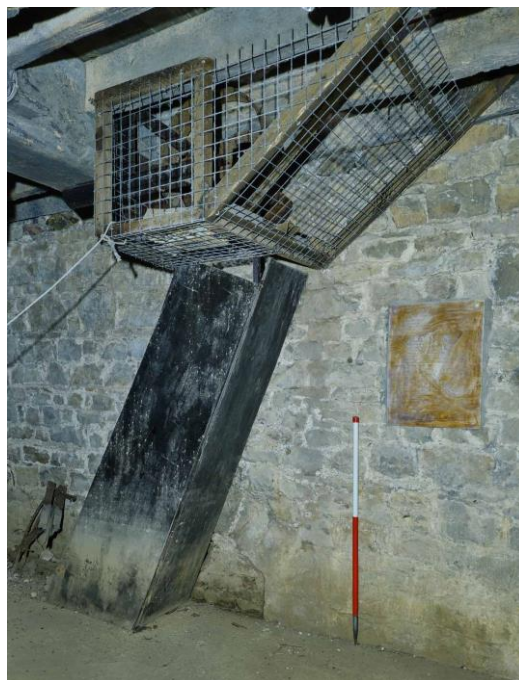
*Figure 15. Drive from the secondary wheelpit in the basement.*

The secondary waterwheel has what appears to be wooden buckets, and a cast-iron axle. Given the level of water in the mill race, it is likely to be a breastshot wheel. Power was distributed to the floor above by means of line shafting and belt drive, which is set against the basement wall on the outer side of the wheelpit, and is boxed and guarded with mesh for the safety of visitors (fig 15). The belt drive is connected to the main ground-floor lay shaft at the north-east end. There is no surviving transmission associated with hoisting sacks from moored barges, as was once the case.

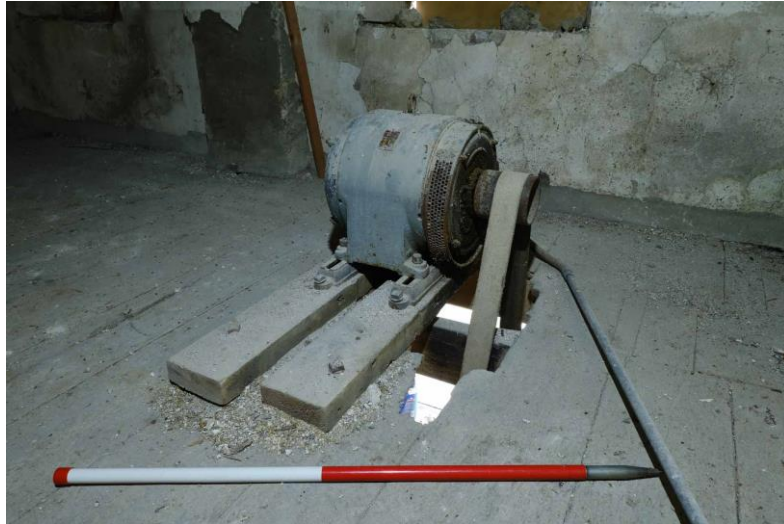
Figure 16. Brooks electric motor on third floor.

At the north-east end of the ground floor is also a belt drive by which means power was transmitted from an electric motor. The motor, by Brooks Motors Ltd of Huddersfield, is on the third floor and the shafts and pulley wheels that deliver power to the line shaft on the first floor are re-used from the sack hoist installed in 1901 (fig 16).

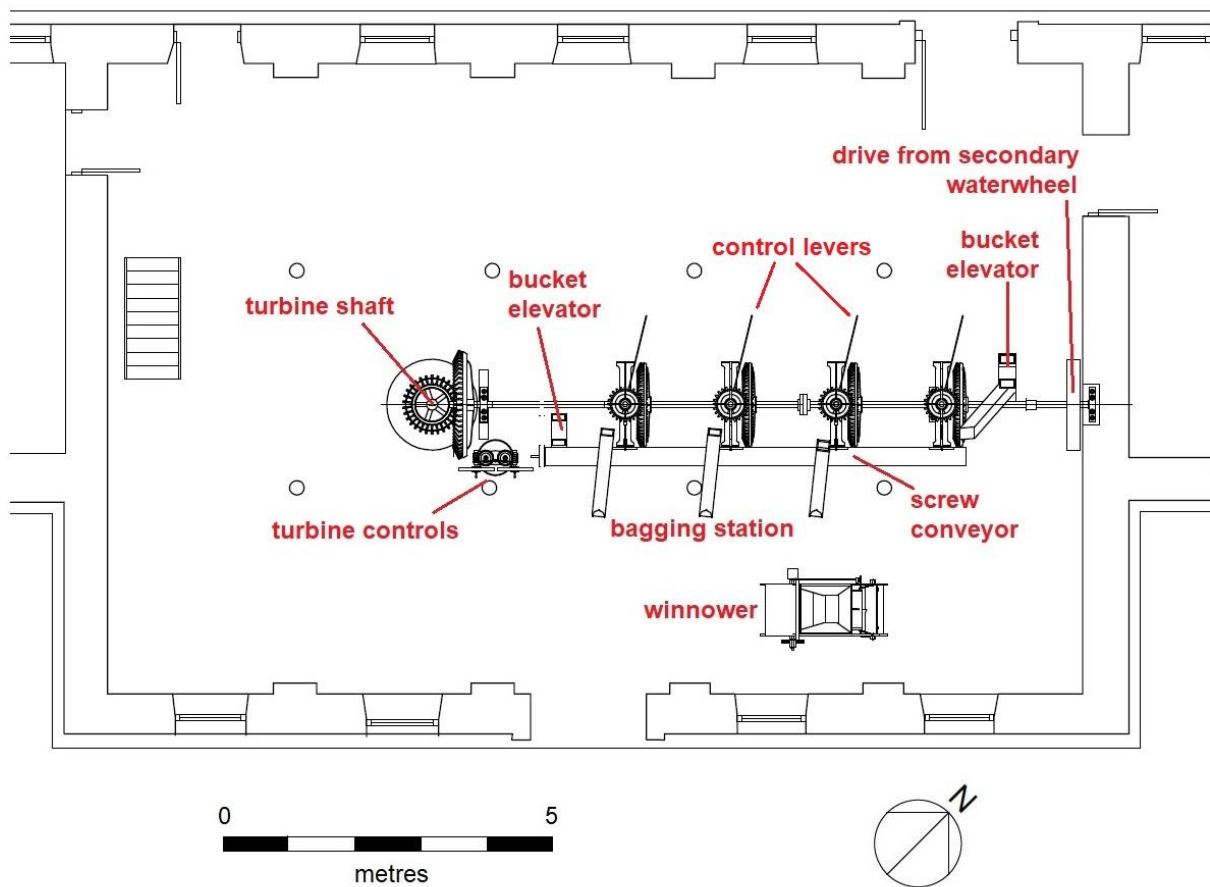
Figure 17. Ground-floor machinery.

On the ground floor, cast-iron bevelled cogs were manoeuvred into position by cast-iron levers, distributing power to the individual millstones above, which are supported by cast-iron hurst frames (figs 17, 18). This arrangement allowed a combination of millstones to be used rather than powering all of them. At first-floor level are the four pairs of stones, three encased in wood with iron straps (fig 19). These were numbered 1-4 from the south-west end, nearest the turbine. Three were for grinding the meal, the other for grinding flour. The runner stone for number 3 has been removed and lies close by.

Hatches on the south side of each floor mark the position of the sack hoist (fig 17, 19, 20). In the attic there are two beams to which the pulleys were attached, but the mechanism has been dismantled and re-used for the electric motor, as described above.

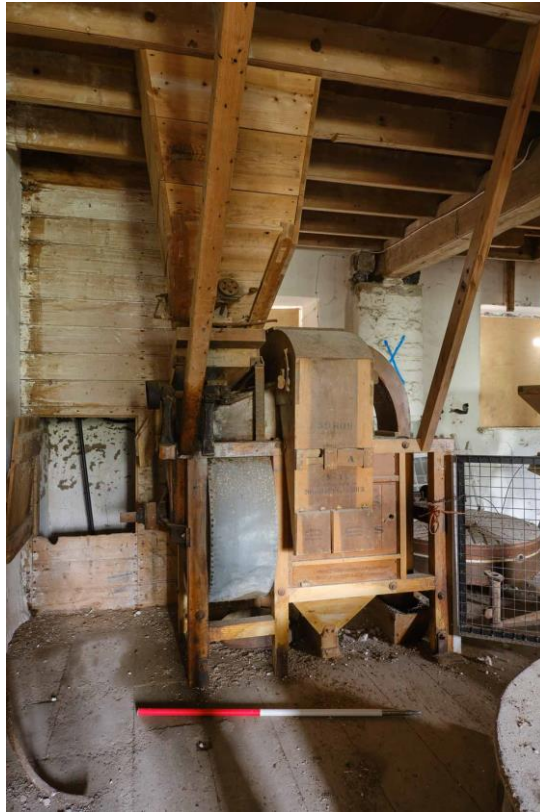
*Figure 24. Howes smutter on first floor.*

Also, on the first floor is the smutter by S. Howes, also probably of 1915 (figs 12, 13, 19, 24). The smutter was used to remove spores of smut, a fungus which attacks wheat. Typical of smutters in British mills, it was built in the USA. Their introduction coincided with the large-scale imports of grain across the Atlantic and was important when milling grain by gradual reduction, which was practised at Blackpool Mill from the early twentieth century. The oat crusher on the first floor is a type that could be used on farms, and therefore contributed to the decline in purpose-built mills for animal feed (fig 12, 13, 19, 25). On the ground floor is a hand-operated winnowing machine, although this is not in situ and its original position or provenance is unknown (figs 12, 13, 17, 26).

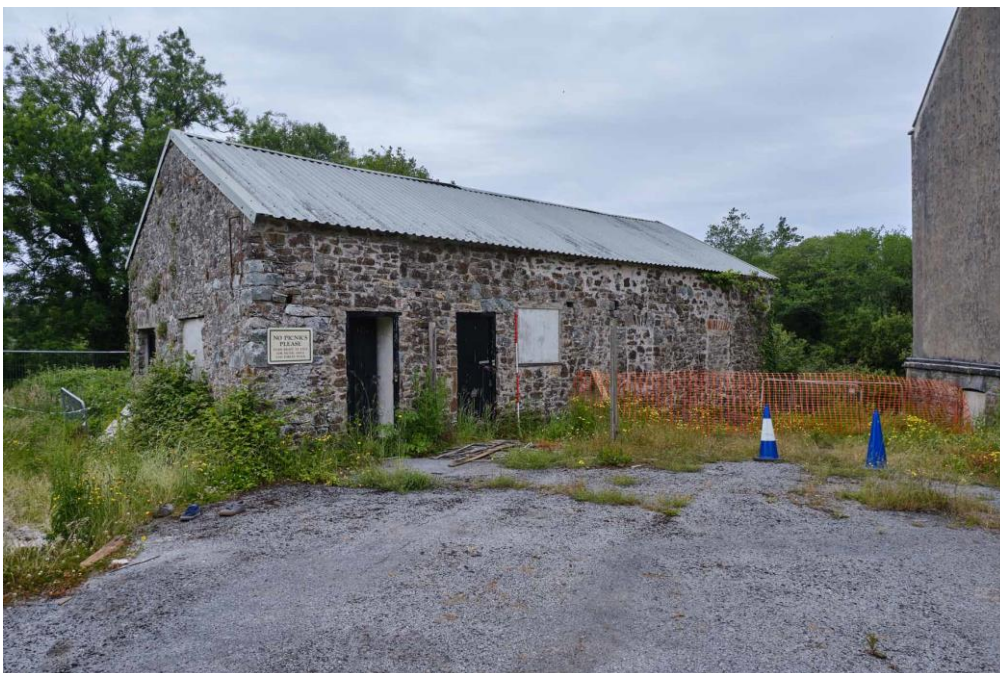
*Figure 27. Store, looking north from the yard.*

The Store is a single-storey building of random rubble stone under a roof of corrugated metal sheets (figs 27, 28). Original openings are under cambered stone heads, whereas the second-phase ones are under brick heads. The heads of the modern openings are not articulated in any way. Facing the mill, the east side has one blocked window under a stone head, and one to its right under a brick head, both with thin slate sills. Further left are two modern doorways and windows, which are part of the conversion of the building to toilets. The north gable end facing the river has a pronounced batter and is buttressed at the north-east angle. The west wall has three windows under stone heads, of which the southernmost is blocked, and an inserted door under a concrete lintel. Only in the south gable end is there evidence of an early doorway, offset to the left side under a stone cambered head and with boarded door. To its right is a modern window that lit the toilets but has been blocked.

Inside the building the toilets are simply a blockwork structure at the south end of the building. There are re-used cross beams, on stop-chamfered, that suggest a former loft, and two tie-beam trusses.

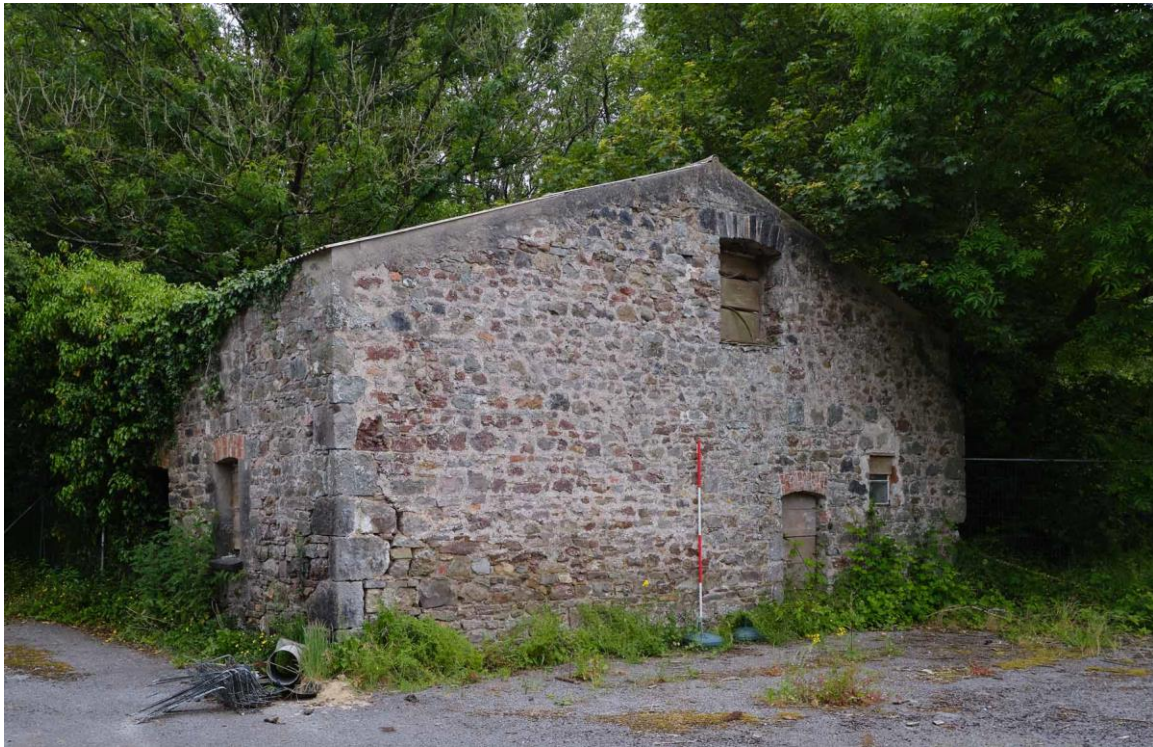
*Figure 28. Cottage & Forge.*

The former Cottage & Forge is a lofted building of random rubble stone with bigger quoins, under a corrugated metal roof of shallow pitch (fig 29). In the east wall, facing the drive to the mill, is a central doorway flanked by windows, all under cambered heads. A small square window is in the loft above. In the north gable end the doorway and loft window under cambered heads are offset to the right, with a small lintelled opening right of the doorway. In the rear (west) wall a former opening for a cart shed is under a timber lintel but has been part blocked, with inserted boarded door and shutter.

Inside the building there is an original spine wall. There are three tie-beam trusses. There is no evidence of a hearth for a forge nor a domestic fireplace.
