ARCHAEOLOGICAL EVALUATION REPORT

Trevor Basin, Pontcysyllte Aqueduct World Heritage Site

ARS Report N°: 2021/53

An Archaeological Evaluation at Trevor Basin, Pontcysyllte Aqueduct World Heritage Site, Wrexham

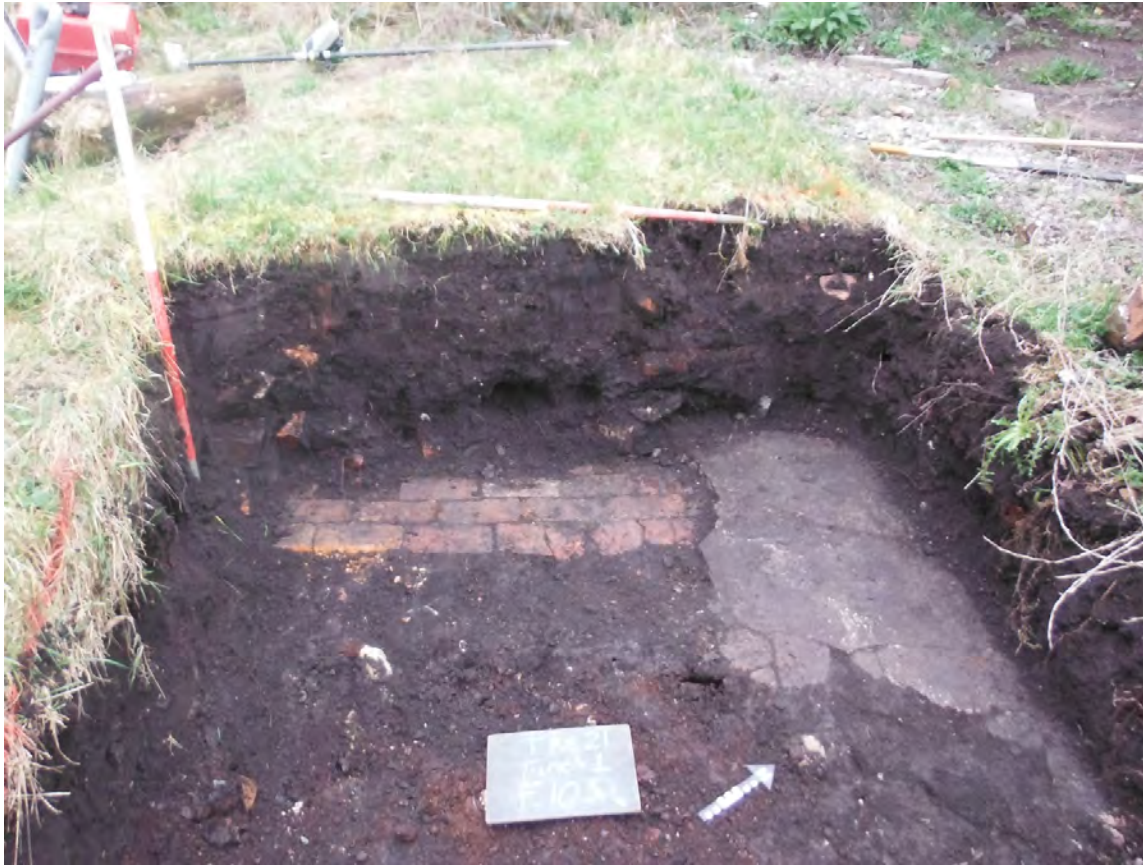
Figure 5: View of brick feature (103). Facing north-west – Scale 1x1m.

Three features of archaeological interest were identified. A single course of bricks (103) at the north-western extent of Trench 1 and a hardstanding surface (105). These features may have been associated with c.1836 structures depicted on historic mapping to the west of the trench. Trench 3 contained three parallel linear features on a north-south alignment which may be connected with railway tracks depicted on historic mapping.

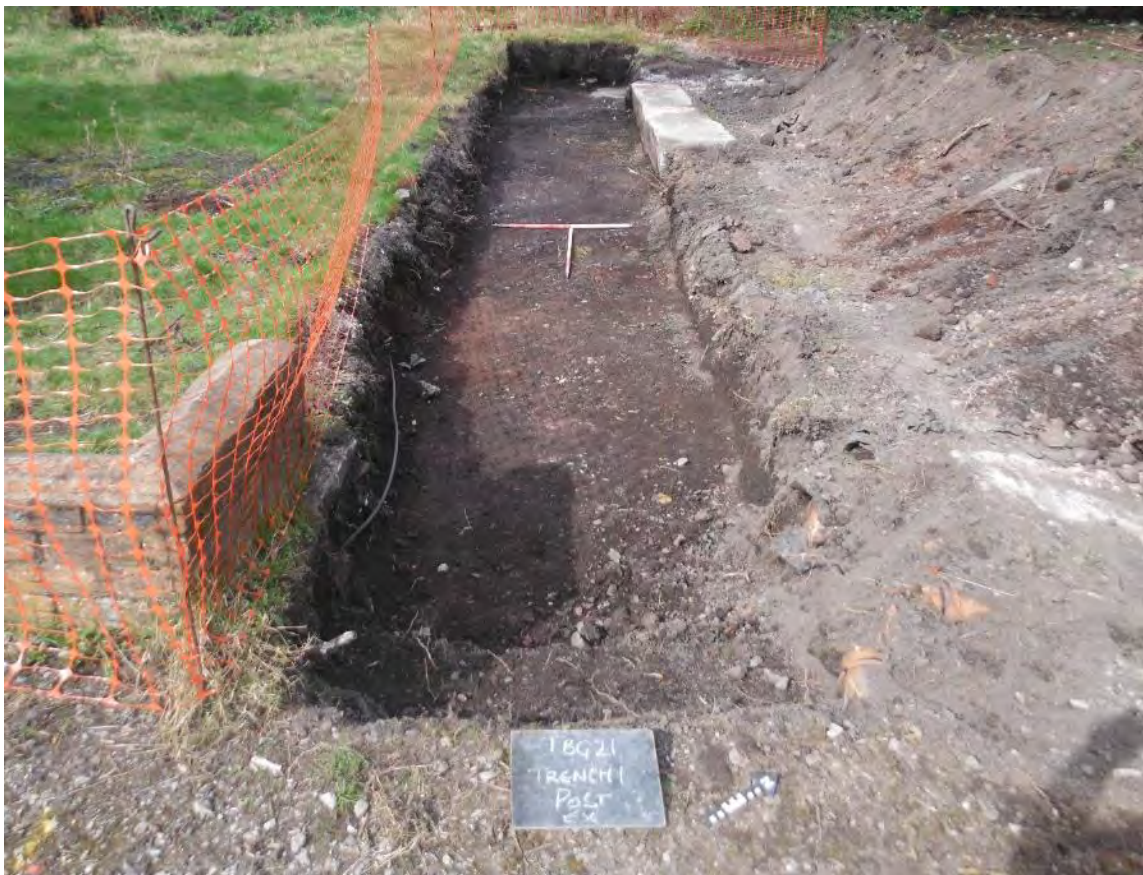
Figure 6: View of hardstanding feature (105). Facing north-west – Scale 1x1m.

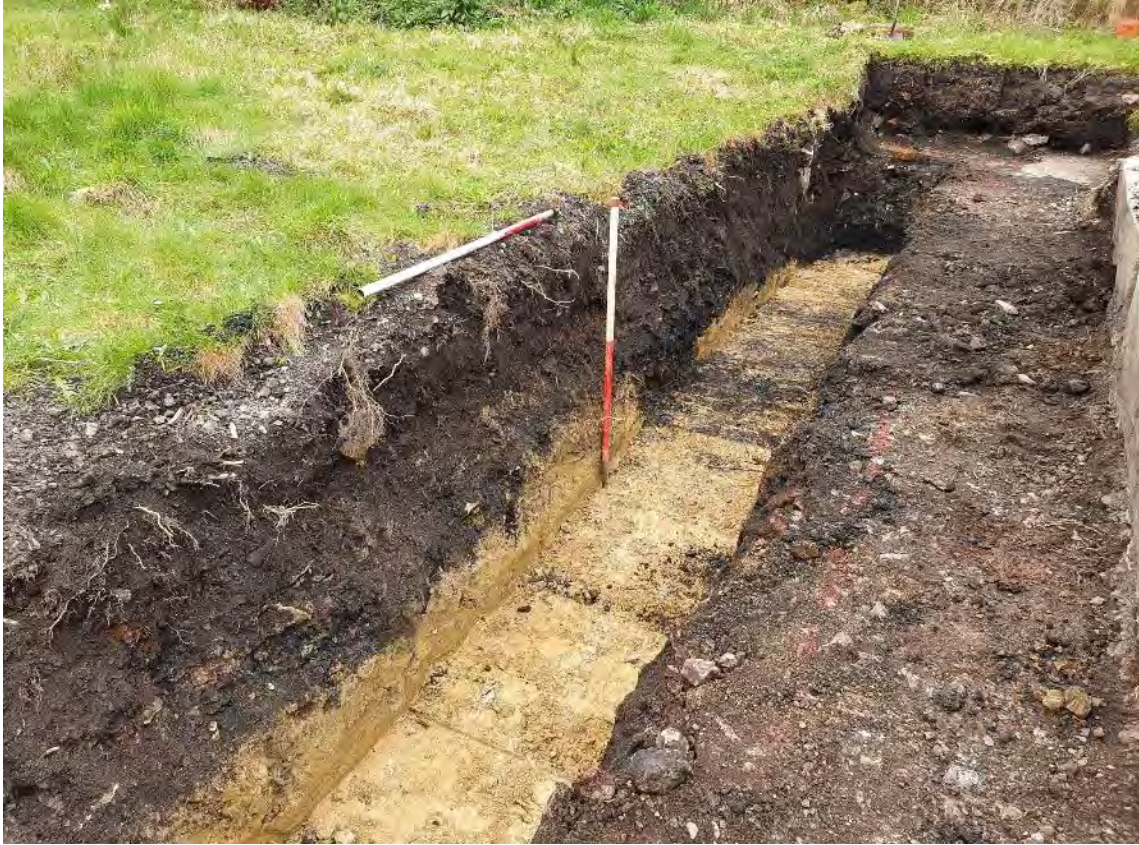
Figure 7: View T1 (Section A). Facing south-west – Scale 1x1m.

- 4.2.5 A sondage measuring 11m x 0.5m was machine excavated along the north-east facing section wall of the trench. It was excavated through deposit (105) and a deposit of dark brown silty clay (111) which was overlying natural pale yellow sandy clay (109) at a maximum trench depth of 0.87m BGL, 97.66m aOD (Figure 7).

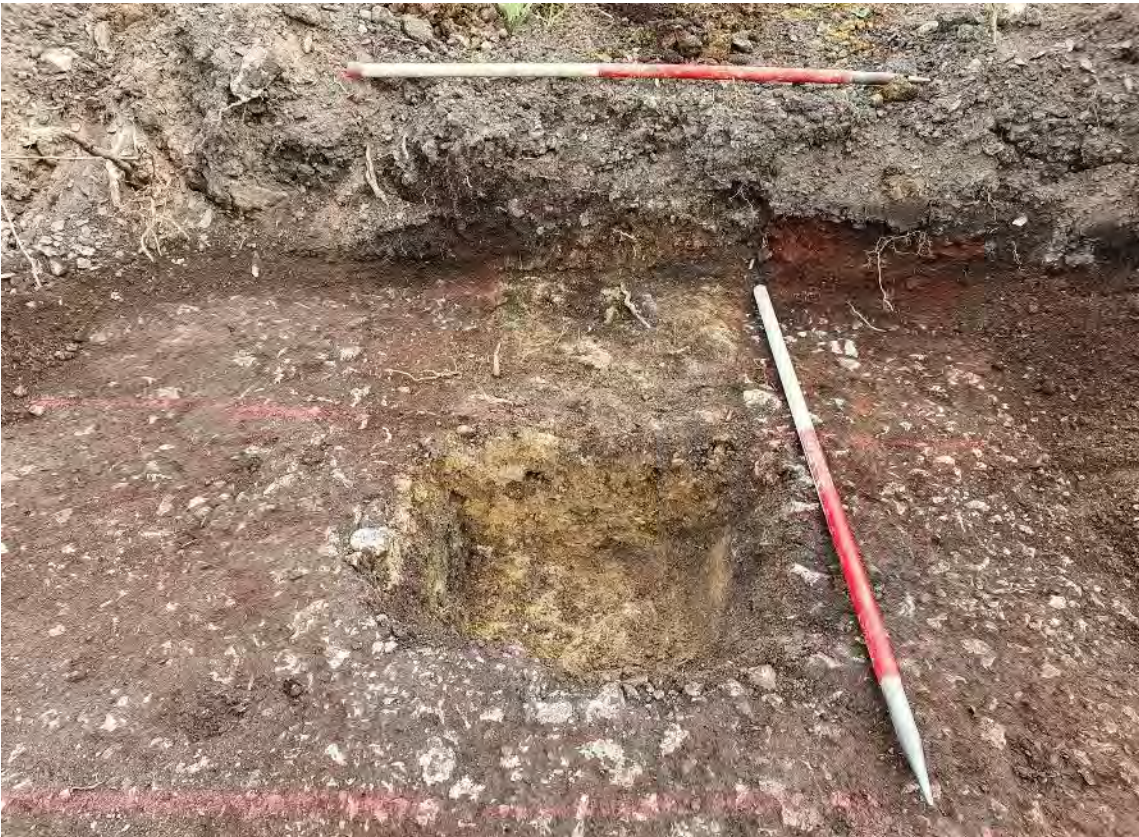
Figure 8: View of cut feature [107] (Section B). Facing north-east – Scale 1x1m.

- 4.2.4 Deposit (105) was truncated towards the south-east of the trench by a rectangular shaped cut feature [107] with a flat base and straight vertical edges and was filled by redeposited mottled dark yellow sandy silty clay (108) (Figure 8). The trench south-west facing section wall of the trench shows that this feature measures 1m x 0.56m x 0.78m and was cut through (102) and (105) (Figure 8).

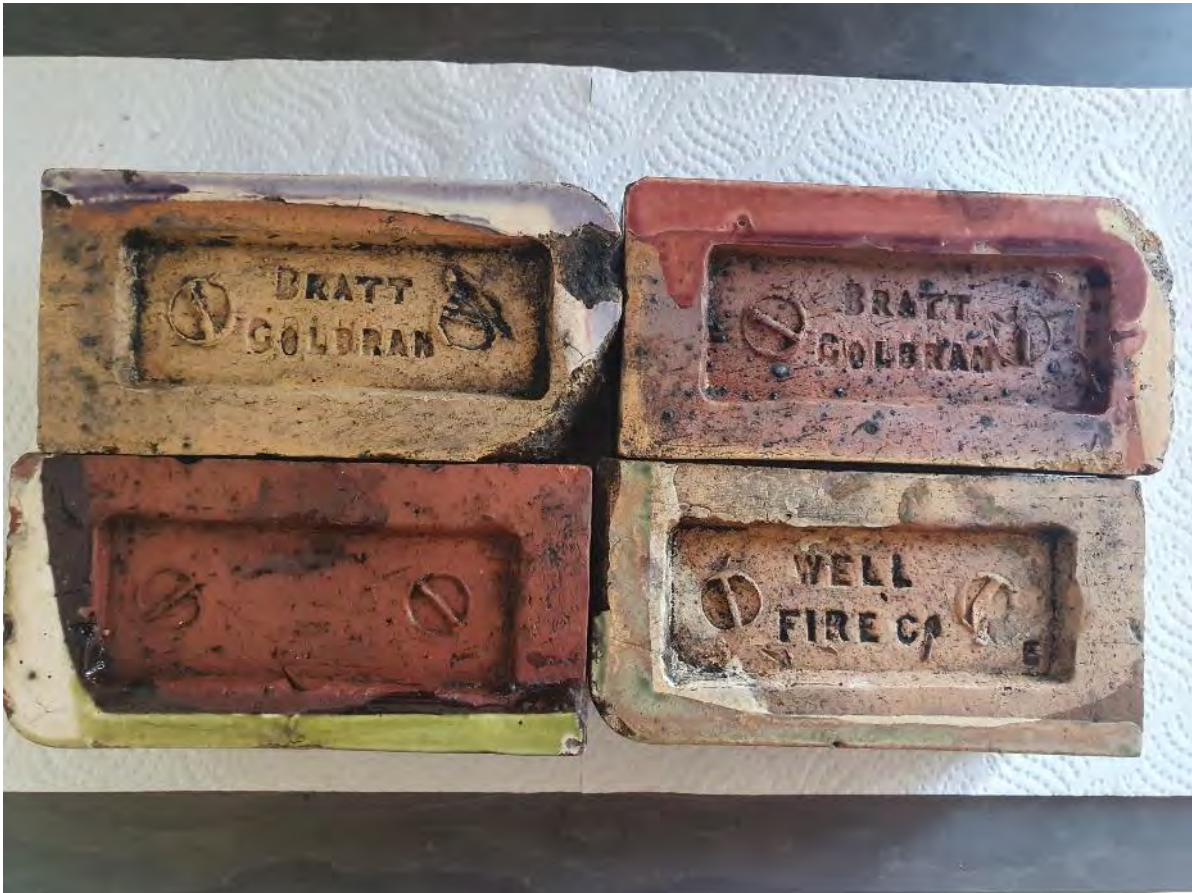
Figure 10: Bratt Colbran and Well Fire Company bricks retrieved from demolition deposit (202).

- 4.2.7 An undulating deposit of redeposited mottled dark yellow sandy silty clay (206) was found to be underlying demolition deposit (202). (206) covered the entire trench at a depth of 0.58m BGL, 93.21m aOD and six features were identified as being cut into (206). However, upon investigation (205), (210), (211) and (212) were found to be dumped deposits of red and black cinder below (206) and these deposits had been revealed as a result of machine excavation of the trench removing undulations in the surface of (206) (Figures 10 and 11).

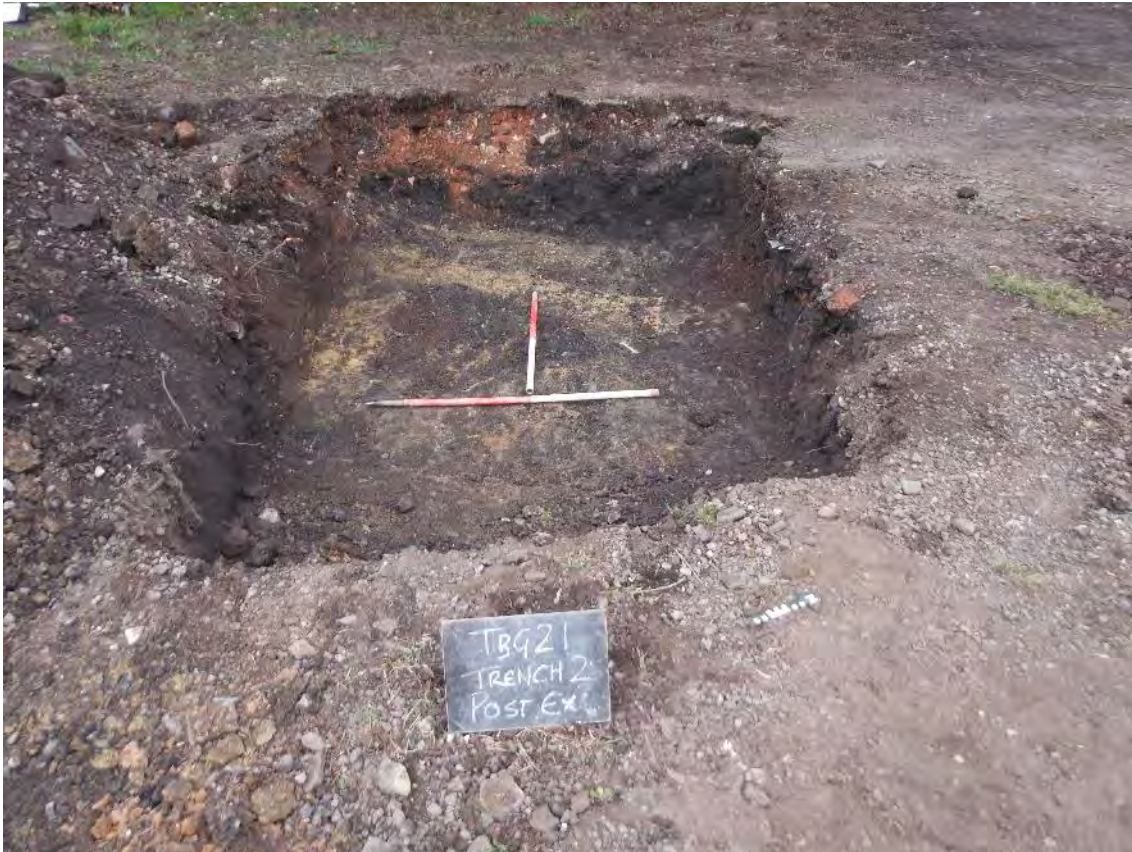
Figure 11: View of redeposited natural deposit (206) and linear feature [204]. Facing west – Scale 1x1m

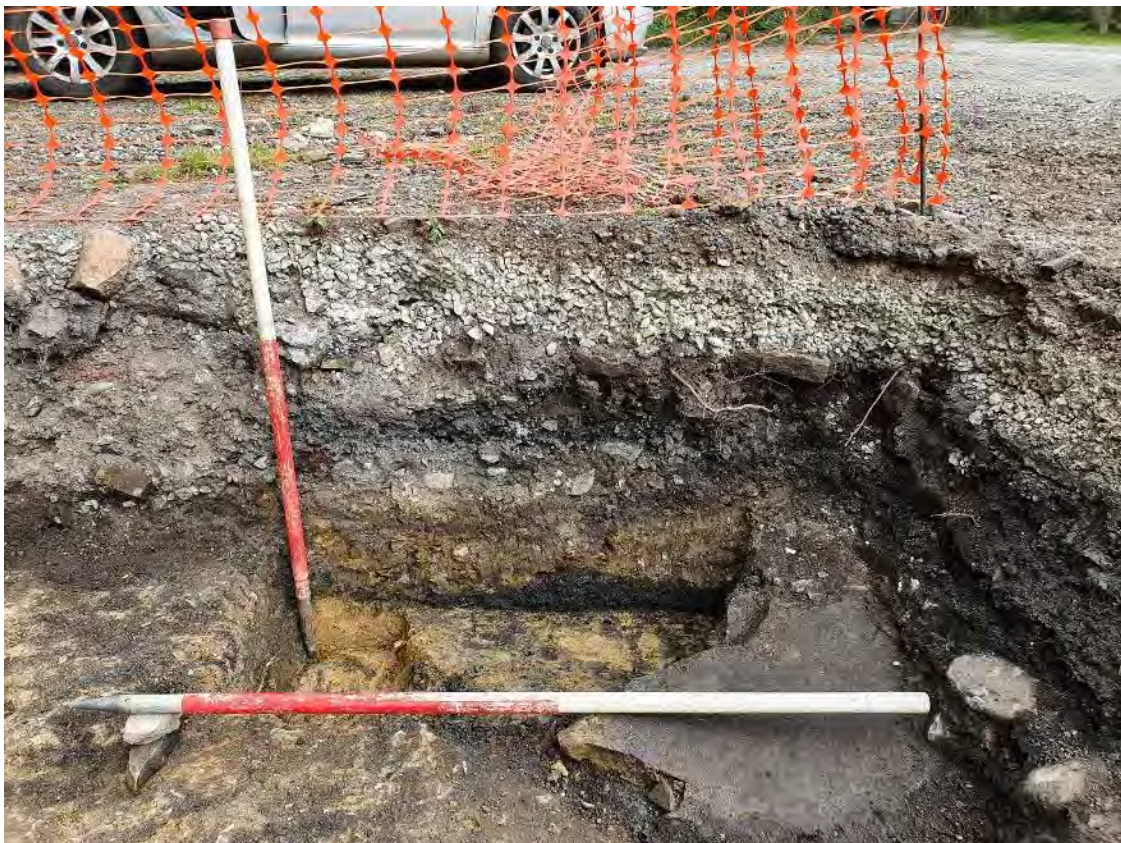
Figure 12: View of sondage in Trench 2 (Section C). Facing north – Scale 1x1m.

- 4.2.8 A linear cut demolition/robber trench [204] was identified on a north-east to south-west alignment before turning a right angle to the south-east at the south of the trench. [204] had straight vertical edges with a flat base and was filled by redeposited pale yellow sandy clay (203) (Figure 12).

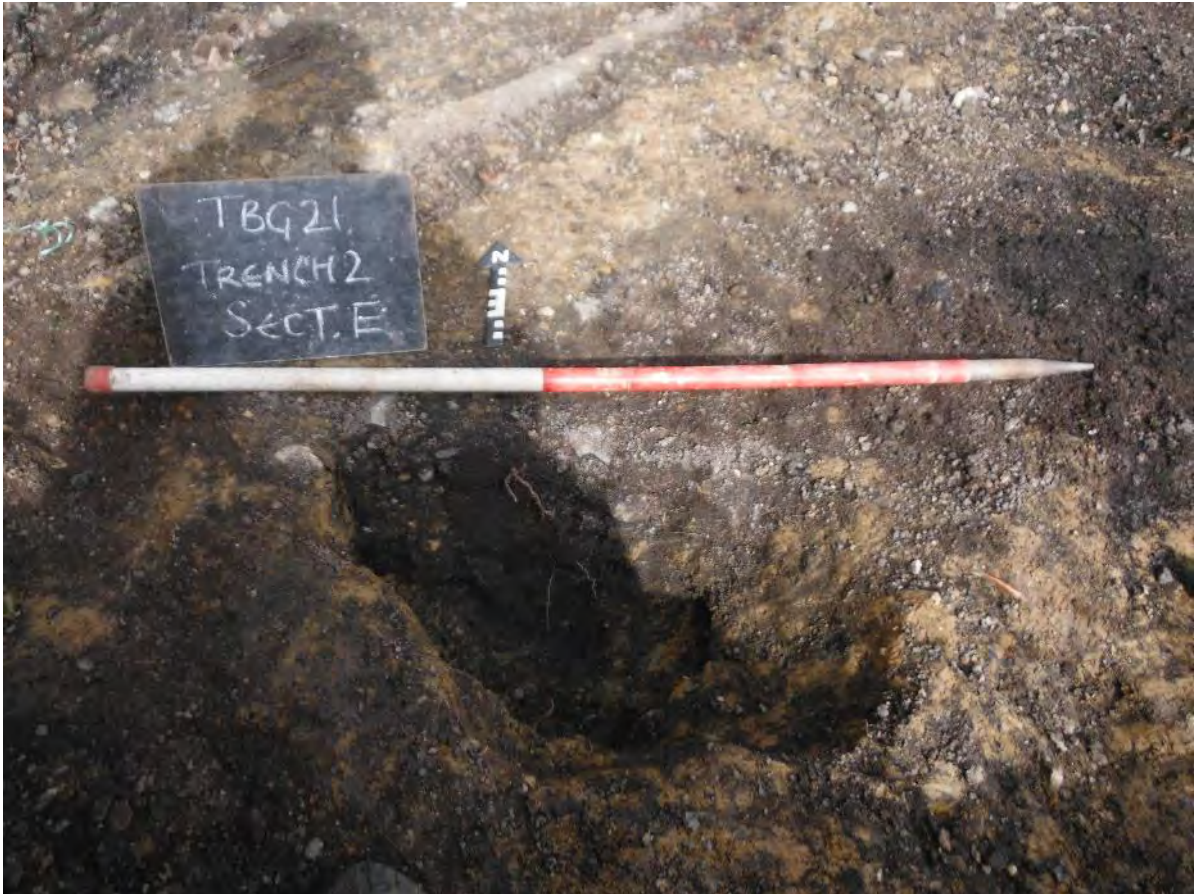
Figure 13: (Board Mislabeled) View of feature (205) in Trench 2 (Section D). Facing north – Scale 1m.

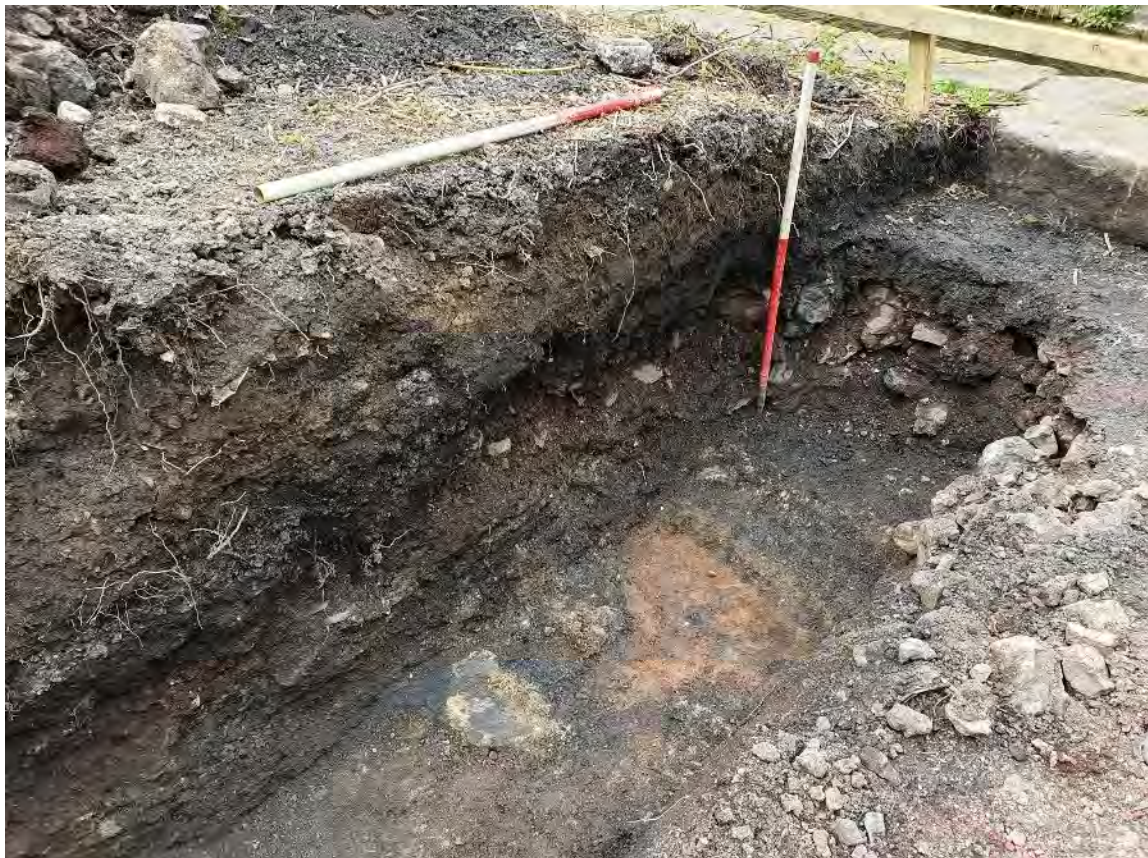
Figure 16: View of Trench 3 sondage (Section E) and linear features (310), (312) and (314). Facing south-west – Scale 1x1m.

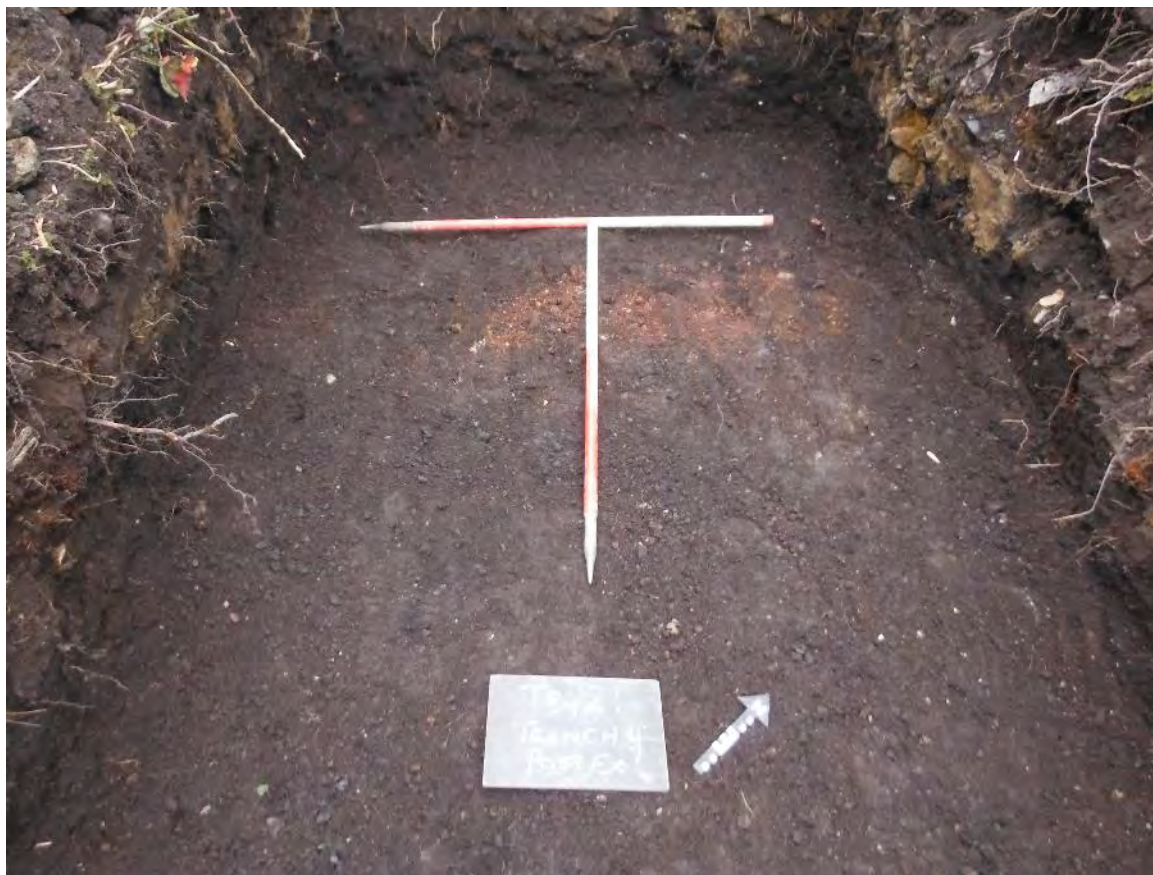
Figure 18: View of dumped deposit (403). Facing north-west – Scale 1x1m.

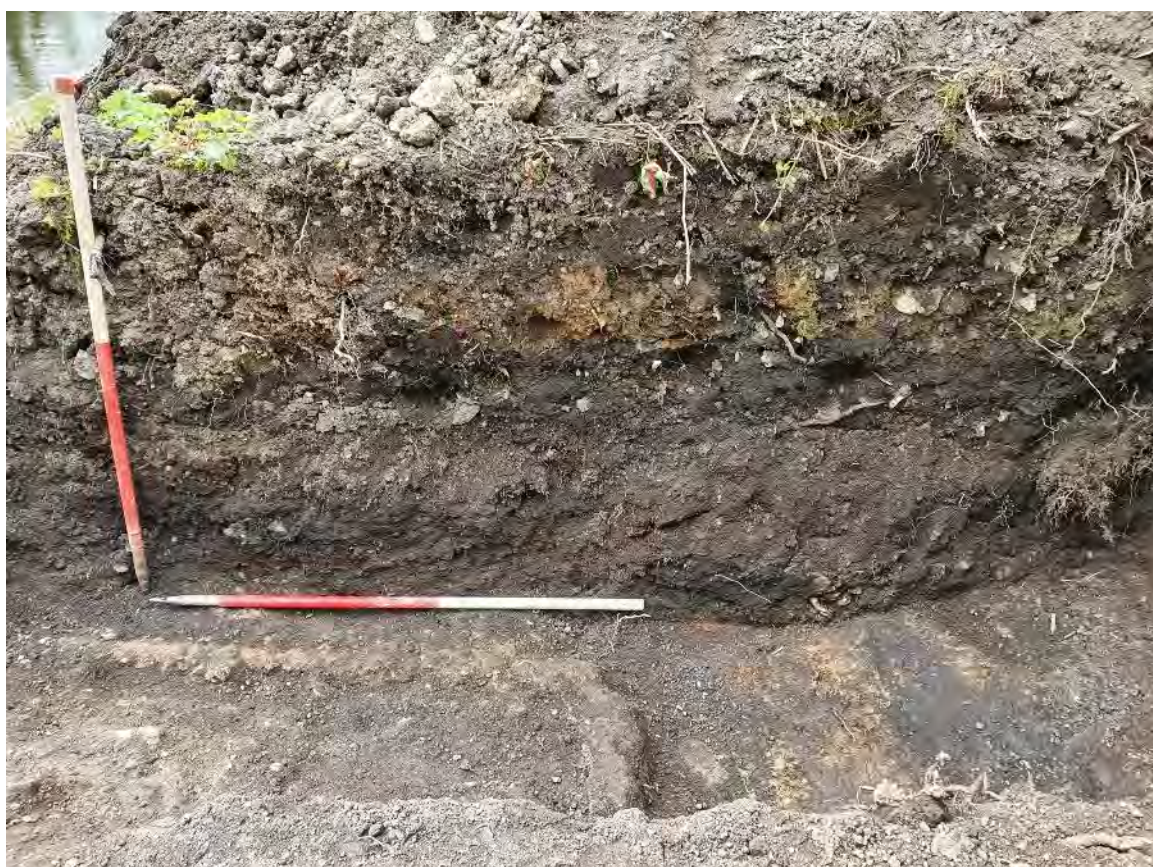
Figure 19: View of Trench 4 sondage (Section F) and deposits (404), (405) and (406). Facing south-east. Scale 1x1m.
