Agents House, Brymbo Ironworks, Wrexham

Photographic Record

Project #: AD031 February 2017

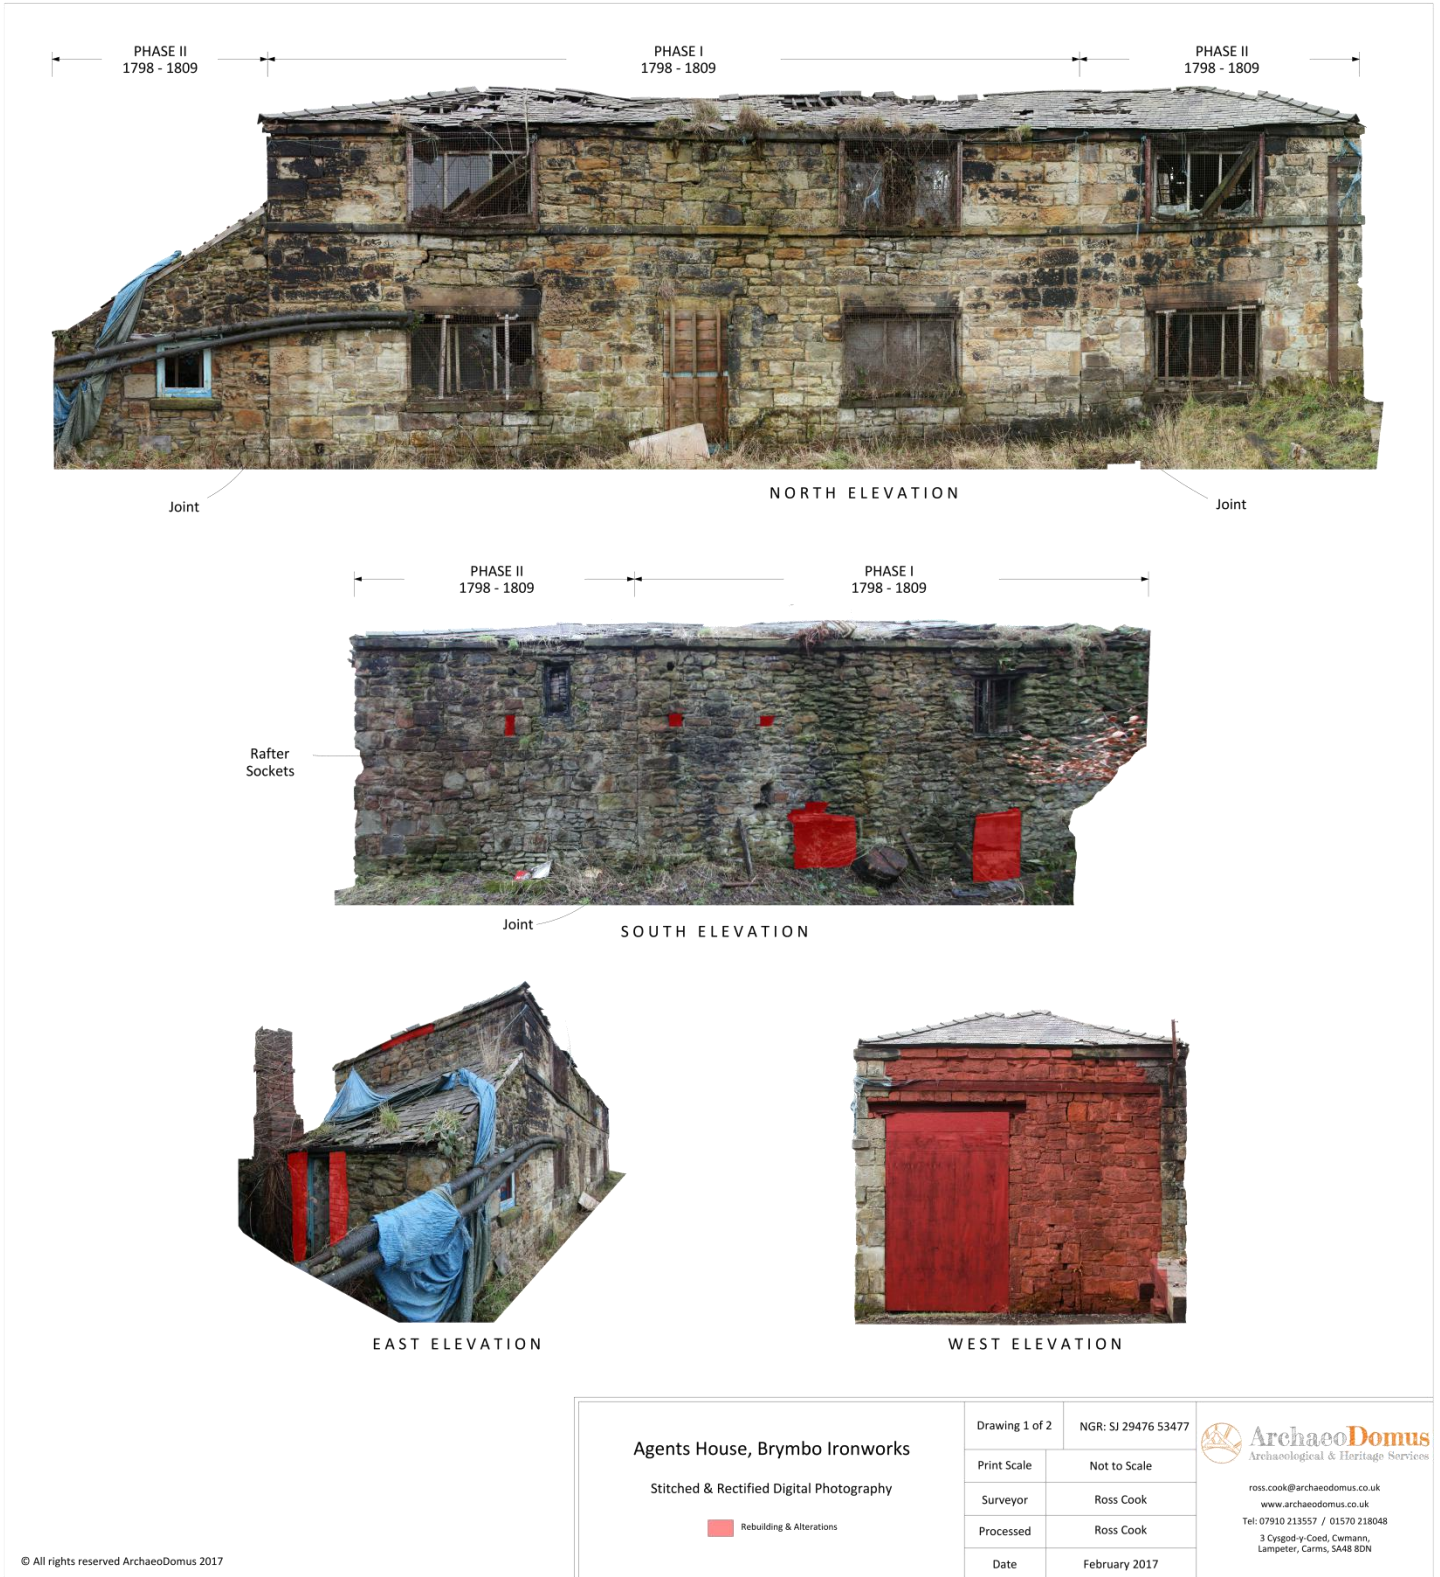
Fig. 4 - Photo Elevation Plans.

- 4.1.3 **Externally (Photos 001-041)** the building retains much of its original features, however it is notable that all chimneys have been removed, apart from that to the lower extension to the east end. The windows have all been removed and altered during one of its later uses, with casement fixed light windows now in situ. Both rear doorways appear to be inserted.
