# Outer Bailey Curtain Wall, Cilgerran Castle, Pembrokeshire

## Archaeological Record

Scheduled Monument No.: PE002

Date: July 2021

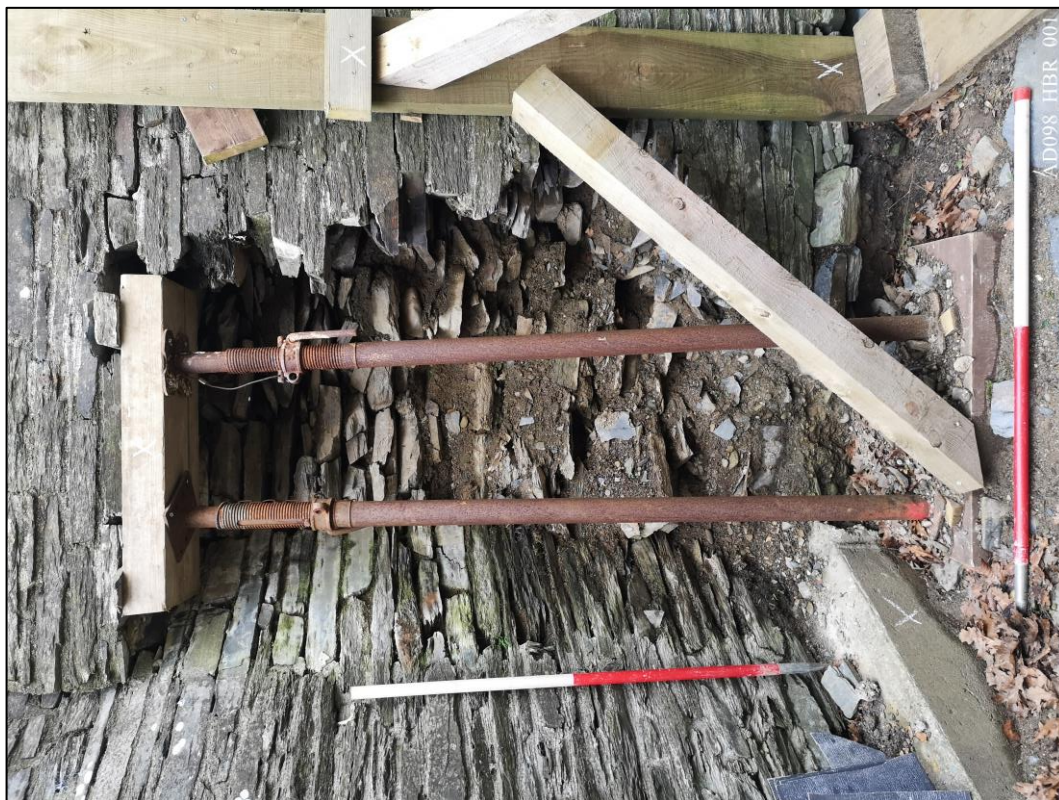
- 8.4.1 In mid-2020, the retaining wall collapsed and exposed the core of the earlier curtain wall (**Plates 1-6; Fig. 9**). This caused the loss of a small amount of historic mortar from the core of the medieval curtain wall.

Plate 1 – View towards north, showing area of collapsed. Photo rotated 90° anticlockwise.

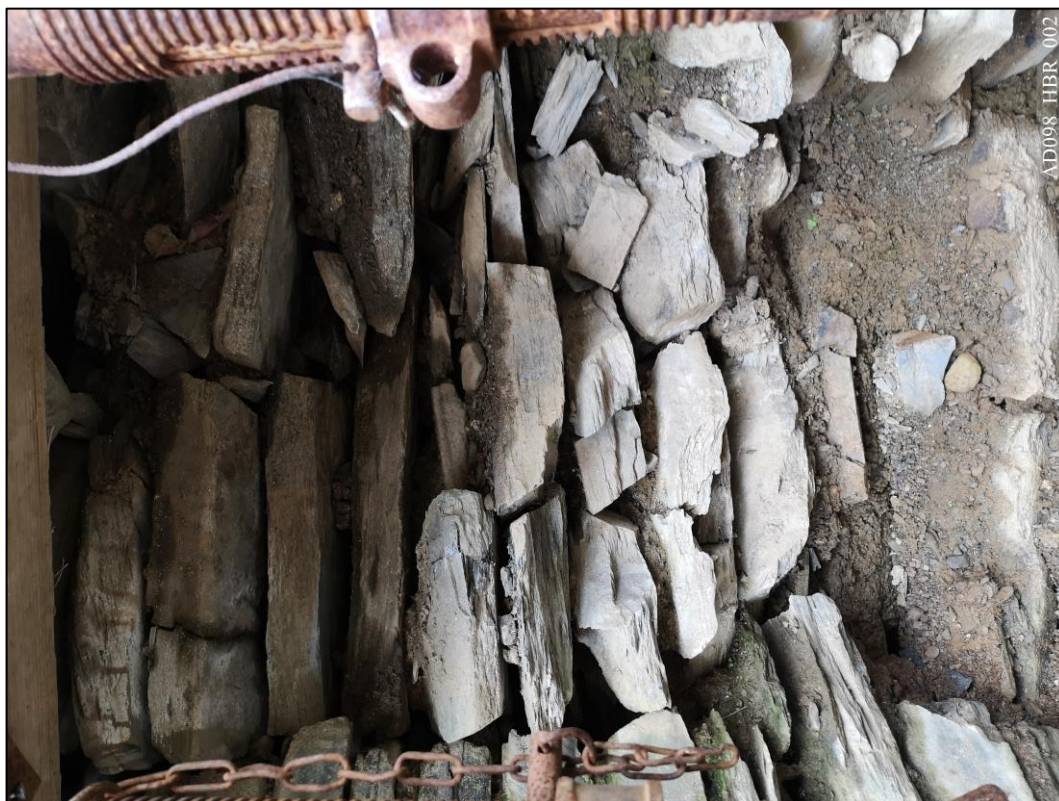
Plate 2 – View north, showing coursed rubble fill of wall core, with earth-clay bedding mortar.  
Photo rotated 90° anticlockwise.

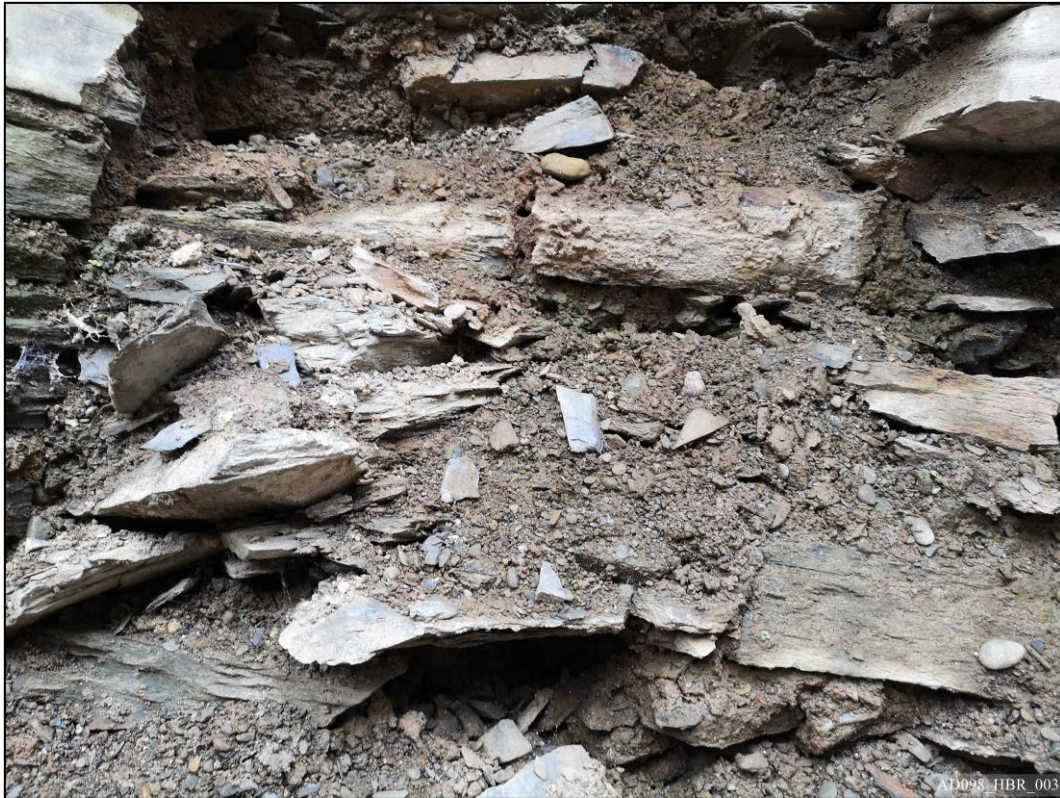
Plate 3 – View north, showing earth-clay mortar of bonding matrix of curtain wall.

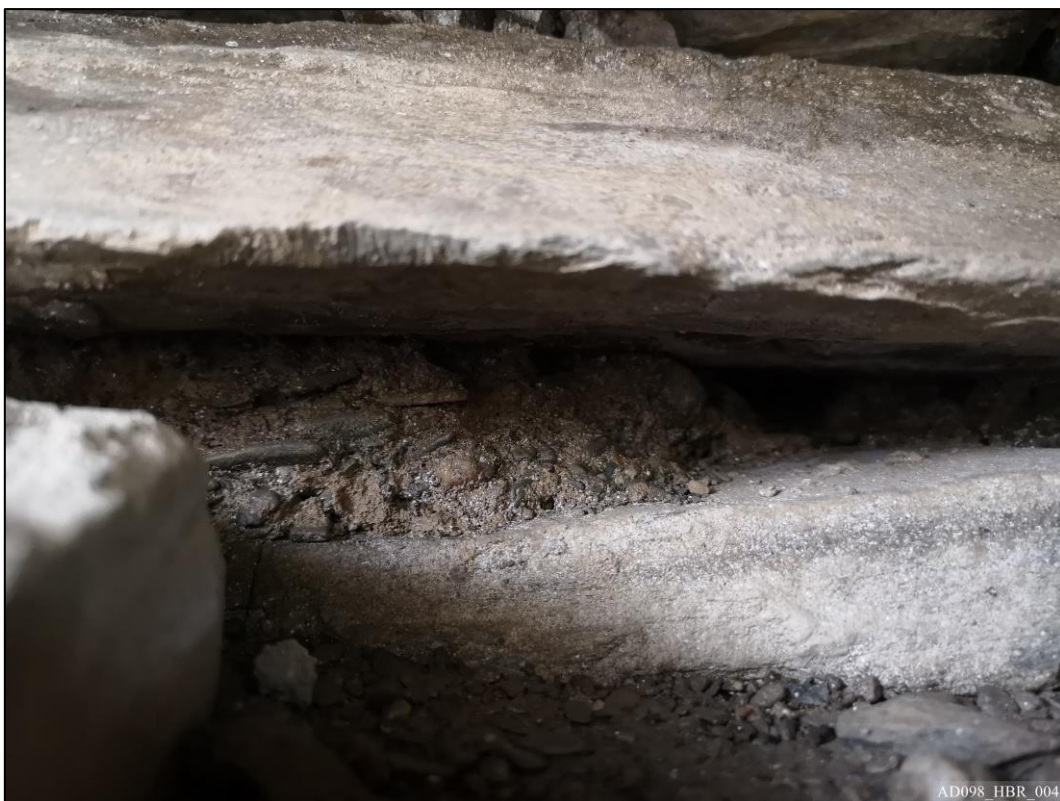
Plate 4 – View north, showing mortar *in situ* between coursed rubble fill of curtain wall core.

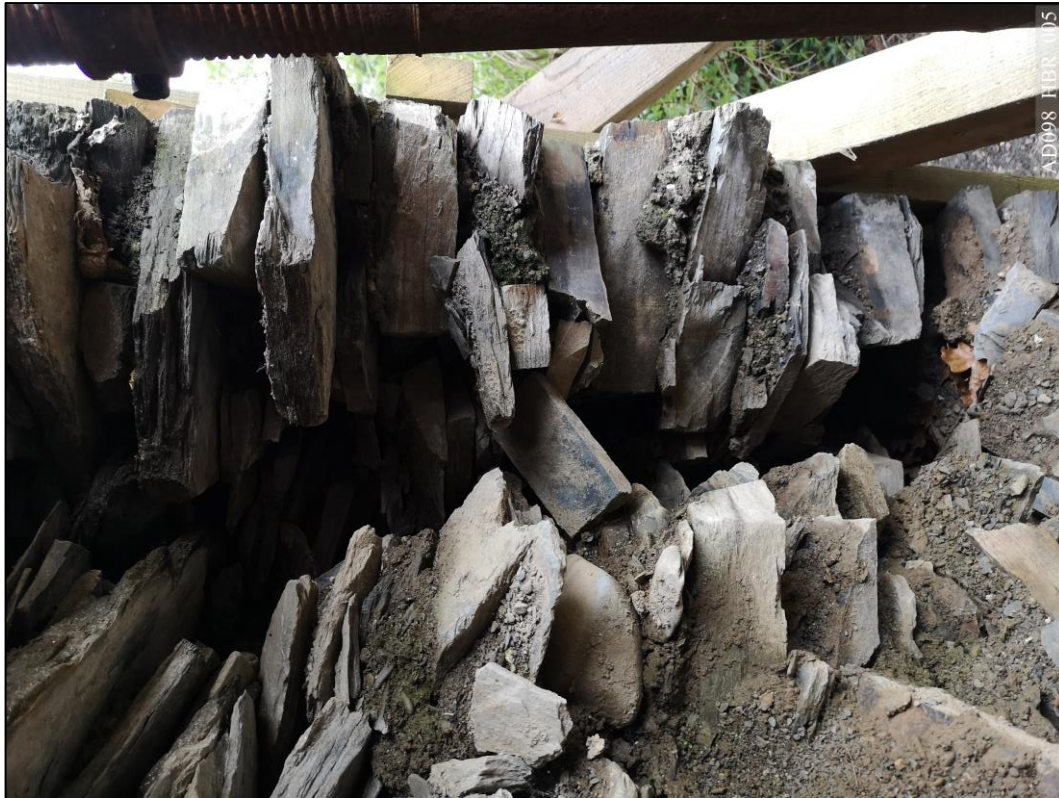
Plate 5 – View east, showing encasing modern retaining wall. Photo rotated 90° anticlockwise.

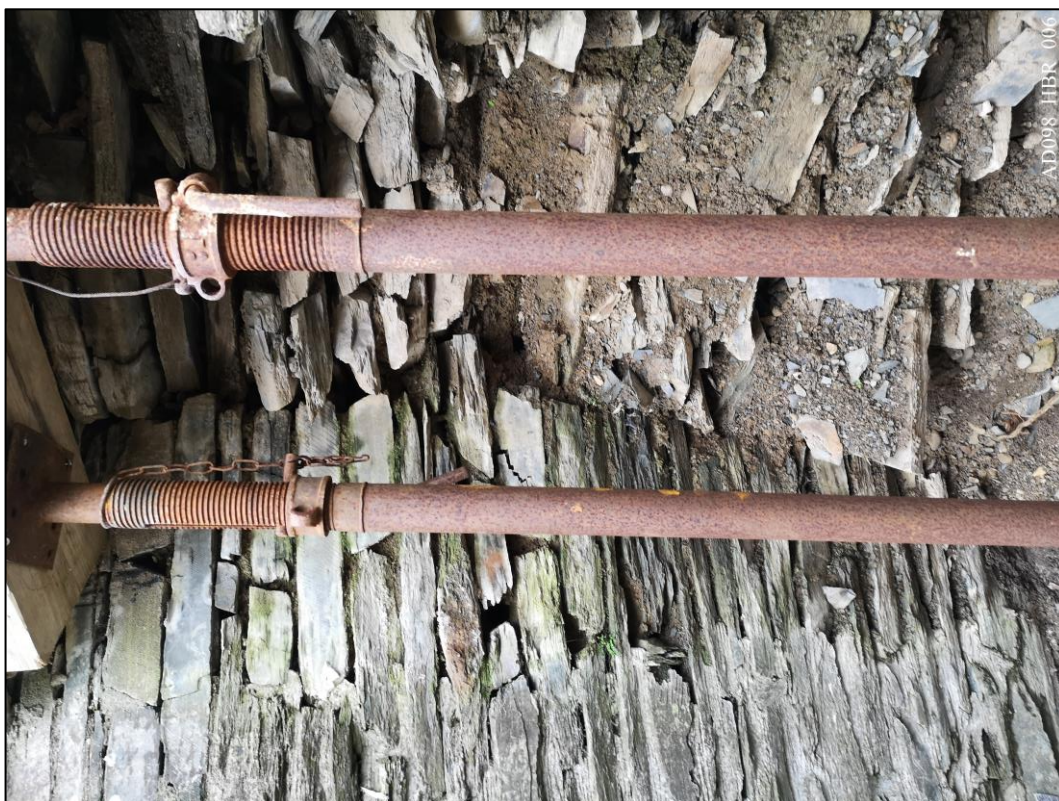
Plate 6 – View north-west, showing joint between modern retaining wall and historic core.  
Photo rotated 90° anticlockwise.

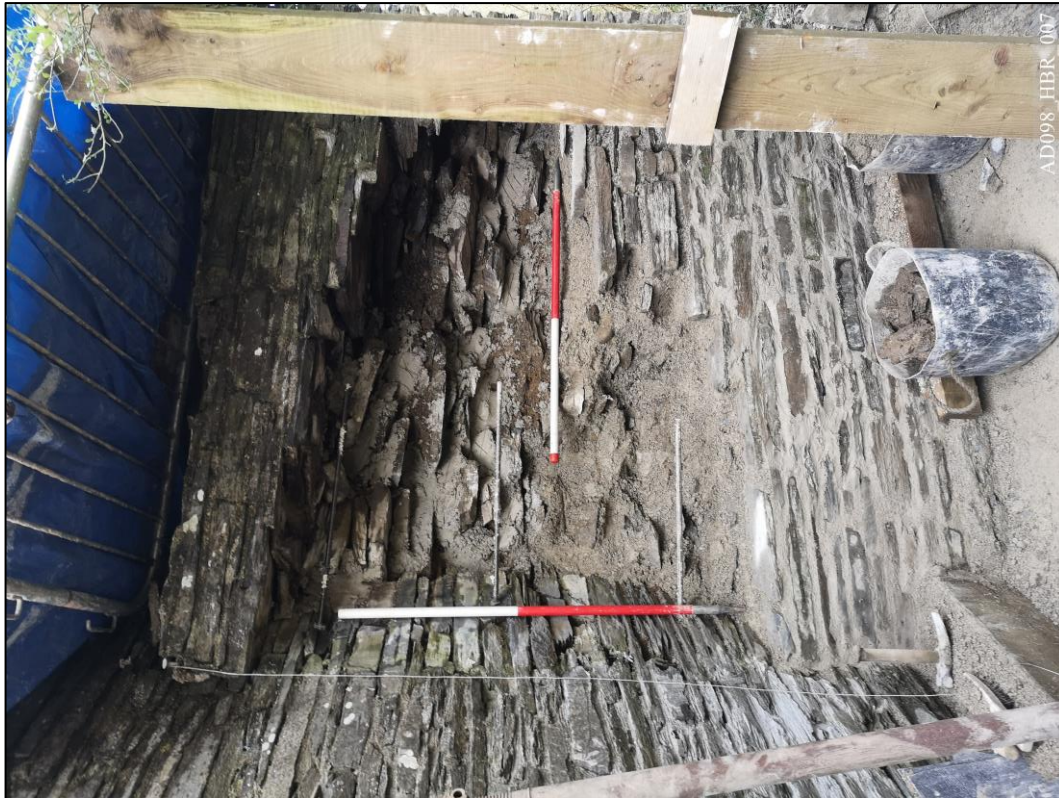
Plate 7 – View north, showing rebuilding of new retaining wall to historic core.  
Photo rotated 90° anticlockwise.

7.4.3 Between, 12<sup>th</sup> January and 21<sup>st</sup> January 2021, the retaining wall was rebuilt using retained masonry from the collapse and dismantling. The existing foundations were used to rebuild the wall and new stainless-steel ties were used to anchor the modern masonry together.

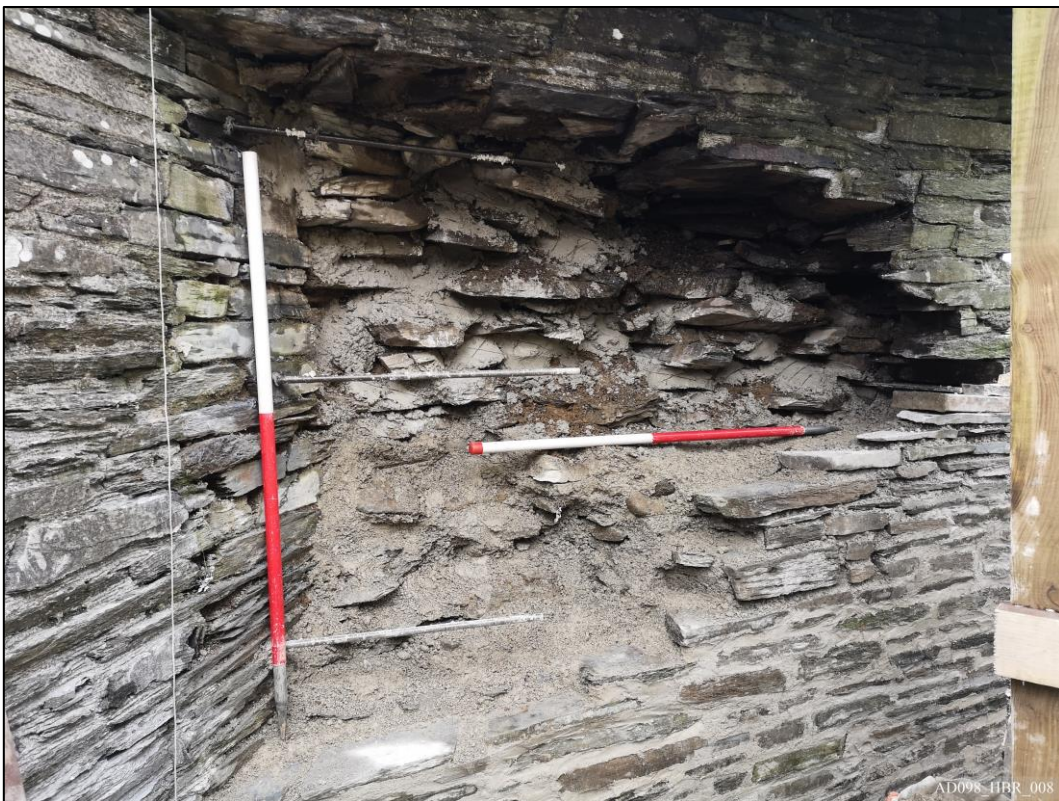
Plate 8 – View north, showing full width of rebuild, including stainless steel ties.

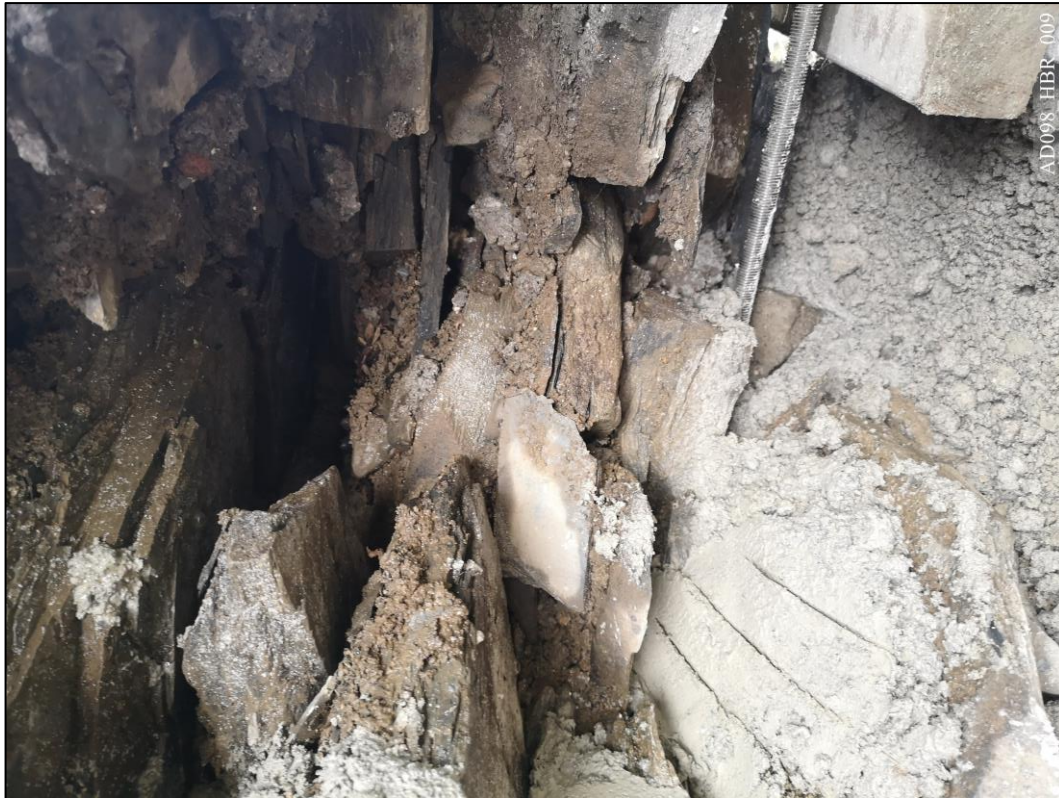
Plate 9 – View north-west, showing insertion of stainless-steel tie and introduction of lime mortar.  
Photo rotated 90° anticlockwise.

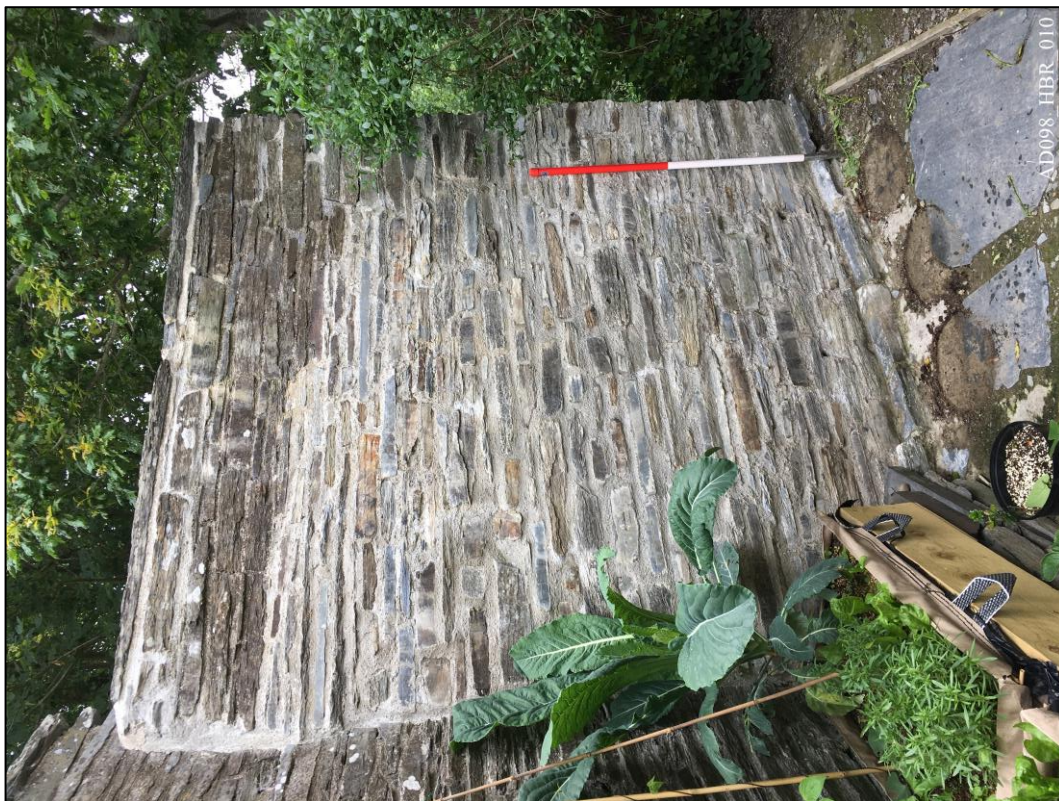
Plate 10 – View north, showing completed rebuild or retaining wall.  
Photo rotated 90° anticlockwise. Photo courtesy of Joseph Cliff, Cadw.

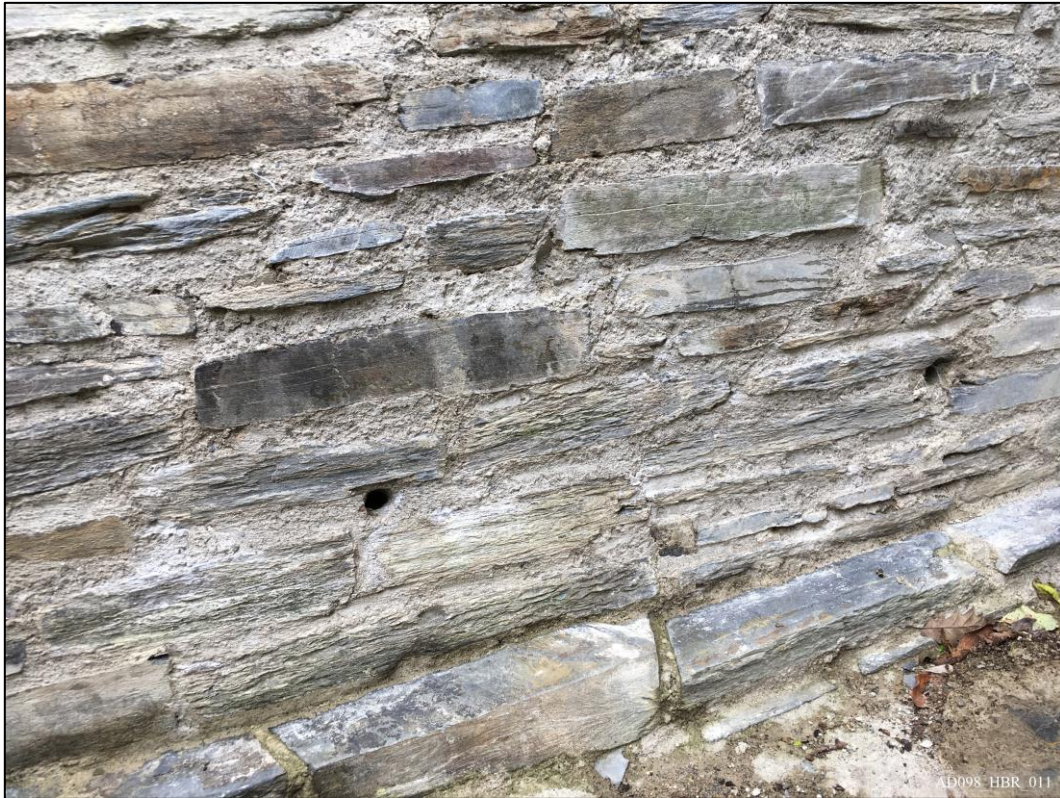
Plate 11 – View north, showing drainage holes to base of new retaining wall.  
Photo courtesy of Joseph Cliff, Cadw.

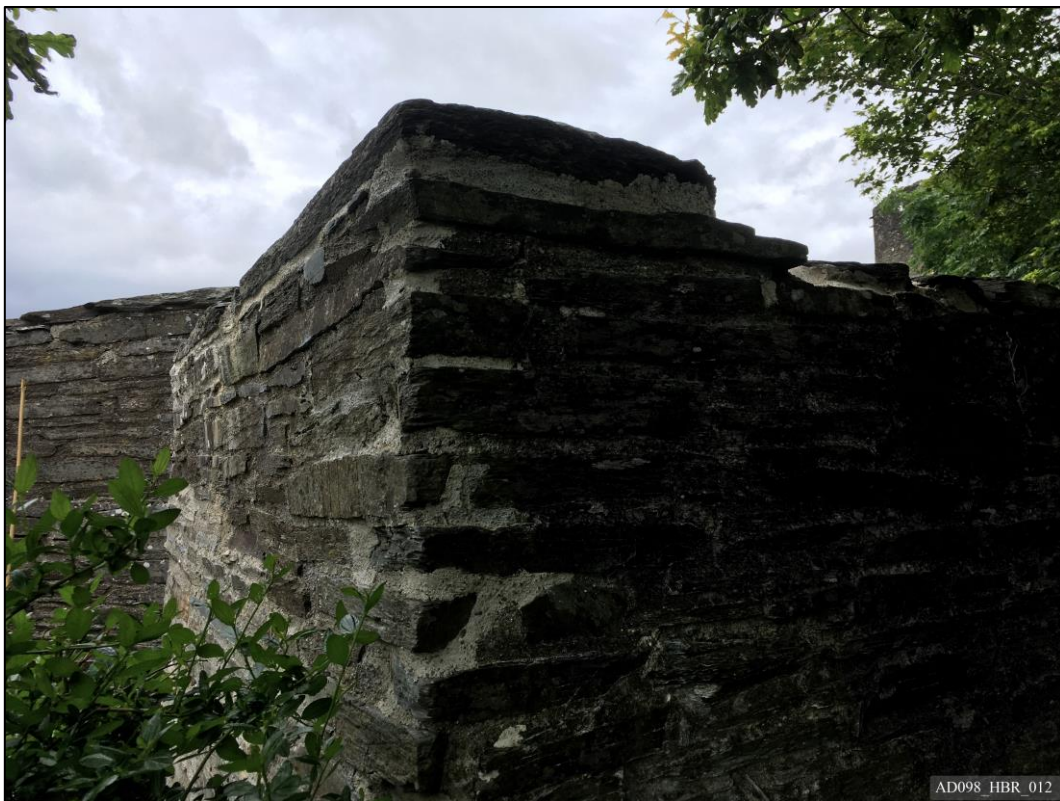
Plate 12 - View north-west, showing repair to south-west corner of retaining wall.  
Photo courtesy of Joseph Cliff, Cadw.

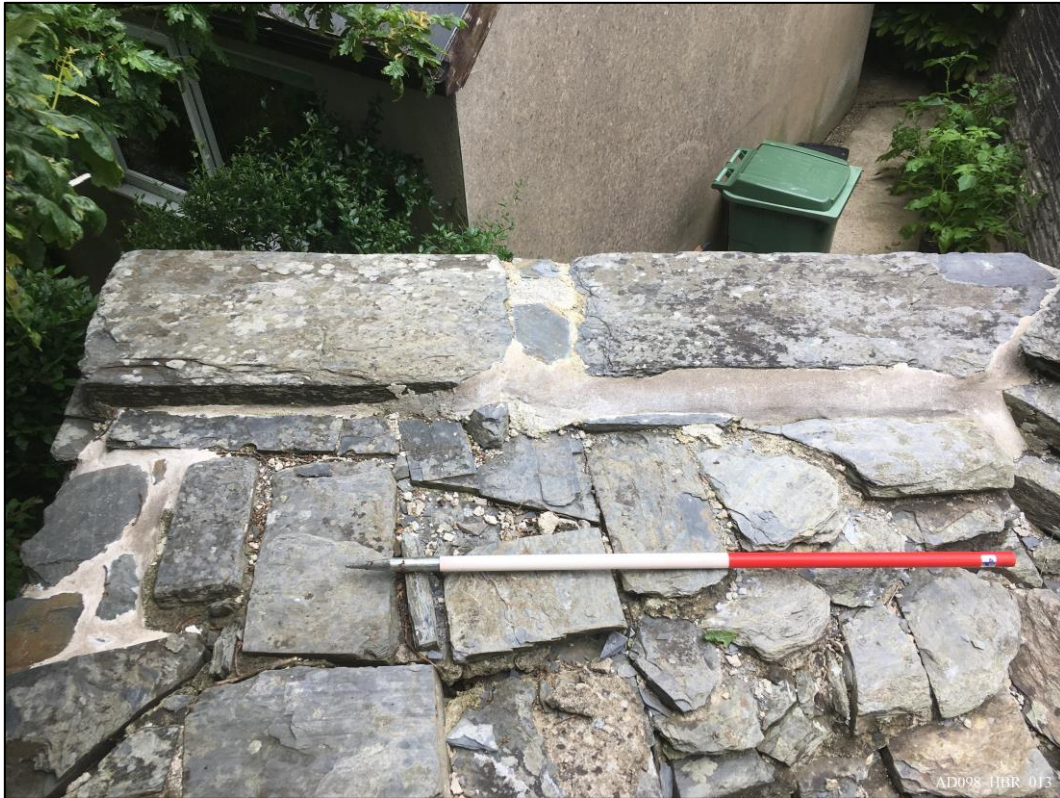
Plate 13 – View south, showing the modern retaining wall capping.
