Former Brymbo Ironworks, Wrexham County Borough

Archaeological Assessment

Phase 1 - Version 2.0

Project #: AD079

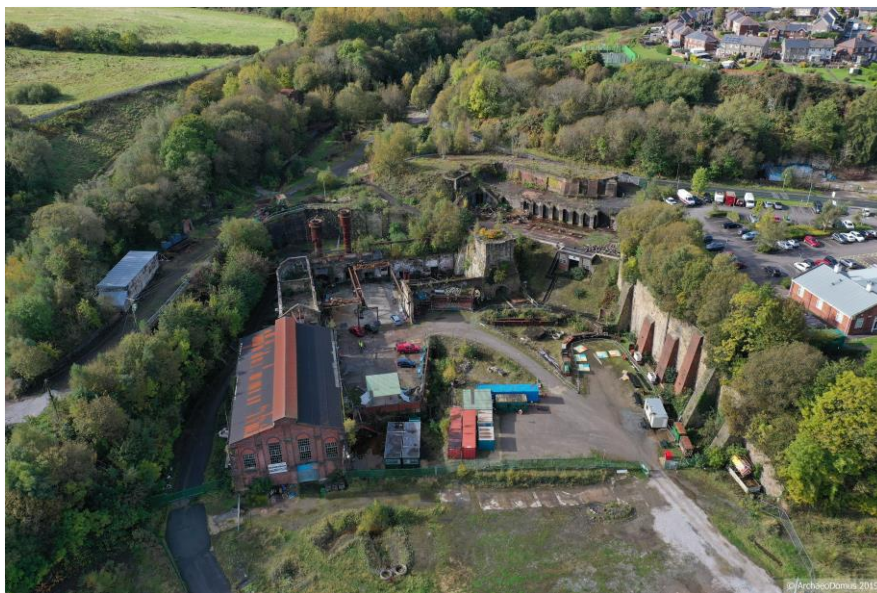
Fig. 1 – Brymbo Heritage Area

- 1.1 ArchaeoDomus has been commissioned by Brymbo Heritage Trust to undertake an Archaeological Assessment of the former Brymbo Ironworks (hereafter also referred to as ‘the site’) (*Fig. 20*), as part of the Trust’s Phase 2 Heritage Lottery Fund bid, submitted November 2019.

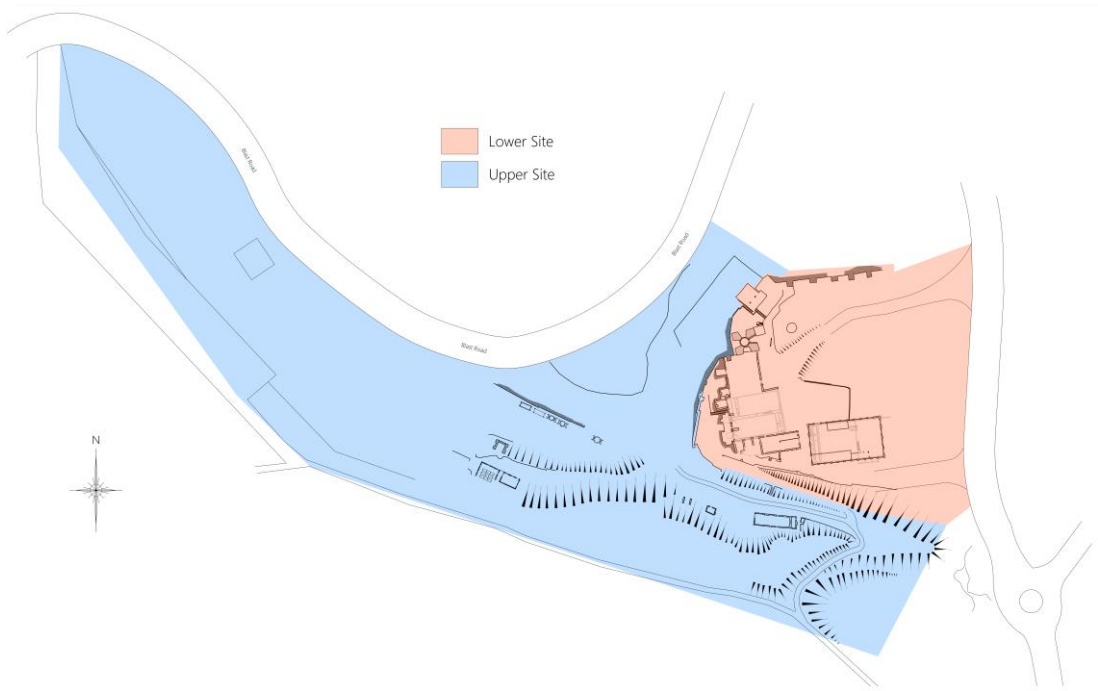
Fig. 5 – Brymbo Ironworks Upper and Lower Site.

2.1.2 The surviving ironworks is divided between the ‘lower site’ and ‘upper site’ (*Fig. 5*). The lower site forms what can be considered the core of the heritage area, with the Scheduled Monument Area, Machine Shop and Winch Room (*Fig. 6*), and is the point of entry for all visitors. The upper site starts on arriving at the Agent’s House, after rising up via the site road, and extends to the western reaches of the site bounding Blast Road and the end of Mount Zion (road) to the west. In this section of the site, the Agent’s House, Pit Head, Winding House, Ancillary Railway Buildings and Rail Platform (*Fig. 6*) are to be found.

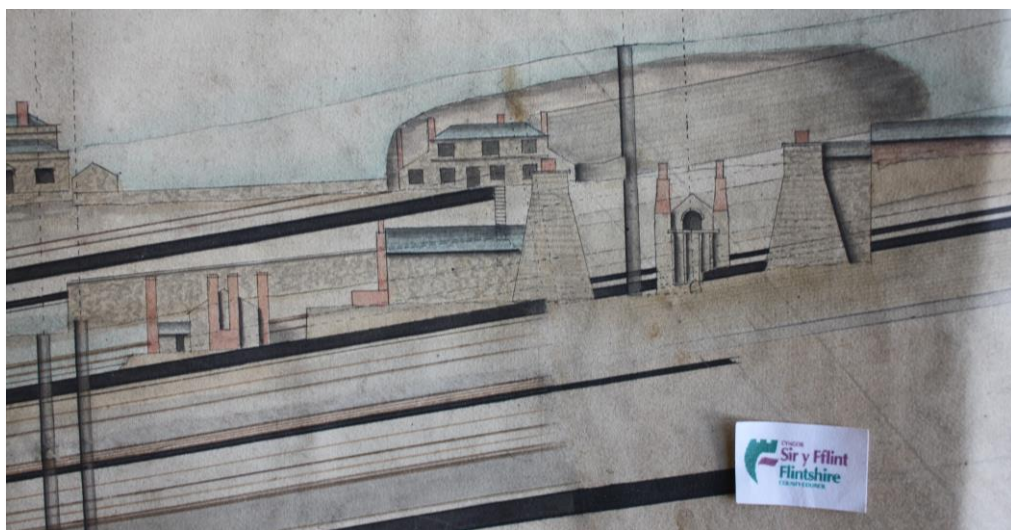
Fig. 8 – Longitudinal Section of the Strata at the Brymbo Colliery. Dec. 1812. Flint Archives.

- 5.3.2 Colliery plans made in 1809 and 1812, commissioned by the executors and trustees of the Wilkinson estate, show the ironworks at the same level of development as those shown on the 1798 Estate Plan. It may be at this time that the earlier estate plan was updated to reflect the addition of No. 2 Blast Furnace. Importantly, a section of the coal strata (*Fig. 8*), shows the works in section, with clear depictions of the blast furnaces, puddling furnaces and the Agent’s House.

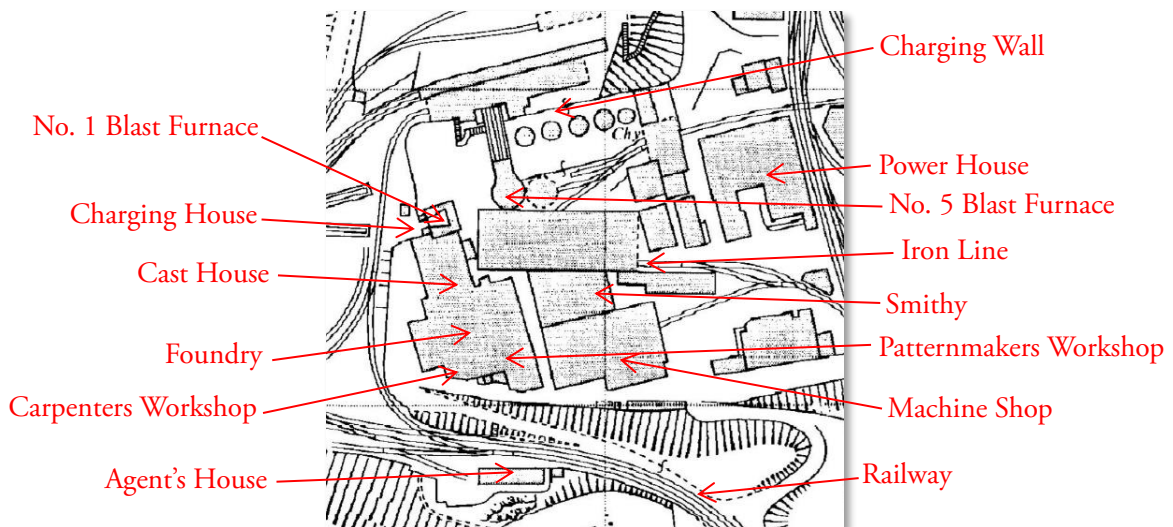
Fig. 12 – 1963 1:2,500 map, OS.
© Landmark Information Group Limited 2019.

5.3.7 The next edition of the 25 Inch to One Mile, by now referred to as the 1:2,500 scale, is produced in 1963 (*Fig. 12*). This map shows large developments within the historic ironworks site including the demolition of No. 4 Blast Furnace, the covering of the sunken iron line with a cast house, construction of the 1921 Machine Shop, the Smithy to its immediate north, and tanks and chimneys to the face of the Charging Wall. By this time, the additions to the Agent’s House have been demolished, returning the property to the size shown on the section of 1812. A range of new, small buildings are built to the immediate west of the Power House, likely incorporating some elements of the buildings shown on the 1912 map.

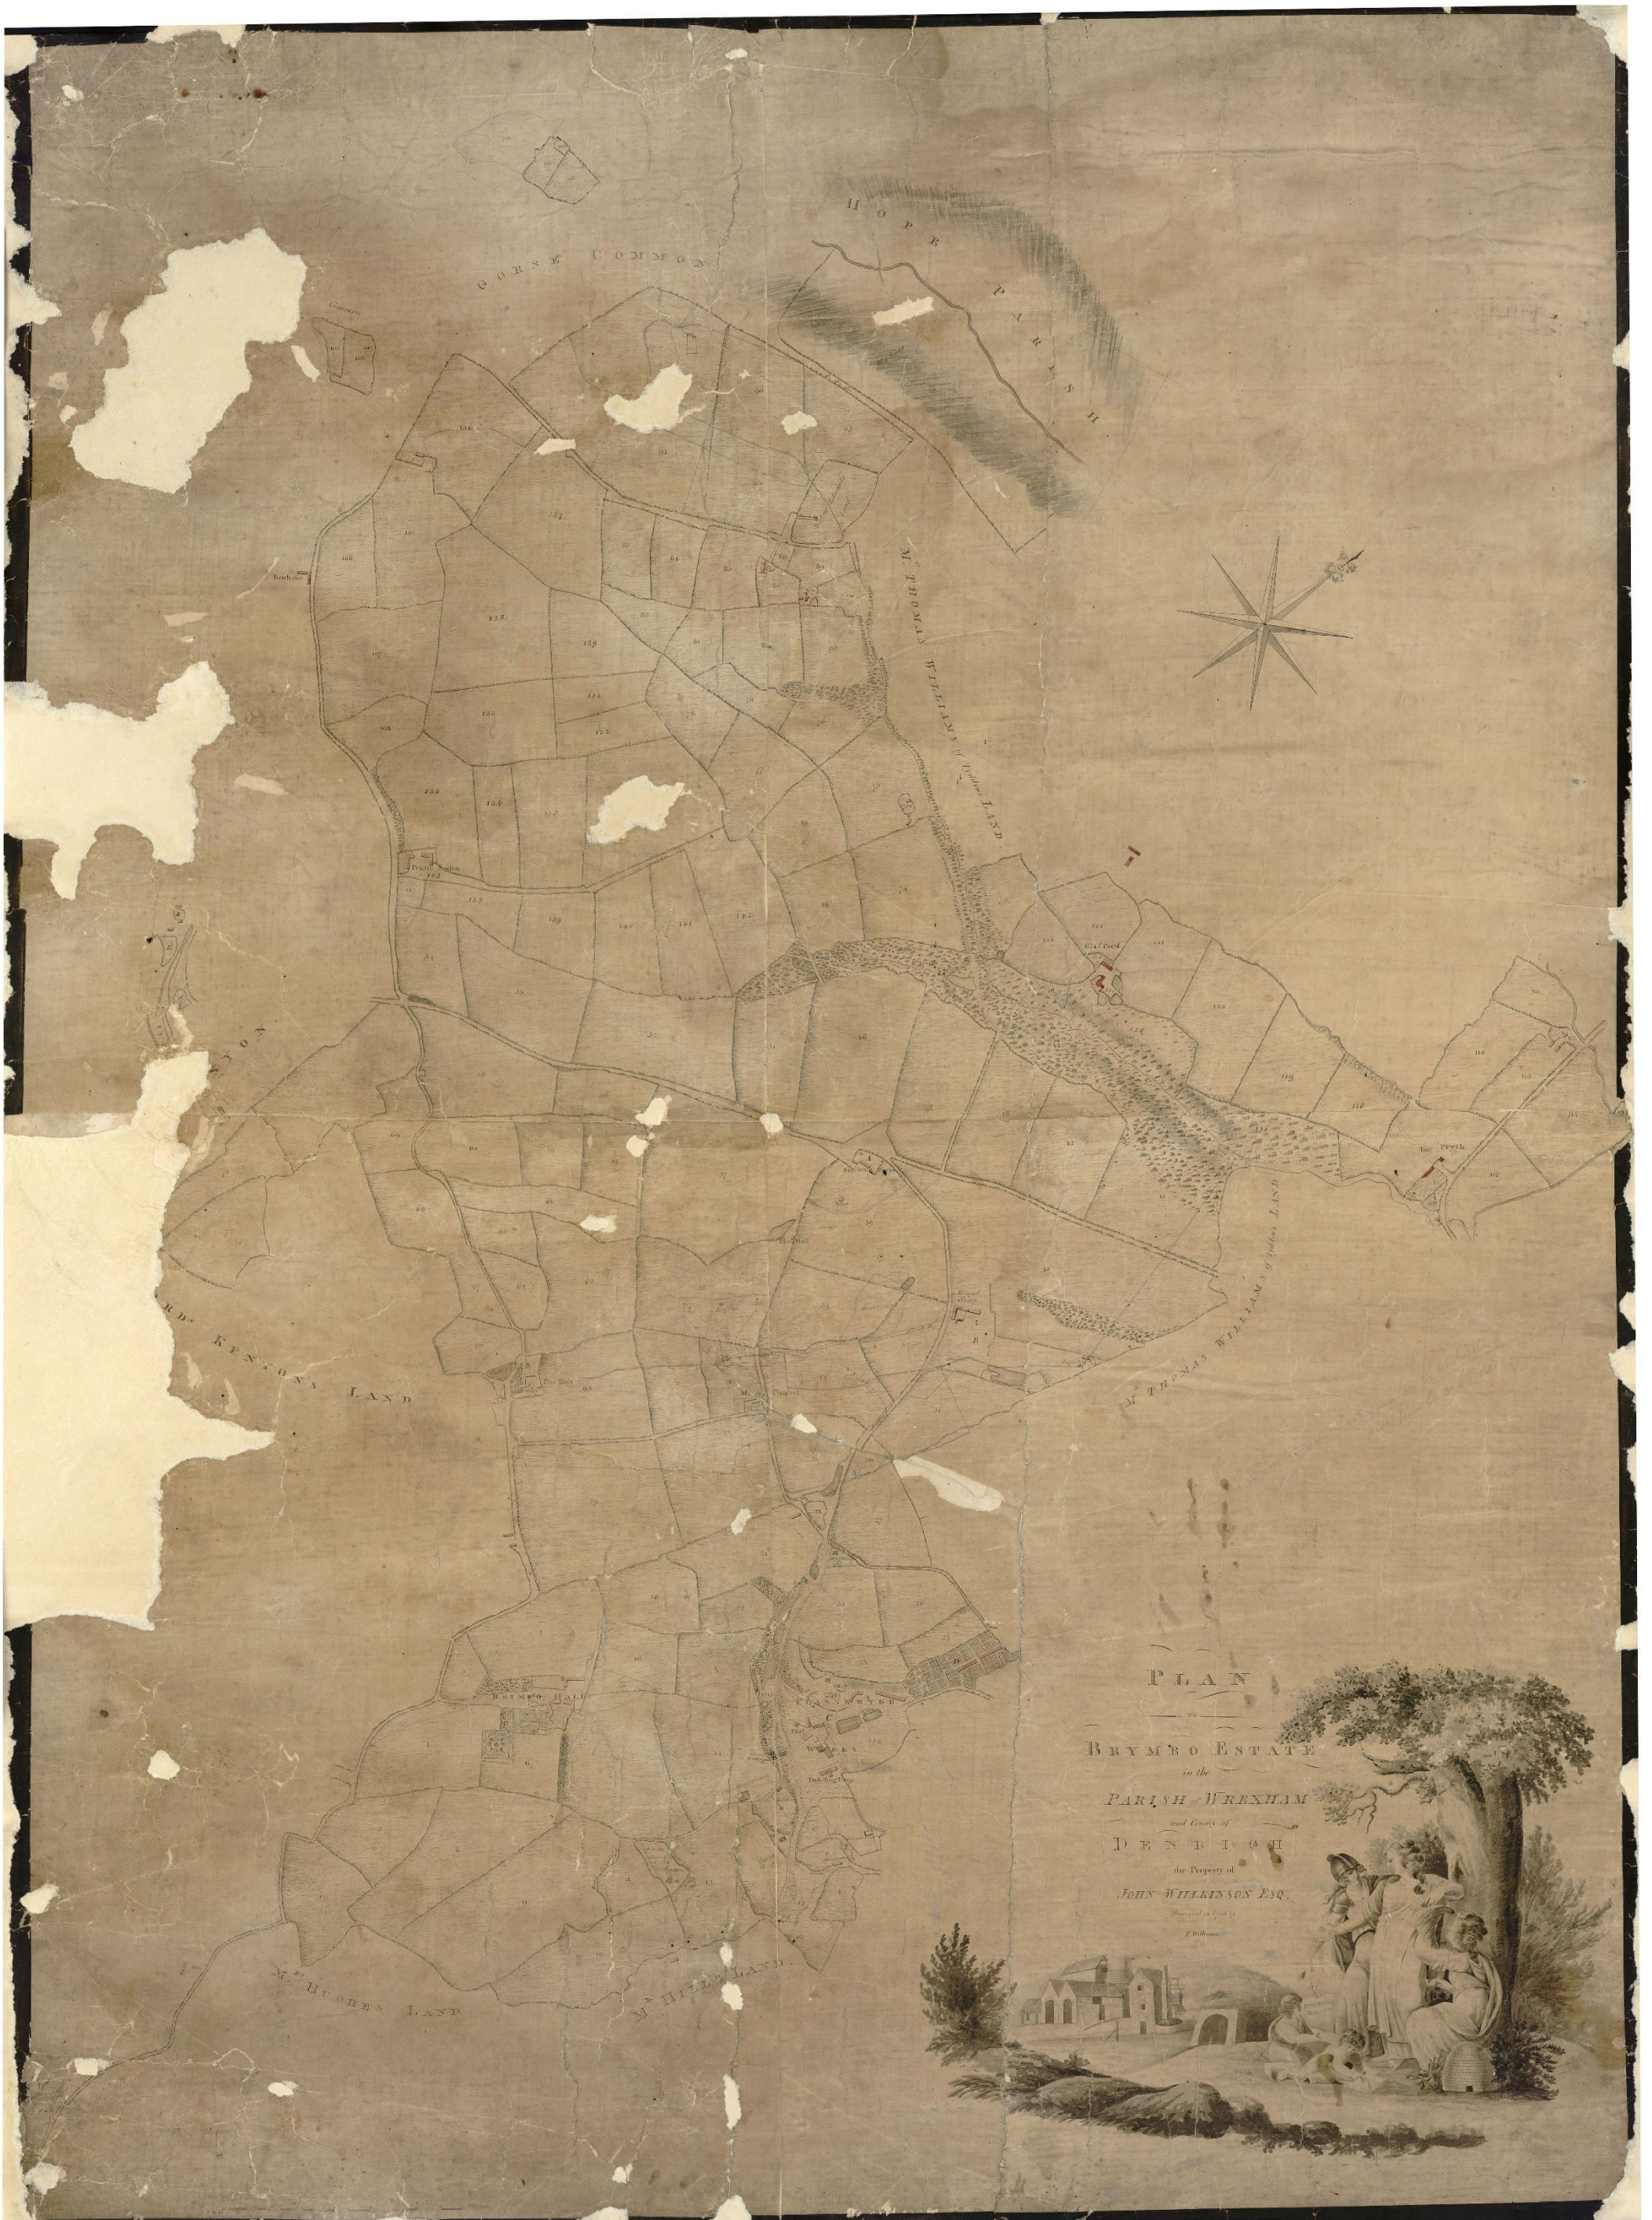
Fig. 14 – Plan of the Brymbo Estate. © National Library Wales.

- 5.3.1 One of the most significant pieces of evidence for the early development of the Brymbo Ironworks is the Brymbo Estate Plan of 1798 (*Fig. 14*). The plan was commissioned by Wilkinson and produced by T. Williams. The plan is likely to have been surveyed sometime between 1796-8, as it shows the works complete with blast furnace with the blast engine house, charging house and cast house. At this time the ironworks are labelled as the ‘Plasnewydd Works’. Latterly, the estate plan was updated to reflect the addition of No. 2 Blast Furnace. This has been drawn onto the map in black ink, with hatching to the new buildings, which is unlike the pink shading to the original.

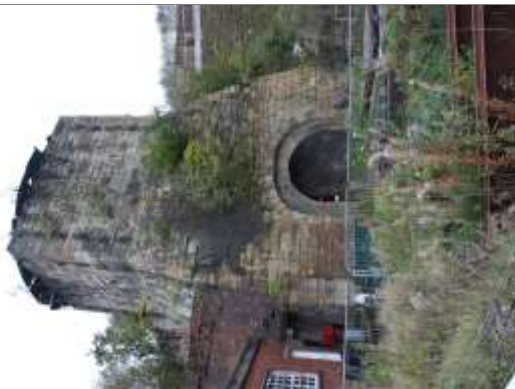
The archaeological potential of Old Number One is mainly derived from the structure itself, which provides a complete example of an early 19th century blast furnace. There is potential that the foundations and below ground structure are those reused from Wilkinson's original furnace. The remains of slag to the firebrick lining provide a source of analysis for the mineral and chemical composition of late 19th century blast materials and iron.

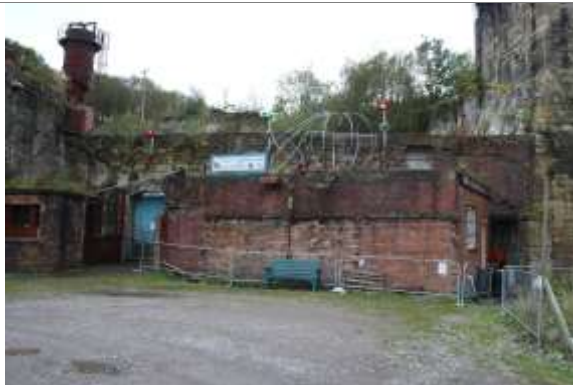
There is a high potential of encountering archaeological deposits beneath the current working surface of the Cast House. Whilst there is a poured and slabbed concrete floor to the Cast House, the full extent of any earlier casting beds is not known. Information from Walter Salisbury, a former Foundryman, tells us that there were once two coke fired furnaces just to the south of No. 1, which were covered with the later work surface. As such, any works within the Cast House should be subject of an archaeological evaluation should be undertaken to explore the potential for survival of these earlier surfaces.

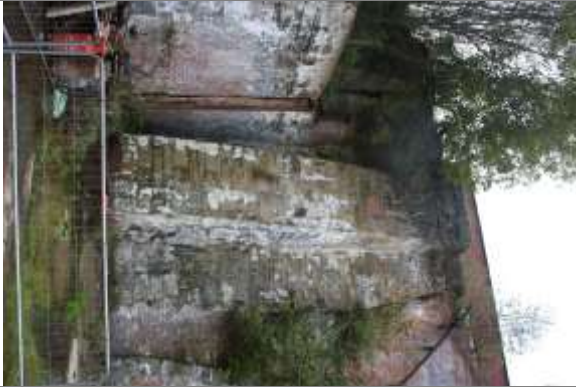
Condition				
<p>The remains of the Charging House are only visible to its south elevation, as such the condition can only be partially assessed. The condition of the visible wall is good. However, the upper west end of the wall has a large crack where the buttress has started to peel away from the main structure.</p>				
Archaeological Potential				
<p>There is a high potential of encountering archaeological deposits and structures associated with the top structure of the Charging House. This may take the form of the remains of walls, trackways and the charging bridge used to load Old Number One.</p>

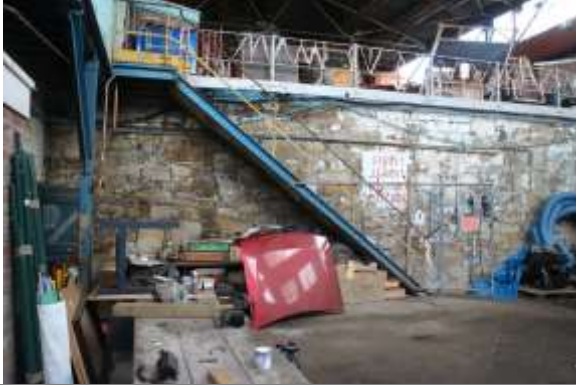
Images

History				
<p>A letter sent by James Watt, Jr. to his father in 1793, describes Wilkinson had spent £20,000 on levelling the site, constructing a parapet wall and building a puddling furnace (Soldon 1998: 73). An estate plan of 1798 confirms the existence of a number of Wilkinson's early buildings, but not any site infrastructure, such as walls. Ordnance Survey maps of 1873 (Denbighshire XXVIII.2) is the first time the wall is represented in plan form.</p>				
Condition				
<p>Good overall condition. Protection afforded by being within 1921 Machine Shop.</p>				
Archaeological Potential				
<p>Despite being a part of Wilkinson's original development of the site, the archaeological potential is low as it is at a low risk or being altered or removed. However, it should be considered to be of high significance due to its association with Wilkinson and the sites early development.</p>

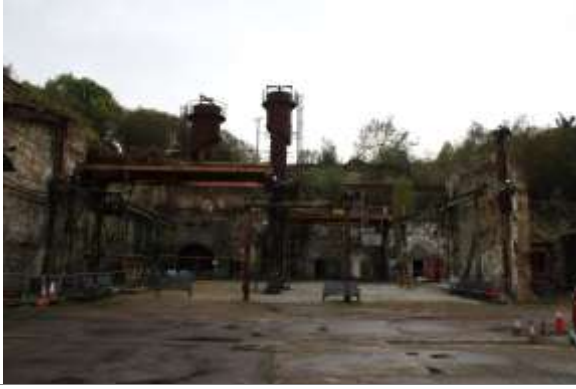
There is a high potential of encountering archaeological deposits beneath the current working surface of the Foundry. Whilst there is a poured and slabbed concrete floor beneath the current surface, it is not known whether this has disturbed the original foundry floor and casting troughs. As such, any works within the Foundry should be subject to an archaeological evaluation in advance of any development, to explore the potential for survival of earlier surfaces.

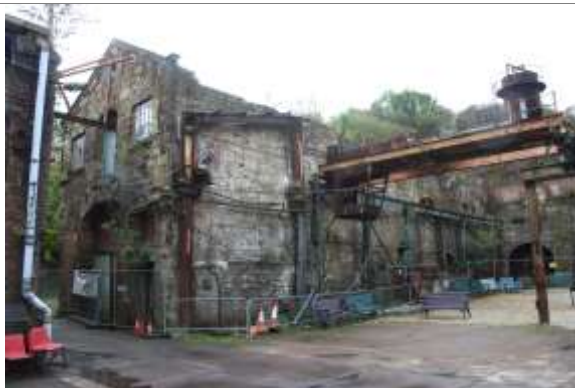
Images

There is a moderate potential of encountering features of both buried and structural archaeological and historical significance. Within the fabric of the building there is the potential for the uncovering of industrial artefacts pertaining to the buildings original use, such as machine bases, industrial deposits associated with machining, or evidence of their means of power (line shaft).

A laser scan survey was undertaken in 2019, with archaeological drawings prepared under ArchaeoDomus project AD065.

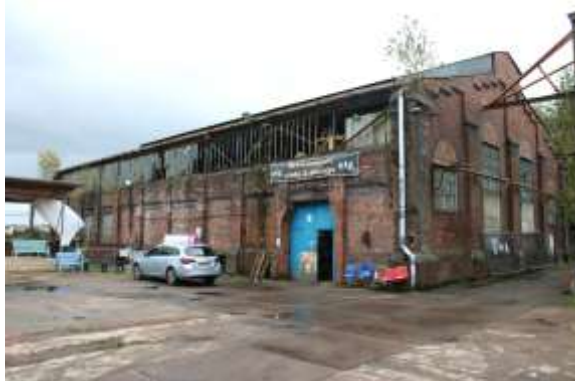
Images

The building itself is important as an intact survival of early 20th century industrial architecture. However, the greatest archaeological potential comes in the deposits below the shop floor, as the area over which it has been built was once a storage and processing yard, with a workshop of unknown use. It is therefore likely that archaeological deposits associated with the areas previous use lays beneath the floor of the Machine Shop.

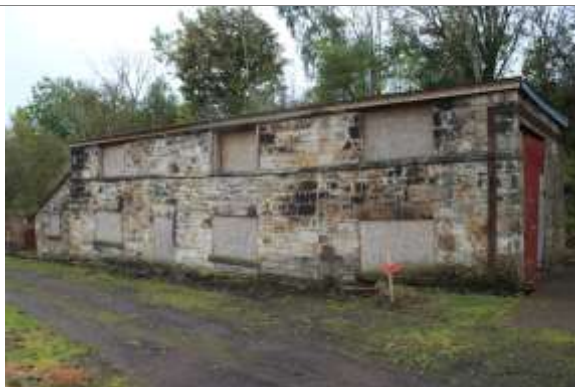
Images

Despite the alterations that have beset the building, there is a high potential of encountering archaeological deposits relating to the buildings development. To the north of the building, there is evidence for a small, enclosed garden area fronting the road. To the west elevation, buildings relating to the railway stood until 1963 and therefore there is a high risk of encountering underground remains or deposits pertaining to their date of construction and use. Internally, it is not known what survives under the present surface and therefore evidence may survive relating to the development of the Agent's House and the 'Three Cottages' as noted, albeit at a later date, on the 1798 estate plan.

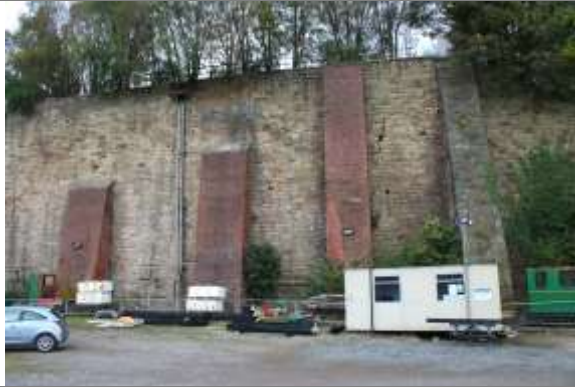
Images

History				
<p>No records have currently been found relating to the Charging Wall. Ordnance Survey mapping demonstrates that the Charging Wall was not in existence when No. 3 Blast Furnace was constructed in 1872 (Denbighshire XXVIII.2), but it had been built by 1899 (Denbighshire XXVIII.2). It is therefore likely that the Charging Wall was built when No. 3 Blast Furnace was decommissioned and replaced by No. 4 Blast Furnace (also known as 3b) in 1894.</p>				
Condition				
<p>Overall in good condition. A subsidence crack suggests that there is some movement associated with the east end of the wall.</p>				
Archaeological Potential				
<p>The archaeological potential of the Charging Wall is somewhat limited. However, excavations around the base of the wall do pose a risk of disturbing archaeological remains and deposits associated with the blast furnace, slag line and their workings.</p>

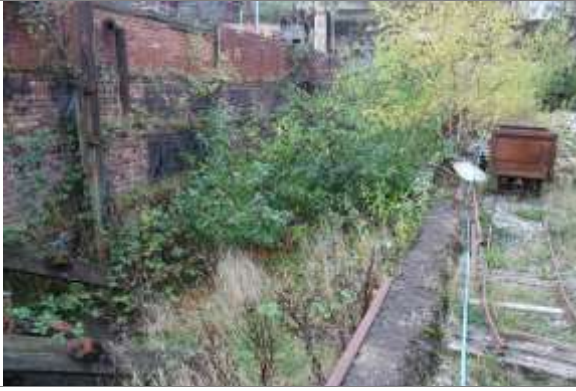
Condition				
<p>Currently overgrown and covered in later site debris.</p>				
Archaeological Potential				
<p>There is a moderate potential for archaeological remains and deposits within the area of the Iron Line. The construction of the sunken railway cut away some parts of the site to enable its construction and therefore it is likely to have removed potential remains of earlier structures and features. However, as it is difficult to substantiate fully whether deposits have been wholly removed by later activities, a watching brief should monitor all excavations within the area of the Iron Line.</p>

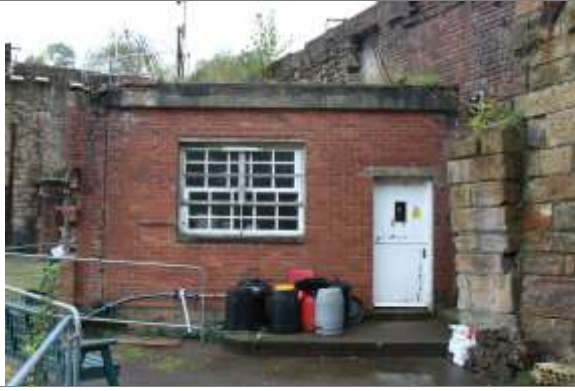
Images

History				
<p>Mapping evidence demonstrates that this ancillary building was constructed sometime between 1949 (Denbighshire XXVIII.NW) and 1963 (Denbighshire XXVIII.2). However, it is likely to have been built with the programme of works to the building during 1943.</p>				
Condition				
<p>The building is generally in a good condition. Weathering has caused the wash of some mortar from the joints. The ironwork to the roof risks causing damage through oxide jacking/rust burst.</p>				
Archaeological Potential				
<p>The archaeological potential of the building is low. However, beneath the buildings footprint, there is the possibility for archaeological deposits and remains associated with the early operations of the Cast House.</p>

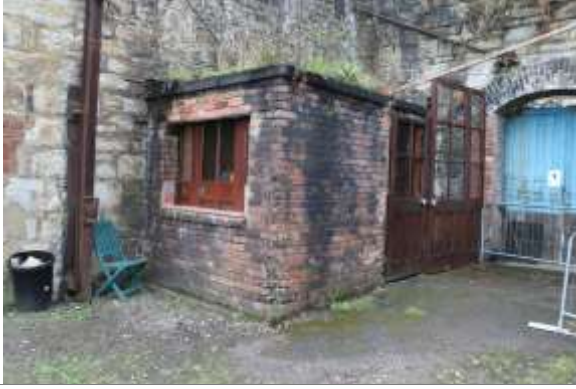
Condition				
<p>The building is generally in a good condition. Weathering has caused the wash of some mortar from the joints. Works in the last 5 years have repaired the building.</p>				
Archaeological Potential				
<p>The archaeological potential of the building is low. However, beneath the buildings footprint, there is the possibility for archaeological deposits and remains associated with the early operations of the Cast House.</p>

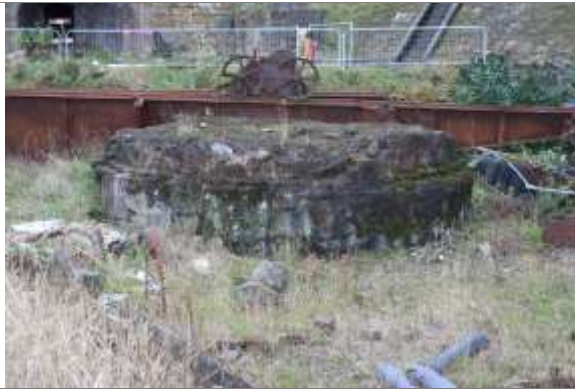
No. 5 Blast Furnace base is of high significance to the surviving works, as it represents the very purpose of Brymbo Ironworks existence - the production of iron from raw materials. The potential for archaeological survival beneath the structure is limited as the foundations are likely to have disturbed earlier structures or deposits. However, as the extent of the foundations are unknown, there is the moderate potential for the survival of plumbing associated with the blast furnace operation or structures relating to an earlier phase of the sites development.

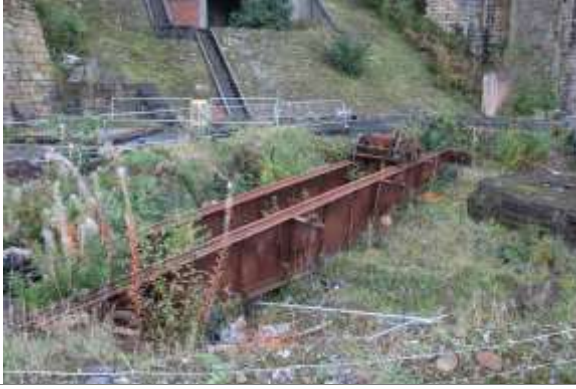
Archaeological Potential				
<p>Low archaeological potential. However, the crane remains a significant industrial artefact relating to an early 20th century Powerhouse.</p>

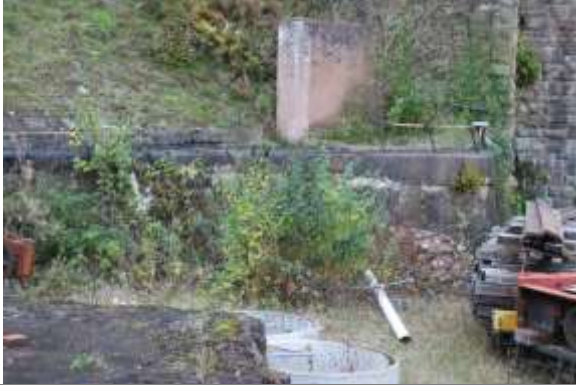
Condition				
Good overall condition.				
Archaeological Potential				
As little is known regarding the asset, there is a moderate potential for archaeological deposits and remains pertaining to the sites early development.

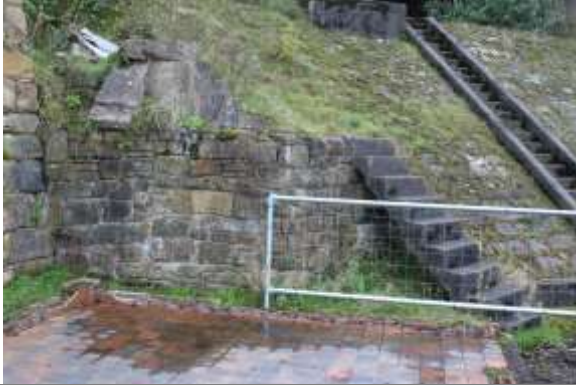
Images

Entry Number				
17				
Asset Name				
Steps and Wall to North-East of No. 1				
Date Range	Asset Number	Asset Type		
1960s	S20	Structure		
NPRN	NGR	Scheduled	Listed	ID
	SJ 29450 53566	<input type="checkbox"/>	<input type="checkbox"/>	
Description				
Two flights of cast concrete steps, once leading to the roof of the former Shower Block (S21). Steps rise over a stone-faced red brick chamber, partially filled with rubble.				
History				
Constructed during upgrade works associated with No. 5 Blast Furnace in the 1960. Not shown on any mapping.				
Condition				
No comment.				
Archaeological Potential

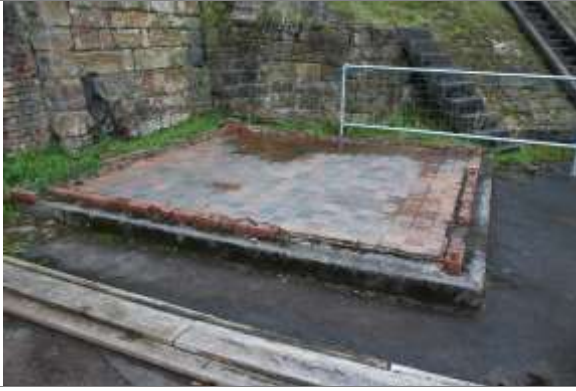
Images

Entry Number				
18				
Asset Name				
Shower Room Floor to North-East of No. 1				
Date Range	Asset Number	Asset Type		
1960s	S21	Structure		
NPRN	NGR	Scheduled	Listed	ID
	SJ 29451 53563	<input type="checkbox"/>	<input type="checkbox"/>	
Description				
Shower Room floor of cast concrete with ceramic tile over. Some brick of the east wall survives. Doorway to north-east corner.				
History				
Constructed during upgrade works associated with No. 5 Blast Furnace in the 1960. Not shown on any mapping.				
Condition				
No comments.				
Archaeological Potential				
Demonstrate the upgrade in amenity's to the plant for the use of the workers.

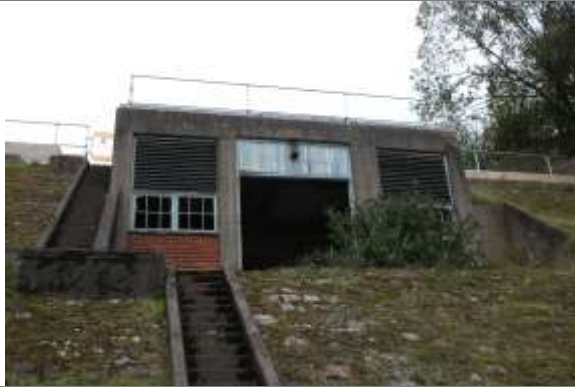
Images

History				
<p>The Winch House was built in 1964 to mechanise the charging of No.5 Blast Furnace. The construction comes alongside a number of other improvements made during the 1960s to improve the blast and yields. Most closely associated with the Winch House are the Ore Bins (W27) to the west of the building. Mapping evidence shows that the area to the north of No. 1 was devoid of buildings in 1963 (Denbighshire XXVIII.2), with the construction in 1964 backfilling this area. However, earlier maps of 1873, 1989 and 1912 (Denbighshire XXVIII.2) all show this area previously occupied by site buildings.</p>				
Condition				
<p>Generally the Winding House is in good condition. However, water ingress is causing deterioration of the I-beams to the roof, which risks destabilising the flat roof.</p>				
Archaeological Potential				
<p>The archaeological potential of this area is limited as a result of the building up of ground in for the construction of the Winch House in 1964. As a result there is a low potential of encountering archaeological remains or deposit alongside any works related to the Winch Room and the associated structure.</p>

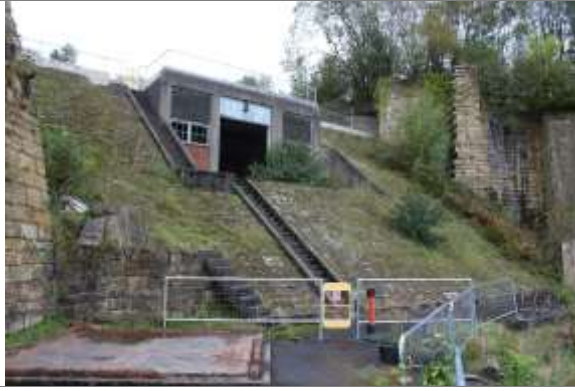
Images

Condition				
No comments.				
Archaeological Potential				
The archaeological potential of this area is limited as a result of the building up of ground in for the construction of the Winch House in 1964. As a result there is a low potential of encountering archaeological remains or deposit alongside any works related to the Winch Room and the associated structure.

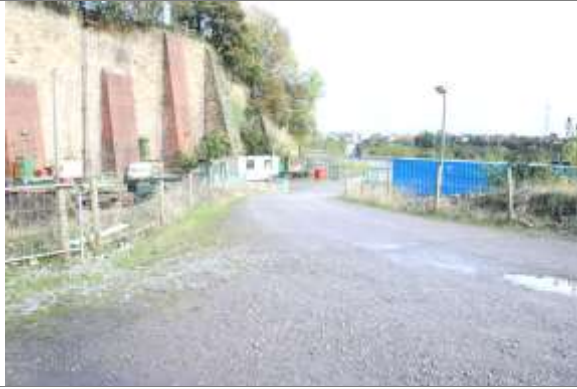
Images

Entry Number				
21				
Asset Name				
Trackway to Front of No. 1 Blast Furnace				
Date Range	Asset Number	Asset Type		
2000s	N/A	Road / Track		
NPRN	NGR	Scheduled	Listed	ID
	SJ 29472 53555	<input type="checkbox"/>	<input type="checkbox"/>	
Description				
Site trackway to provide access up to Scheduled Area/Machine Shop level. Constructed of compacted rubble and hardcore.				
History				
Constructed in 2000s.				
Condition				
N/A				
Archaeological Potential				
The trackway covers part of the retaining walls associated with the Iron Line (H02) and retaining wall to the front of No. 1 Blast Furnace (W05; W06). Mapping evidence shows the trackway covers an area once occupied by the site slag line and tapping house associated with No. 5 Blast Furnace. As such, any works to the trackway would result in a high potential for the exposure of archaeological deposits and remains associated with the workings of Brymbo's blast furnace. It is therefore recommended that archaeological evaluation should be undertaken

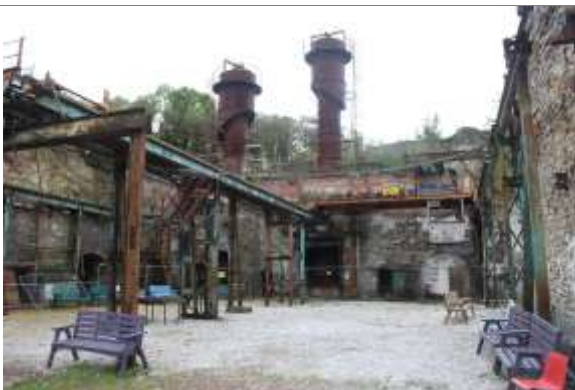
Images

Condition				
Overall in good condition. However, the more vulnerable element of the structure have suffered from severe rust.				
Archaeological Potential				
Archaeologically the crane itself has low archaeological potential.

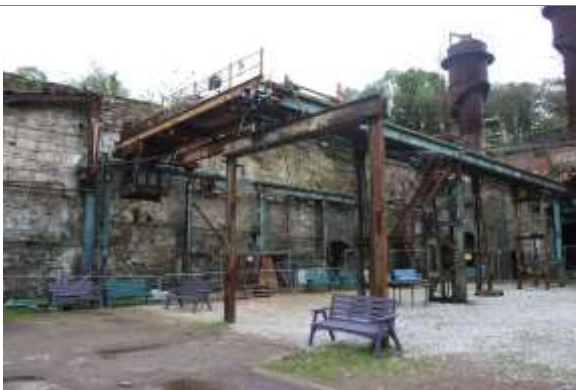
Images

Condition				
Overall in good condition. However, the more vulnerable element of the structure have suffered from severe rust.				
Archaeological Potential				
Archaeologically the crane itself has low archaeological potential.

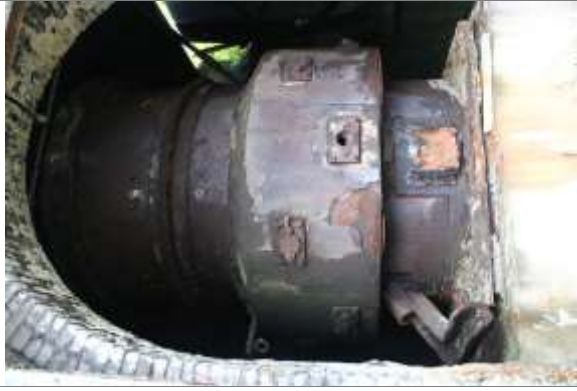
Images

History				
<p>Although no written accounts have been found for the Cupola Furnaces, an account provided by Walter Salisbury, a former Foundry Worker, tells us that these were installed in circa 1970, with the roof being renewed at the same time. The cupola furnaces were designed by Walter and a colleague, which were then manufactured at the works. Walter admits that the furnaces could have been 50% taller again, as the heat created by the furnaces was so great that it melted the spark arresters. As such, they were only able to produce 2 tonnes per week, rather than the potential of 5 tonnes.</p>				
Condition				
<p>Covered in iron oxide, giving iconic red colouring. Firebrick lining fallen in places. Legs now concreted to give greater support around base.</p>				
Archaeological Potential				
<p>The archaeological potential of the cupola furnace comes largely from the survival of internal deposits left from the smelting process. Such deposits, including the firebrick lining, have the potential to provide evidence for the materials and agents used in the process of recycling waste materials.</p>

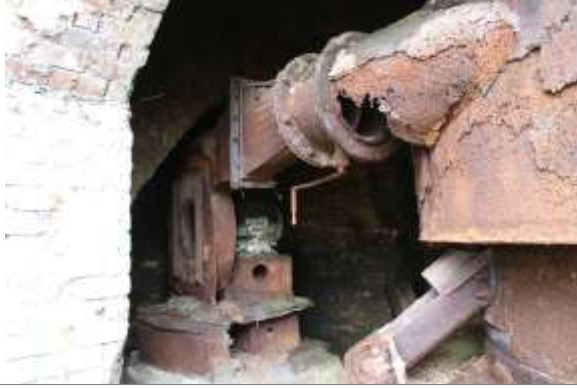
Images

History				
<p>Although no written accounts have been found for the Cupola Furnaces, an account provided by Walter Salisbury, a former Foundry Worker, tells us that these were installed in circa 1970, with the roof being renewed at the same time. The cupola furnaces were designed by Walter and a colleague, which were then manufactured at the works. Walter admits that the furnaces could have been 50% taller again, as the heat created by the furnaces was so great that it melted the spark arresters. As such, they were only able to produce 2 tonnes per week, rather than the potential of 5 tonnes.</p>				
Condition				
<p>Covered in iron oxide, giving iconic red colouring. Firebrick lining fallen in places. Legs now concreted to give greater support around base.</p>				
Archaeological Potential				
<p>The archaeological potential of the cupola furnace comes largely from the survival of internal deposits left from the smelting process. Such deposits, including the firebrick lining, have the potential to provide evidence for the materials and agents used in the process of recycling waste materials.</p>

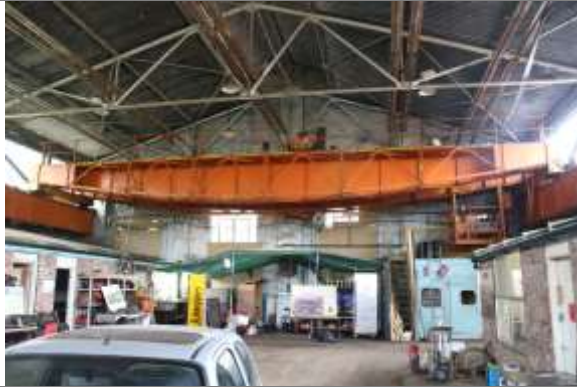
Images

History				
<p>Installed as an integral element of the Machine Shop of 1921.</p>				
Condition				
<p>Overall in good structural condition. The only element in poor condition are the controls within the control box.</p>				
Archaeological Potential				
N/A

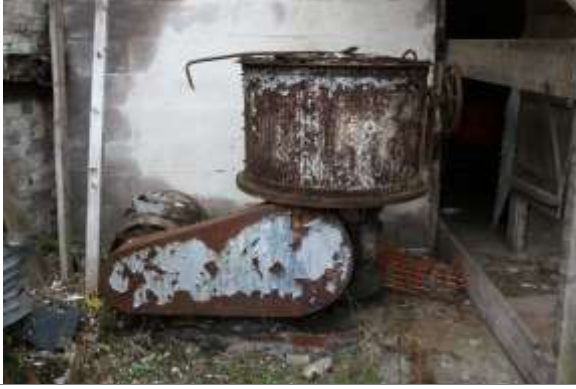
Images

Entry Number				
28				
Asset Name				
Sand Mixer 1				
Date Range	Asset Number	Asset Type		
20th Century	N/A	Machinery		
NPRN	NGR	Scheduled	Listed	ID
	SJ 29447 53550	<input checked="" type="checkbox"/>	<input type="checkbox"/>	DE202
Description				
<p>Machinery in the Cast House for mixing materials for production of sand castings. 20th century. Located next to south face of No. 1 Blast Furnace, east of two in this location. Steel sheet construction. Powered by belt/chain drive from electric motor. No manufacturer marks.</p>				
History				
N/A				
Condition				
Moderate condition. Deterioration caused by exposure to elements, causing paint loss and surface rust.				
Archaeological Potential				
N/A

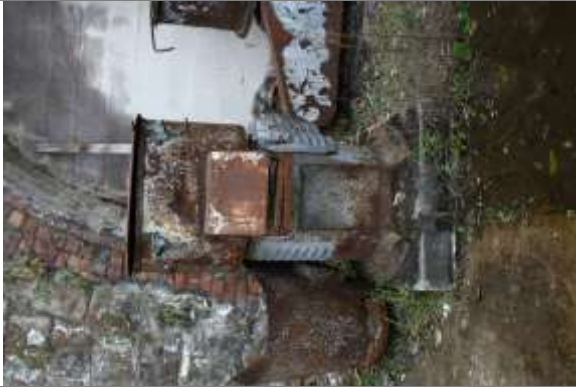
Images

Entry Number				
29				
Asset Name				
Sand Mixer 2				
Date Range	Asset Number	Asset Type		
20th Century	N/A	Machinery		
NPRN	NGR	Scheduled	Listed	ID
	SJ 29447 53549	<input checked="" type="checkbox"/>	<input type="checkbox"/>	DE202
Description				
Machinery in the Cast House for mixing materials for production of sand castings. 20th century. Located next to south face of No. 1 Blast Furnace, west of two in this location. Steel sheet construction. Direct drive from electric motor. No manufacturer marks.				
History				
N/A				
Condition				
Moderate condition. Deterioration caused by exposure to elements, causing paint loss and surface rust.				
Archaeological Potential				
N/A

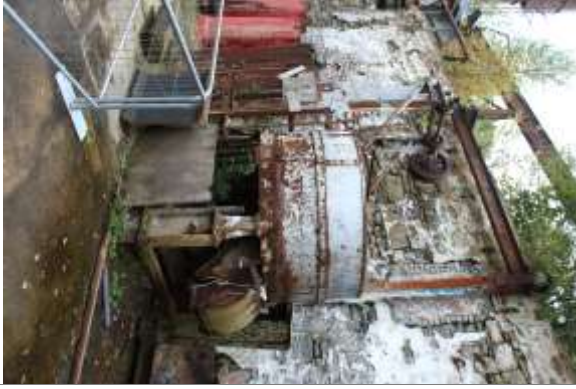
Images

Entry Number				
30				
Asset Name				
Sand Mixer 3				
Date Range	Asset Number	Asset Type		
20th Century	N/A	Machinery		
NPRN	NGR	Scheduled	Listed	ID
	SJ 29442 53541	<input checked="" type="checkbox"/>	<input type="checkbox"/>	DE202
Description				
<p>Machinery in the Cast House for mixing materials for production of sand castings. 20th century. Located to west of side of Cast House. Largest of three sand mixers. Steel sheet construction. Powered by direct drive from electric motor. Lever operated lift mechanism for heavy casting boxes; within safety caging. No manufacturer marks.</p>				
History				
N/A				
Condition				
Moderate condition. Deterioration caused by exposure to elements, causing paint loss and surface rust.				
Archaeological Potential				
N/A

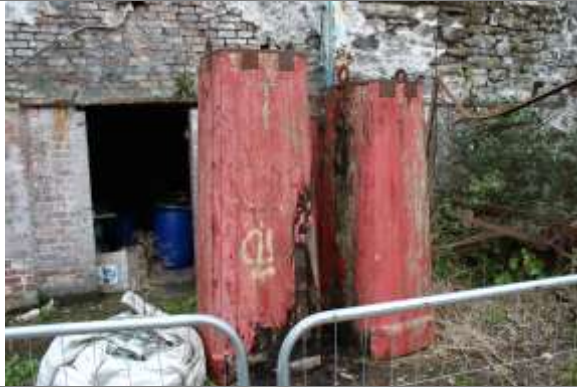
Images

Entry Number				
31				
Asset Name				
Ingot Patterns x 4 (Cast House)				
Date Range	Asset Number	Asset Type		
20th Century	N/A	Misc.		
NPRN	NGR	Scheduled	Listed	ID
	SJ 29444 53536	<input type="checkbox"/>	<input type="checkbox"/>	
Description				
Four large patterns for ingot moulds. Made in the on site Pattern Shop. Range from 3.4 to 2.4 tonnes. Pine with steel fixings. Painted red. Used to produce casting moulds for casting in the Foundry.				
History				
N/A				
Condition				
Poor condition. Large amounts of water damage/rot.				
Archaeological Potential				
N/A

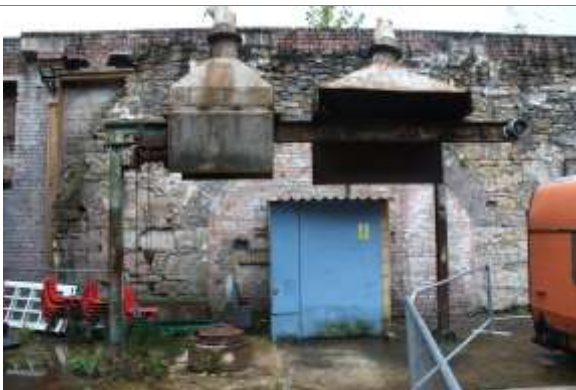
Images

Entry Number				
32				
Asset Name				
Brass Furnace				
Date Range	Asset Number	Asset Type		
1960s	N/A	Machinery		
NPRN	NGR	Scheduled	Listed	ID
	SJ 29452 53545	<input checked="" type="checkbox"/>	<input type="checkbox"/>	DE202
Description				
<p>Brass Furnace in Cast House, installed in 1960s. Furnace to floor, centrifugal blast fan and extraction hood over. Winch hook over; Ardegar Hoistmaster, SWL ½ ton. Diesel oil fired. Produced molten brass, in graphite crucibles, for casting of bearings and other specialist parts.</p>				
History				
<p>Installed in the 1960s for the production of bearings and other maintenance parts for the steel plant. Operational life ceased in 1992. Walter Salisbury the last Foundryman to work the furnace.</p>				
Condition				
<p>Good to poor. Deteriorating as a result of exposure to elements.</p>				
Archaeological Potential				
<p>N/A</p>

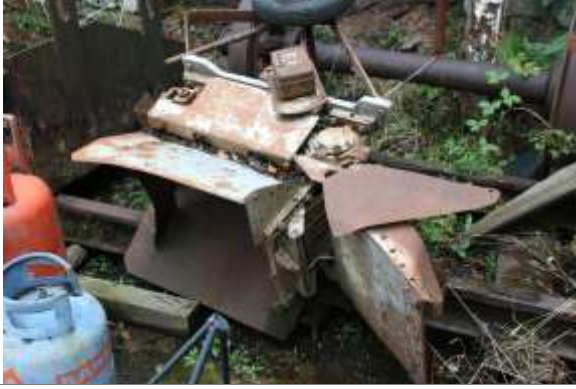
Images

Entry Number				
33				
Asset Name				
Cast Mould Breaker x 2 (Cast House)				
Date Range	Asset Number	Asset Type		
1960s	N/A	Machinery		
NPRN	NGR	Scheduled	Listed	ID
	SJ 29441 53545	<input type="checkbox"/>	<input type="checkbox"/>	
Description				
Cast Mould Breakers, 1960s. Used to break apart casting moulds after cast. Two loose in Cast House. Electric motor driven. Toothed belt over motor driven drums. On wheeled base for moving around work area. Made painted steel sheet.				
History				
Used in the Cast House from 1960s until its closure in 1992.				
Condition				
Good to poor. Deteriorating as a result of exposure to elements.				
Archaeological Potential				
N/A

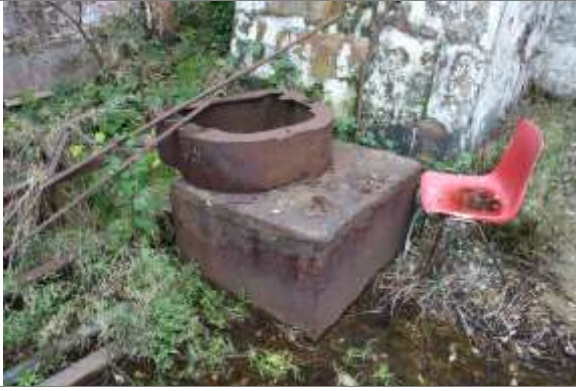
Images

Entry Number				
34				
Asset Name				
Ingot Casting Head (Cast House)				
Date Range	Asset Number	Asset Type		
Mid-Late 20th Century	N/A	Misc.		
NPRN	NGR	Scheduled	Listed	ID
	SJ 29439 53546	<input type="checkbox"/>	<input type="checkbox"/>	
Description				
Cast iron ingot casting head, 20th century. Square top, with ingot mould shaped extrusion to base. Sat on top of casting mould to direct pour from crucible suspended by overhead travelling crane. Ingots used transported via Iron Line (H02) for processing in steel plant.				
History				
Manufactured in the mid-20th century for use in the Foundry (B03) in the production of iron ingots from recycled material.				
Condition				
Poor condition. Rapidly deteriorating, rust and delamination				
Archaeological Potential				
N/A

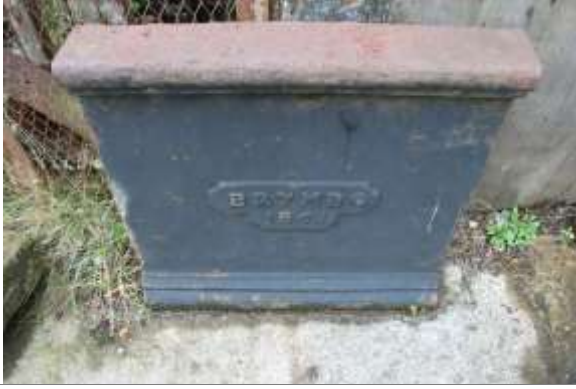
Images

Entry Number				
35				
Asset Name				
Cast Iron Beam with 'Brymbo 1861'				
Date Range	Asset Number	Asset Type		
1861	N/A	Misc.		
NPRN	NGR	Scheduled	Listed	ID
	SJ 29443 53541	<input type="checkbox"/>	<input type="checkbox"/>	
Description				
Cast iron beam with 'Brymbo 1861' in high relief. Painted grey. Decorative moulding to top and bottom edge.				
History				
Presumably cast at Brymbo in 1861.				
Condition				
Good general condition. Pain flaking in placed, rust pitting to the top surface.				
Archaeological Potential				
N/A

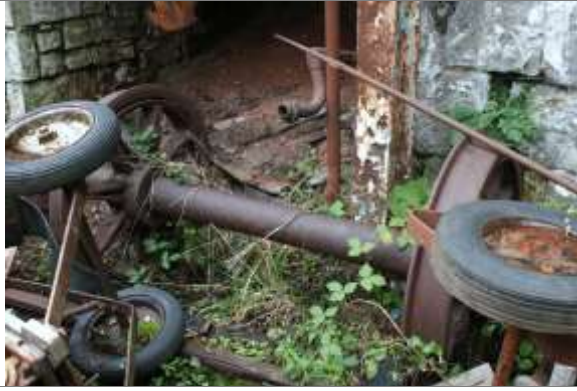
Images

Entry Number				
36				
Asset Name				
Railway Wagon Wheelset				
Date Range	Asset Number	Asset Type		
	N/A	Misc.		
NPRN	NGR	Scheduled	Listed	ID
	SJ 29439 53546	<input type="checkbox"/>	<input type="checkbox"/>	
Description				
Railway Wagon Wheelset (axle and wheels). Unknown association to Brymbo Steelworks. Loose in Cast House.				
History				
N/A				
Condition				
Good. Surface rust and pitting.				
Archaeological Potential				
N/A

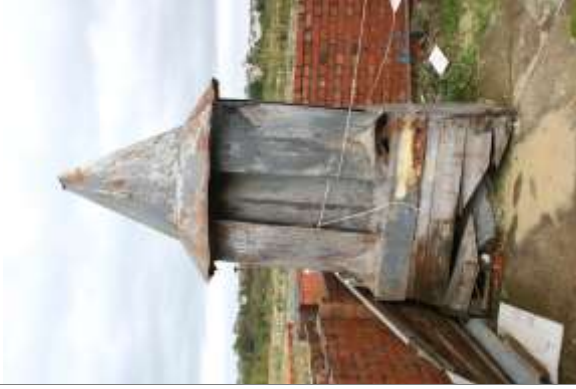
Images

Entry Number				
37				
Asset Name				
Powerhouse Cupolas x 2				
Date Range	Asset Number	Asset Type		
1902	N/A	Misc.		
NPRN	NGR	Scheduled	Listed	ID
	SJ 29496 53540 / SJ 29499 53527	<input type="checkbox"/>	<input type="checkbox"/>	
Description				
Two large cupola vents from the former Powerhouse of 1902. Only surviving of three to the main ridge. Galvanized/tinplate steel construction. Loose/movable. Iconic shape.				
History				
Installed as ventilation to the Powerhouse in 1902 and surviving until its demolition in the 2000s.				
Condition				
Moderate and deteriorating. Damage to edges causing exposure and rust.				
Archaeological Potential				
Low. However, significance is derived from...

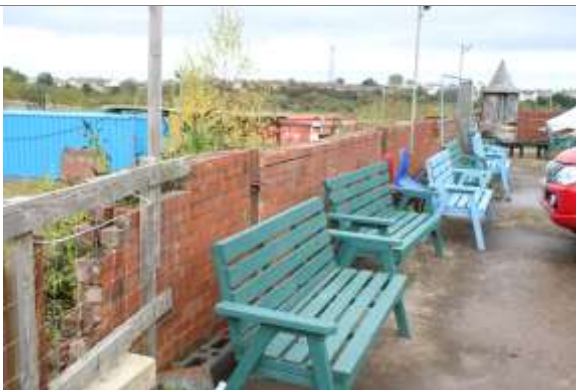
Images

Condition				
<p>Poor. As a result of being a partially dismantled wall, the top courses of brickwork are susceptible to freeze-thaw action due to the stepped nature of some of the brick coursing.</p>				
Archaeological Potential				
<p>The wall has some limited archaeological value, as the survival of the cut I-beams provides some clues for the origins of the wall as a structure.</p>

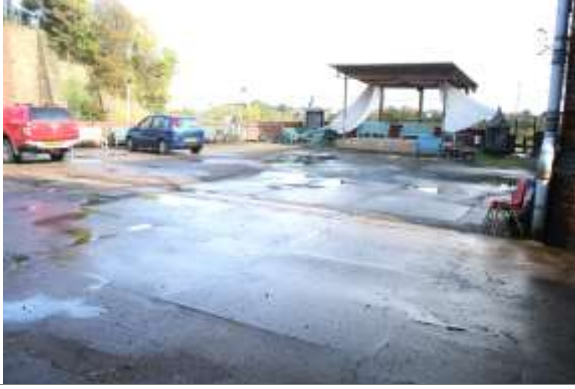
Condition				
N/A				
Archaeological Potential				
<p>There is potential to encounter archaeological remains and deposits within the yard area is high. These are likely to be in the form of foundations and workings associated with the buildings depicted on the 1873 and 1899 Ordnance Survey maps (Denbighshire XXVIII.2). There is also the potential to encounter earlier working floor surfaces to the Smithy. Any groundwork within this area will need or have as a requirement of a condition of Scheduled Monument Consent, an archaeological evaluation in advance of any such work.</p>

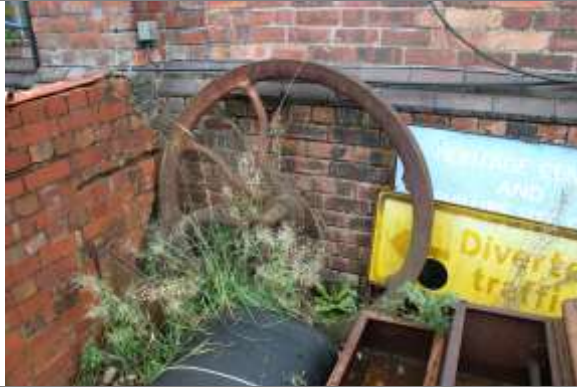
Entry Number				
40				
Asset Name				
Pulley Wheel				
Date Range	Asset Number	Asset Type		
Early 20th Century(?)	N/A	Machinery		
NPRN	NGR	Scheduled	Listed	ID
	SJ 29500 53526	<input type="checkbox"/>	<input type="checkbox"/>	
Description				
Large Pulley Wheel, early-20th century(?). Cast iron. Grooved. Use unknown. Loose to north of Machine Shop (B01).				
History				
N/A				
Condition				
Poor condition. 4 spokes missing. Rust pitted.				
Archaeological Potential				
N/A

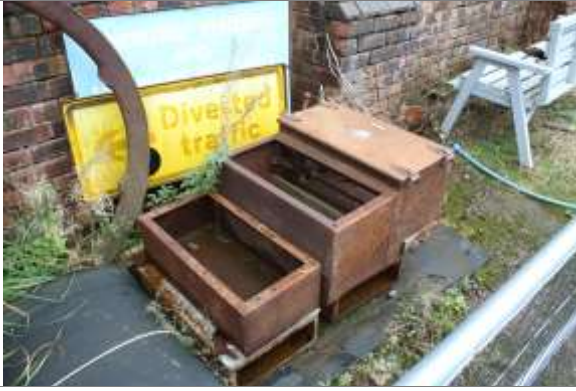
Entry Number				
41				
Asset Name				
Fuse Boxes				
Date Range	Asset Number	Asset Type		
20th Century	N/A	Machinery		
NPRN	NGR	Scheduled	Listed	ID
	SJ 29498 53526	<input type="checkbox"/>	<input type="checkbox"/>	
Description				
Fuse boxes, 20th century. Pressed steel. Rectangular. Various depths. One with door surviving. Loose to north of Machine Shop (B01).				
History				
N/A				
Condition				
Poor. Covered in surface rust and pitting. Rapidly deteriorating.				
Archaeological Potential				
N/A
