Former Brymbo Ironworks, Wrexham County Borough

Archaeological Assessment

Phase 1 - Version 2.0

Project #: AD079

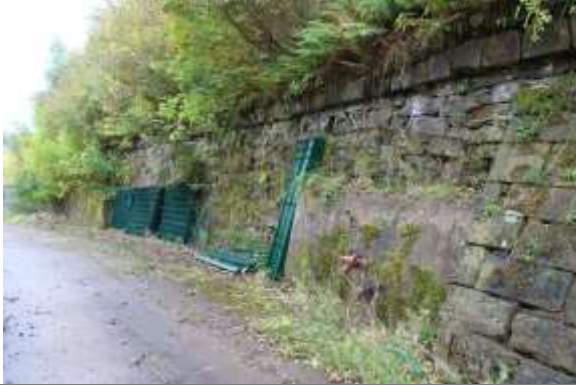
Entry Number				
42				
Asset Name				
Retaining Wall to Site Road				
Date Range	Asset Number	Asset Type		
1792 - 1940	N/A	Wall		
NPRN	NGR	Scheduled	Listed	ID
	SJ 29480 53500	<input type="checkbox"/>	<input type="checkbox"/>	
Description				
<p>Retaining Wall to Site Road rising from front of Machine Shop (B01) towards rear of Foundry (B03); on east-west alignment. South of Scheduled area. Multiple phases of construction from late 1792 to circa 1940. Mix of large, dressed sandstone blocks, red brick and concrete. Stone phase has an projecting coping course to the top. Stone buttresses provide support, with later brick fill between.</p>				
History				
<p>The Brymbo Estate Plan of 1798 shows a road passing to the south of the main workings, to which later penmanship has added a set of steps from and to the front of the Agents House, then labelled Three Cottages. This early road is shown to continue straight on from its current path, without the turn just beyond the Carpenters Workshop, instead continuing to meet Blast Road to the west. The construction of the retaining wall is therefore likley to have been built as part of Wilkinson's levelling of the site as described by James Watt Jr. in 1792-3. The later additions to the plan also show a wagon way; running the same route, from the ironworks to the Mount Pleasant Pits. Although we cannot ascribe an exact date to this, the Estate Sales Inventory tells us that there are 'six Iron Rail Roads' in existence by 1829. By 1873 (Denbighshire XXVIII.2), evidence demonstrates that the progression of the road up to Blast Road has been curtailed at the rear of the Carpenters Workshop, with the link from here up to the Agent's House now formed. To enable this, the ground level around the south and west of the site appears to have been made up sometime in the 19th century. Additions to the wall, in red brick appear to be of circa 1900, with late 20th century additions and repairs in concrete.</p>

Condition				
<p></p>				
Archaeological Potential				
<p>The archaeological potential of the Retaining Wall is high, although excavations and interventions to the wall are unlikely due to the risk of destabilisation of the wall and bank, the relationship of this wall to the early development of the site provides a key historic link to the formation of the ironworks. The historic value of the wall is high, due to its associations with Wilkinson and the early development of the site.</p>

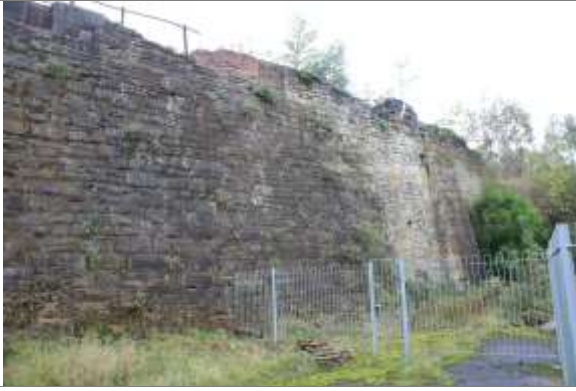
Entry Number				
43				
Asset Name				
Retaining Wall to West of Site				
Date Range	Asset Number	Asset Type		
19th & 20th Century	W13	Wall		
NPRN	NGR	Scheduled	Listed	ID
	SJ 29423 53524	<input checked="" type="checkbox"/>	<input type="checkbox"/>	DE202
Description				
<p>Retaining Wall to west of site, behind Cast House (B04) and Foundry (B03), mid-19th century. Constructed of large, dressed sandstone blocks, bedded in lime mortar. Evidence of former building; purlin and ridge pockets survive. Two main phases to the stone construction, with the northern end of representing the earlier, the southern the later. Final alterations create a concrete and steel face to part of the elevation, used to drop scrap metal down to the charging floor of the cupolas, with parapet wall to the top of the wall.</p>				
History				
<p>First present on the Ordnance Survey 25 inch map of 1873 (Denbighshire XXVIII.2). The Sales Catalogue estate plan of 1829 shows a change in the road leading from the east, by this time being shown to turn south to the rear of the lower part of the site. This tentatively suggests that some alterations have been undertaken and may relate to the construction of the Retaining Wall as seen today. However, this is conjecture. Another possible date for construction would relate the retaining wall to the building of the Machine Shop (B02) (Patternmakers and Carpenters Workshop) in 1843, under the stewardship of the Darby brothers. Sometime in the late 19th century, the ground was built up to the south-west of the site, obscuring the lower sections of the wall. The 1899 map (Denbighshire XXVIII.2) demonstrated the existence of a building connecting the wall to the Foundry, which had not existed in 1873 (Denbighshire XXVIII.2). By 1963, this building has been demolished, but leaving purlin and ridge pockets visible in the wall today. In circa 1960, shuttered concrete and steel rails were applied to the southern end of the wall to allow for scrap metal to be dropped to the charging floor of the cupola furnaced below.</p>

Condition				
<p>Overall the wall is in good condition. However, the top sections of masonry and concrete have become susceptible to freeze-thaw actions and oxide jacking/rust burst to the I-beam rails.</p>				
Archaeological Potential				
<p>The archaeological potential of the Retaining Wall is moderate, as whilst excavations and interventions to the wall are unlikely due to the risk of destabilisation of the wall and bank, the wall provides developmental evidence of the banking and building up of land to this area of the ironworks. Any excavations immediately to the east of the wall would demonstrate the depth of and nature of the material used to build up this area of the site.</p>

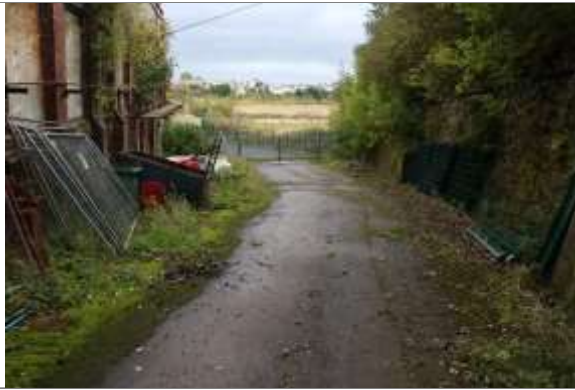
Condition				
N/A				
Archaeological Potential				
<p>The roadway through the site has a high potential for the encountering of deposits relating to the sites development, particularly in relation to the historic landform. Importantly, the deposition of materials to create and raise the road, have the portential to have burried other natural and man-made features, which could provide information on land usage and occupation before the ironworks. Further to this, the works early wagon and later railway both ran over the upper sections of this area (B).</p> <p>Importantly, the developments and changes to this road come as a result of the deposition of waste materials associated with the iron and coal works. The Cast House (B04), Foundry (B03) and Pattermakers and Carpenters Workshop (B02) buildings all display evidence of this build up of ground levels, blocked arches, doors and windows now sitting below ground level. This deposition of materials suggests that the rear of the site has been significantly built up, likley filling a small vale.</p> <p>Due to the nature of the development of the site road and its potential to cover historically significant remains, all works to</p>

this should be archaeologically supervised, with an archaeological evaluation undertaken prior to any major schemes, such as resurfacing.

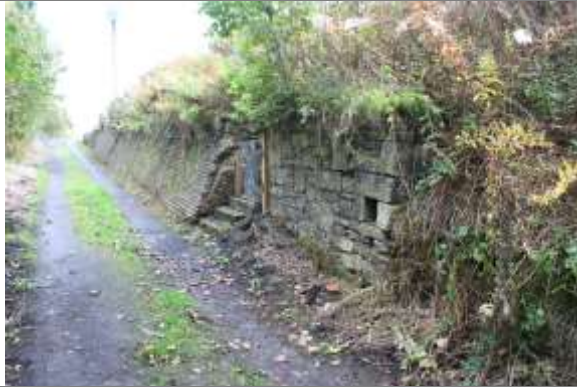
Condition				
<p>Good overall condition. Spalling brick masonry, though not structurally serious.</p>				
Archaeological Potential				
<p>The archaeological potential of the Retaining Wall is moderate. Although excavations and interventions to the wall are unlikely due to the risk of destabilisation of the wall and bank, the potential for materials and deposits behind the wall may provide evidence for the material build-up and deposition of materials on the site during the course of the 19th century.</p>

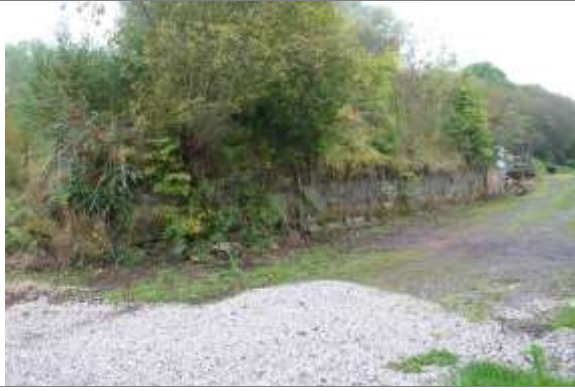
Entry Number				
47				
Asset Name				
Retaining Wall to East of Agent's House				
Date Range	Asset Number	Asset Type		
19th Century	W20	Wall		
NPRN	NGR	Scheduled	Listed	ID
	SJ 29496 53479	<input type="checkbox"/>	<input type="checkbox"/>	
Description				
Retaining Wall to Site Road to east of Agent's House (B07), on east-west alignment. South of Scheduled area. Single phases of construction from late 1792 to circa 1940. Large, dressed sandstone blocks.				
History				
The history of the retaining wall is difficult to fully assess and its construction could be associated with several different periods. However, its construction is may be associated with the construction of the site wagonway sometime in the first half of the 19th century.				
Condition				
Good overall condition. Some mortar wash.				
Archaeological Potential				
The archaeological potential of the Retaining Wall is moderate. Although excavations and interventions to the wall are unlikely due to the risk of destabilisation of the wall and bank, the potential for materials and deposits behind the wall may provide evidence for the material build-up and deposition of materials on the site during the course of the 19th century.

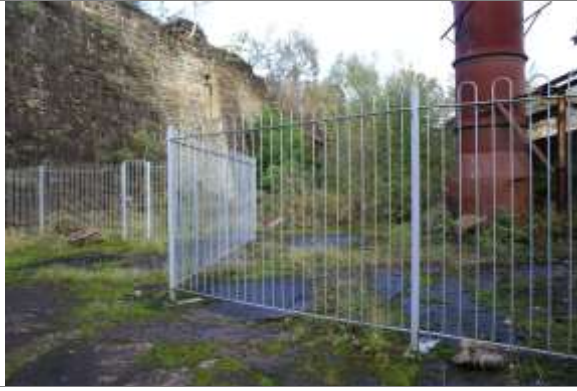
Entry Number				
49				
Asset Name				
Charging Floor				
Date Range	Asset Number	Asset Type		
1970s	N/A	Misc.		
NPRN	NGR	Scheduled	Listed	ID
	SJ 29439 53510	<input type="checkbox"/>	<input type="checkbox"/>	
Description				
Charging Floor to cupola furnaces (S32;S38 / S33;S37), poured in 1970s. Supports cupola furnace superstructure. Reinforced concrete. Used to charge cupolas with material; scrap, limestone and coke. Area retained by Foundry wall to the east.				
History				
In the 1970s, the original cupola furnaces were dismantled and replaced by two Brymbo designed cupolas. As part of this upgrade, a number of alterations and upgrades were made to the surrounding infrastructure, including the pouring of a new charging floor.				
Condition				
Good overall condition, with some spalling caused by freeze-thaw.				
Archaeological Potential				
The archaeological potential of the charging floor is low as the greater part of this area to the east is suspended over the base of the cupolas beneath. The area to the west has a moderate potential for materials and deposits relating to the building up of the land surface to the west of the Foundry. As such, any planned works within this area should be subject to archaeological monitoring and investigation.

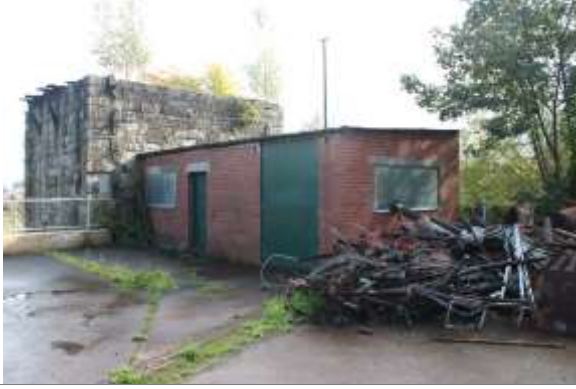
History				
<p>Mapping evidence shows the building was constructed sometime between 1967 (Denbighshire XXVIII.2) and 1984 (Denbighshire XXVIII.2). Likely associated with upgrade works to No. 5 Blast Furnace in the 1970s.</p>				
Condition				
<p>Good condition with little deterioration.</p>				
Archaeological Potential				
<p>Whilst the building is unlikely to be altered or demolished, the potential for archaeological deposits and remains is high. As a result of being built over Wilkinson's original Charging House, the building potentially protects valuable information and materials relating to the development of a late 18th century industrial building. Any development to the building that requires ground disturbance will require an archaeological evaluation prior to development to assess the extent of any deposits and remains.</p>
