Land Adjacent to Trem Y Bannau Llangorse Brecon Powys LD3 7UB 17/15038/FUL

Archaeological Field Evaluation

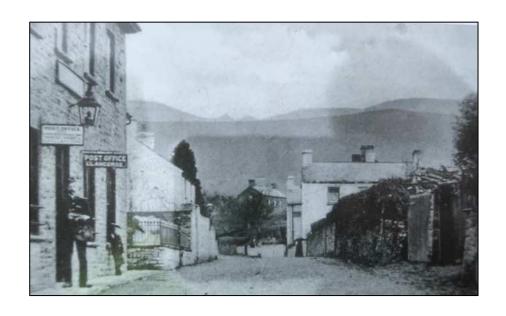
Front cover: Postcard (1890s) showing main road to Bwlch through Llangorse with the old Post Office to the left and the development area to right.

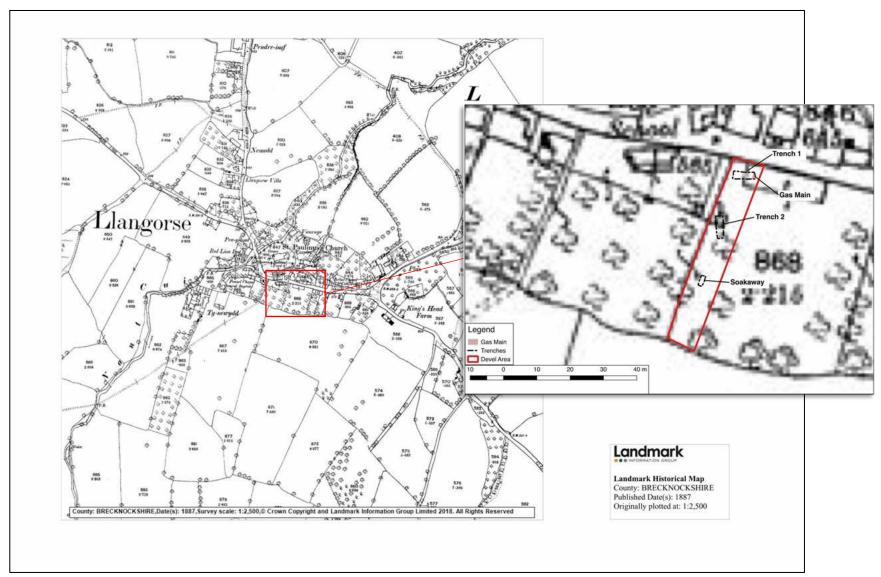
Figure 2. First Edition Ordnance Survey Map 1887. Insert shows overlaid trench location plan.

- 3.1.4 Level of present ground surface: West 173.047mOD, East 173.067mOD.
- 3.1.5 Trench 1 was positioned over buildings shown on historic mapping (OS 1st 1887; Figure 2) depicting a terrace of houses along the road frontage. The trench measured 7m in length by 2m in width; the average depth excavated to 0.8m. A gas main was noted at the eastern end of the trench with the consequence of the shortening of the excavated area by 1m.

- 3.1.9 Level of present ground surface: North 173.609mOD, South 174.009mOD.
- 3.1.10 Trench 2 was positioned over several small buildings shown on historic mapping (OS 1^{st} Ed 1887; Figure 2 and OS Ed 2^{nd} 1904; Figure 3) in the centre of the development area and within the footprint of the proposed new building. The trench measured 7m in length by 2m in width and had an average excavated depth of 0.9m.

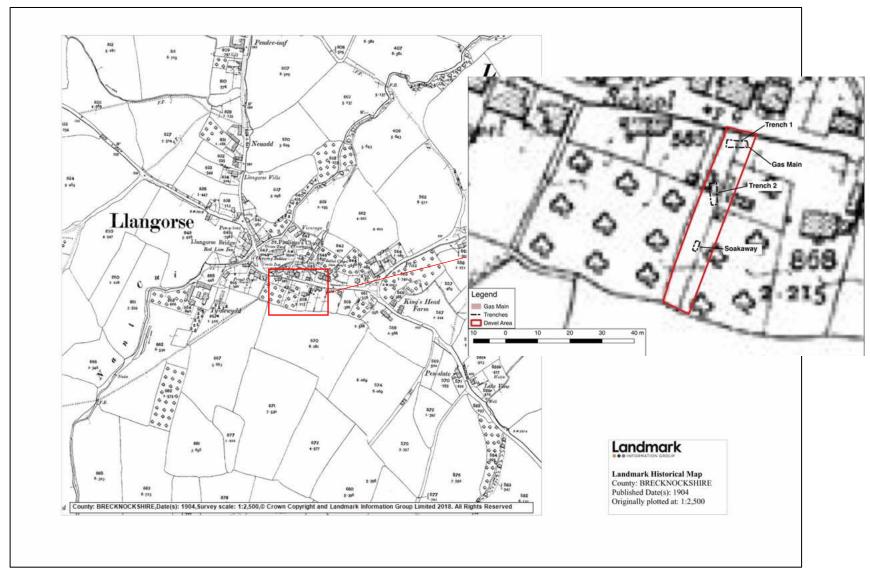
Figure 3. Second Edition Ordnance Survey Map 1904. Insert shows overlaid trench location plan. Ordnance Survey maps are reproduced under licence 100058761

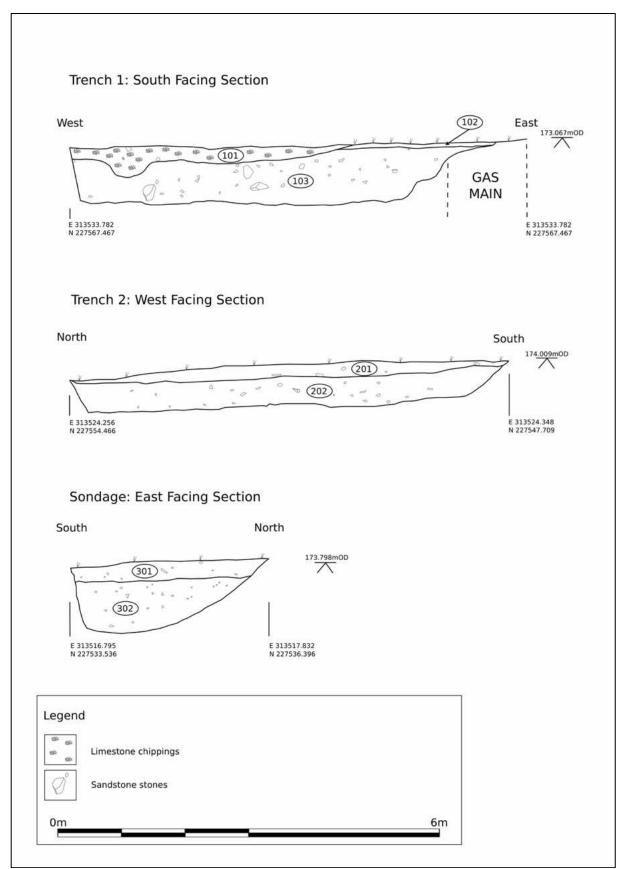
Figure 4. Section drawings of Trenches 1 and 2, and the Sondage.

- 3.1.6 The general stratigraphy followed natural clay silts (103), with frequent sandstone inclusions, overlain by a limestone chippings deposit (101) c0.2m thick extending for 4.5m from the western end of the trench. The remaining 1.5m length of trench consisted of a thin layer of dark-brown silt-loam topsoil and grass (102), which is at odds with the much deeper topsoil deposits found in both Trench 2 and the Soakaway trench (201 and 301). The lack of topsoil here is likely to indicate some past ground remediation of higher deposits.

- 3.1.11 The general stratigraphy identified was natural clay silts (202), with frequent sandstone inclusions, overlain by a fairly thick friable dark-brown clay silt loam garden topsoil deposit (201). The depth and uniformity of the deposit suggests that this has been under cultivation (garden) for many years.

- 3.1.16 The general stratigraphy mirrored Trench 2. The basal deposit identified as natural clay silts (302), with frequent sandstone inclusions, overlain by a fairly thick friable dark-brown clay silt loam garden topsoil deposit (301).
- 3.1.17 No archaeological deposits or features was present in the trench. Topsoil 301 contained fecks of degraded bone and moderate clinker/coke. The depth and uniformity of the deposit (301) suggests that this has been under cultivation (garden) for many years.

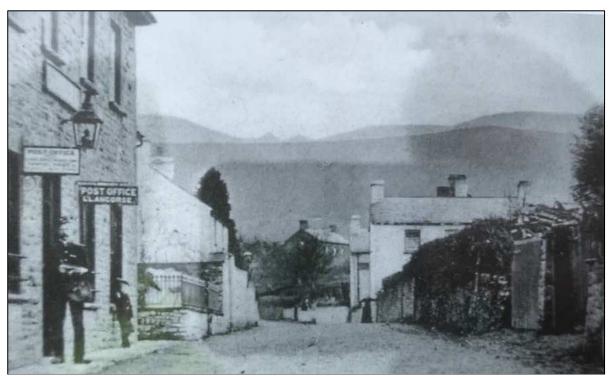
Plate 1. Postcard (1890s) showing main road to Bwlch through Llangorse with the old Post Office to the left and the development area to right.

- The archaeological field evaluation did not identify any features or deposits of archaeological origin in any of the three trenches. There was no sign at all in Trench 1 of the buildings shown on historic mapping (OS 1st 1887; Figure 2) depicting a terrace of houses along the road frontage. Plate 1 shows an old postcard (1890s) of the main road through Llangorse, with the old Post Office to the left and the area of the terrace housing to the right. It is difficult to see clearly but some roof timbers are just discernible behind the wall and hedge line on the road frontage possibly showing the terrace set back from the road and in a very dilapidated state prior to demolition. The buildings are not shown on later historic mapping (OS Ed 2nd 1904). Plate 2 shows the opposite view perhaps around the same time. The walls on the road frontage are just discernible as is the gateway to the west of the terrace. The lack of any topsoil or stratified structures or deposits relating to the buildings and structures shown in Plate 1 and 2 would suggest that this area has been subjected to significant ground remediation in the past. The presence of limestone chippings and modern glass and plastic fragments may indicate this lowering of the ground level happened more recently than the OS mapping suggests (1904).

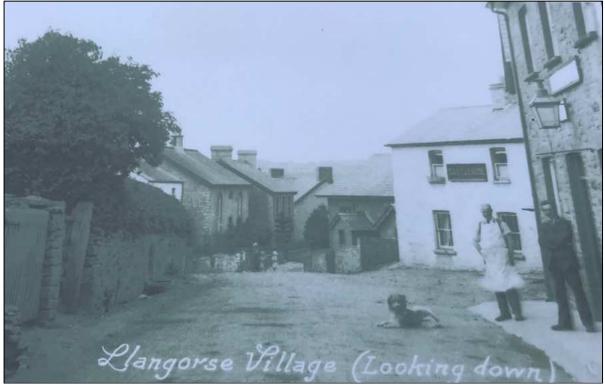
Plate 2. Postcard (undated c1900) showing main road to Brecon through Llangorse with the old Post Office to the right and the development area just visible to left.

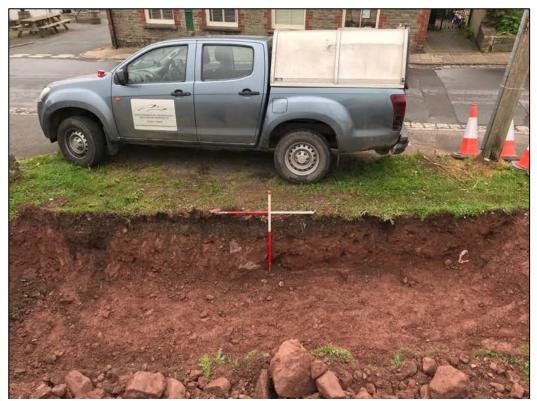
Plate 3. Trench 1, view N. Scale 1m in 0.5m sections.

- 3.1.7 No archaeological deposits or features was present in the trench. Deposits 101 and 102 contained modern glass, plastic and stone chippings.
- 3.1.8 **Trench 2** (Figures 1-4; Plates 5-6)

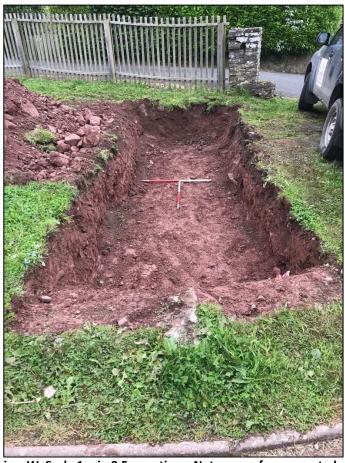
Plate 4. Trench 1, view W. Scale 1m in 0.5m sections. Note area of unexcavated gas main bottom of photograph.

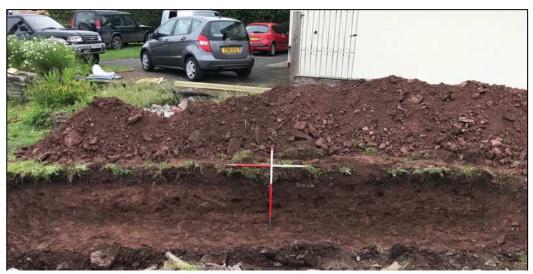
Plate 5. Trench 2, view to NE. Scale 1m in 0.5m sections

- 3.1.12 No archaeological deposits or features was present in the trench. Topsoil 201 contained two sherds of 19th century ceramics (white earthenware transfer printed ware) and three fragments of bone.
