Refurbishment of the Powerhouse, Hafod-Morfa Copperworks

Site Investigation (SI) Works Archaeological Watching Brief Report

**Prepared for
City and County of Swansea**

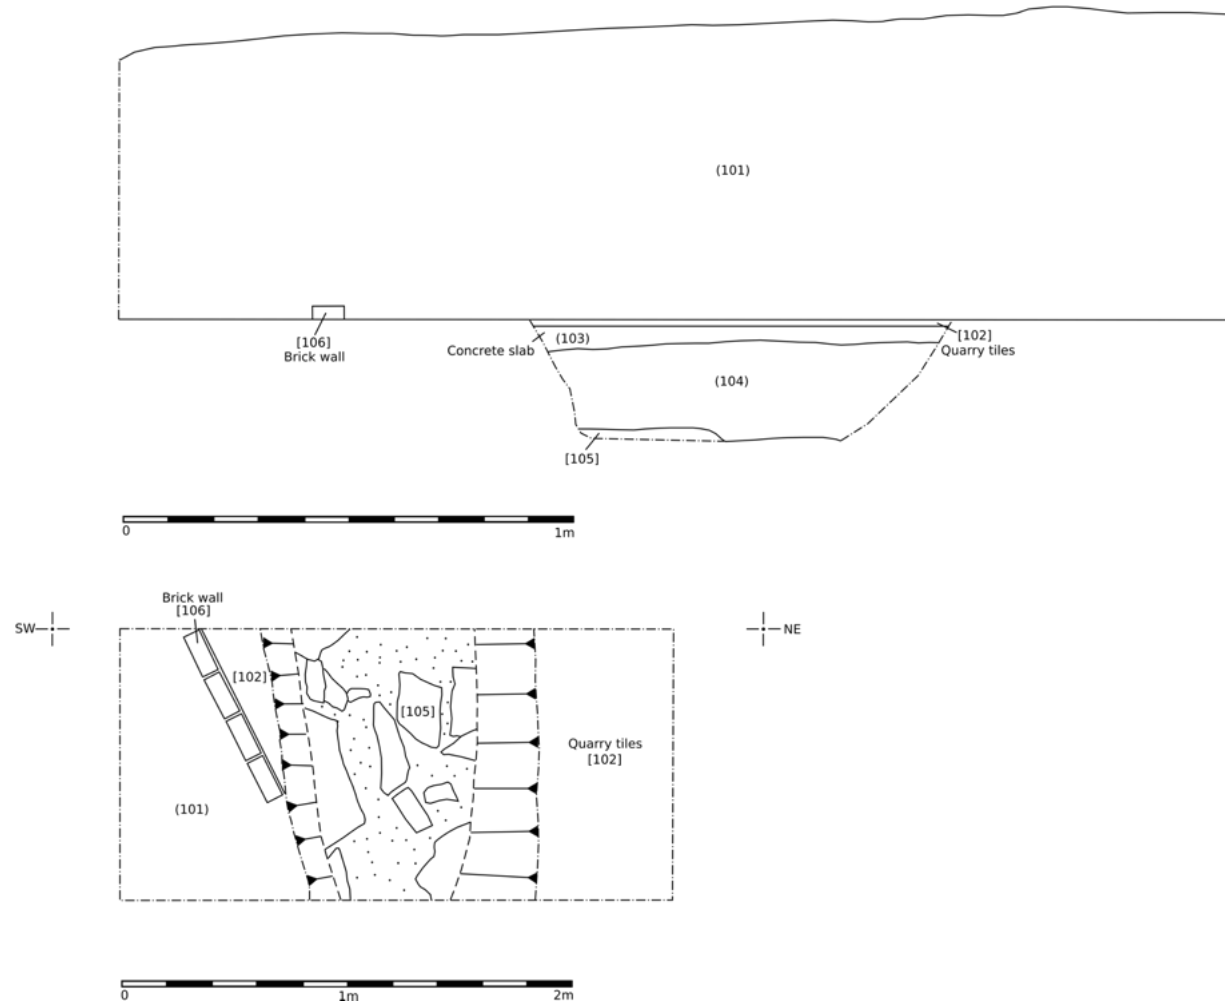
Figure 4. Plan and section of Test Pit 1

- 3.1.6 The test pit measured 2.47m x 1.2m with a depth of 0.9m and was aligned SW/NE. The surface deposit was a dark grey brown demolition rubble (101) with a depth of 0.6m. It was a very loose and friable silty loam containing fragments of brick, tile, slate and other general demolition material and industrial waste.

- 3.1.8 A section of the quarry tile floor was removed to reveal a 18-20cm layer of dark grey-black, coal dust-rich, loose silty loam (104) with very few inclusions apart from very occasional CBM flecks and fragments <5cm.

- 3.1.9 At the base of this deposit, at a depth of 0.9m, a substantial masonry structure [105] was uncovered extending across the whole test pit. Constructed of limestone rubble blocks of c. 10-25cm bonded in a white lime mortar with charcoal flecks that is mostly very compact with some soft and yellowed areas where water damage has occurred. The nature and size of this feature suggests a significant structure, probably related to the earlier building recorded on the First Edition Ordnance Survey map. The excavation was ceased pending full archaeological investigation and recording.

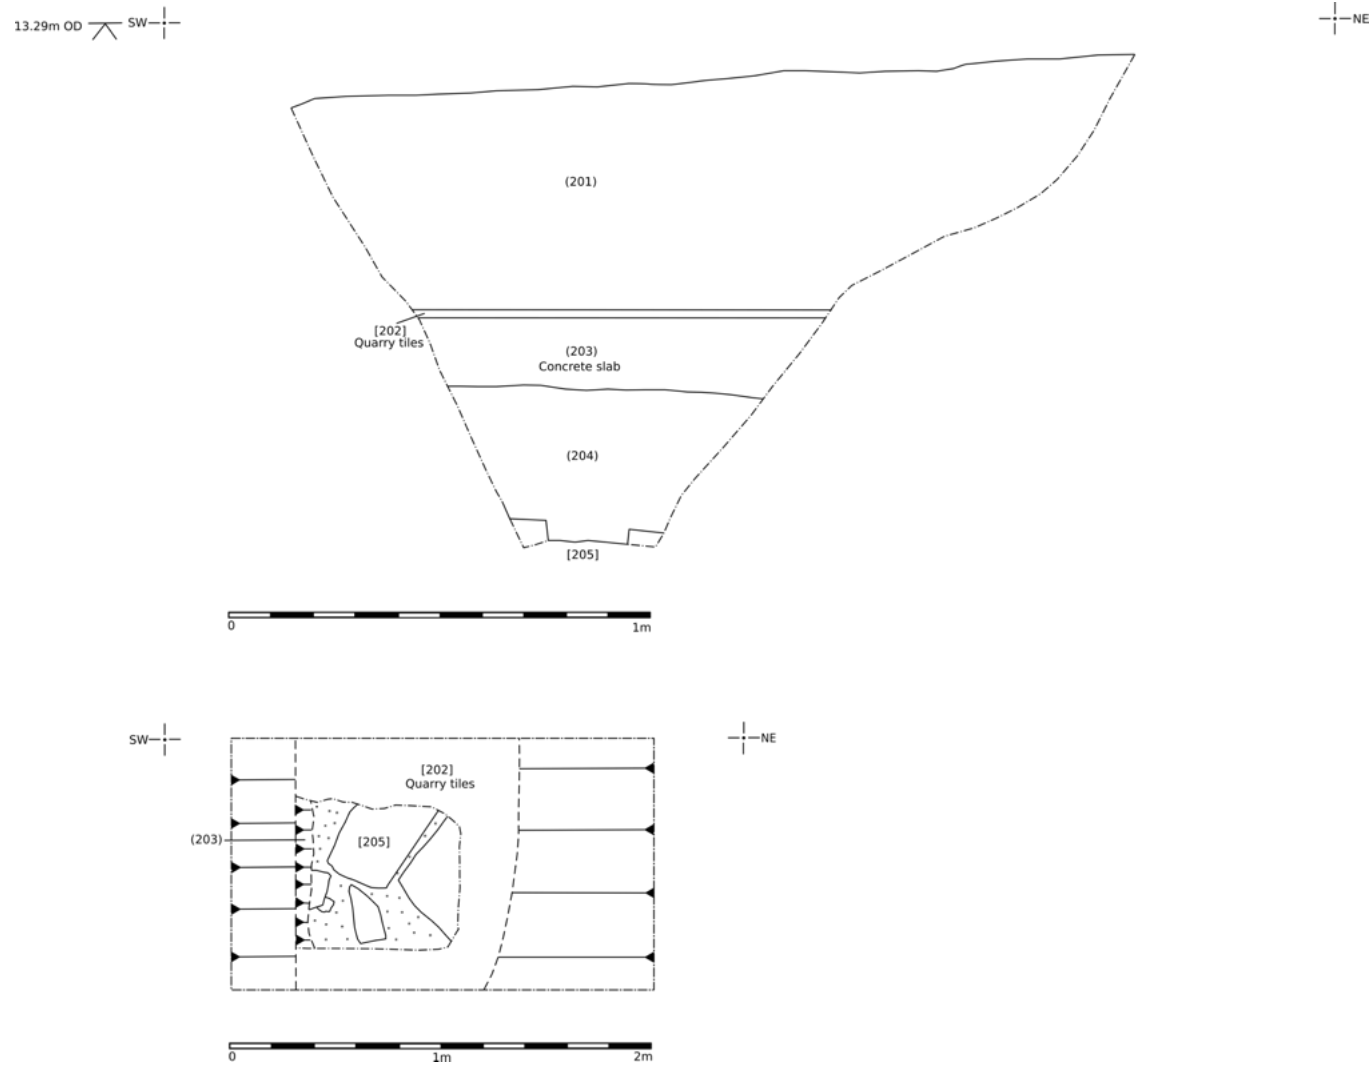
Figure 5. Plan and section of Test Pit 2

- 3.1.13 The test pit measured 2m x 1.2m with a depth of 1.2m and was aligned NE/SW. Demolition rubble (201) had a depth of 60cm. It was a dark grey brown very loose and friable silty loam containing fragments of brick, tile, slate and other general demolition material and industrial waste. This was removed to reveal a quarry tiled floor surface consisting of 15x15x2cm machine-made red quarry tiles [202] bedded on a 17-20cm thick concrete slab [203], a continuation of the floor surface [102]/[103] uncovered in TP1.

- 3.1.14 A section of the quarry tile floor was removed to reveal a 30-38cm layer of dark grey-black, coal dust-rich, loose silty loam (204) with very few inclusions apart from very occasional CBM flecks and fragments <5cm.

- 3.1.15 Beneath this deposit, at a depth of 1.1m, a substantial masonry structure [205] was uncovered extending across the whole test pit. Constructed of limestone rubble blocks of c. 10-25cm bonded in a white lime mortar with charcoal flecks that is mostly very compact with some soft and yellowed areas where water damage has occurred. A continuation of masonry structure [105] discovered in TP1. The excavation was ceased pending full archaeological investigation and recording.

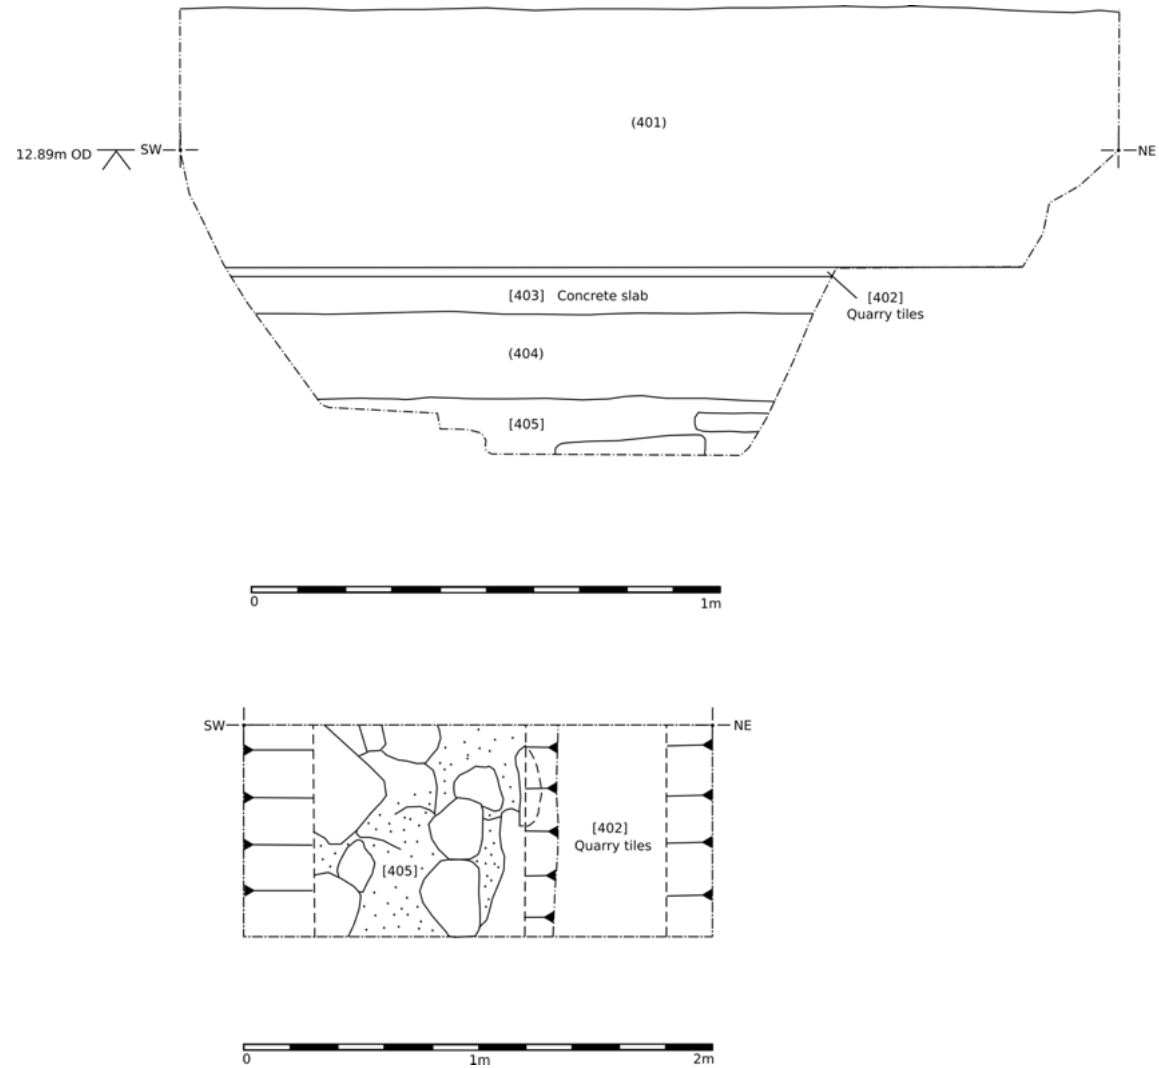
Figure 6. Plan and section of Test Pit 4

- 3.1.19 The test pit measured 2m x 0.9m with a depth of 0.95m and was aligned NE/SW. Demolition rubble (401) had a depth of 55cm. It was a dark grey brown very loose and friable silty loam containing fragments of brick, tile, slate and other general demolition material and industrial waste. This was removed to reveal a quarry tiled floor surface consisting of 15x15x2cm machine-made red quarry tiles [402] bedded on a 8cm thick concrete slab [403], a continuation of floor surface [102]/[103] uncovered in TP1 and [202]/[203] uncovered in TP2.

- 3.1.20 A section of the quarry tile floor was removed to reveal a 18cm layer of dark grey-black, coal dust-rich, loose silty loam (404) with very few inclusions apart from very occasional CBM flecks and fragments <5cm.

- 3.1.21 Beneath this deposit, at a depth of 83cm, a substantial masonry structure [405] was uncovered extending across the whole test pit. Constructed of limestone rubble blocks of c. 10-25cm bonded in a white lime mortar with charcoal flecks that is mostly very compact with some soft and yellowed areas where water damage has occurred. A continuation of masonry structures [105] discovered in TP1 and [205] discovered in TP2. The excavation was ceased pending full archaeological investigation and recording.

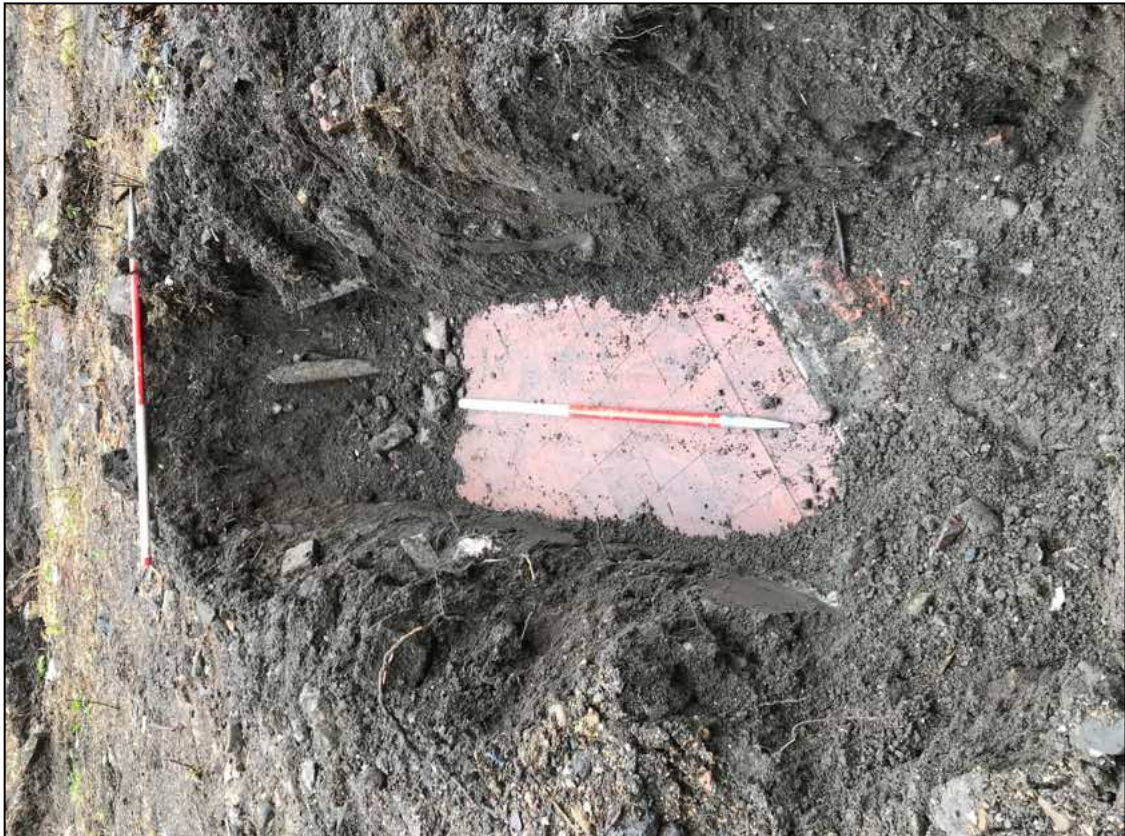
Plate 1. Pre-excitation view, facing north, of Test Pit 1 showing quarry tile floor [102].

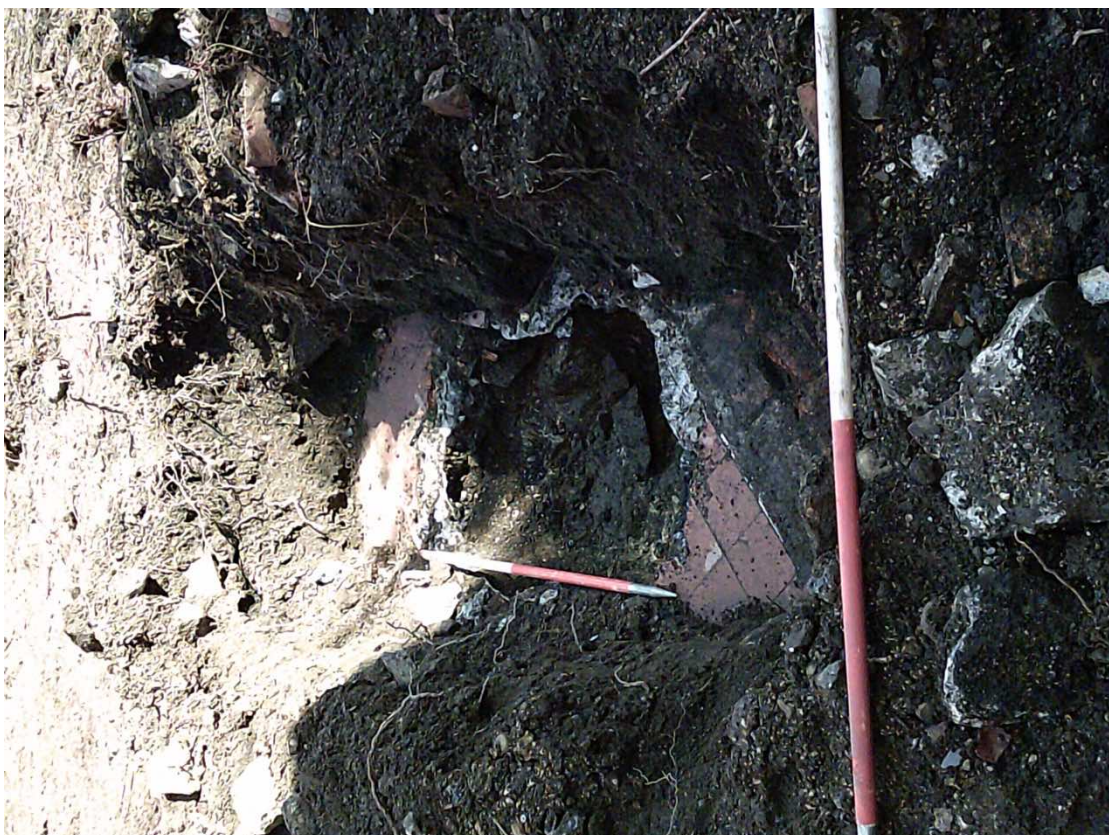
Plate 2. Post-excitation view, facing north, of Test Pit 1 showing quarry tile floor [102] and masonry structure [105].

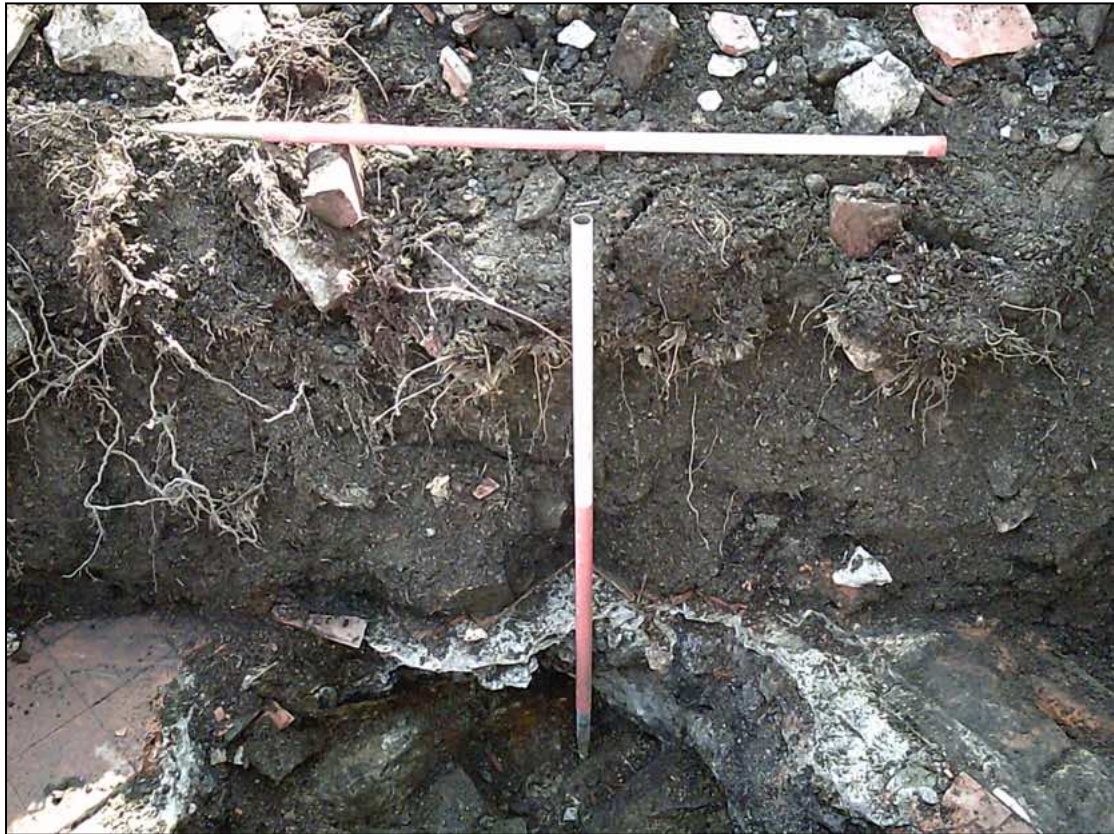
Plate 3. West facing section of Test Pit 1 showing quarry tile floor [102] and masonry structure [105].

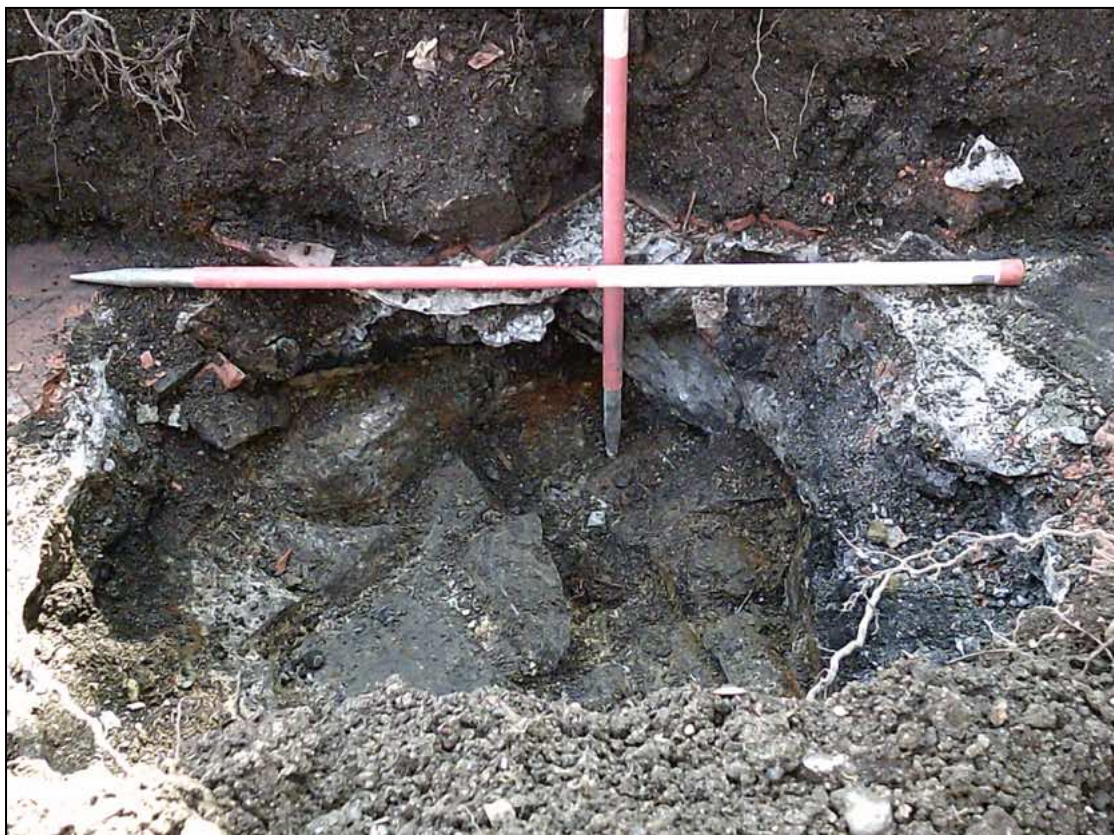
Plate 4. West facing section of Test Pit 1 showing quarry tile floor [102] and masonry structure [105].

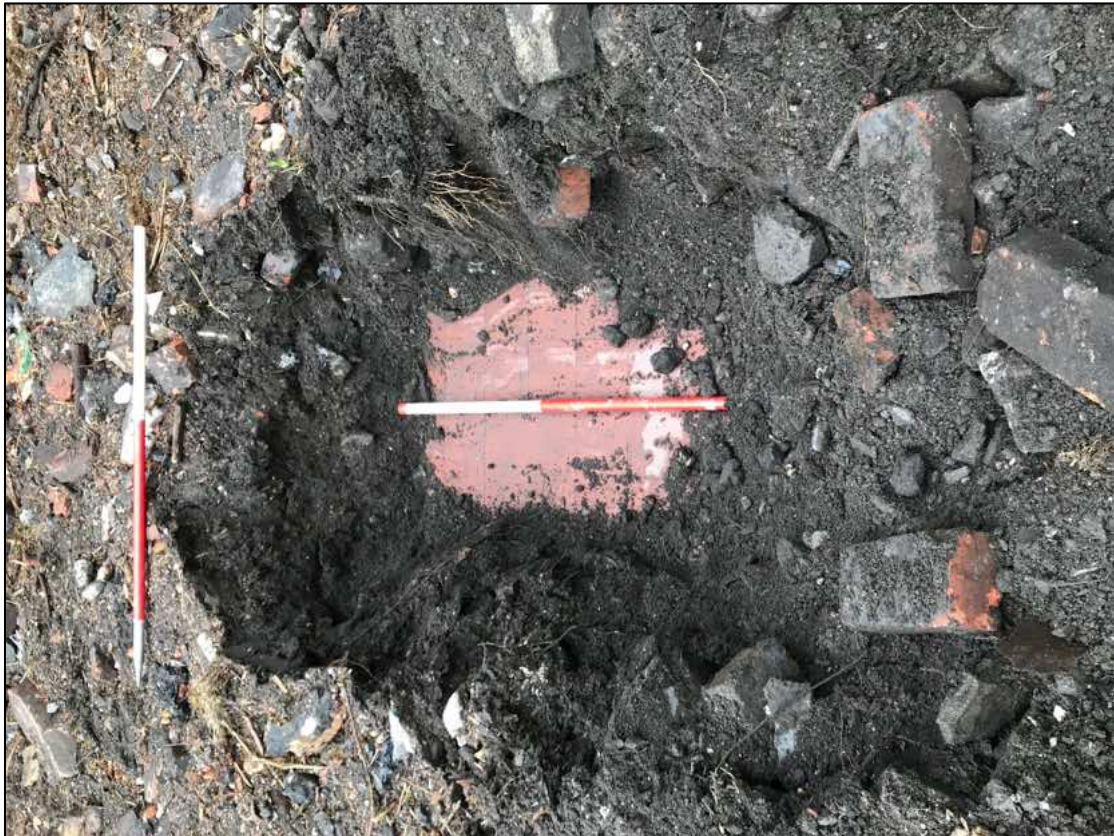
Plate 5. Pre-excitation view, facing west, of Test Pit 2 showing quarry tile floor [202].

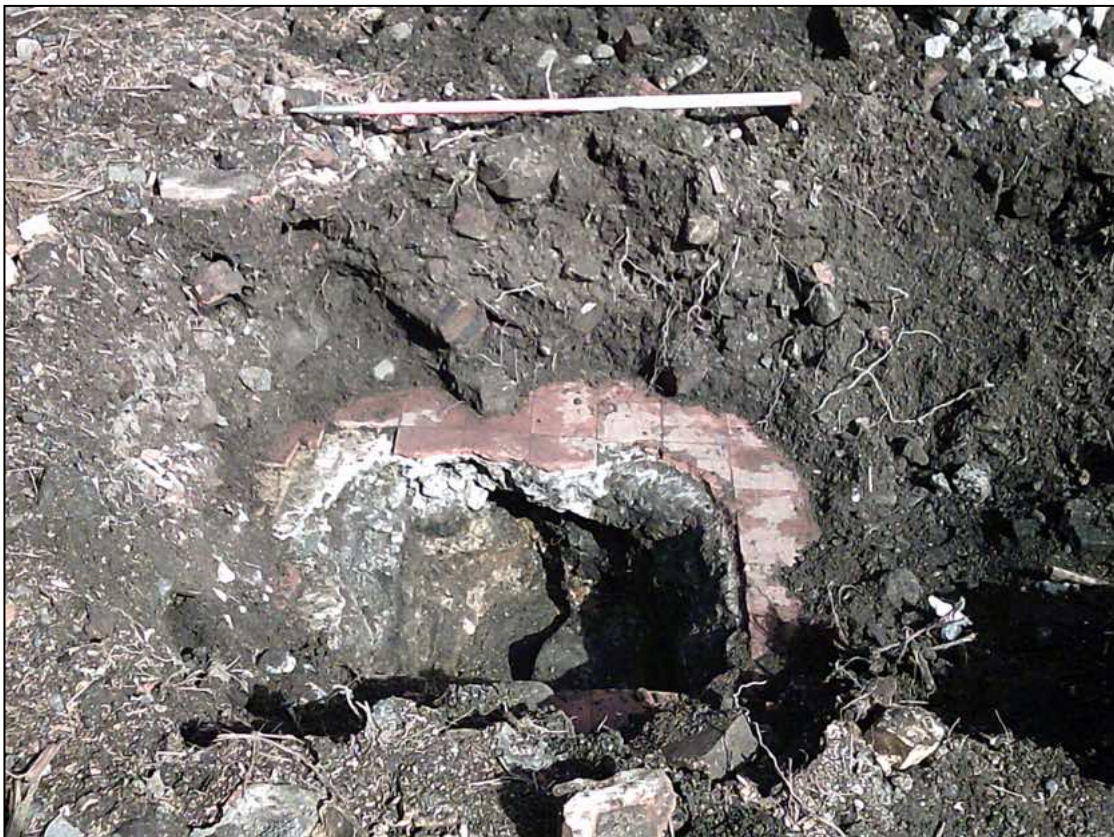
Plate 6. South facing section of Test Pit 2 showing quarry tile floor [202] and masonry structure [205].

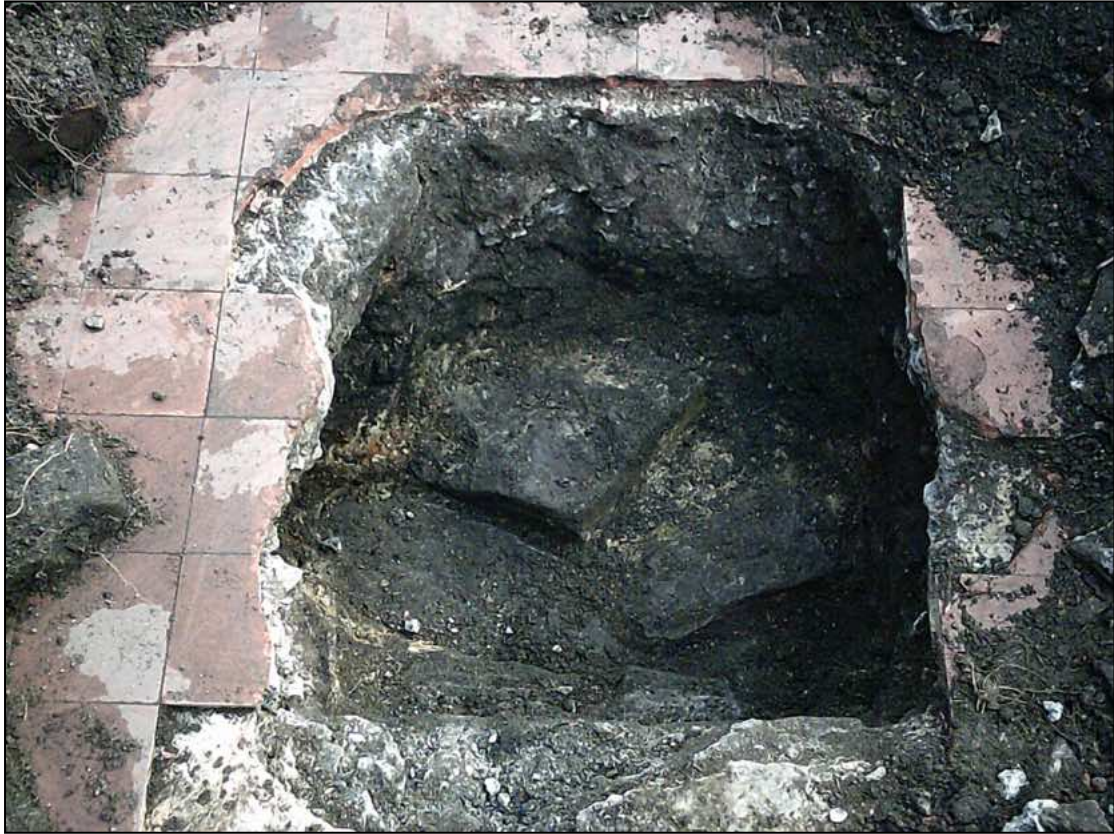
Plate 7. West facing section of Test Pit 2 showing detail of masonry structure [205].

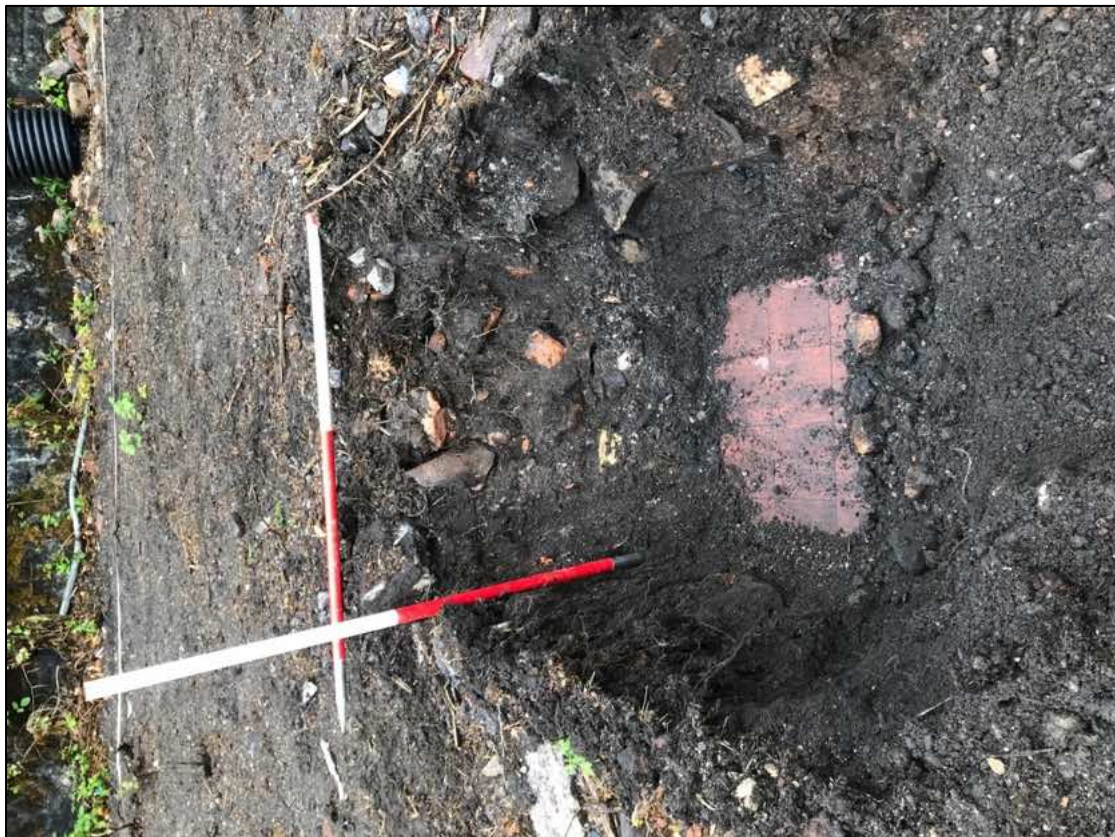
Plate 8. General view, facing west, of Test Pit 4 showing quarry tile floor [402].

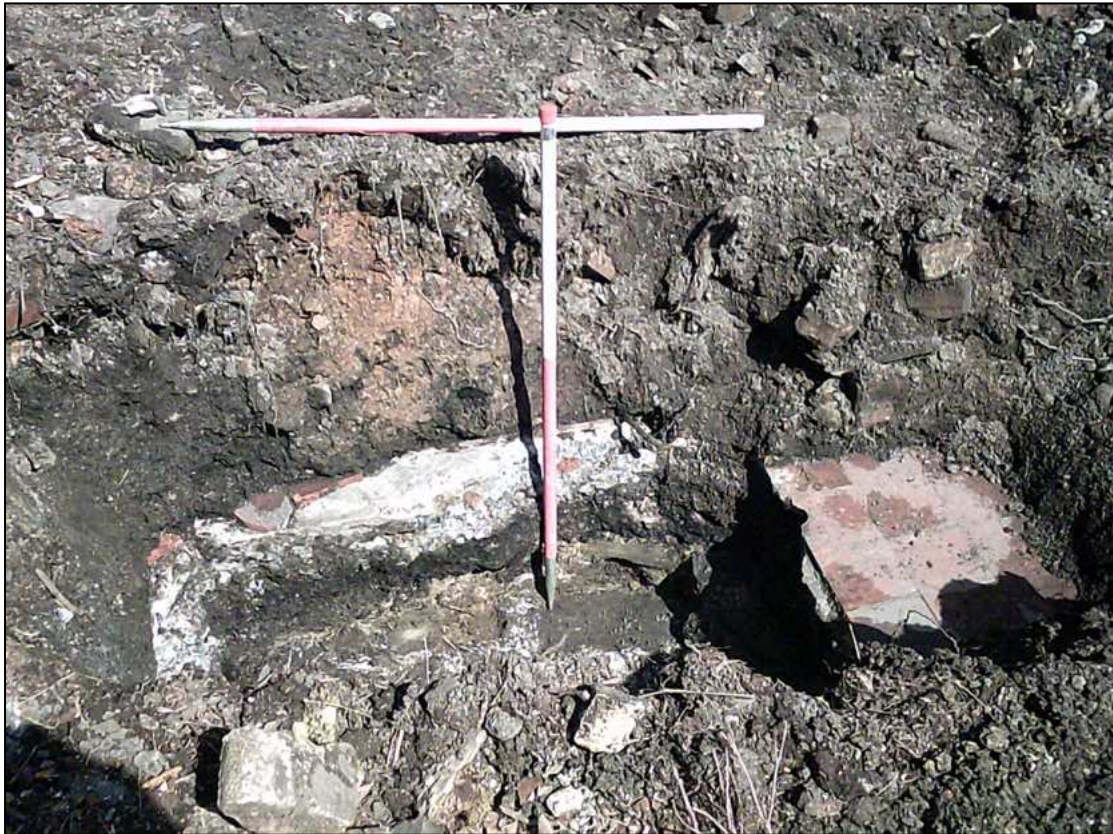
Plate 9. South facing section of Test Pit 4 showing quarry tile floor [402] and masonry structure [405].

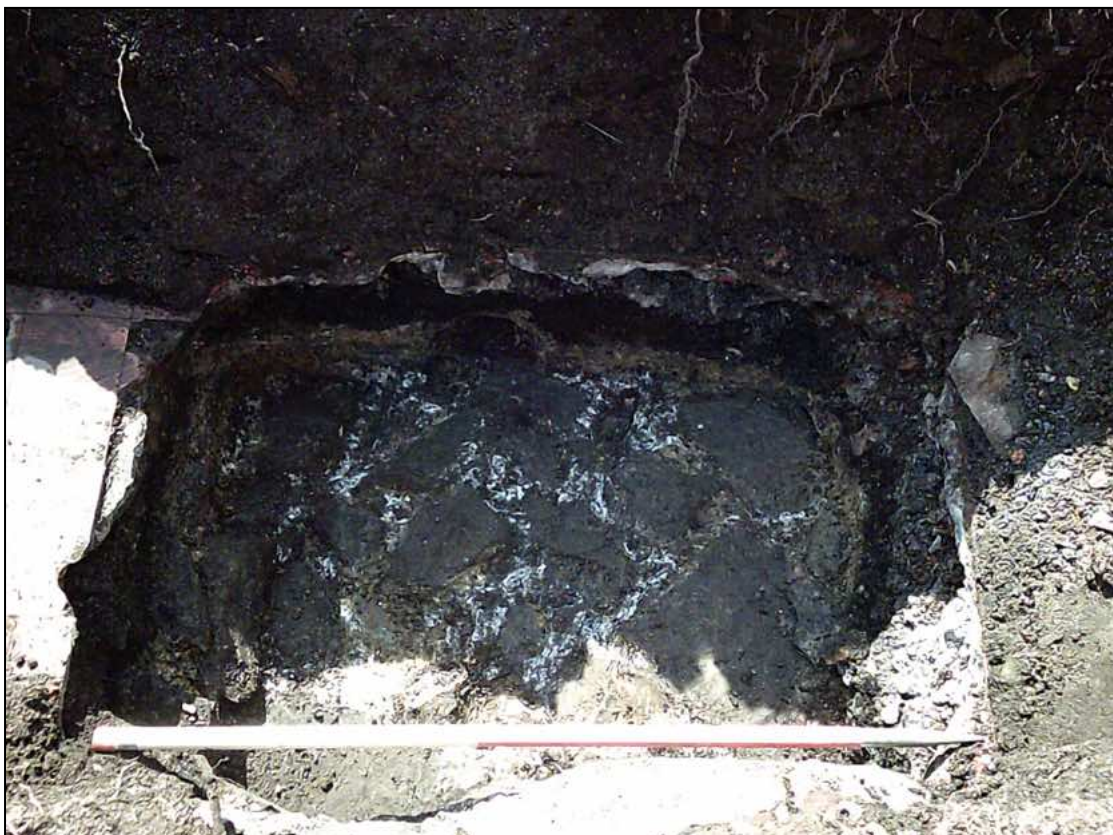
Plate 10. Plan view, facing south, showing detail of Test Pit 4 masonry structure [405].

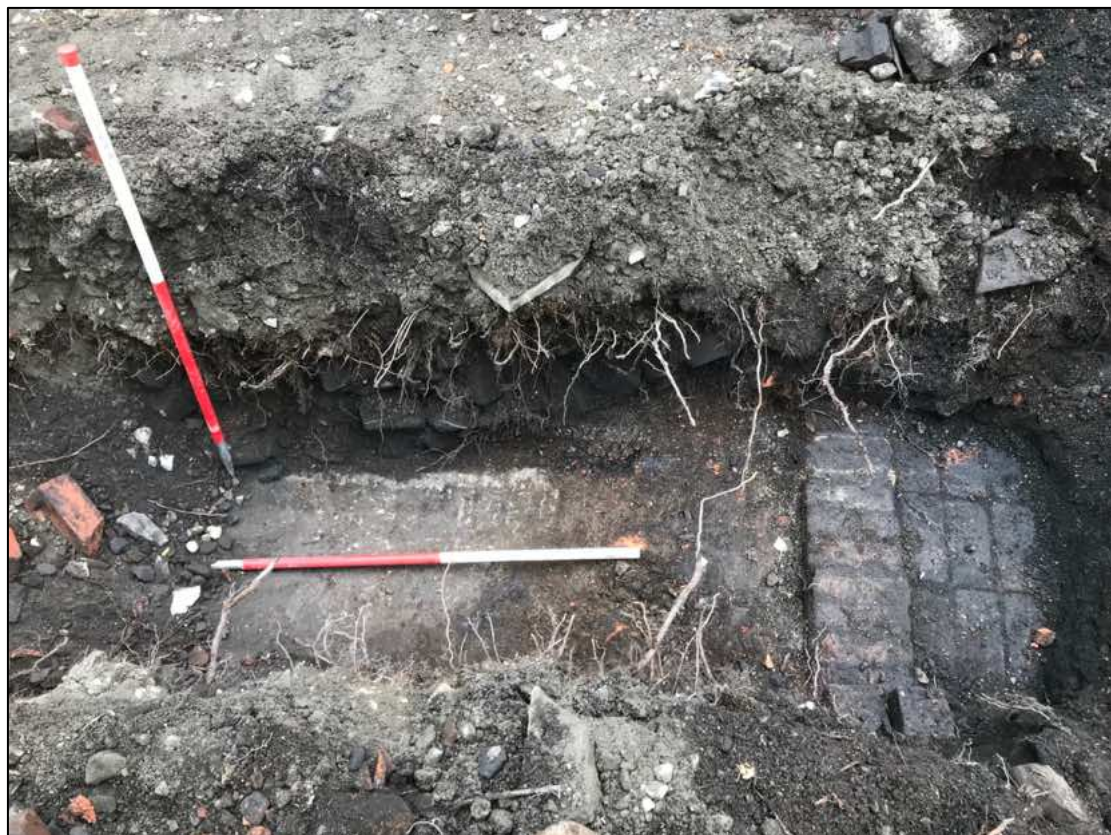
- 4.1.3 In Test pit 11 the N/S aligned wall [1106] and brick-lined floor [1108] in particular have survived in relatively good condition. Their function is not currently understood but they may relate to the extended 'Cast House' marked on historic mapping (Figure 2). Certainly, the lower metal surface (1104) uncovered to the east of wall [1106] falls within the footprint of the extended 'Cast House' building and may relate to its floor surface or foundations.

Plate 12. Plan view, facing south, of Test Pit 11 showing N/S brick wall [1106], brick floor [1108] and concrete slab [1102] prior to excavation.

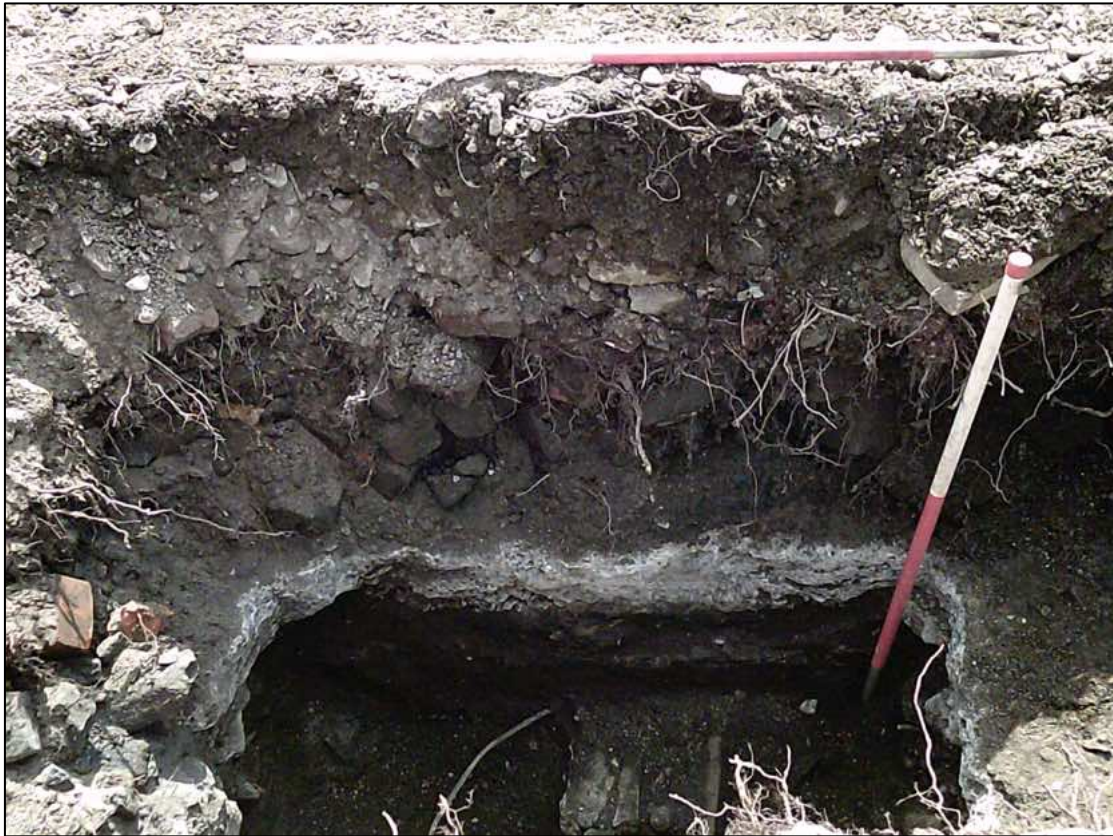
- 3.1.27 On the east side of NW/SE wall [1106] was a concrete slab [1102] with a depth of 17-20cm. A section of this slab was removed to reveal a 30-33cm deep deposit of dark-grey black, coal dust-rich loose silty loam (1103) that contained very few inclusions apart from occasional CBM and some cast copper waste.

Plate 13. North facing section of Test Pit 11 showing concrete slab (1102) and underlying slag-rich deposit (1104).

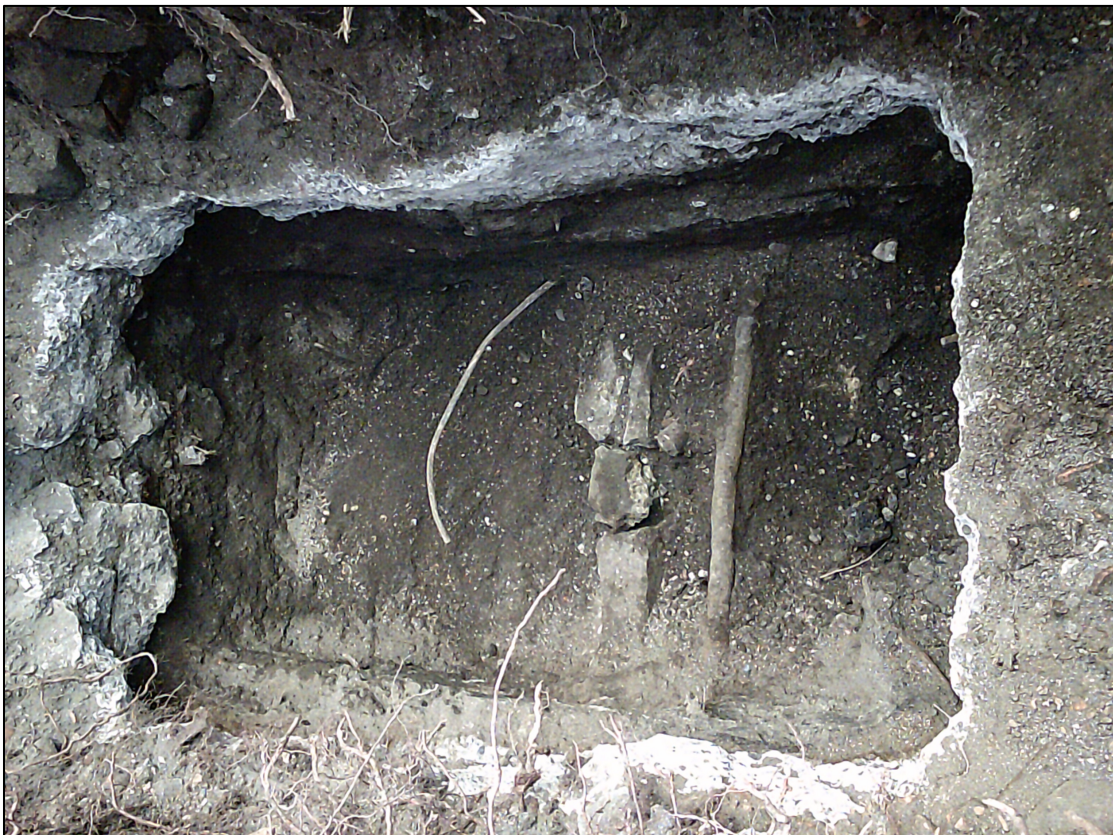
Plate 14. Plan view, facing east, showing *in-situ* lead service pipe, N/S aligned kerb and adjacent slag-rich deposit (1104).

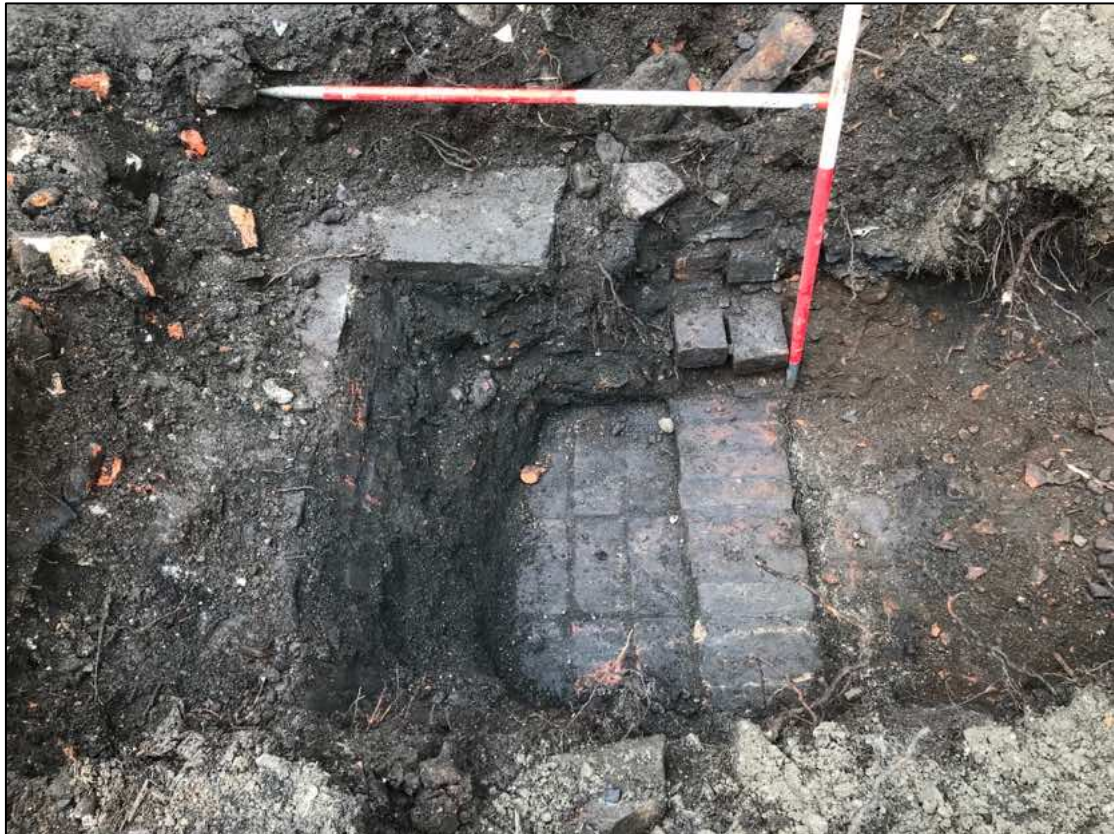
Plate 15. South facing section of Test Pit 11 showing N/S brick wall [1106] and brick floor [1108].

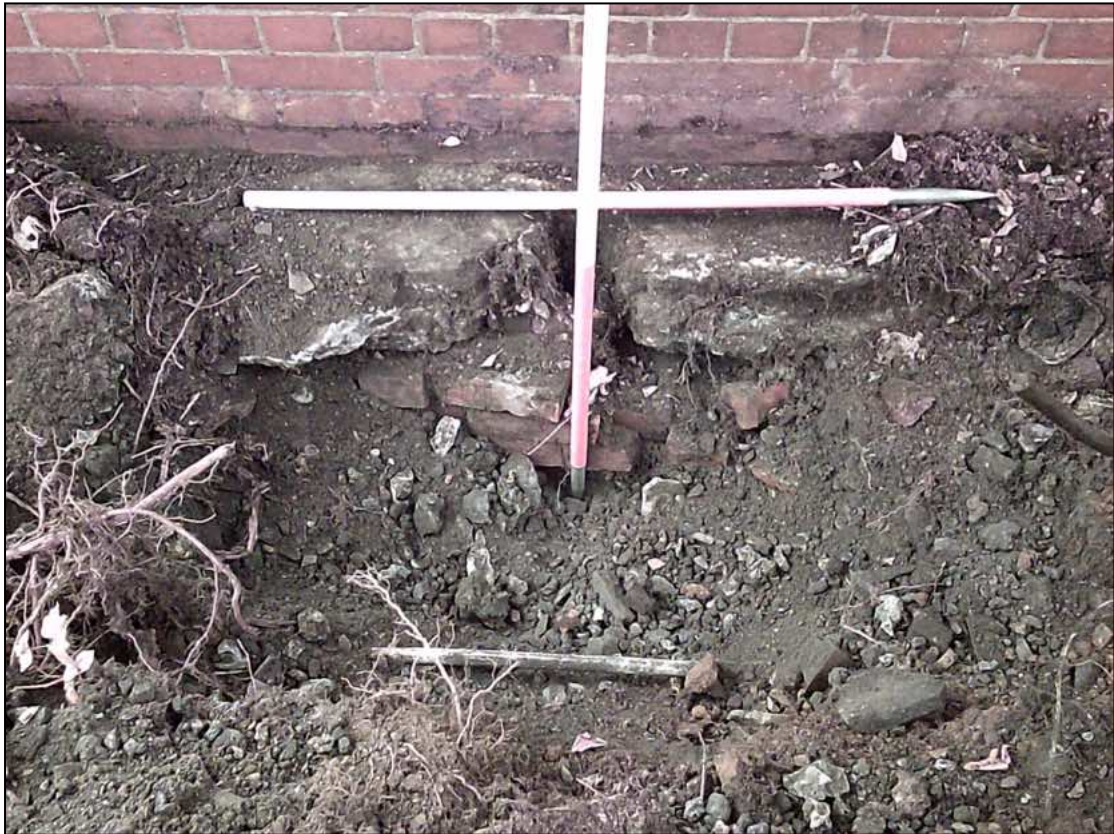
- 3.1.32 The test pit measured 1.5m x 1m with a depth of c. 0.6m and was aligned NE/SW. The test pit revealed demolition rubble (1201), a loose dark grey brown silty loam containing fragments of brick and other waste material. Within (1201) contained an *in-situ* lead pipe servicing the weighbridge office building. Along the base of the weighbridge office wall was concrete slab (1202) with a thickness of c.20cm. Beneath this a brick foundation was uncovered with a depth of c.25cm consisting of three courses of red brick with no mortar. On reaching the lead pipe, excavation was ceased.

Plate 17. North facing section of Test Pit 12 showing foundation pier [1203] and concrete foundation slab [1202]. The *in-situ* lead pipe can be seen in the foreground.

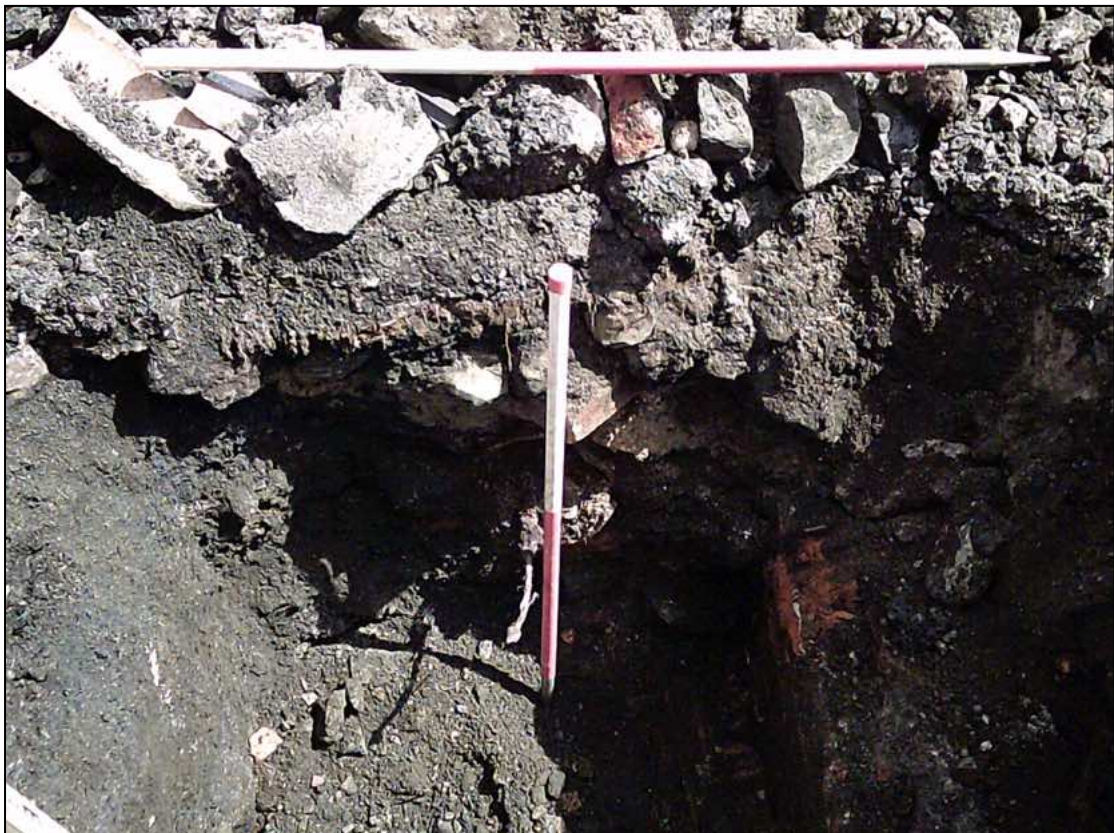
- 4.1.5 The large gauge ceramic pipe (1303) uncovered in Test Pit 13 is recorded on the 1951 ICI plan (Plate 31) where it can be seen to carry water from the canal to the Cast House and the wider Morfa site. The section cut through the pipe trench [1304] has demonstrated that the pipe post-dates the weighbridge and is therefore inserted after the 1930s. The metal pipe found in test pit 15 is of unknown date.

Plate 18. West facing section of Test Pit 13 showing E/W pipe trench [1304]/(1303) and the north wall of the weighbridge [1305] to the right of the picture. The vertical scale is standing on E/W masonry wall [1306].

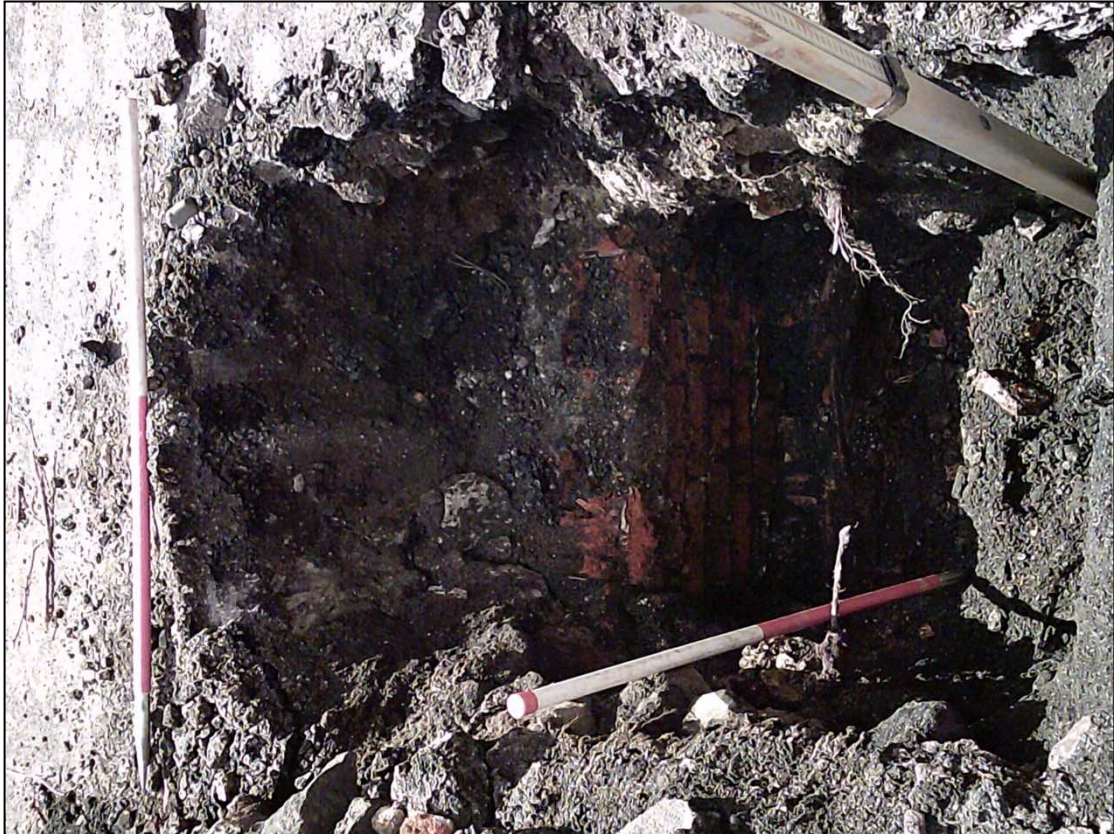
Plate 19. North facing section of Test Pit 13 showing the north wall of the weighbridge [1305]. The vertical scale is standing on E/W masonry wall [1306].

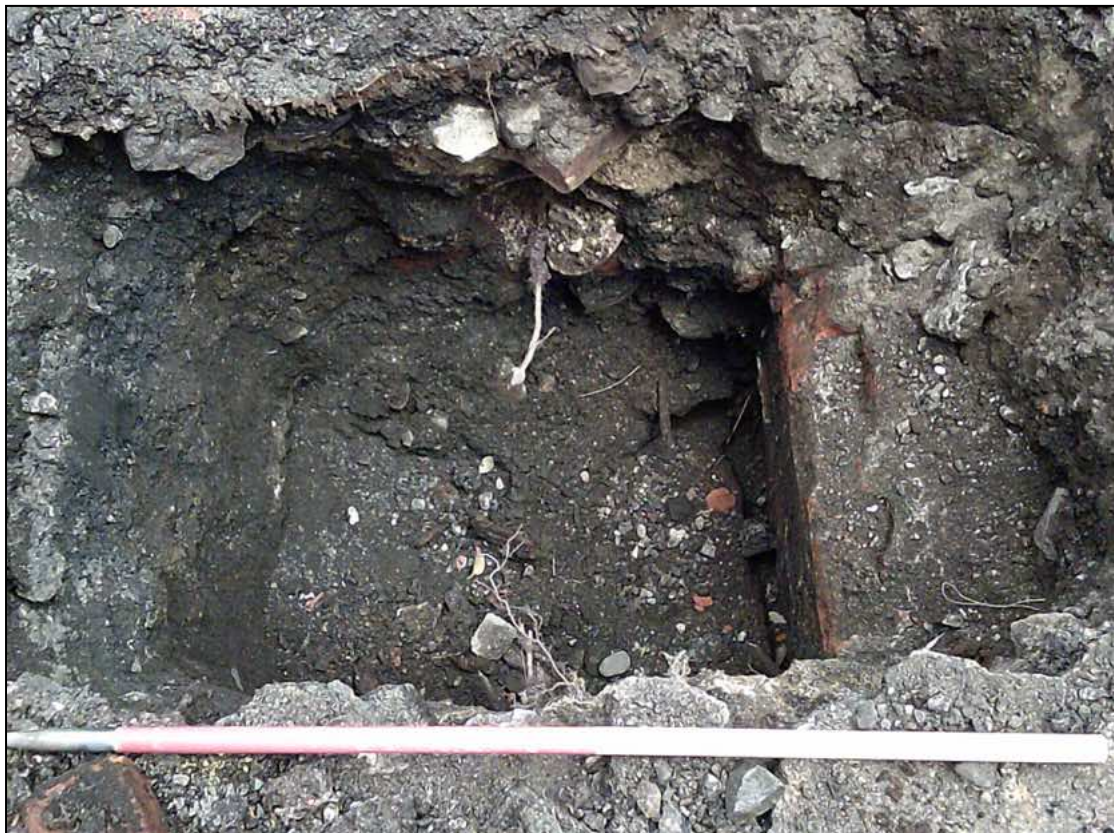
Plate 20. Plan view, facing east, showing the north wall of the weighbridge [1305] and E/W masonry wall [1306] immediately to its left in the picture in Test Pit 13.
