Refurbishment of the Powerhouse, Hafod-Morfa Copperworks

Site Investigation (SI) Works Archaeological Watching Brief Report

**Prepared for
City and County of Swansea**

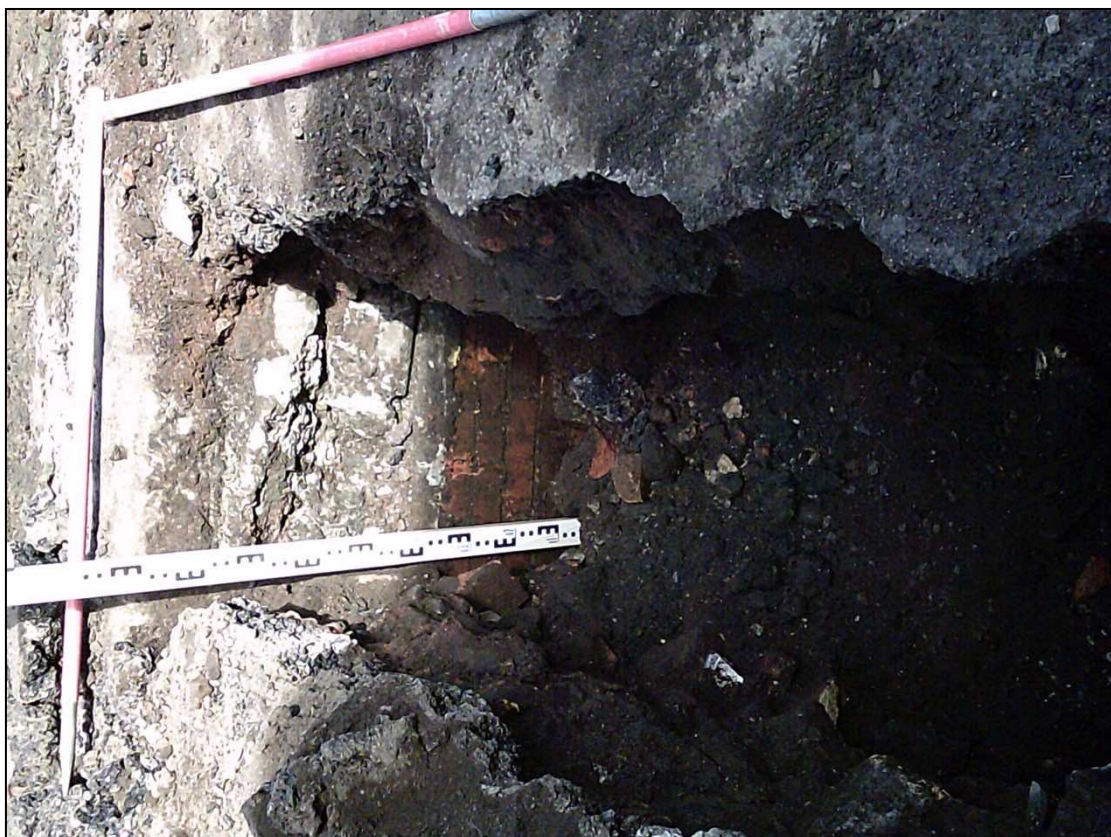
Plate 22. West facing section of Test Pit 14 showing the east wall of the weighbridge [1406] and concrete kerb [1405].

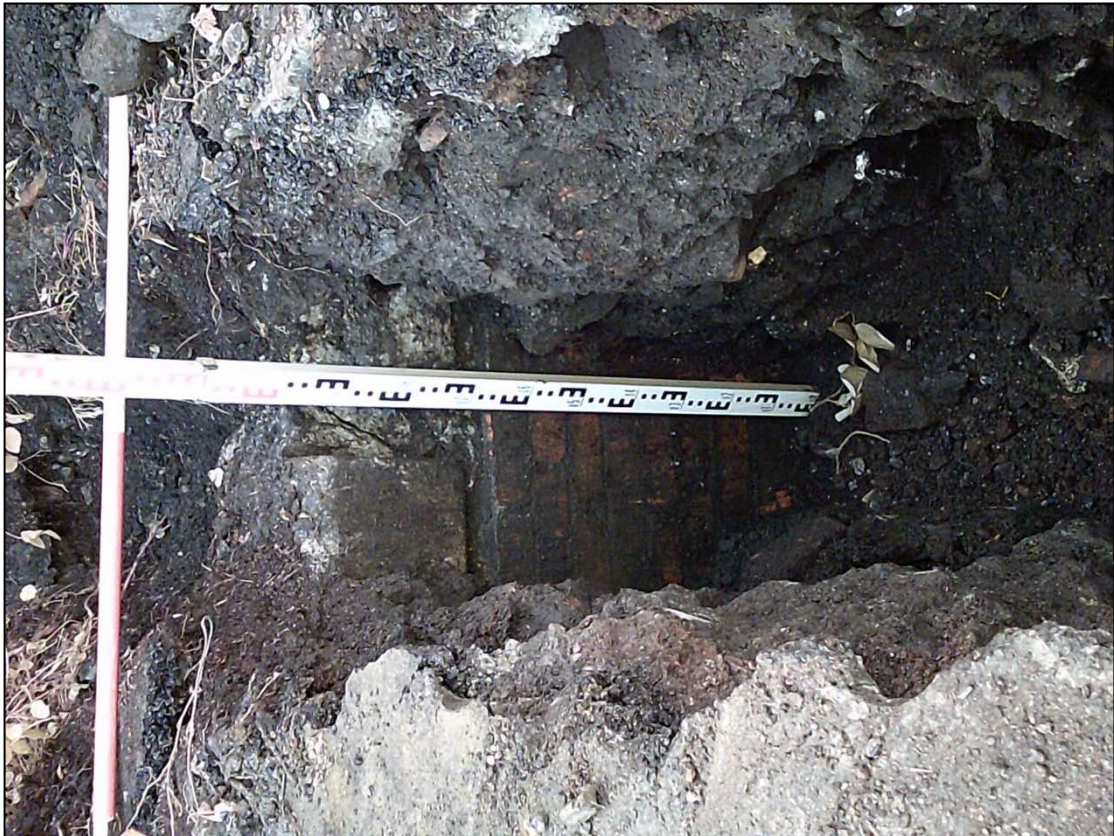
Plate 23. East facing section of Test Pit 14 showing the west wall of the weighbridge [1404] and concrete kerb [1303]. Also showing demolition rubble infill deposit (1402).

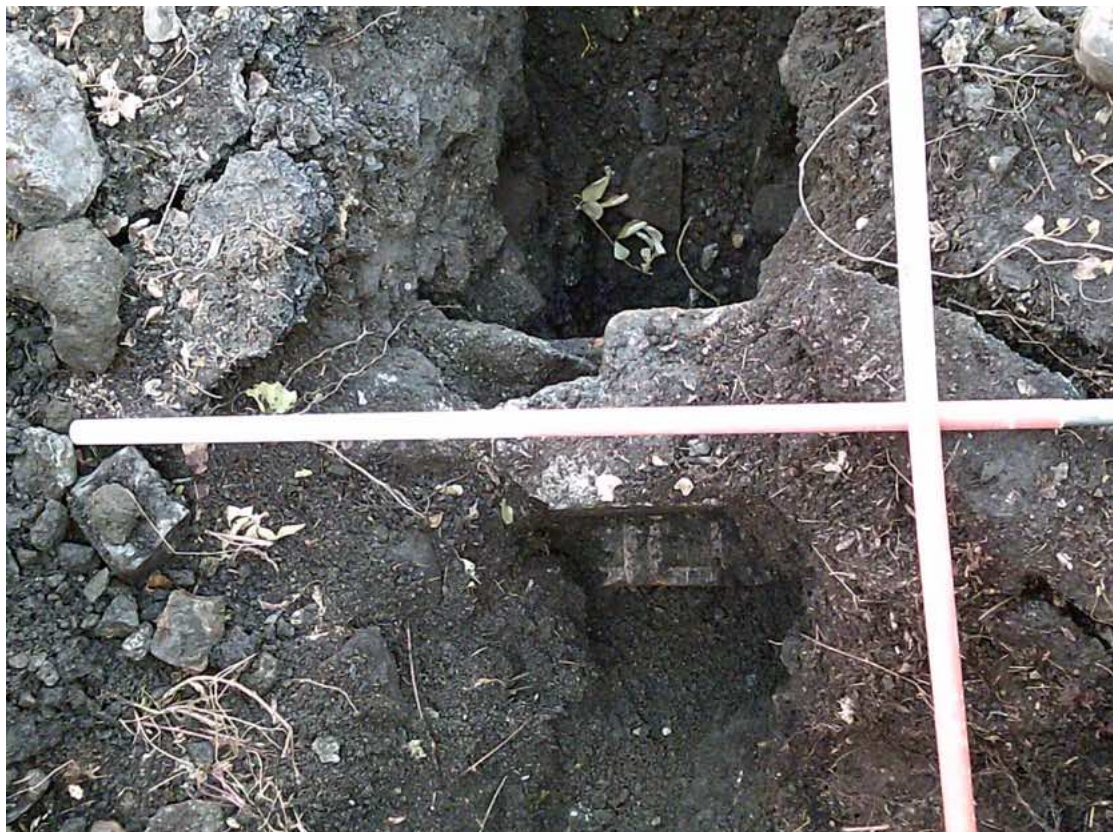
Plate 24. Plan view, facing west, of the west wall of the weighbridge [1404] and concrete kerb [1403] in Test Pit 14.

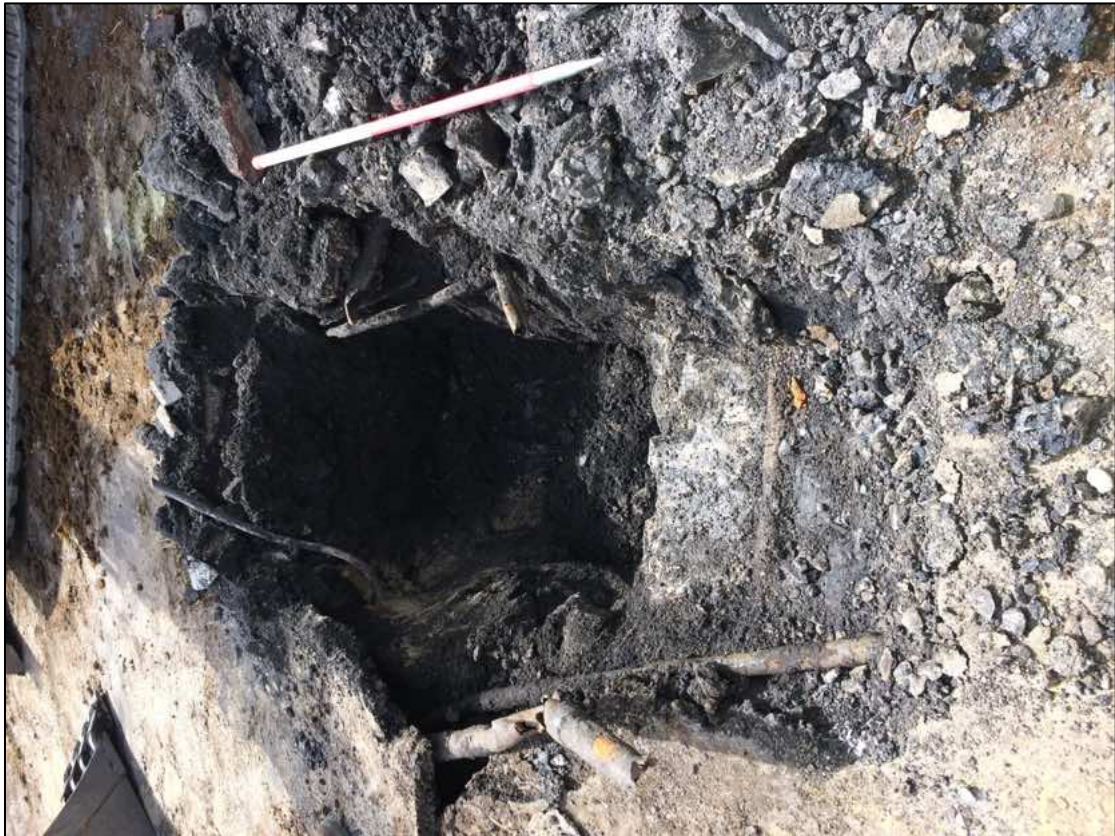
Plate 27. General view, facing south east, of Test Pit 15 showing NW/SE aligned masonry wall [1504].

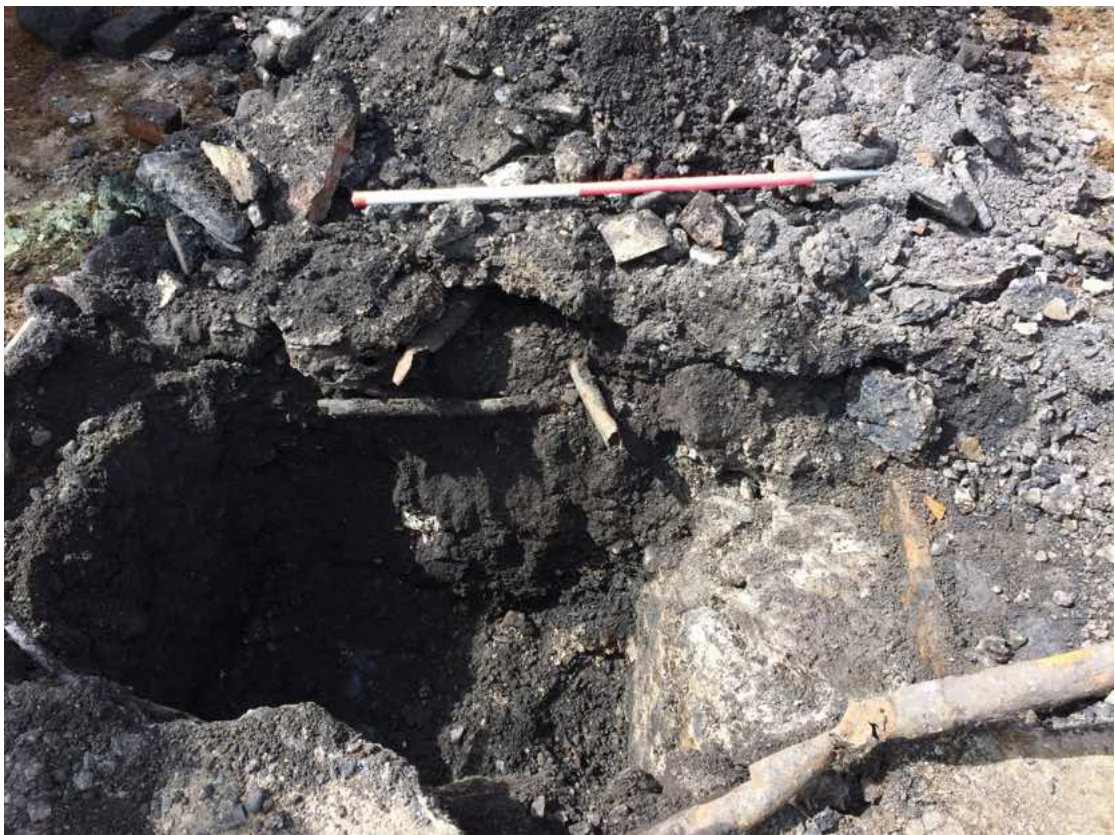
Plate 28. North west facing section of Test Pit 15 showing E/W aligned masonry wall [1504].

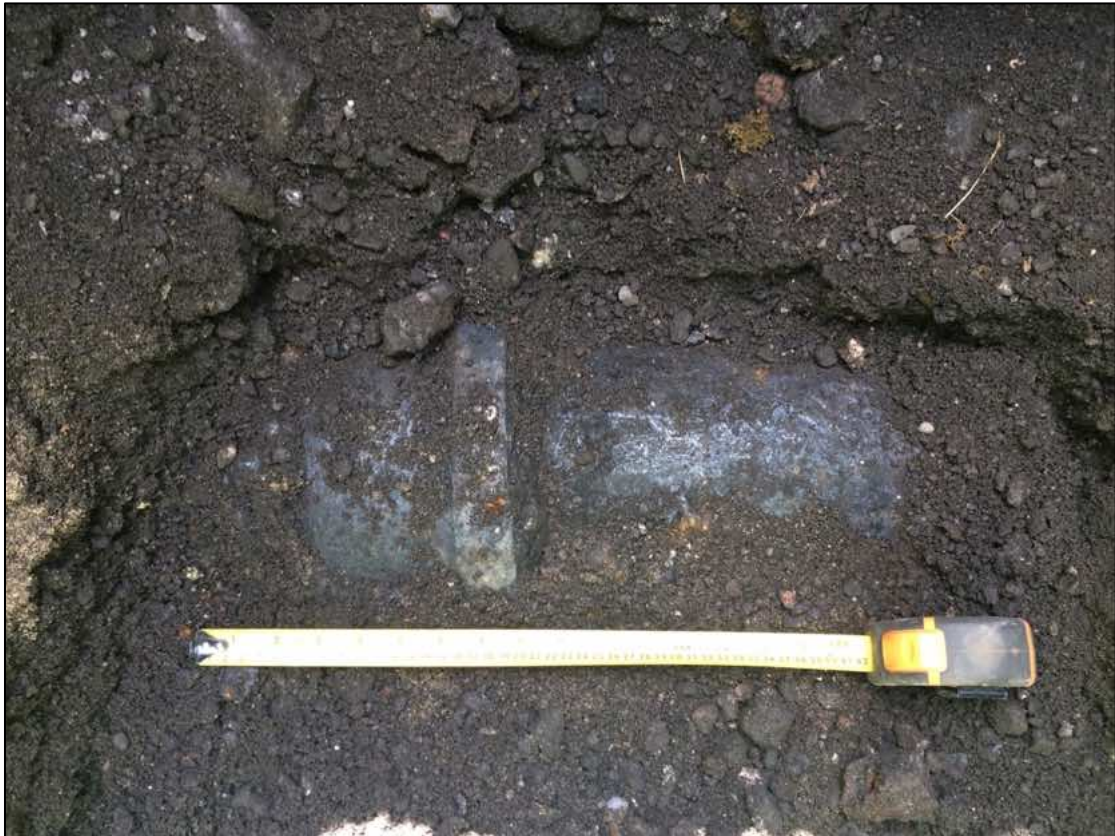
- 4.1.5 The large gauge ceramic pipe (1303) uncovered in Test Pit 13 is recorded on the 1951 ICI plan (Plate 31) where it can be seen to carry water from the canal to the Cast House and the wider Morfa site. The section cut through the pipe trench [1304] has demonstrated that the pipe post-dates the weighbridge and is therefore inserted after the 1930s. The metal pipe found in test pit 15 is of unknown date.

Plate 29. Large gauge NW/SE aligned metal water pipe uncovered in the base of Test Pit 15.

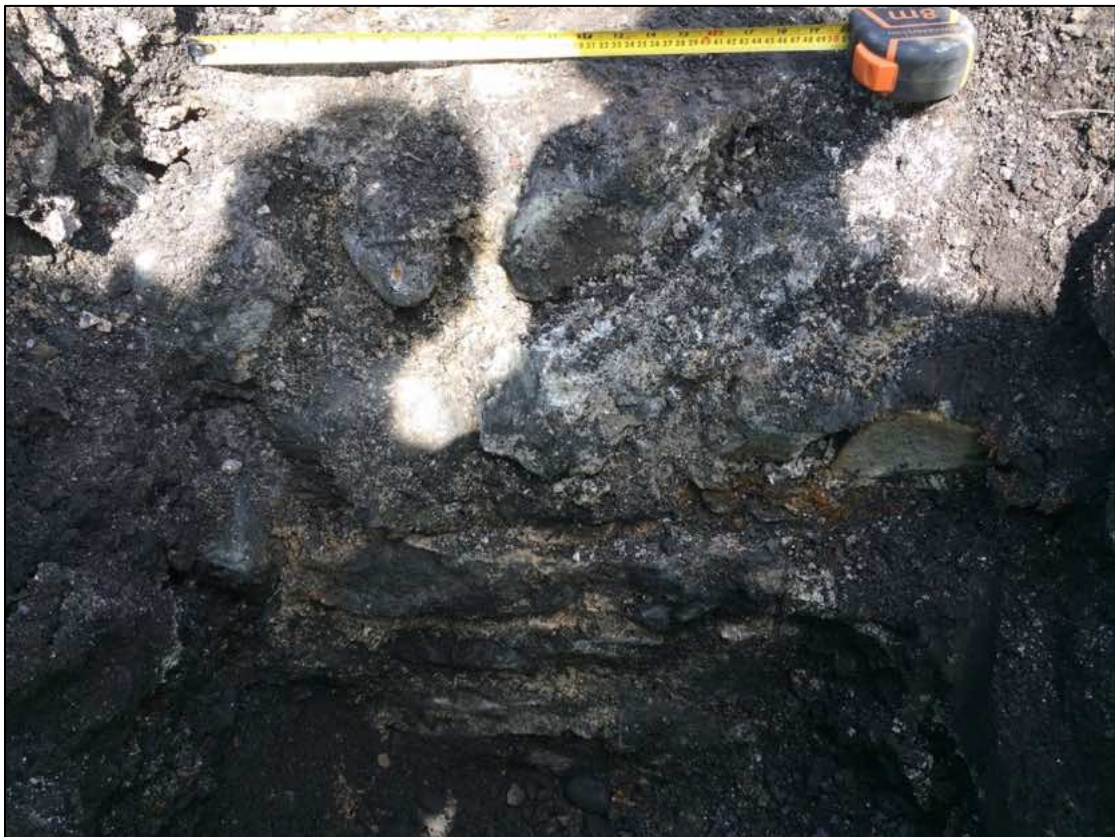
Plate 30. South east facing section of Test Pit 15 showing masonry wall [1504].

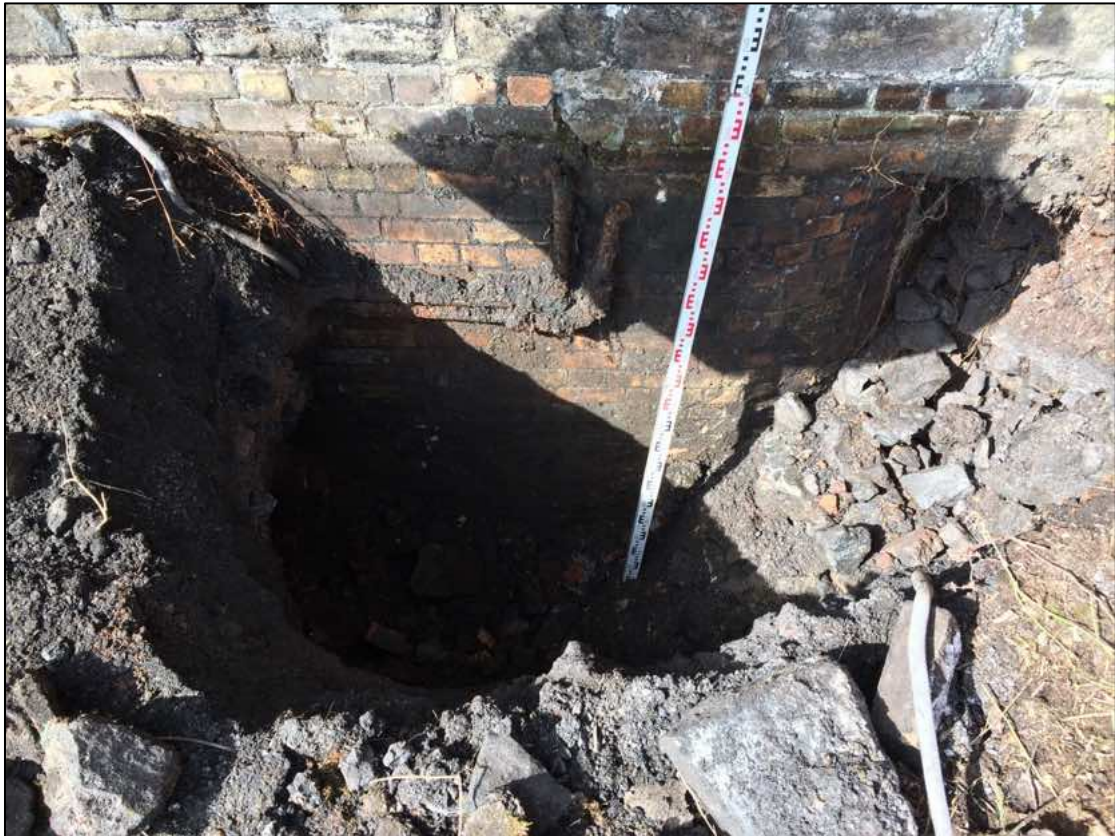
- 4.1.6 Test Pit 16 uncovered the foundations of the Porter's Lodge which was found to sit on top of an earlier brick wall, which may represent the west wall of the canal basin. A rounded corner feature of this earlier brick wall in the northern end of the test pit may represent the entranceway of the canal basin.

Plate 31. North East facing section of Test Pit 16 showing Porter's Lodge foundations and earlier wall [1602] with its curved feature to the right of the picture.
